STAFF REPORT 02-07-2024 REGULAR MEETING

APPLICATION NUMBER: HDC2024-00028

ADDRESS: 708 PALLISTER

SCOPE: ADD ROOF DORMERS, REHABILITATE DWELLING

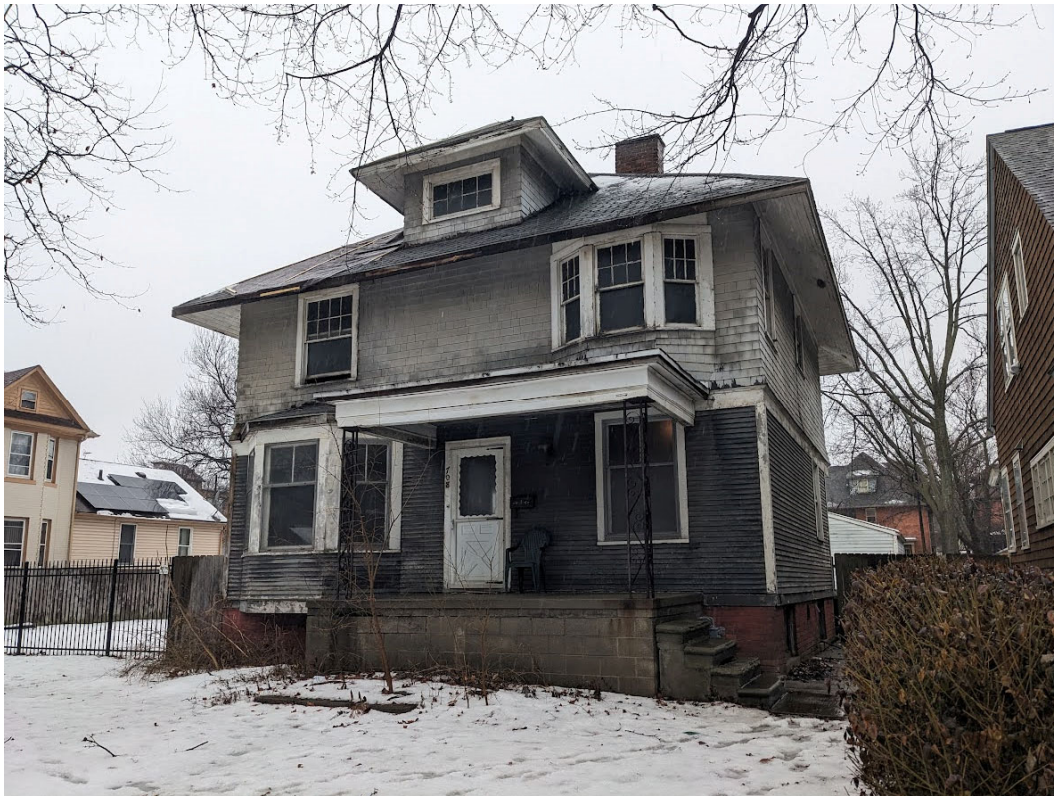
View of 708 Pallister, looking northwest from the sidewalk. Staff photo, January 24, 2024.

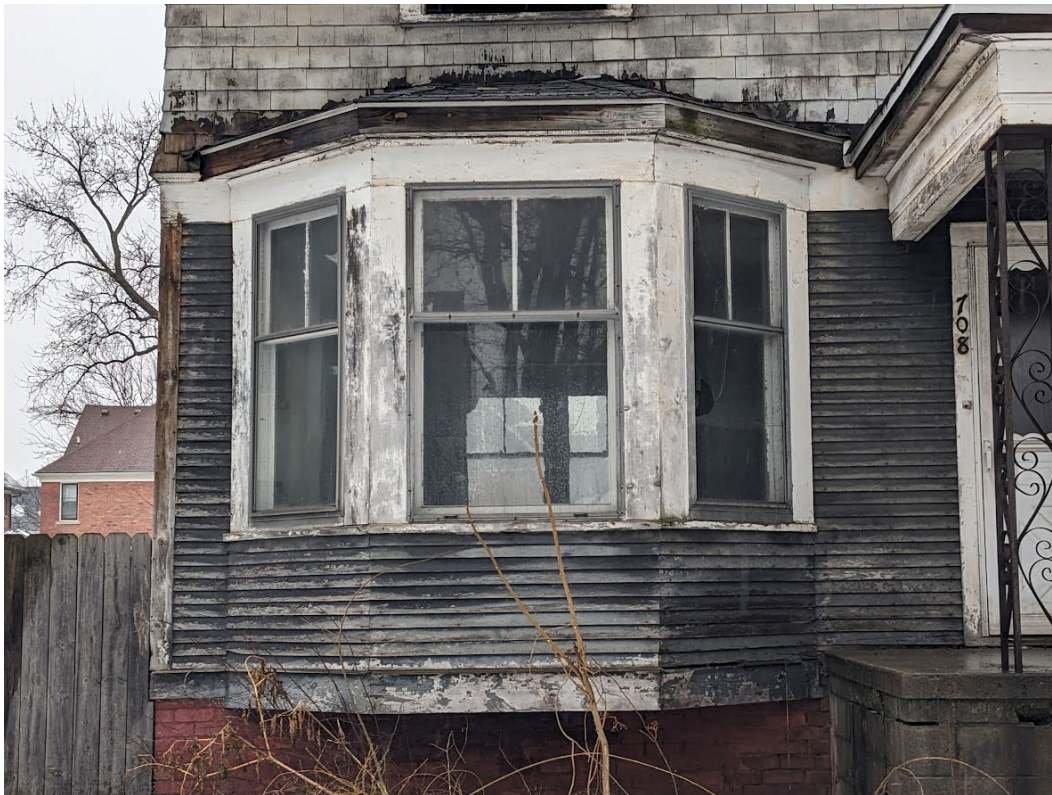
Detail view of 1st floor bay window at front, showing narrow-exposure clapboard siding, original 2/1 windows, cedar shake at the second floor, and deterioration due to deferred maintenance. The 2/1 windows at the rear, proposed for removal, are partially visible in this view through the house. The incompatible porch is also partially visible at far right. Staff photo, January 24, 2024.

- Compared to nearly every other house on the street, 708 Pallister has obviously suffered from years of neglect and deferred maintenance, and is thus in obvious need of attention. The proposed rehabilitation, in general, has the potential to finally restore this house to its proper position in contributing to a well-preserved historic streetscape.

- Staff recognizes the historically correct treatments proposed for rehabilitation of the original wood shakes and siding, and restoration of the majority of the original wood windows. These should be found appropriate by the Commission, in staff's opinion.

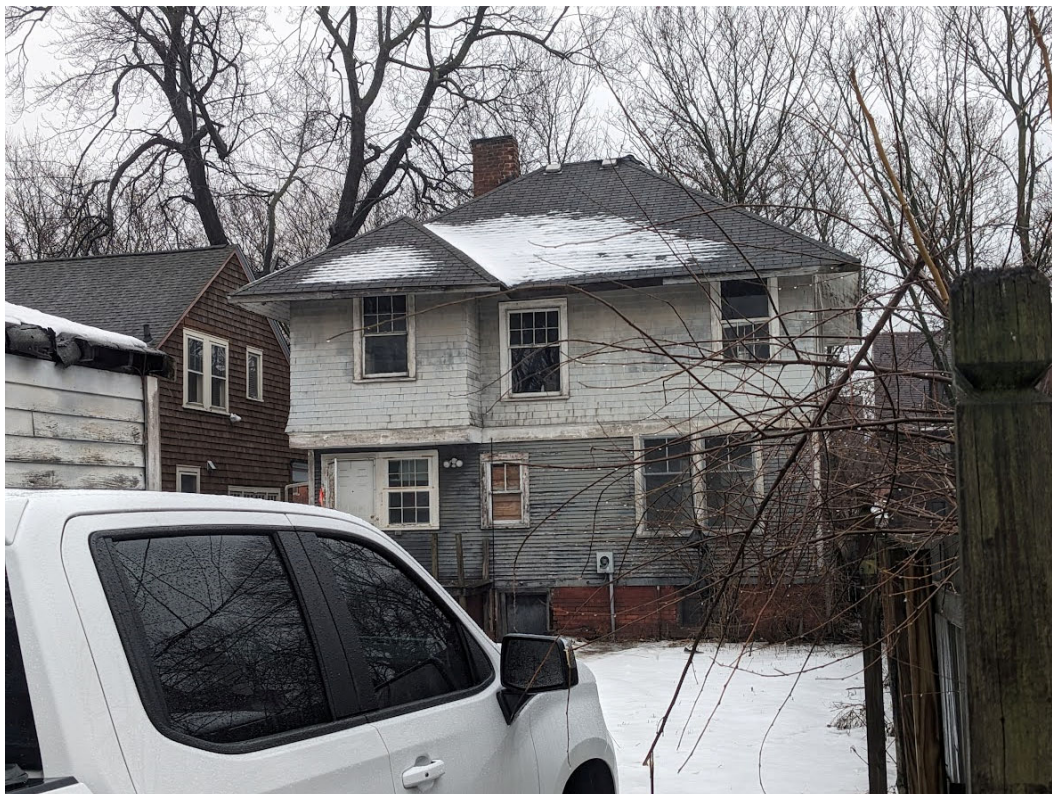
View of the rear elevation, from alley. Note the high level of historic integrity here, with original windows and historic siding fully wrapping the house. The pair of 2/1 windows at lower right are proposed for replacement with a sliding glass door. Staff photo, January 24, 2024.

- Staff assesses that the rear of 708 Pallister does indeed retain significant and important historic character; in fact, given that the original porch is missing from the front and has negatively impacted that elevation, the historic character of the front and rear are quite similar, in staff's opinion. In particular, the original paired 2/1 windows at the rear, which perfectly complement corresponding units on the front elevation, are improbably still intact and should be preserved. This 2/1 configuration is a relatively rare design in Detroit houses, and to see it still extant on a non-primary elevation is rarer still. Notice also how the building's "belly band", an apparently 8" width of trim board dividing the first floor from the second, serves as the top of the window framing for the bay window at the *front* of the house, continues around the west side, and then also serves as the top of the paired windows at the *rear* that are proposed for removal. This belly band similarly incorporates the line of the surviving historic porch roof and continues around the east side, fully encircling the building. The relationship between the rear 2/1 windows and the "belly band" is a deliberate and historically resonant design element that would be lost in the proposed alteration. In staff's opinion, removal of these paired windows and replacement with a modern sliding door assembly is inappropriate. If new access to the rear is desired, staff suggests that a smaller swing door, installed adjacent to the historic windows, may be a more appropriate option. This may or may not be possible given the interior layout, but the Commission's principal concern should be

- There is another small original 2/1 window at the rear, which is indicated to be removed and replaced with matching clapboard to accommodate interior reconfiguration. Though it is small, in the context of this house its surviving 2/1 design is important and valuable, and shows a deliberate and historically significant design decision on the part of the original designer. Staff recommends that it be preserved.

- The three 2/1 historic windows at the rear (two large paired windows, and one small individual window) are distinctive character-defining features and must be preserved; if new rear access is desired a less destructive solution incorporating a swinging door should be considered.
- The front porch and rear deck rail designs should be further developed, and distinct from each other, as they have different roles to play in the historic understanding of this house. The front porch rail should be historically correct, while the rear deck balustrade should be of a more contemporary character distinguishing the deck as a later addition.

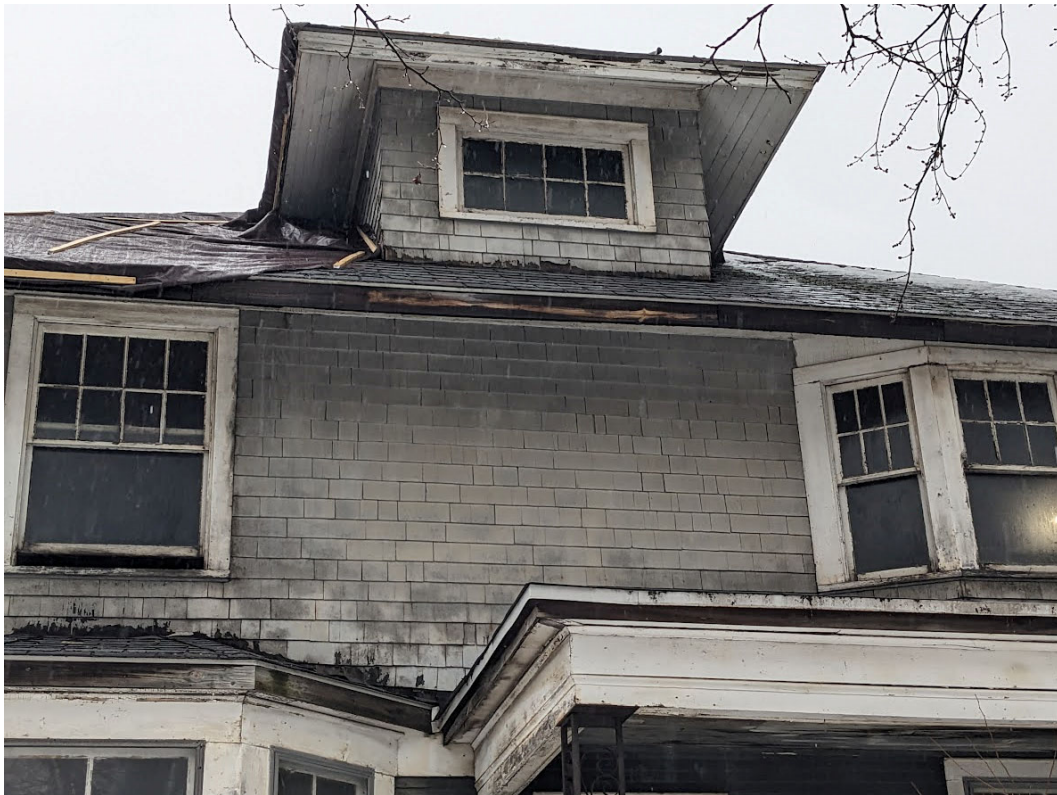
Detail view of second floor and dormer at front, showing historic materials and conditions. Staff photo, January 24, 2024.

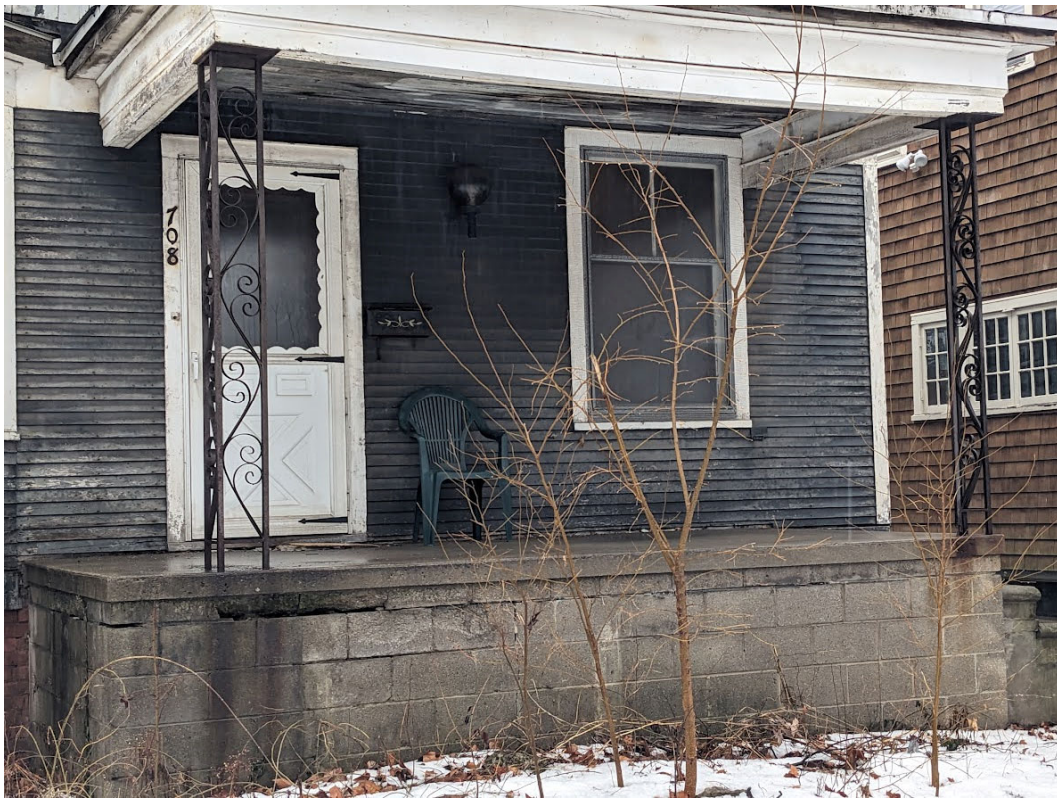
The original porch is missing, with only its original roof surviving, and was replaced decades ago by a concrete block porch of poor design, which negatively impacts the overall historic character.

View of existing non-historic concrete block porch at front entrance. Staff has confirmed that the porch, including the incompatible 1970s-style support columns, was extant at the time of district designation in 1982 (not a violation). Staff photo, January 24, 2024.

- Wood frame houses of this type often have wood frame porches; though staff has not located an earlier photo, it is highly likely that the house originally had an ornamental wooden porch, with wooden steps, that matched or exceeded the design quality of the rest of the building. The current plain concrete block porch, with steel support columns, existed legally at the time of historic designation in 1982, and can continue to be maintained in its present form, despite its abject lack of character. However, staff recommends that the owner, when feasible, seriously consider replacing this incompatible porch deck with a new wooden design that restores historic character. In the current application, the proposed wooden columns and balustrade are a positive first step, and their design is compatible with the house. The relocation of concrete steps to the front is reasonable and appropriate, in staff's opinion, given the porch's current non-historic condition and appearance.
