REVISED STAFF REPORT: 02/07/2024 REGULAR MEETING PREPARED BY: J. ROSS

ADDRESS: 4440 E. CANFIELD

APPLICATION NO: HDC2024-00026

SCOPE: REPLACE SLATE ROOF WITH SYNTHETIC TILES

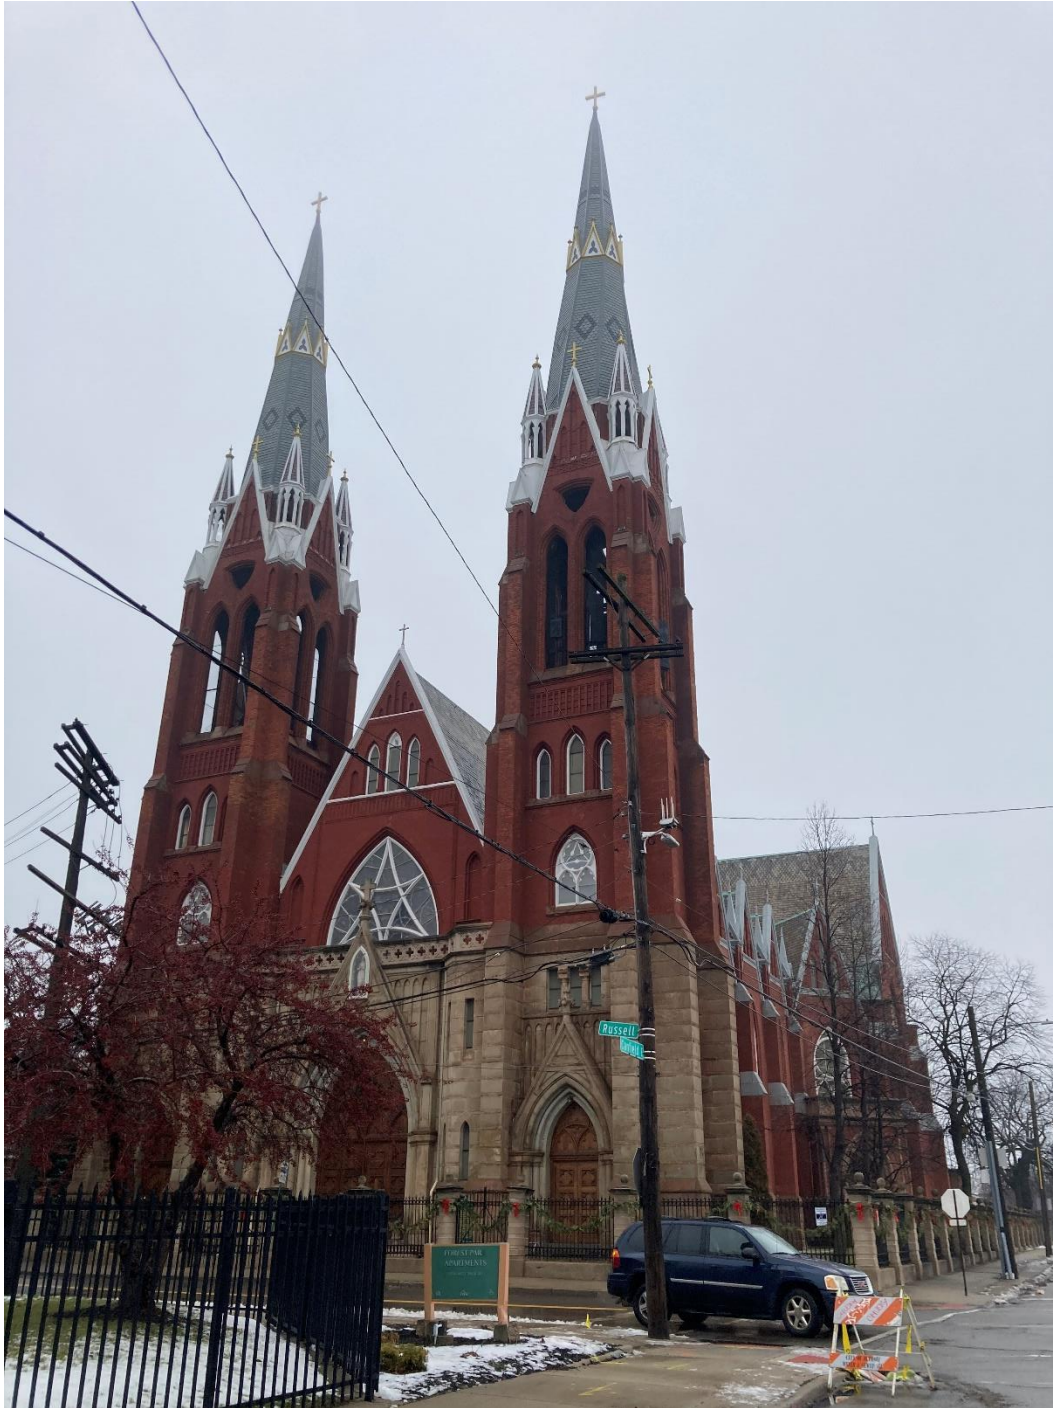
Current conditions, facing northeast showing primary façade. Staff photo taken 1/25/2024

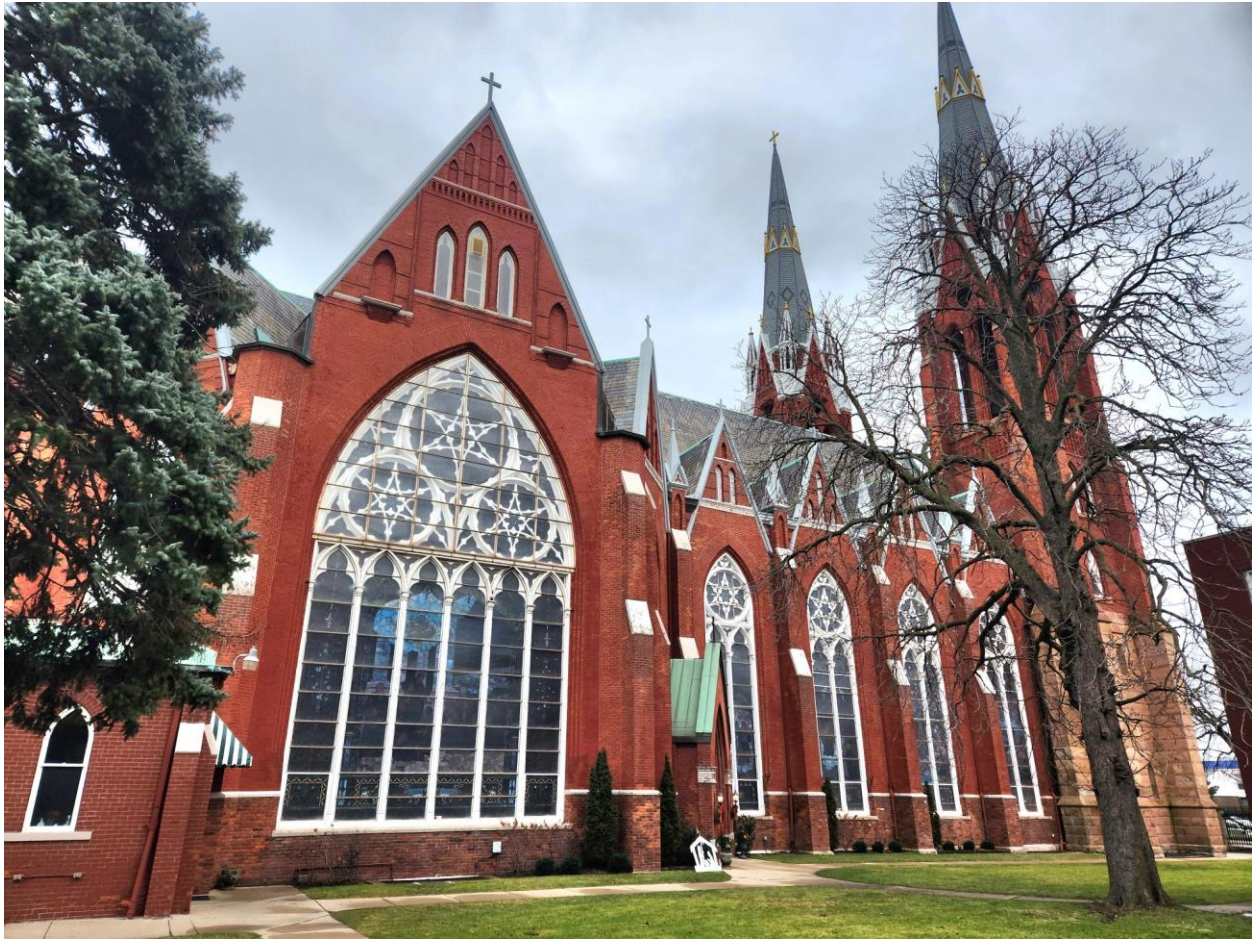
Current conditions, facing southwest showing north side. Photo provided by applicant

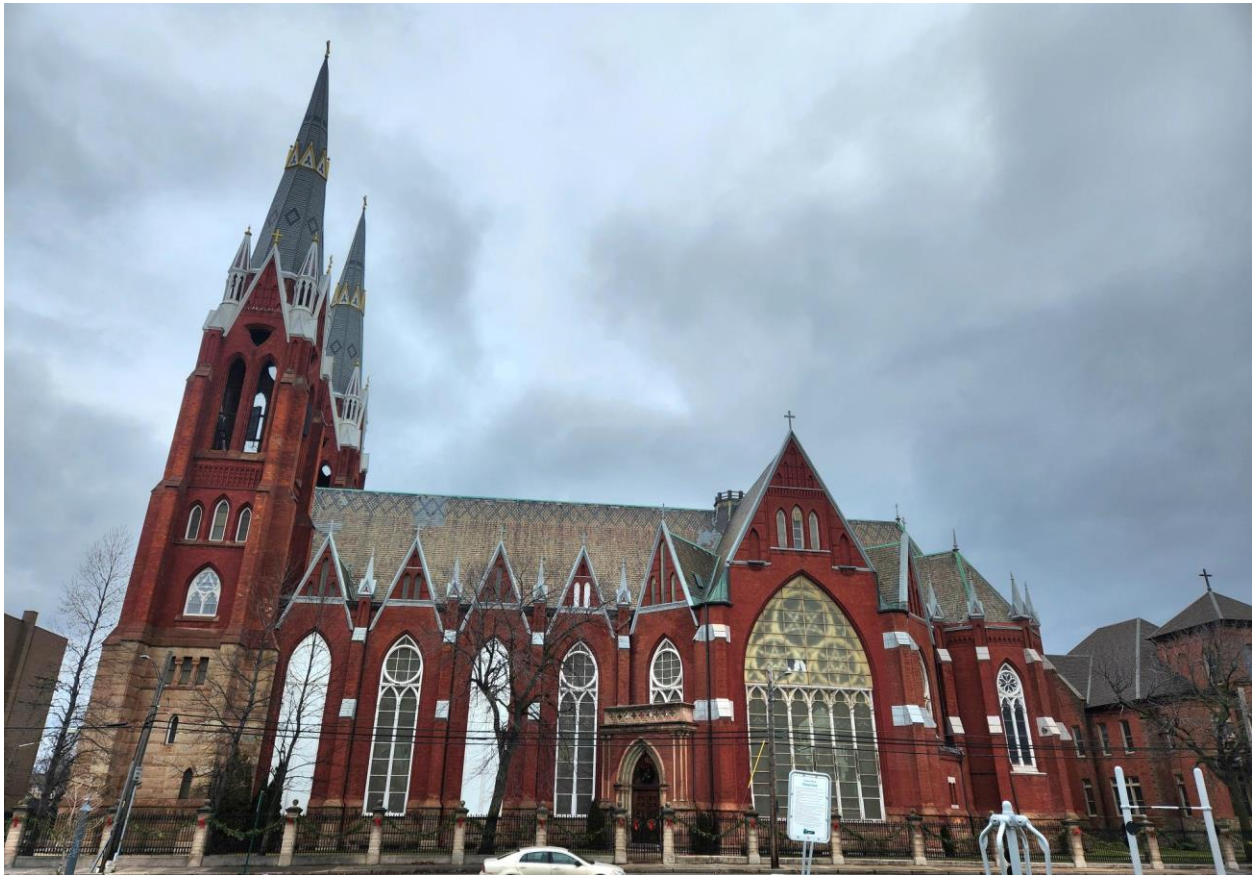
Current conditions, facing north showing south. Staff photo taken 1/25/2024. Note decorative diamond pattern directly below ridgeline

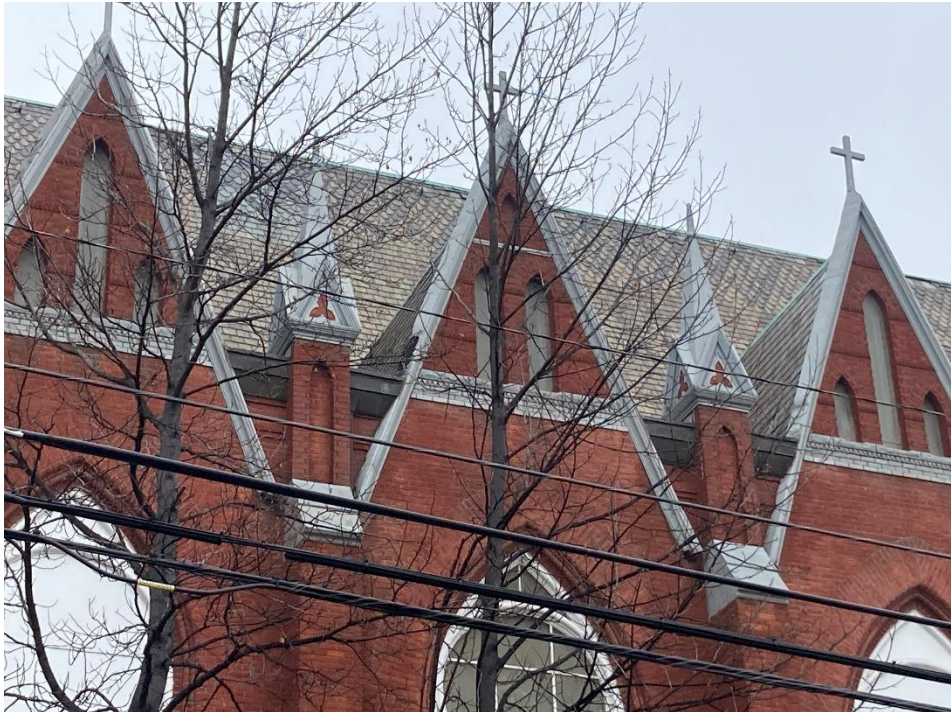
Current conditions, facing northeast, detail showing metal fascia with cross-shaped finials, metal spires with trefoil detailing, and copper gutters typical at roof. These elements will be removed in whole/throughout and will be replaced with new copper elements to match the existing. The slate near the ridgeline (i.e. the area of the decorative diamond pattern) is of a scalloped type/shape, while the remainder is a more typical square edged slate Staff photo taken 1/25/2024

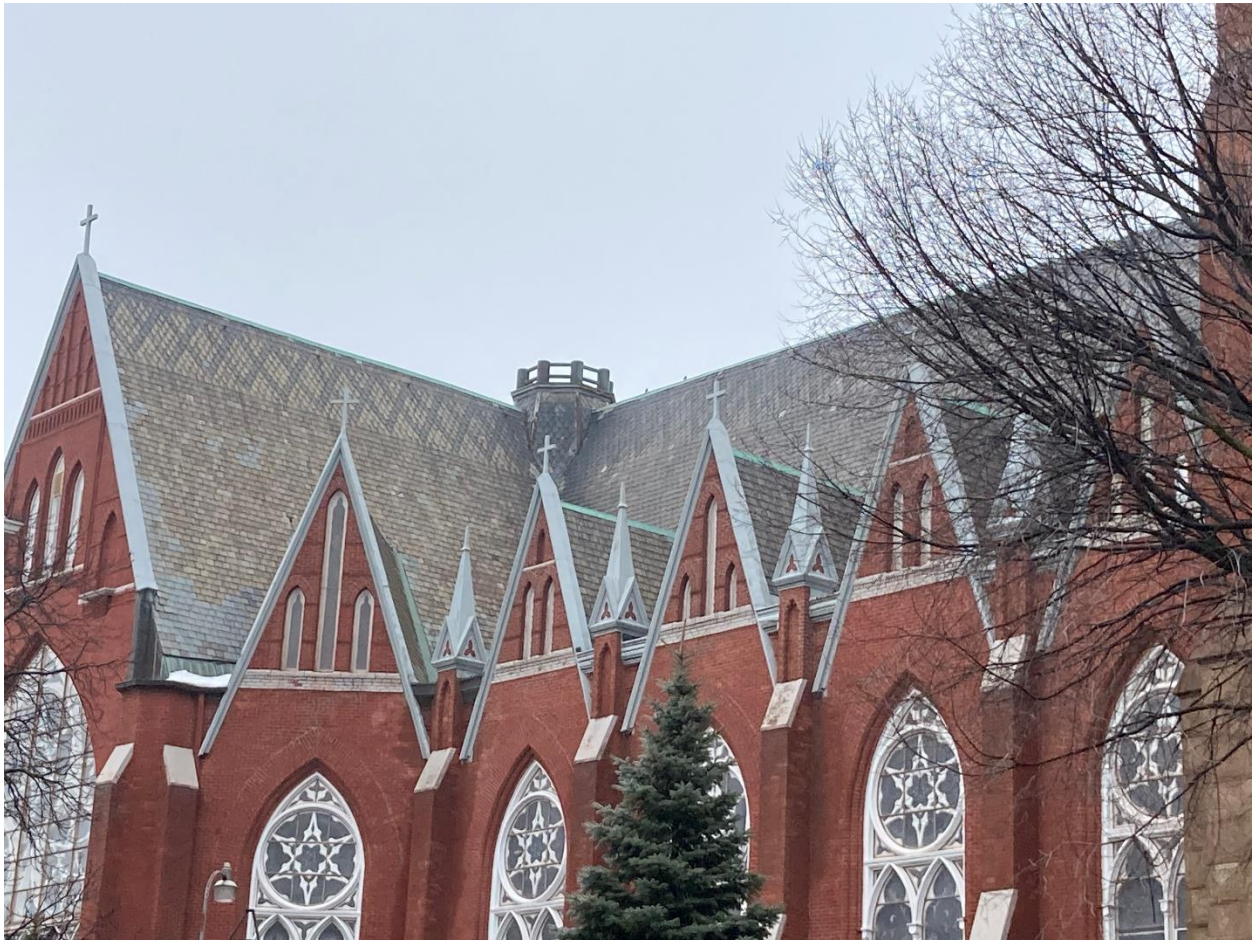
Current conditions, facing northwest, detail showing metal fascia with cross-shaped finials, metal spires with trefoil detailing, copper gutters, copper ridge caps typical at roof. These elements will be removed in whole/throughout and will be replaced with new copper elements to match the existing. Staff photo taken 1/25/2024

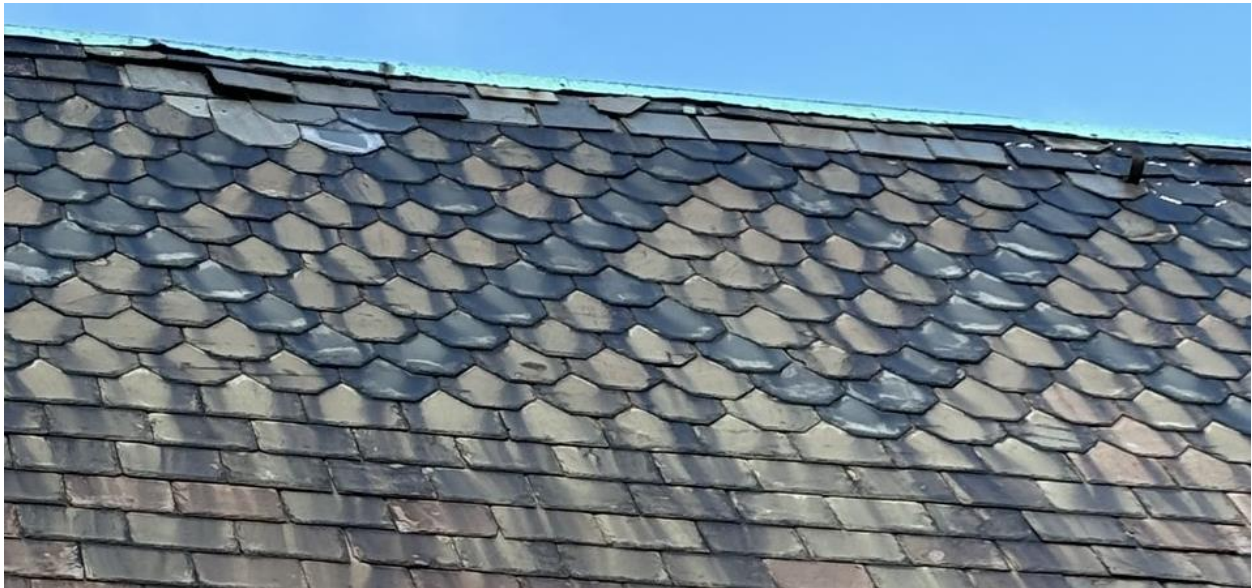
Scalloped shingles and diamond pattern at roof's ridgeline. Photo provided by applicant.

- It is staff’s opinion that the current slate roof system to include the use of multicolored, **scalloped** shingles to create diamond-**shaped** patterns below the ridgeline, decorative metal elements, metal spires, and copper gutters and downspouts are highly distinctive character-defining features of the building, as is the distinction between scalloped and square-edged slate.

- The new roof shall replicate the distinctive diamond pattern and **textural variation** through the use of multicolored scalloped shingles.
- The applicant shall provide HDC staff a design document which clearly outlines the manner in which ~~all roof elements, to include the shingles and the~~ decorative metal elements will be fabricated and installed prior to the initiation of the work. If staff determines that any work item does not meet the Secretary of the Interior's Standards for Rehabilitation, the project will be routed to the Commission for review at a future regular meeting.

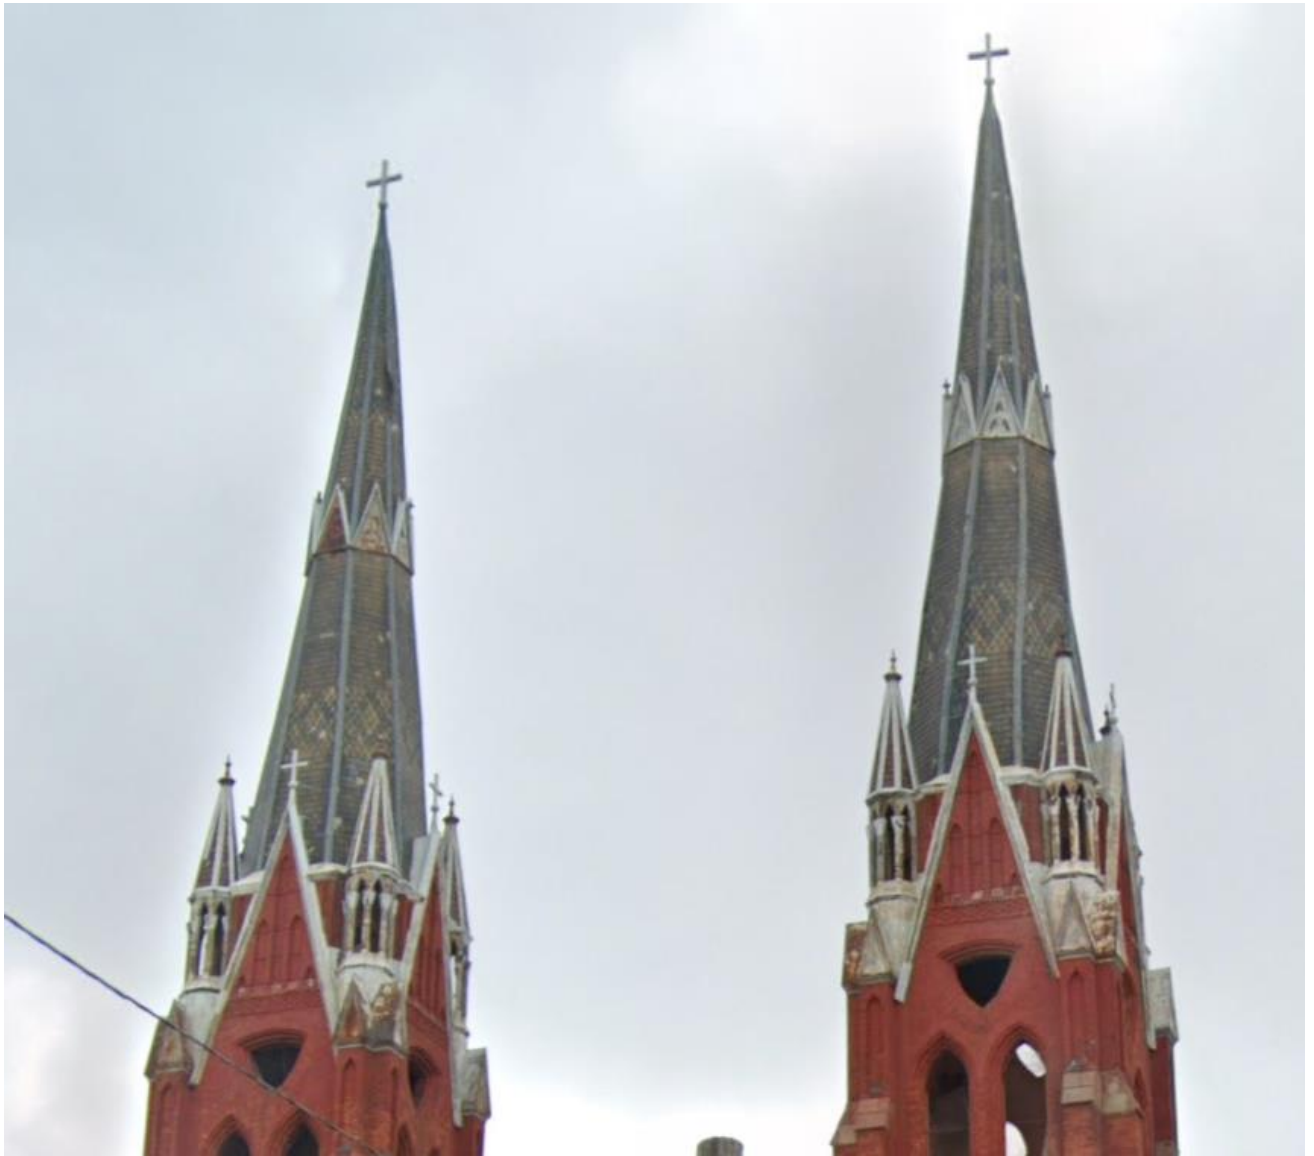
Google Streeview, August 2018, prior to steeple repair

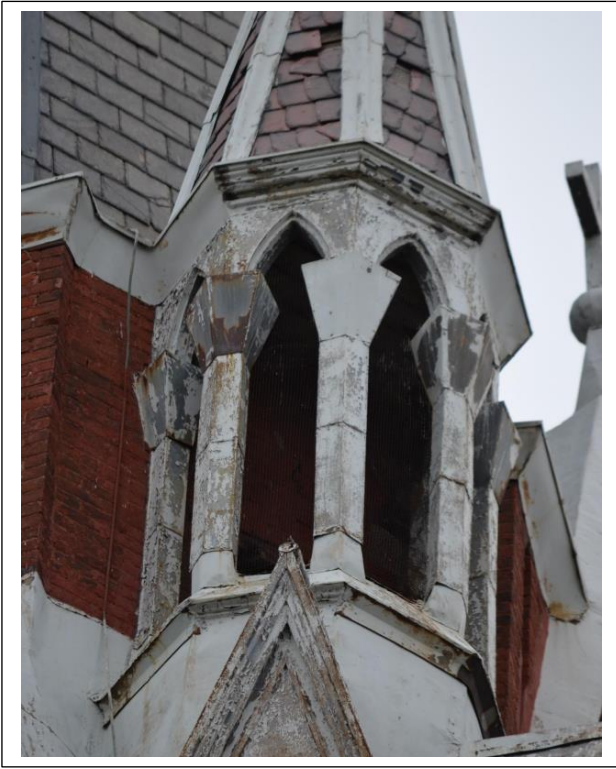
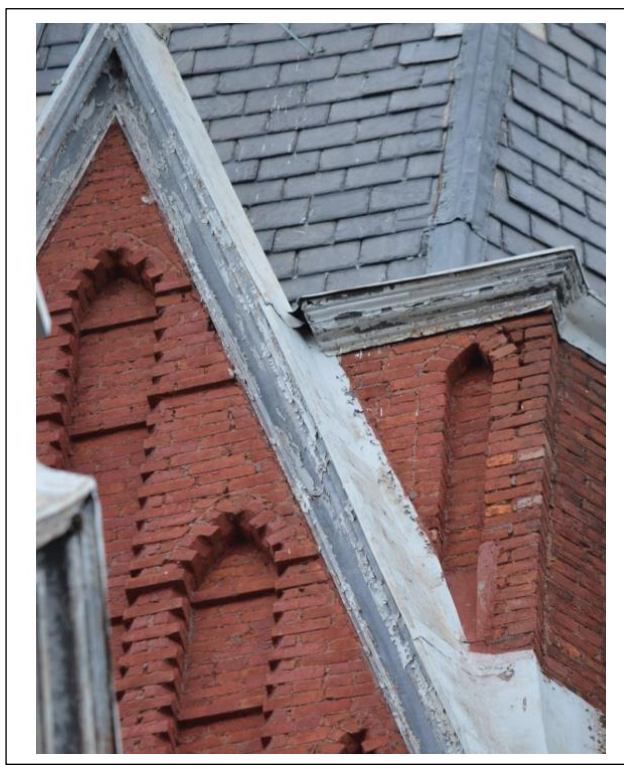
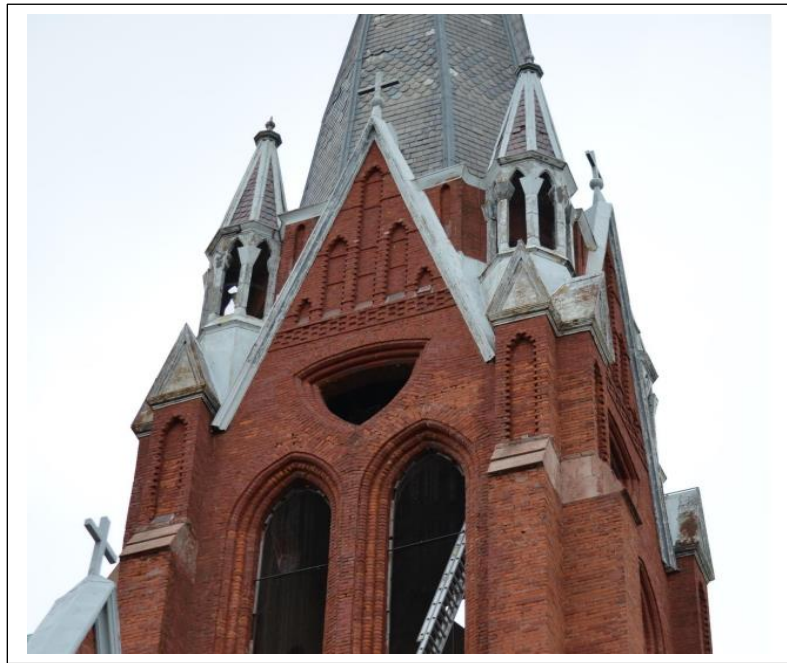
Photos provided by applicant, 2017, prior to steeple repair

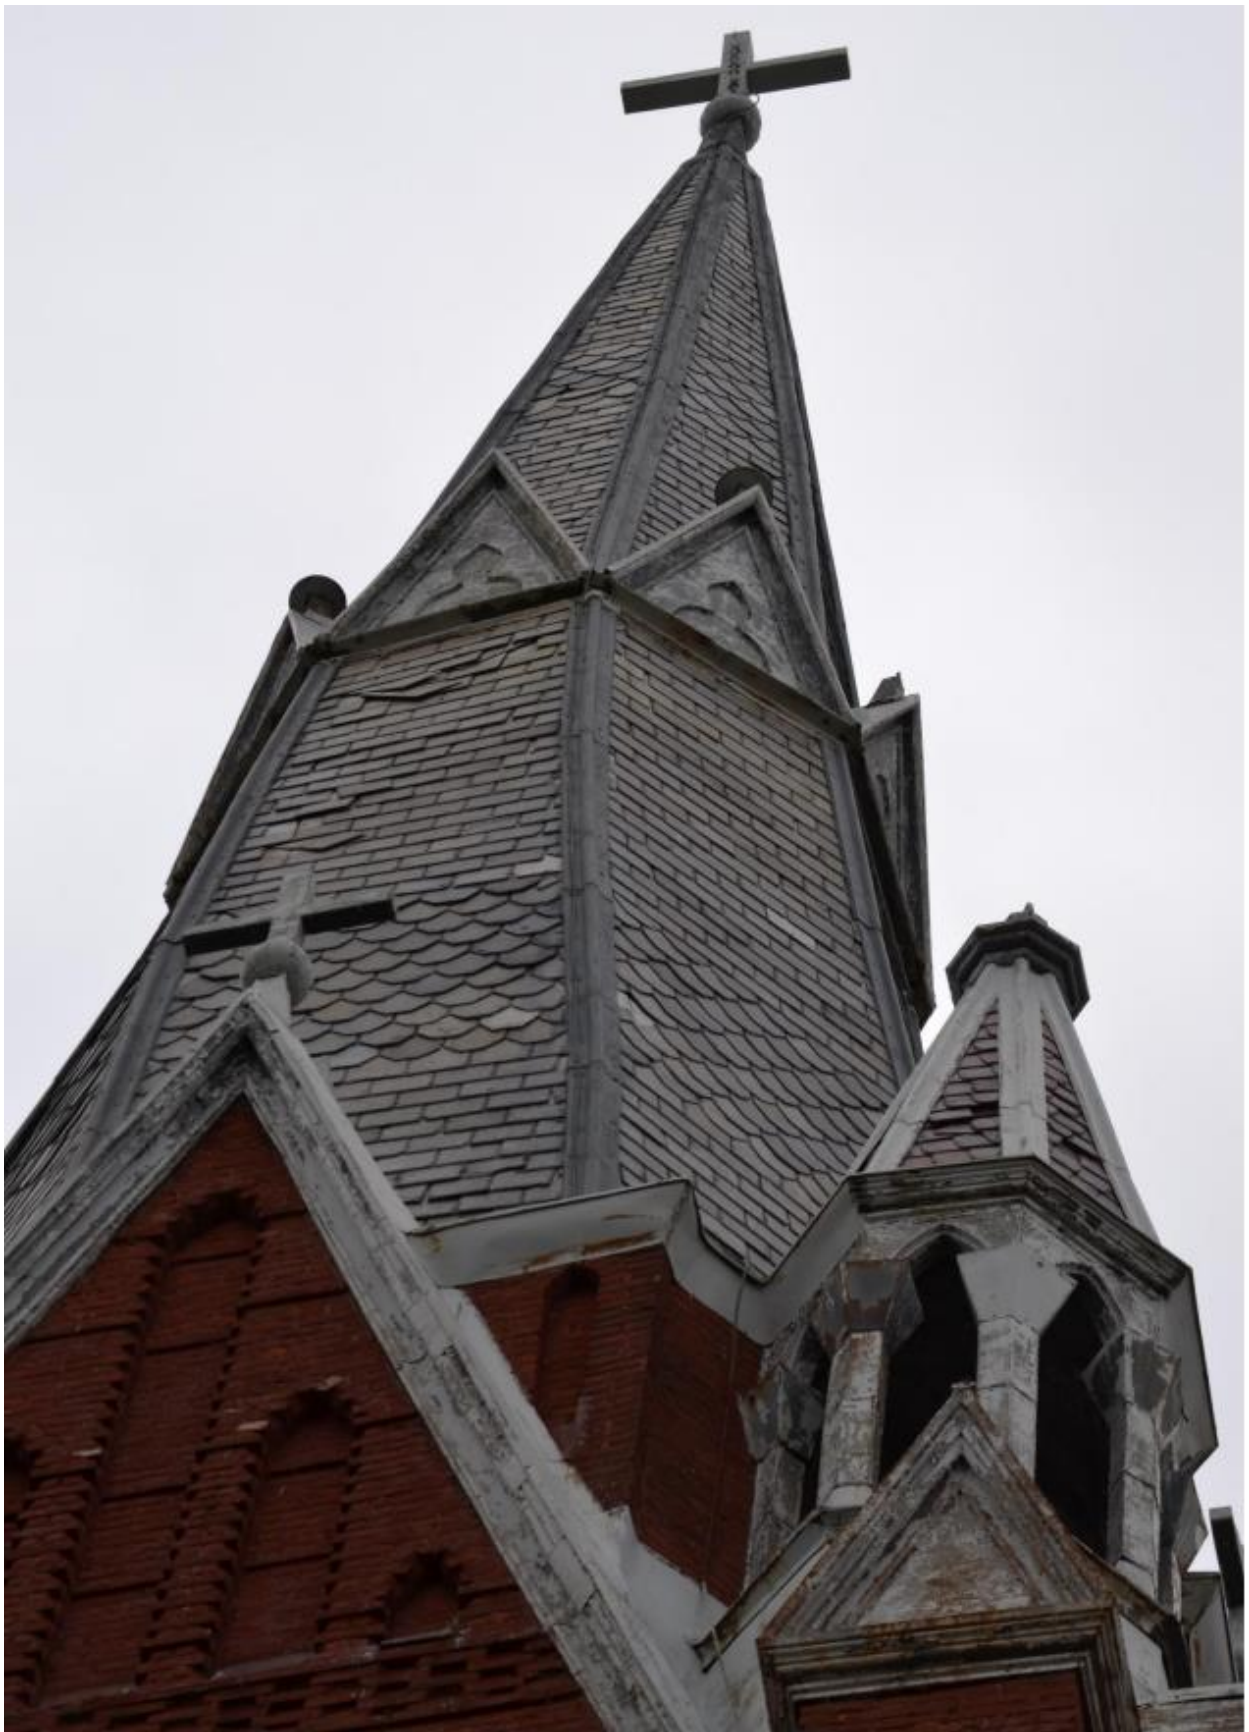
Photo provided by applicant, 2017, prior to steeple repair

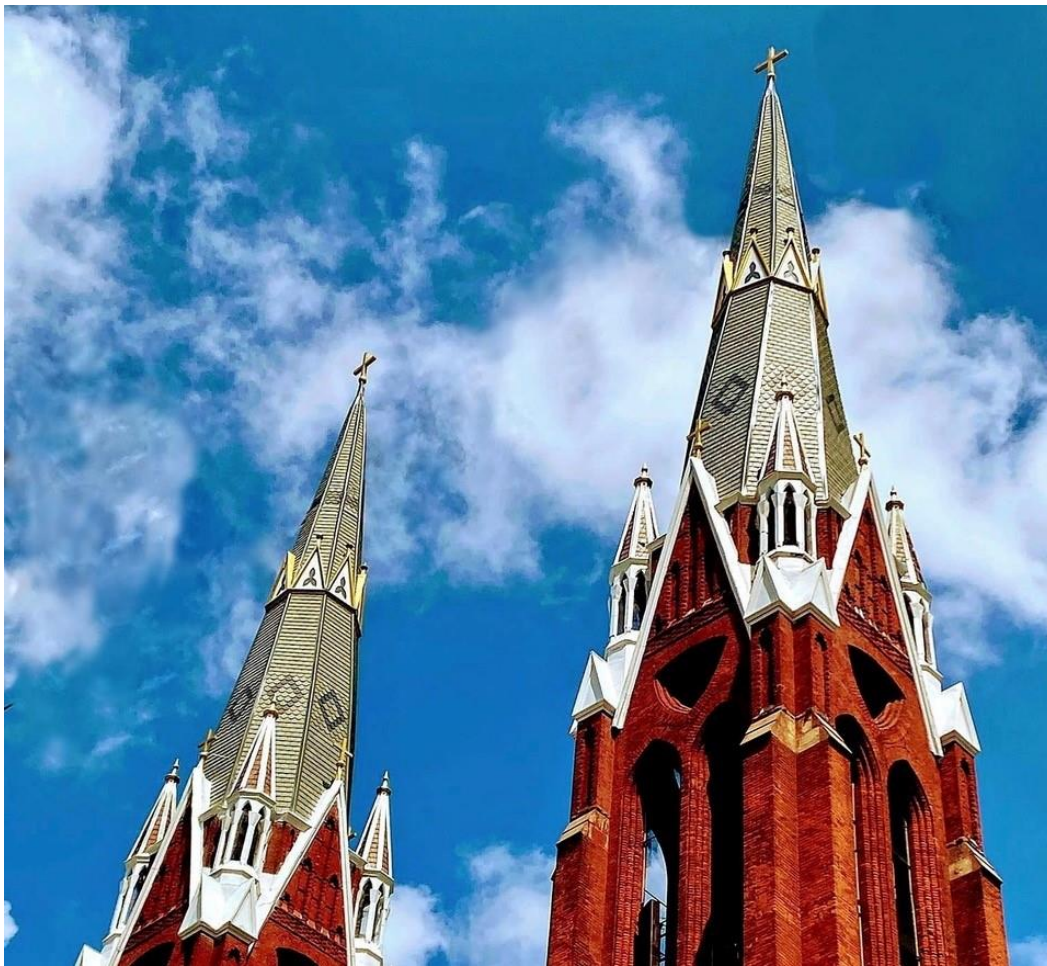
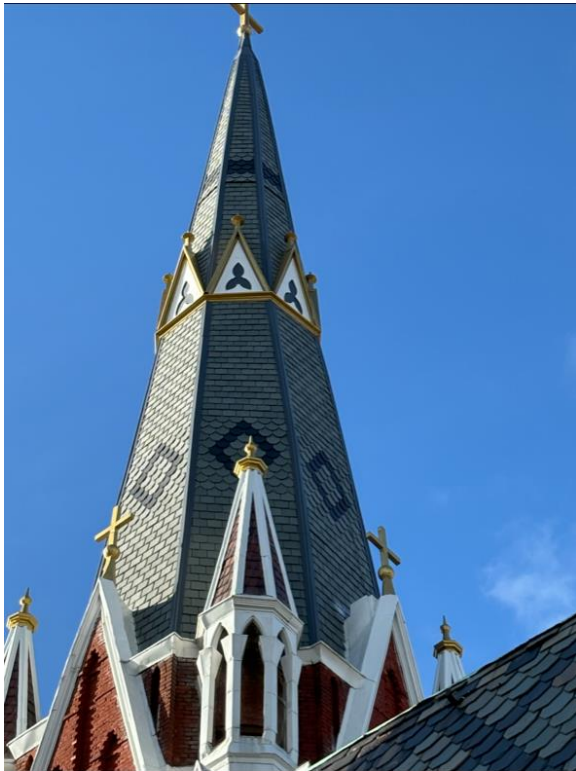
Spires showing recently installed Davinci synthetic slate roofing, photo provided by applicant

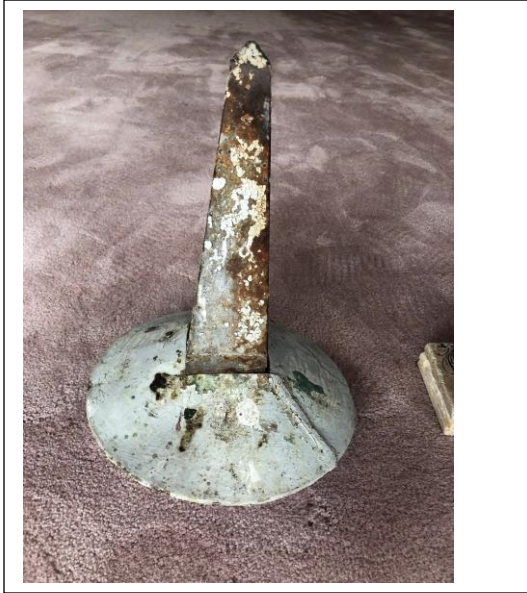
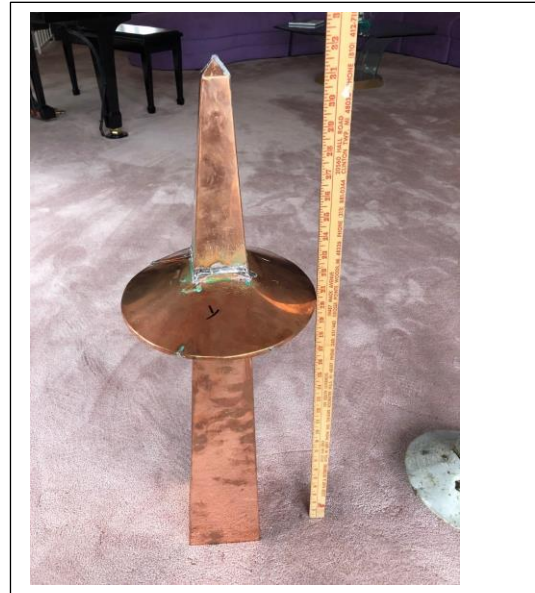
Photo showing an original finial and a copper replication, provided by applicant
