STAFF REPORT: 02/07/2024 REGULAR MEETING

APPLICATION NUMBER: HDC2024-00010

ADDRESS: 13134 BROADSTREET

SCOPE: REPLACE WINDOWS, ROOF, GUTTERS (WORK COMPLETED WITHOUT APPROVAL), DEMOLISH GARAGE

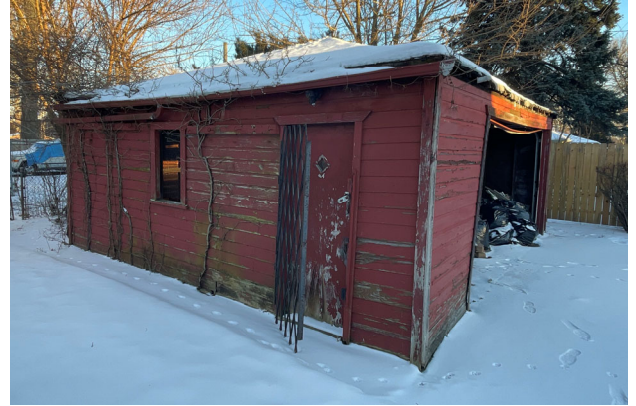
Site Photo 2, by Staff January 17, 2024: (West) front and side elevation of the garage.

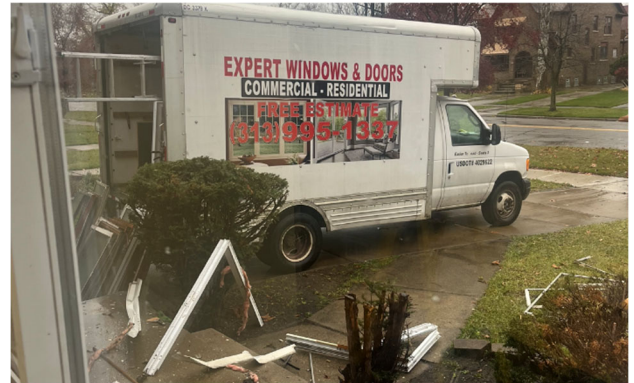
Site Photo 2, by Applicant date unknown showing original wood windows and vinyl window installation company.

- As noted above, staff requested information on both the conditions of the original windows and the product information of the installed vinyl windows. Staff received only a few photos as shown in the application material and Site Photo 2. It is Staff's opinion that the original 1/1 wood windows, as shown in the designation photo were historic, character-defining features of the building that have been altered by introducing a new material and features: vinyl windows with grids between the glass.

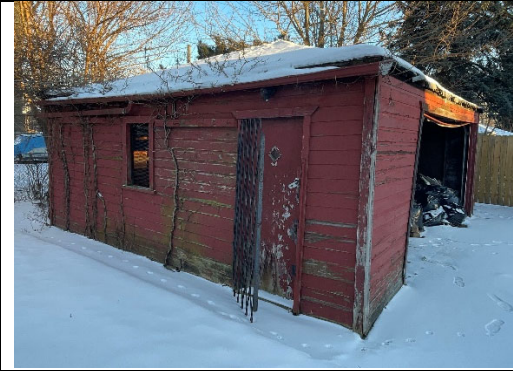
- Staff observed that the garage requires considerable repair but has not yet undergone a professional structural assessment nor observed that the structure has reached a point of irreparable damage. As stated above, the applicant has not yet provided this information at the time of this report. The applicant allowed staff access to the garage and staff was able to compile the following photos for the Commission:

North elevation of garage showing wood damage along the foundation and roofline.

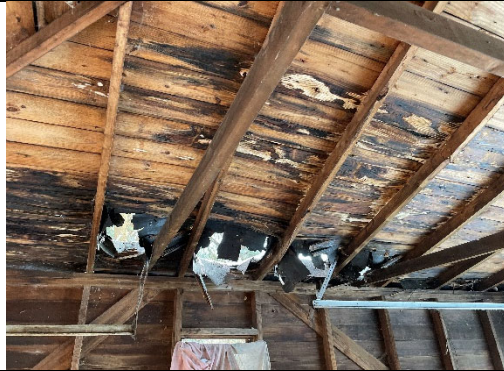
Garage roof and beam damage along south face area of the roof.

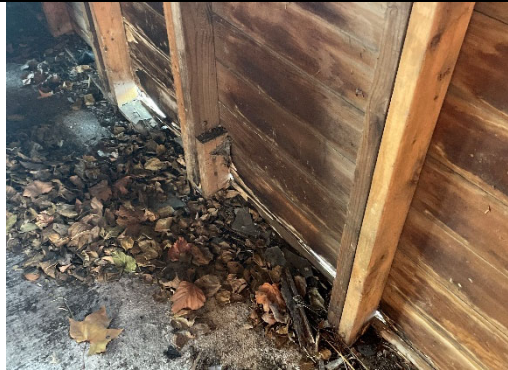
Interior baseboard damage of the garage.

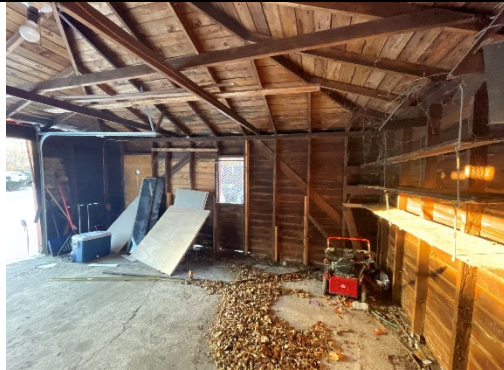
Interior roof and siding of the garage condition of the north, east and west sides.

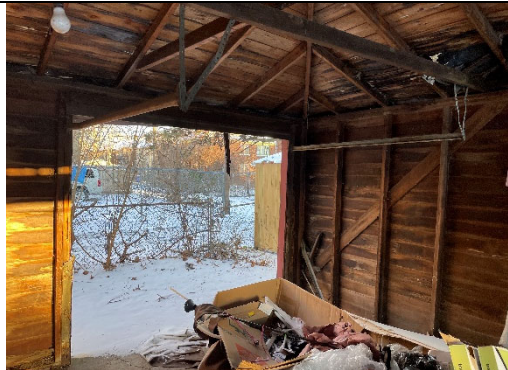
Rear door facing the alley, showing some roof damage.

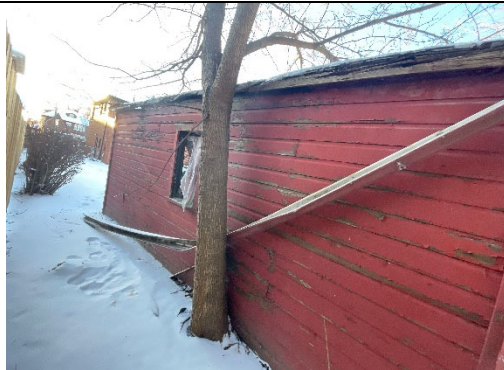
South side of garage, showing roof damage and non-historic mulberry tree, which is likely one of the sources of roof damage.

- Some of the work in this application was completed without Historic District Commission (HDC) approval.
- Beyond a verbal repair cost estimate of \$8-\$10,000, **\$15,100 (which includes vinyl, rather than wood siding)**, no documentation establishing that the original condition of the original garage was beyond repair was submitted or available. Also, there is no plan to replace the garage with an in-kind structure. With these conditions, staff has the opinion that this garage can be repaired and recommends that the adjacent mulberry tree also be removed to ensure this structure's longevity.

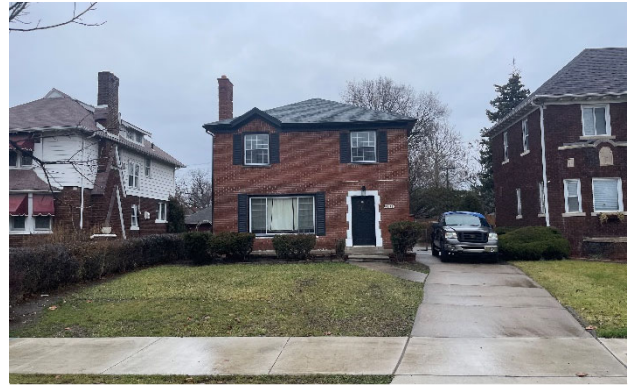
- Staff visited the site January 3rd, 12th and 30th; snow cover obscured some of the house surfaces. Despite not receiving materials from the applicant at the time of this report, staff observed that the shingles on the roof were dimensional asphalt shingles, and the front door was a wood door. These materials, in staff's opinion, are appropriate for the district. (See Site photo 3.)

Site Photo 3, by Staff January 3, 2024 showing new roof, painted soffits, and new front door.

It is staff's opinion that the installation of asphalt shingles, storm gutters and drains, front door, and paint trim is appropriate. Staff therefore recommends the Commission issue a Certificate of Appropriateness for the work because it meets the Secretary of the Interior Standards for Rehabilitation and the Russell Woods-Sullivan Historic District Elements of Design.

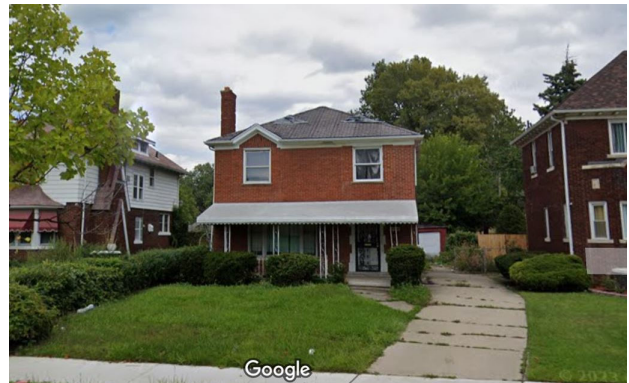
Site Photo 4, by Google Streetview Sept 2023 showing previous conditions: windows, porch awning and roof.
