**STAFF REPORT: JUNE 12, 2024 MEETING**  
**APPLICATION NUMBER: HDC2024-00273**  
**ADDRESS: 3417 SEMINOLE**

**HISTORIC DISTRICT: INDIAN VILLAGE**  
**APPLICANT: NICOLE RODRIGUEZ**  
**PROPERTY OWNER: NICOLE RODRIGUEZ**  
**DATE OF PROVISIONALLY COMPLETE APPLICATION: MAY 20, 2024**  
**DATE OF STAFF SITE VISIT: MAY 22, 2024**

**SCOPE: DEMOLISH GARAGE, ERECT GARAGE**

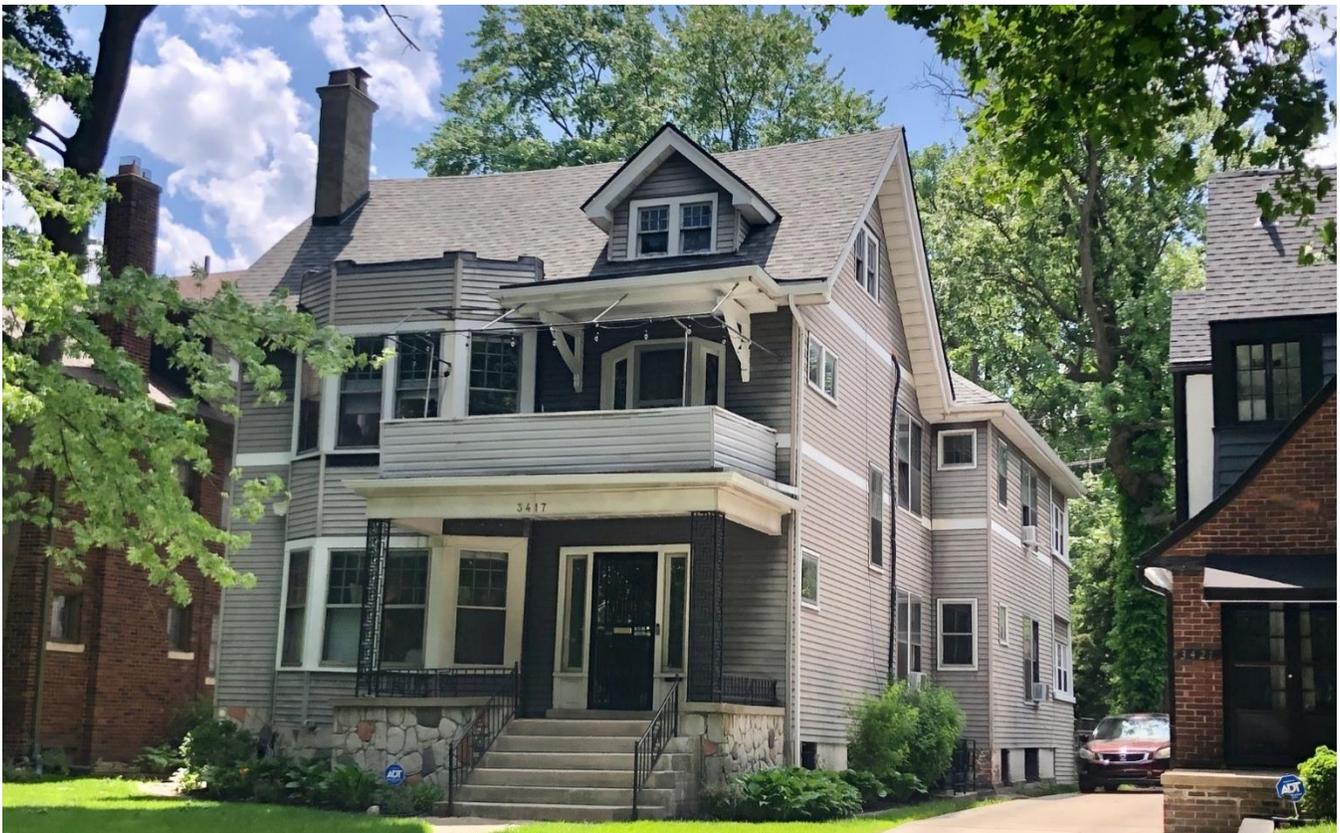
*Façade, east-facing wall. Staff photo, May 22, 2024.*

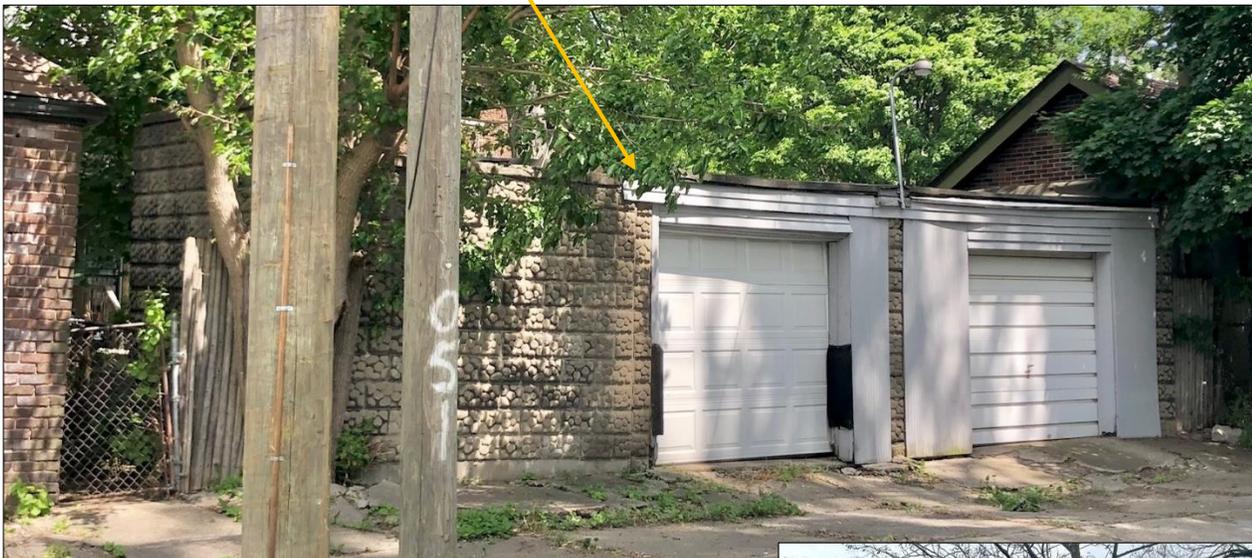
A one-story garage is located at the rear of the property and similarly fills the majority of the lot's width. The west and north walls give evidence of a three-bay structure; however, the applicant's photos show the roof and east wall of the northernmost bay are missing. The structure is constructed of cast-concrete blocks with a cobblestone pattern. The flat, minimally sloped roof is covered with rolled roofing material. Currently two single-opening overhead doors face Maxwell street, and two pedestrian doors and single-opening double-hung windows (six over-one pattern) are located on the east wall, facing the house. Due to the relatively narrow lot and the placement of the full width house, the garage is not visible from the sidewalk or front yard of the house.

*Staff photo, May 24, 2024. The garage doors face west and open onto Maxwell street.*

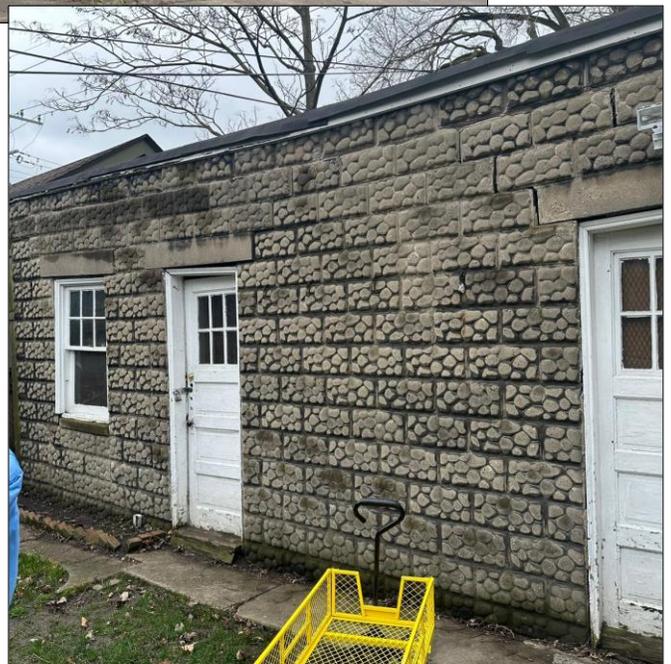
*Right: Applicant photo. Partial view of east wall facing the rear yard and house.*

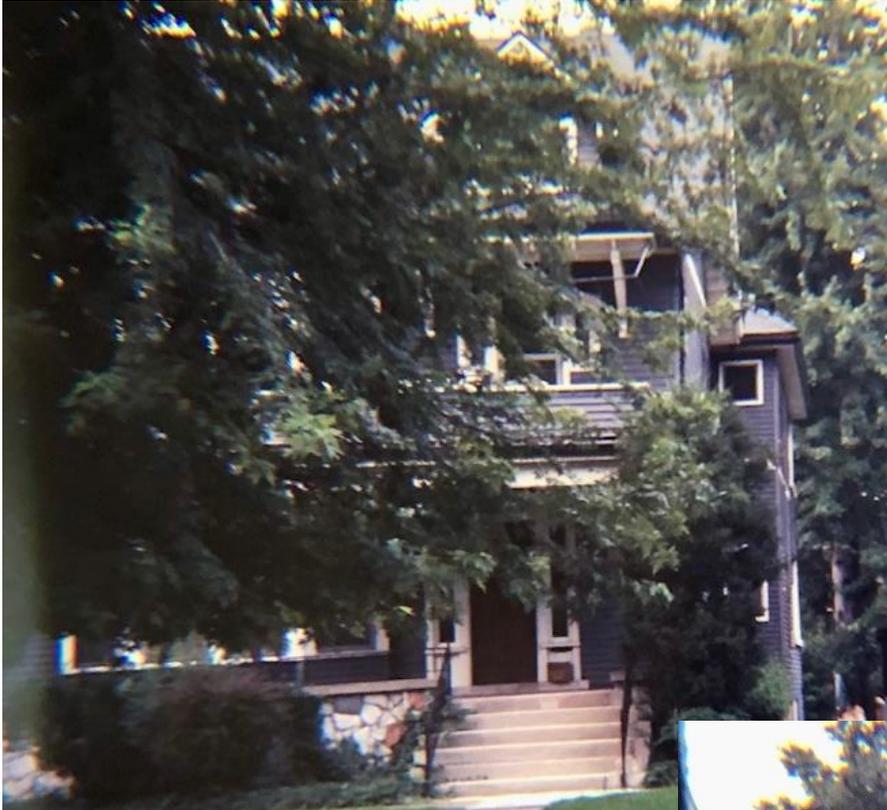
*Above and right: Historic Designation Advisory Board photos, 1971. The front porch has been altered and vinyl siding was in place.*

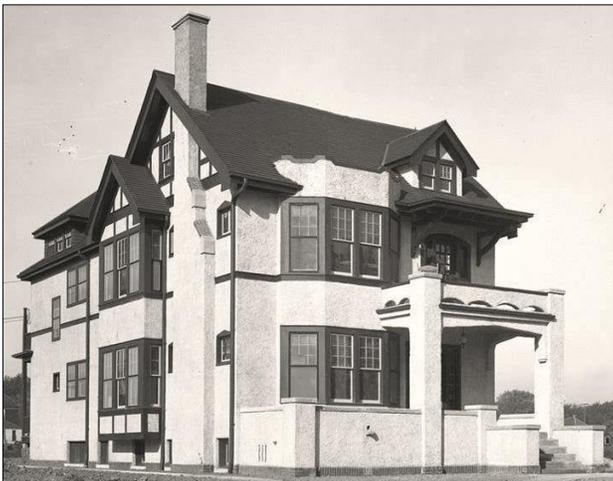
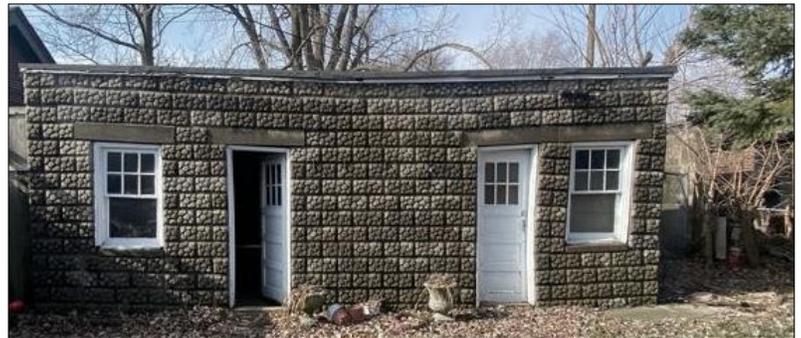
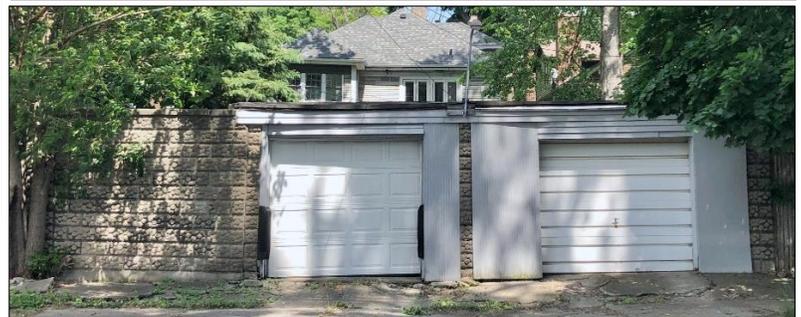
*Viewing the historic house and current garage “side-by-side” allows the original relationship of the selected wall materials to be understood.*

- Staff research shows the existing garage is an appropriate design for the property. The installation of vinyl siding on the house altered the material and architectural relationship between the dwelling and garage. At some point in the future, the vinyl siding on the house will need to be replaced, giving the property owner the opportunity to repair the house's stucco finish as well as the decorative details within the gables that likely remain intact, thus reclaiming the historic cohesive design of the property.

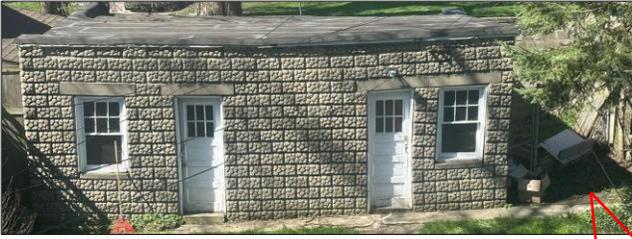
As shown in the Sanborn map, the south bay (left side) was the largest of three bays; the middle and north were about the same size.

At an unknown time, the roof and east wall of the northern bay were removed, and the overhead door on the west wall was filled in with matching concrete block (likely reused from the now-demolished east wall). Staff didn't find Commission approval for this alteration.

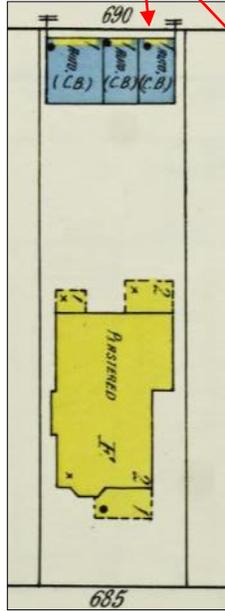
NW corner of garage.

Staff is concerned about the tree growing at the northwest corner of the garage. Its removal is not mentioned in the application. Due to its location and impact on the structure, staff recommends, and has authority to approve, its removal.

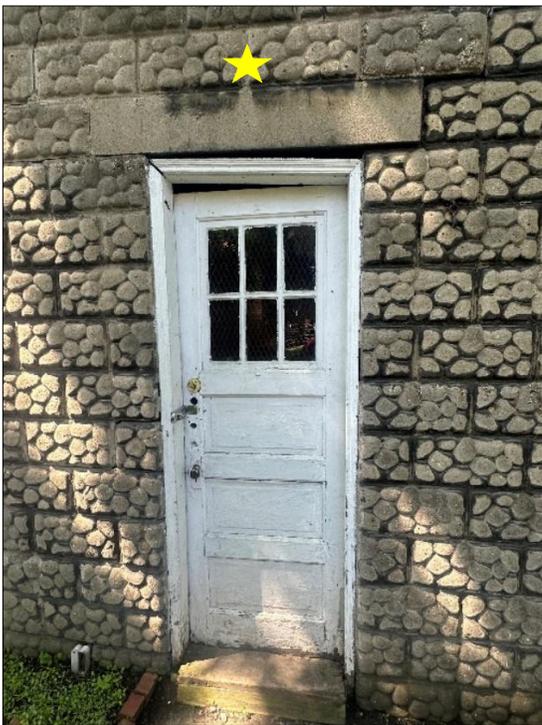
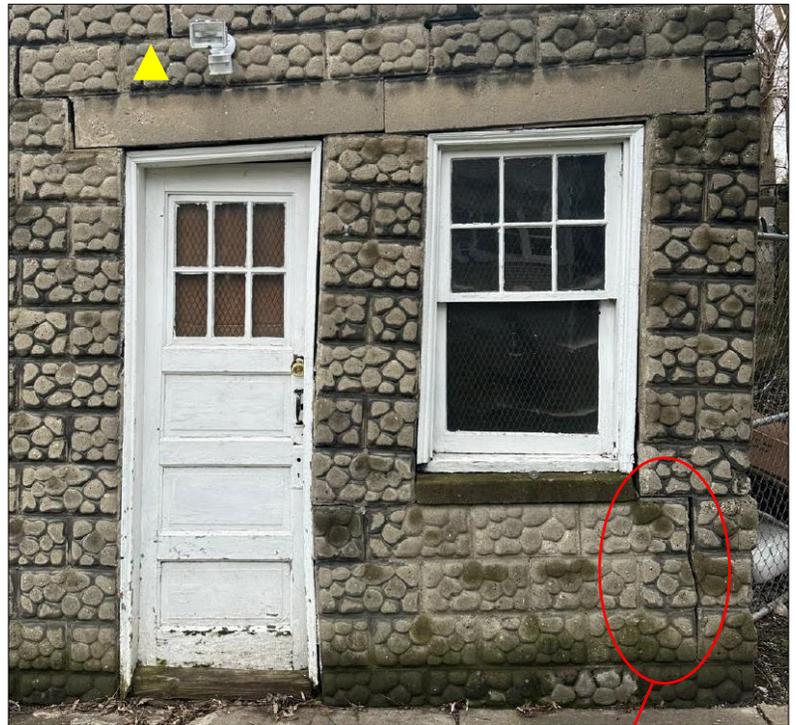
*These photos show there may be a long-standing issue with settlement, causing the frames and lintels to become unlevel. There is one area where a crack occurred in the middle of a block (circled). The doors and window openings contain historic-age wood components that are in repairable condition.*

*Photo at right is an interior view of the same area.*

- Based on the engineer’s review and the applicant’s photographs, it appears that it is possible the condition of the garage extends beyond in-situ repair, and would need to be deconstructed, a new foundation poured, and then rebuilt, reusing the historic concrete blocks (the majority of which appear to be in sound condition), wood pedestrian doors and double-hung windows. The remaining garage elements - concrete floors, flat roofing material and overhead doors can be replaced for the following reasons; the floors are interior components of the structure, and the rolled roofing and overhead metal doors are not historic age (and composite roofing was original to the structure).

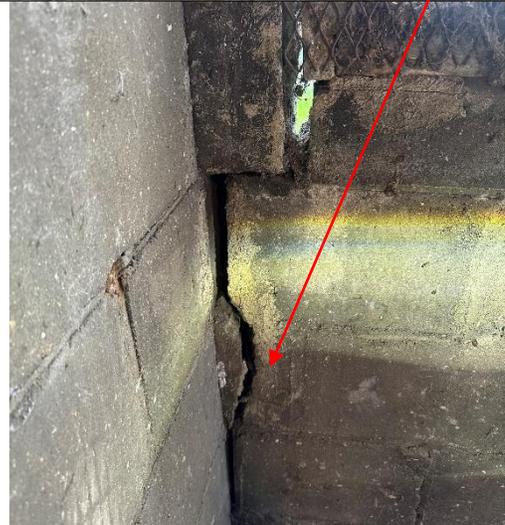
*North Bay*

*North wall (this interior wall is now the exterior southern wall of the missing bay).*

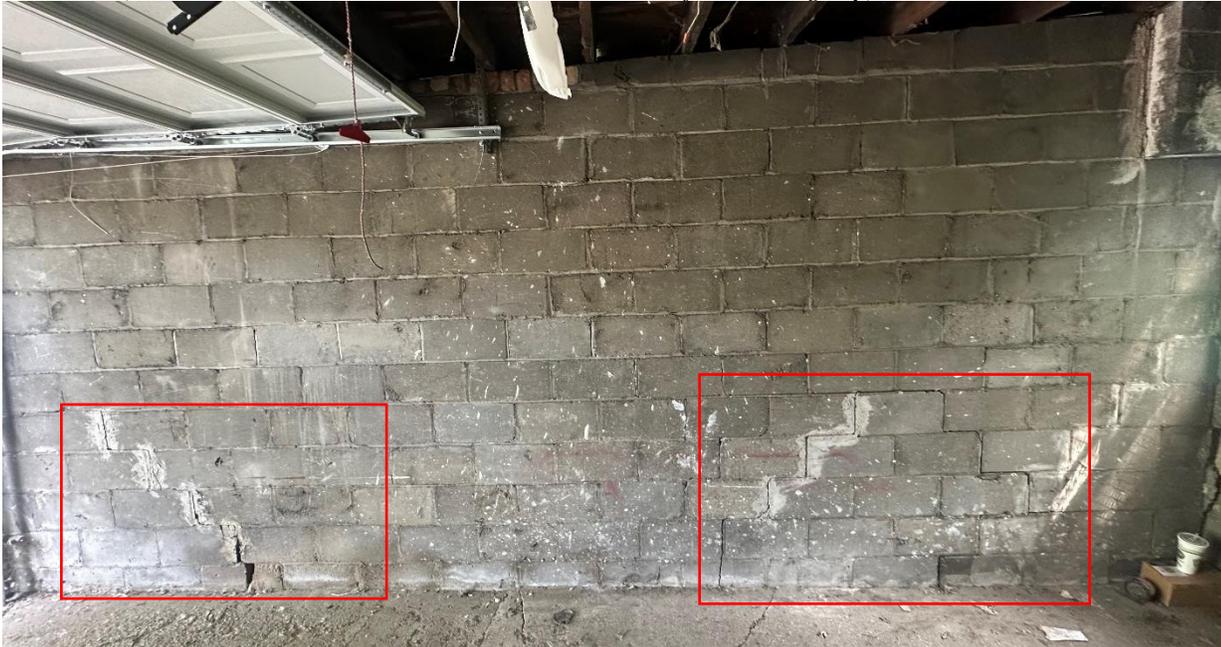
*South wall*

*Step crack and cracked block*

*Step cracks*

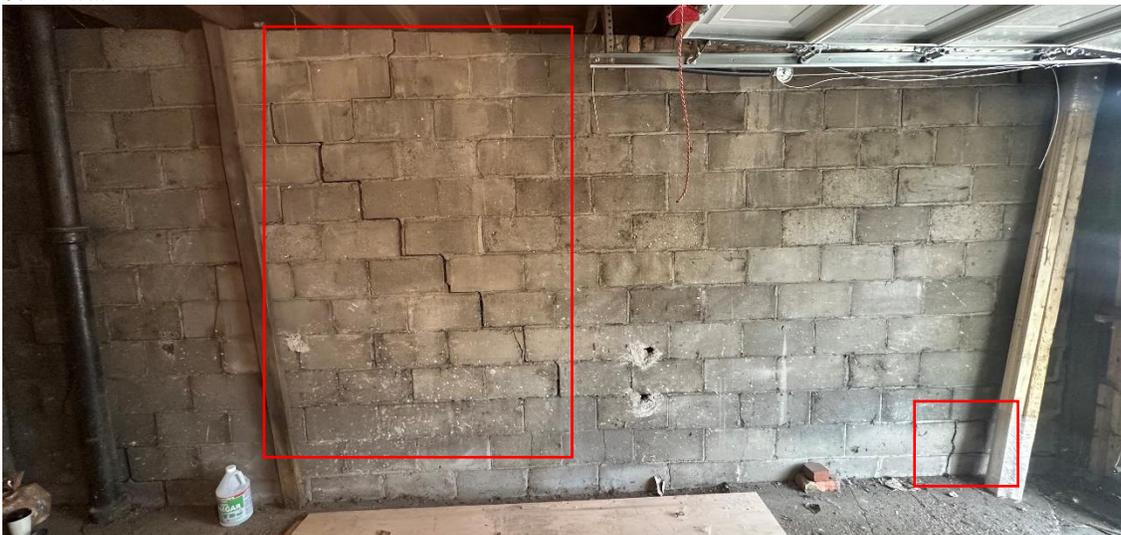
South Bay  
East wall

*Large step crack, broken block at top, near middle of box*

*Broken block*

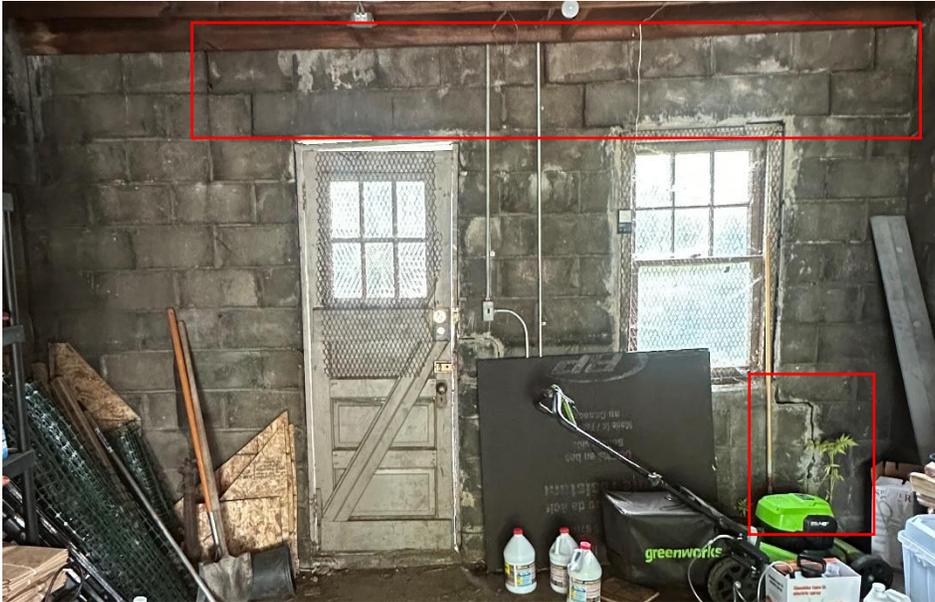
North wall

Step cracks above window and door. Cracked tile below window.

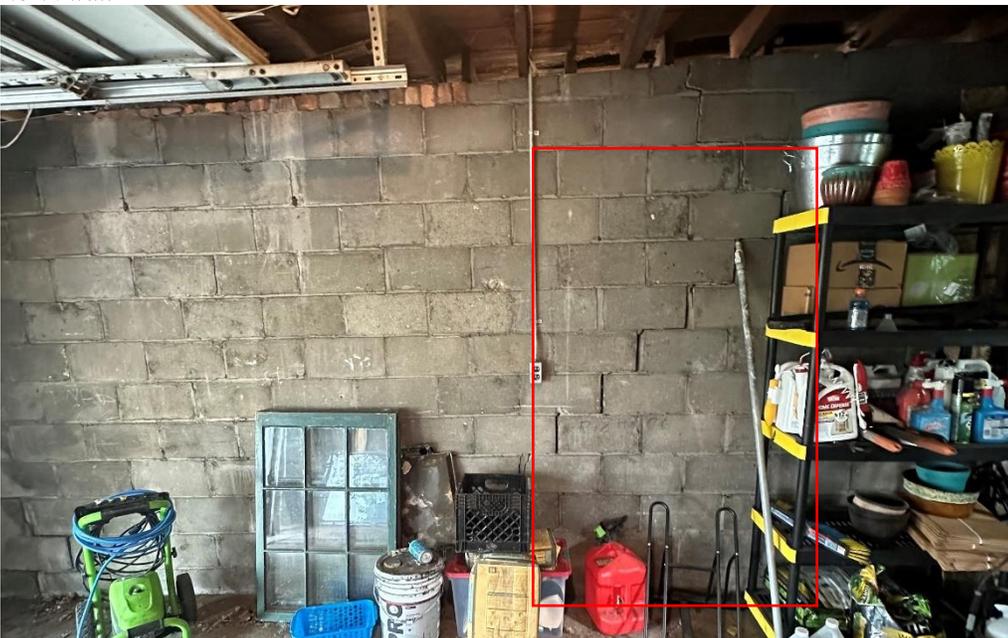
Other side of step crack, shown on page 8.

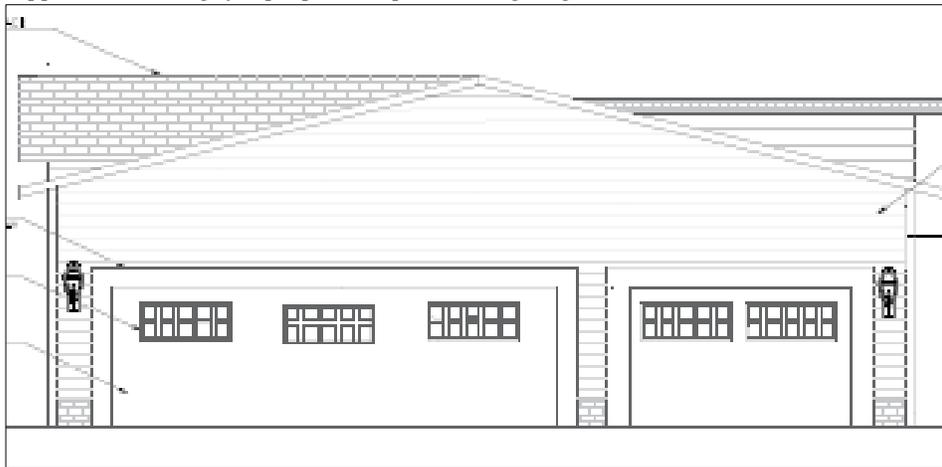
*West wall, facing Maxwell Street.*

- The proposed design includes a front facing gable roof with cross gables, both of which have differing ridge heights, dormers, and multiple wall materials. These features create a complex massing and oversized design which is atypical of the environment in which it is to be placed.

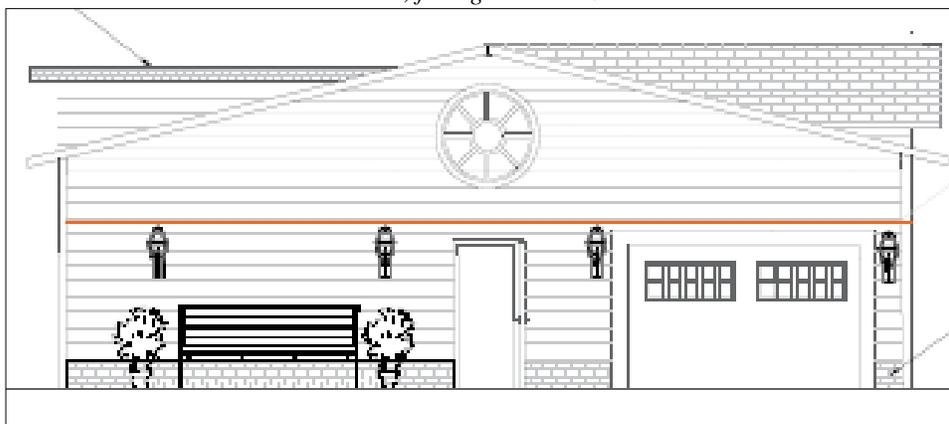
*East wall, facing the house.*
