REVISED 7/8/2024 STAFF REPORT: 7/10/2024 MEETING PREPARED BY: J. ROSS

ADDRESS: 1108 VAN DYKE

APPLICATION NO: #HDC2024-00355

SCOPE: DEMOLISH GARAGE; ERECT GARAGE; REHABILITATE DWELLING

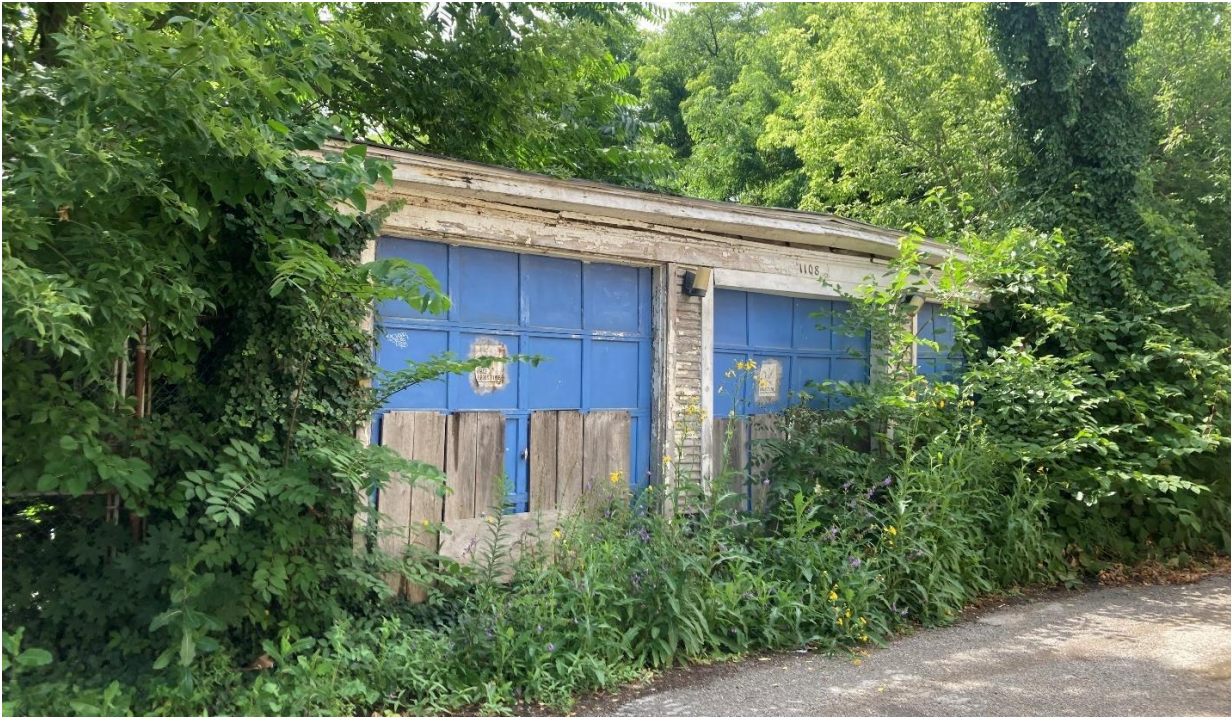
1108 Van Dyke garage, facing northwest showing current appearance of garage. Staff photo taken on 6/25/2024

The property's garage sits in poor condition to the rear. The building retains its historic lapped wood siding on the east and west elevations and original double hung wood windows. Siding on the north and south elevations is non-historic plywood and the shed roof has caved in. Three non-historic metal overhead doors (installed ca. 2000 per a former owner) are located at the building's east elevation.

- Regarding the existing historic-age garage, note that the applicant has stated that the owner is seeking to demolish the structure due to its poor condition. The applicant has provided numerous photos and a letter from a licensed structural engineer to support his statement that the garage is structurally deteriorated to an extent which merits its demolition. It is staff's opinion that the garage was a contributing structure to the property and the historic district at some point. However, staff does accept the application's condition assessment and is of the opinion that garage has lost the integrity necessary to convey its historic significance because of its current ruinous condition. Given the garage's current level of deterioration, it is staff's opinion that it is reasonable to approve demolition rather than require a complex and expensive repair. Demolition of a contributing structure that has lost its historic integrity due to catastrophic damage meets the Standards.

- Demolish existing garage
- Erect a new garage that has the same footprint as the existing per submitted drawings. The building, which includes a ground floor and a mezzanine level, will measure 20'-9" in height (at the roof ridgeline). The roof is side gabled, exterior walls will be clad with lapped cement fiber siding, and windows are aluminum-clad wood units.

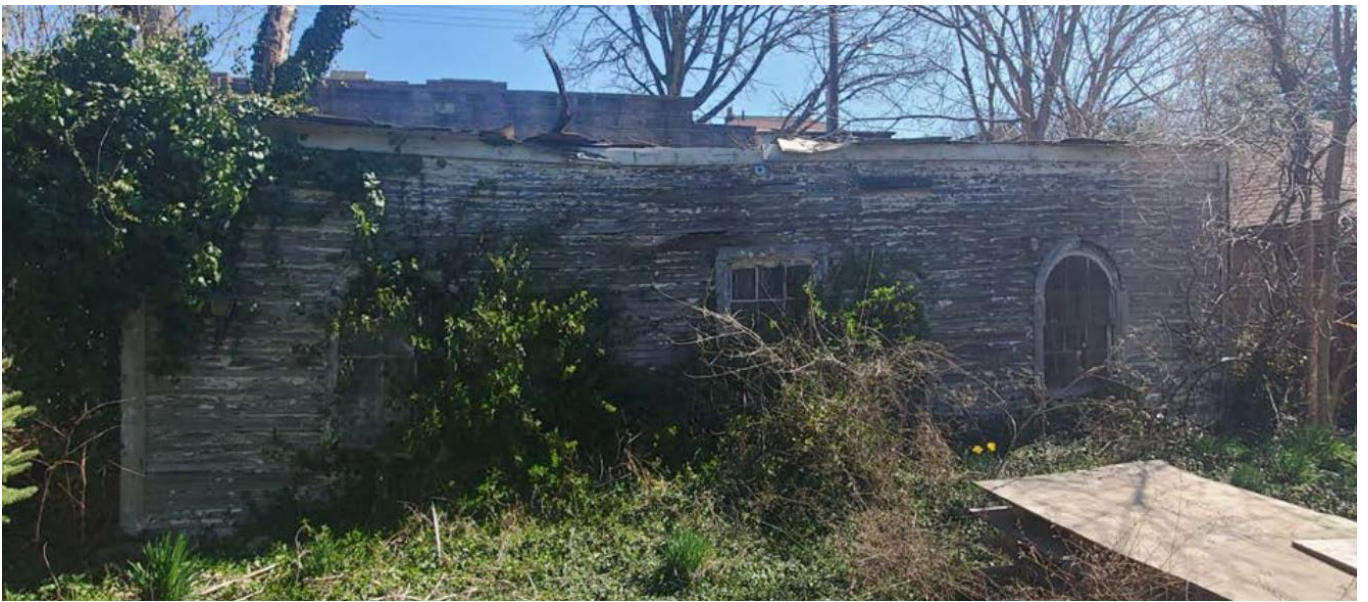
1108 Van Dyke garage, facing southeast showing current appearance. Photo provided by applicant

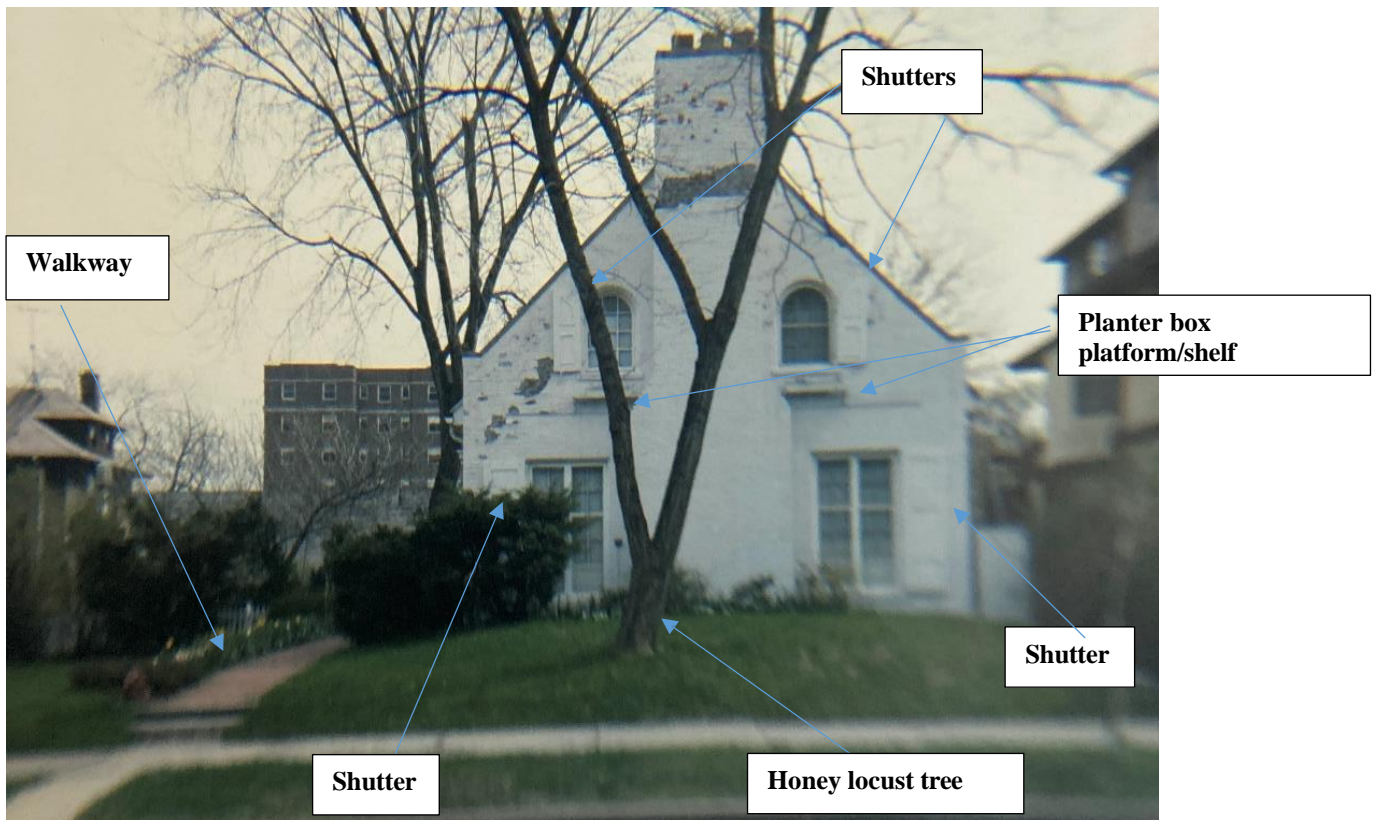
Designation slide, west elevation. Note that the house sits on a raised terrace. Also, note the presence of the honey locust tree to the west of the building, as well as the brick walkway, shutters, and planter box platforms/shelves below the second story windows. The honey locust tree, brick walkway and planter box platforms/shelves below at the west elevation still remain, while the shutters at this elevation are no longer extant

- At the time of designation, the home retained its distinctive wood panel shutters at the north, south, and west sides. A review of Google Streetview images indicate that the shutters at the west were gone by 2009, while the westernmost shutters at the north were removed between 2019 and 2021. The application proposes to replicate the missing shutters at the north and south. However, per the submitted drawings, the missing shutters at the west will not be replicated.

replicate shutters which are missing on north and south elevations, the missing shutters at the west elevation will not be replicated. It is staff's opinion that the character-defining shutters at the west elevation should be replicated according to the house's appearance in the designation slides as a review of HDC records indicates that removal of the shutters was not approved.

- The wood shutters which were originally located at the building's west side shall be replicated according to the house's appearance in the designation slides.

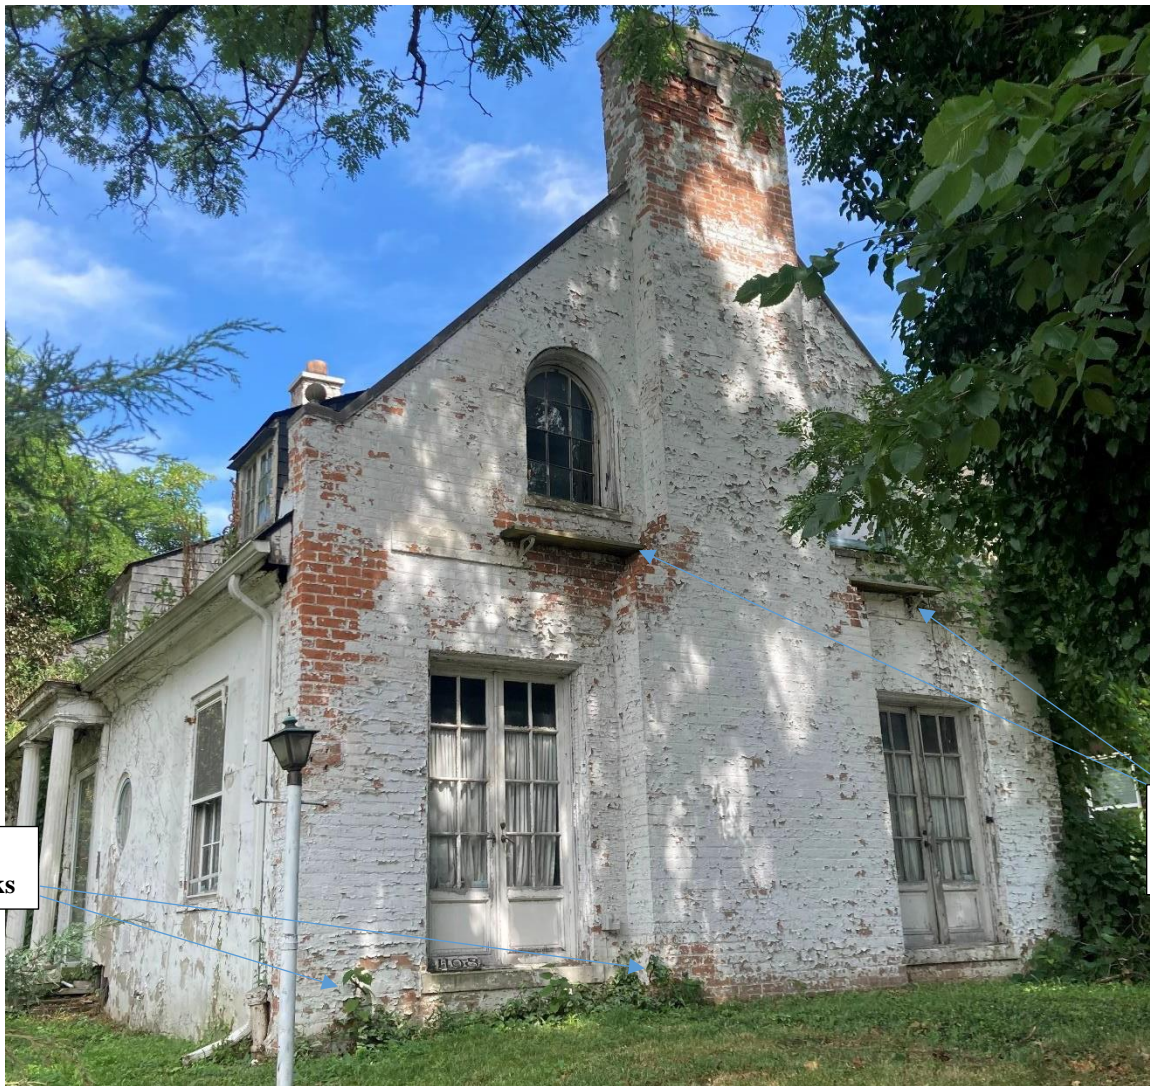
Shutter dogs/tie backs

Planter box platform/shelves

1108 Van Dyke, facing southeast, showing current appearance. Staff photo taken on 6/25/2024. Note remaining historic planter box platform/shelves and iron shutter dogs at west elevation.

- Staff identified a number of additional distinctive, character-defining elements such as the planter box platforms/shelves below the second story windows at the west windows and shutter dogs/tiebacks (see above). The submitted drawings indicate that these features will be removed. Staff recommends that the planter box platforms/shelves and all remaining shutter dogs be retained as their removal would not meet the Standards

- Staff identified a number of additional distinctive, character-defining elements such as the planter box platforms/shelves below the second story windows at the west elevation windows and iron shutter dogs/tiebacks throughout. The submitted drawings indicate that these features will be removed. Staff recommends that the plant holder platforms and all remaining shutter dogs be retained as their removal would not meet the Standards

- All remaining shutter dogs/tie backs at all walls and the existing planter box platforms/shelves at the shall be retained.
- The primary entry porch rebuild/repair shall be in kind/match the existing in material, dimension, and design to include the current brick elements.

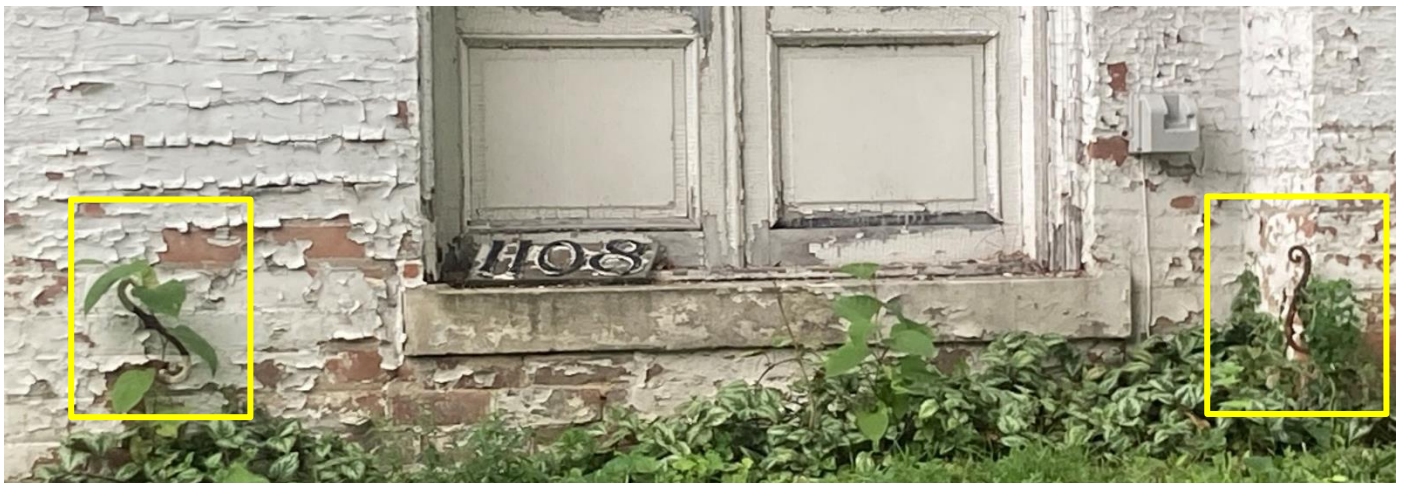
1108 Van Dyke, facing southeast, showing iron shutter dog (outlined in yellow) at west elevation Staff photo taken on 6/25/2024.

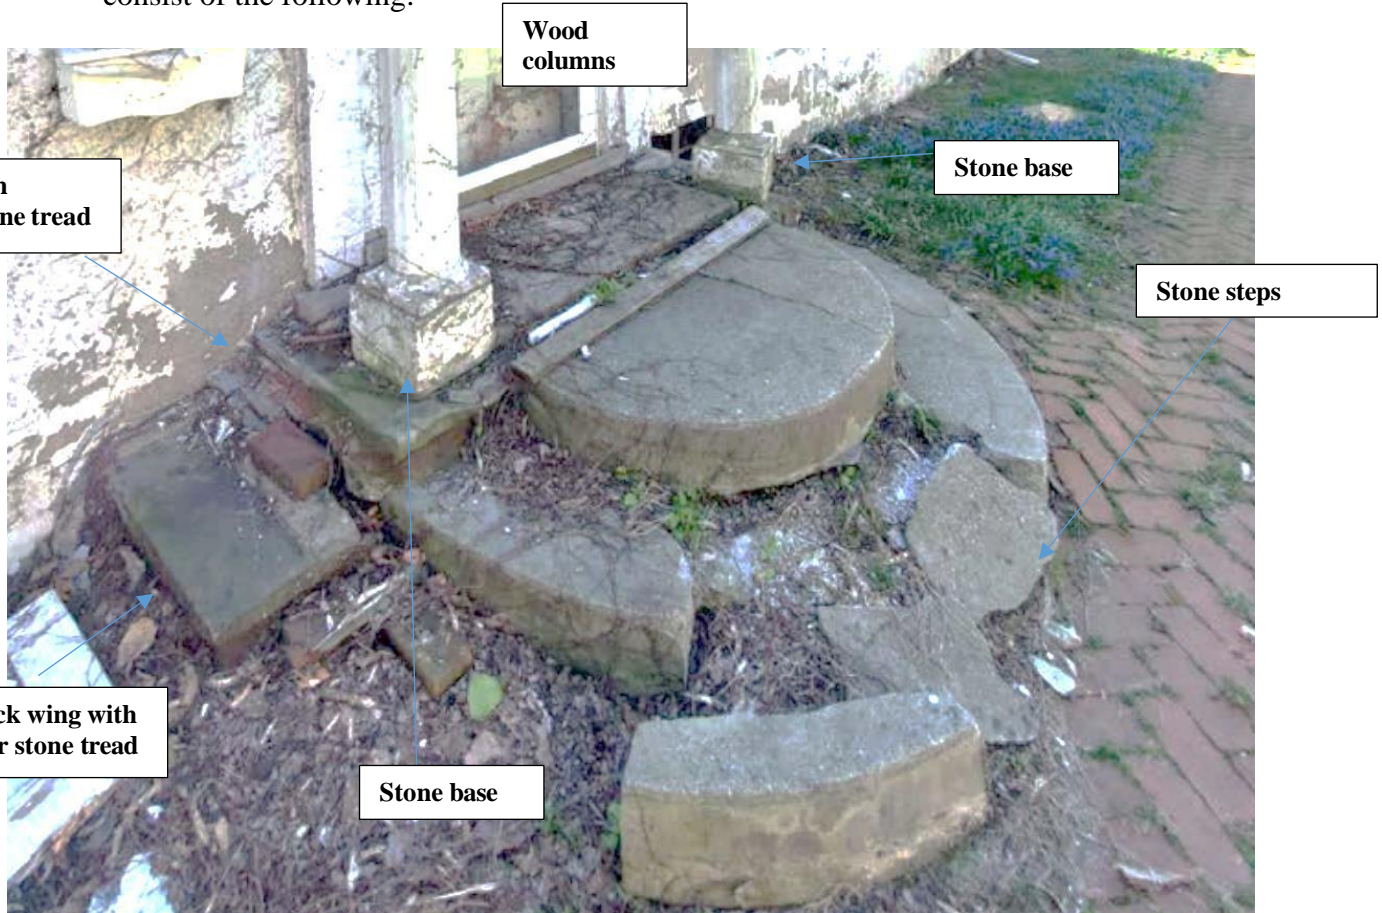
Front porch, detail. Photo provided by applicant

- The drawings and the narrative documentation do not provide a full accounting of the current porch materials as they only refer to the porch's stone elements. Staff recommends that the porch rebuild/repair match the existing in material, dimension, and design to include the current brick elements.
- The application proposes to remove locust sapling trees (DBH of 8" and 9") that are directly adjacent to the north wall's bay window because they are contributing to foundation/structural issues at that location (see the below photo). Staff supports the removal of these trees in order to forestall further damage to the house.

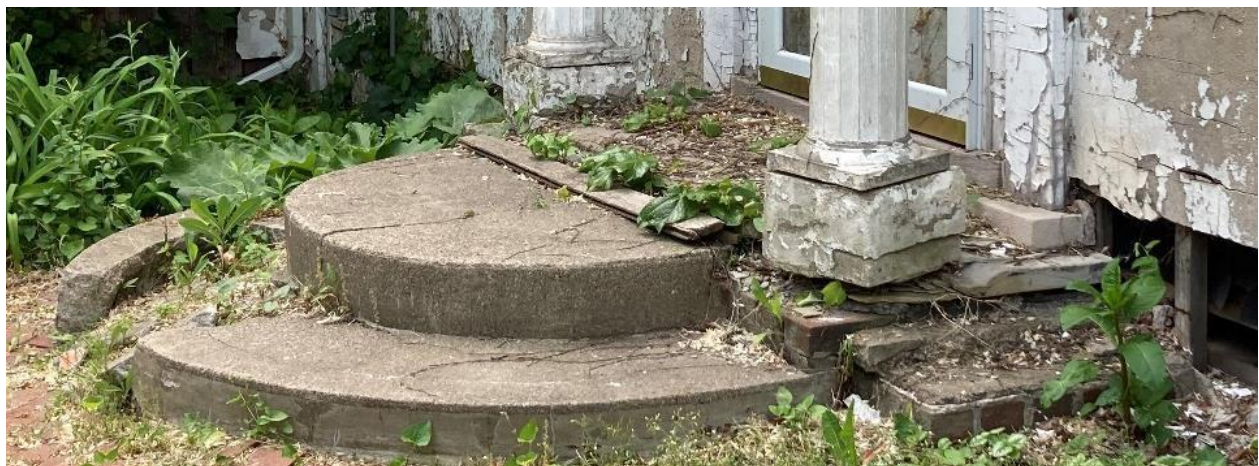
Front porch, detail. Photo provided by applicant

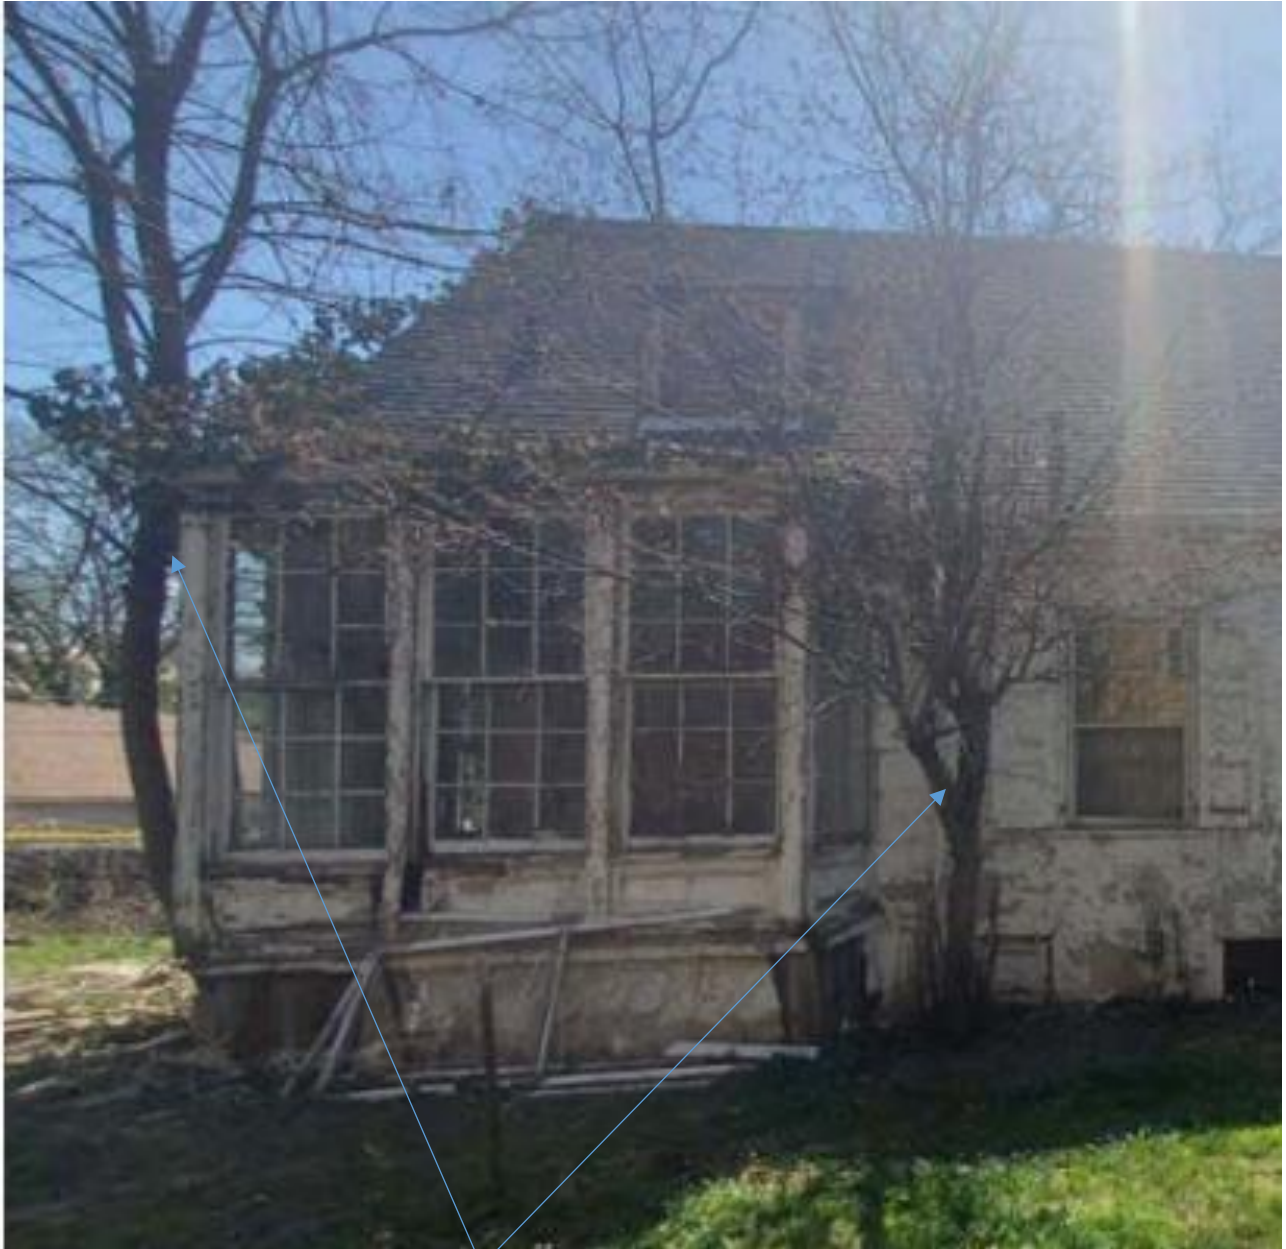
1108 Van Dyke, north bay. These two trees are proposed for removal due to their close proximity to the building's foundation and their potential to damage the foundation

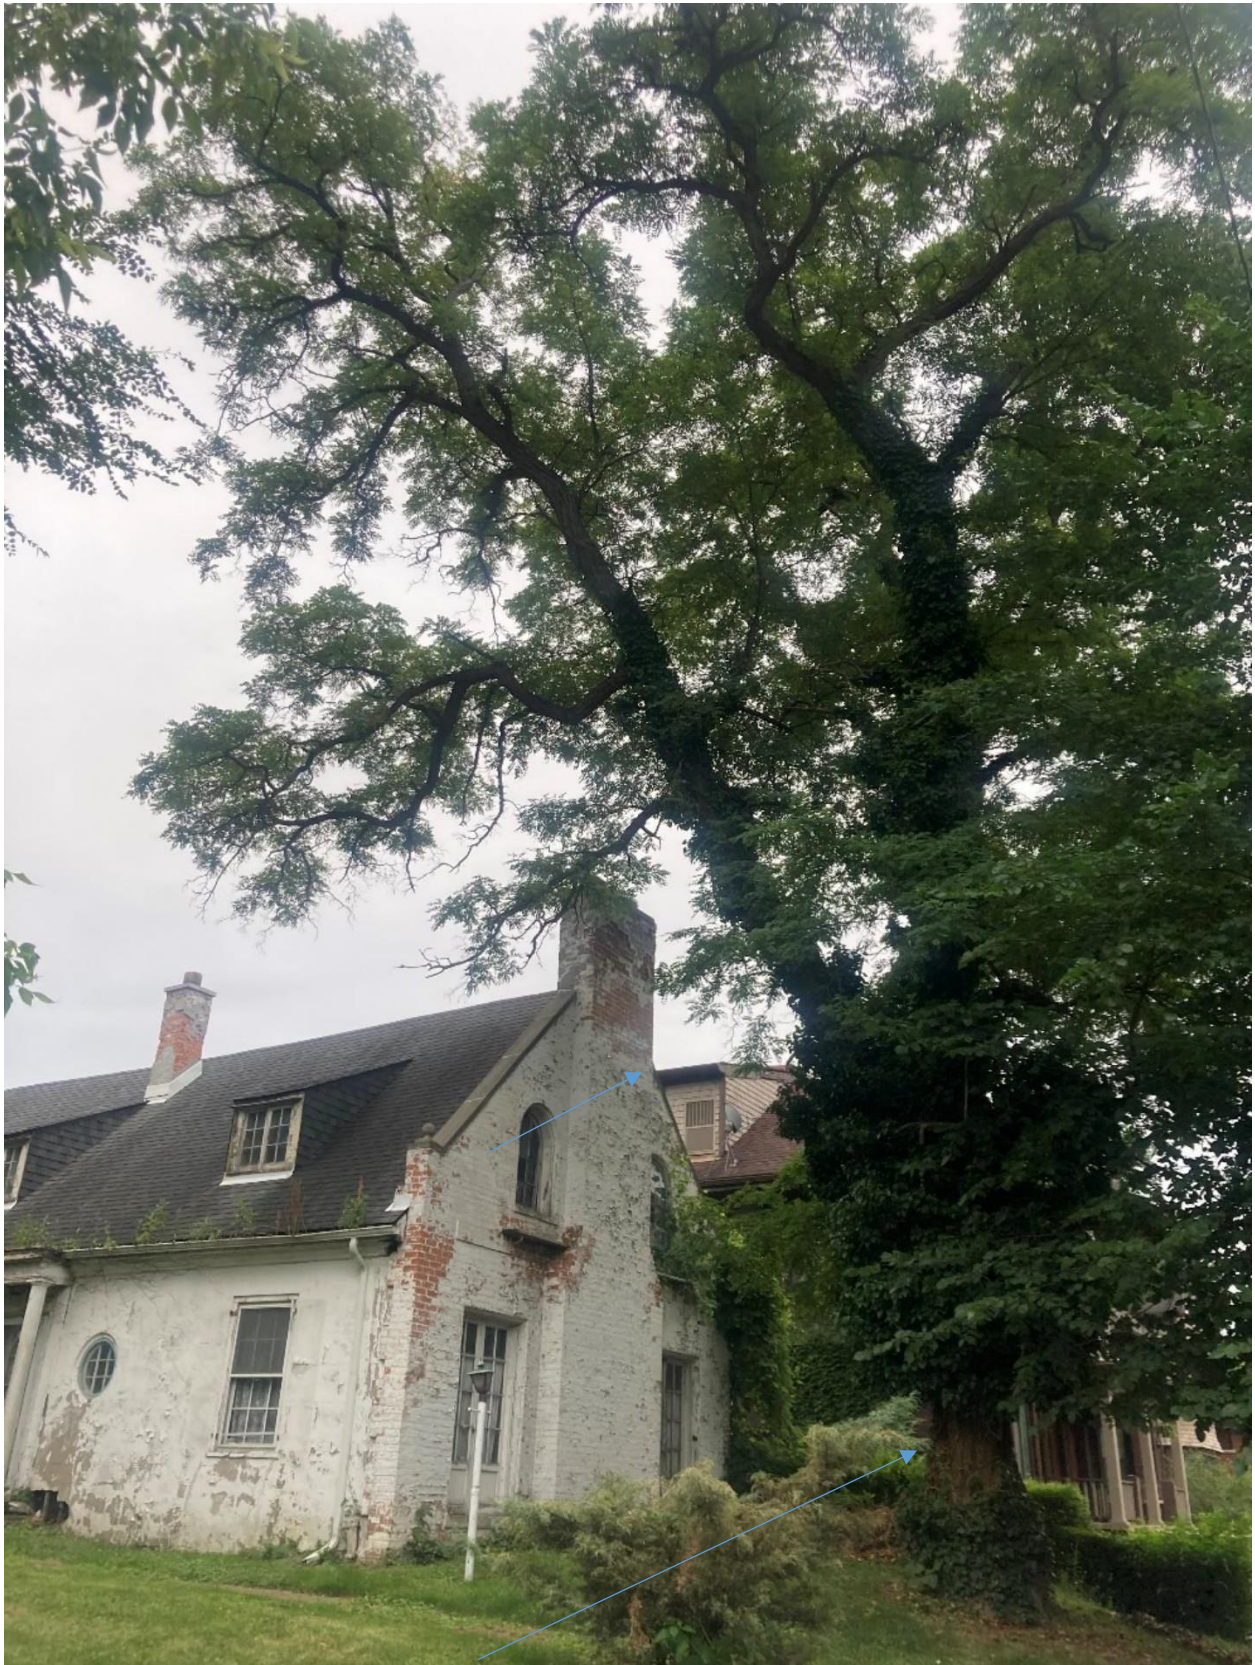
- A third tree (see below photo), located to the west at Van Dyke of the building, is proposed for removal. Staff notes the following re: this tree:
 - The applicant has submitted a statement from an arborist which notes that the tree has a DBH of 40" and its "...very close to foundation and large portion of tree over roof. The tree has a history of failure. The main stem is covered with a vine. The

tree is nearing the end of its life cycle and should be removed to protect the historical structure/ house”. Staff estimates that the tree is 15’ west of the house

- A review of the property’s designation slides indicate that the tree was present in 1983. The HDC staff landscape architect reviewed photos of the tree and has estimated that the tree is 70 years old. He also noted that the arborist statement does not clearly state that the tree is in poor health/dead/diseased and stated the following:

The tree’s canopy appears healthy with no major dead branches (maybe some smaller minor ones). The lean over the house is a potential future problem if the canopy or trunk shows sign of damage and disease, but I see no sign of that. The tree could be limbed up in areas over the house. The roots are well established and will not pose a future danger to the house unless there are signs of damage occurring now, which no evidence has been shown. It’s true that a tree of this species usually does not live past 100 but until there are signs of damage or health conditions to this particular tree, regular maintenance can be done to prevent damage. Besides trimming branches, the ivy could be removed to preserve the longevity of the tree.

1108 Van Dyke, facing southeast, showing honey locust tree proposed for removal. Staff photo taken on 6/25/2024

- Staff therefore recommends that the tree be retained as it is an historic, distinctive character-defining feature of the property/landscape. However, if the Commission does approve its removal, staff recommends that a new compatible shade tree be planted on the property or the adjacent parcel/1116 Van Dyke to maintain the neighborhood’s historic canopy.

- It is staff's opinion that the historic-age honey locust tree to the west of the house that is proposed for removal is a distinctive character-defining feature of the property/landscape. As it is not currently dead or diseased and can be limbed to ensure that its branches do not hang over the house, it is staff's opinion that its removal would not meet the Standards.

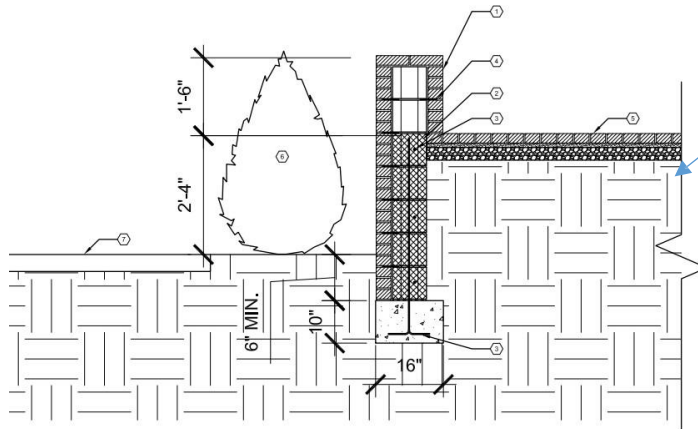
1 PATIO DETAIL SECTION
SP1.1 SCALE: 1/2" = 1'-0"

- The applicant further proposes to install a new brick paver patio, masonry retaining wall and shrubs beyond to the west of the new patio. As noted previously, the yard's sloping terrace is a distinctive, character-defining feature of the property/landscape. The new patio, retaining wall and shrubs will destroy the terrace's gentle, organic slope which currently exists at the west property line (primary expression facing Van Dyke) as the area behind the retaining wall will be to even out the surface of the patio area. This graded area would change the current sloping terrace to raised flat patio, altering the landscape and giving the lawn an incompatibly more formal appearance when the property/yard is viewed from Van Dyke Street. It is staff's opinion that this work item does not meet the Standards.

Detail section of retaining wall and shrubs proposed for installation along west property line/adjacent to sidewalk

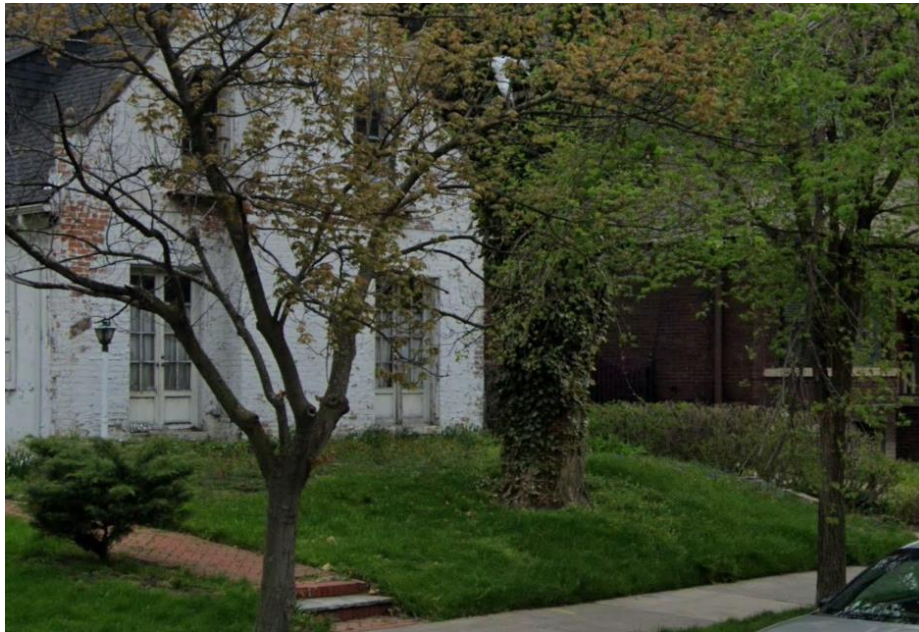
Google Streetview, 2019. Showing westward slope of yard that will be obscured when viewing the yard from Van Dyke by the proposed retaining wall and shrubs

- As noted previously, the yard's sloping terrace is a distinctive, character-defining feature of the property/landscape. The new patio, retaining wall and shrubs will destroy the terrace's gentle, organic slope which currently exists at the west property line as the area behind the retaining wall will be to even out the surface of the patio area. This graded area would change the current sloping terrace to raised flat patio, altering the landscape and giving the lawn an incompatible more formal appearance when the property/yard is viewed from Van Dyke Street. It is staff's opinion that this work item does not meet the Standards.
