STAFF REPORT: 7/10/2024 MEETING

ADDRESS: 1628 LEVERETTE

APPLICATION NO: #HDC 2024-00113

SCOPE: REHABILITATE EXTERIOR

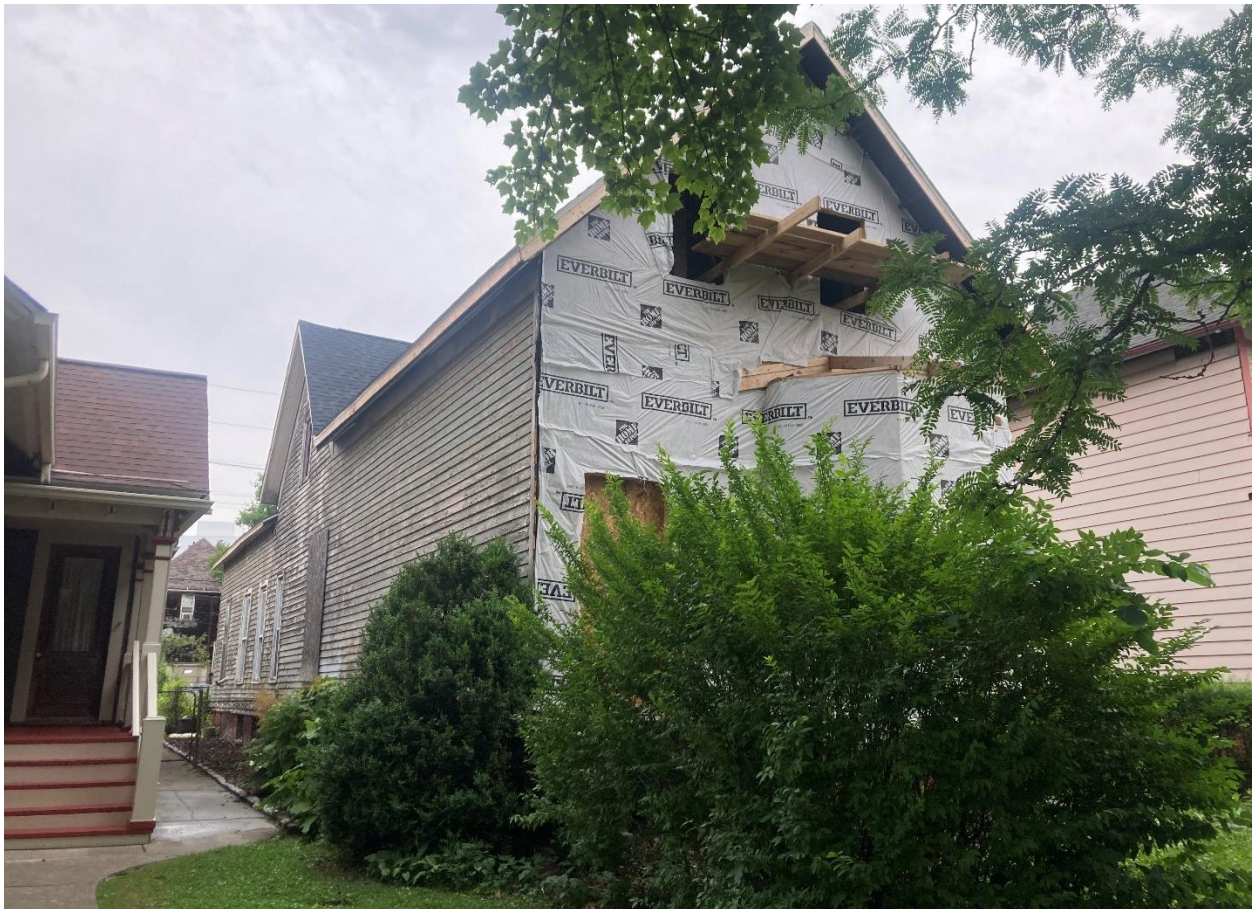
1628 Leverette, current conditions facing northeast. Staff photo taken 6/25/2024

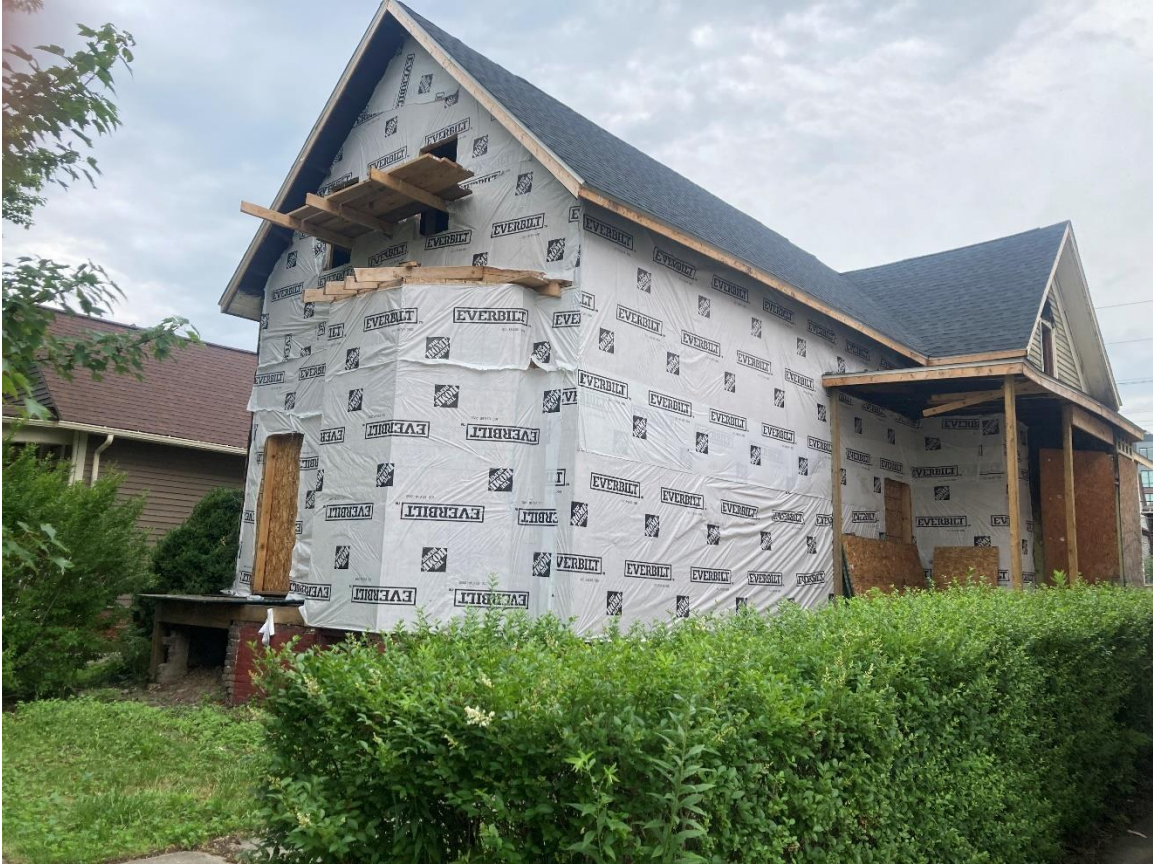
1628 Leverette, current conditions facing northwest. Staff photo taken 6/25/2024

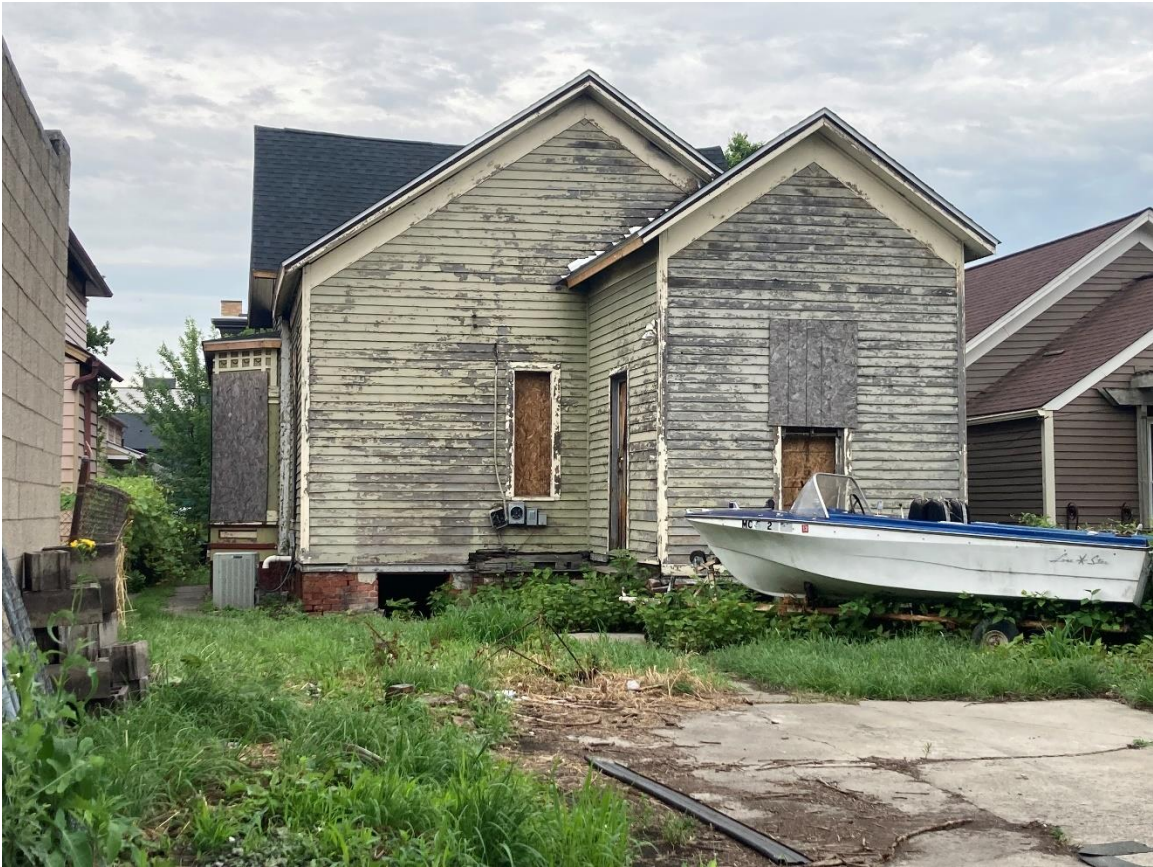
1628 Leverette, current conditions facing south. Staff photo taken 6/25/2024

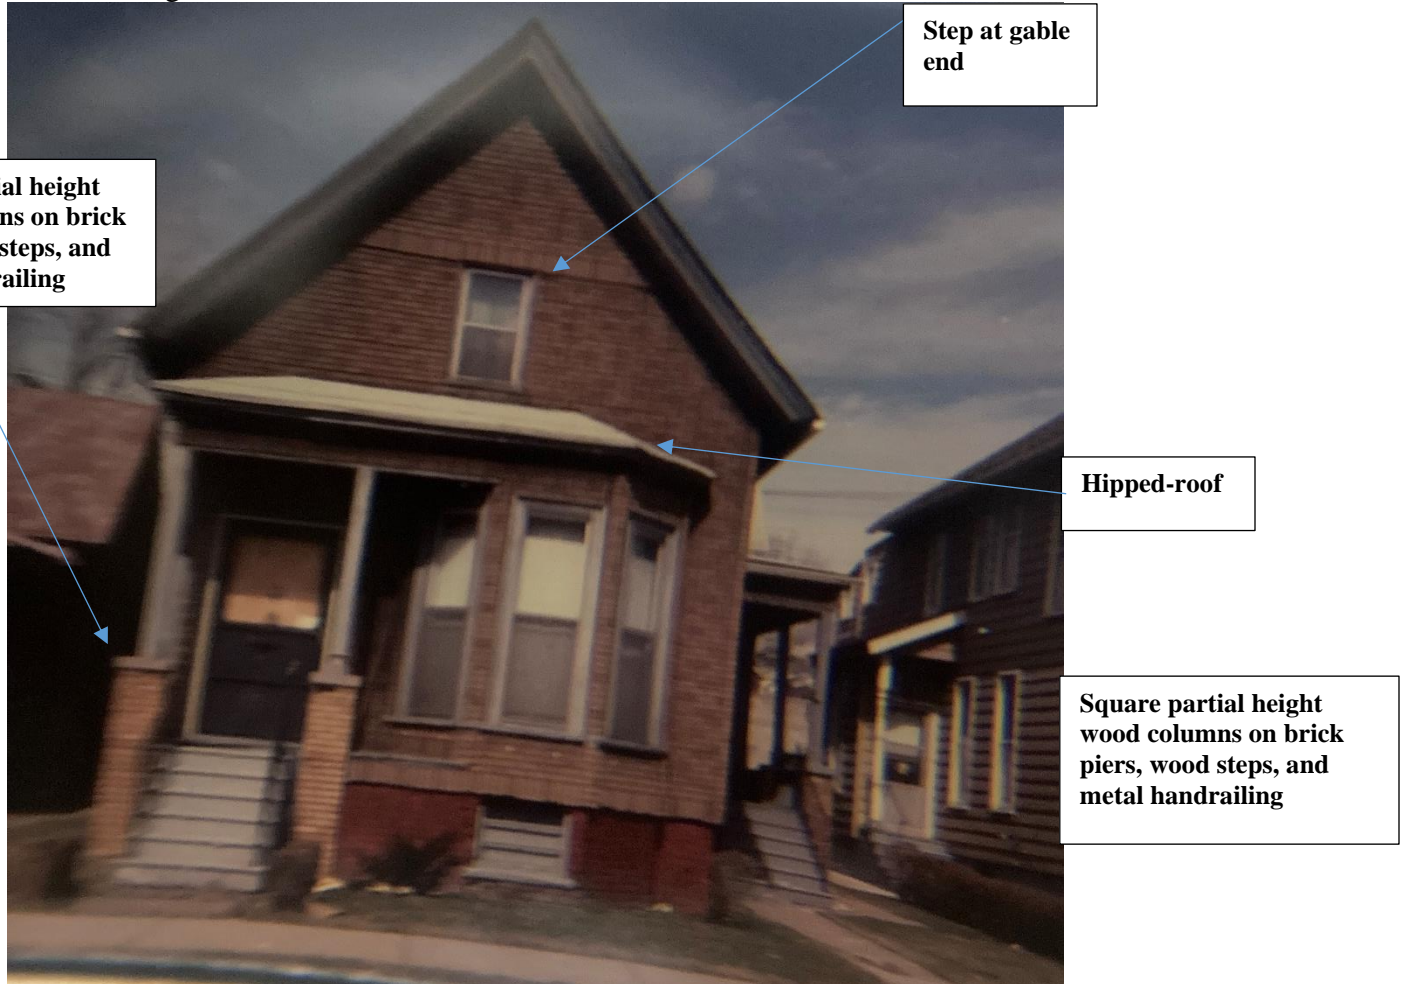
1628 Leverette, photo taken in 1983 by HDAB. Note that any exterior decorative detailing/trim is covered by the siding

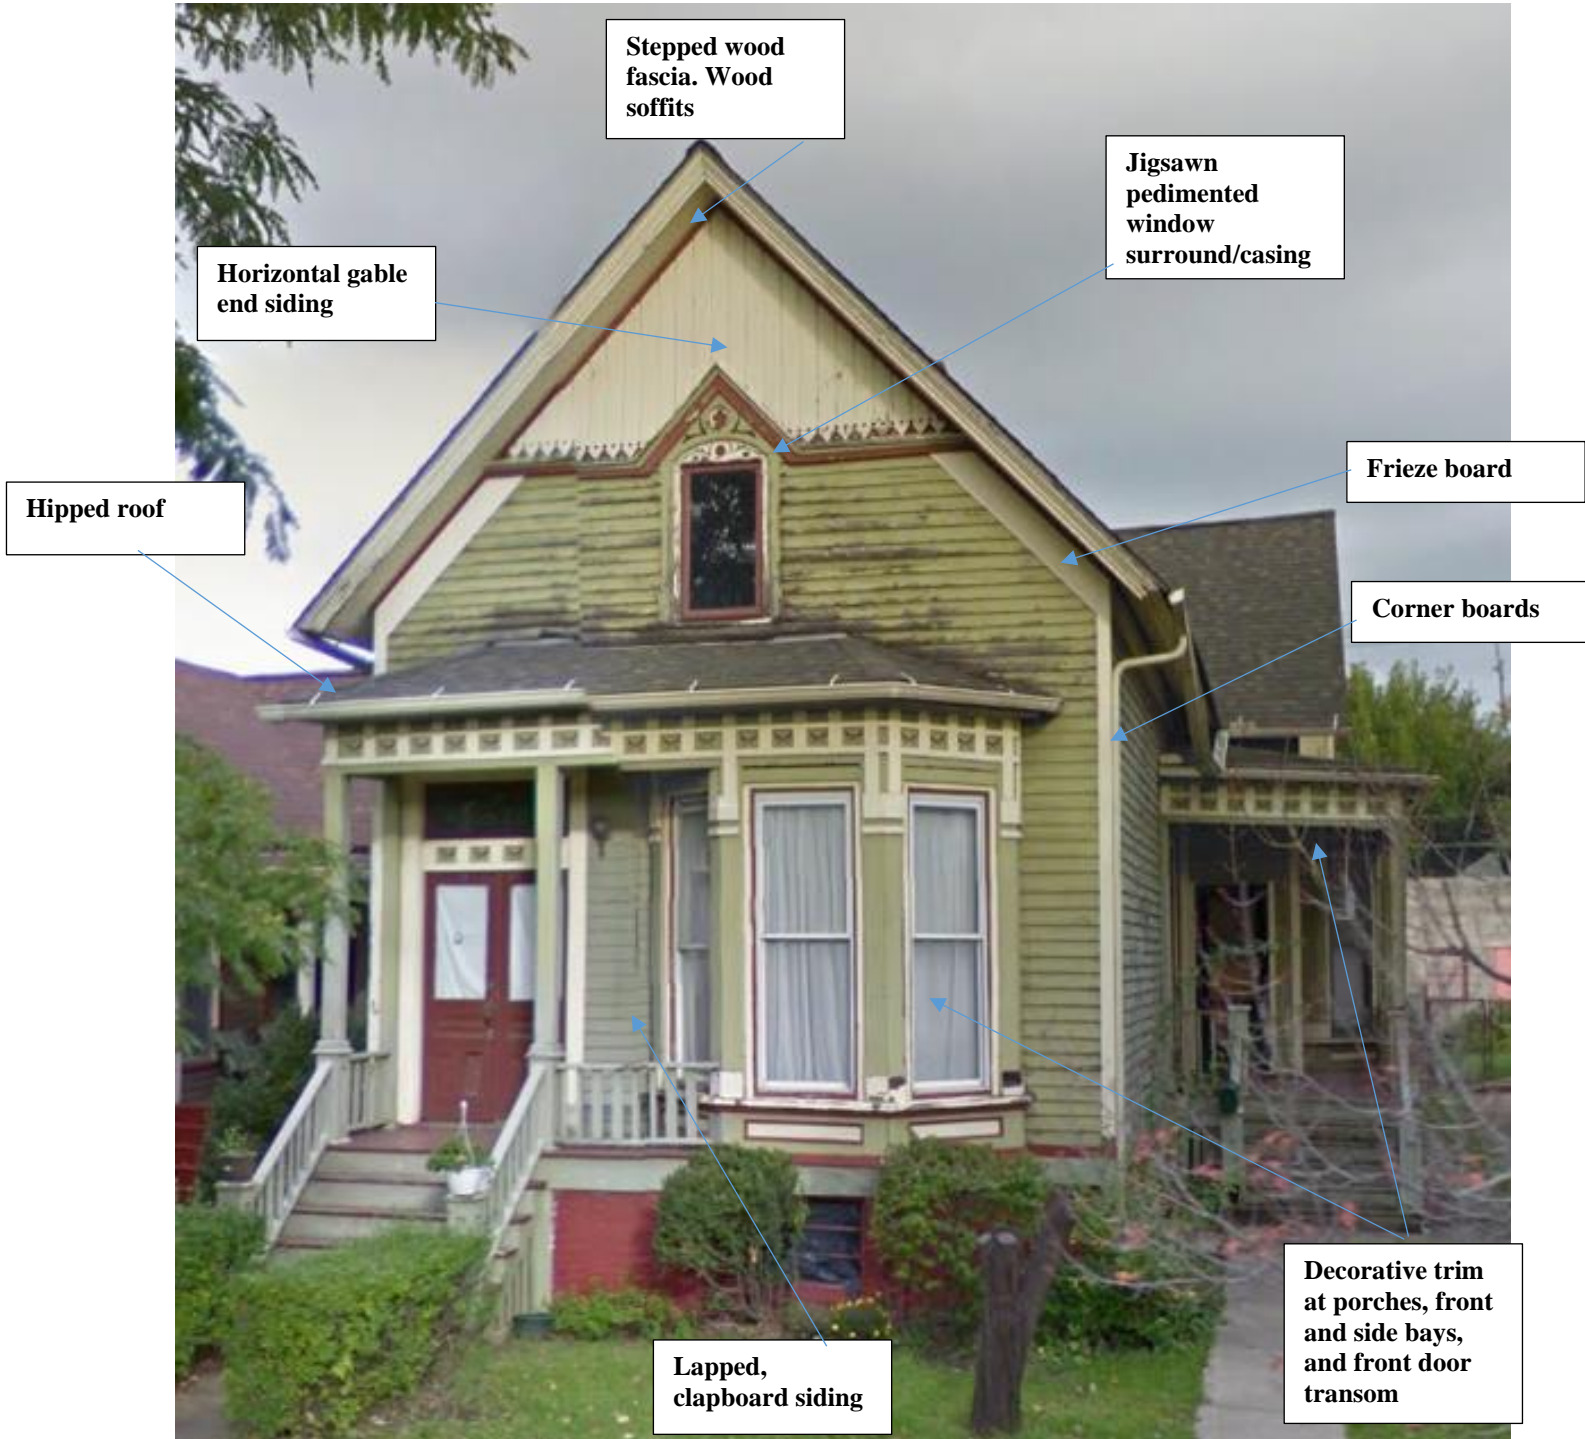
Appearance in 2016, after faux brick asphalt siding was removed. Note exposed decorative detailing at front gable end, above the front door, at the front porch roof and bay window, and at the side porch roof and bay window. Also, the front and side porch posts, piers, decking, and steps which were extant in 1983 have been replaced by this time. Source: Google Streetview

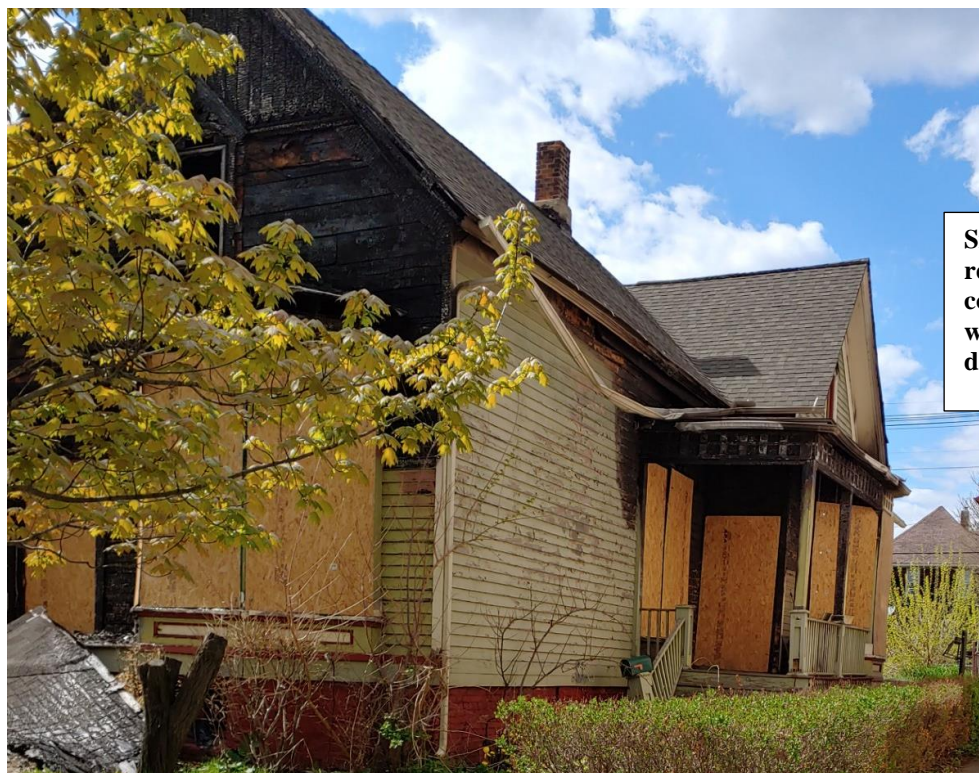
Conditions in 2019. Photo taken by Debra Walker, facing northwest.

Side porch and bay window remain in fire damaged condition Siding at this wall also remains in damaged condition

- At the east side wall, the roof fascia/soffits, porch, bay, and siding were heavily damaged by fire. It appears that most historic elements could have been retained and repaired in kind where required. The condition of any remaining windows at this wall is unclear to staff as they were boarded up in the 2019 photos and the current application does not provide a clear account of their condition.

- As the side porch and bay were not destroyed by the fire, they must be repaired where possible or replicated where necessary to match their historic appearance. Although a new porch is under construction at this location, the current application does not include enlarged drawings specifying dimensions, materials, and details of the proposed conditions. Staff is therefore unsure if this scope item meets the Standards

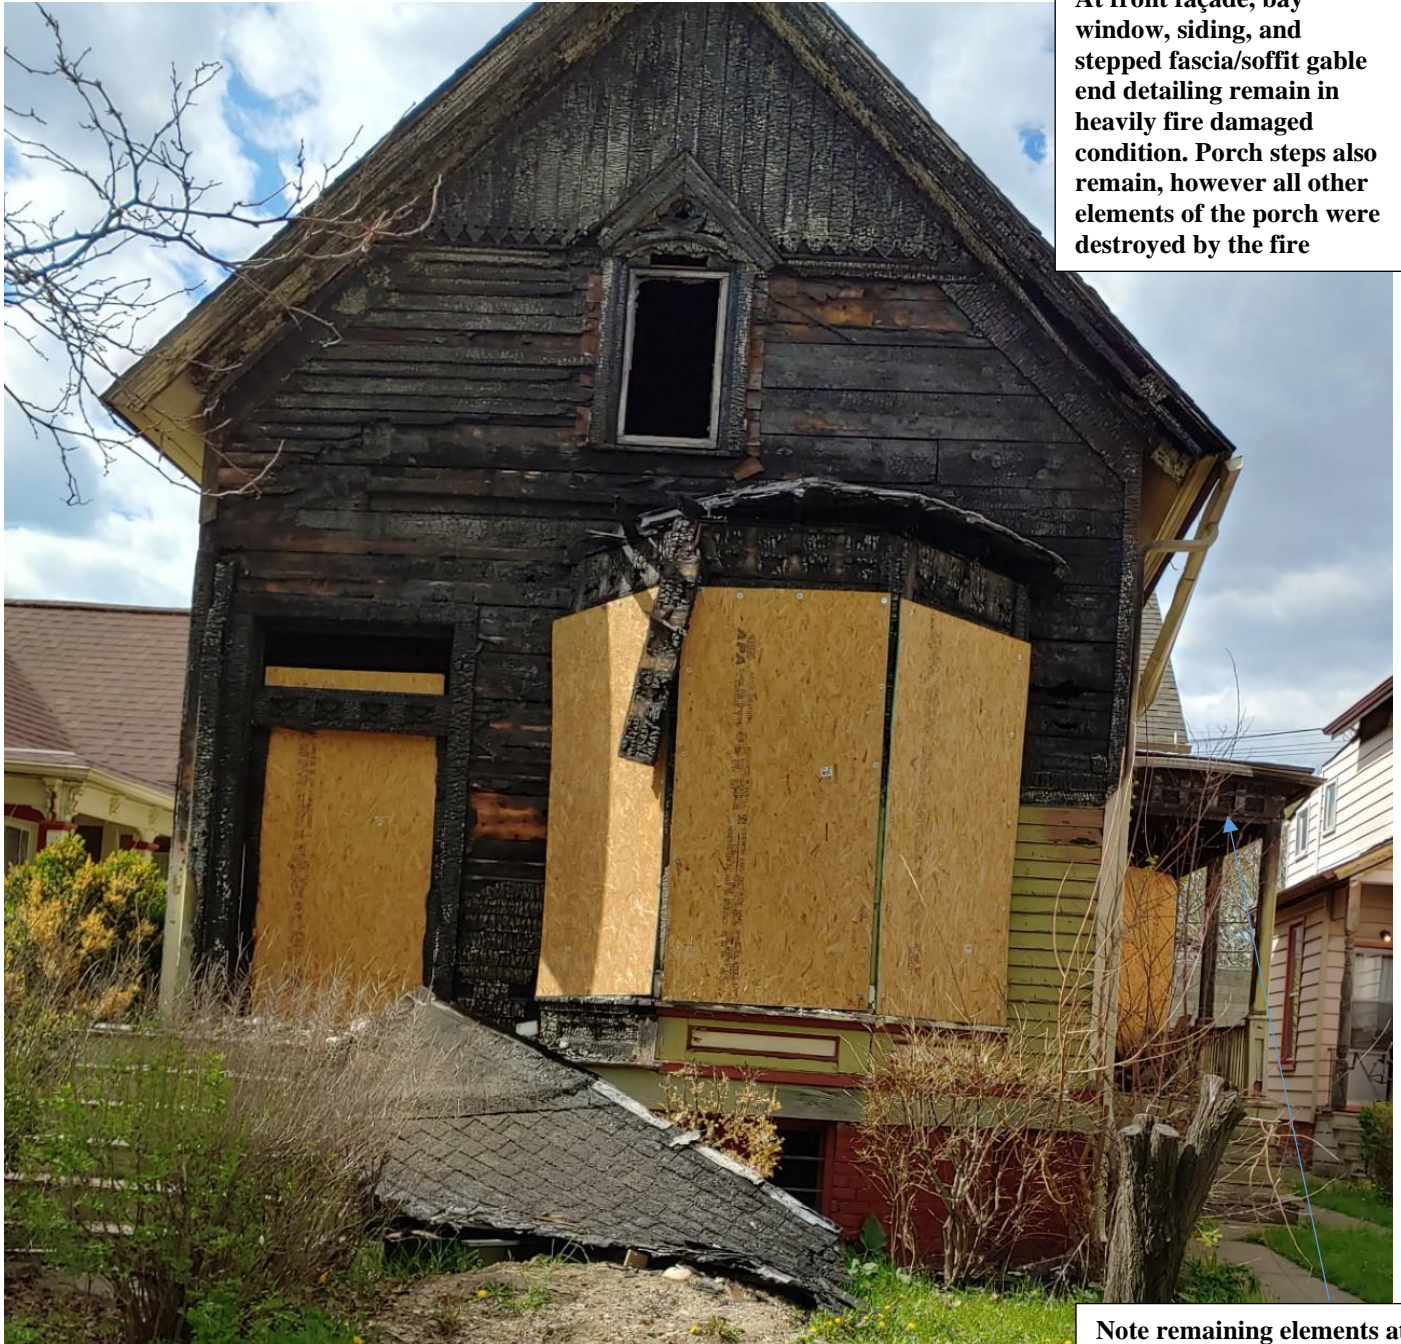
Conditions in 2019. Photo taken by Debra Walker, north.

At front façade, bay window, siding, and stepped fascia/soffit gable end detailing remain in heavily fire damaged condition. Porch steps also remain, however all other elements of the porch were destroyed by the fire

- At the front façade, the roof fascia/soffit, siding, window units and trim/casing, bay, door and door trim remained but were deteriorated beyond repair as a result of the fire

- The front façade bay was not destroyed by the fire. Therefore, it must be repaired where possible or replicated in kind where necessary to match its historic appearance. While the current application proposes to rebuild the bay, the drawings do not include enlarged drawings depicting dimensions, materials, and details of the proposed conditions at this location. Staff is therefore unsure if this scope item meets the Standards

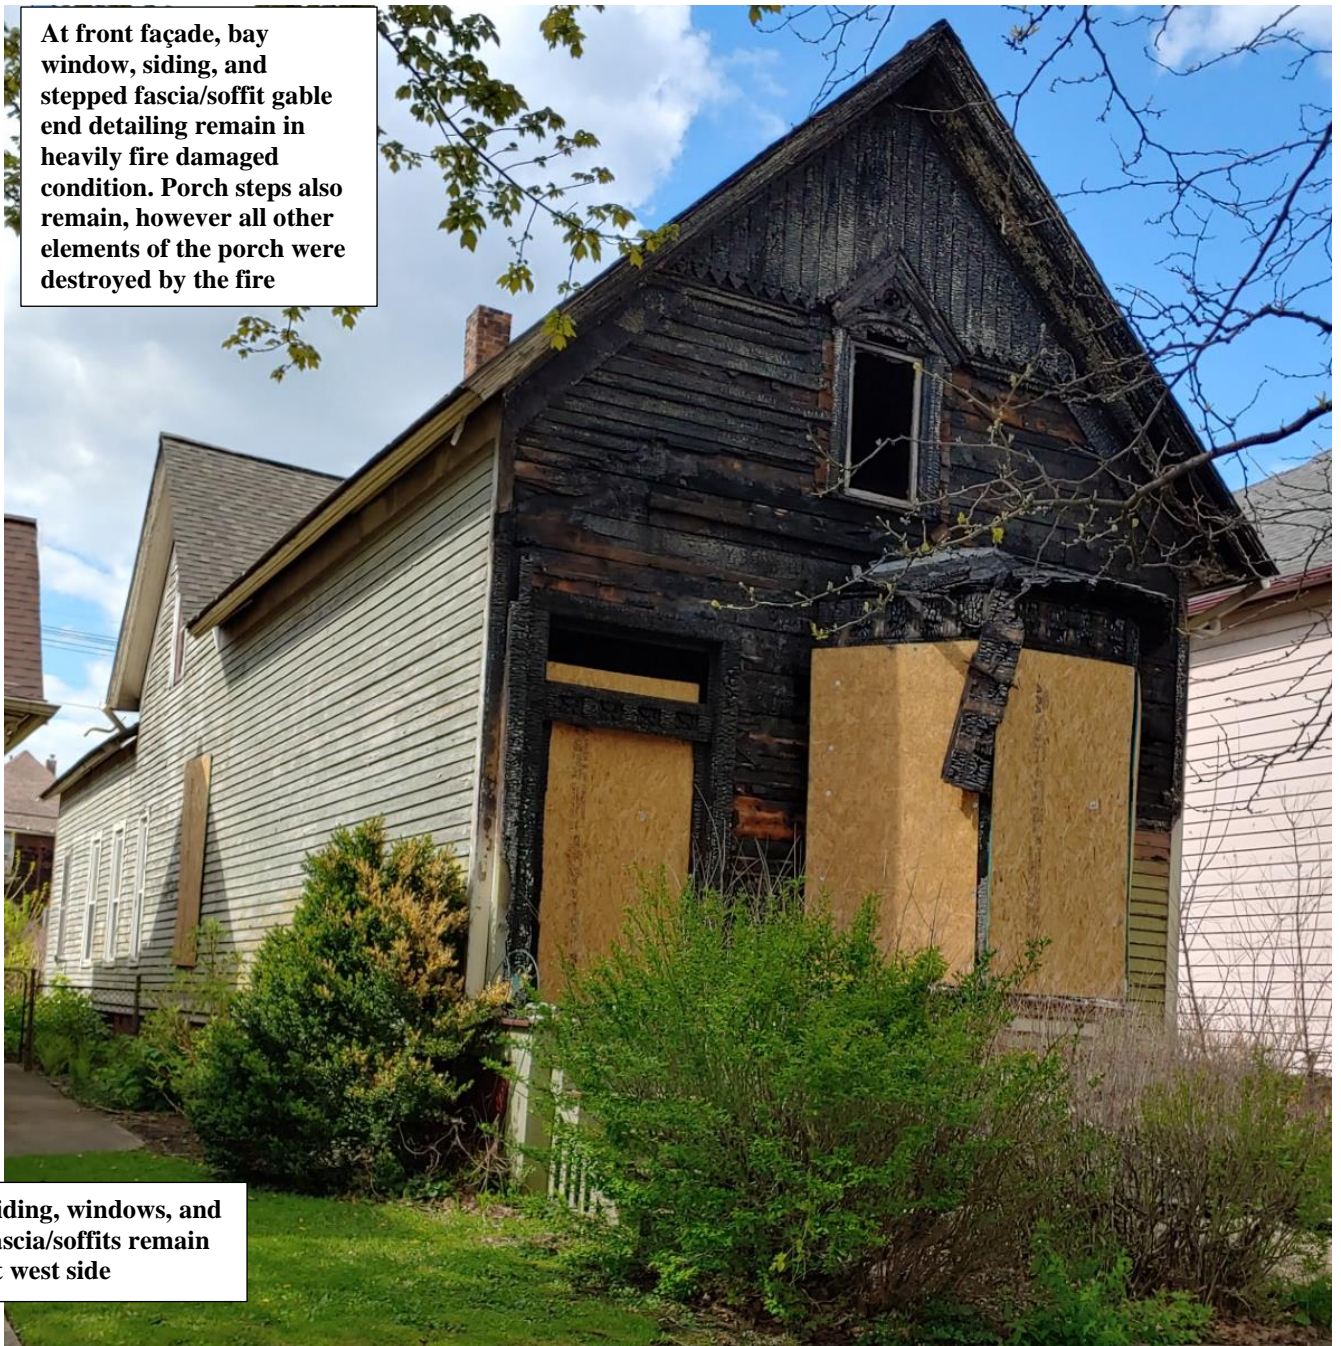
Note remaining elements at side porch

At front façade, bay window, siding, and stepped fascia/soffit gable end detailing remain in heavily fire damaged condition. Porch steps also remain, however all other elements of the porch were destroyed by the fire

Siding, windows, and fascia/soffits remain at west side

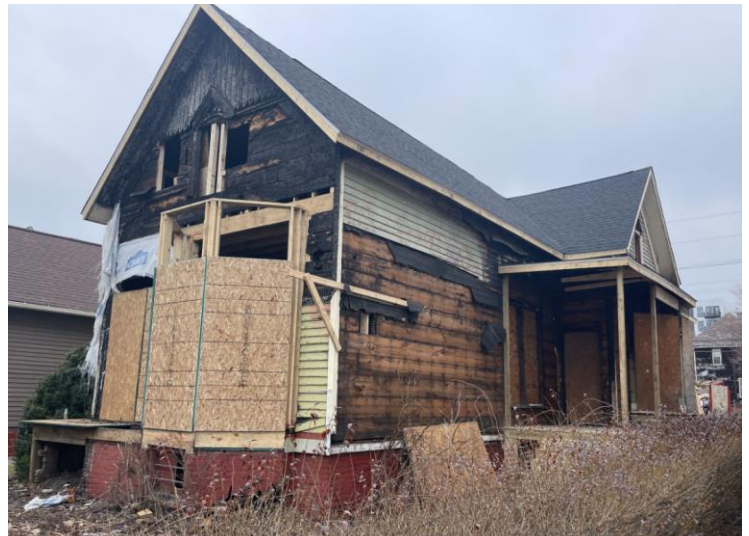
Appearance in 2/2024, after unapproved work. HDC staff

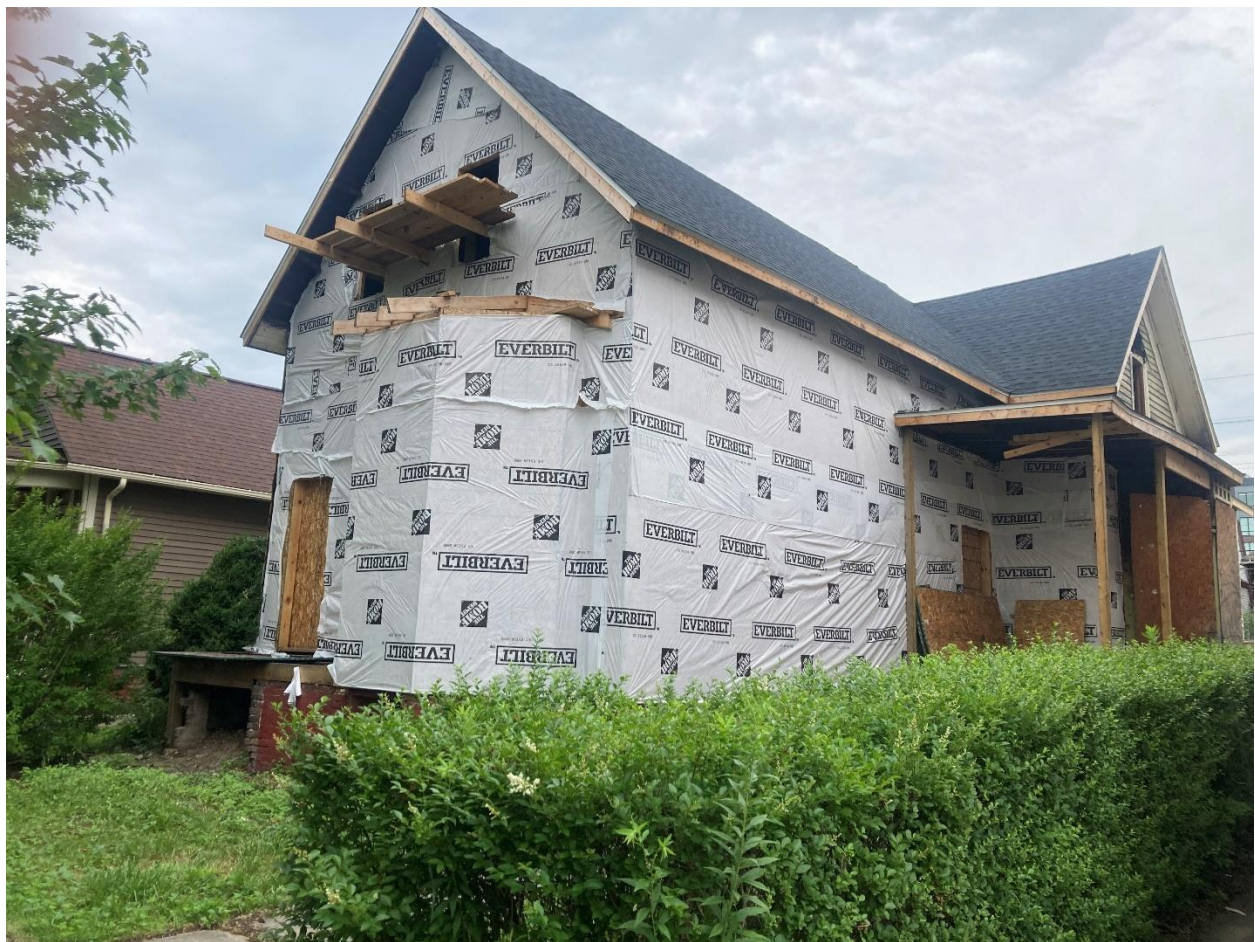
Current appearance, facing northwest. Photo taken by HDC staff on 6/25/2024

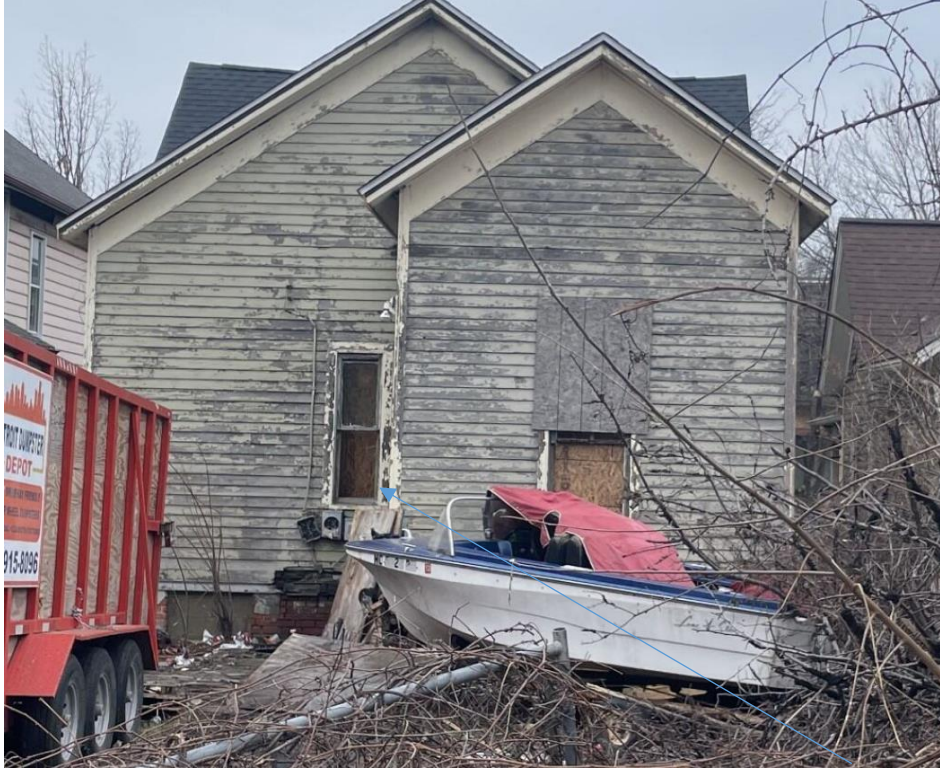
Rear, photo taken by HDC staff in 2/2024. Note that the window to the left was removed without HDC approval sometime between 2/2024 and 6/2024.
