STAFF REPORT: JULY 10, 2024 MEETING
APPLICATION NUMBER: HDC2024-00266
ADDRESS: 1651 EDISON
HISTORIC DISTRICT: BOSTON-EDISON
APPLICANT: MERISA LEWIS
PROPERTY OWNER: MERISA LEWIS
DATE OF PROVISIONALLY COMPLETE APPLICATION: JUNE 18, 2024
DATE OF STAFF SITE VISIT: JUNE 21, 2024

SCOPE: REPLACE WINDOWS, ALTER EXTERIOR (WORK DONE WITHOUT APPROVAL)
7/10 – Revised report in red; in response to recent submittal of additional information by applicant.

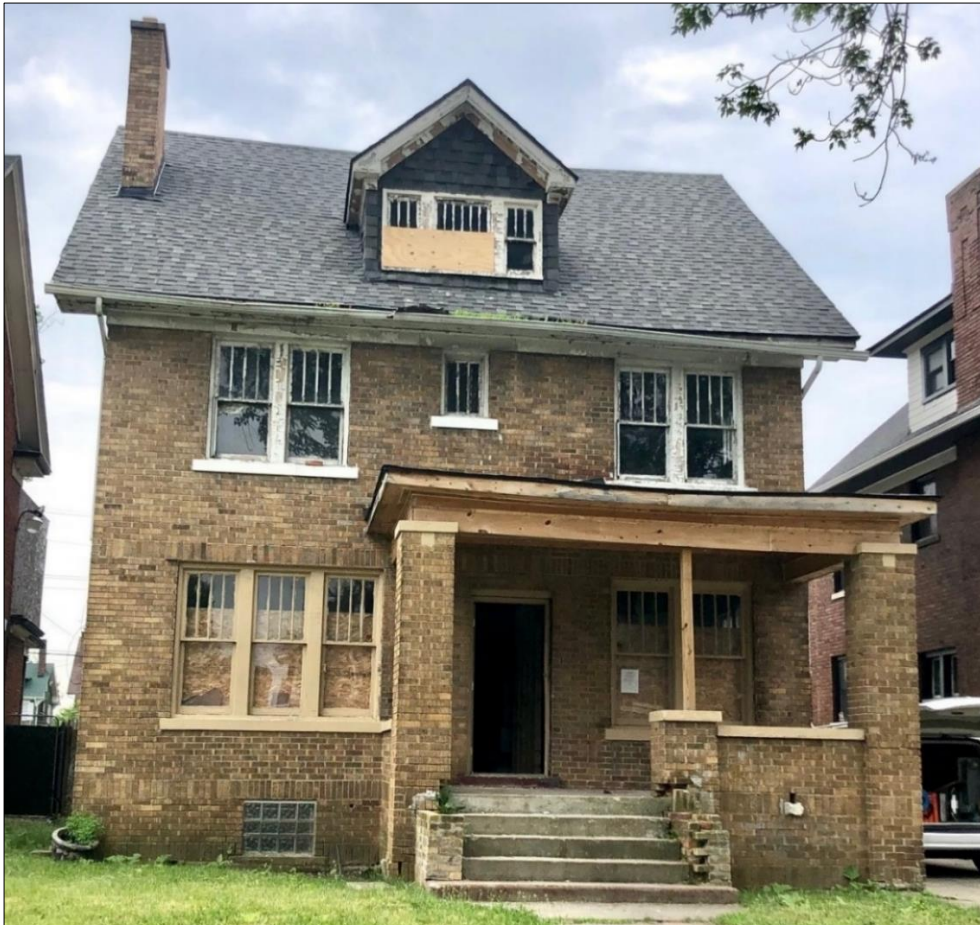
Façade, north-facing wall. Staff photo, June 21, 2024.

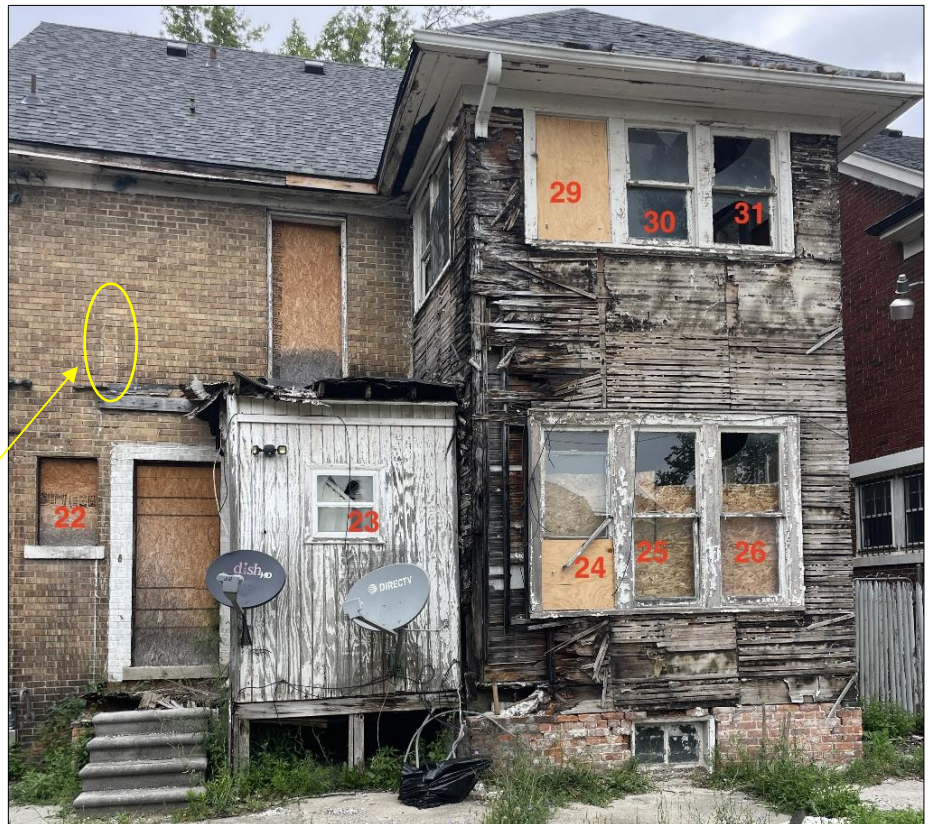
At the rear, a two-story extension fills the eastern half of the wall. Grouped one-over-one double-hung windows are set within the three walls of the structure. The exterior cladding is missing.

Single door openings at the first and second floor of the masonry-clad structure are enclosed with plywood panels. One single window opening with raised sill is also enclosed with plywood.

Remnants of a two-story open porch (including a ghost image of the upper deck's wood railing) offer physical evidence of its original footprint. The first floor porch is partially enclosed and covered with T-11 siding and one small non-historic window. Prefabricated concrete steps remain in place adjacent the first floor door, but the wood entry platform/deck has deteriorated to the point of collapse.

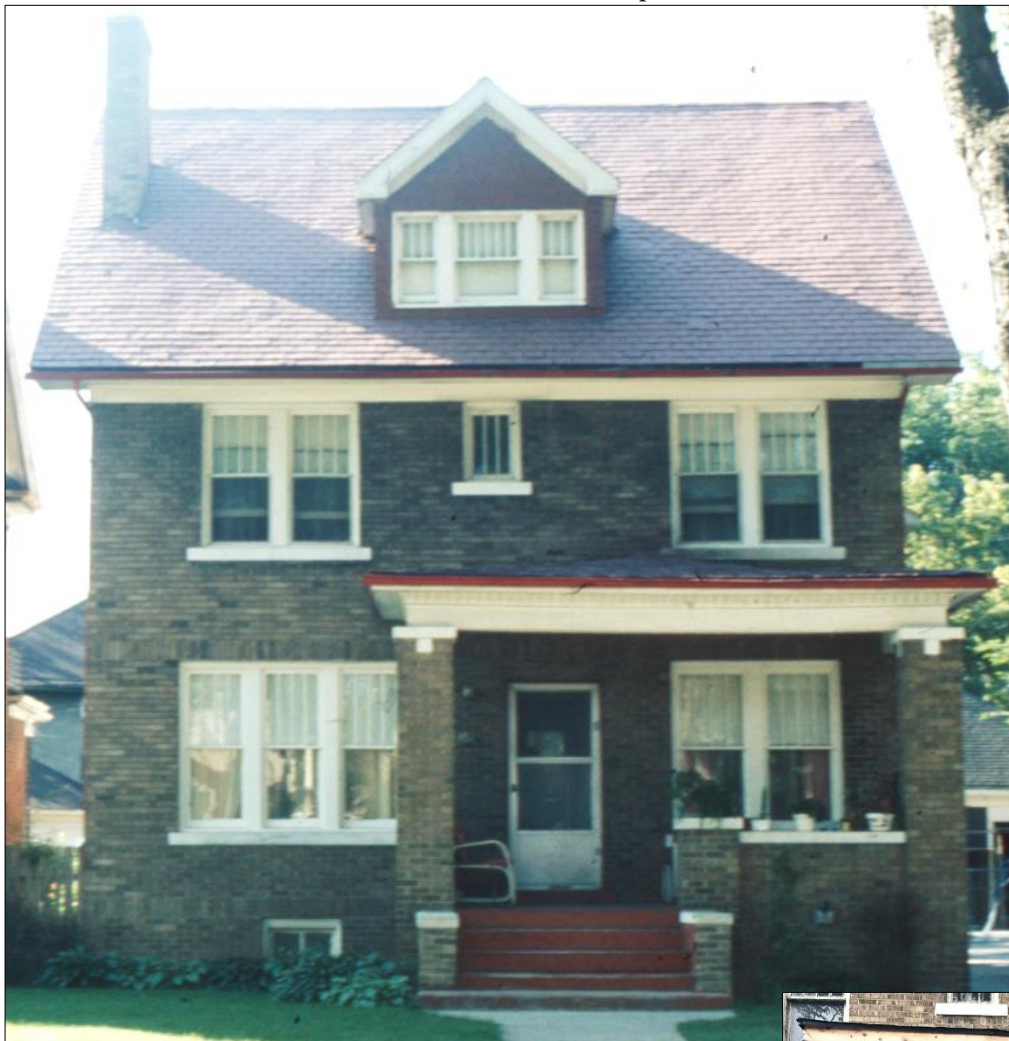
1974 designation photo, HDAB.

The designation photo shows the original design of the entry porch which is a distinctive character-defining feature. The minimally visible shallow-pitch roof and overhanging eaves allow the tall and profiled fascia to be a dominate detail which accentuates the wide expanse between corner columns, creating a strong horizontal massing to the porch.

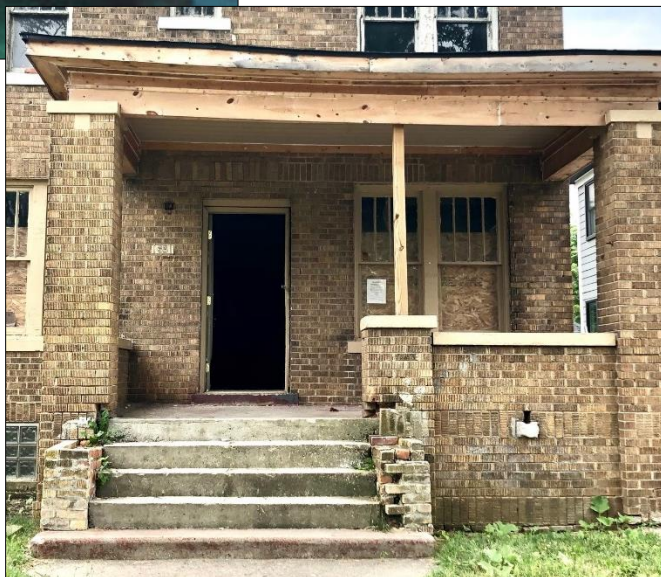
According to Google street view, the roof structure was removed between June 2019 and July 2022, and was done without HDC approval. The dimensions and overall profile of the new structure is similar to the historic design. However, the roof appears to be sagging in the middle, thus a wood support post was placed on the brick pier. The wing walls were partially dismantled, and the stone caps have disappeared.

The applicant must submit a detailed scope of work and dimensioned drawings to staff for review that rectify the following conditions: the sagging roof, to show how the fascia will be modified (or rebuilt) to match the historic condition, and that the existing wing walls will be repaired to their historic height by adding courses of brick that were lost as well as cast concrete caps.

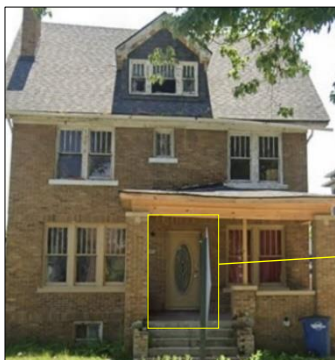
The existing “non-historic Victorian” door has contemporary Victorian styling and is not an appropriate design for this early 20th century house that has Prairie influences. The minimally detailed selected door offers compatible proportions to the architectural style of the house.

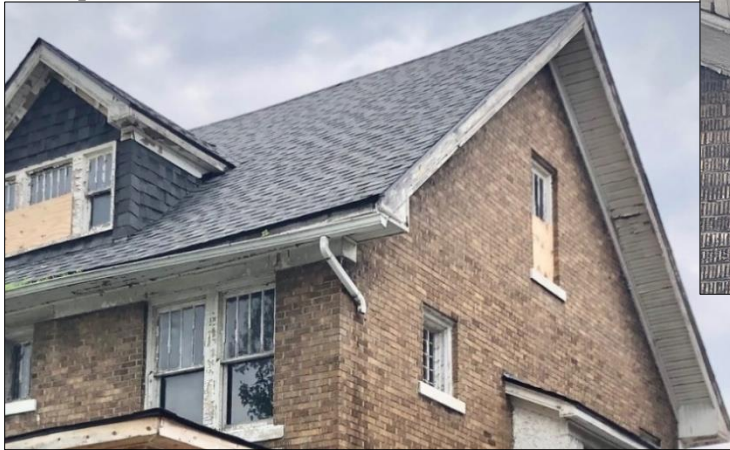
The existing eaves and soffits are character-defining features of the dwelling. Their condition consists of peeling paint and the occasional deteriorated or missing wood board, and therefore are in repairable condition. The installation of a manufactured product would remove the profile and surface texture of the wood soffits, altering the appearance and architectural proportions of the house. Wood is commonly available, reasonable, and a typical repair treatment for these locations.

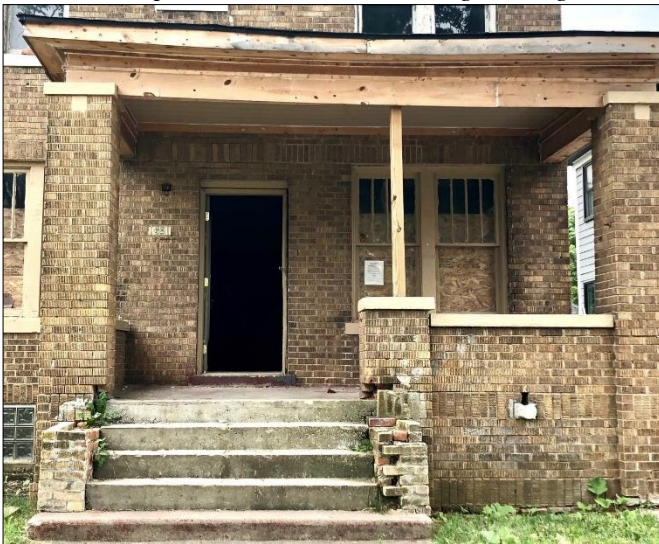
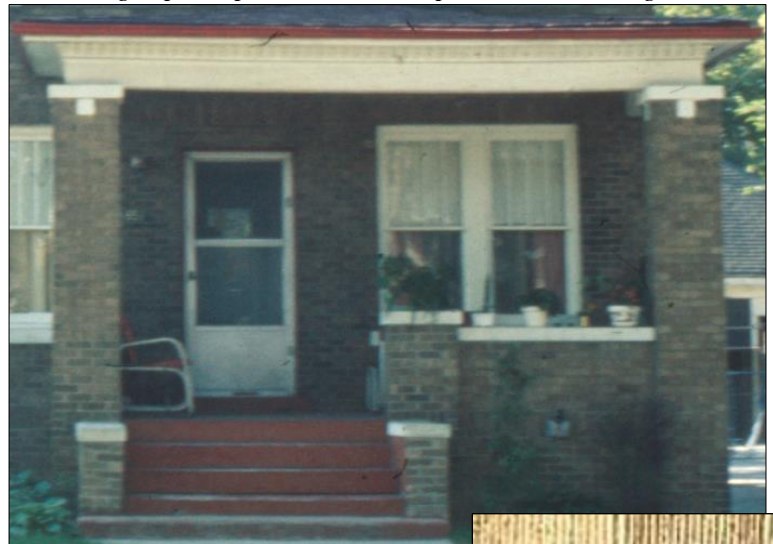
The applicant states the wing walls will be repaired and caps installed. The brick used on this house has a special vertical cut texture so brick purchased for any repair/replacement must match the existing bricks in color, texture, finish and dimension. New mortar must also be a historic composition so that it isn't harder than the existing mortar and bricks. Contemporary mortar mixes have different ingredients than early 20th century mortar and are therefore much stronger, which is problematic when used with/around older mortar and bricks.

- Bricks needed for masonry repair and replacement must have a similar vertical cut texture, color, finish and dimension. New mortar joints will match the existing mortar composition (no pre-mixed off the shelf mortar shall be used), dimension, and joint profile. The front porch wing walls will be rebuilt to match the historic height and cast stone caps will be used to top the rebuilt wing walls.

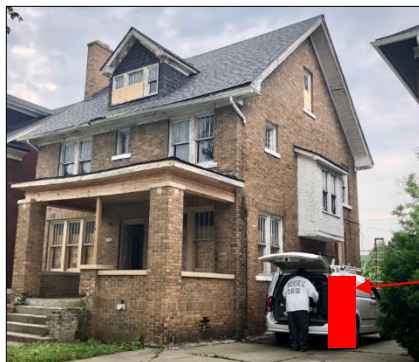
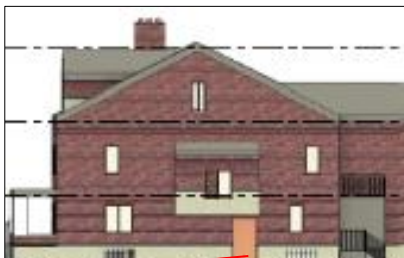
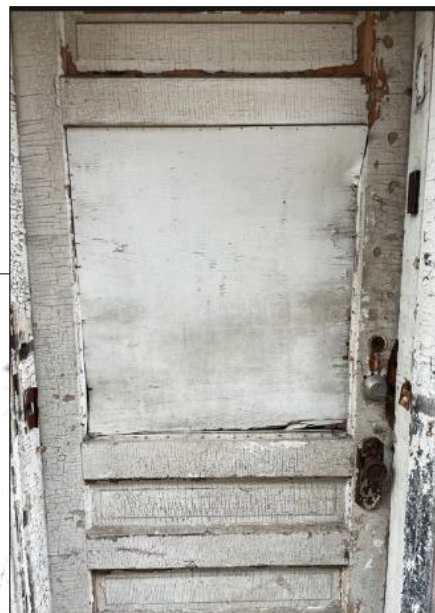
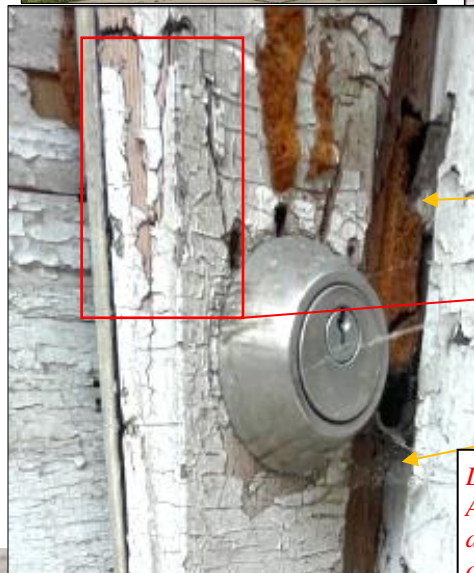
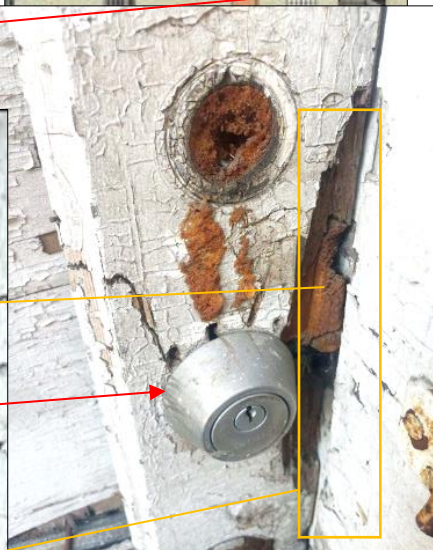
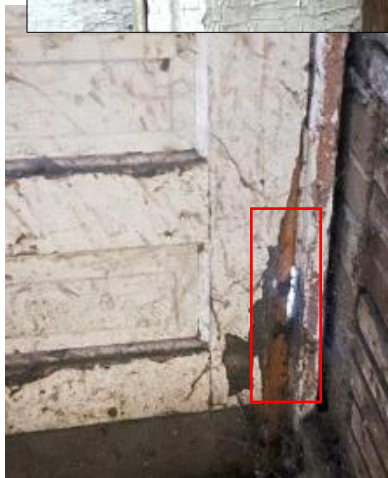
Top left: Staff photo, June 2024, identifying location and visibility of door.
Top middle: Applicant drawing.
Top: Applicant exterior photo, partial view, of door.
Remaining photos provided by applicant.

Left – red box identifies cracked frame.
Above: orange box and arrows to adjacent photo show dimensional views of missing sections of door frame.
Bottom left: additional section of missing door frame.

Additional photos submitted by the applicant show there is a crack through the frame directly above the deadbolt, as well as adjacent deeper sections of missing wood, all of which can compromise the strength and security of the door. Therefore, it is staff's opinion this door can be replaced with a new door that matches the horizontal design of the existing historic panel wood door.

wasn't submitted, ~~and the photographs provided by the applicant show the door to be in repairable condition.~~ The additional photos submitted by the applicant changed staff's opinion on the door's condition. Therefore, it is staff's opinion that the door can be replaced with a similar horizontal patterned door.

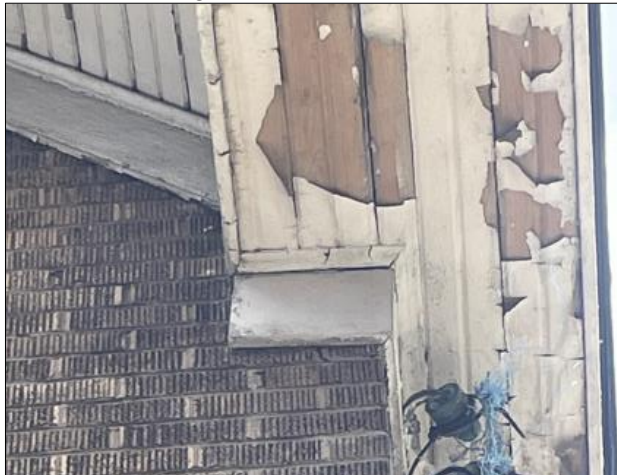
The existing eaves and soffits are character-defining features and in repairable condition, with peeling paint and the occasional deteriorated/missing board. The installation of a manufactured product such as the proposed Hardie Soffit, would alter the profile and surface texture/beadboard expression of the soffits, altering the appearance and architectural design of the house.

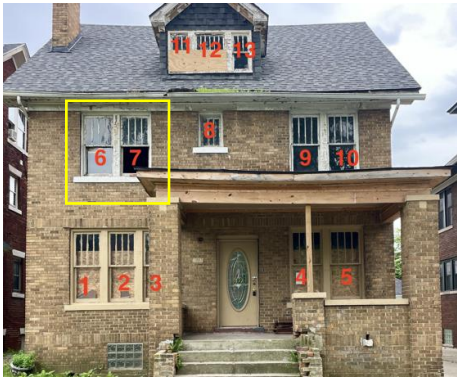
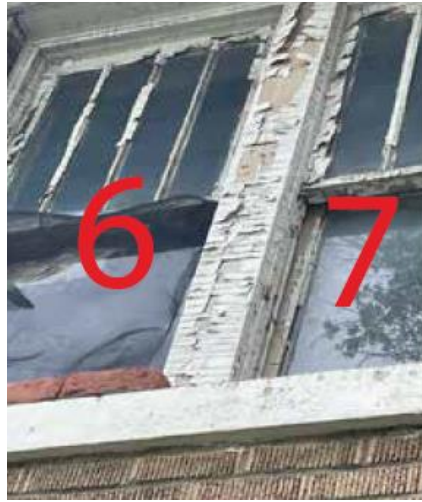
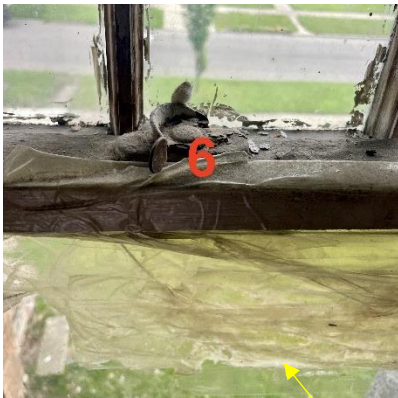
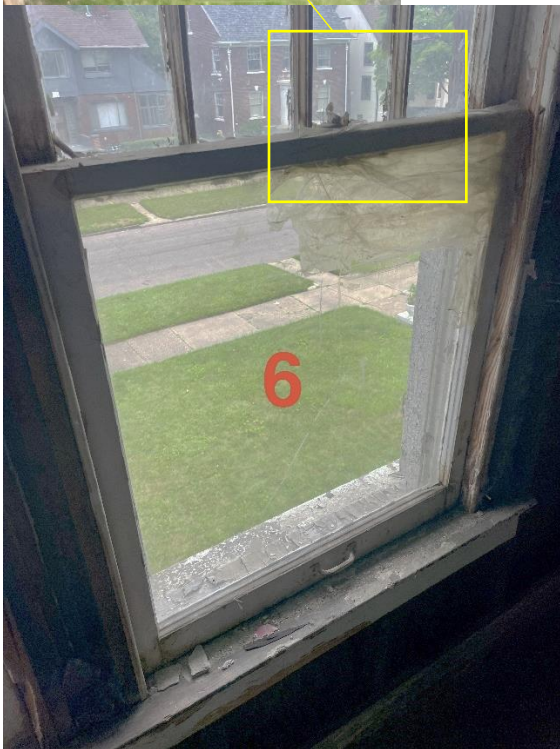
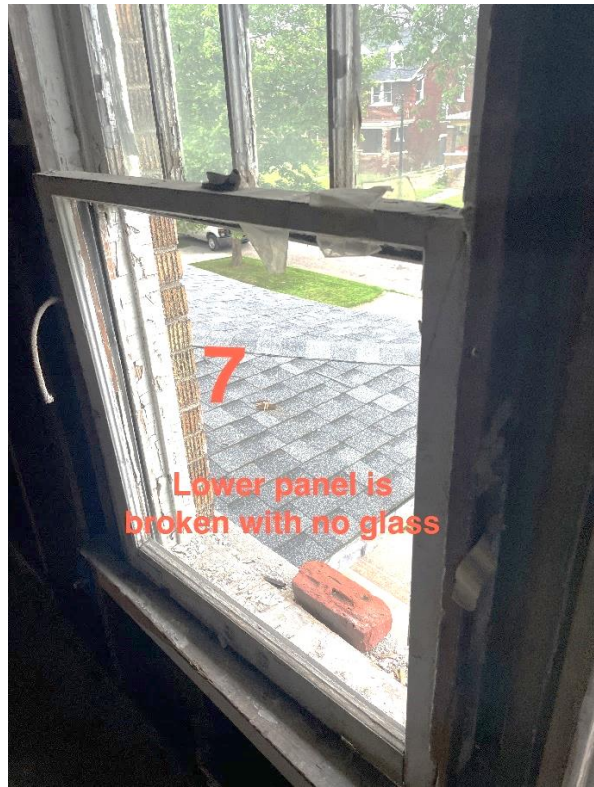
The glass in the bottom sash (6) may need to be replaced and new glass is needed for (7).

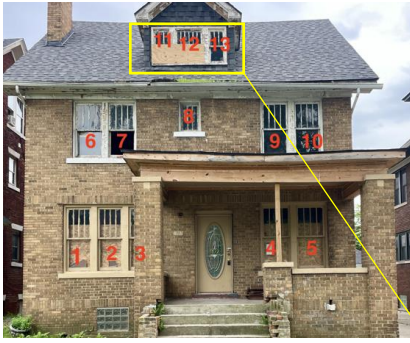
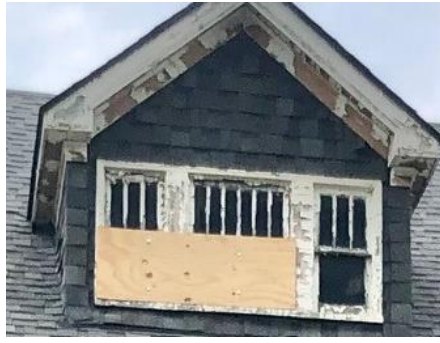
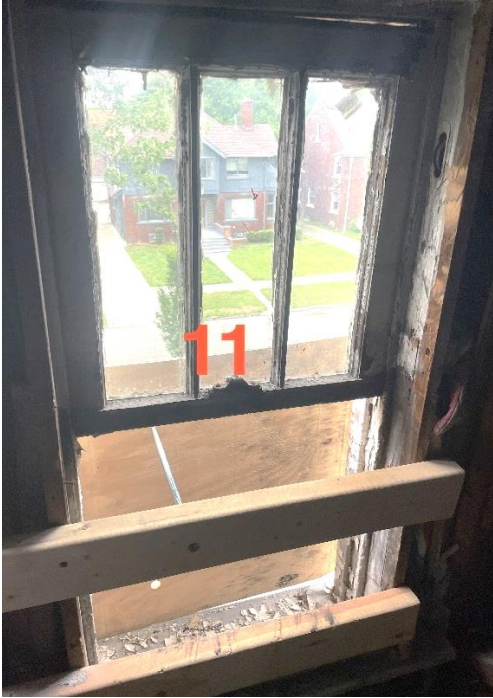
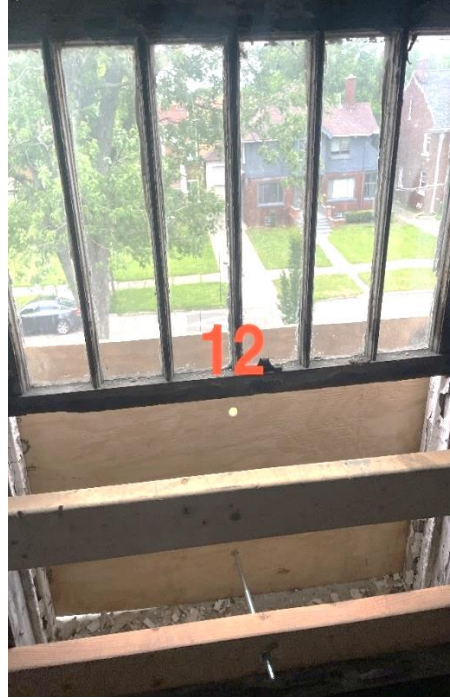
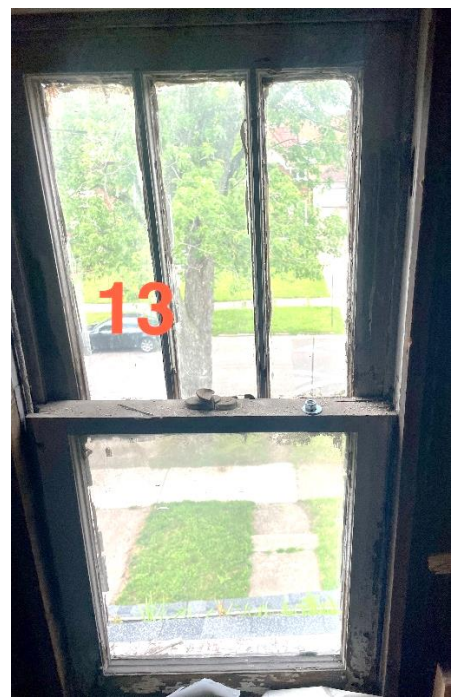
Missing lower sash (11, 12); new bottom sashes can be fabricated.

As evidenced in the muntin pattern, the middle window is wider than the flanking windows.

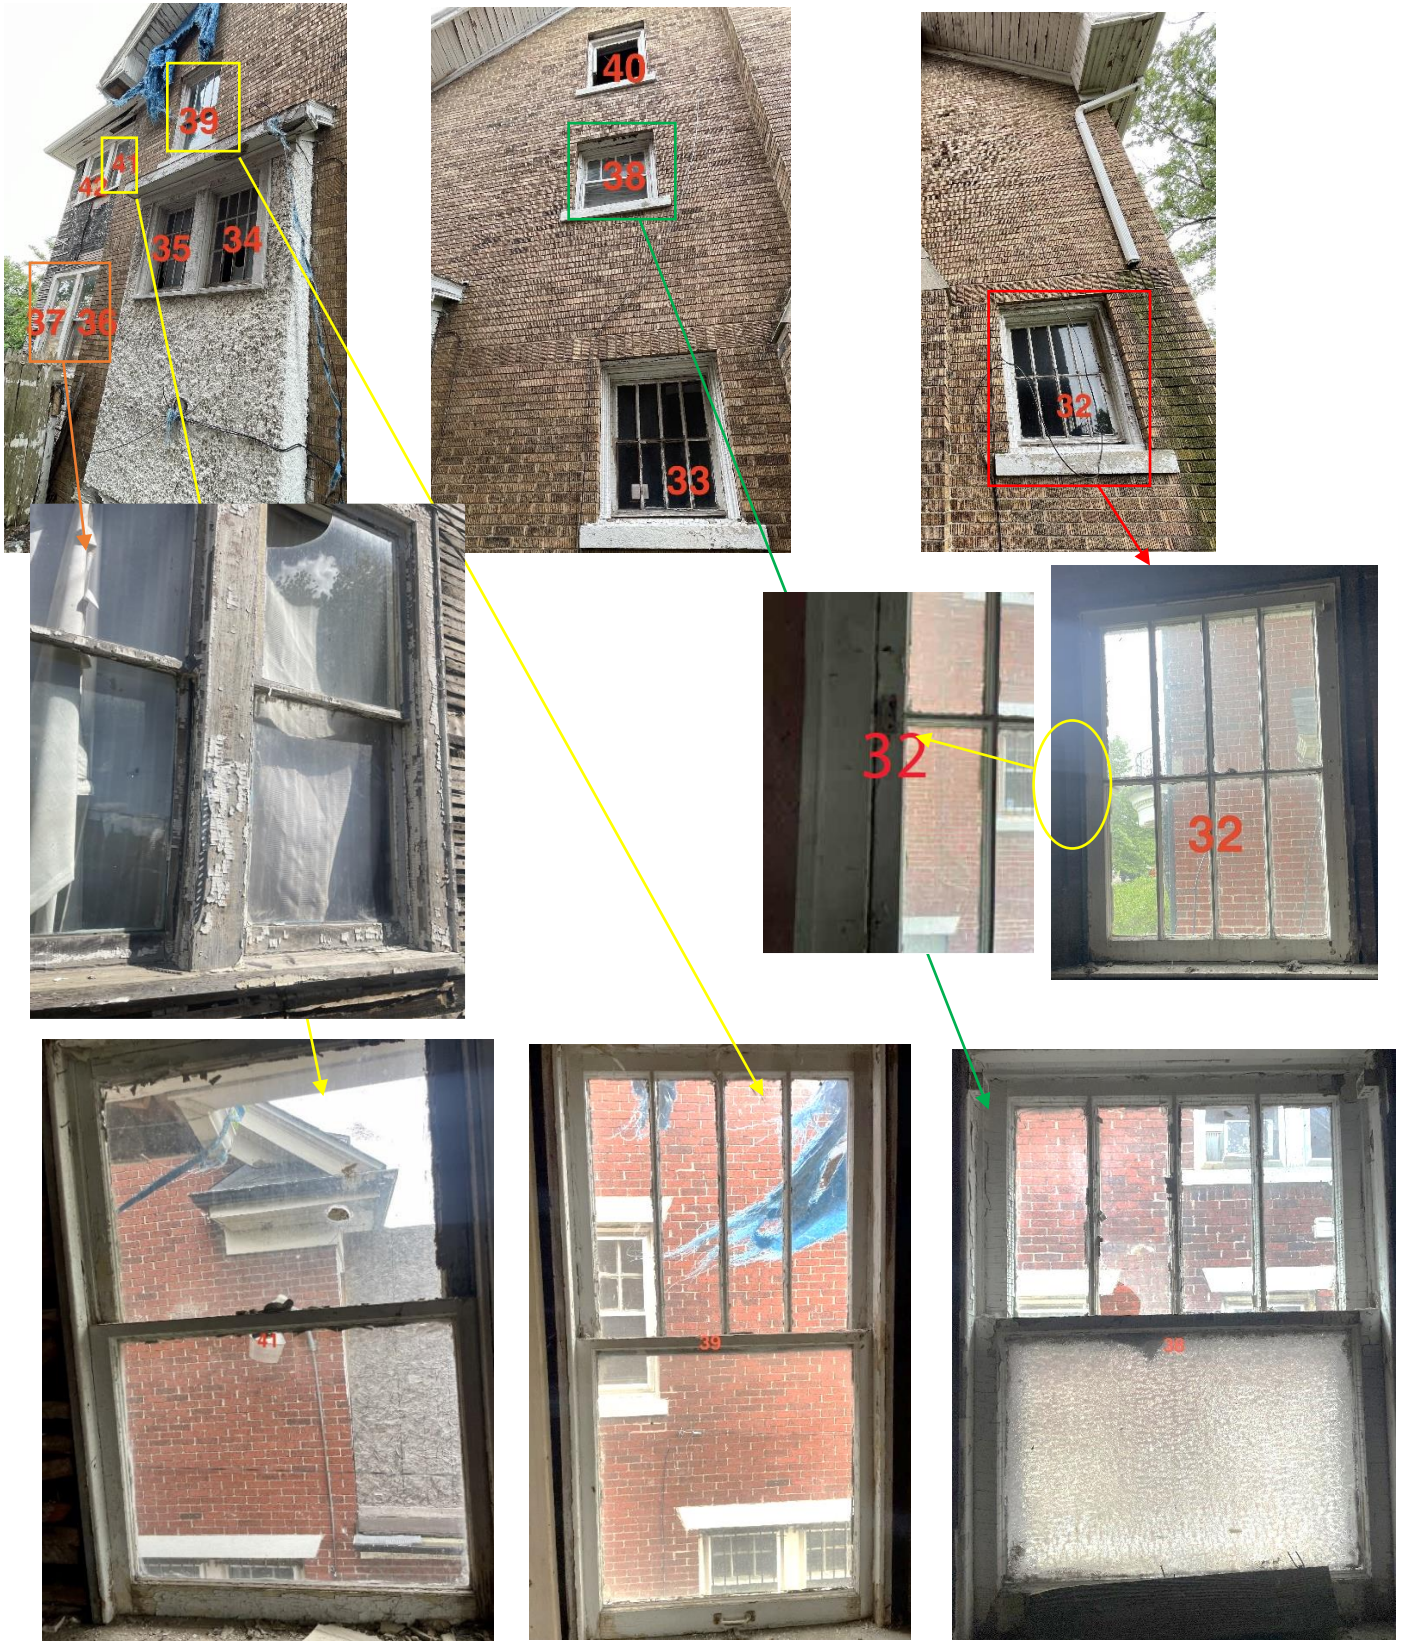
It appears there is no window in the third floor window (40), so a new unit in this location will be needed.

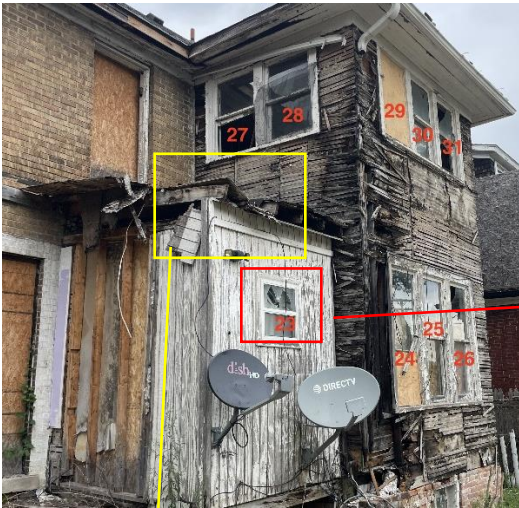
#23 is a non-historic window in a non-historic wall.

#28 is numbered wrong, as all the windows in the rear extension have one-over-one windows, and it appears this window looks towards 1659 Edison (to the west).
