STAFF REPORT: JULY 10, 2024 MEETING

APPLICATION NUMBER: HDC2024-00326

ADDRESS: 19511 SHREWSBURY

SCOPE: REPLACE PORCH TILES

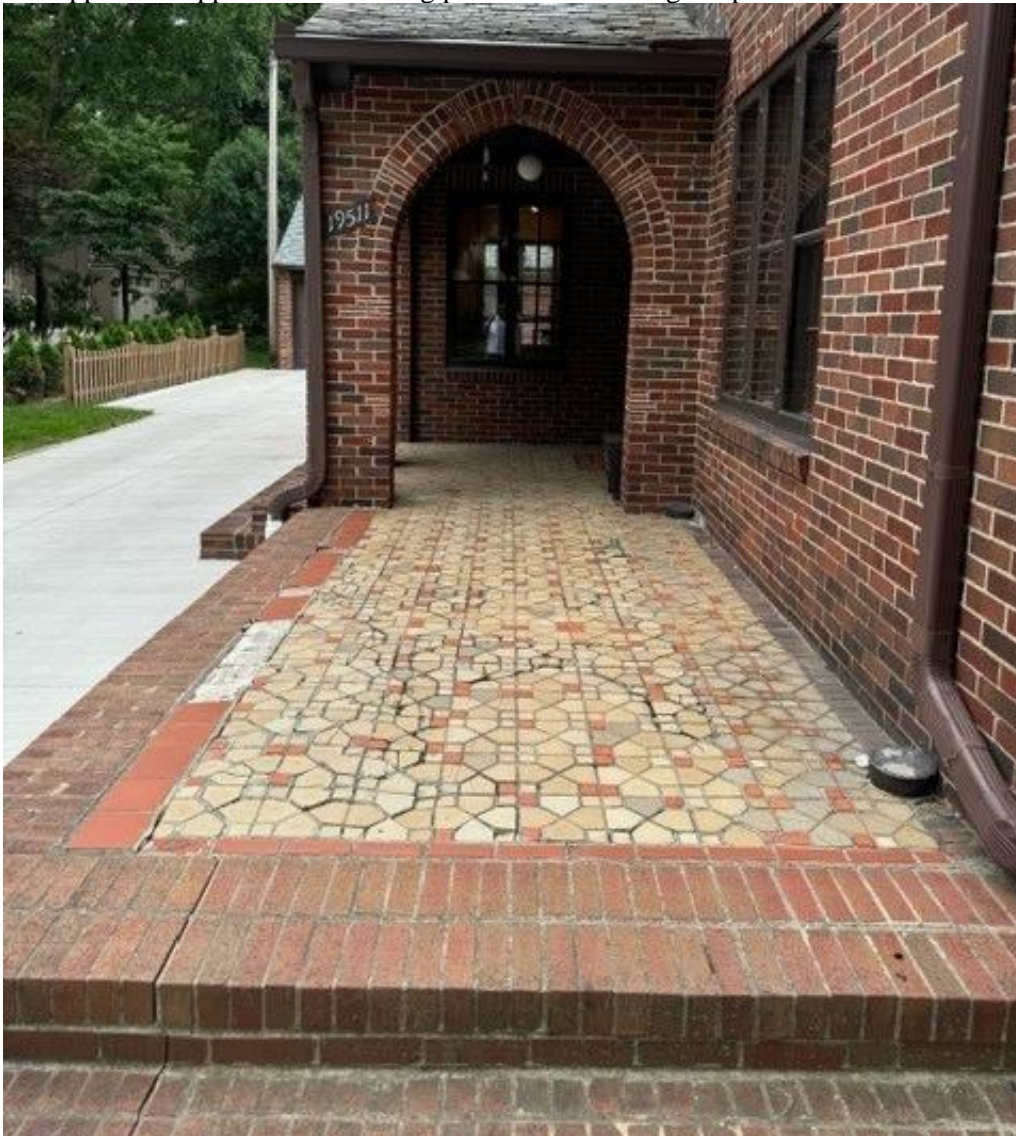
Applicant photo. View from steps at front walkway. Three different materials are used to edge the tile floor: square clay or quarry tiles at the west perimeter, narrow rectangular tiles at the northern perimeter, and a rowlock course of dark colored bricks at the western perimeter adjacent the house.

It is staff's opinion that the above photo and close up images on the following pages document a high level of deterioration to the exposed tiles. Evidence of numerous repairs is also noticeable due to a large number of mismatching tile colors and subsequent altered patterns. The inconsistent design and materials used to frame the tile floor is incongruous with the restrained Tudor Revival design and the finely detailed brick accents (including those framing the arched porch entrances).

As a large number of the tiles on the open porch are broken, and is more than half the surface area of the porch, staff agrees that the existing porch floor is deteriorated beyond repair.

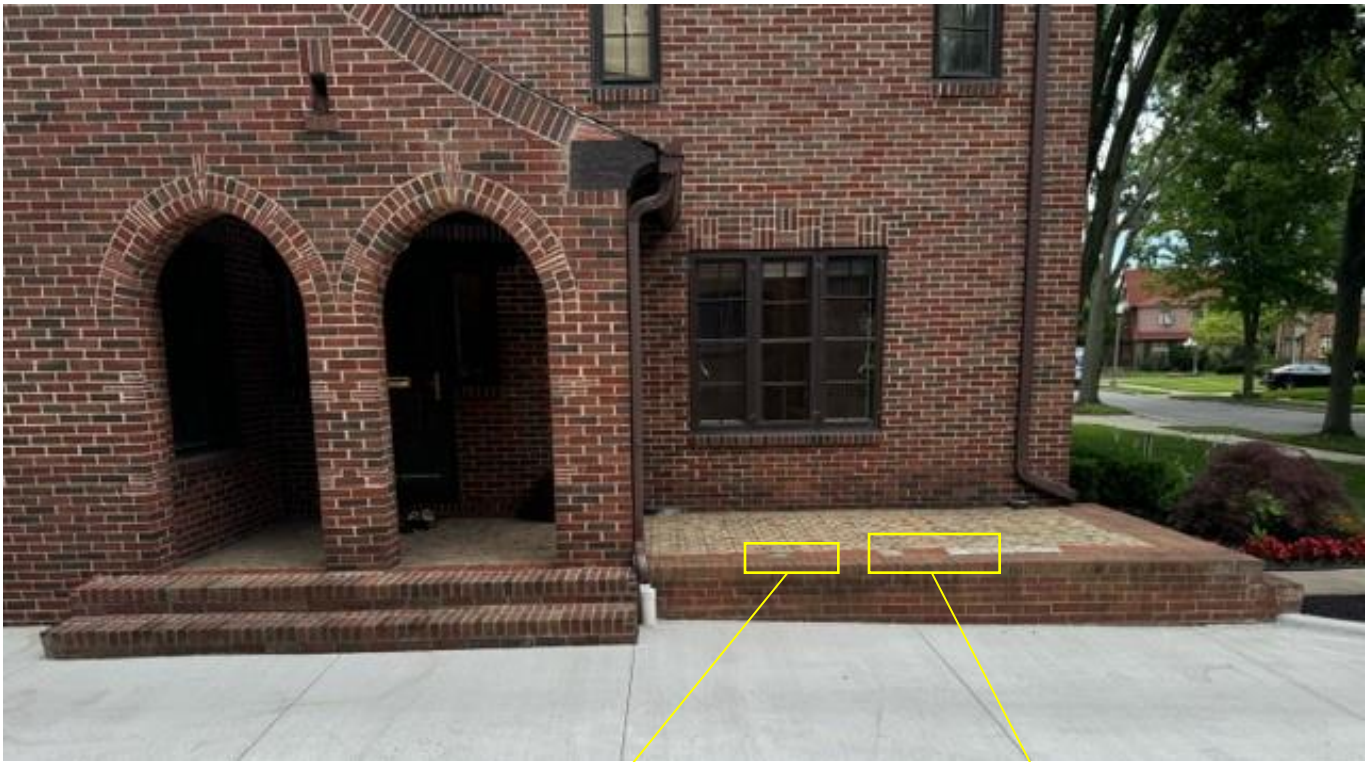
Applicant photos. View looking west from driveway.
