STAFF REPORT: JULY 10, 2024 MEETING
APPLICATION NUMBER: HDC2024-00329
ADDRESS: 1450 SEYBURN
HISTORIC DISTRICT: WEST VILLAGE
APPLICANT: VOYTEK MARDULA
PROPERTY OWNER: VADELLA LLC
DATE OF PROVISIONALLY COMPLETE APPLICATION: JUNE 18, 2024
DATE OF STAFF SITE VISIT: JUNE 21, 2024

SCOPE: ALTER PORCH (WORK COMPLETED WITHOUT APPROVAL), PAINT TRIM AND PORCH POSTS, RETAIN FRONT DOOR SURROUND

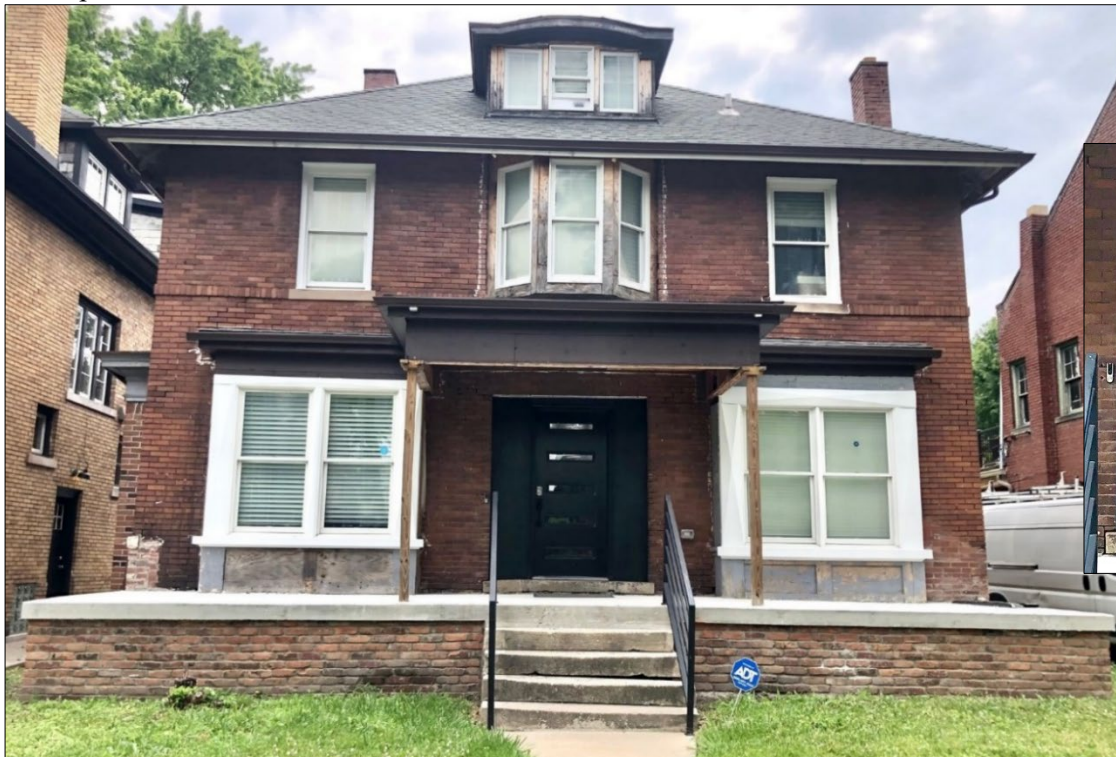
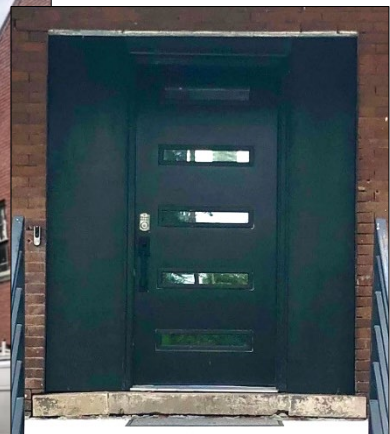
The full width porch with new concrete pad has walls veneered with reclaimed brick. A portico extends the depth of the porch; small wood posts support the extended roof. Concrete steps lead to the porch and aluminum black railings with horizontal balusters are in place on either side of the steps. An outline of the original porch wall is evident at the northern corner of the house, giving solid evidence of the height of the original porch wall. The front door and surround include a black contemporary panel door with five narrow/wide glass panels and plywood that is painted black.

Façade, west-facing wall. Staff photo, May 21, 2024.

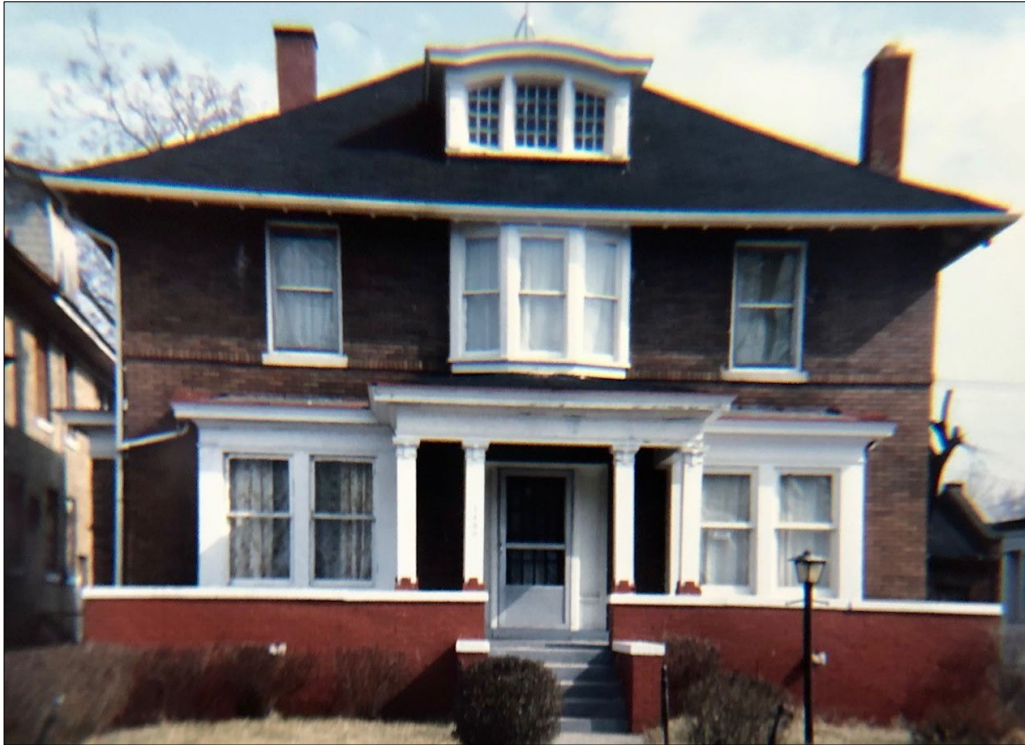
1983 designation photo, HDAB.

The character-defining features of the façade are evident in the designation photo: hip roof, box bays with full surround wall trim and cottage-style windows (the upper sash are slightly shorter in height than the lower sash), double-hung windows at the second floor, overhanging eaves with exposed rafters, brick band/integrated stone sills at the second floor, and an eyebrow dormer with multi-paned arched casement windows that match the dormer's roofline. The porch was accessed by concrete steps enclosed with brick/cast stone topped wing walls, and the porch was fully enclosed with a low brick wall, topped with cast stone. The portico was supported by paired porch columns with geometrically designed capitals and bases.

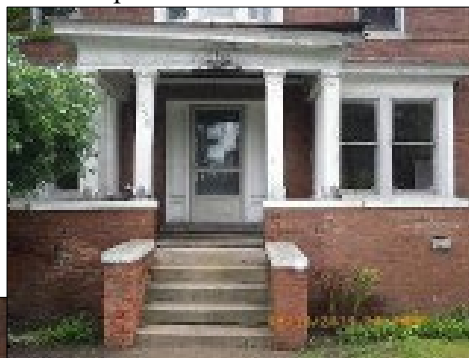
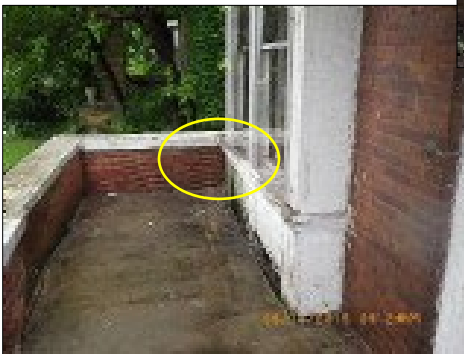
These circa 2013 photos, provided by the applicant as part of a rehabilitation application, show the porch enclosed by low walls, whose height matched that of the box bay panels.

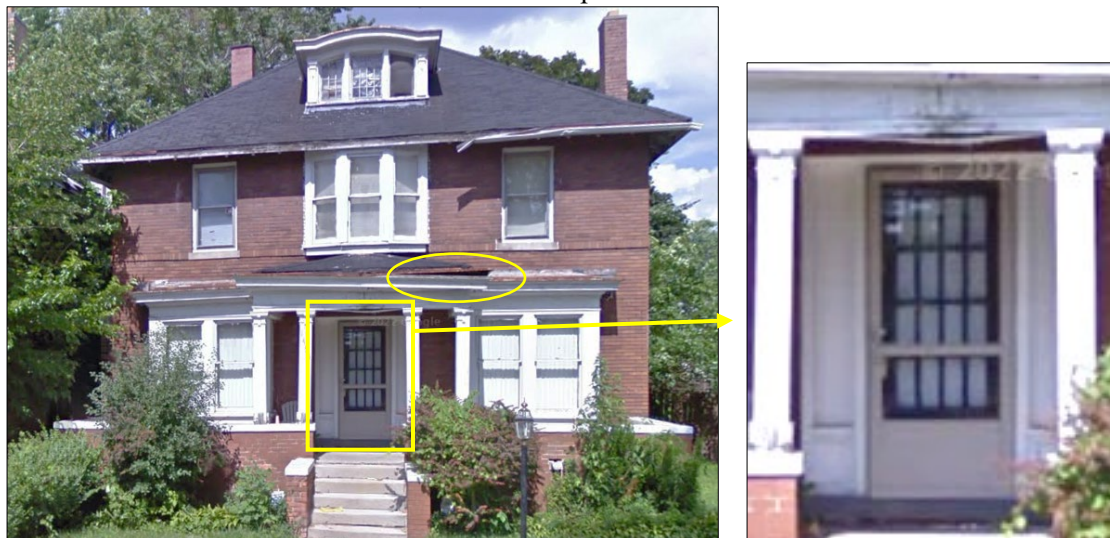
July 2009, Google streetview. The porch roof is beginning to sag, but otherwise the façade is intact. This photo offers a good view of the 16-light wood front door and wood side panels.

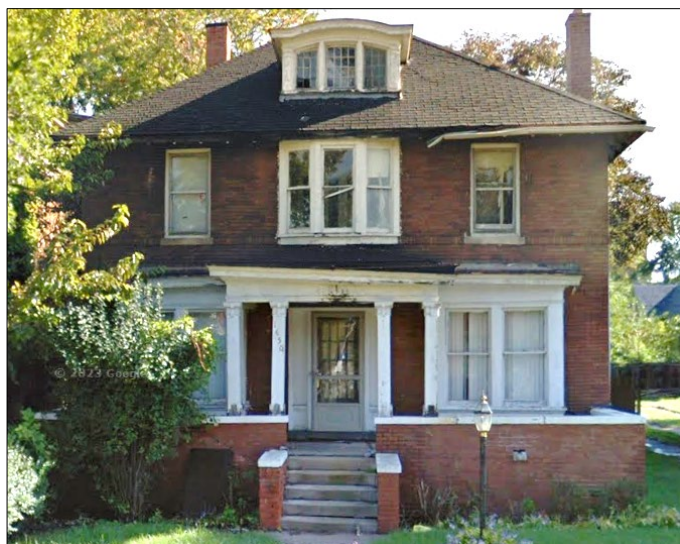
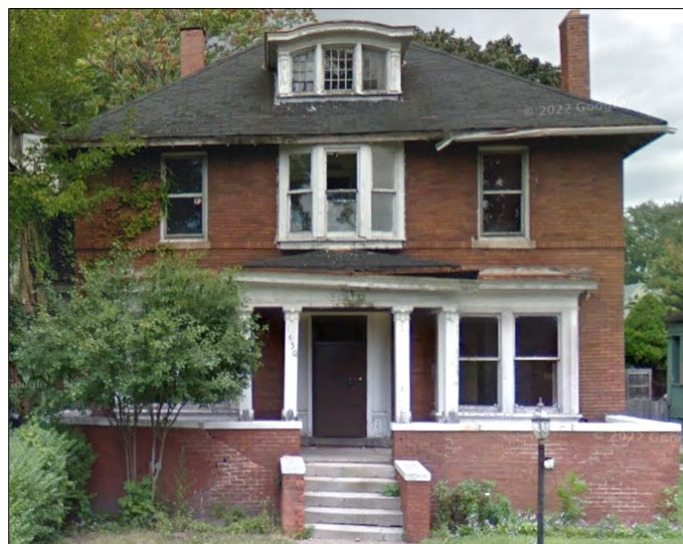
September 2011, Google streetview.

September 2013, Google streetview.

It appears the historic front door was replaced during the time between these two images, but the side panels remain. The new door appears to be a solid panel unit.

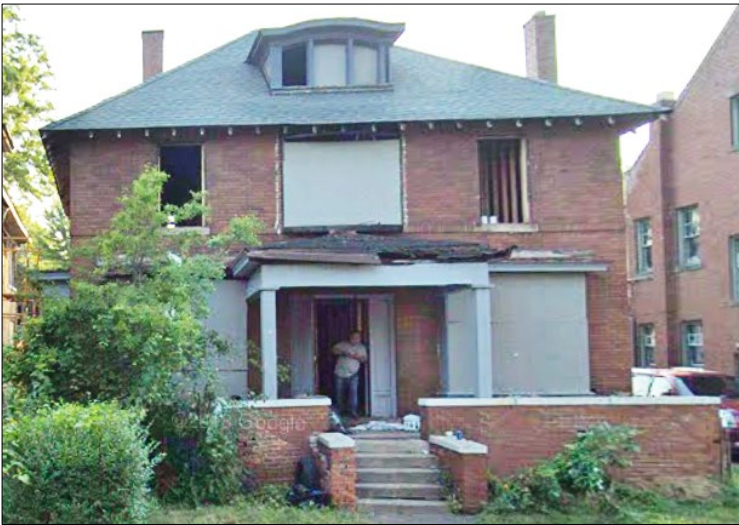
August 2018, Google streetview.

Within one month of a COA being issued for the asphalt shingle roof and front porch repair, a new roof was installed, wood windows were removed from the second floor and dormer, and the box bay windows were covered. The rafter tails are clearly visible here due to the missing fascia.

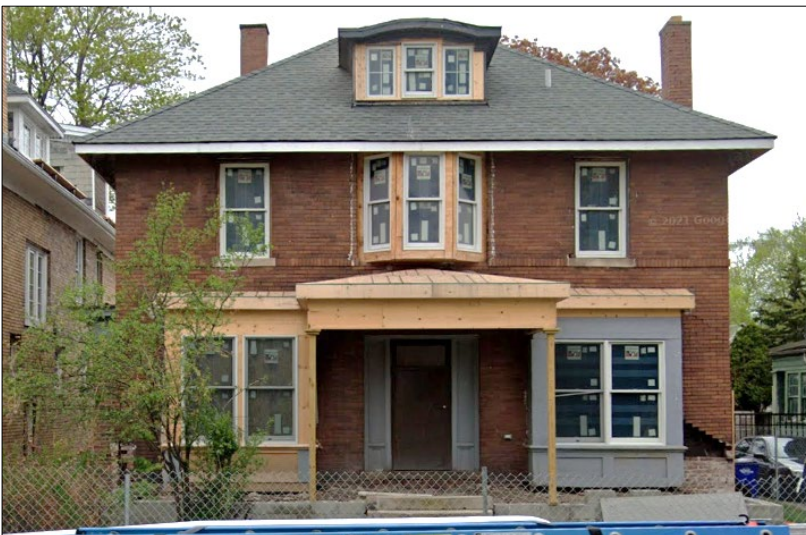
May 2019, Google streetview.

This 2019 photo shows extensive work continuing to take place on the façade, including the removal of the rafter tails, new windows (most of which don't match the historic window units in operation, design, and possibly material), and the removal and rebuilding of the box bays, front porch and portico.

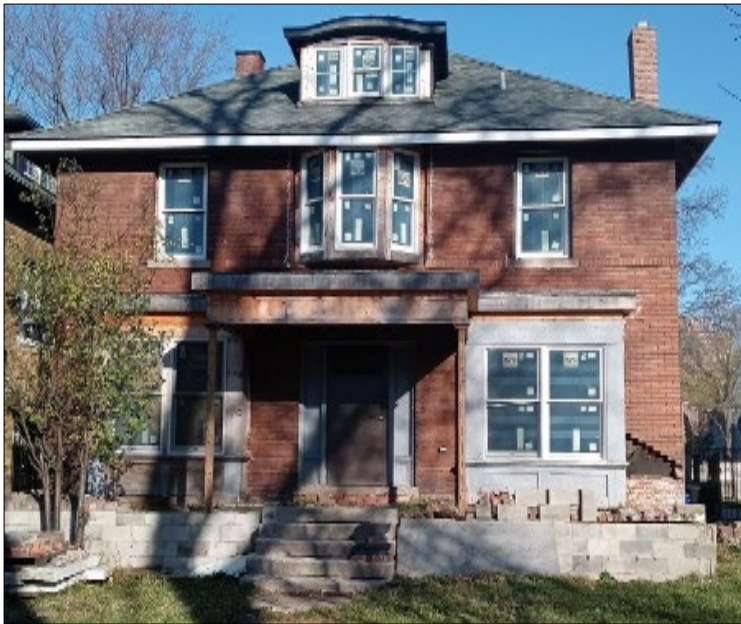
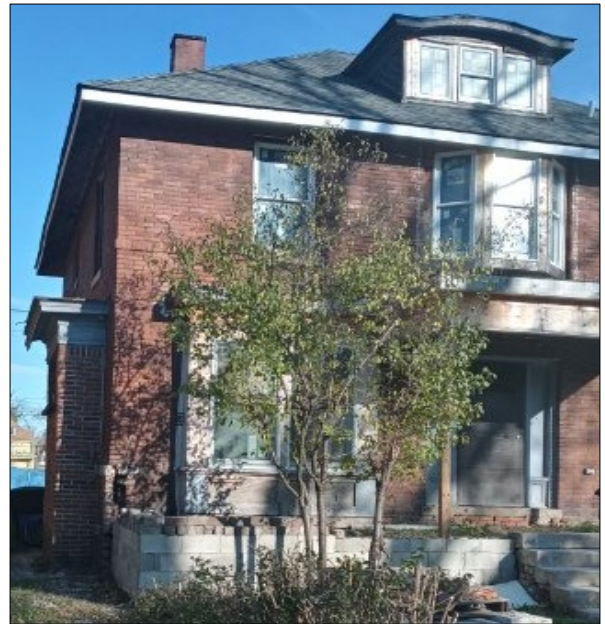
Fall 2020 photos submitted with the application for the installation of new gutters and downspouts. FYI - The wood panels on either side of the door remain in place.

Continued documentation of the rebuilding of the box bays and front porch/portico appears in the 2020 photos. The wood posts supporting the portico offer intermediary support for roofs while construction around these posts occur. However, once the porch floor was finished, these posts should have been wrapped in wood, with trim applied for the base and capital, matching the historic design's dimensions and details. This was not done, and the posts remain per the 2020 condition.

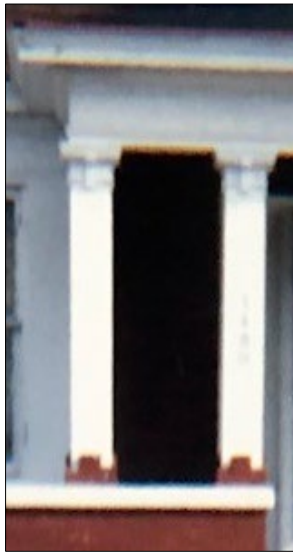
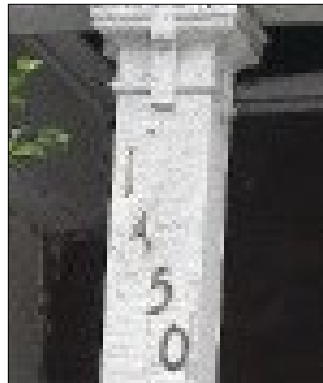
*Left: 1983 designation photo. The design of the almost flat trim at the base of the columns is accentuated by red paint.
Right: This zoomed-in 2013 applicant photo offers a fairly clear view of the design that was at the top of the columns.*

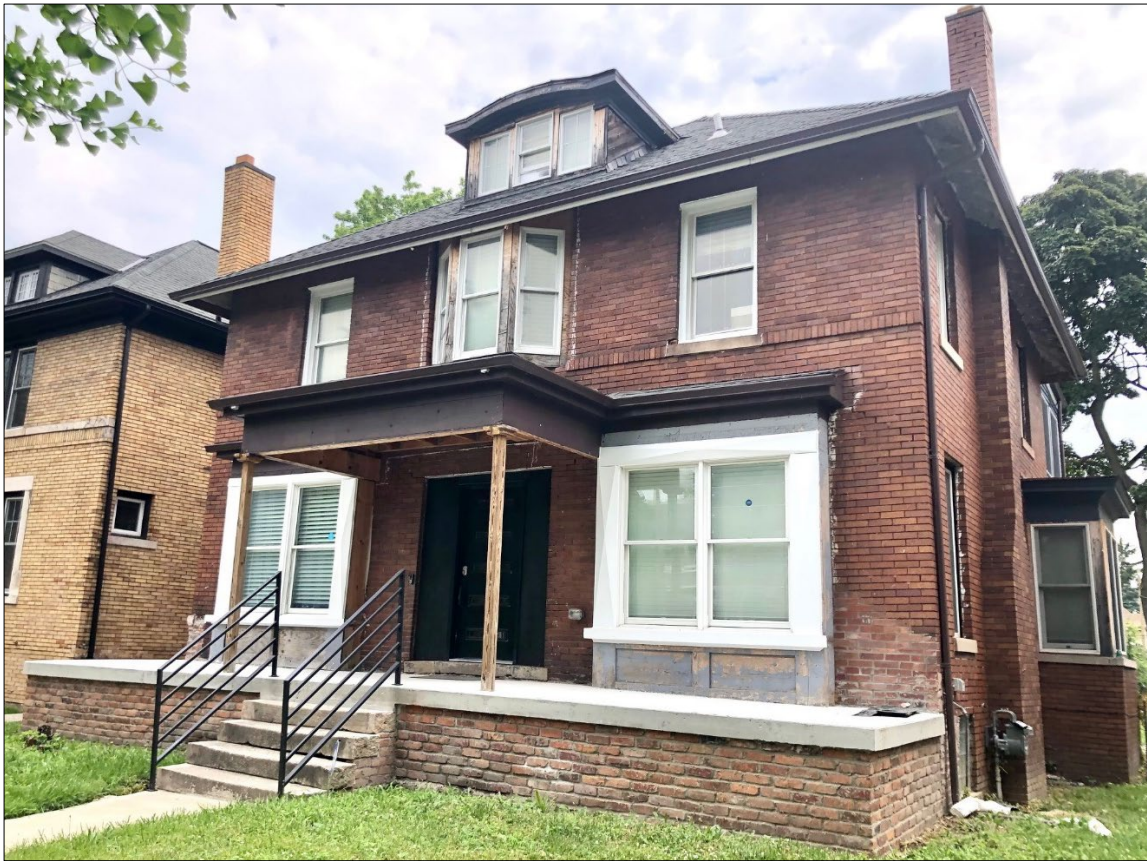
Staff photo, May 2024.

As character-defining historic features and elements were present at time of designation, and even as recently as 2013, the removal of these features is a violation, and the installation of new designs, features and dimensions which are not appropriate and do not meet the Secretary of the Interior's Standards, add to the violation. Unless the Commission approves these alterations, the ordinance will require that the original architectural features be restored in full.

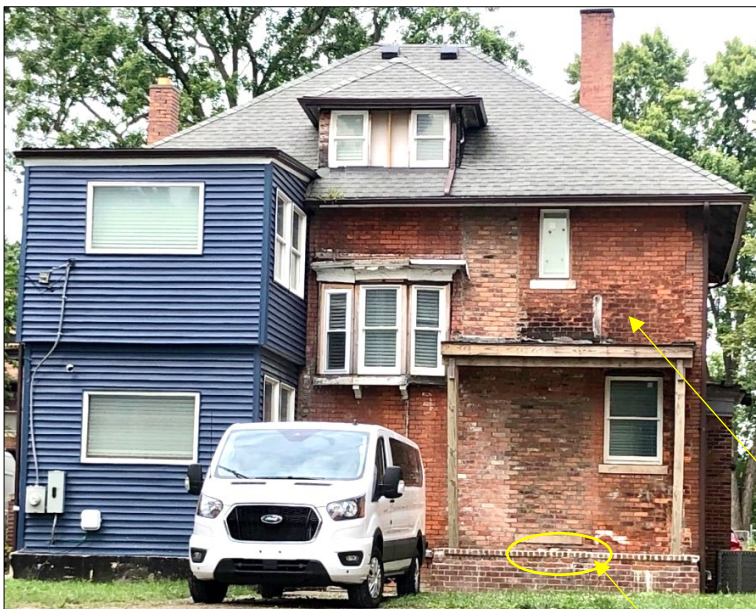
Above and bottom right: Staff photos, May 2024. Stone threshold.

- Removal of the central (one of three) windows in the dormer; and window operation changed from multi-light casements to one-over-one double-hung.
- Door leading to the upper porch was removed and bricked in; and the narrow double-hung window was changed to fixed/casement. Upper porch railing was removed (ghost image is present).

- Two doors at the first floor that led to the raised porch were removed and bricked in, but the historic opening's stone threshold remains. It appears as though there are not any stairs that lead from the yard to the raised open porch. Unadorned, thin posts support the roof.
- The two-story extension was not built as approved.
 - Window openings at the rear wall changed in size and operation; mullied one-over-one double-hung openings are now smaller single fixed openings with clear glass.
 - Vinyl siding was installed on all walls, rather than brick at the first floor and wood clapboard siding at second floor.
 - The door, wood platform and stairs at the rear wall were not installed.

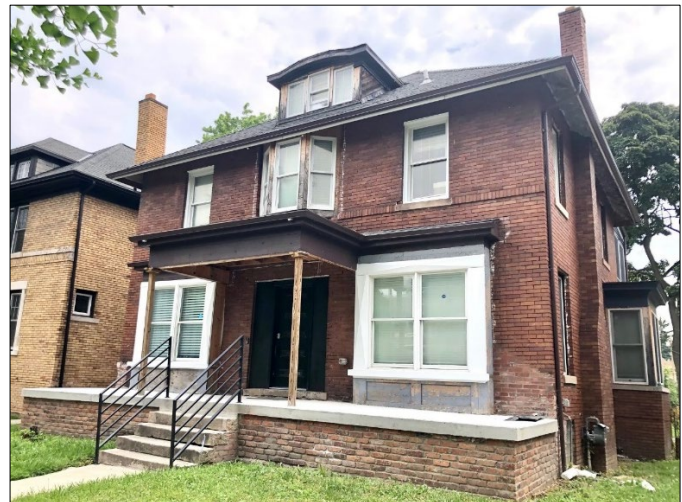
- Paint front and rear porch pillars. Paint all existing window trim and pillars in black (Color System E) for 20th Century composite. *The applicant doesn't propose to wrap the posts to create columns. The retention of the supporting posts as a finished detail is not appropriate for this house's design and era of construction, as well as their prominent locations. One of the hallmark features of Neo-Georgian houses is contrasting trim. As this house has dark brown brick, the appropriate colors for the trim (windows, posts, etc.) are various shades of white to yellowish white, not black..*

May 2024 staff photo.
