**ADDRESS:** 1667 EDISON

**APPLICATION NO:** #HDC-2024-00373

**HISTORIC DISTRICT:** BOSTON-EDISON

**SCOPE:** REPLACE WINDOWS, ALTER REAR PORCH, INSTALL VINYL SIDING

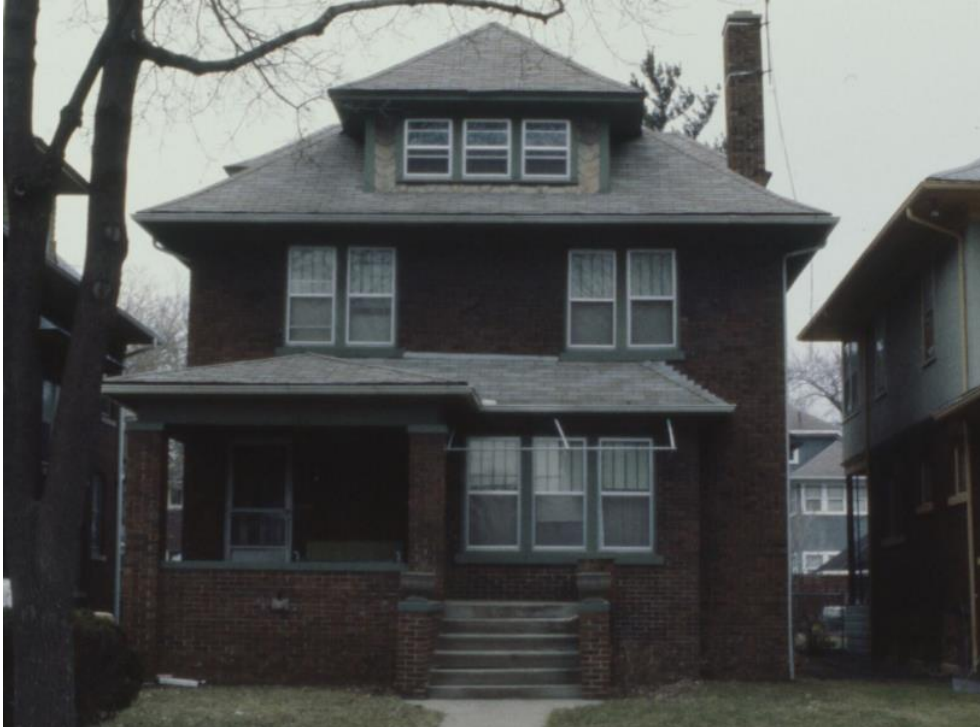
1667 Edison, designation slide taken by the HDAB in 1980. Note that the property has aluminum storm windows. However, all of the original/historic wood windows remained intact behind the storms

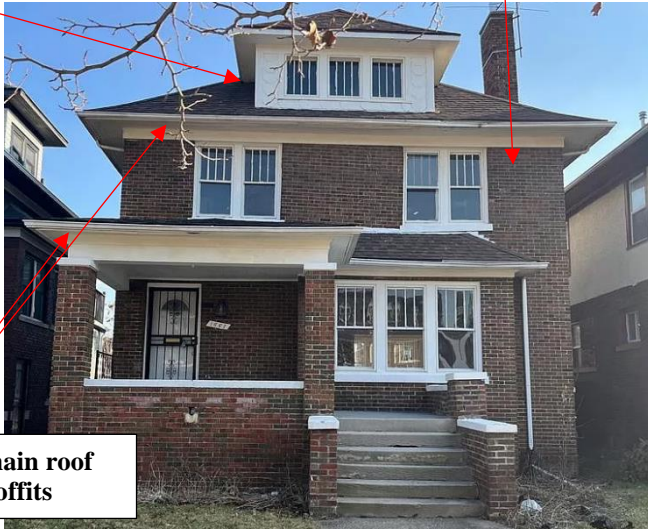
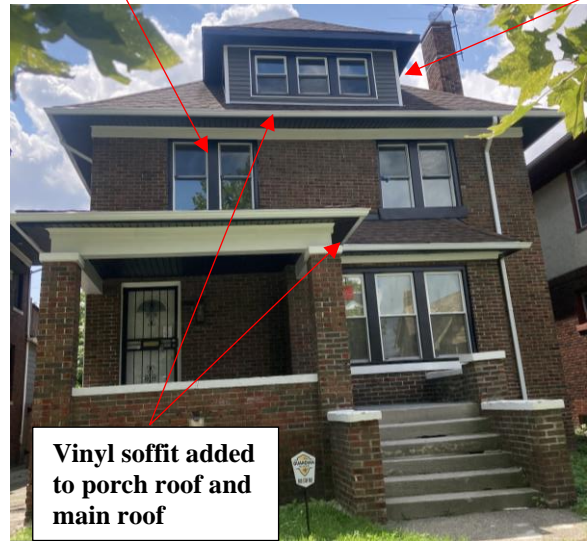
**Dormer has stucco front and sidewalls, retains original 4-light casement windows, and has wood soffits**

**4/1 wood windows throughout**

**1/1 vinyl windows with aluminum trim throughout**

**Dormer now clad with vinyl, windows are 1/1 vinyl units with aluminum trim, and vinyl soffit has been added**

**Porch and main roof have wood soffits**

**Vinyl soffit added to porch roof and main roof**

Front façade, left photo taken in early 2024 by Realcomp (included in real estate listing) and right photo taken by staff showing current condition/appearance after the recent unapproved work

Staff therefore recommends that the Commission issue a denial for the vinyl windows, aluminum trim, vinyl soffits at house and garage, vinyl siding at house (dormers) and garage because the work does not conform to the district's Elements of Design, nor does it meet the Secretary of the Interior's Standards for Rehabilitation, in particular Standards number:

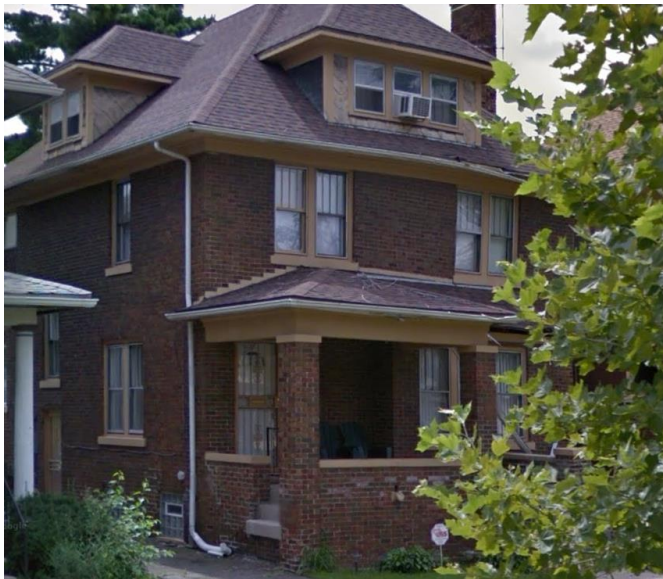
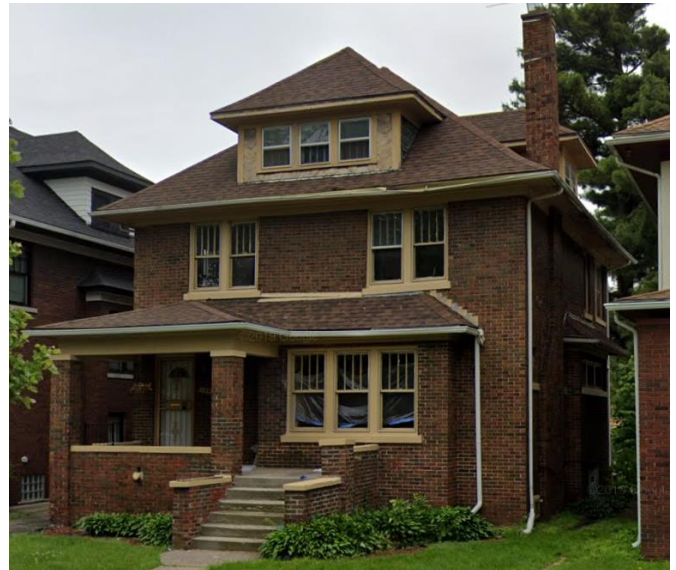
Google Streetview images, taken in 2016. Note that the attic/dormer 4-light wood windows are present but covered on the exterior by storm windows. Also, note that windows at the side elevation appear to be the same 4/1 type which were present at the front façade.

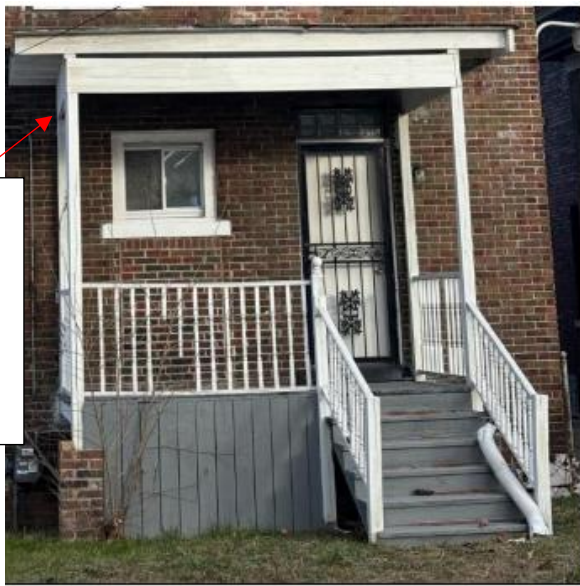
This porch was erected sometime after 1971 according to the below Sanborn Map

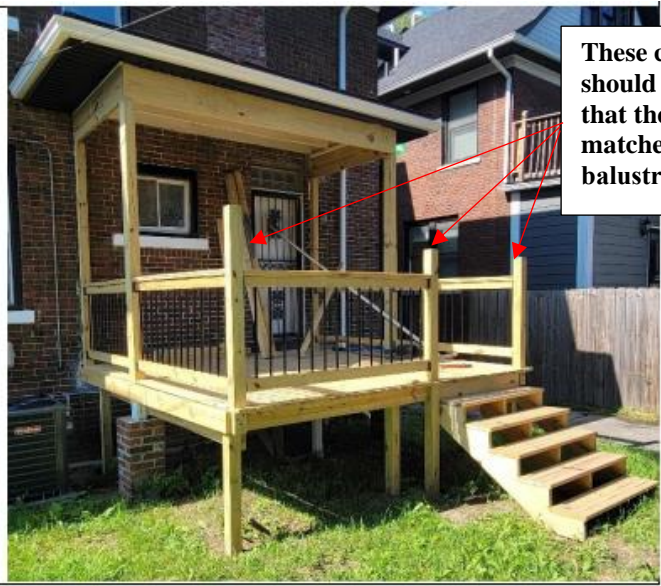
These columns should be reduced so that the height matches that of the balustrade's top rail

Rear porch, conditions prior to the current work on the left and after/current condition on the right. Photo provided by applicant.

- A review of Sanborn Fire Insurance maps indicated that the rear porch that was removed without approval was not erected until after 1971. It was therefore not a character-defining feature. It is staff's opinion that the current rear porch is compatible with the building's historic appearance with the condition that the vinyl soffit be replaced with wood, the height of the southmost columns be reduced to a height that matches the top rail of the balustrade, and that it be painted or stained an appropriate color within one calendar year.

- At the new rear porch, the height of the southmost columns shall be reduced to a height that matches the top rail of the balustrade prior to the issuance of the project’s permit. It also shall be painted or stained an appropriate color within one calendar year.
- Regarding the proposed tuckpointing, the new mortar shall match the historic in color, texture, and composition/strength.

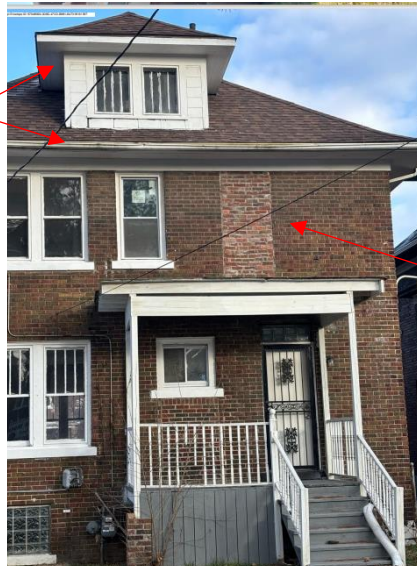
Wood siding at dormer and wood soffits at dormer and main roof

4 original windows at dormer and first story. 5 vinyl windows have been installed and one door opening above the porch has been infilled

Rear wall conditions, prior to the current unapproved work on the left and after the unapproved work on the right. Photos provided by applicant

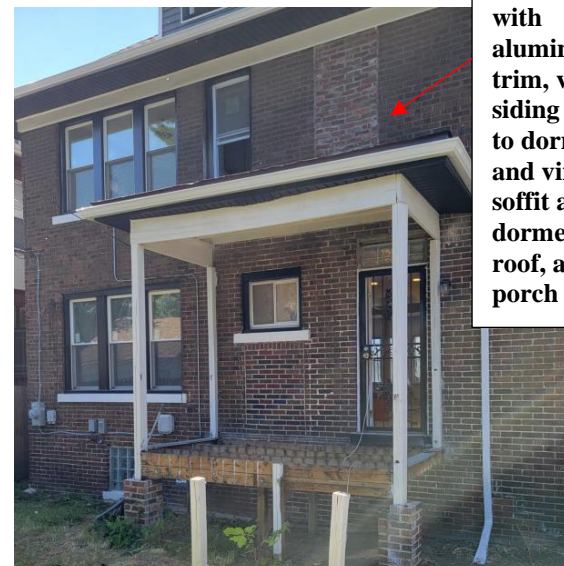
All windows are 1/1 vinyl with aluminum trim, vinyl siding added to dormer, and vinyl soffit added to dormer. Main roof, and porch roof

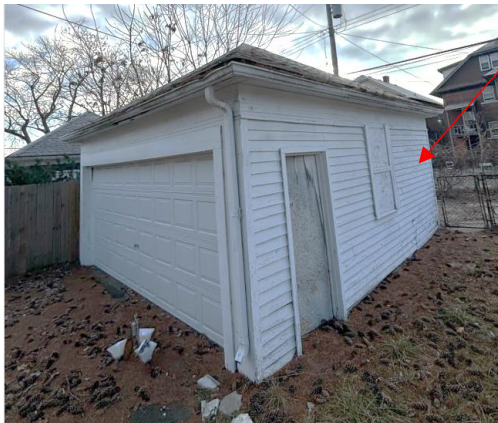
Lapped wood siding

Garage conditions, prior to the unapproved work on the left and after the unapproved work on the right. Photos by applicant

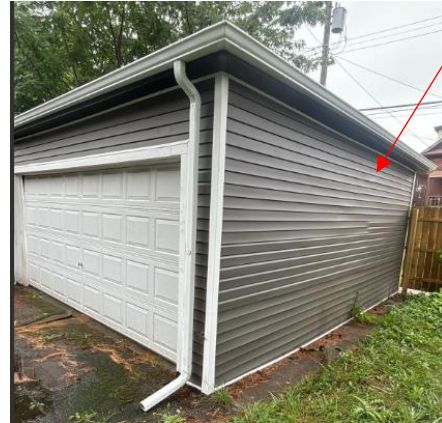
Vinyl siding and soffit. A door and window have also been eliminated

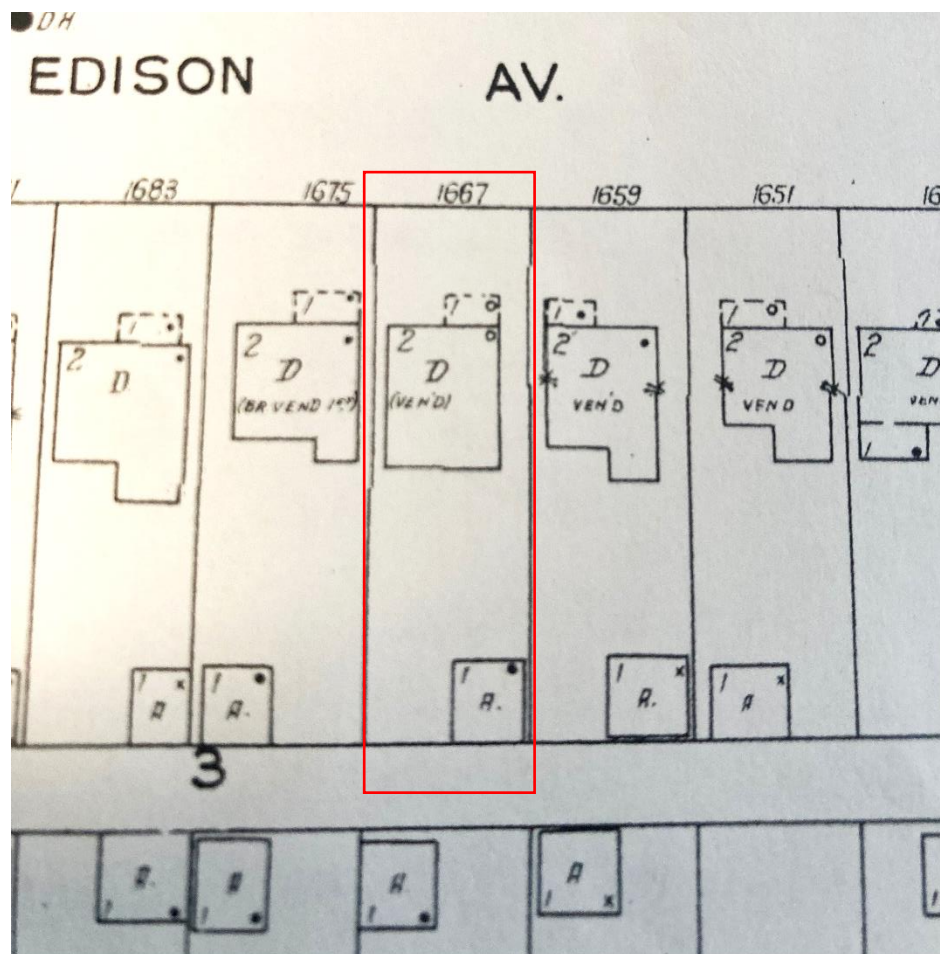
Sanborn Fire Insurance Map, 1971. 1667 Edison outlined in red. Note that it did not have a rear porch at that time. The porch which was recently removed without approval and/or permit was erected after the district's period of significance and therefore was not a character defining feature of the property.
