**STAFF REPORT: AUGUST 14, 2024 MEETING**

**APPLICATION NUMBER: HDC2024-00381**

**ADDRESS: 3747 TYLER**

**SCOPE: INSTALL VINYL WINDOWS\* (WORK COMPLETED WITHOUT APPROVAL), ALTER PORCHES**

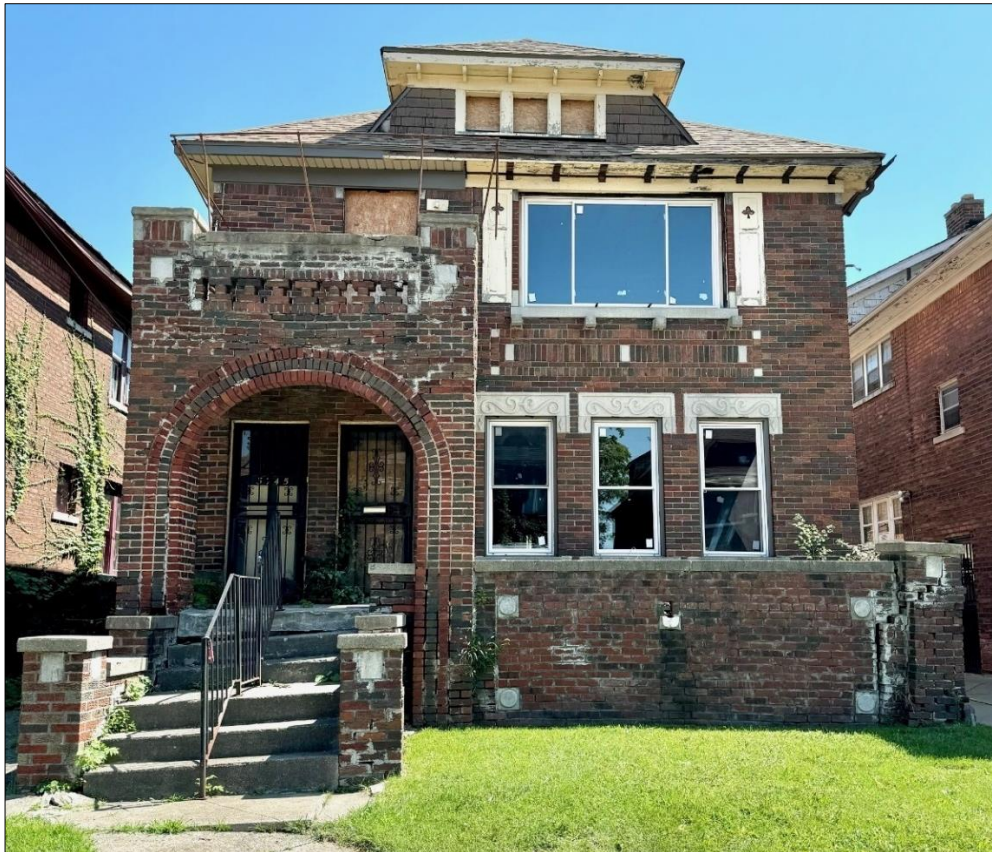
*Staff photo, July 26, 2024.*

Erected ca. 1927, the property at 3747 Tyler is a 2 ½ story two-family residence. The house and driveway (immediately east of the house) fill the width of the lot; the two car garage is at the rear lot line. The hipped, asphalt-shingled roof has a low shed dormer at the east elevation and a dominant hip roof dormer at the front elevation which features wood shingled sloping walls, bracketed eaves and three, square mullied window openings. The house is clad in dark brown brick and cast stone details, including the first story window hoods and sills, and decorative square and rectangular pieces set within the patterned brick walls. The side-by-side front doors are accessed through an arched masonry opening that is accentuated by alternating dark red and brown brick. A single door at the second floor opens to the porch above the main entrance where cross-shaped openings create a dimensional pattern between the corner masonry piers. An elevated open front porch extends across the first story's front wall and stepped brick wing walls enclose the front stairs. It appears one historic door is present at the front entrance, but the leaded glass window has been replaced with clear glass. Vinyl windows fill the openings at the first and second floor, and the windows within the dormer and the porch door are covered or missing.

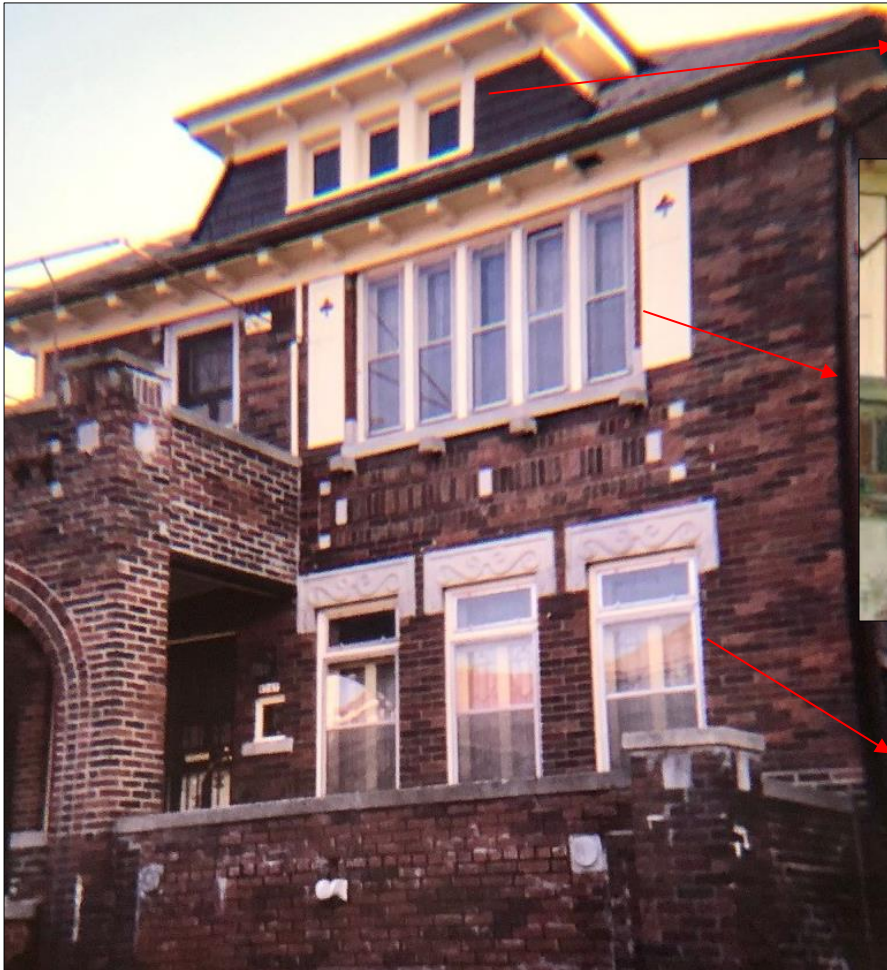
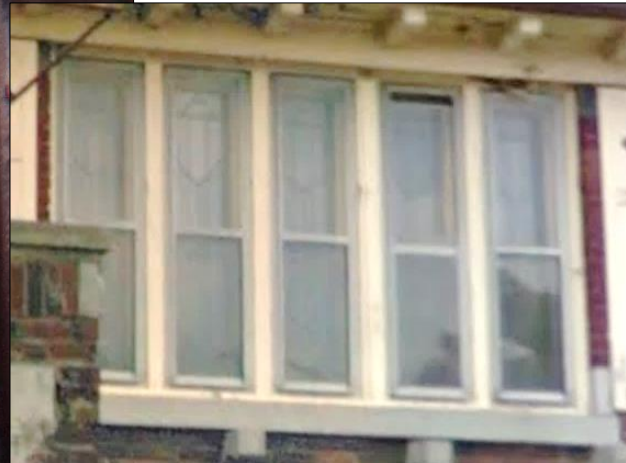
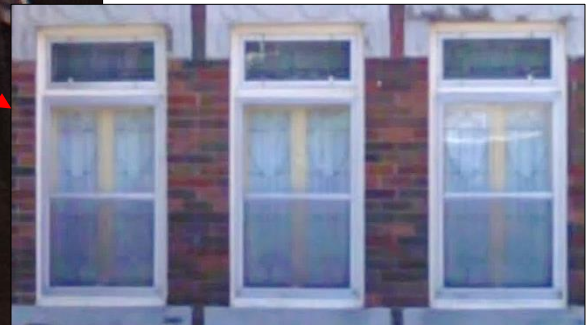
1999 Designation photo, HDAB.

- The Russell Woods-Sullivan historic district was established in 1999.
- The designation photo shows leaded glass windows within each window opening on the front wall, as well as the three doors (two entrance and one upper porch). The first and second floor windows were vertically oriented casement units (casement design visually obscured by storm windows). The third floor had small square windows. The windows and doors were distinctive character-defining features and were replaced, without HDC approval, between 2013 and 2022.

Bottom right: 3755 Tyler, Google street view, June 2022.

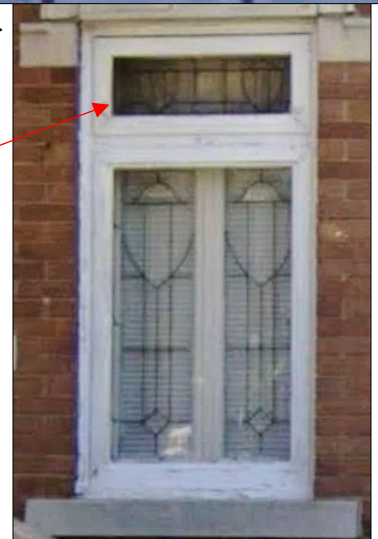
- The window shown at right is in the neighboring house (3755 Tyler) which has an identical leaded glass pattern to what had been in place at 3747 Tyler. This photo clearly shows the repeating leaded glass pattern in the transom window.
- The installation of storm windows in a double-hung operation obscured the casement windows, and once the windows were gone, gave erroneous and misleading information as to the original window operation and decoration.

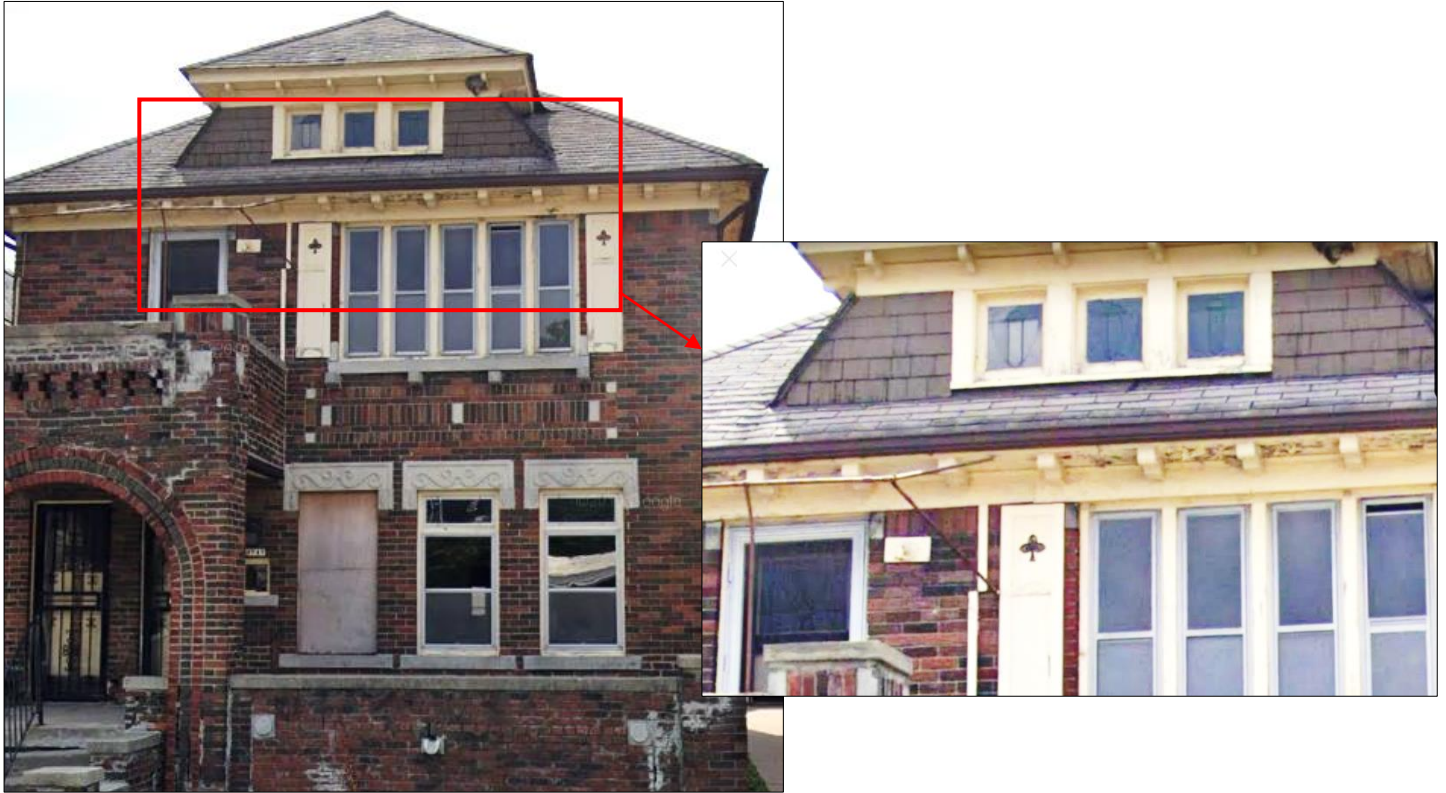
*Google street view, August 2019.*

- According to Google street view, the leaded glass windows and doors were all still in place as of August 2013.
- The next available image is from August 2018 and shows the windows at the first floor and second floor had been removed but the double-hung storm windows remained in place. The leaded glass windows in the dormer remained, as did the leaded glass within the original doors at the front entrance and second floor door porch. The 2019 image below offers visual clarity of the aforementioned conditions.

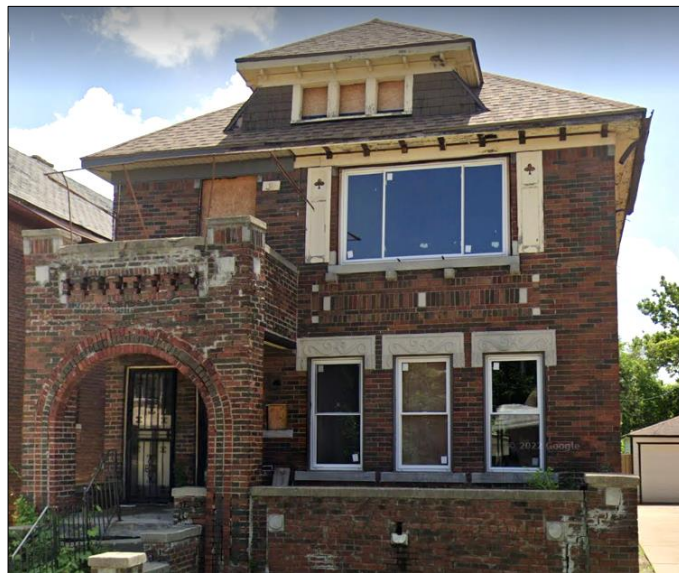
*Google street view, June 2022.*

- Reviewing additional Google street view images, the remaining windows and doors were removed between June 2019 and June 2022 and the existing vinyl windows were installed.

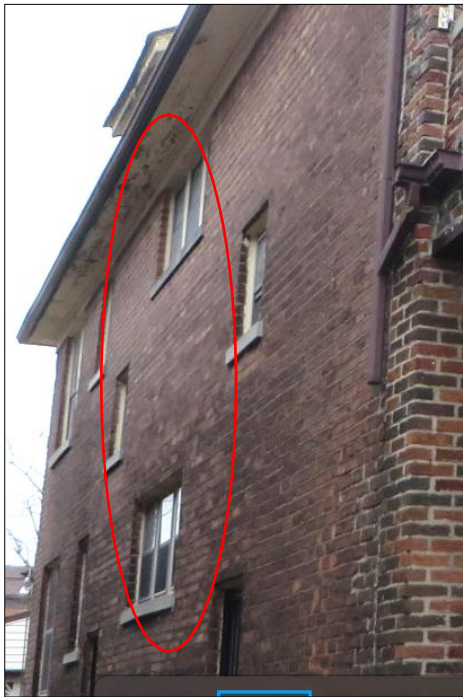
- The 2018 photos of 3747 Tyler show mulled units in the wider than tall window openings on the east side wall. The rear photo of 3747 Tyler shows three-over-one double-hung units, which also captures identical windows on the east side wall of 3755 Tyler. Therefore, it is staff's opinion the side and rear elevation windows at 3747 were consistently three-over-one double-hung units in single and mulled window openings.
- This double-hung window pattern emphasizes the verticality of the window opening, in a way similar to the casement windows that were in place on the front elevation.

*3747 Tyler, 2018 east elevation. Triple, equally proportioned mulled window frames are visible.*

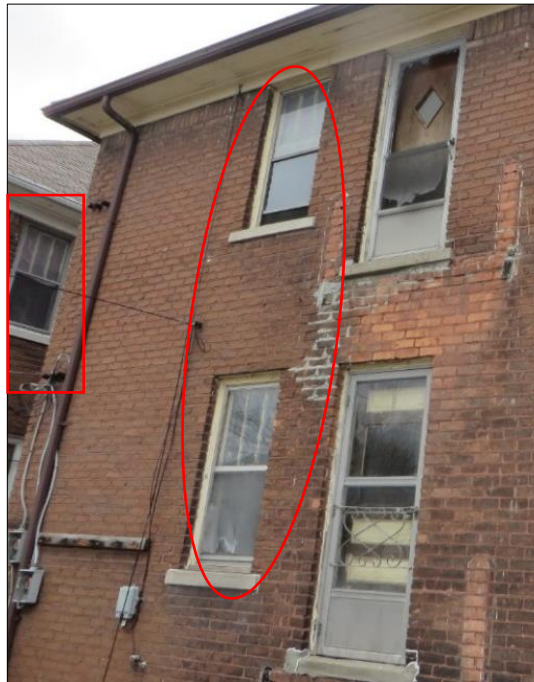
*3747 Tyler, 2018 rear elevation. Vertical upper sash pattern is visible at both properties. (3755 Tyler partially shown.)*

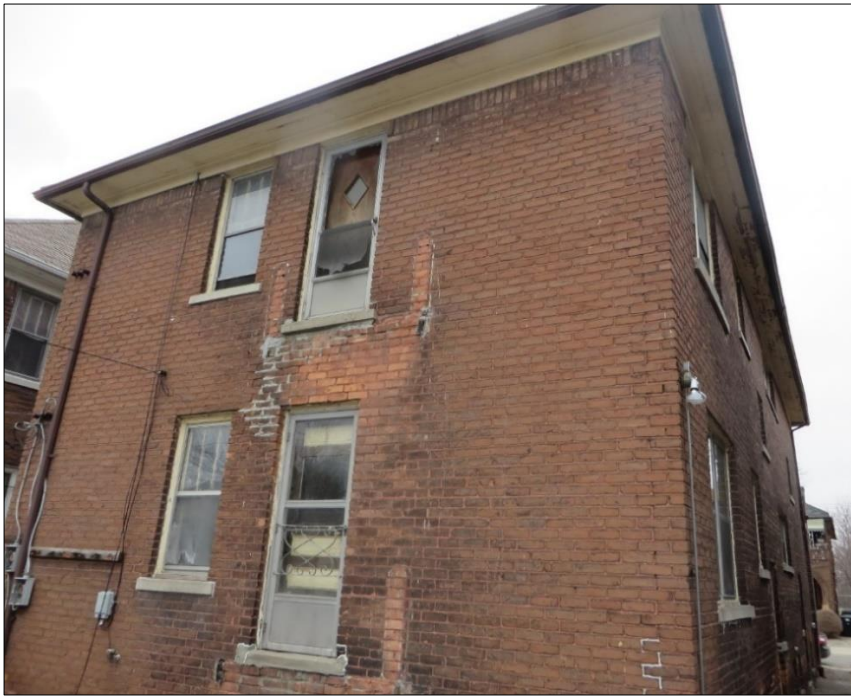
*These two photographs were in a folder from a previous incomplete application and offer a clear before and after comparison of the rear elevation.*

*Left - January 2018.  
The window openings have wood double-hung windows with a three-over-one pattern. The first floor paneled/glass door may be original, while the second floor door design reflects a later replacement door.*

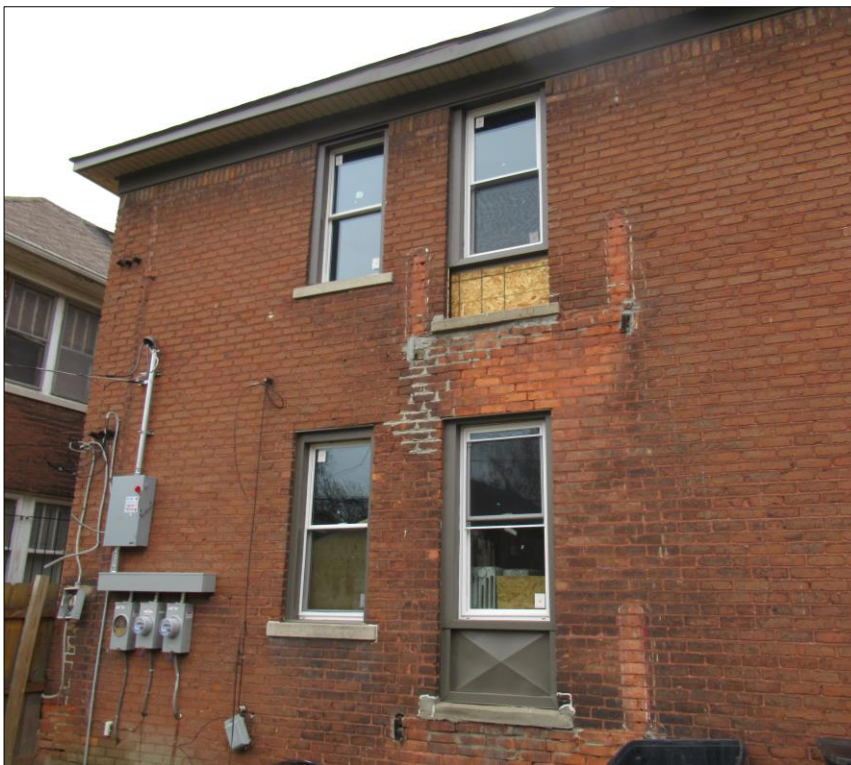
*Bottom left – November 2021 – existing conditions.*

*The window openings have one-over-one vinyl windows, the wood brick mould has been covered, and the door openings have been resized/infilled to accommodate one-over-one vinyl windows.*

*Staff doesn't know when the two-story porch was removed but found photographic confirmation that it was removed before 2006.*

*The ghost images offer evidence that the porch was constructed of wood, due to the proportions of the porch railings.*

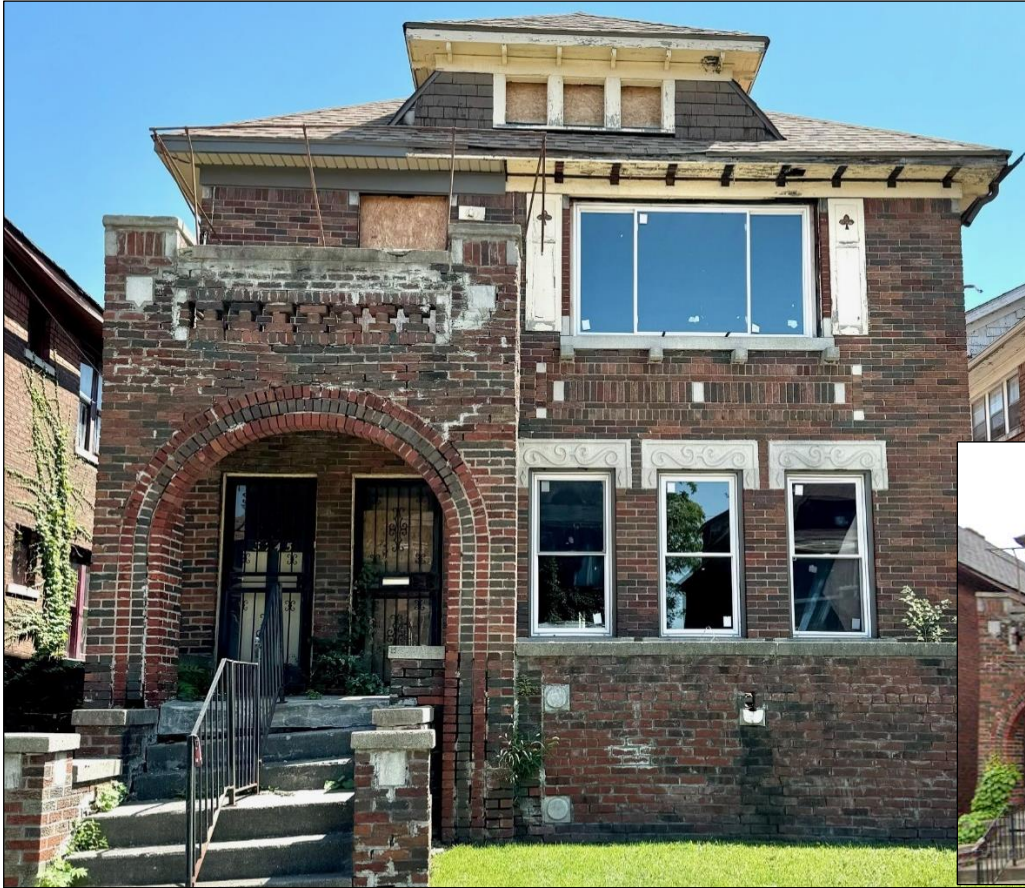
- This property is subject to the Detroit Land Bank Authority’s (DLBA) Nuisance Abatement Program (NAP), which required the property owner to rehabilitate the house. However, the rehab work was undertaken without HDC approval.
- Additional work identified which is NOT included in this application - the partial removal of the soffit brackets and covering of the wood soffit and fascia. This work occurred between June 2019 and September 2021.

*Left: Staff photo, July 26, 2024. This condition of the soffit and fascia has been in place since at least September 2021 when staff first photographed this property.*

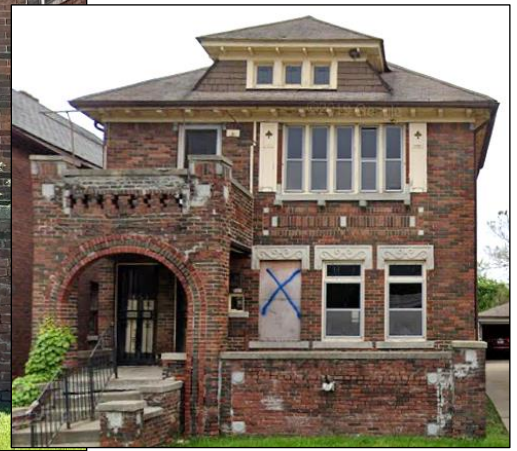
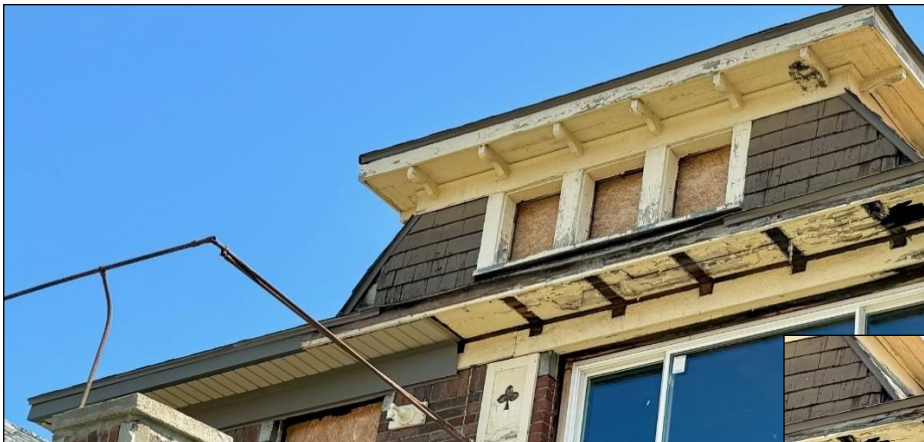
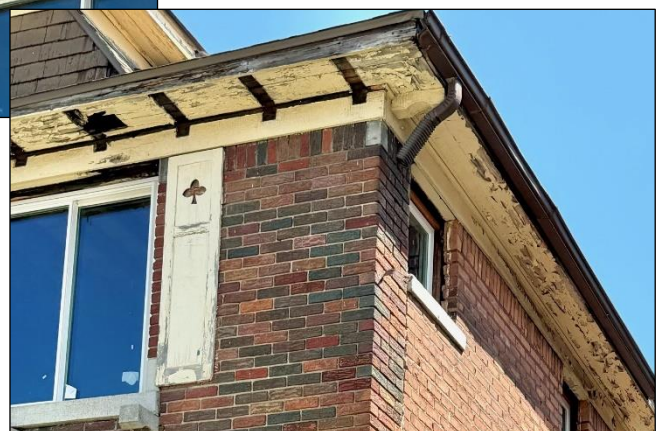
*Below: The 2019 Google street view image shows the wood bracketed soffit and wood fascia still intact.*

*Left and below: 2024 staff photos showing existing conditions at the second floor eaves and the intact historic design at the dormer eaves.*

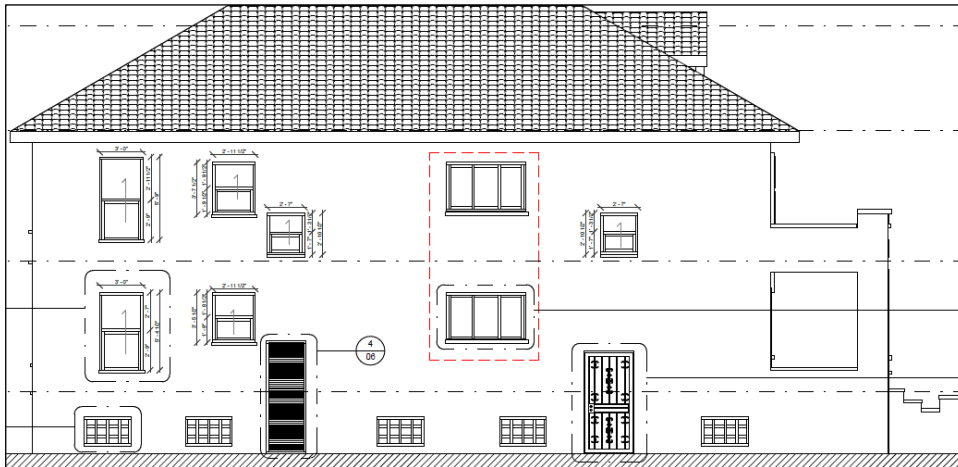
**Left- East Side Wall**

- The taller than wide windows on this wall currently have a sliding window within each individual opening. The applicant proposes to replace the small sliders with single-hung vinyl units covered aluminum-clad wood double-hung frames. The two wider than tall openings would receive new equally sized triple slider windows with matching operation aluminum-clad frames on the outer side. The dark rectangle shows the door opening that is currently covered with vinyl siding; the applicant proposes to fill the opening brick veneer.

- This dwelling is a two-family flat, so staff would like to note that the building code may require two entrances/exits per unit. As the rear porch door openings are proposed to be changed to windows (within two of the suggested options), the side doors may be required to remain operational. With regards to the design, the door is one component of a somewhat symmetrical design (based on the number and size of openings, rather than a fully symmetrical placement) which offers visual evidence to the two-family dwelling function.

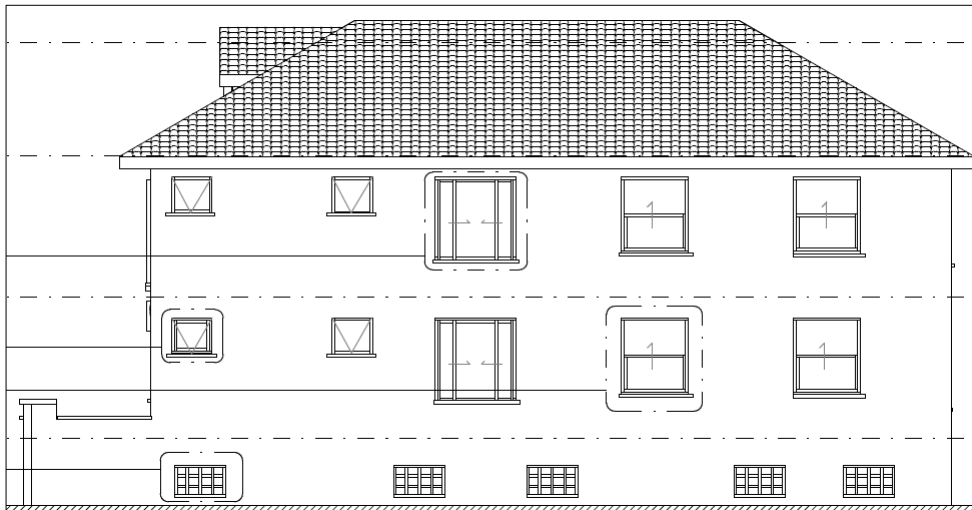
**Right- West Side Wall**

- Similar to the other side wall, the taller than wide openings will receive new single-hung vinyl windows covered with aluminum-clad wood frames as shown in this drawing. The four small windows will retain the existing wood window frames. The tall central openings will receive new vinyl sliding units covered with aluminum-clad wood frames.

- The west side entrance that is currently covered should be reopened, with a solid panel door installed.

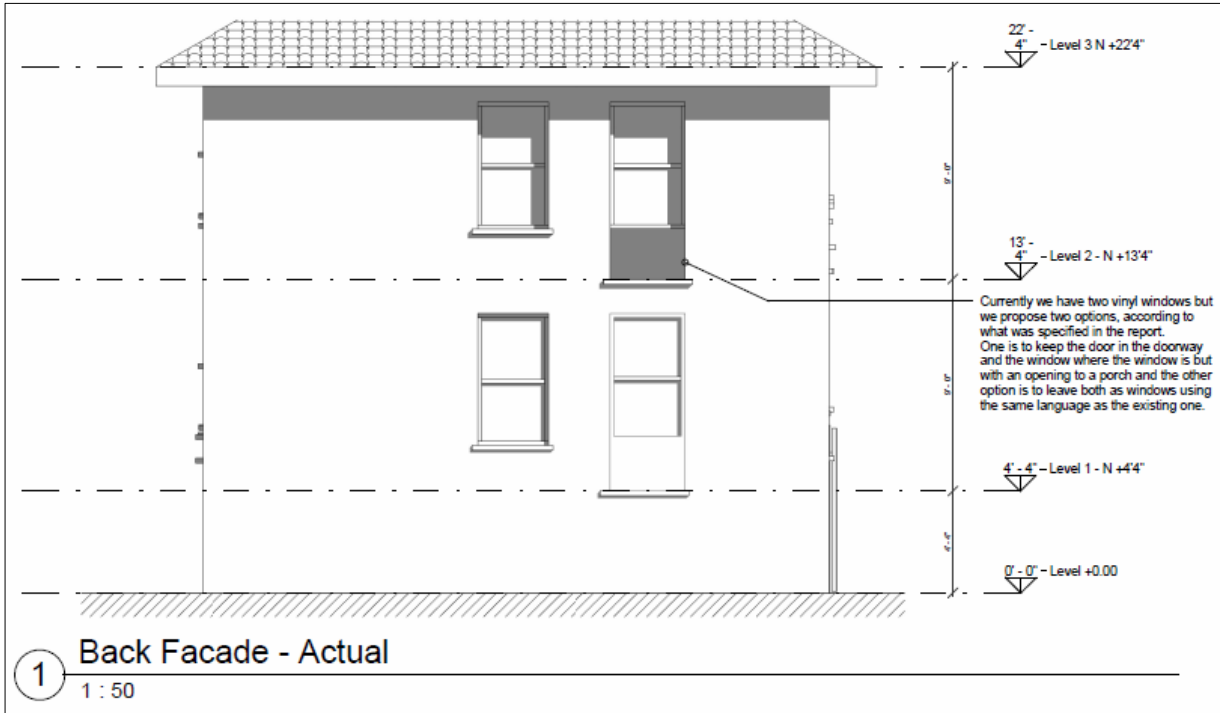
- If a porch is to be rebuilt, it is staff's opinion that it should be a wood porch with wood railings to be similar to the likely historic condition.
- If a porch isn't to be rebuilt at this time, the openings should remain intact offering a future owner the opportunity to build a porch. With this in mind, staff believes the only option presented that should be considered is option one. A double-hung window fills the width and about 2/3 the height of the door opening, and a panel fills the remaining area. The door's stone threshold remains in place.

- Within this application, the applicant proposes to install an identical metal panel at the second floor door opening.
- As these openings are on the rear elevation, are not part of the public view, and don't remove distinctive features, it is staff's opinion this alteration to the door openings falls within Standard #10: *New additions and adjacent or related new construction shall be undertaken in such a manner that if removed in the future, the essential form and integrity of the historic property and its environment would be unimpaired.*
- Staff's comments relate only to the generalized scope of work at this elevation – the existing windows and wrapped brick mould are not part of staff's supportive review of this option.

- At the rear wall, the proposal to install a double-hung window and panel below within the two door openings is the least intrusive of the three options provided by the applicant. However, the proposal as it is currently designed with vinyl single-hung windows, aluminum covered brick mould and panel, will not be approved.

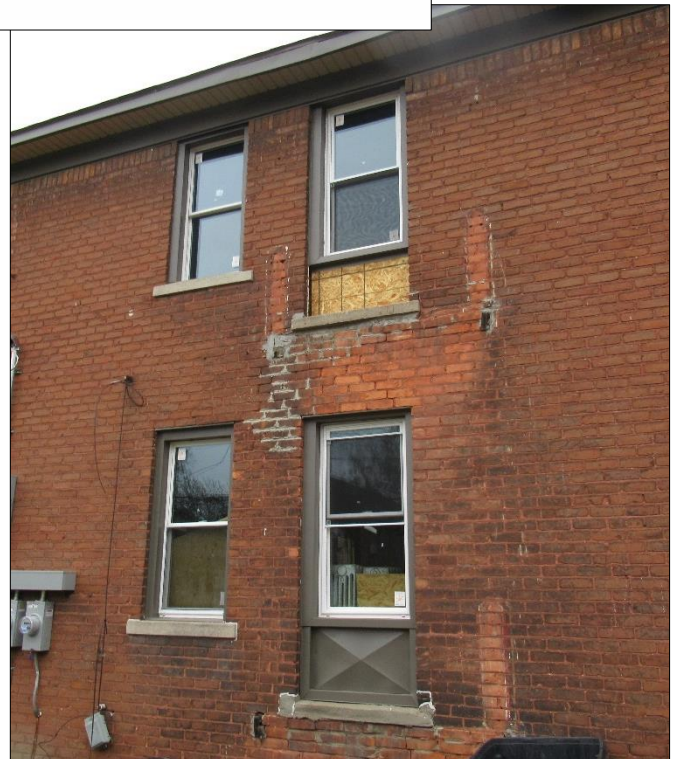
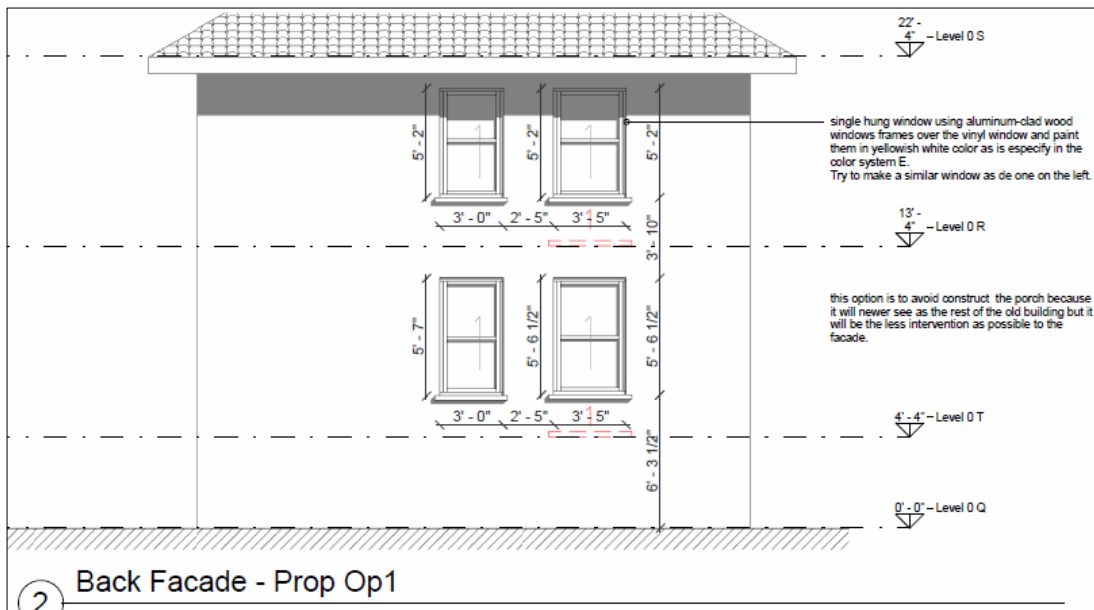
- This proposal offers a somewhat permanent change to the door opening, by its solid enclosure, relocated stone threshold/sill and installation of brick. This option doesn't offer any difference in the internal use of the four windows but is significantly more destructive to the exterior wall and historic openings.

- The option to permanently alter the rear door openings to smaller window openings significantly reduces the opportunity to re-establish a wood porch at this area at some time in the future .

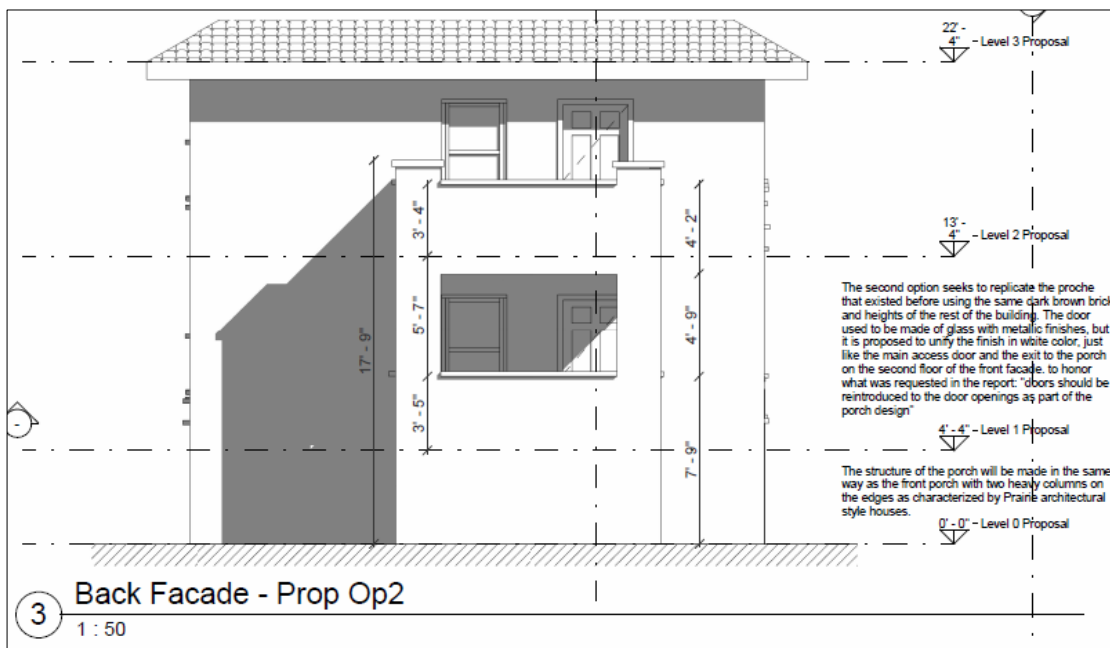
- This option retains the functional door openings but creates a non-historic element at the rear of the house. The ghost images of the wood railing shows that a masonry porch was not in this location. The opulence of the details that were designed for the front public-facing wall, including cast concrete window hoods, highly decorative leaded glass windows, larger dormer and full width front porch, is quite different than this relatively unadorned private, rear-yard facing elevation. The erection of two story masonry porch is akin to Standard 3 which says, "Changes that create a false sense of historical development...shall not be undertaken."

- The option to erect a two-story masonry porch would create a distinctive non-historic element at this location, and conflict with Standard 3 which says, "Changes that create a false sense of historical development...shall not be undertaken."

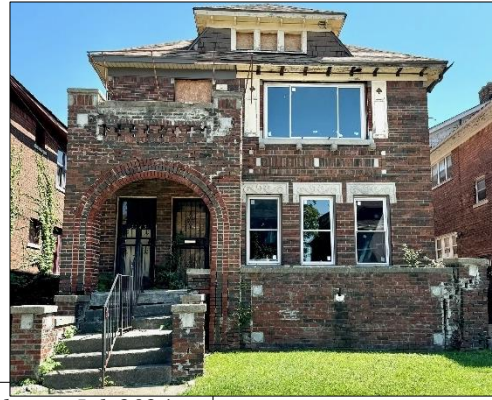
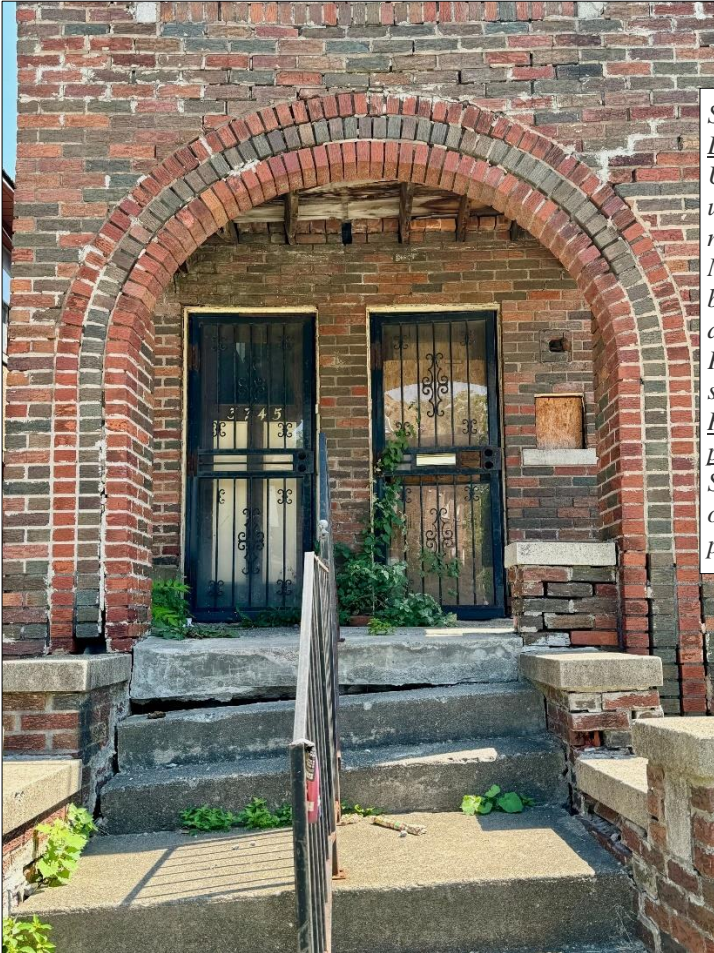
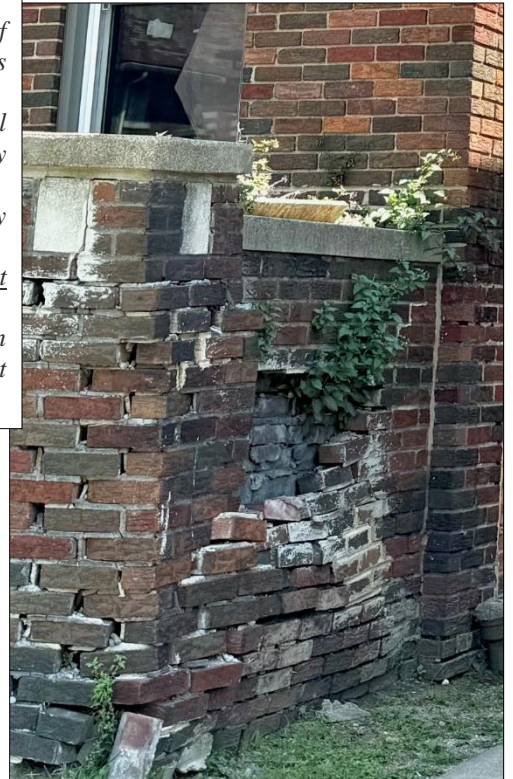
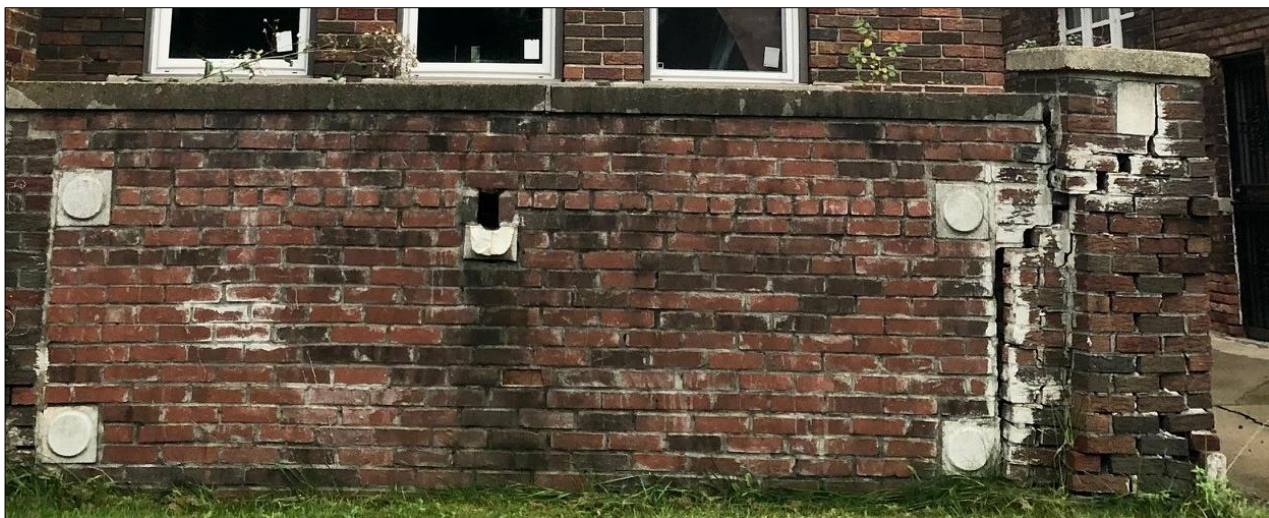
- The applicant proposed to rebuild portions of the front elevation's masonry porch. Based on the photos and staff's site visits, a high level of deterioration, some structural as well as masonry deterioration due to poorly executed tuckpointing, is evident.

Staff photos, July 2024.  
Left: Front entry.  
 Underside support of upper porch floor is missing and sagging.  
 Mortar and occasional brick missing and poorly done tuckpointing.  
 Porch steps significantly sinking at left/west side.  
Right and below: Front porch.  
 Structural problems with outer wall and right/east pier.

- The applicant’s condition assessment is not fully documented, and the scope of work is not detailed to the level needed, in order to clearly understand the areas of concern as well as the construction methods that will be used to repair this porch.

- Dimensioned drawings confirming the historic design and construction are needed, as is additional pictorial and written description of existing conditions.

- Detailed processes to embark on, such as “clean structures using the gentlest means possible” need to be fully explained, including method, material and pressure of cleaning proposal.

- If a section of the existing porch is to be deconstructed and rebuilt (like possibly the outer, east masonry pier which isn’t identified in the current scope of work), a dimensioned drawing confirming how it will be reconstructed is required.

- Assuming that some new brick may be needed, on this porch or the house, brick samples that closely match the existing brick in dimension, color, pattern, finish and profile will be submitted to staff for review against the historic brick. Also, specification of the new mortar, including composition and installation dimension, profile, etc. must be submitted to staff for review.

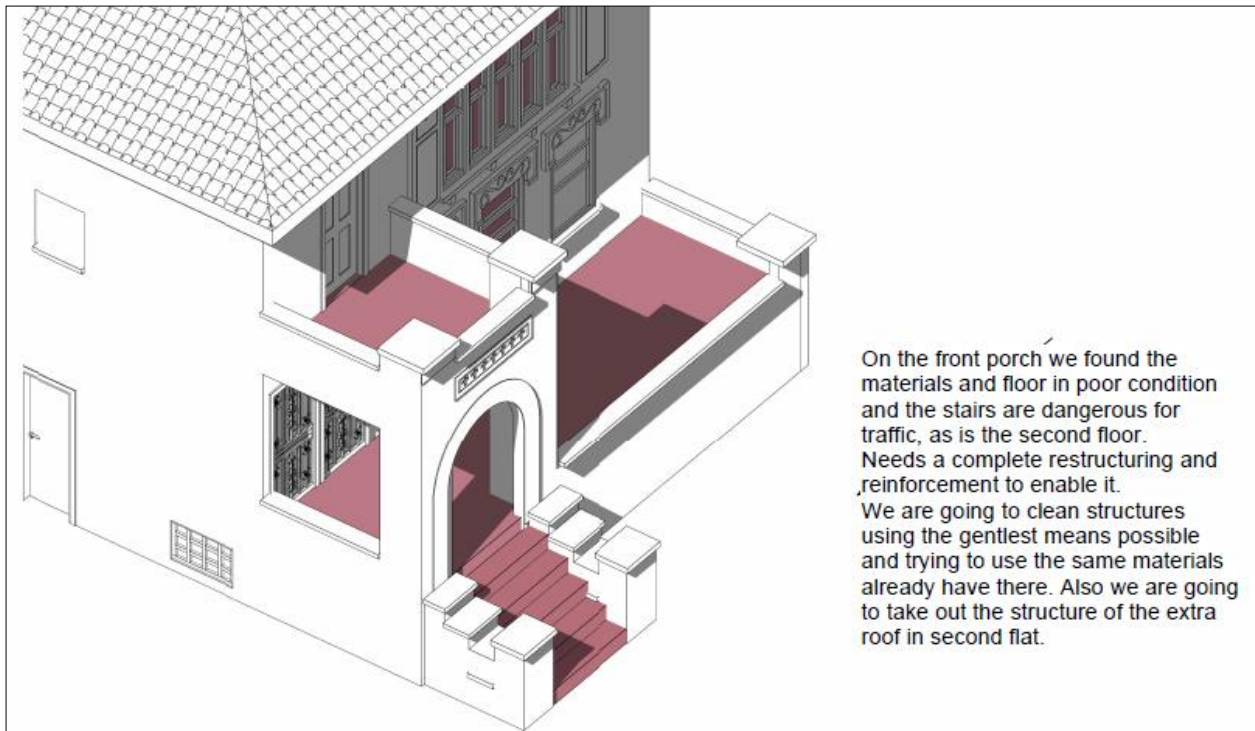
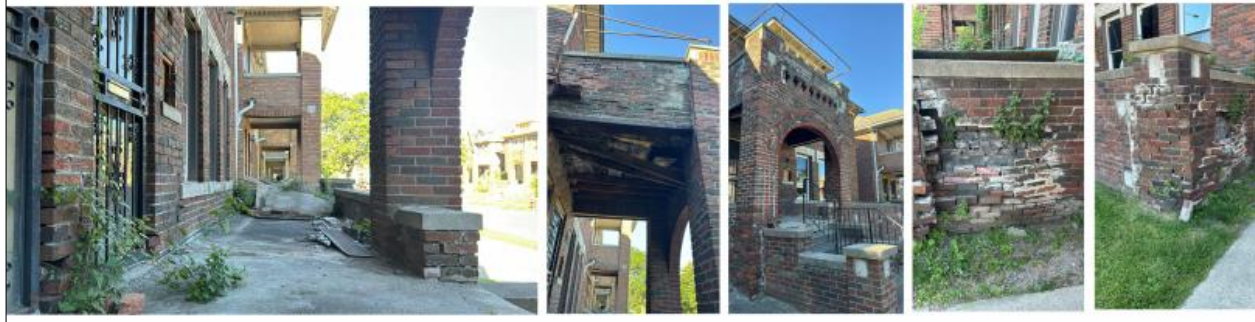
FRONT PORCH

On the front porch we found the materials and floor in poor condition and the stairs are dangerous for traffic, as is the second floor. Needs a complete restructuring and reinforcement to enable it. We are going to clean structures using the gentlest means possible and trying to use the same materials already have there. Also we are going to take out the structure of the extra roof in second flat.
