**STAFF REPORT: SEPTEMBER 11, 2024 MEETING**

**APPLICATION NUMBER: HDC2024-00369**

**ADDRESS: 372 W. GRAND BLVD**

**SCOPE: REPLACE WOOD WINDOWS WITH ALUMINUM-CLAD WINDOWS**

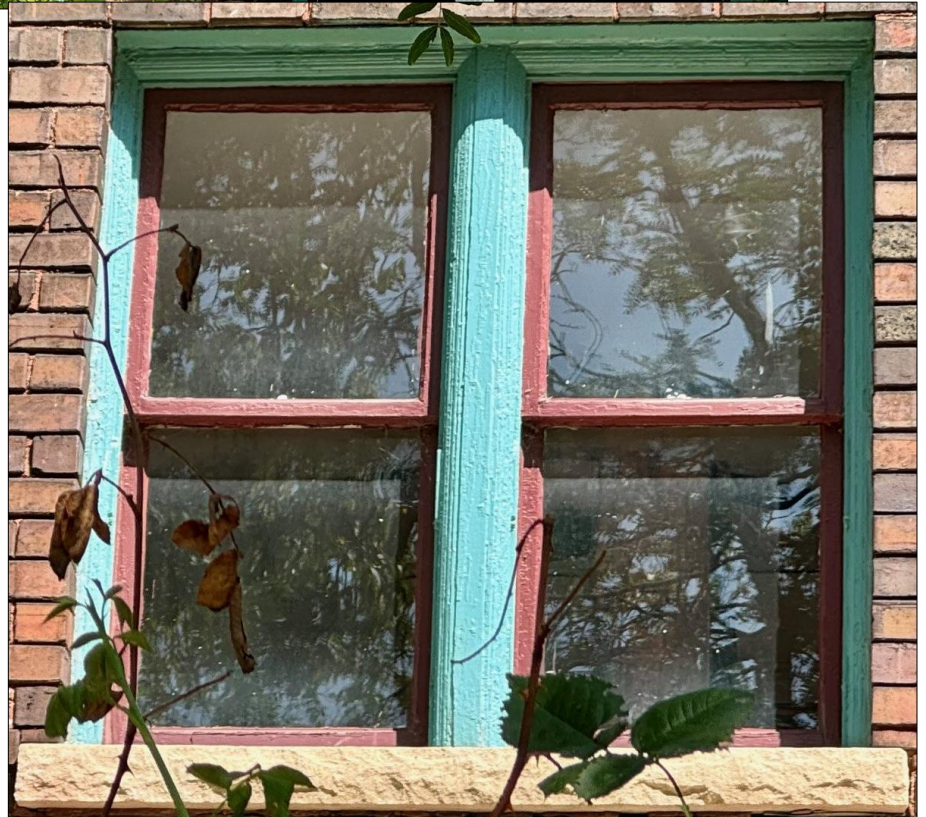
- The window openings have thick stone sills, highly profiled wood brickmould, and are deeply recessed within the masonry walls. The grouped windows are separated by mullions that have a stepped back, angled design that creates an illusion of a rounded shape. All of these details further contribute to the architectural complexity of the house's design and help identify its era of construction.

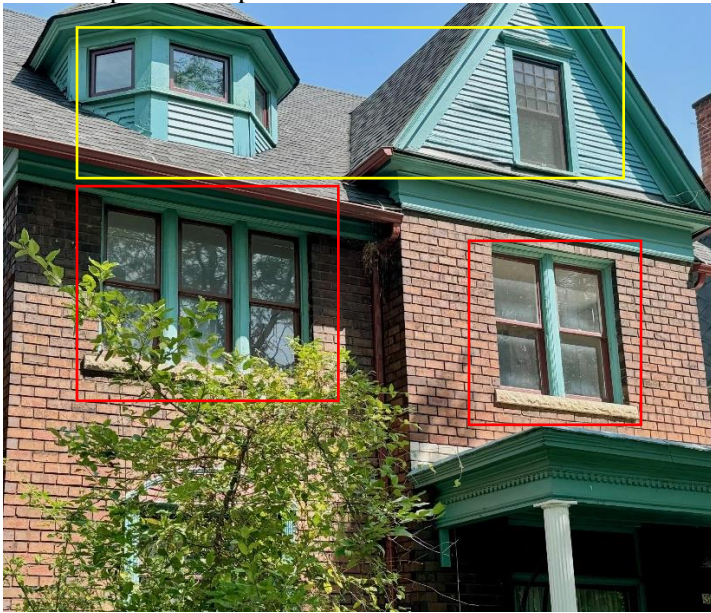
Front – west wall

Window openings identified by yellow boxes were part of the HDC staff approved 2018 window replacement application. Staff photos, August 2024.

Windows identified with red boxes are the openings staff has identified for the current application.

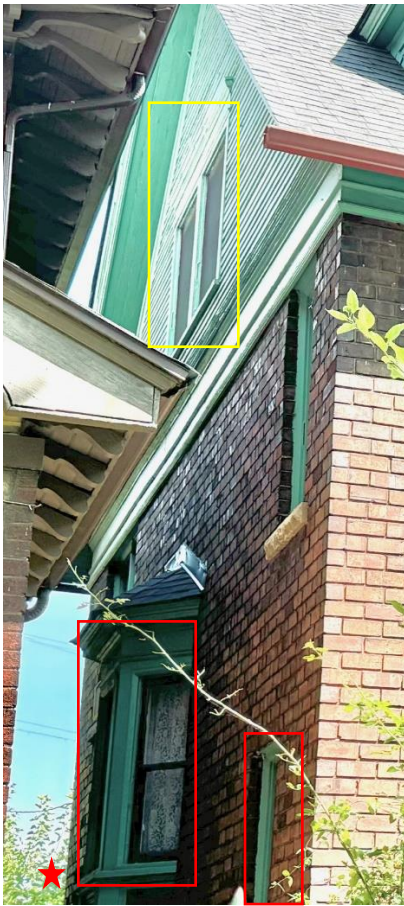
Side – North wall

It appears that two additional window openings in the current application (listed as dining room and kitchen) can't be seen in these photographs, and are likely on the north wall near the rear, and behind the bay window. ★

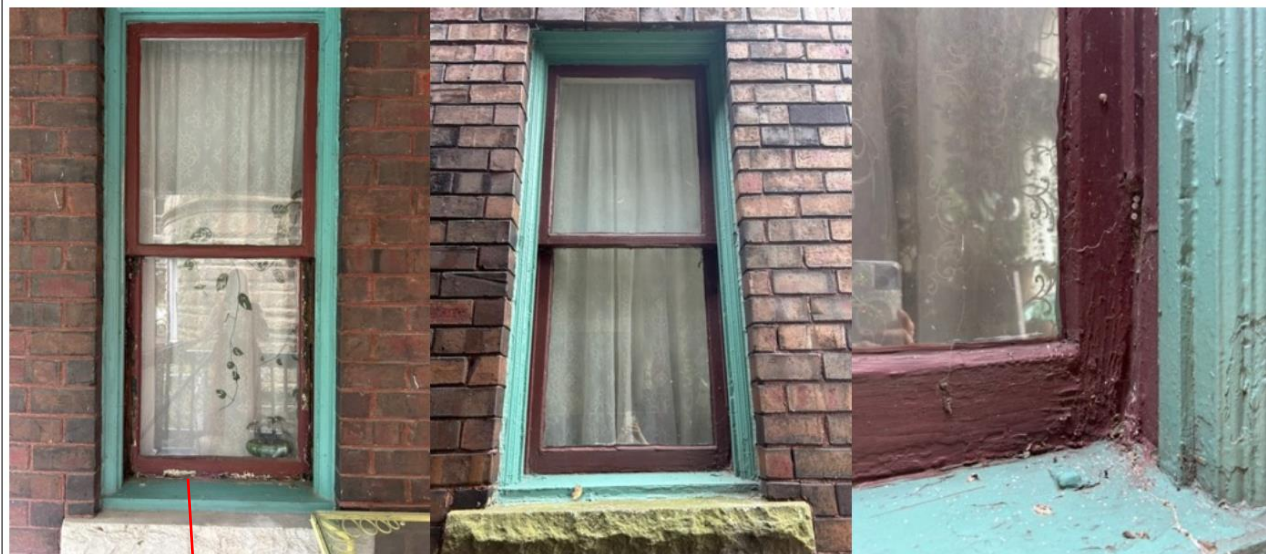
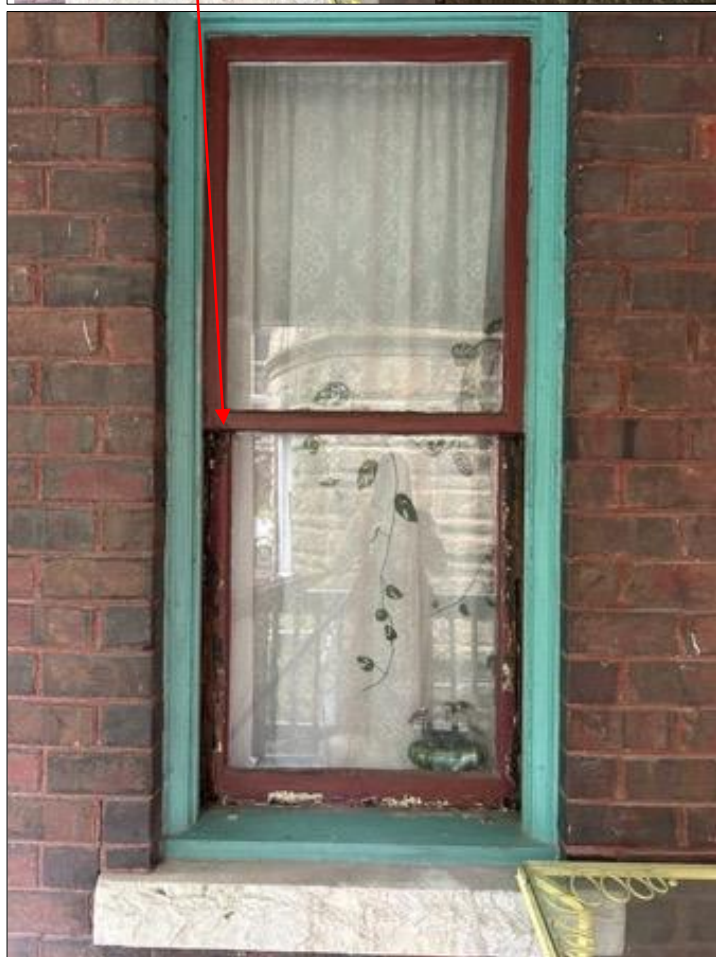
**Window detail.** First floor living room south (left); dining room left (center), dining room center (right); substantially damaged and inoperable

It is staff's opinion that extensive deterioration, worthy of removing and replacing a window, isn't evident within these photos. The paint on the frames is intact, and only the lower sash of one window is flaking. There doesn't appear to be missing/crumbling wood. Even if there was, wood filler can be used where there are areas of wood rot.

- The applicant states the windows are painted and caulked shut rendering them inoperable. Removing the caulk and cutting through the paint are straightforward repairs that can be completed with standard tools. The historic early 20<sup>th</sup> century windows were made from individual components, so they can be repaired by replacing specific parts. If weights and sash cord are missing, these items can be purchased and installed, allowing for the full operability of double-hung windows to be regained. Extensive moisture damage for some windows was noted by the applicant, but the photos don't show rotted, missing wood. The paint is intact, with the exception of some flaking paint.

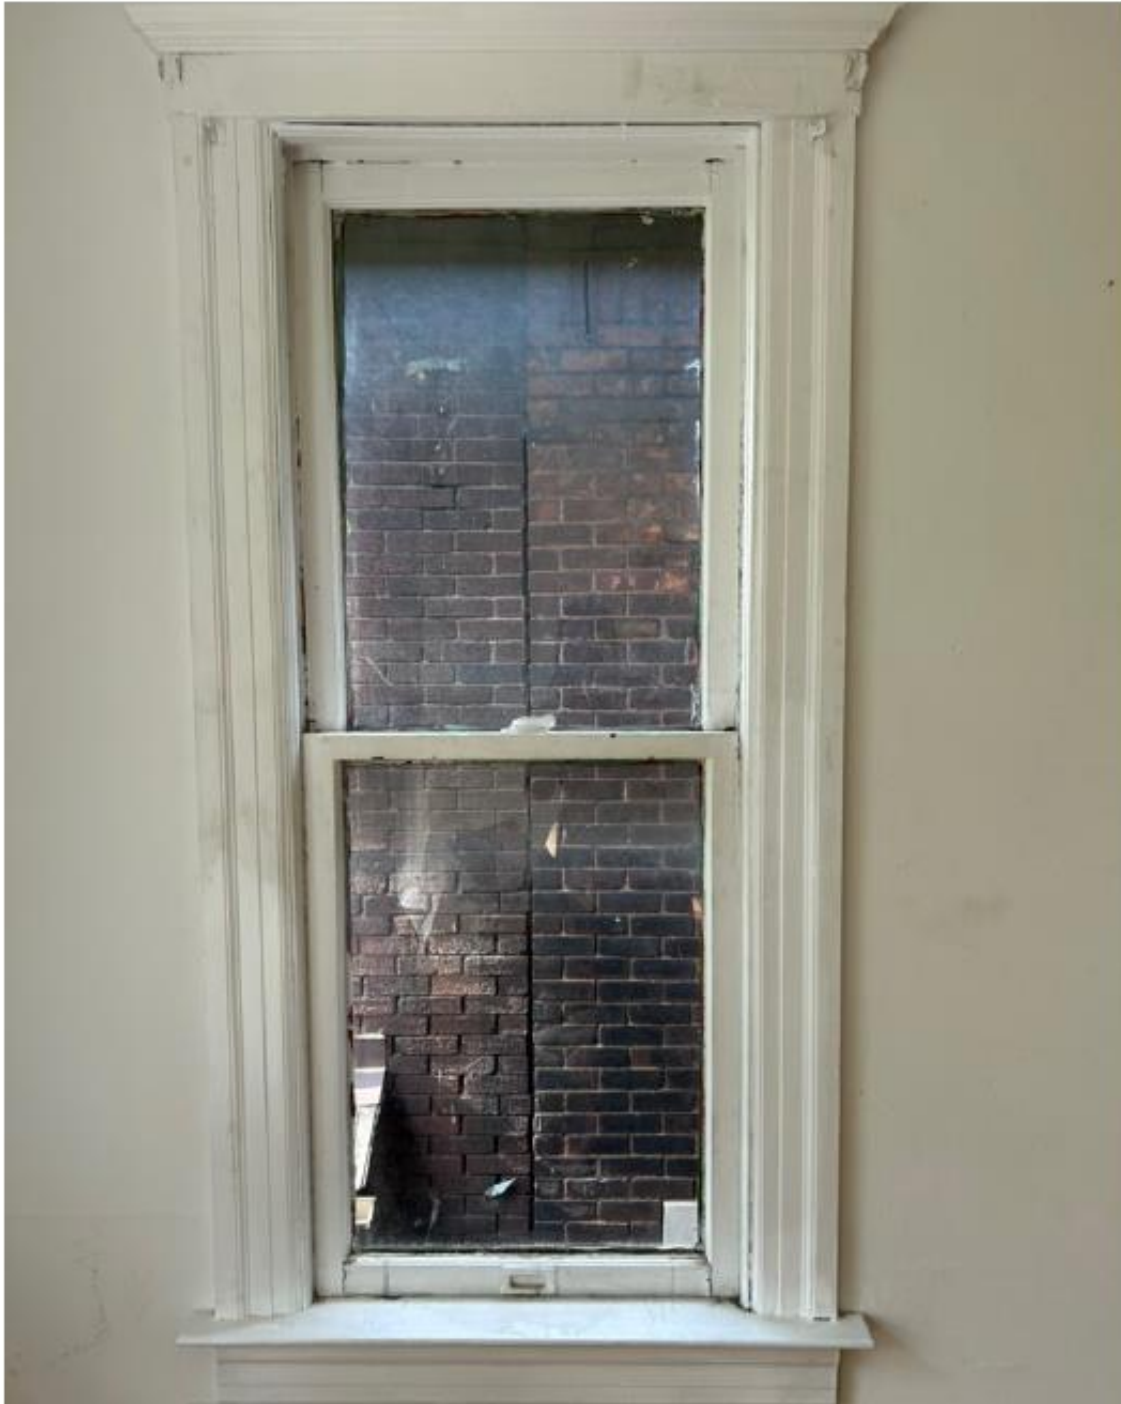
Below: Living room (north). On this window, we see separation on the stops on the top of the frame, and serious damage to the rail-and-stile joints on the bottom from decades of unmanaged moisture from the non-insulated glass (condensation on the interior from dewpoint). Various other deterioration is evident.

As stated on the previous page, this window shows signs of deterioration, but the frames are intact and can be repaired.
