STAFF REPORT: SEPTEMBER 11, 2024 MEETING

APPLICATION NUMBER: HDC2024-00436

ADDRESS: 1321 LABROSSE

SCOPE: DEMOLISH GARAGE, ERECT GARAGE (WORK COMPLETED WITHOUT APPROVAL)

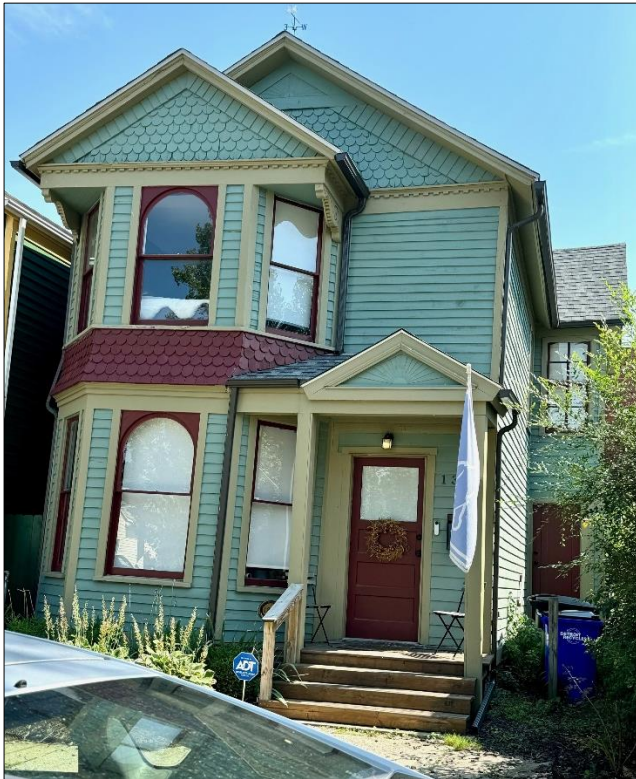
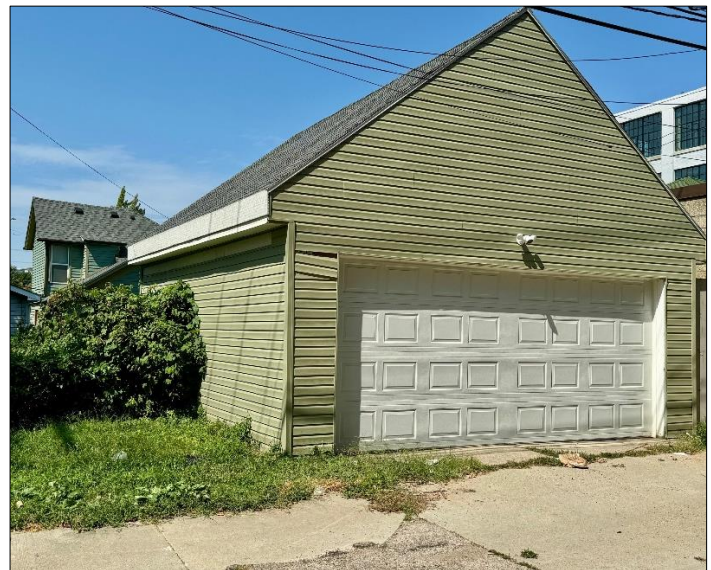
Staff photos, August 2024.

The garage at the rear lot line is a recently built structure (2020 or 2021) that was erected on top of the former garage's foundation. The two-car structure has a steeply pitched gable roof covered with asphalt shingles; vinyl siding covering the walls. Some siding is already visibly deteriorating/loose at the upper left of the overhead door.

- The vinyl siding will be replaced with wood or cementitious lap siding. If a cementitious product is used, it must have a smooth finish. The wall and trim paint colors will be submitted to staff for review.
- The proposed window will be an aluminum-clad wood product. A cut sheet confirming operation, material, finish and color will be submitted to staff for review.
- The drawings submitted for permit will be revised to show the placement of the proposed window, list the approved siding product and the width of its exposure, and exterior color palette for the siding, trim, and window. The window cut sheet will also be included in the applicant's documents.

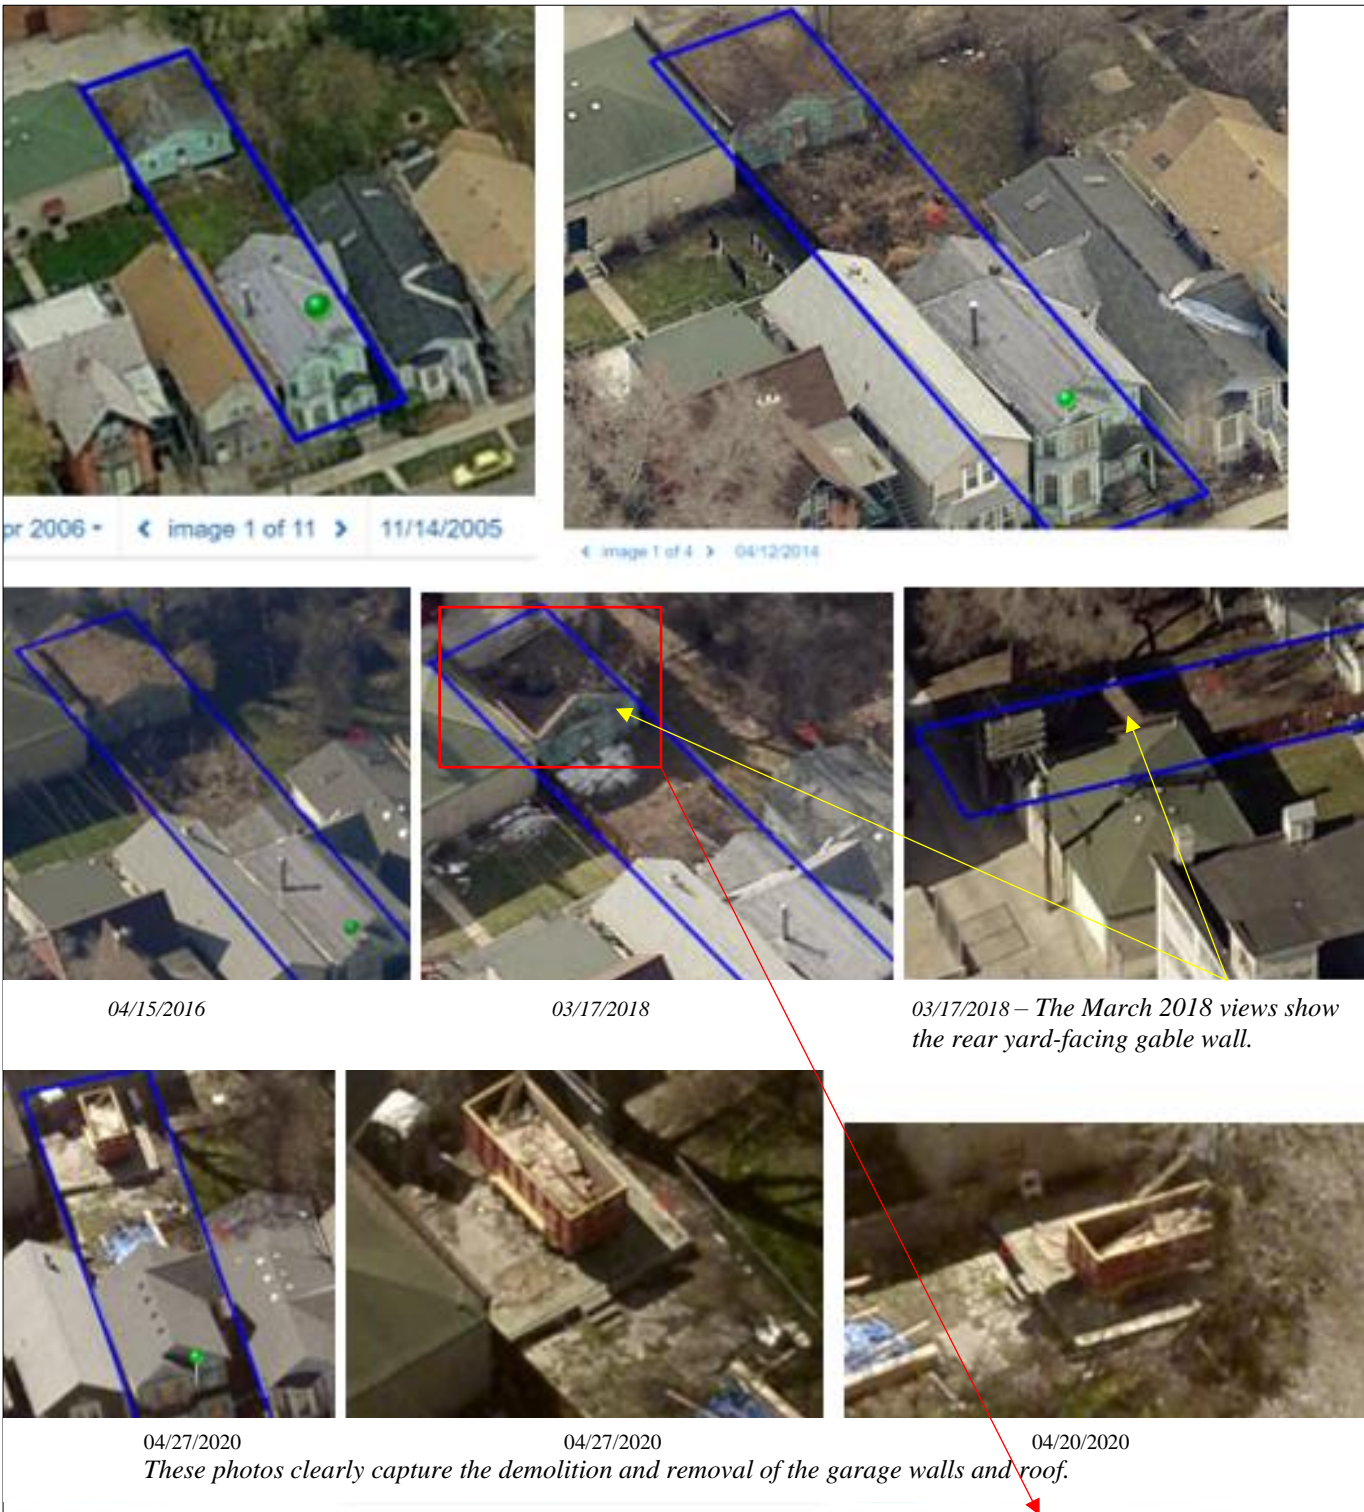
Aerial view photos, 2005 – 2020, EagleView.

- Staff compiled aerial photos capturing conditions from 2005 – 2020. The collapse of the garage roof and rear wall is visible in the 2018 image at the far bottom right.

03/17/2018 – The March 2018 views show the rear yard-facing gable wall.

These photos clearly capture the demolition and removal of the garage walls and roof.

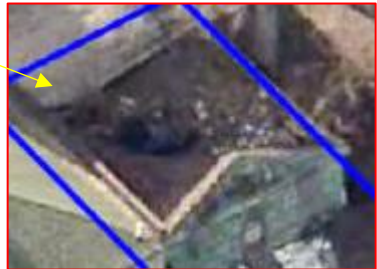
This close-up view appears to show the back/alley-facing wall had fallen inward.

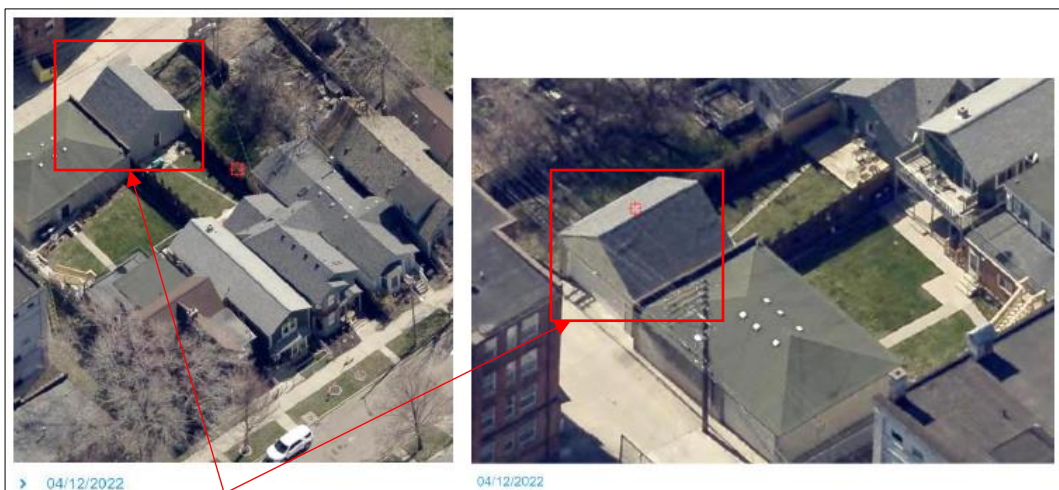
Garage erected without HDC approval. Aerial images, April 2022. EagleView.

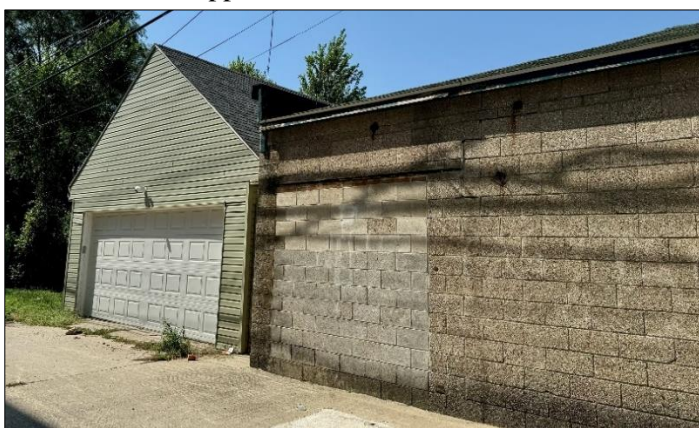
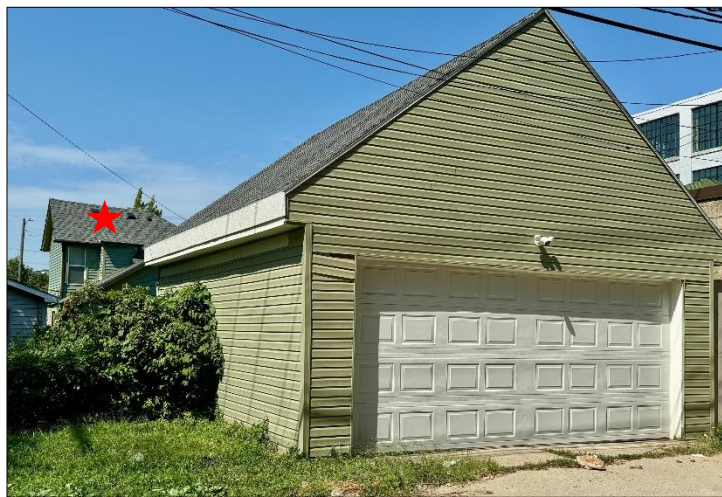
HDC staff photos taken from alley, August 2024.

- However, the use of vinyl siding and the proposal to install a vinyl window is not compatible with the historic district.
 - Staff notes that the new vinyl siding installation is already failing, consistent with the low quality of those materials.

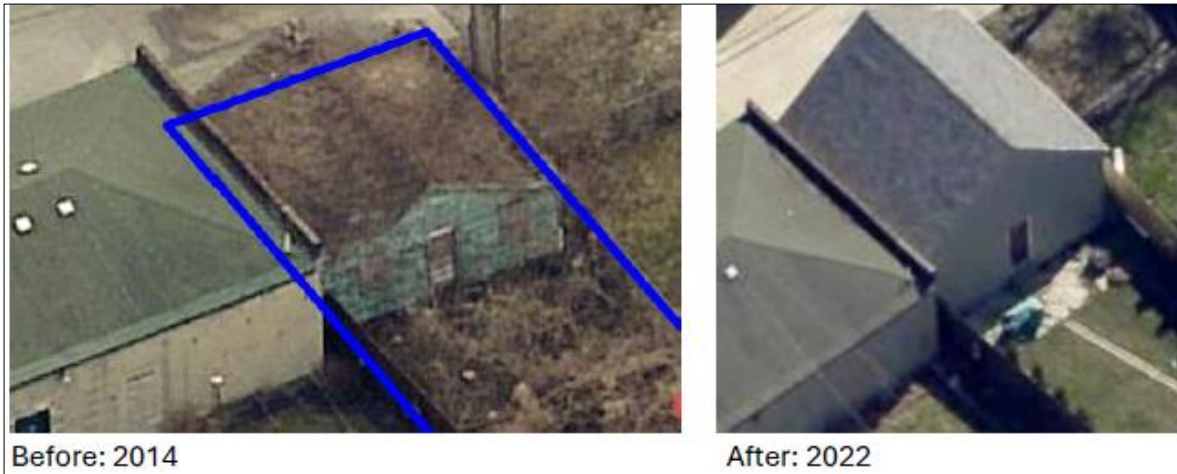
- It is staff's opinion, the demolished garage was not historically significant, and its collapsed walls and roof offered confirmation that the structure was deteriorated beyond repair. The erected structure has a compatible massing and design for this property and alley location.

- The existing garage sits on the former garage's concrete foundation, which fills the width of the lot.
 - The roof has the same forward-facing gable design but was erected with a higher pitch.

- The centrally placed door on the yard-facing wall is similar, but the wall doesn't have any window openings. The applicant is proposing to install one centrally placed window above the door within the gable area.
