STAFF REPORT: SEPTEMBER 11, 2024 MEETING (*Revised 9/10*)

APPLICATION NUMBER: HDC2024-00495

ADDRESS: 3747 TYLER

SCOPE: INSTALL WOOD WINDOWS, DOORS AND ERECT REAR PORCH

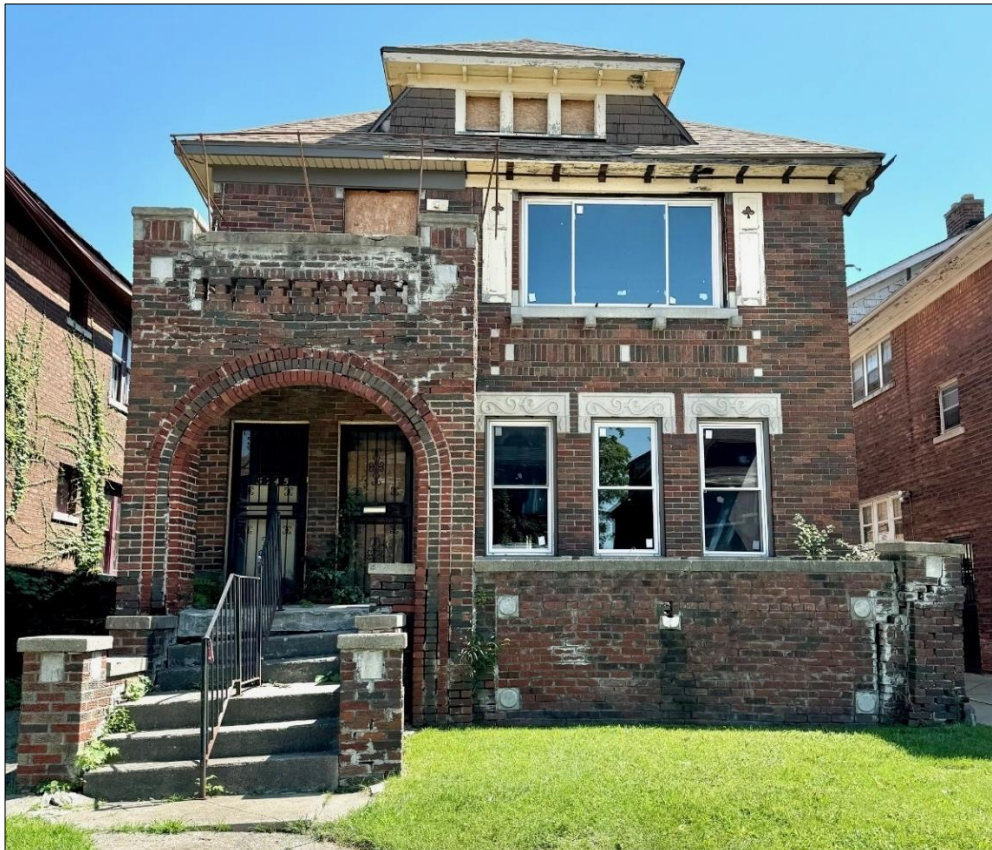
Erected ca. 1927, the property at 3747 Tyler is a 2 ½ story two-family residence. The house and driveway (immediately east of the house) fill the width of the lot; the two car garage is at the rear lot line. The hipped, asphalt-shingled roof has a low shed dormer at the east elevation and a dominant hip roof dormer at the front elevation which features wood shingled sloping walls, bracketed eaves and three, square mullied window openings. The house is clad in dark brown brick and cast stone details, including the first story window hoods and sills, and decorative square and rectangular pieces set within the patterned brick walls. The side-by-side front doors are accessed through an arched masonry opening that is accentuated by alternating dark red and brown brick. A single door at the second floor opens to the porch above the main entrance where cross-shaped openings create a dimensional pattern between the corner masonry piers. An elevated open front porch extends across the first story’s front wall and stepped brick wing walls enclose the front stairs. It appears one historic door is present at the front entrance, but the leaded glass window has been replaced with clear glass. Vinyl windows fill the openings at the first and second floor, and the windows within the dormer and the porch door are covered or missing.

Staff photo, July 26, 2024.

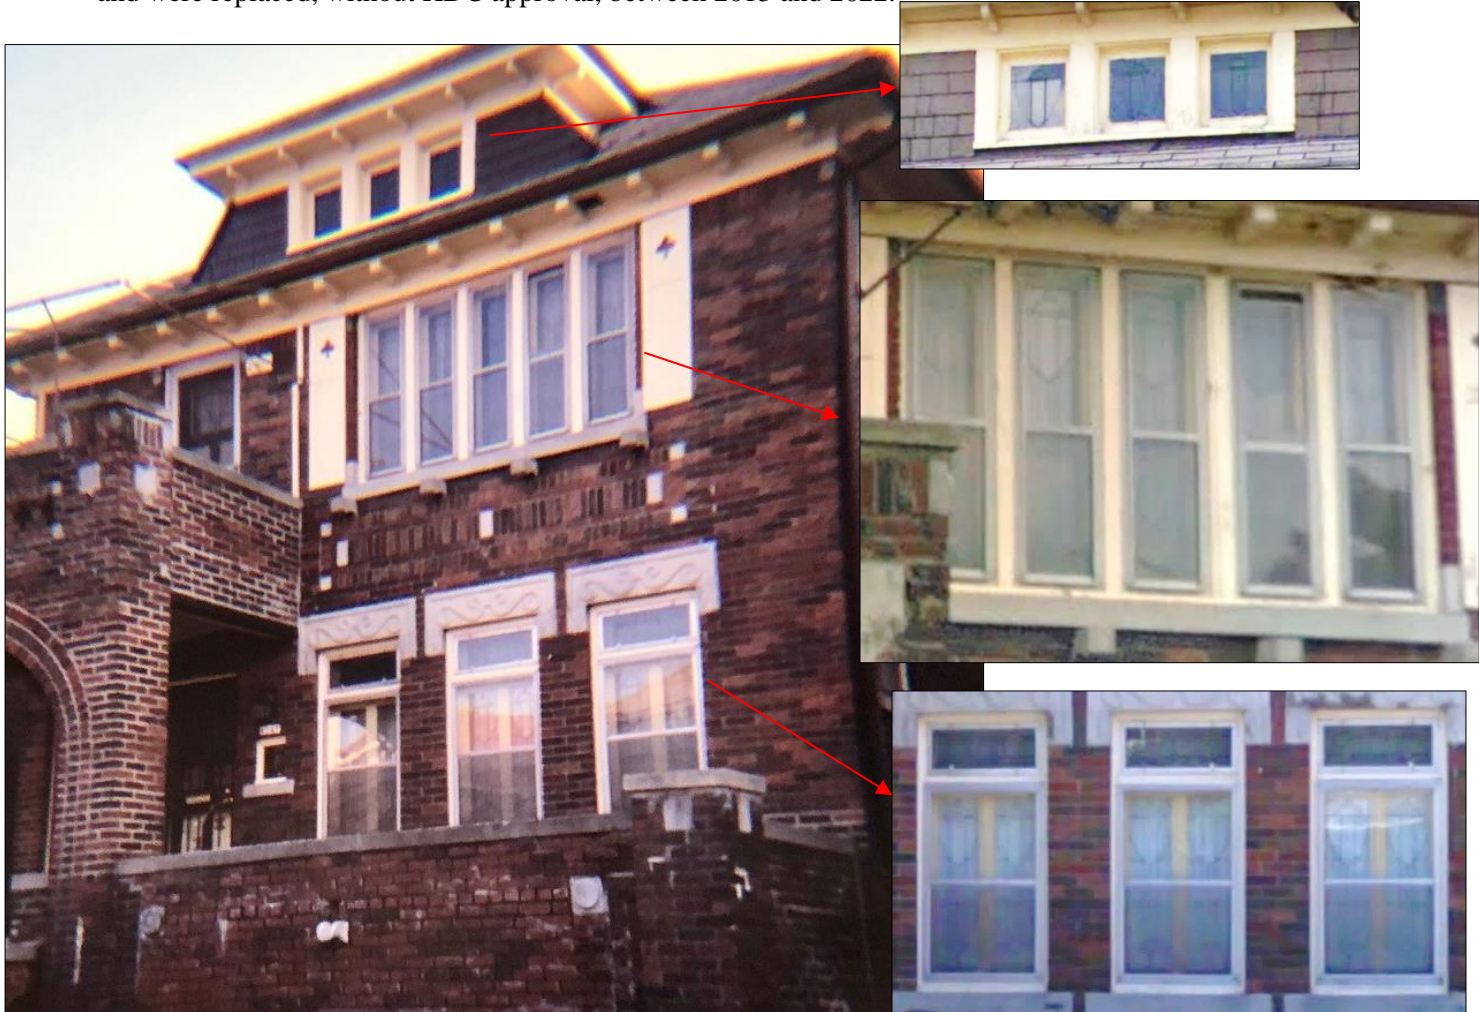
- The Russell Woods-Sullivan historic district was established in 1999.
- The designation photo shows leaded glass windows within each window opening on the front wall, as well as the three doors (two entrance and one upper porch). The first and second floor windows were vertically oriented casement units (casement design visually obscured by storm windows). The third floor had small square windows. The windows and doors were distinctive character-defining features and were replaced, without HDC approval, between 2013 and 2022.

1999 Designation photo, HDAB. Bottom right: 3755 Tyler, Google street view, June 2022.

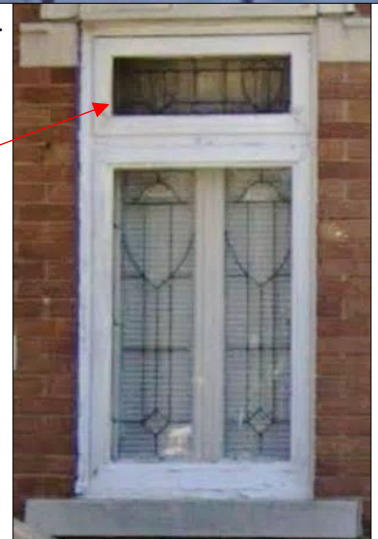
- The window shown at right is in the neighboring house (3755 Tyler) which has an identical leaded glass pattern to what had been in place at 3747 Tyler. This photo clearly shows the repeating leaded glass pattern in the transom window.
- The installation of storm windows in a double-hung operation obscured the casement windows, and once the windows were gone, gave erroneous and misleading information as to the original window operation and decoration.

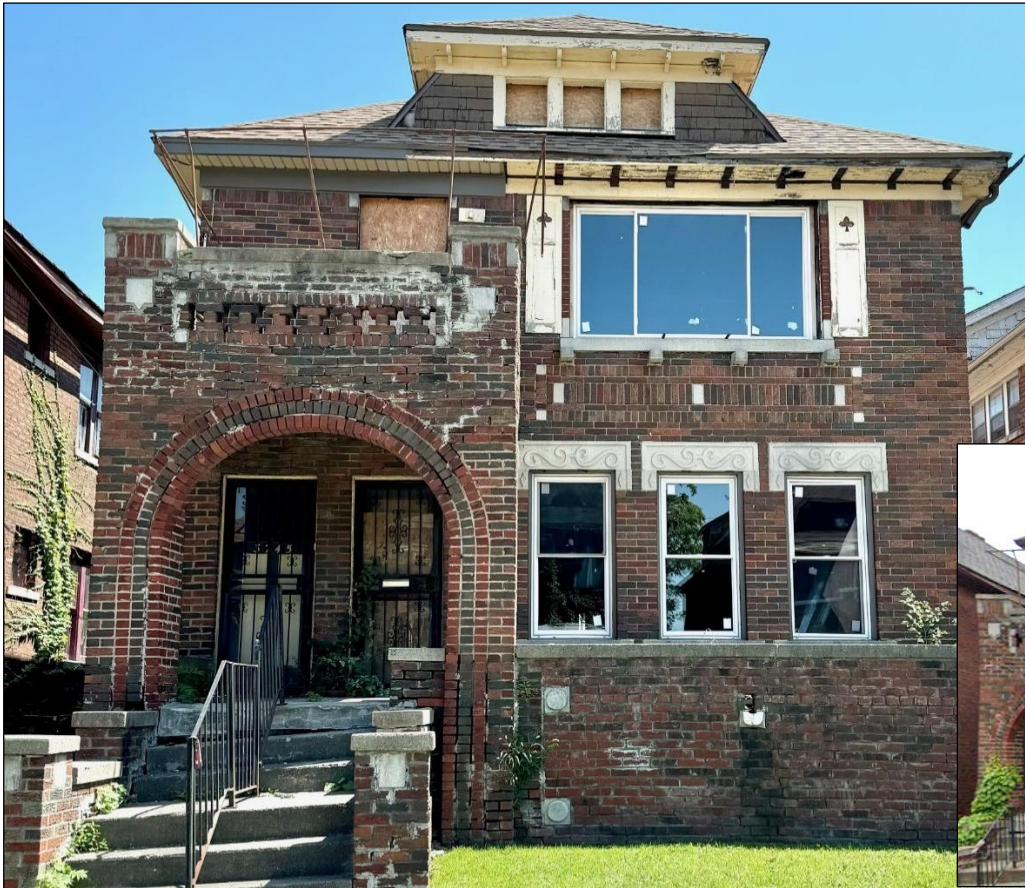
- This property is subject to the Detroit Land Bank Authority’s (DLBA) Nuisance Abatement Program (NAP), which required the property owner to rehabilitate the house. However, the rehab work was undertaken without HDC approval.
- Additional work identified which is NOT included in this application - the partial removal of the soffit brackets and covering of the wood soffit and fascia. This work occurred between June 2019 and September 2021.

Left: Staff photo, July 26, 2024. This condition of the soffit and fascia has been in place since at least September 2021 when staff first photographed this property.

Below: The 2019 Google street view image shows the wood bracketed soffit and wood fascia still intact.

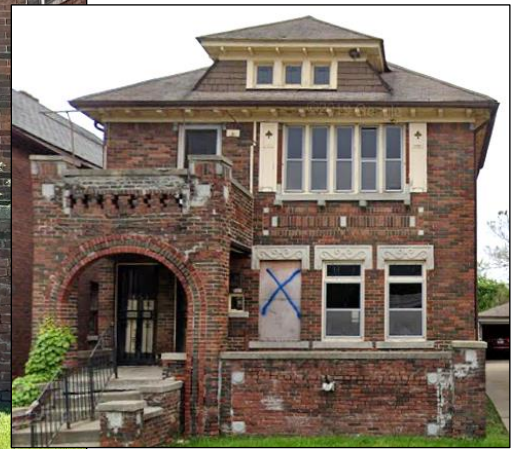
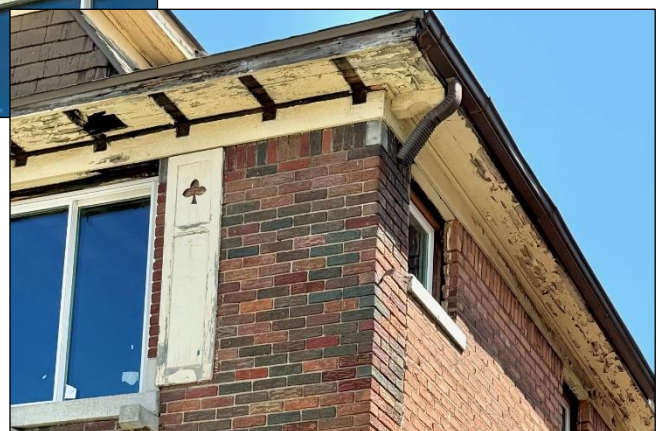
Left and below: 2024 staff photos showing existing conditions at the second floor eaves and the intact historic design at the dormer eaves.

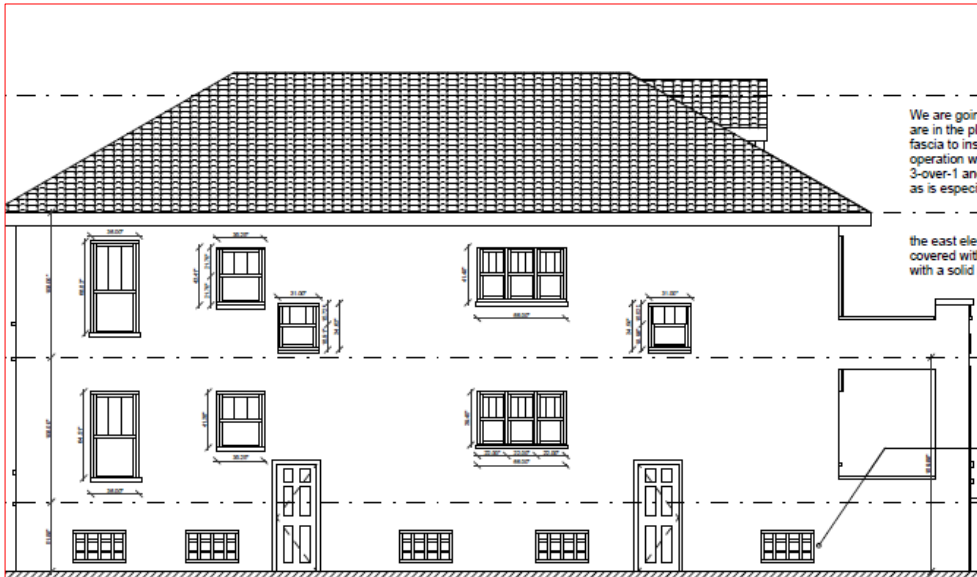
Applicant drawing, revised 09/10/24.

- ~~The current application reverts to matching the historic window operation of each opening on this wall. However, the historic muntin pattern was a linear 3 over 1, not 4, 6 and 9 over 1.~~
- This dwelling is a two-family flat, and the application includes the installation of a new doors within each existing door opening. The six-panel offers a minimal design with vertical proportion, and it is staff's opinion they are compatible for this property, however the selected color of white is not compatible with the architectural design of the dwelling.

- For the replacement windows at the side and rear walls, solid wood or aluminum-clad wood windows will be selected. Cut sheets confirming the manufacturer, product line, material, operation, color, and simulated divided light dimension and profile will be submitted for staff review. All double-hung windows will have a 3-over-1 pattern, and the small square windows will not have any glass pattern. A window schedule that confirms the details for each window will be submitted for staff review.

- The six-panel doors proposed for the side and rear elevations will be dark brown. A cut sheet confirming the design, color and material will be submitted for staff review.

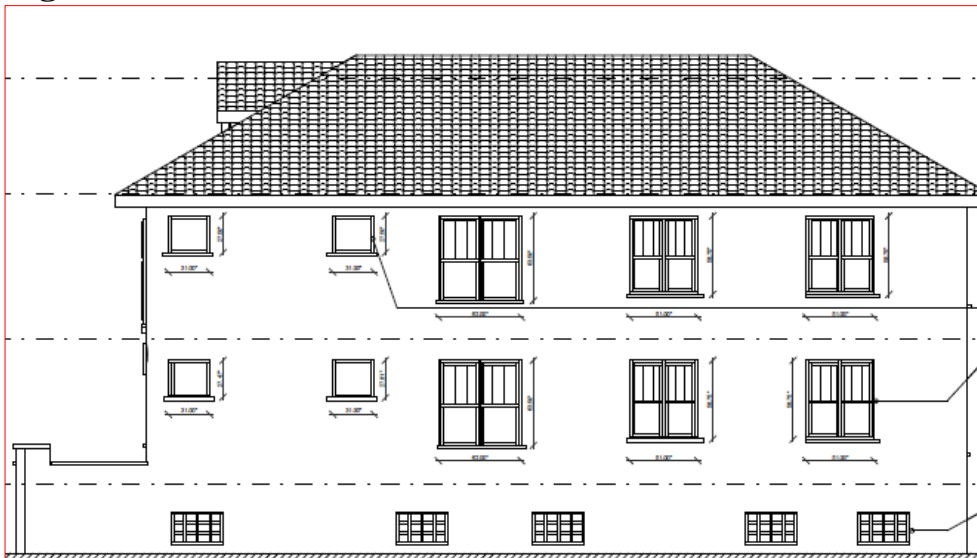
Applicant drawing, revised 09/10/24.

- Similar to the other side wall, the applicant proposes to remove the vinyl windows and install double-hung units in the taller-than-wide windows and has drawn the historically correct muntin pattern on this side of the house. However, it is staff's opinion the small square windows should not have a muntin pattern as these special windows historically often had a different glass design (possibly leaded glass). Staff did not find a photo to document if a pattern was historically present on these windows, therefore glass with no pattern is a compatible design.

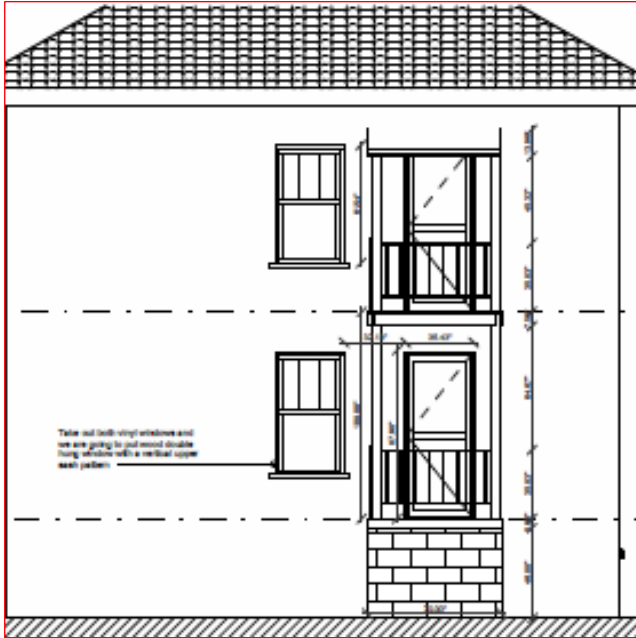
Applicant drawing, revised 9/10/24

- The application proposes to remove the vinyl windows and install wood windows with a 3-over-1 pattern to match the documented historic condition. A two-story porch is proposed in a dimension and design that is similar to the ghost images shown in the 2018 photo that documents the placement of the former porch.

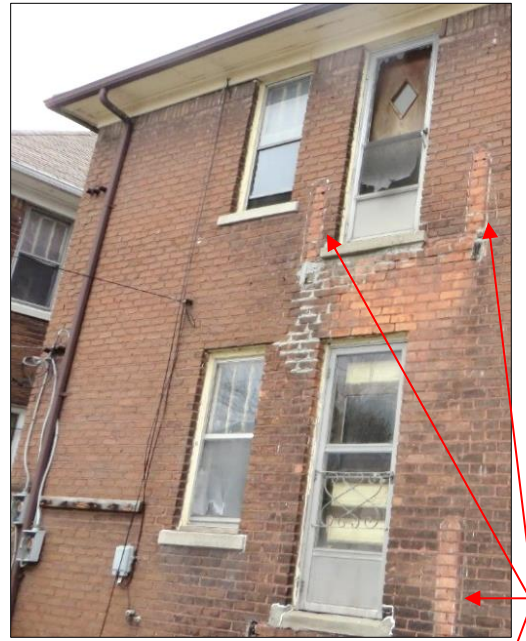
2018 photo of rear elevation. "Ghost" images of the original porch are evident on the brick.

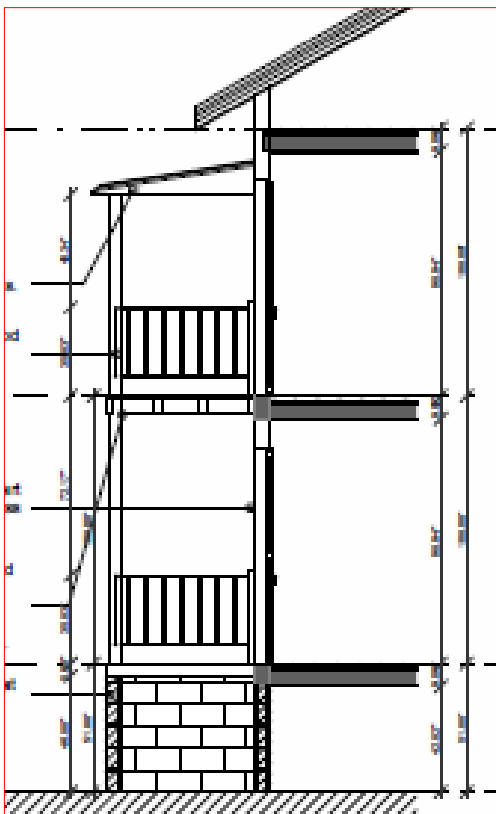
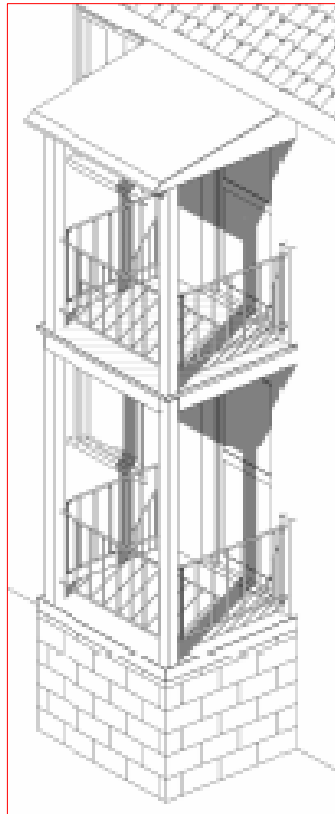
Applicant drawings, revised 09/10/2024

- It is staff's opinion that the historic porch was likely wood construction (based on the width of the railing profiles) and that wood construction for the new *footings*, posts, railings and landings (no concrete block or iron railings/posts) would be compatible at this rear, secondary location. An awning for the upper porch, as drawn, is also a compatible design option at this location.

- The aluminum coil stock that was installed to cover the window opening's wood brickmould will be removed.
- The two-story rear porch will specify wood components for the **footings**, posts, railings and decking. The perimeter railings will have a top and bottom rail and vertical spindles and will be tied into the porch's supporting posts; a freestanding, independent railing system as currently proposed will not be selected. The entire porch system will be painted three – six months after installation; paint color will be submitted to staff for review. If an awning is selected to cover the upper porch, a catalog cut of the product that includes the dimensions, method of installation, materials, fabric color and pattern will be submitted to staff for review. A revised dimensioned elevation drawing of the two-story porch that calls out materials and finishes will be submitted to staff for review.

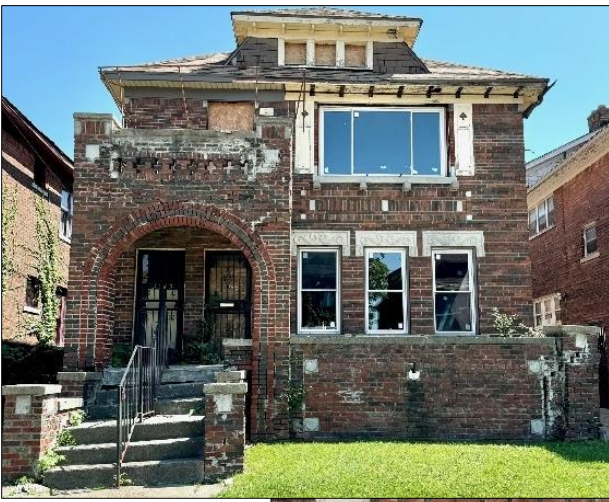
Staff photos, July 2024.

- The applicant proposes to repair/rebuild portions of the front elevation’s masonry porch. Based on the photos and staff’s site visits, a high level of deterioration, some structural as well as masonry deterioration due to poorly executed tuckpointing, is evident.

- The applicant will create a condition assessment for the masonry front porch that fully documents existing conditions and corresponding repairs that meet the Secretary of the Interior's Standards, as discussed in National Park Service Preservation Briefs #1 and #2.

- Scopes of work, need to be fully explained, including method, material and pressure of cleaning.
 - If a section of the existing porch is to be deconstructed and rebuilt (like possibly the outer, east masonry pier which isn't identified in the current scope of work), a dimensioned drawing confirming how it will be reconstructed is required.

- Assuming that some new brick may be needed, brick samples that closely match the existing brick in dimension, color, pattern, finish and profile will be submitted to staff for review. Also, specification of the new mortar, including composition and installation dimension, profile, etc. must be submitted to staff for review.

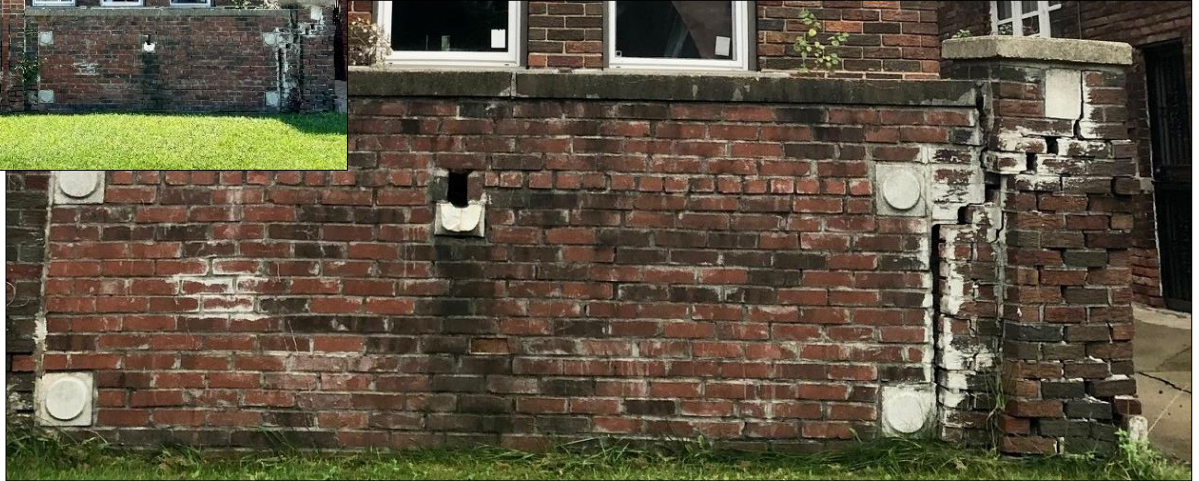
Page from applicant’s document, revised 09/10/2024.

- The applicant’s condition assessment is not fully documented, and the scope of work is not detailed to the level needed, nor described in a way (ex. “*prepare it with cement and re-glue the original bricks...*”) that meets the Secretary of the Interior’s Standards.
 - Scopes of work, such as “*clean the surface well*” need to be fully explained, including method, material and pressure of cleaning.
 - If a section of the existing porch is to be deconstructed and rebuilt (like possibly the outer, east masonry pier which isn’t identified in the current scope of work), a dimensioned drawing confirming how it will be reconstructed is required.

- Assuming that some new brick may be needed, brick samples that closely match the existing brick in dimension, color, pattern, finish and profile will be submitted to staff for review. Also, specification of the new mortar, including composition and installation dimension, profile, etc. must be submitted to staff for review.
- National Park Service Preservation Briefs, available online and from HDC staff, offer information documents directly related to masonry cleaning and tuckpointing historic brick. See links below.
