STAFF REPORT 10-09-2024 REGULAR MEETING PREPARED BY: G. LANDSBERG

APPLICATION NUMBER: HDC2024-00519

ADDRESS: 3628-3644 LINCOLN

SCOPE: DEMOLISH REAR WINGS, CONSTRUCT NEW REAR ADDITION, REHABILITATE EXTERIOR. DEMOLISH GARAGE, ERECT NEW CARRIAGE HOUSE

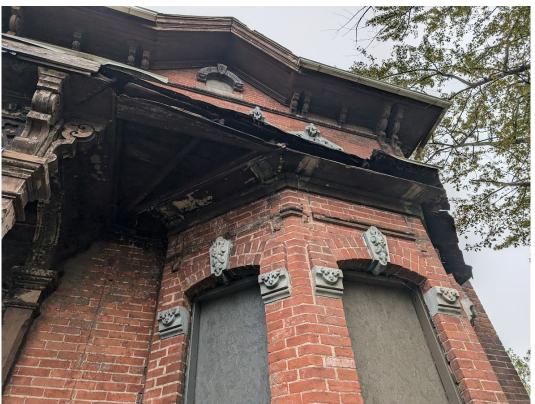
View towards top of front bay window, showing original surviving stone and wood detailing. Staff photo, September 30, 2024.

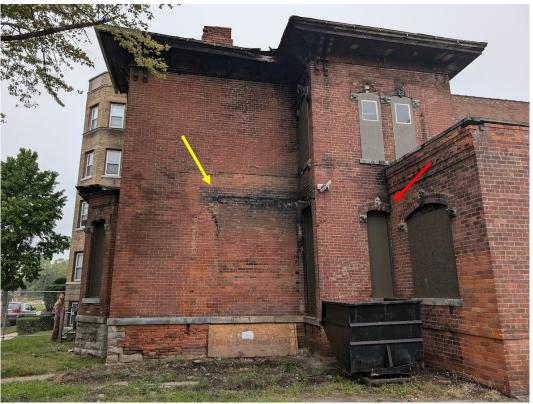
View to the north, showing south-facing wall of main house and, to the right, the oddly attached "south-extending addition" which awkwardly intersects with one of the original windows (red arrow). Ornament from another window was apparently moved to this new wing's window, or perhaps sourced from the same supplier. The wing has only a crawlspace, while the original house has a full basement. This interesting historic condition will be preserved in the proposal. Note "ghost" of former frame porch (yellow arrow). Staff photo, September 30, 2024.

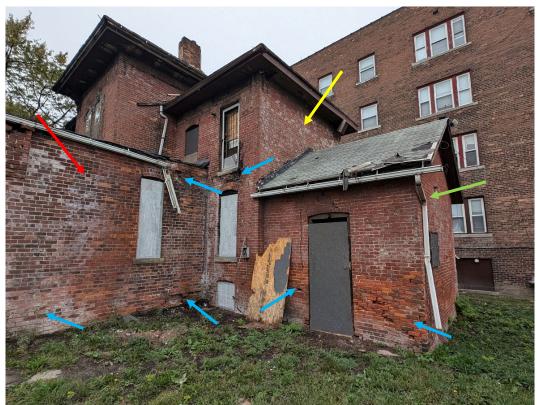
View towards the northwest, showing rear additions/wings proposed for alteration/removal. To the left, the "south-extending addition" is marked with a red arrow. The two-story wing in yellow, and the gable-roofed addition in green. Note substantial brick distress (blue arrows). Staff photo, September 30, 2024.

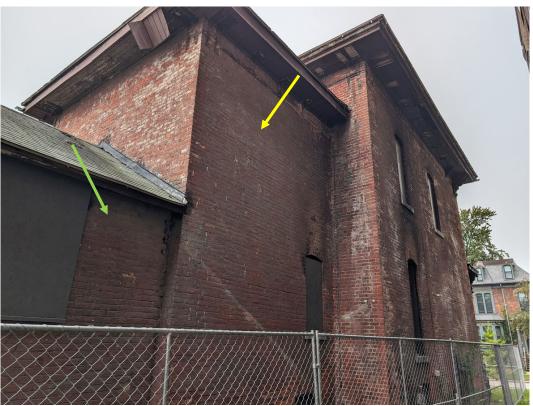
View to the southwest at north property line, towards Lincoln. The main house portion is at right. Yellow arrow shows two-story wing to be replaced with "hyphen", green arrow shows gable-roofed addition. Staff photo, September 30, 2024.

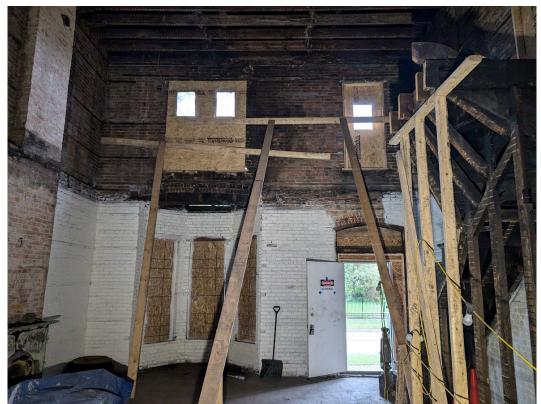
Interior view of main house interior, looking towards front door/Lincoln. Note complete lack of second floor and bracing in place to support exterior brick walls. Staff photo, September 30, 2024.

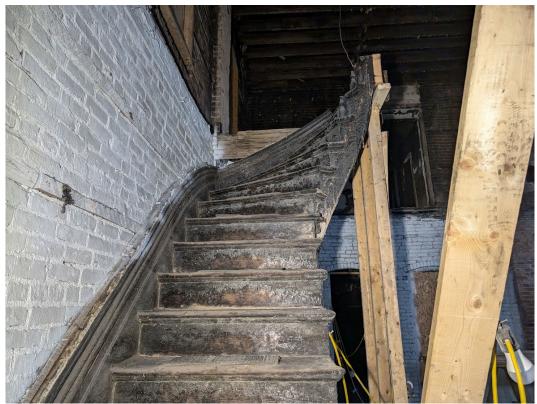
Detail view of salvaged and braced interior monumental stair, prepped for rehab. Staff photo, September 30, 2024.

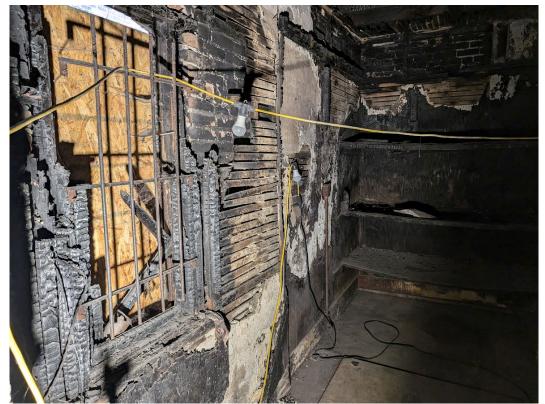
Typical damage at rear addition. Note condition of window. Staff photo, September 30, 2024.

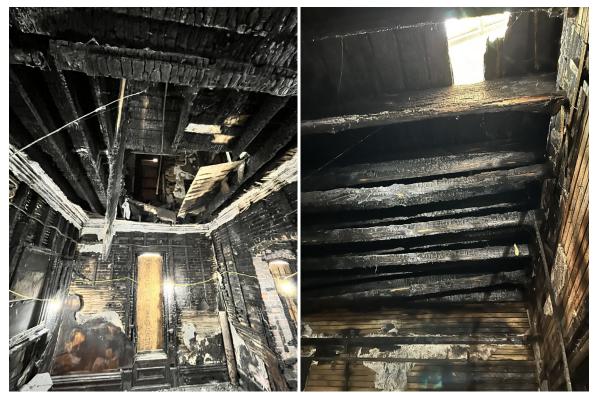
View into the south-extending wing showing extent of fire damage, including collapsed floor and bowed roof joists. This area, excepting the west (front) facing wall visible in the photo below, will be replaced by a sunroom. Applicant photos, September 30, 2024.

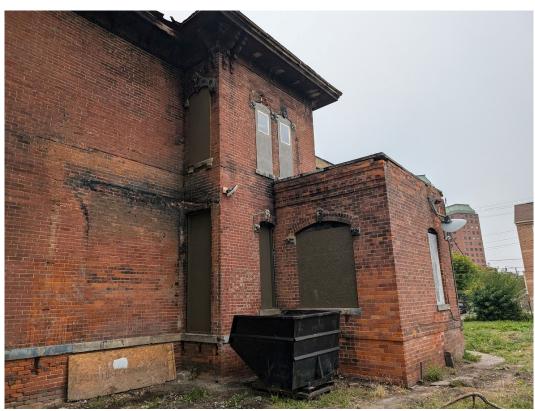
Another view of the "south-extending addition". The wall fronting the dumpster, featuring the large arched window, will be preserved, whereas the south facing wall (at right) will be replaced with sunroom windows extending further south. Staff photo, September 30, 2024.
