STAFF REPORT: 11/13/2024 MEETING (REVISED 11/12/20224) PREPARED BY: J. ROSS
ADDRESS: 1118 SEYBURN
APPLICATION NO: HDC2024-00593
HISTORIC DISTRICT: WEST VILLAGE
APPLICANT/OWNER: JULIE PINCUS
DATE OF STAFF SITE VISIT: 10/16/2024
DATE OF PROVISIONALLY COMPLETE APPLICATION:10/15/2024

SCOPE: INSTALL WOOD SIDING AT REAR ELEVATION AND REBUILD FRONT PORCH

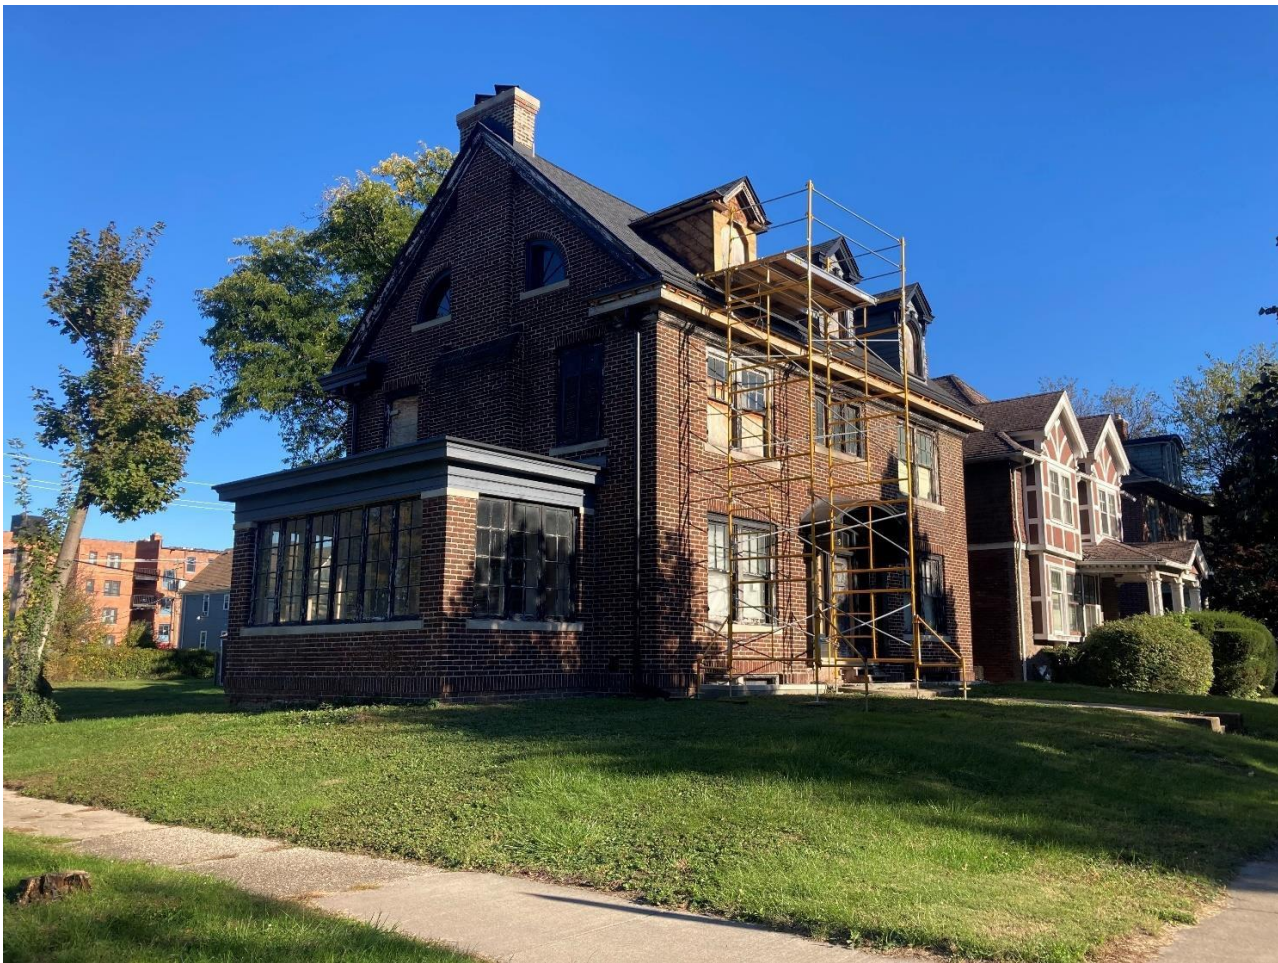
The building at 1118 Seyburn is a 2½-story, single-family Colonial Revival dwelling that was erected in 1913 and occupies a prominent corner lot at Agnes Street. A brown brick veneer is found at the building’s front and side walls. Much of the original brick has been removed/fallen off the rear wall and a large opening at the wall has been enclosed with plywood. The house features a side gabled roof with Classical eave returns which is framed by chimneys, each flanked by fan windows, with the north-facing chimney particularly prominent. Three front-gabled dormers with wood shingle-clad front and sidewalls top the roof at the front elevation, with a fourth at the rear elevation. Windows include paired 6/1 wood sash units, 6-light wooden casements, and arch top multi-light windows at the dormers. The entry door is flanked by windows and the porch features columns and an arched pediment. Many historic details are extant, though in considerably deteriorated condition.

Current condition, staff photo taken on 10/16/2024

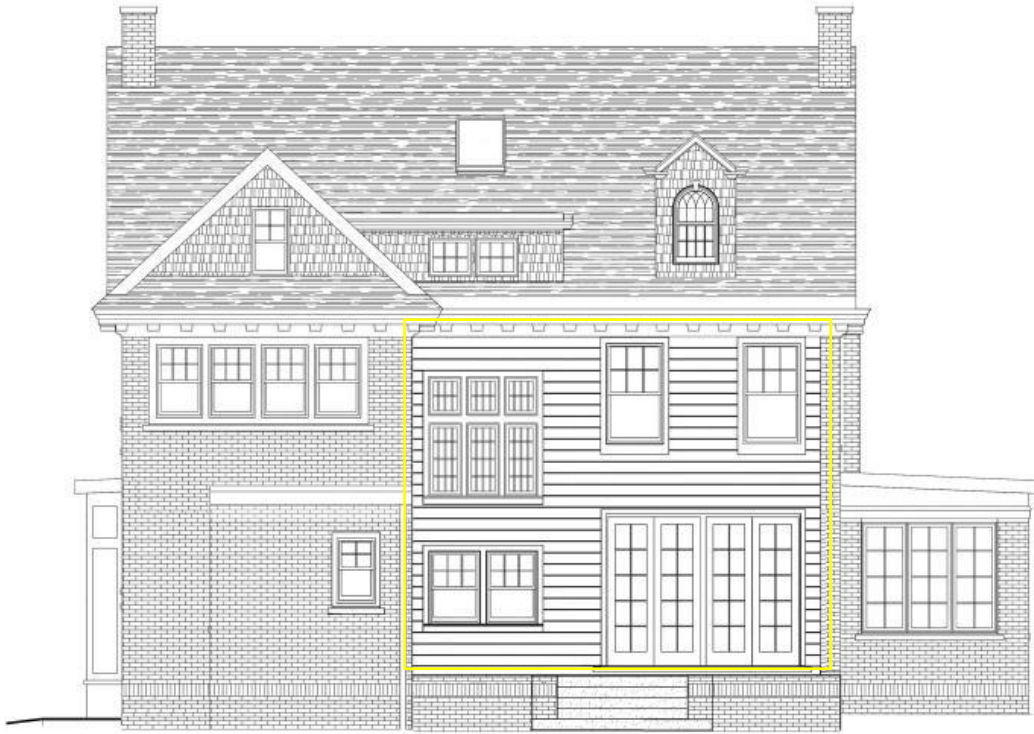
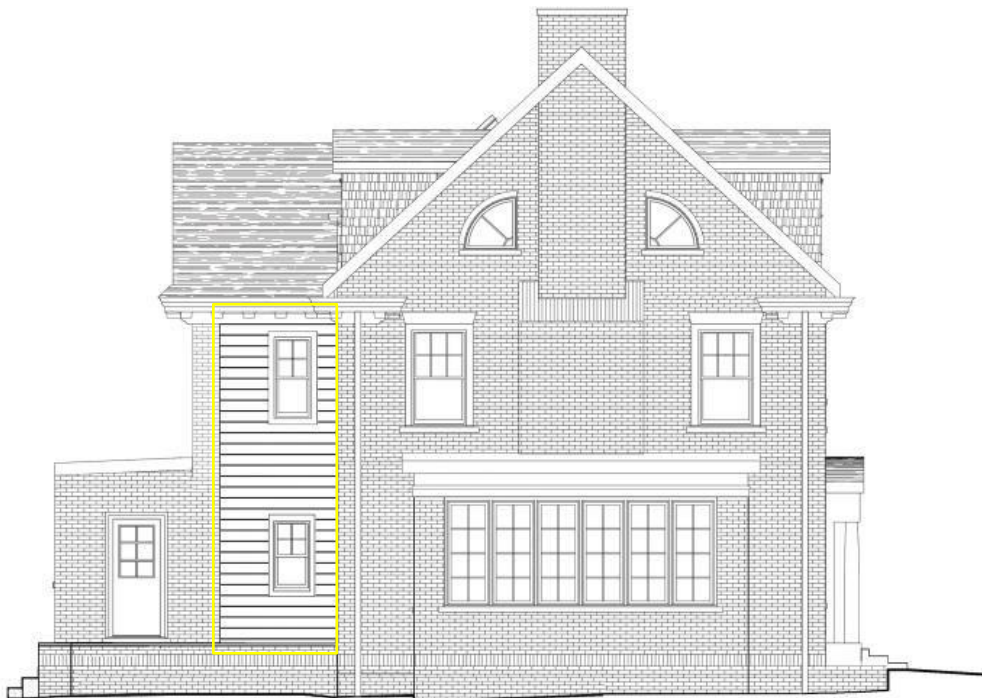
Above elevation drawings, submitted by applicant showing proposed condition/proposed new lapped wood siding at rear wall (outlined in yellow)

- As noted above, it is staff's opinion that the lapped wood siding proposed for the building's rear elevation is not compatible with the building's historic character as this treatment was not observed within the district specifically and is not typical of early 20th century, single-family dwellings. Therefore, the work does not conform to the district's Elements of Design or meet the Secretary of the Interior's Standards for Rehabilitation.

- The new cladding material installed at the building's the rear wall may align with the treatment approved by the Commission at the June 2019 regular meeting. Alternatively, the applicant may install a true stucco finish at the rear wall which is painted a color that complements the dwelling's existing brick cladding.

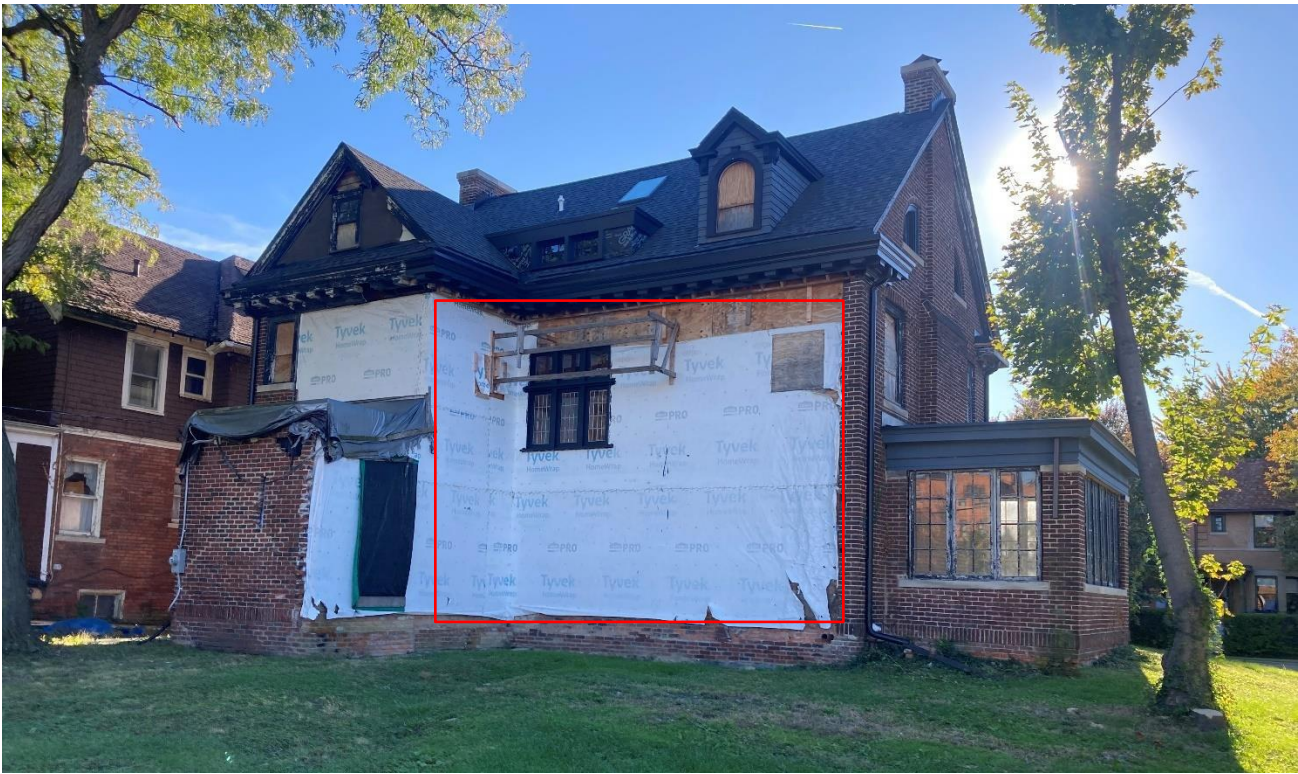
Current condition at rear wall, staff photo taken on 10/16/2024. Area outlined in red indicates proposed location for lapped wood siding.

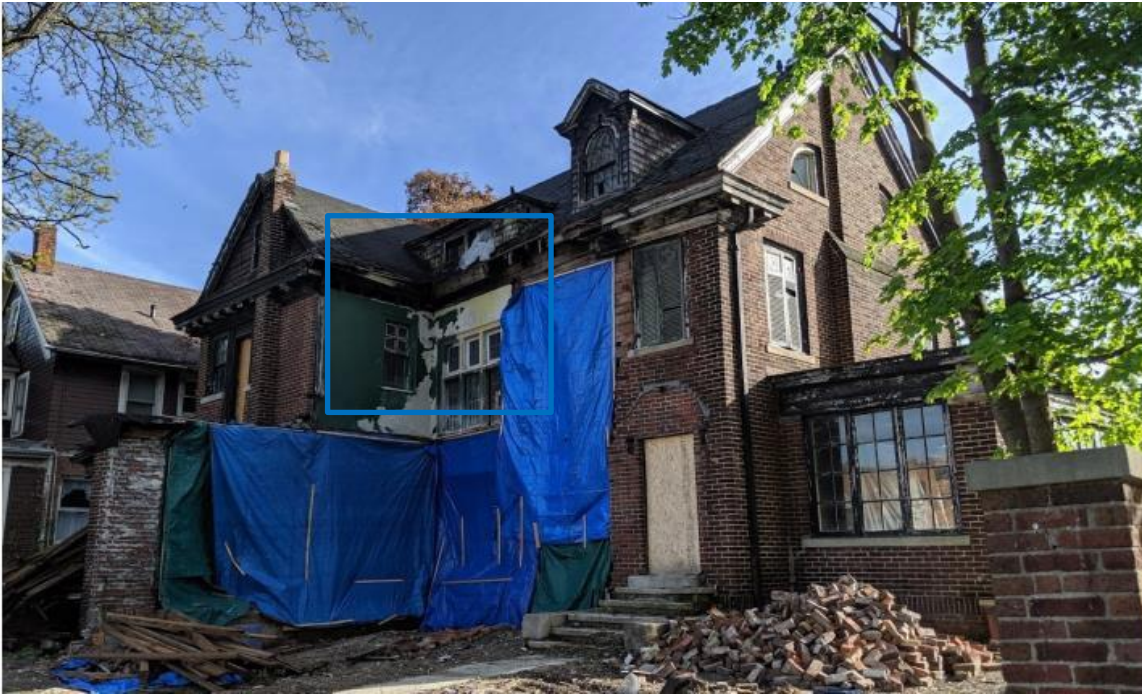
Conditions in 2019. Photo taken by HDC staff. Note the presence of plaster at a small area of the rear wall (outlined in blue)

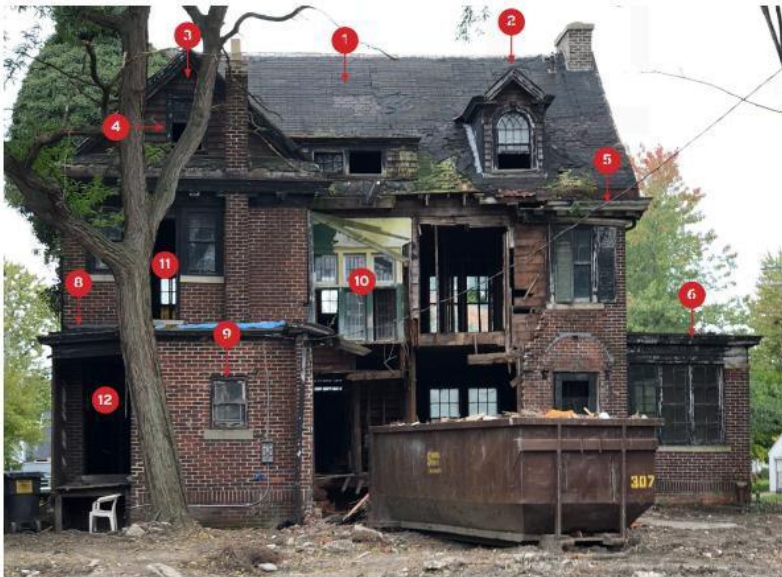
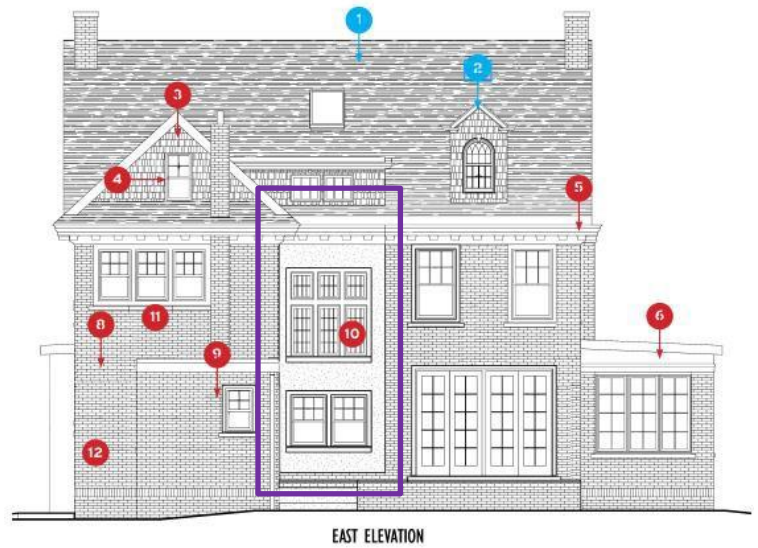
EAST ELEVATION

- 1. Asphalt Shingle Roof is completely ruined and needs a complete tear off;
- 2. Dormer window, Dormer trim and Cedar Shake Siding are in terrible condition;

- 3. Shake Siding is rotten;
- 4. ALL Existing Double Hung Windows with the exception of third floor (Palladian (example #2), 1/4 circle and leaded glass window units) are to be replaced with new as they are beyond repair. The mentioned windows will be renovated by Amy at building hugger (Have COA already);

- 5. Soffits and decorative squares are rotten (Have COA already);
- 6. The sunporch soffits and roof is failing. (It no longer has the pergola-type adornment seen in the original photo).

- 7. Generally Tuck pointing is a must (Have COA already);
- 8. Roof is ruined and needs to be rebuilt. Note: on plans we would like to get rid of extension and door leading into kitchen.

- 9. Remove, relocate and replace window
- 10: Window needs complete renovation
- 11. Remove door
- 12. Remove door

Existing and proposed/approved condition in 2019. Note that the 2019 HDC approval (on the right) allowed for the addition of stucco to a portion of the rear wall (outlined in purple)

- 1. Roof to be completely replaced and installation of a skylight (COA already obtained for both);
- 2. Dormer window to be restored and reinstalled (COA obtained); Dormer trim to be replicated exactly and repaired or replaced if it is too rotten;

- 3. Shake siding to be replaced with same material in same pattern;
- 4. ALL Existing Windows unless indicated are to be replaced with same size and design insulated glass wood window (order specs prepared for review) with exterior metal cladding; wood trim to be replaced with exact replica wood trim (tool already made and sample included in presentation);

- 5. Soffits and decorative squares will be replaced with exact replica wood trim and elements
- 6. The sunporch soffits and roof is failing. The pergola-type adornment seen in the original photo on cover is to be replicated in the design shown in same amount seen on photo. Size and design is our best approximation of what existed based on photo.

- 7. Tuck pointing to be matching existing color and strength of mortar
- 8. We would like to get rid of roof extension and the door leading into kitchen as well as "lean to" wood porch floor. The removal aids in our kitchen design, and the door to the kitchen has been relocated.

- 9. Remove and replace window with a new window in a better location for the layout. This out building is in sad shape, so will need much brick work anyway

- 10: This will be completely restored as it's rotten
- 11. Remove door and replace with windows as per elevation
- 12. Remove door that leads to backyard as the door to the kitchen has been relocated as per plans

- 13. Stucco (top is existing). We propose that it continue to porch for design continuity.

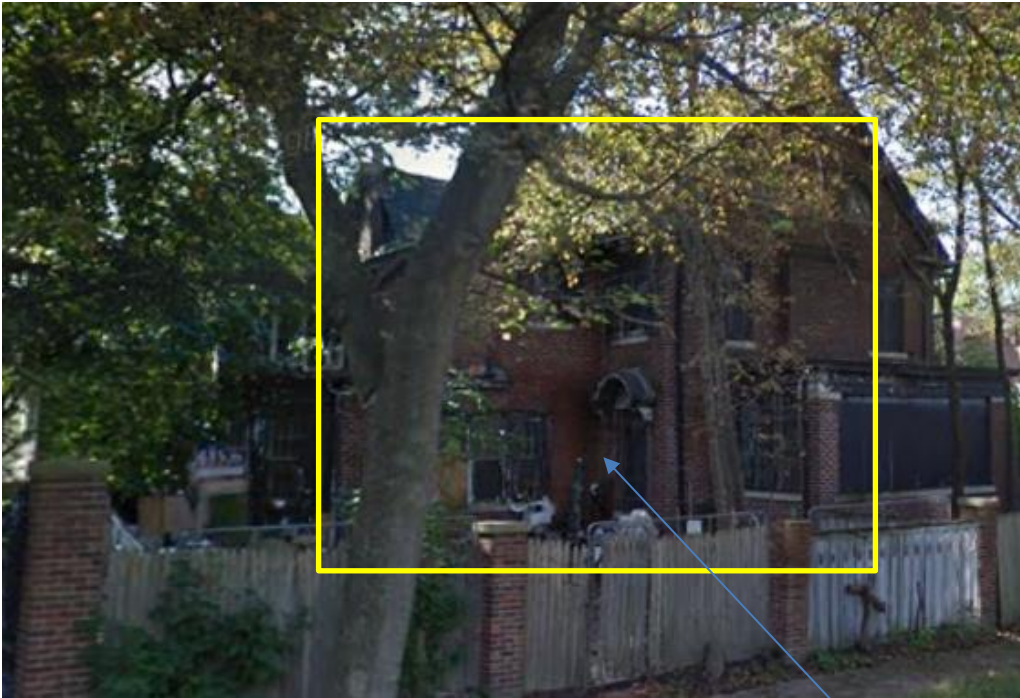
Google Streetview image of the rear dating from 2011. Note that the area outlined in yellow shows the rear two-story addition which had collapsed by 2019. Specifically see where the south wall of the addition is located in relation to the door and canopy at the rear.

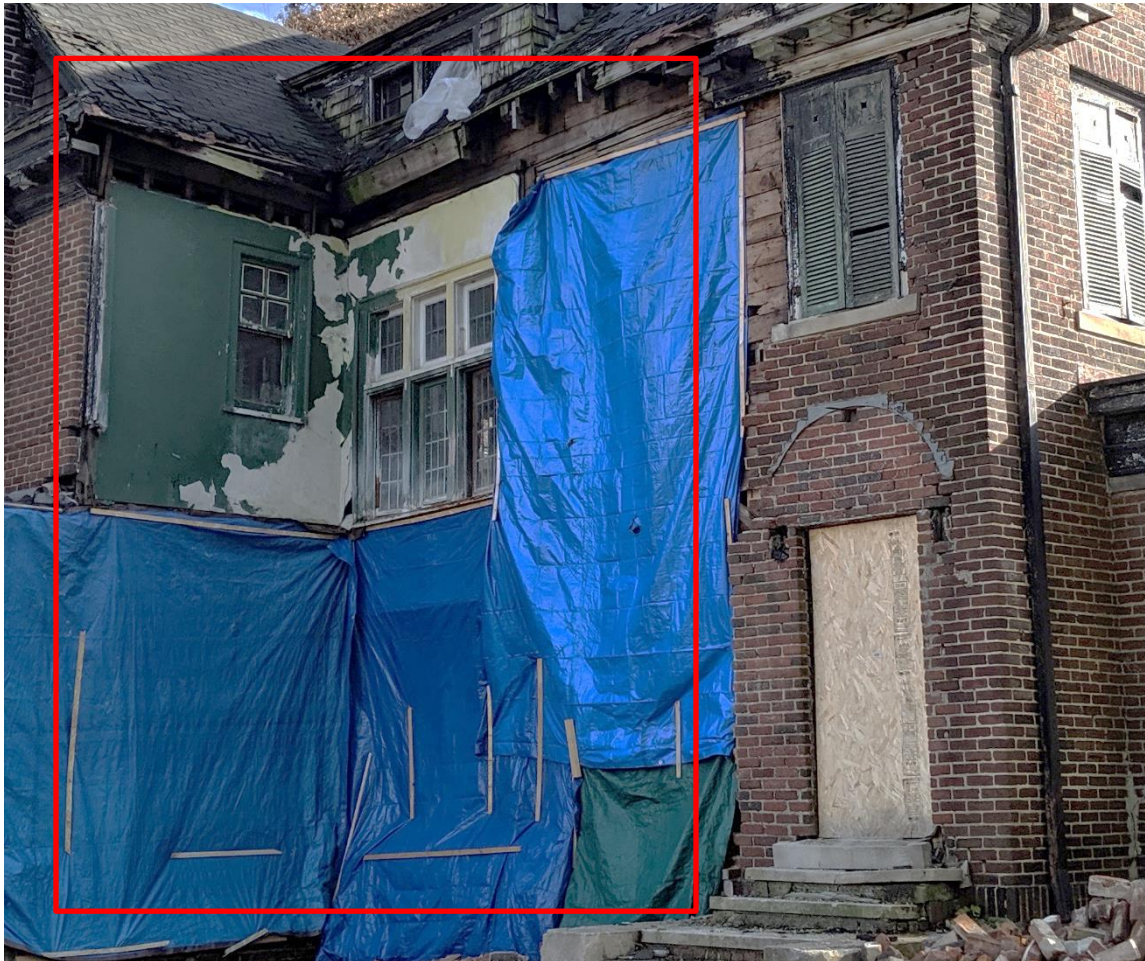
- As noted above, brick was originally located at 1118 Seyburn’s rear wall. A review of the below Google Streetview images from 2011 and the below staff photo indicates that plaster was visible at the building’s rear wall in 2019 as the result of the collapse of a two-story addition which resulted in the exposure of interior walls. As the brick at the rear wall was removed due to deterioration, the Standards would require that the new cladding be brick to match the historic. However, staff does note that the Commission’s 2019 approval did allow for stucco and brick to be added to the rear wall due to its the poor condition at that time. Also, staff has observed at least one example of this treatment, ie. brick at the front and sides and stucco at the rear, at one house of the same vintage and style in the neighboring Indian Village neighborhood. Therefore, it is staff’s opinion that true stucco which would be an acceptable alternate to brick for the cladding of the rear wall.

Staff photo of the rear dating from 2019. Note that the two-story addition is no longer present/had collapsed ca. ca. 2018, leaving the plaster which covered former interior wall exposed (outlined in red).
