STAFF REPORT: 11/13/2024 MEETING

ADDRESS: 1624 EDISON

APPLICATION NO: HDC2024-00434

SCOPE: REHBAILITATE DWELLING AND GARAGE

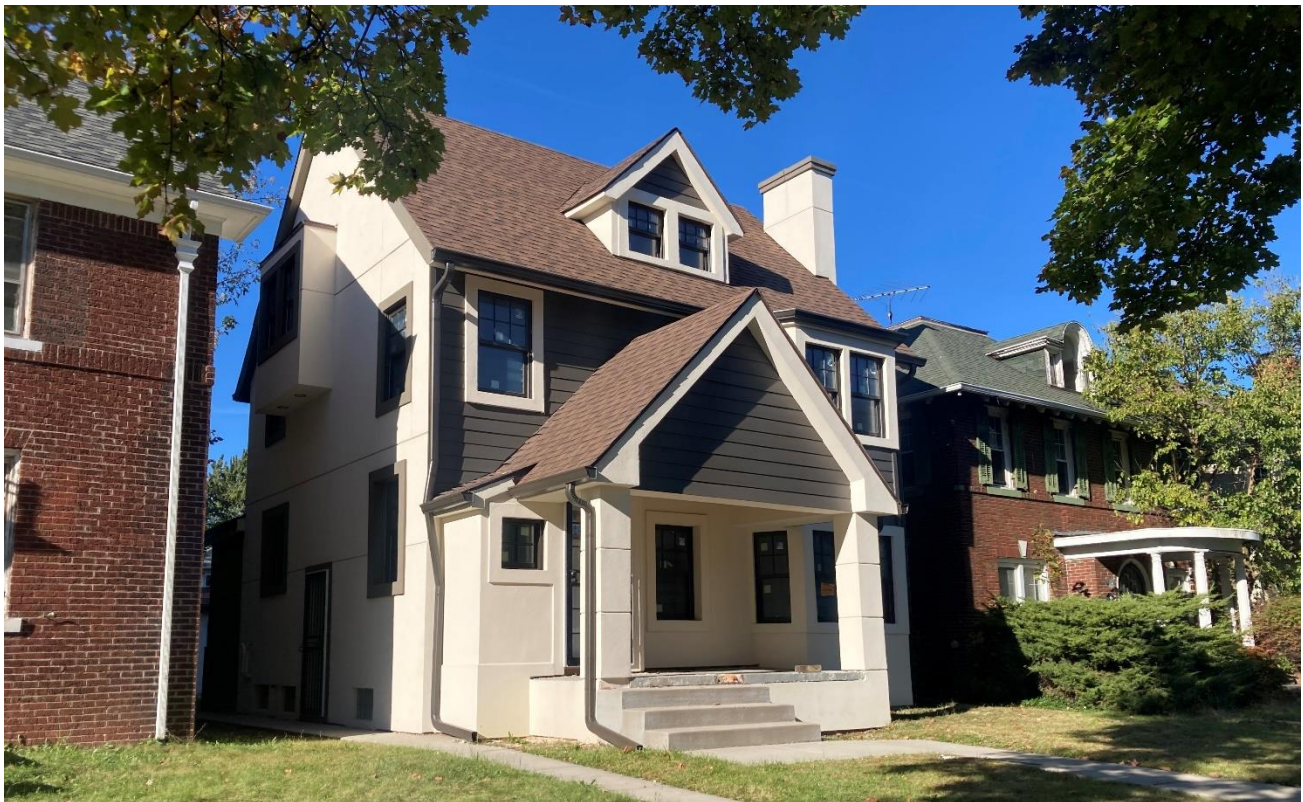
Current condition. Staff photo taken 10/16/2024

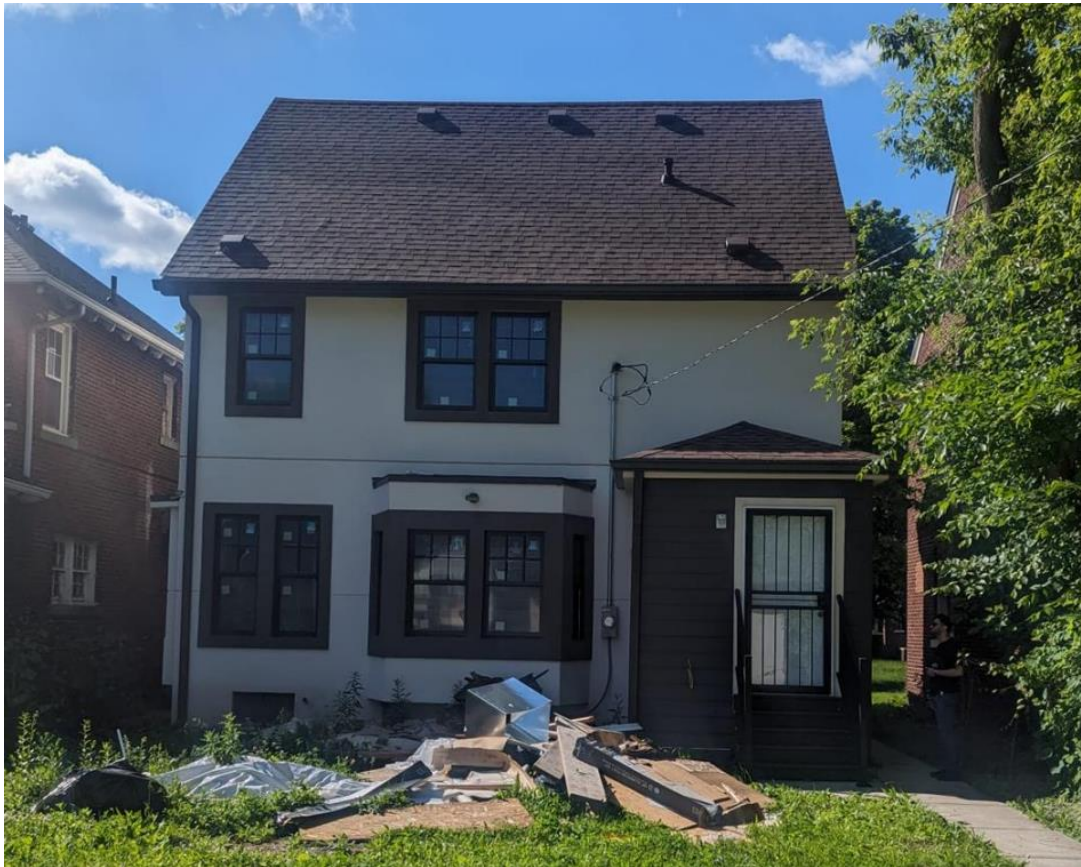
Current condition at rear. Photo by applicant

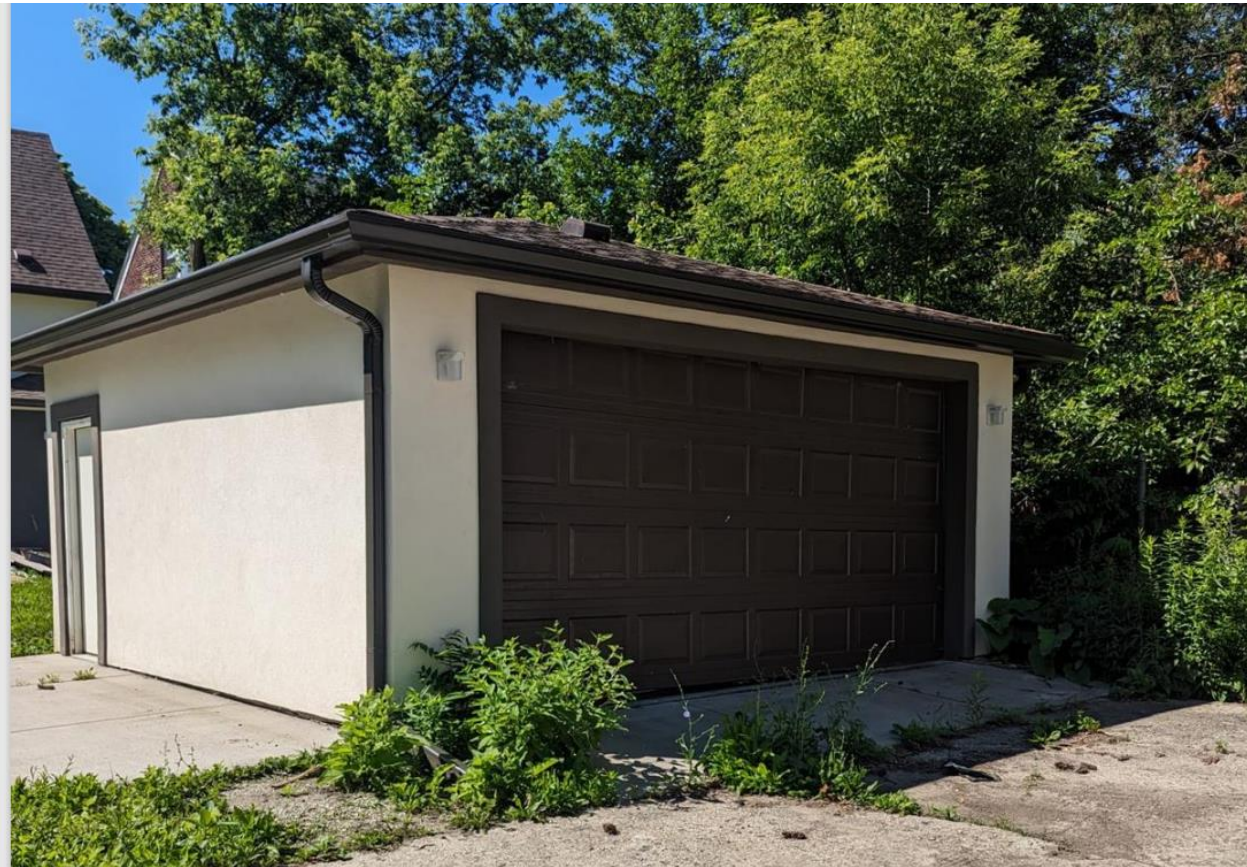
Current condition of garage. Photo by applicant

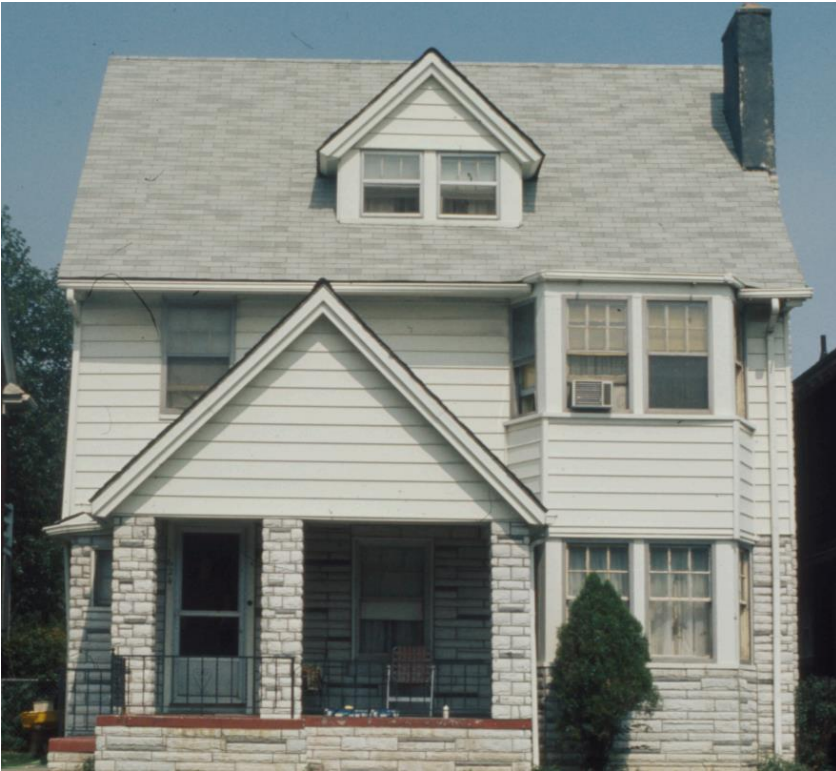
Designation slide, taken in 1974. Source, Detroit HDAB

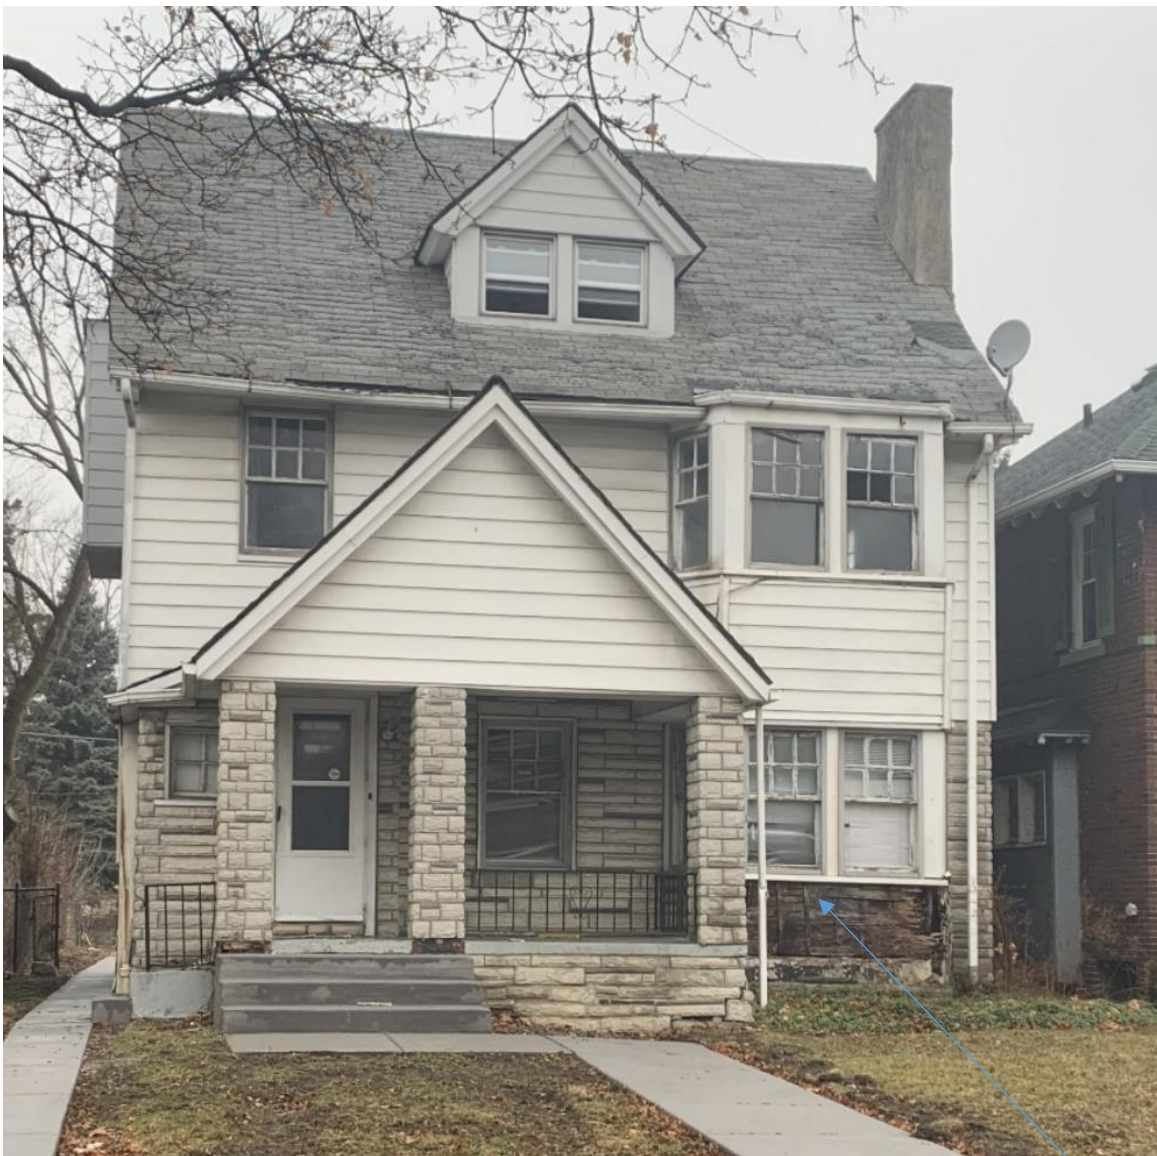
Front façade, 2020 photo taken by previous applicant. Note area where Permastone has fallen off

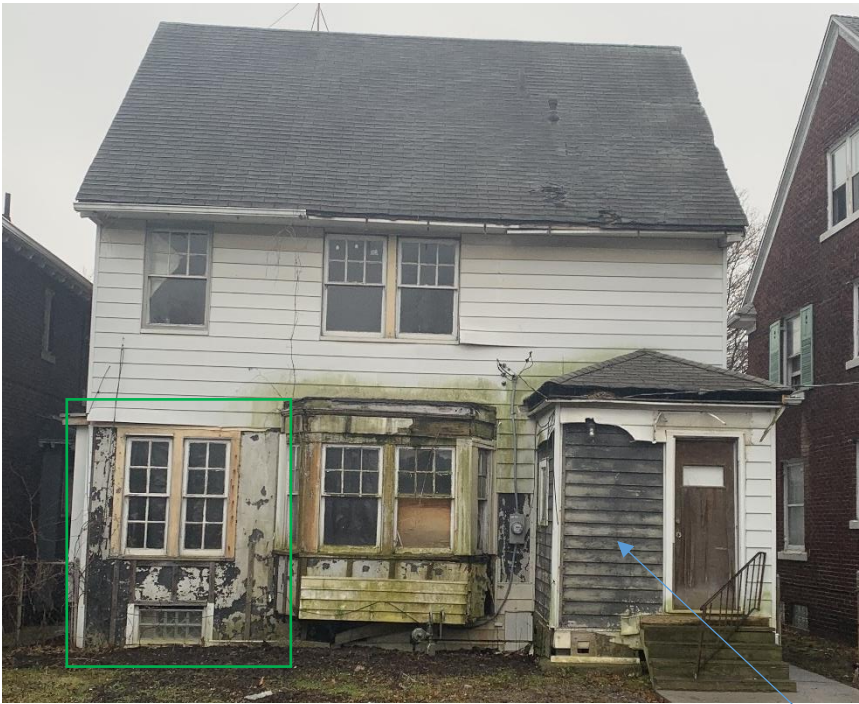
Rear, photo taken in 2020 by previous applicant. Note apparent fire damage at first story. The area outlined in green shows original stucco finish at first story. Also, note that the fire has exposed the historic lapped wood siding at the hipped roof wing

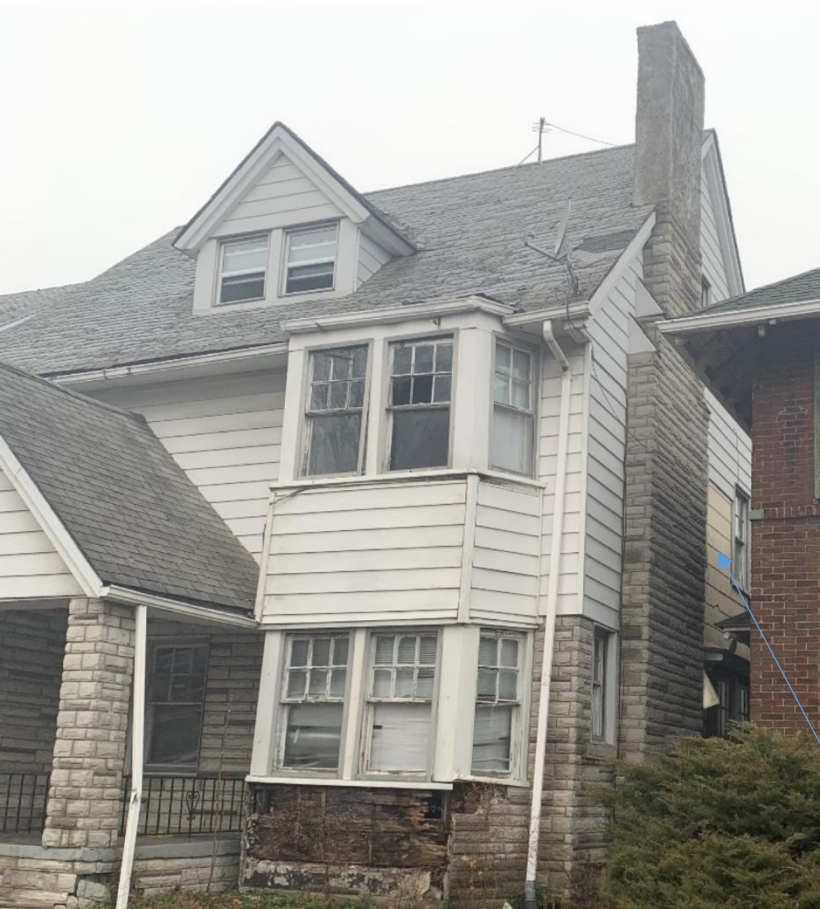
Photo taken in 2020 by previous applicant. Note area where aluminum siding has fallen off, revealing synthetic shingle siding underneath.

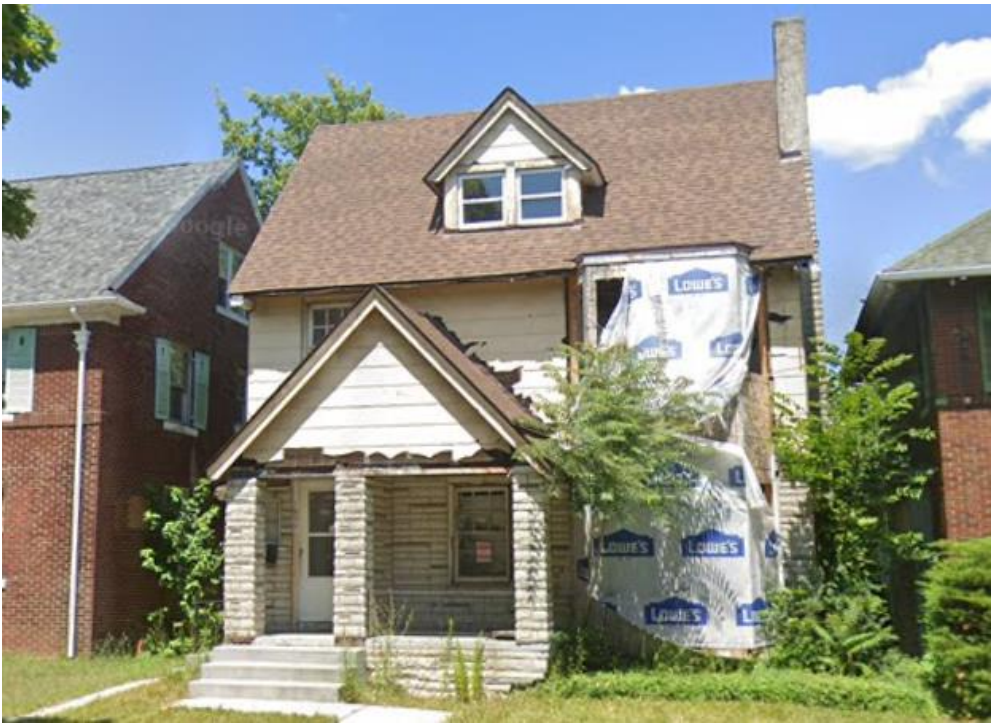
Conditions in 2020, per Google Streetview

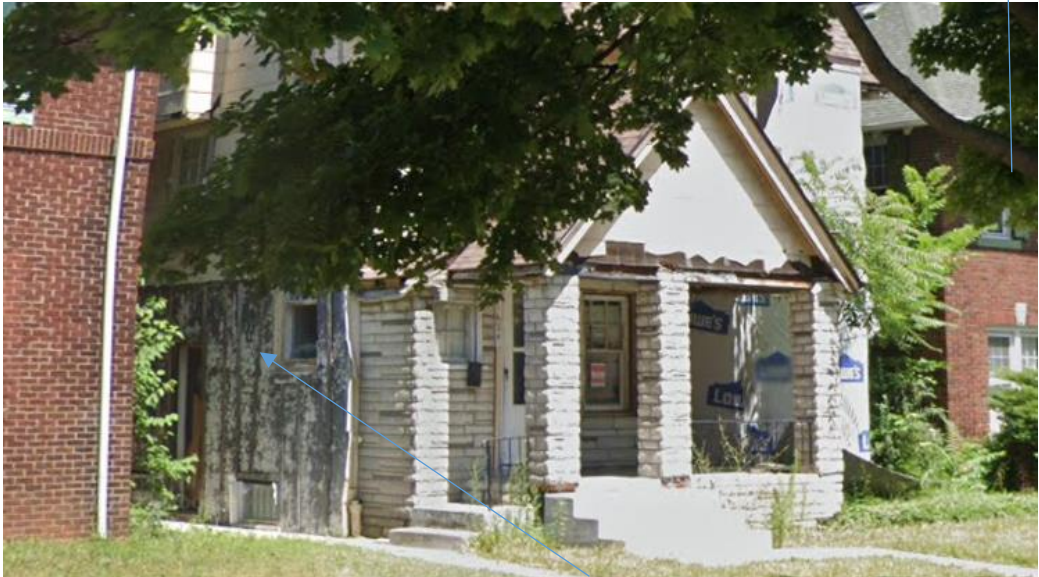
Conditions in 2020, per Google Streetview. Note where PermaStone has been removed to reveal original stucco finish at first story

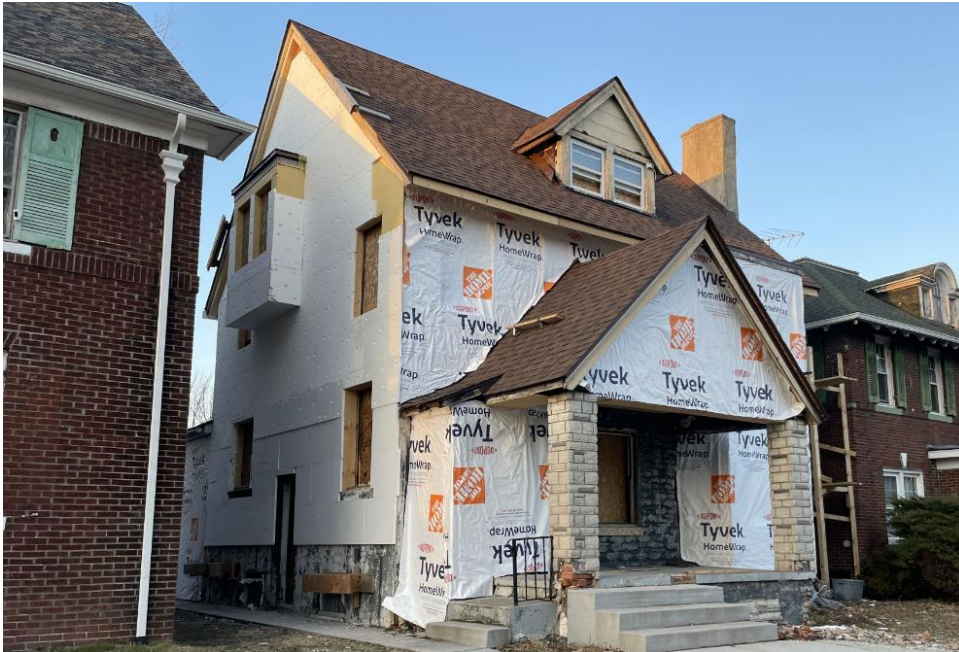
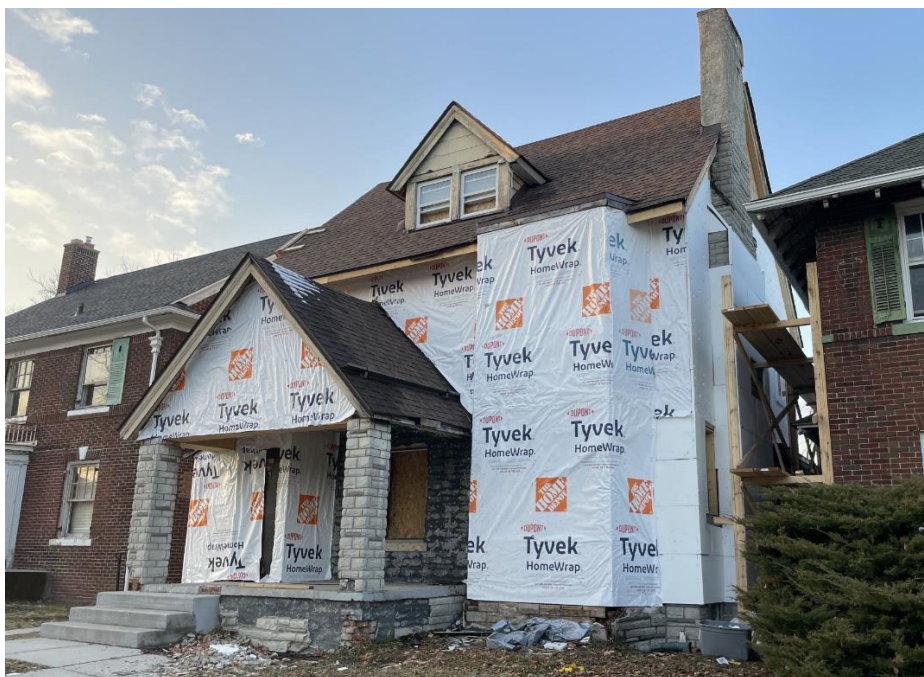
- In January 2023, HDC staff was alerted that the following work had been undertaken without HDC approval:
 - All windows removed
 - All exterior cladding removed
 - Side wall, second story bay rebuilt
 - Original fascia and soffit at main roof and porch roof replaced
 - New driveway added

Conditions on 1/24/2023. Photo by HDC staff

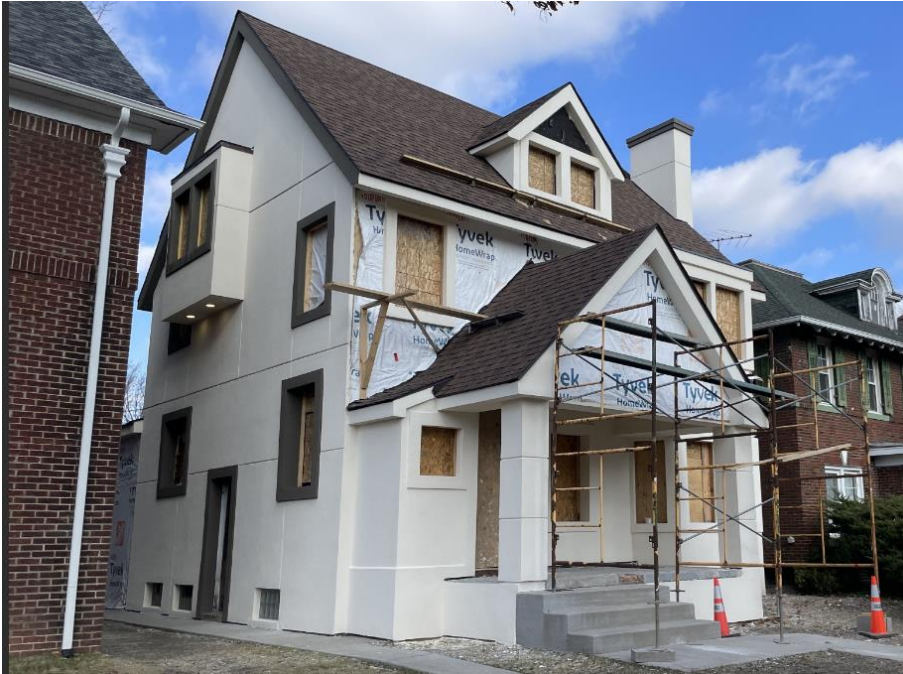
- On December 12, 2023, HDC staff visited the site a second time to note ongoing unapproved work at the property. At this point, new EIFS siding had been added throughout and new fascia and soffit had been installed at the roof. HDC staff forwarded the report of unapproved work to the building department for enforcement that same day. The following photo illustrates conditions in December 2023.

Photo by HDC staff, taken on 12/12/2023

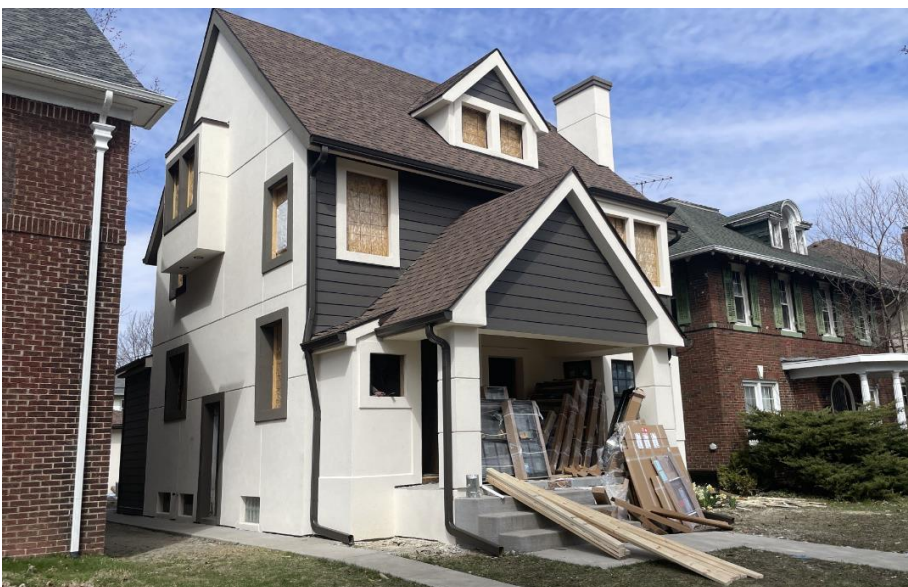
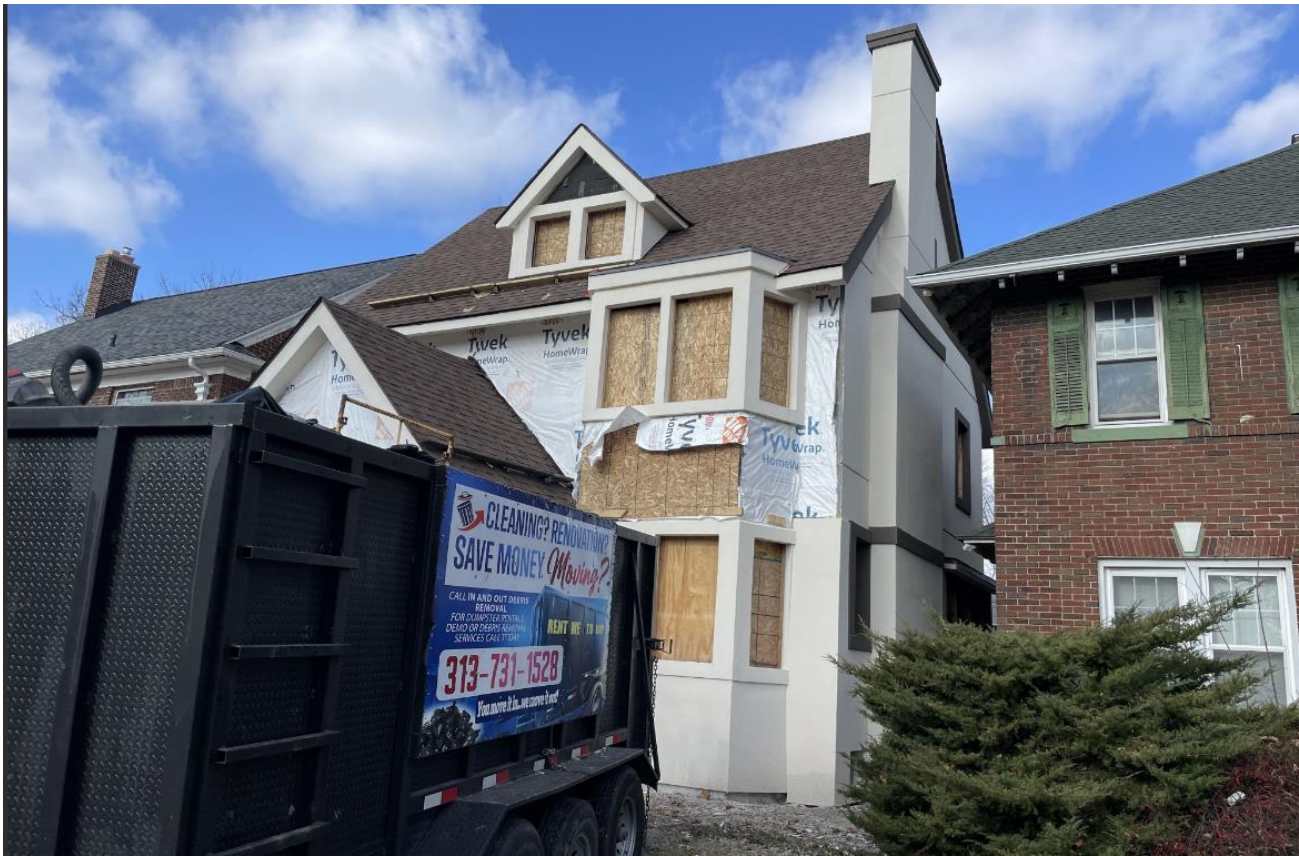
- On March 21, 2024, HDC staff visited the site for a third time, noting that construction continued unabated, to include the installation of cement fiber siding (with a faux grain finish) at the front façade. HDC staff reported the unapproved work to the building department that same day. In response, the building department visited the site on 3/26/2024 and issued a stop work order. Please see the below photos which recorded conditions on 3/21/2024:

Front façade. Photo taken by HDC staff on 3/21/2024
