STAFF REPORT 11-13-2024 REGULAR MEETING

APPLICATION NUMBER: HDC2024-00623

ADDRESS: 708 PALLISTER

SCOPE: UNAPPROVED AS-BUILT REVISION TO PREVIOUSLY APPROVED DESIGN, INCLUDING ALTERATIONS TO EXISTING AND NEW DORMERS, FRONT PORCH, REPLACEMENT OF HISTORIC WINDOWS, ALTERATION OF WINDOW/DOOR OPENINGS, AND OTHER SCOPE ITEMS

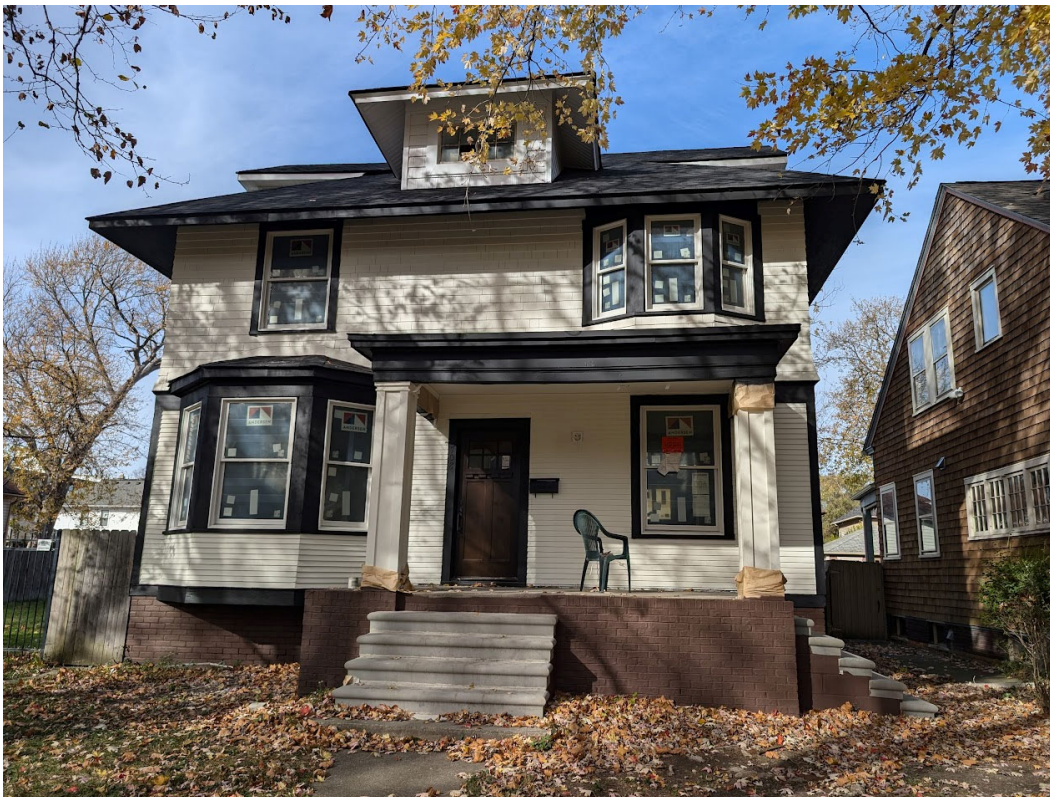
View of 708 Pallister, looking north from the sidewalk. Stop work order (orange sticker) is visible on one of the replaced windows. Staff photo, November 13, 2024.

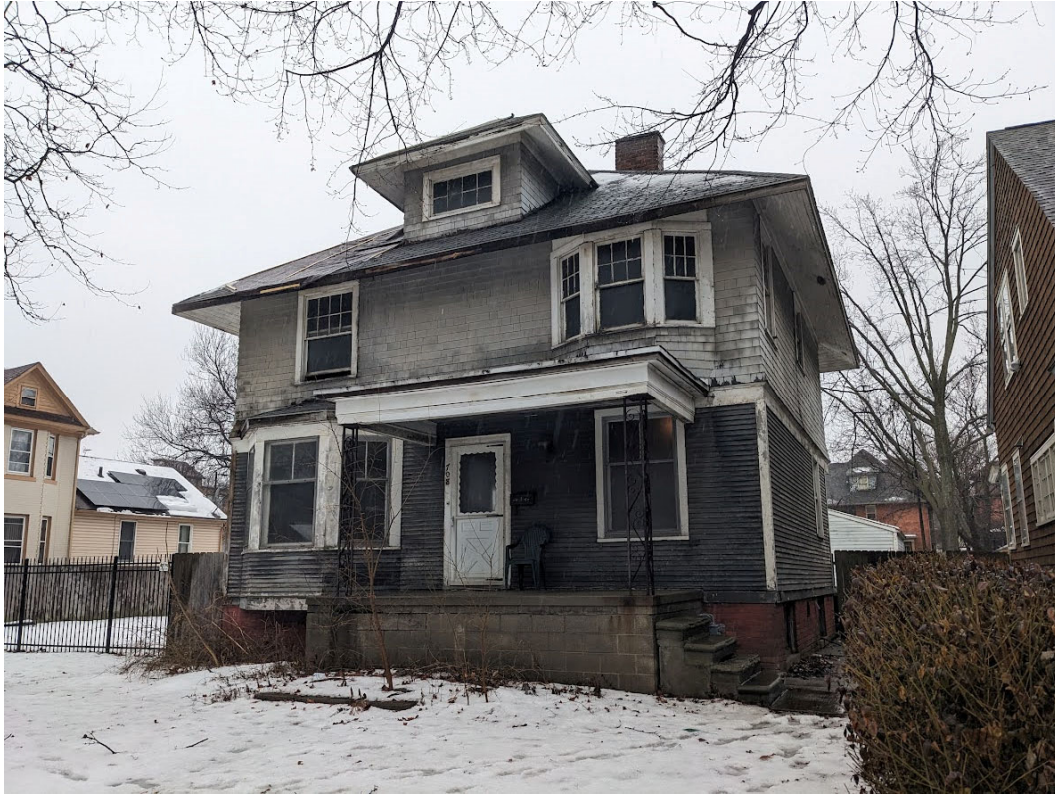
View of 708 Pallister prior to this year's work, looking northwest from the sidewalk. Staff photo, January 24, 2024.

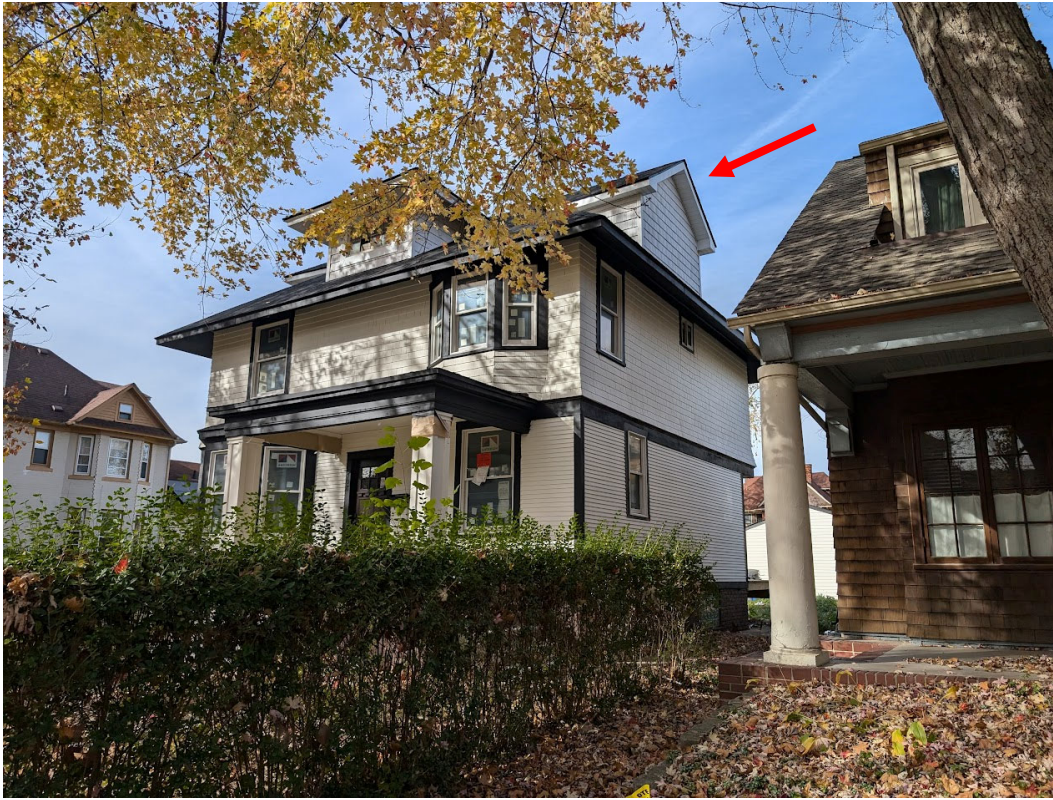
2. New side and rear dormers built 10'-0" wide, contrary to the Commission's approval of 7'-2" wide dormers to match the existing historic front dormer.

3. New side dormers built with gable-end roofs and narrow eaves, contrary to the Commission's approval of hipped roofs with wide eaves, to match the existing historic front dormer. The rear dormer, while showing a more correct roof form, was also built too wide, resulting in incompatibly narrow eaves.

5. At the new east side dormer, no window has been installed at all, contrary to the Commission's approval of an 8-lite, simulated divided lite fibrex (Anderson 100) casement unit to match the historic front dormer window.

View of 708 Pallister, looking northwest from the sidewalk. Note large east-facing dormer at right side, with incompatible gable roof and no window at all. Staff photo, November 13, 2024.

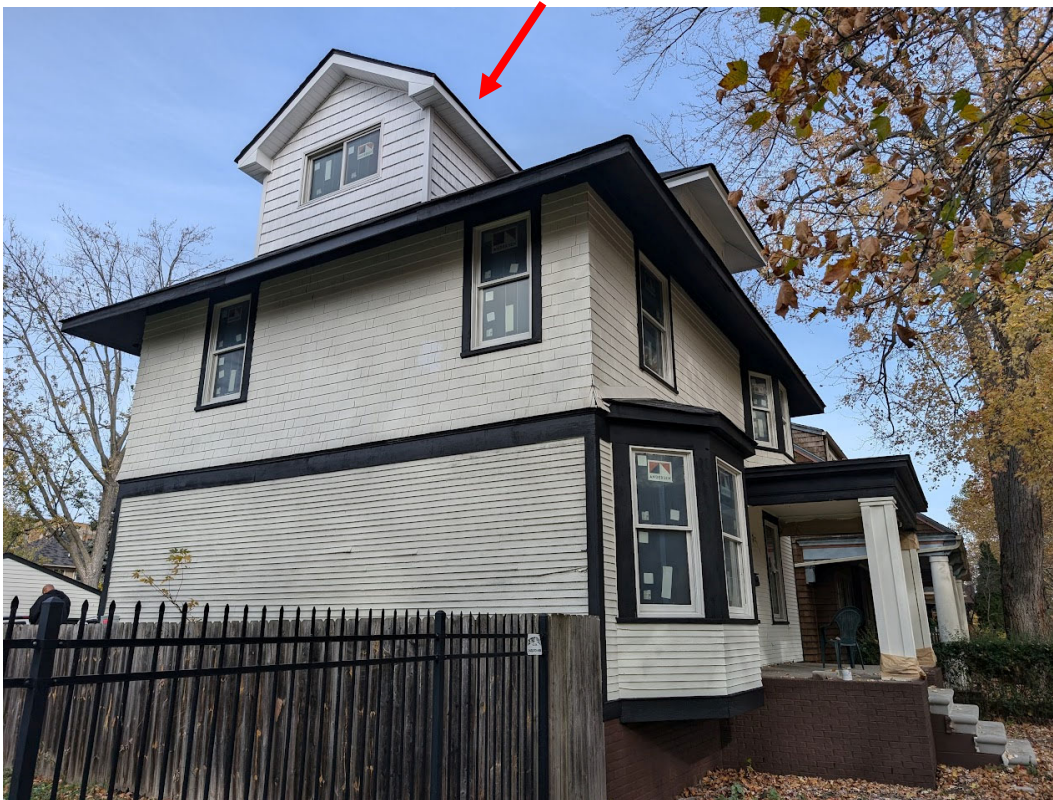
1. Replacement of 14 (fourteen) original 2-over-1 and other multi-lite wooden single-hung windows with vinyl clad wood 1/1 windows, contrary to the Commission's approval of a plan for their preservation and restoration.

4. Sliding, vinyl-clad windows have been installed in the new west side and rear dormer, contrary to the Commission's approval of 8-lite, simulated divided lite fibrex (Anderson 100) casement units to match the historic front dormer window.

6. All dormers, including the historic dormer, have been reclad with apparent vinyl or composition artificial shake shingles with imitation wood grain, contrary to the Commission's approval of true wood shake to match the historic front dormer. This artificial product is notably white in the context of the off-white ("yellowish white") paint at the rest of the house.

View of 708 Pallister, looking northeast. Note replacement windows in all openings, and the large gable-roofed dormer facing west, with incompatible sliding window, which reorients the emphasis from the front facade. Note also the apparent difference in color tone between the factory "white" of the dormer and the correct "yellowish white" color of main house. Staff photo, November 13, 2024.

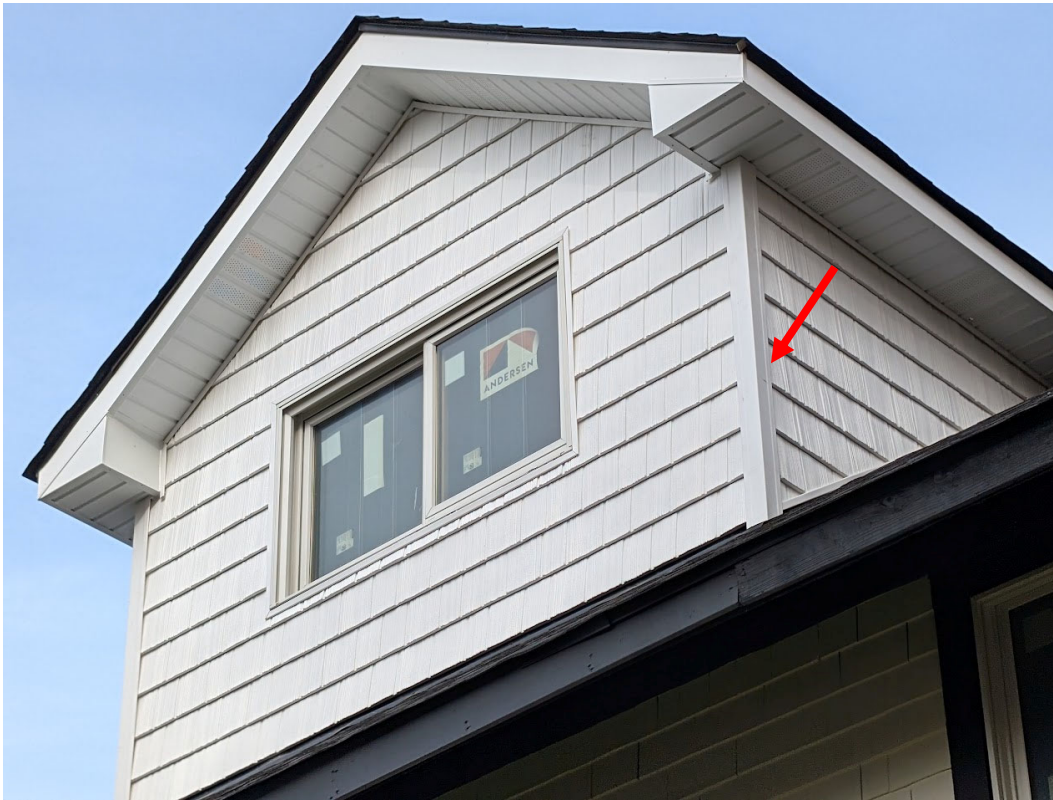
7. In addition to the artificial vinyl/composition shake treatment, all of the dormer eaves (including that of the original) have been covered with artificial siding, contrary to the wood eaves approved by the Commission.

View of 708 Pallister, detail view of newly built west-facing (side) dormer. Note amateurish detailing, artificial shakes with imitation "wood grain" enclosed by corner trim pieces (red arrow), sliding vinyl-clad window, and vinyl clad eaves. Fascia boards also appear to be composite or vinyl rather than wood. Staff photo, November 13, 2024.

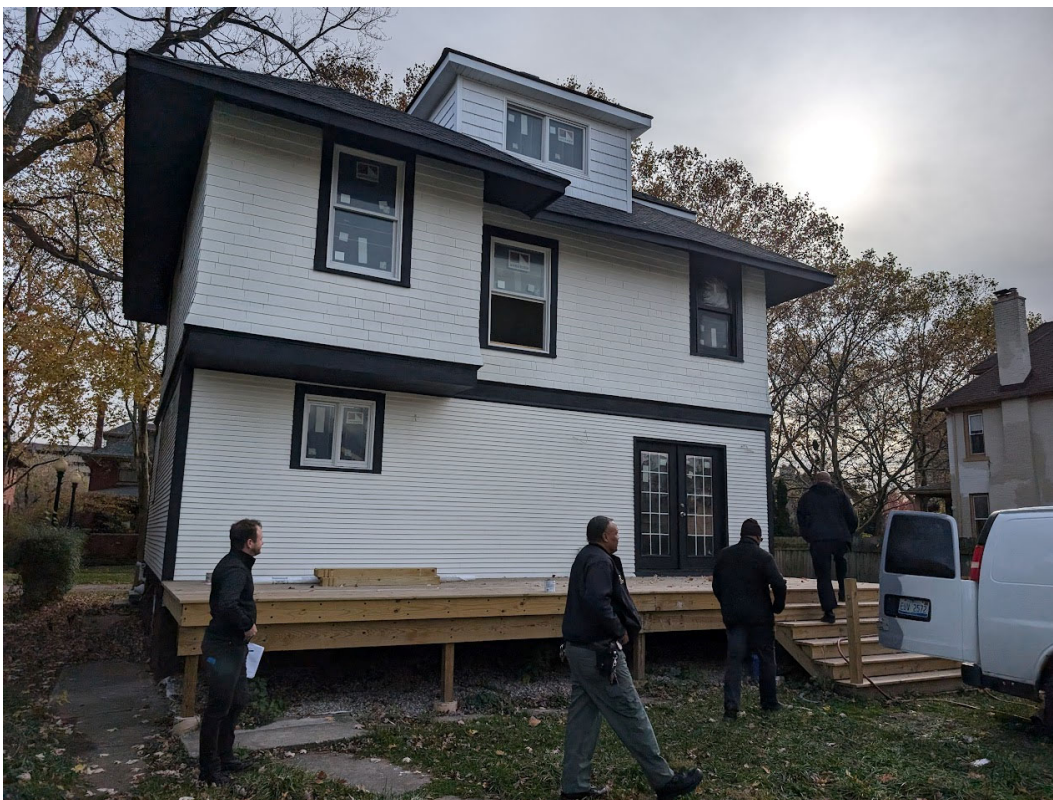
View of 708 Pallister, at the rear. Visible are the incorrect eastward sliding window (left), and the incorrect French doors with "between-the-glass" grids, right. Note also the factory white roof dormer, incorrectly clad with imitation shake and with a sliding window installed, as compared to the "yellowish white" of the approved HDC color choice. Building inspectors and NPO are visible here. Staff photo, November 13, 2024.

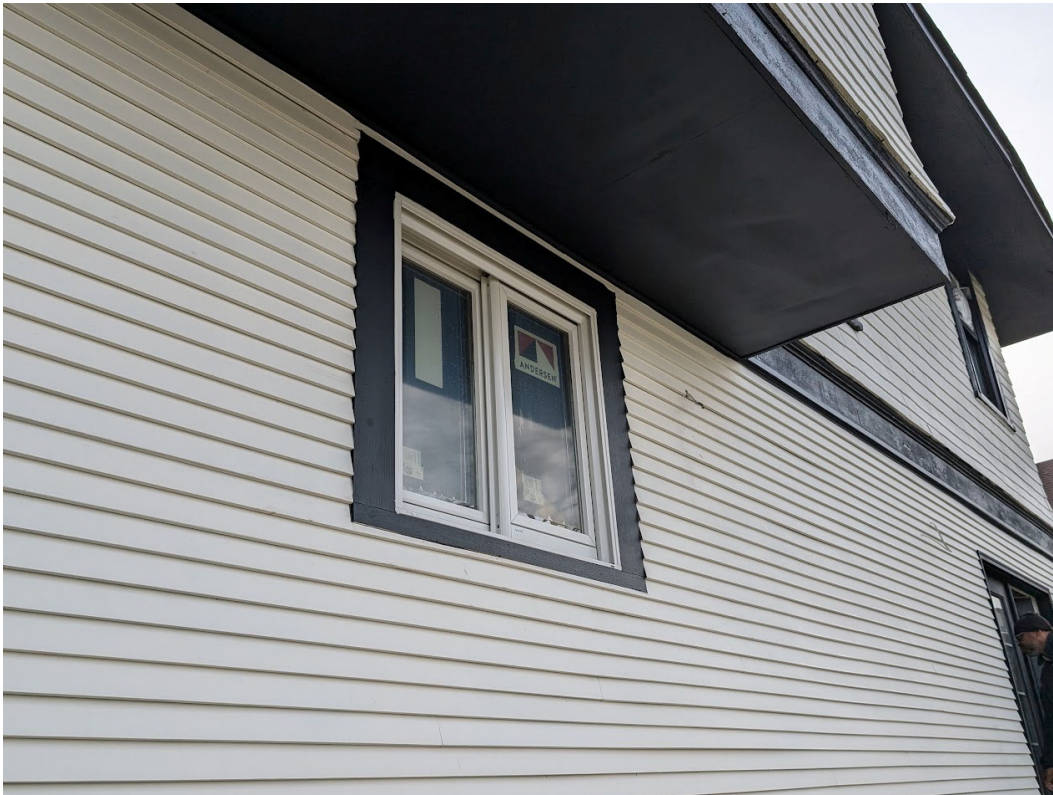
12. At the rear, 1st story, the eastward window has been replaced with a sliding vinyl-clad (Anderson 400) window, contrary to the Commission's approval of a new 12-light single-hung Anderson 100 window with simulated divided lites.

View of 708 Pallister, detail view of incorrect rear sliding window. Note also how the framing is recessed short of the clapboard surrounding it, an incorrect condition. Staff photo, November 13, 2024.

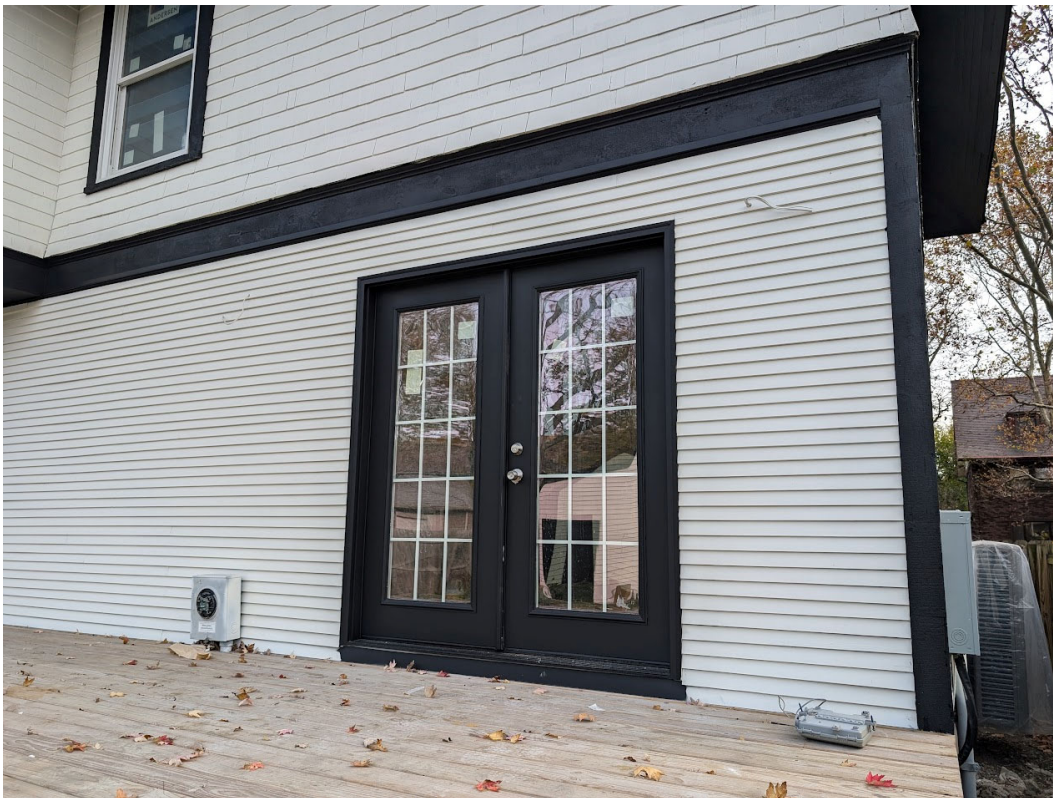
13. Also at the rear, 1st story, the original pair of 2/1 windows has been replaced with a standard set of exterior French doors with between-the-glass grids, contrary to the custom 2/1 simulated divided-lite design approved by the Commission as a condition to the approval, and subsequently approved in revised permit drawings prepared by the architect, which was intended to match the consistent 2/1 historic windows present on all sides of the house.

Rear view of 708 Pallister, detail view of incorrect French doors with internal imitation muntins, contrary to the Commission's conditional approval of custom reproduction 2/1 units. Staff photo, November 13, 2024.

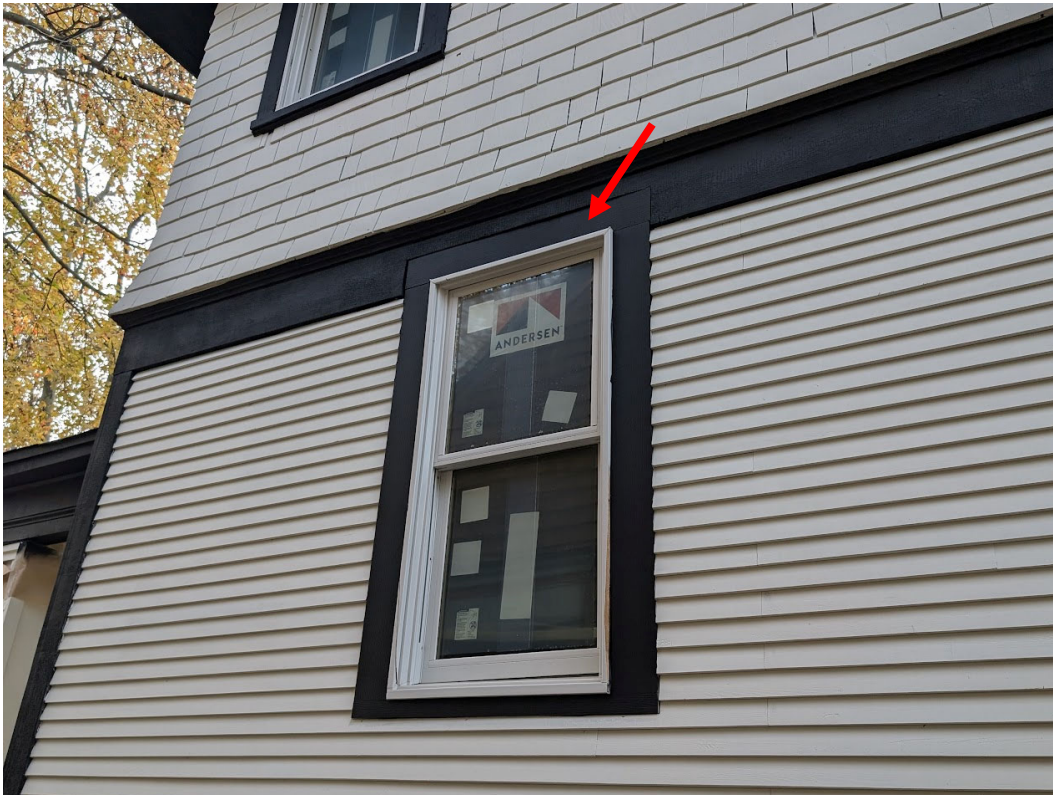
8. At the east (side) wall, a new window framed by vinyl or composite imitation wood grain boards was installed at a forward 1st story location, contrary to the intended replacement of the existing rearward window with an Anderson 100 unit, which location has instead been closed up. The imitation framing of the new window is noticeably wider than those at the historic windows, and extends into the "belt band" separating the 1st and 2nd stories.

View of 708 Pallister, view of west (side) wall. This window opening was not approved, and trespasses into the historic wooden "belt band" between the 1st and 2nd stories (red arrow). The framing is incompatible in width, inset, and material (imitation "wood grain" composite). Staff photo, November 13, 2024.

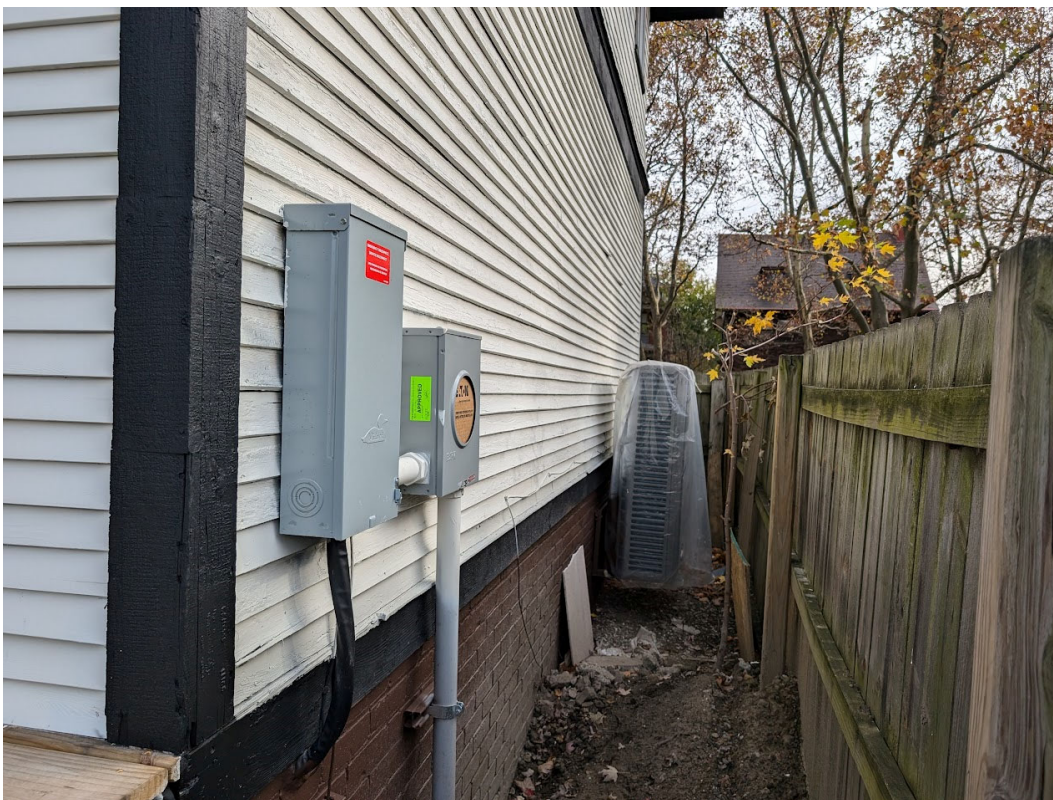
11. At the west wall, not shown on either the original permit or the proposed revised drawings, a large HVAC unit has been installed at a forward position at the 1st story./

View of large HVAC unit under installation at west (side) wall. Staff photo, November 13, 2024.

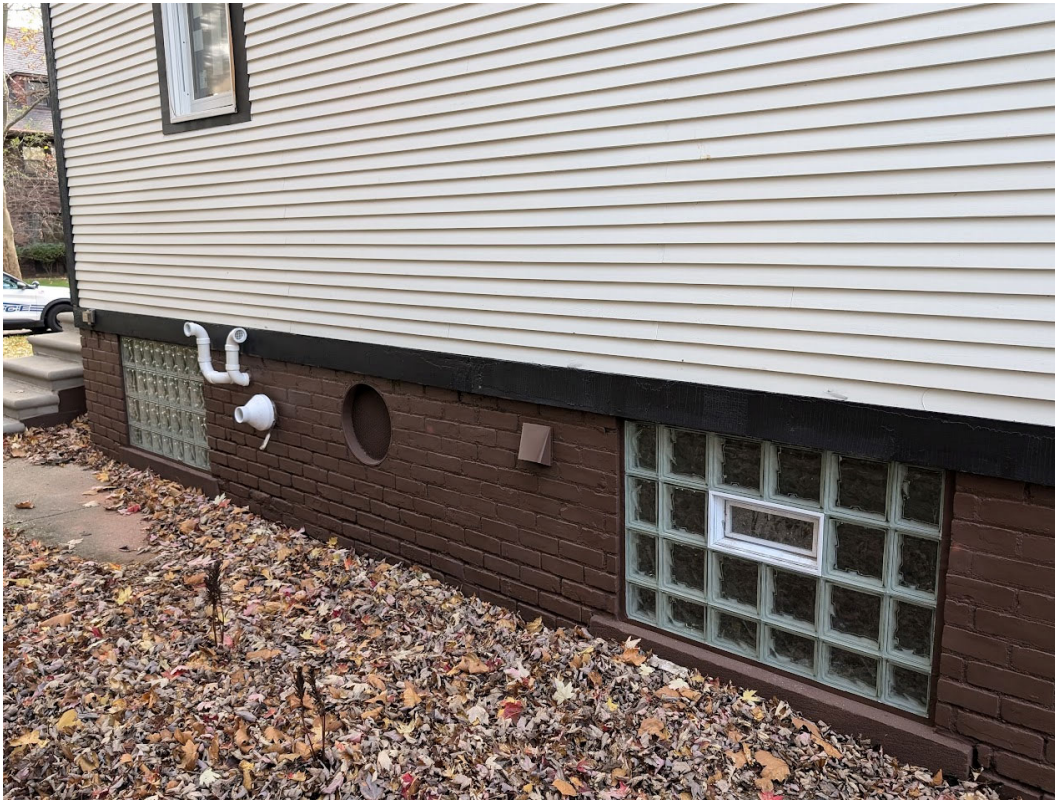
10. Also at the east (side) wall, two basement windows have been replaced with glass block, contrary to the Commission's approval to rehabilitate the existing windows here. The glass block installation is not per HDC staff-approvable guidelines as they are not inset to the plane of the original windows.

View of glass block windows at east side basement wall. Staff photo, November 13, 2024.

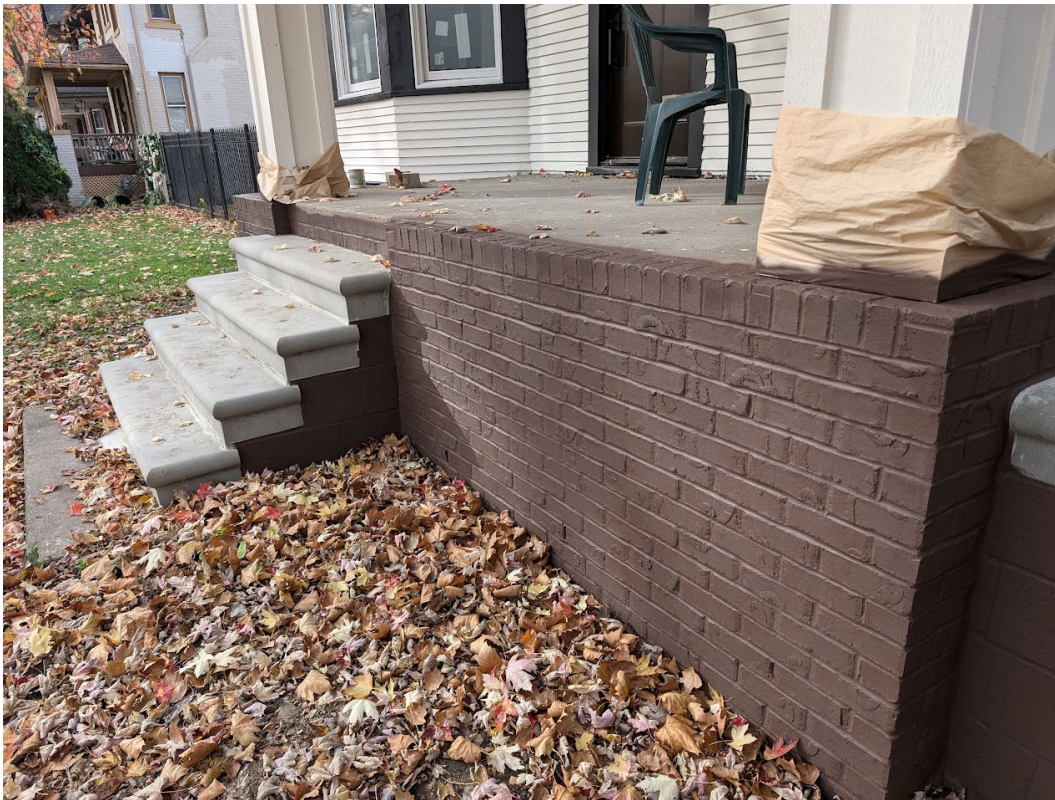
14. At the front, 1st story porch, the concrete block base has been veneered with new brick and then painted, contrary to the Commission's approval of keeping the current condition with paint.

Newly painted brick veneer and steps at front porch. Staff photo, November 13, 2024.
