**STAFF REPORT: NOVEMBER 13, 2024 REGULAR MEETING      PREPARED BY: T. BOSCARINO**

**APPLICATION NUMBER: HDC2024-00609**

**ADDRESS: 932 EDISON**

**SCOPE: REPLACE WINDOWS (WORK STARTED WITHOUT APPROVAL), DOORS, REAR PORCH, AND SIDING, INSTALL POOL**

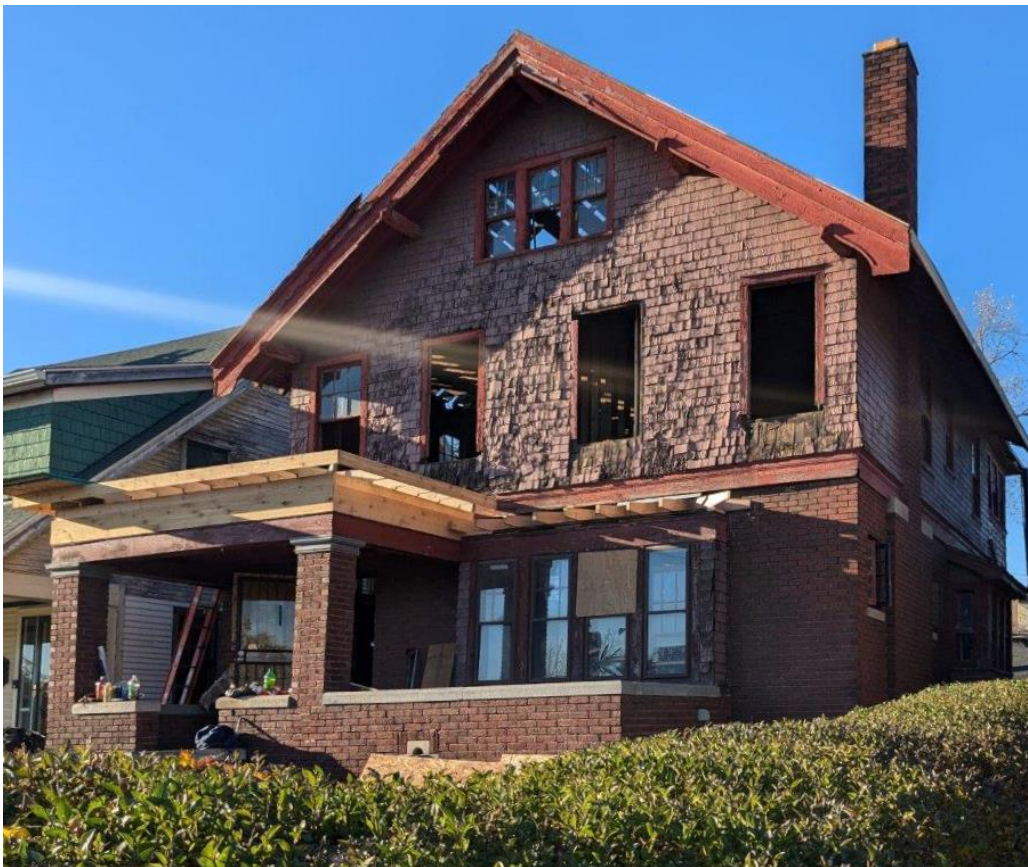
*November 7, 2023 photo by staff. Fascia board on east elevation (upper right of image) added pursuant to November 1, 2024, Certificate of Appropriateness. New work visible above front porch (left side of image) was performed without approval and observed by staff November 7, 2024.*

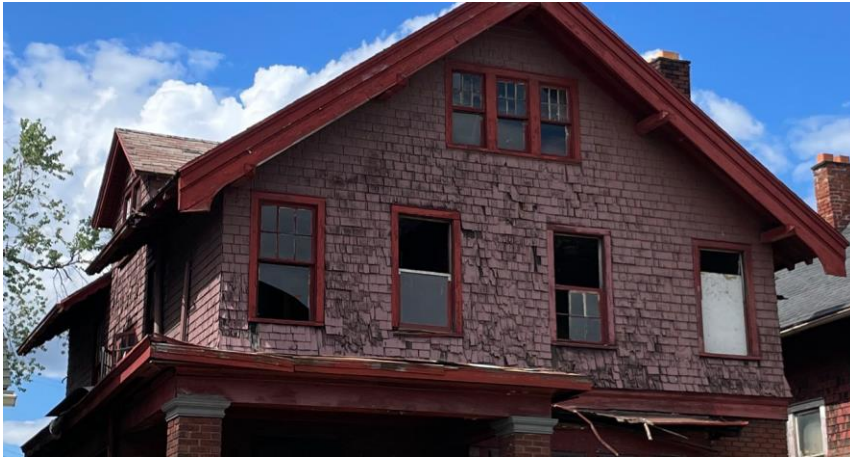
In 2022, staff observed three windows missing from the front façade, second story. This work was not approved by the Historic District Commission.

*August 29, 2022, staff photo showing window removal.*

- The three windows already removed without approval, and the existing windows proposed for replacement, are unambiguously character-defining as they are subdivided, as described in the Elements of Design, adding textural interest to the façade and serving as a prominent visual component of the building. Further, their six-over-one muntin pattern is consistent with the Arts and Crafts style of the building and is important to the overall character of the building and the district.

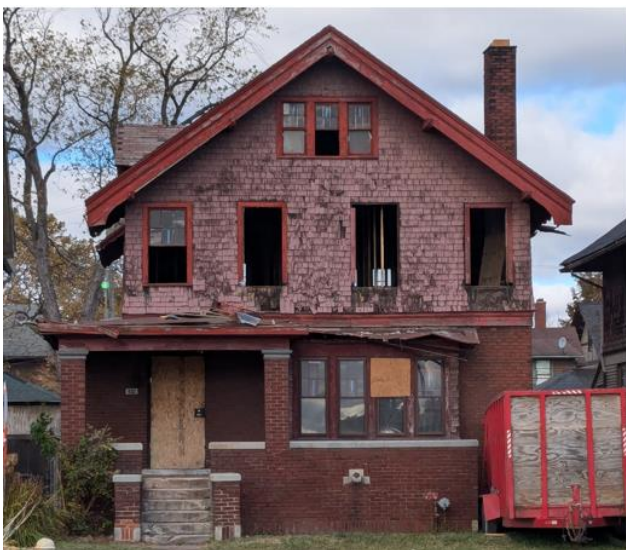
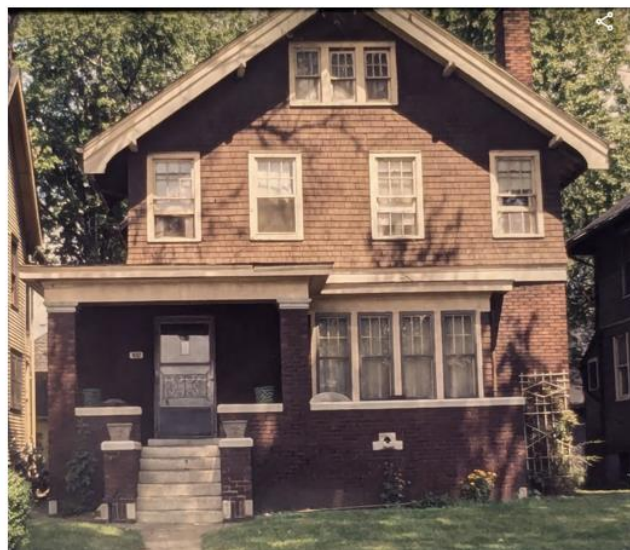
On November 7, 2024, staff observed porch alterations being made. The alterations appear to inappropriately increase the height of the porch frieze and roof but do not otherwise change the character of the porch. This work has not been approved by the Commission. On November 8, 2024, staff requested that the Buildings, Safety Engineering, and Environmental Department issue a Stop Work order. Staff also contacted the applicant by email and encouraged the applicant to submit an application (this work is not subject of the present application).

*Left: November 1, 2024, staff photo, taken prior to unapproved porch work. Right: 1974 photo by the Historic Designation Advisory Board.*

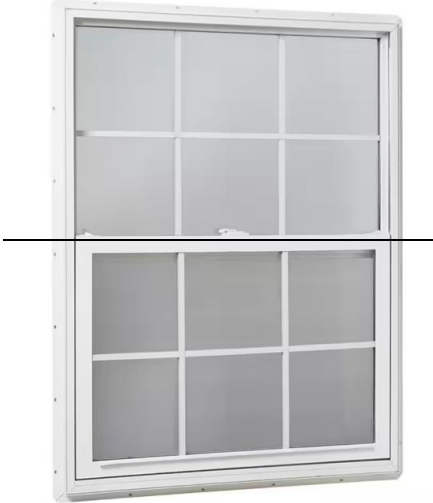
The applicant proposes to remove the existing, historic wood windows and install new replacement windows. ~~Though the application does not provide exact specifications, the image provided depicts a TAFCO single hung window with applied grids.~~ **The proposed window is a Pella Lifestyle, double-hung, six-over-one window, with between-the-glass grids, in “Classic White.”**

*Proposed window. Image from application.*

- ~~The applicant stated that a window schedule and specifications for the proposed new windows are forthcoming. This information has not yet been provided to staff.~~ **The proposed windows approximate the appearance of a historic double-hung wood sash windows; however, the between-the-glass grids and bright white color are not appropriate (simulated divided lites and an off-white color would be appropriate).**

- ~~The proposed new windows do not match the material of the historic windows (they are vinyl).~~
- The proposed new windows do not match the three-dimensional qualities of the historic windows. They have a thinner and flatter profile, and further, as single hung windows, they have a different appearance in elevation (viewed from the front). They also use between-the-glass grids rather than true or simulated divided lites.

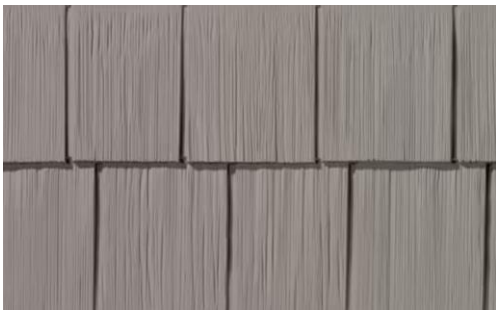
The application, as originally submitted, proposes to replace the original wood shake siding with NovikShake polymer siding in Coventry Gray color. The siding comes in 14.5” by 48.75” panels.

*Proposed siding. Image from application.*

- The vinyl replacement product mentioned in the original application is clearly inappropriate, in staff opinion. Further, the panelized nature of the proposed siding may make it impossible to duplicate the flared, lower courses that are important to the character of the property.

- The application lacks detail regarding the proposed siding installation. As the panelized and obviously synthetic appearance of the proposed siding would fail to duplicate the historic appearance, and as wood shakes are readily available and easy to install, this work would not be appropriate.

- The siding shall consist of wood shakes, subject to staff approval.
- The final siding installation shall be subject to staff approval.
- The new rear porch shall be made of wood and closely match the dimensions and appearance of the existing porch, subject to staff review.
- The new front door shall be subject to staff approval.
- ~~Any site work associated with the pool shall be subject to staff review.~~

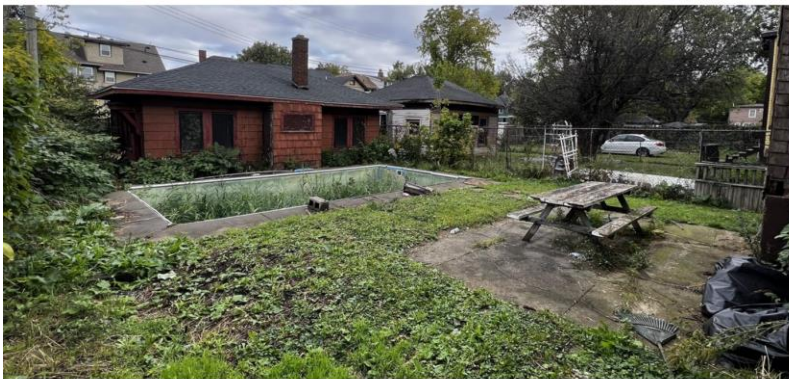
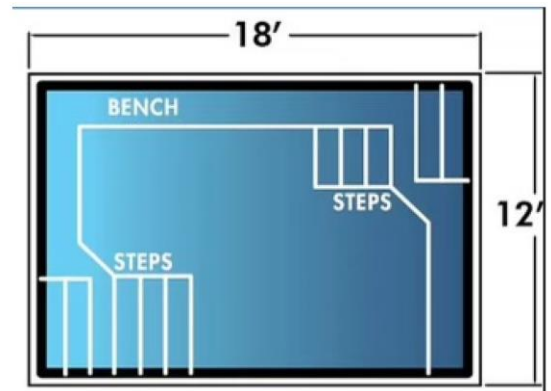
*Left: Existing backyard. Right: Proposed pool. Images from application materials.*

- The current pool is approximately 16' by 27' and does not appear to be a historic feature. The proposed work would reduce the footprint of the pool. This would reduce the visual impact of the pool upon the property; the resulting work does not interrupt a character-defining open space or otherwise detract from the historic property and is appropriate, in staff opinion. **The applicant provided a site plan for the proposed pool on November 9, 2024.**

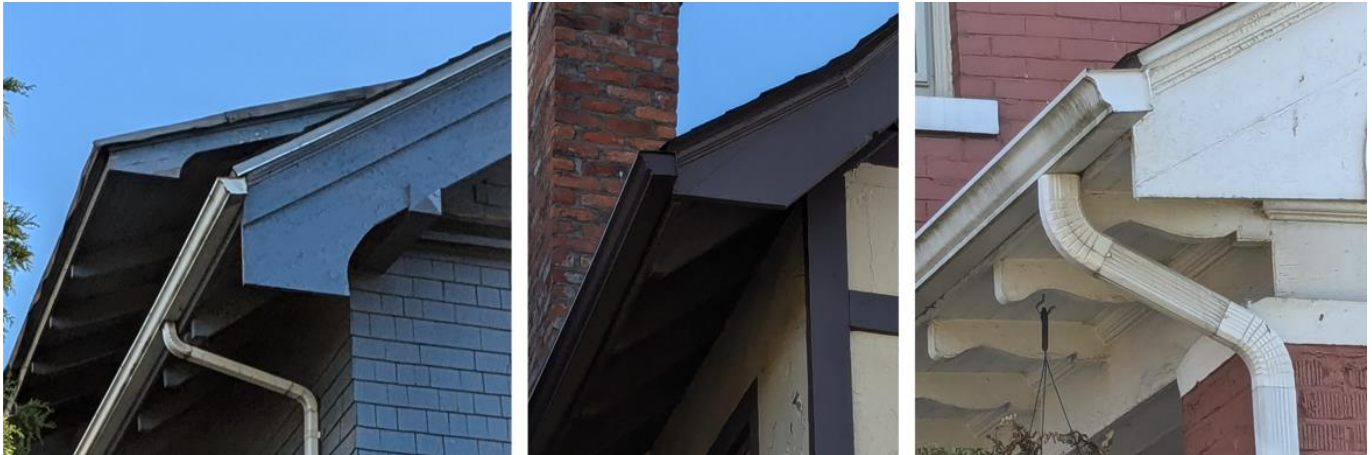
- The decorative beams and rafters beneath the eaves are distinctive features that are historically intended to be exposed. Their enclosure within soffit panels would not be appropriate, in staff opinion.

*Examples of other Boston-Edison houses showing exposed vergeboards, beams, and rafter ends. Obscuring these features with soffit panels would not be appropriate. The use of a narrow fascia board and gutters that do not obscure these features is appropriate. November 2024 photos by staff.*

- ~~The proposed grids on the lower sash introduce a conjectural element not previously found on the building.~~
- The visible beams and rafters are intended to be exposed; they should not be enclosed with soffit panels.

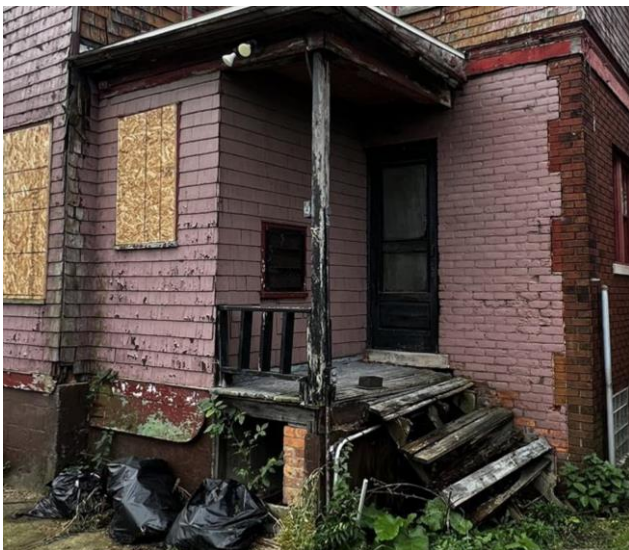
- Application photos show that the wooden porch elements are largely rotten or missing; staff is convinced that the rear porch is beyond feasible repair.
- The applicant stated “we are preparing a measured drawing to confirm that the new back porch dimensions align precisely with the original structure” (November 5, 2024, email to staff). However, staff has not yet received this information.

*Rear porch. Image from application materials.*

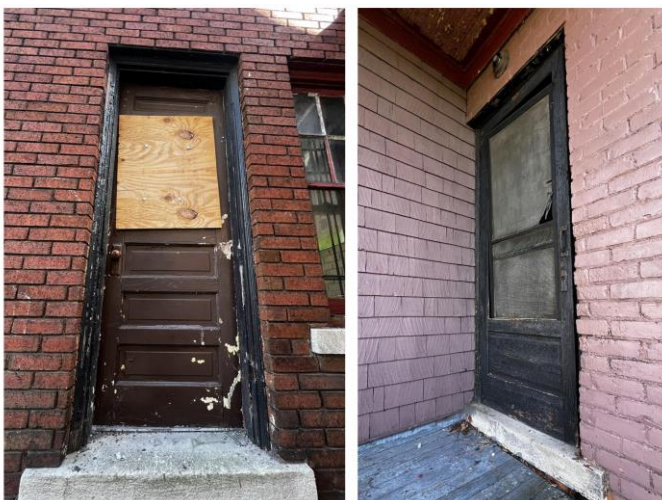
- The side door appears to be a historic and character-defining feature, in staff opinion. It has not been shown to be beyond repair.
- The rear door is not visible in application photos as it is concealed behind a screen door.

Side (left image) and rear (right image) doors. Images from application materials.

- The side door is a historic feature that has not been shown to be deteriorated beyond repair; a photo of the rear door has not been provided.
