**STAFF REPORT:** 12/11/2024 REGULAR MEETING

**APPLICATION NUMBER:** HDC2024-00613

**ADDRESS:** 3960-66 W. 7 MILE RD.

**SCOPE:** REPLACE WINDOWS

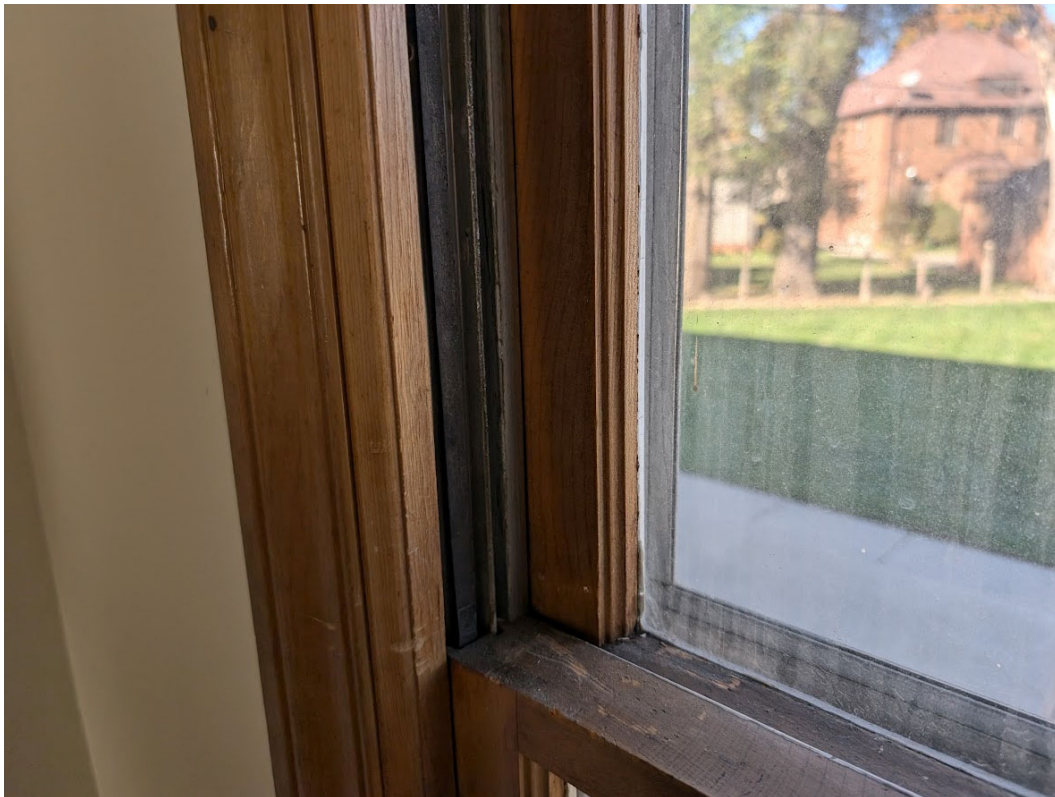
- Staff additionally inspected and reviewed the operation of these windows, and found such operation to be difficult or impossible in most cases, with warping and racking of sash/frames preventing proper operation on the built-in aluminum channels (these windows, as described above, do not feature the pulleys and ropes of pre-war examples). Although physical deterioration due to moisture is only observable in some areas, staff recognizes that deterioration does not have to be limited to degradation of material or loss of integrity, but can also include inability to operate.

*Detail view of window showing unitized nature (note aluminum channels). These windows are much tighter and stiffer than comparable pre-war wooden windows, and do not operate well. Staff photo, November 8, 2024.*

- Per the above observations, staff revises its earlier position concerning the windows, now finding after staff field inspection that the windows are reasonably beyond feasible repair, and replacement is necessary.
- The new window proposal has also been revised by the applicant to include simulated divided lites (SDLs), and a horizontal division of both the upper and lower sash, to replicate the existing historic expression at this property. The proposed aluminum-clad windows are of acceptable quality and appearance for the historic integrity of the building and the district, and “match” the historic prototypes.
- Staff finds the proposed replacement of these irreparably deteriorated windows with matching replacement units to be consistent with National Park Service Guidelines and the Secretary of the Interior’s Standards.

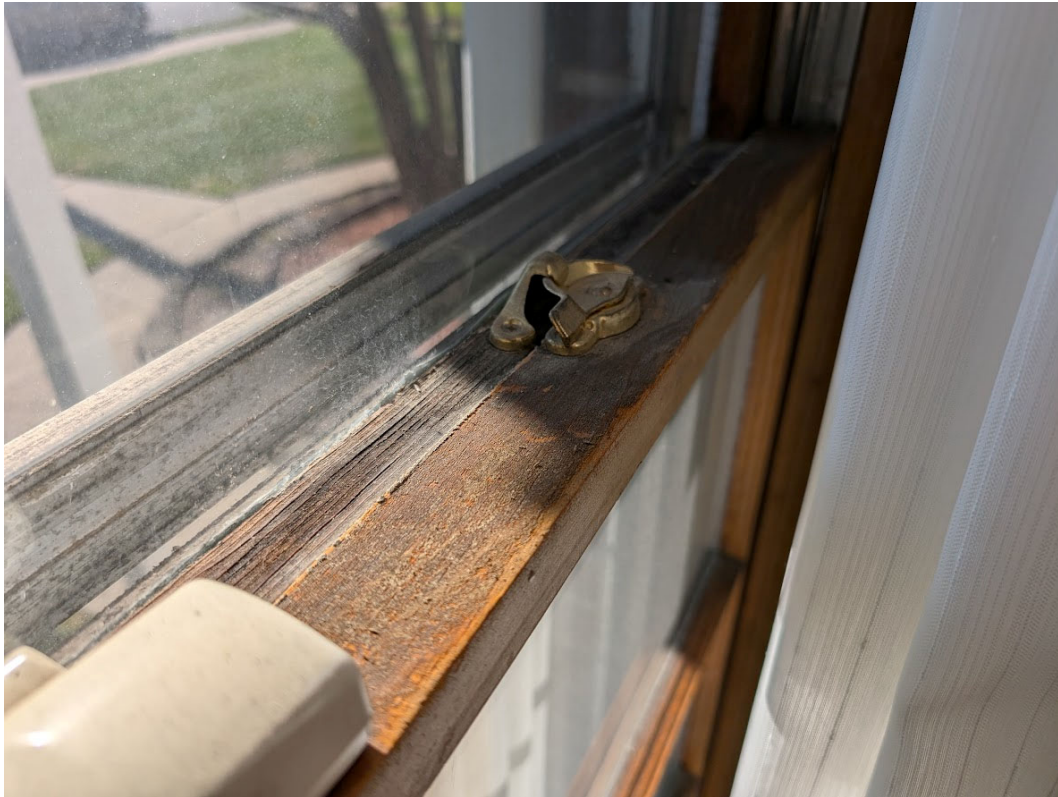
*Detail view of a second floor, front window showing some visible deterioration at meeting rail. Staff photo, November 8, 2024.*

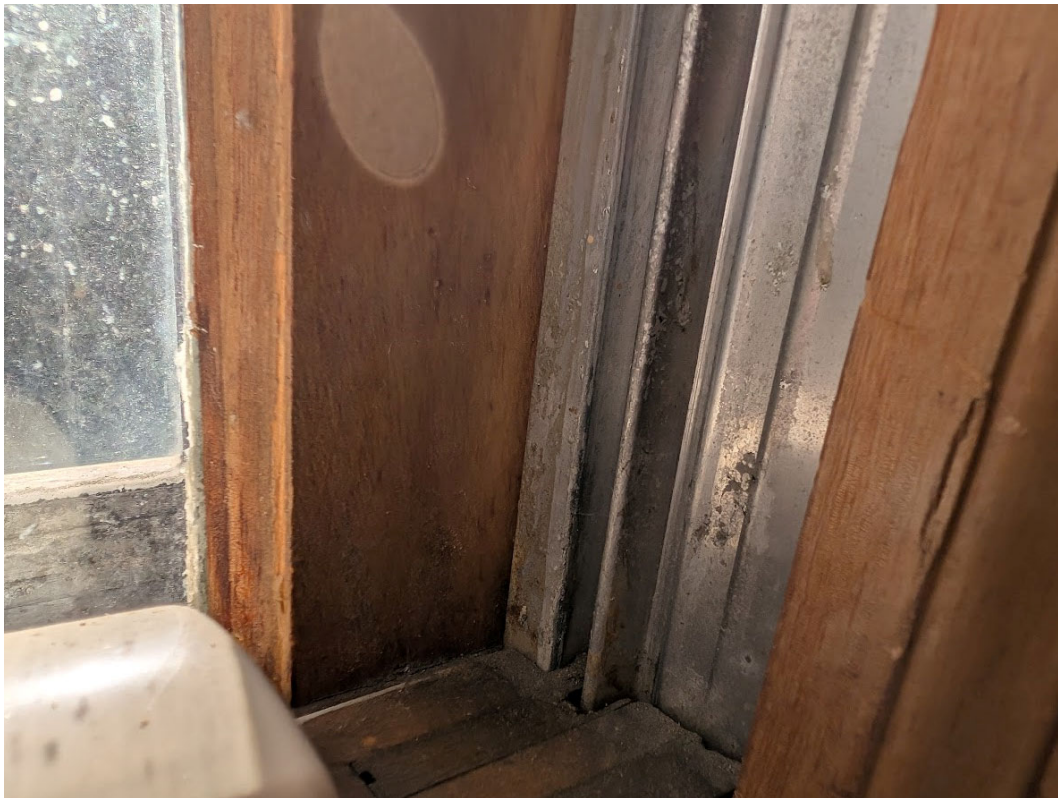
*Detail view of another window showing incorporated sliding surfaces (aluminum channels) on which the unitized operation depends. Staff photo, November 8, 2024.*
