STAFF REPORT: 12/11/2024 MEETING

ADDRESS: 2044 CHICAGO

APPLICATION NO: HDC2024-00265

SCOPE: REPLACE WINDOWS

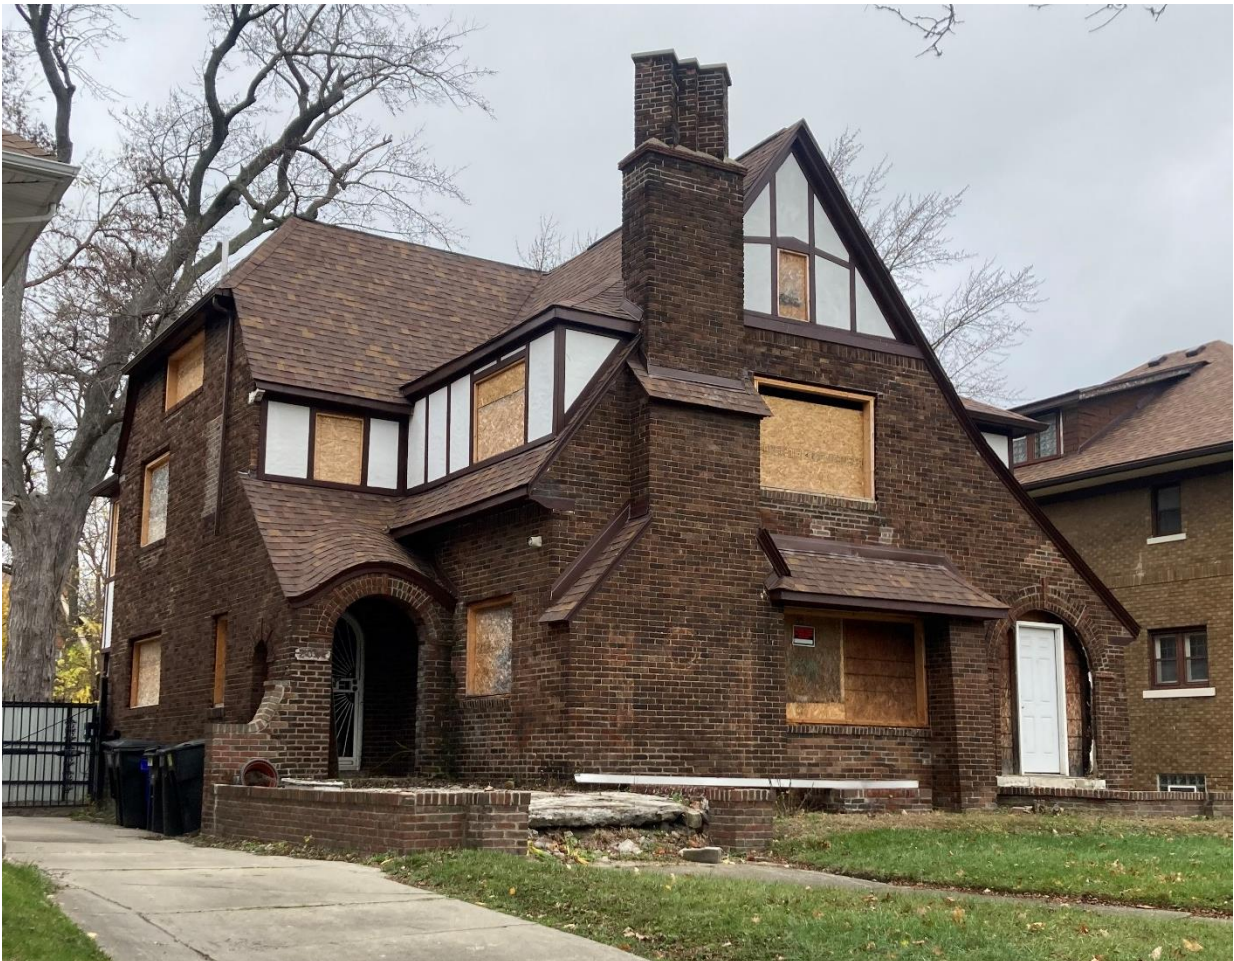
Current appearance. Photo taken by staff, 11/25/2024

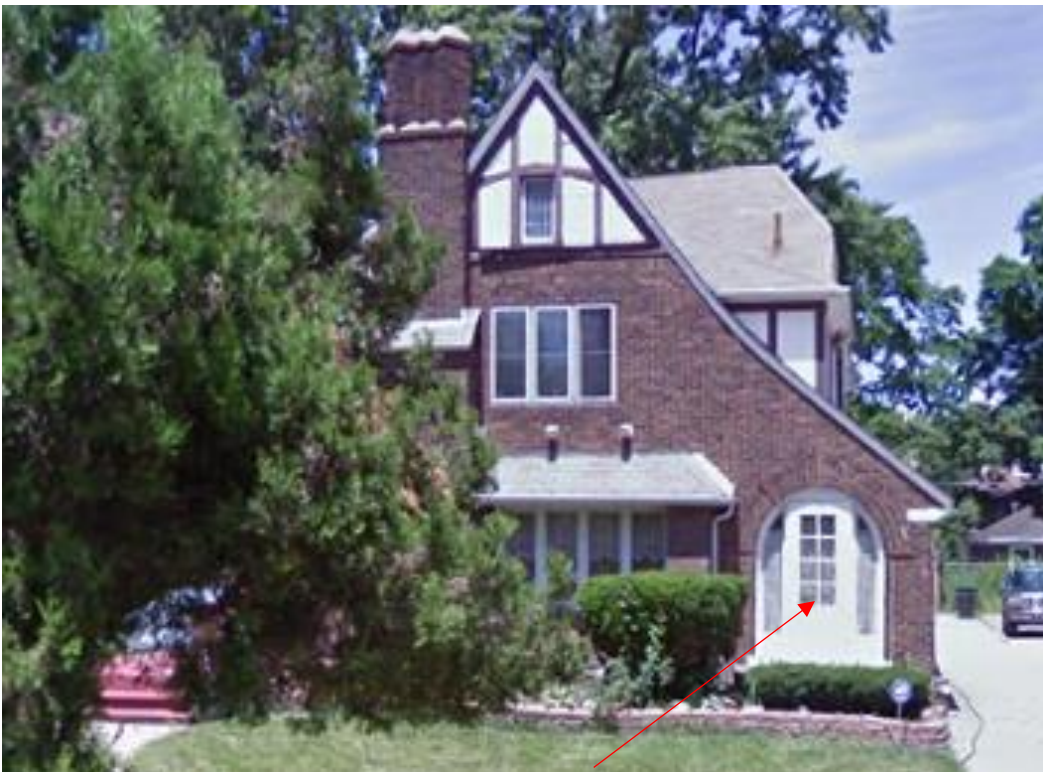
Google Streetview, 2013. Note that historic wood door with leaded glass sidelites are present

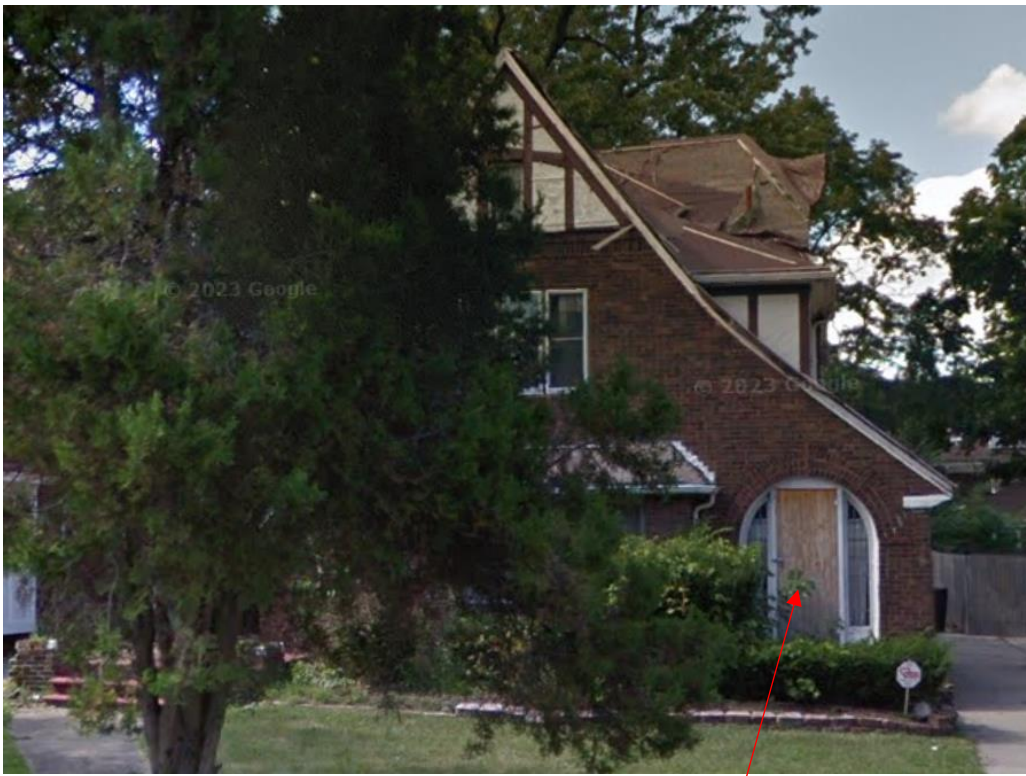
Google Streetview, 2015. Note that sidelites are extant, but the historic door has been removed

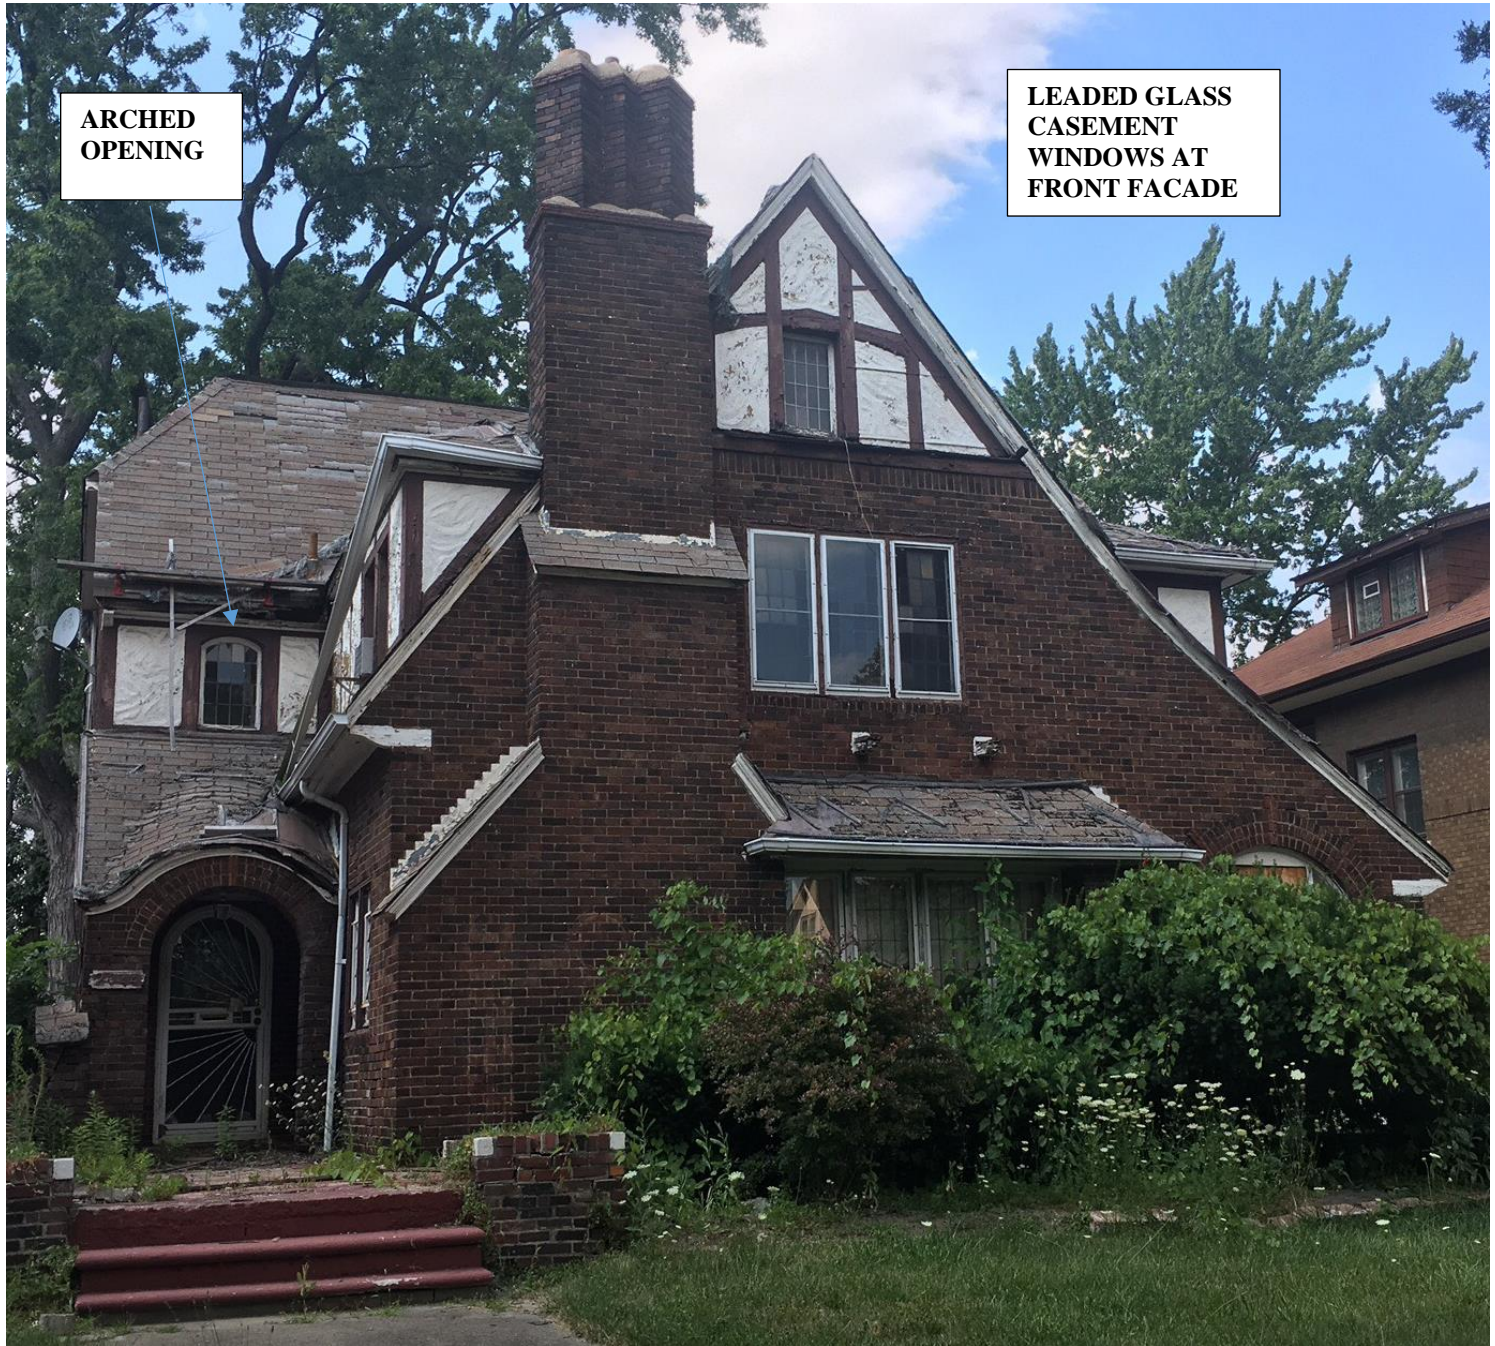
Photo taken in early 2018, prior to the fire. Note that all windows at the front are wood casement windows with leaded glass. The windows at the second story are covered by aluminum windows. Source, HDC files

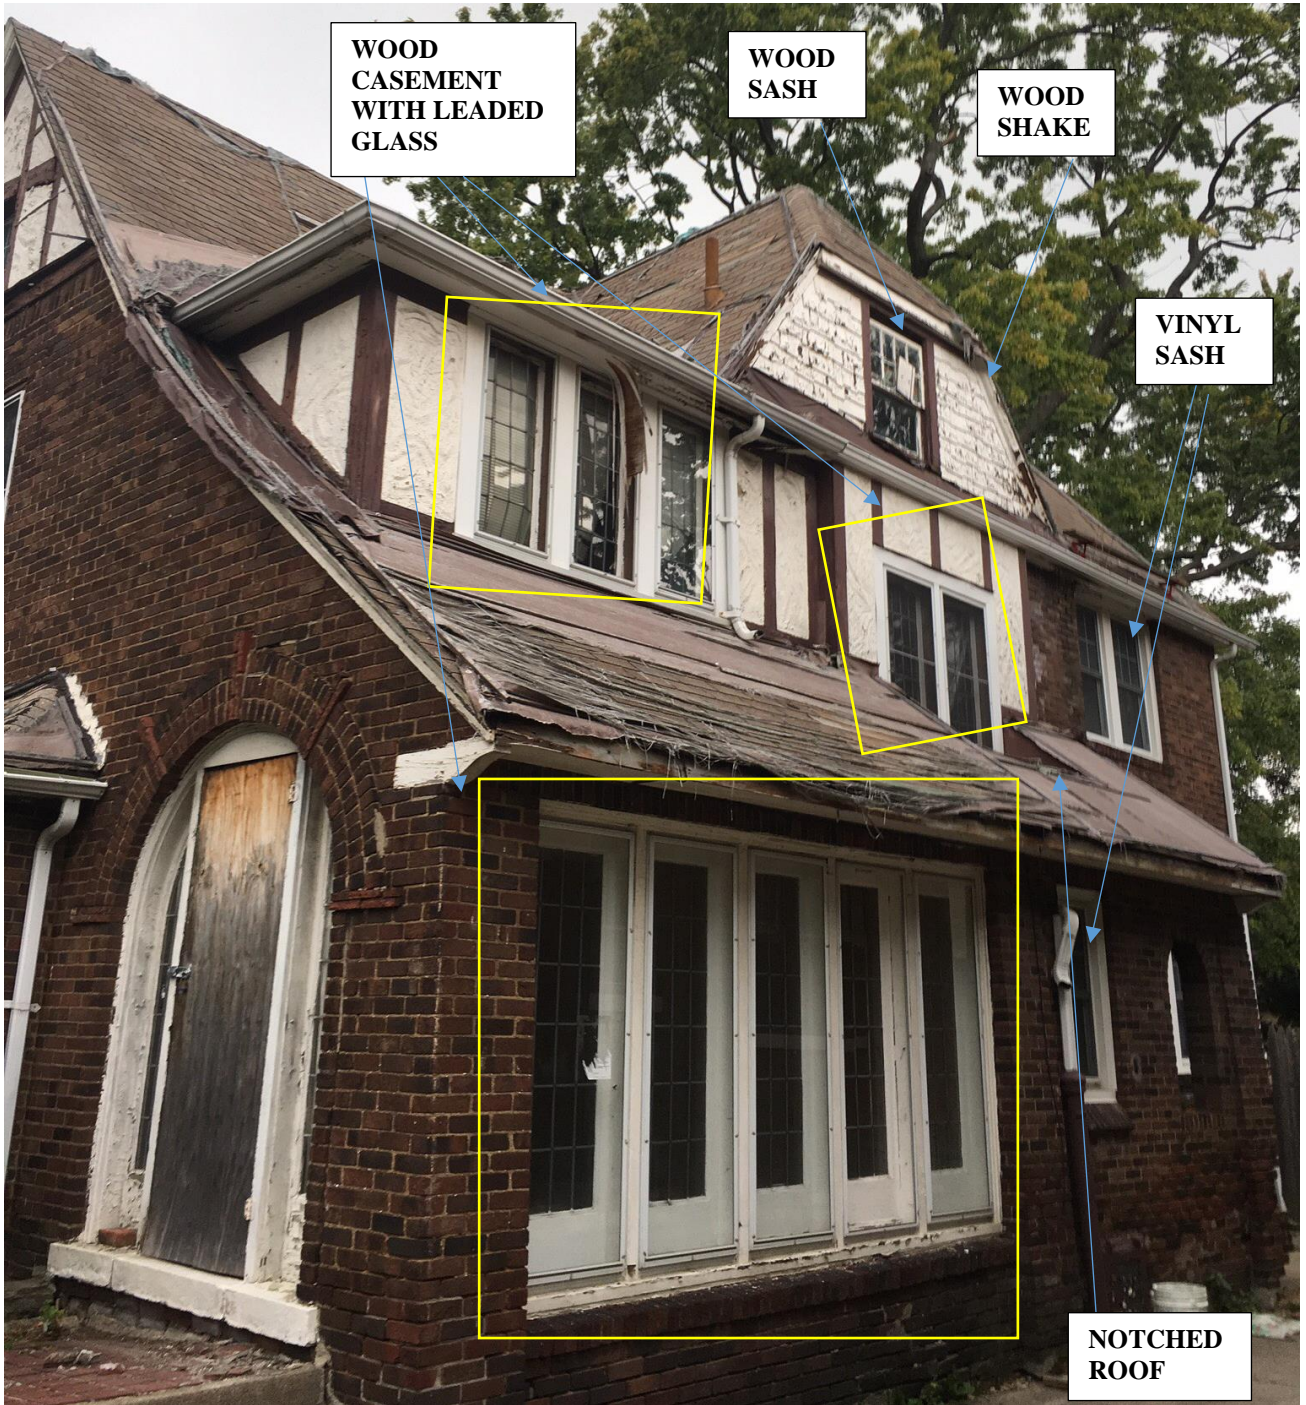
Photo taken in early 2018, prior to the fire. Note that all windows outlined in yellow are wood casement windows with leaded glass. The dormer has wood sash and the remaining visible windows at the second story are vinyl units. Also note the wood shake at the dormer and the notched roof. Source, HDC files.

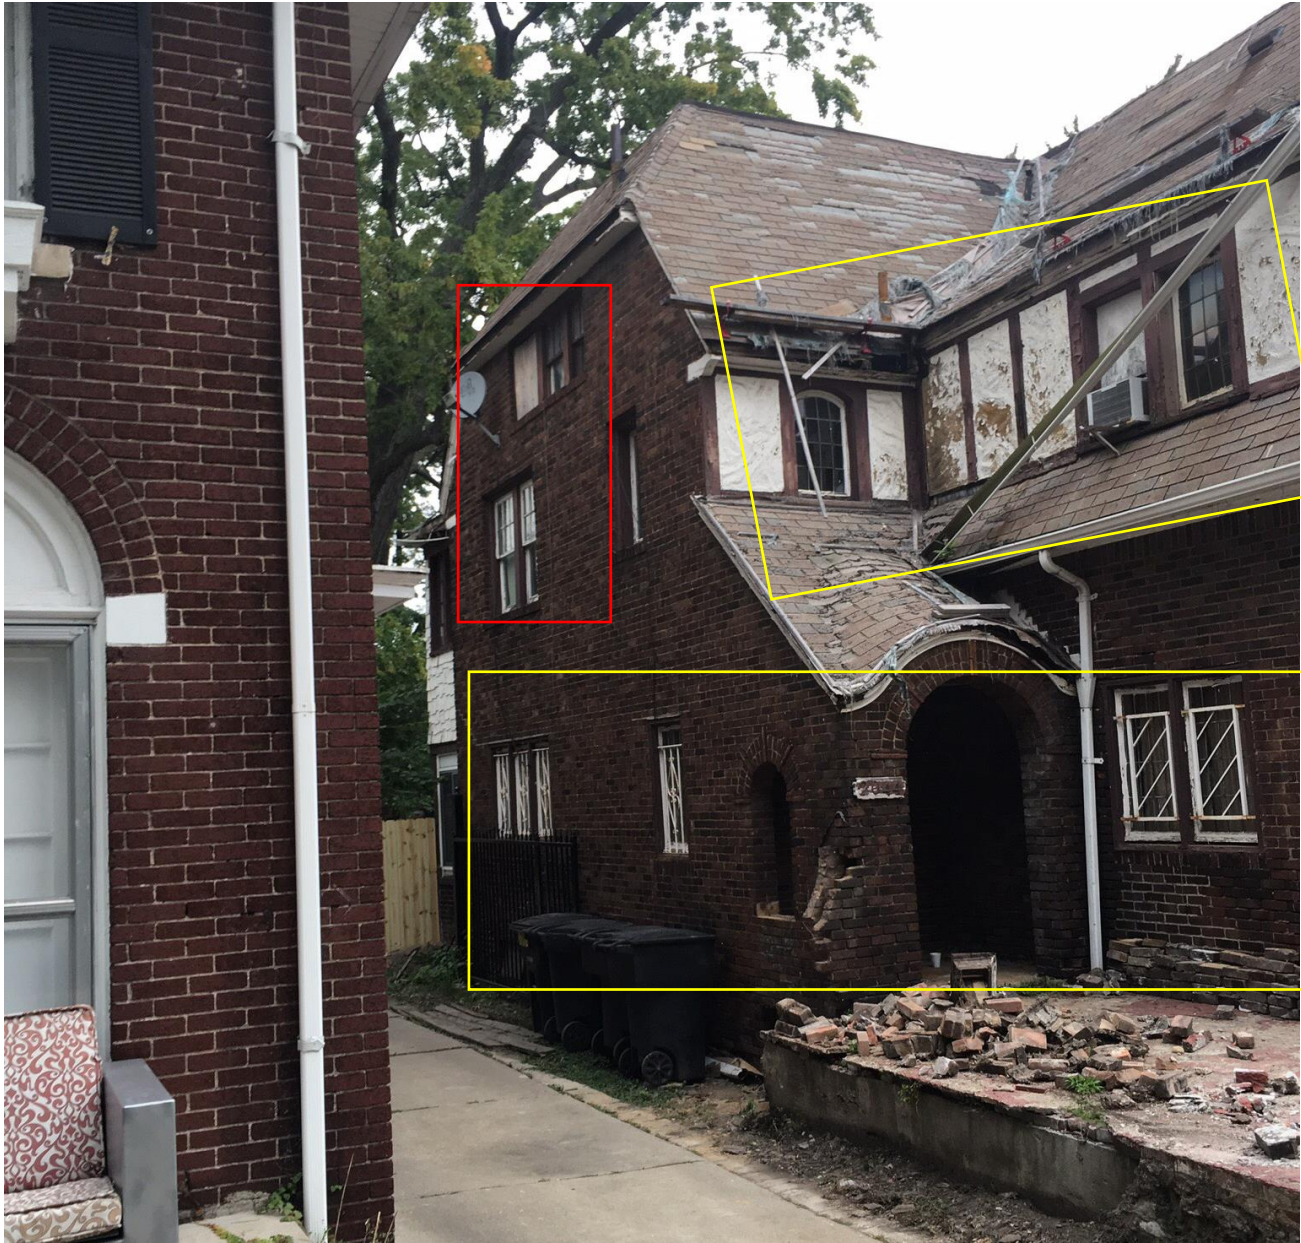
Photo taken in early 2018, prior to the fire. Note that all windows outlined in yellow are wood casement windows with leaded glass and those outlined in red are wood, double hung units. Source, HDC files.

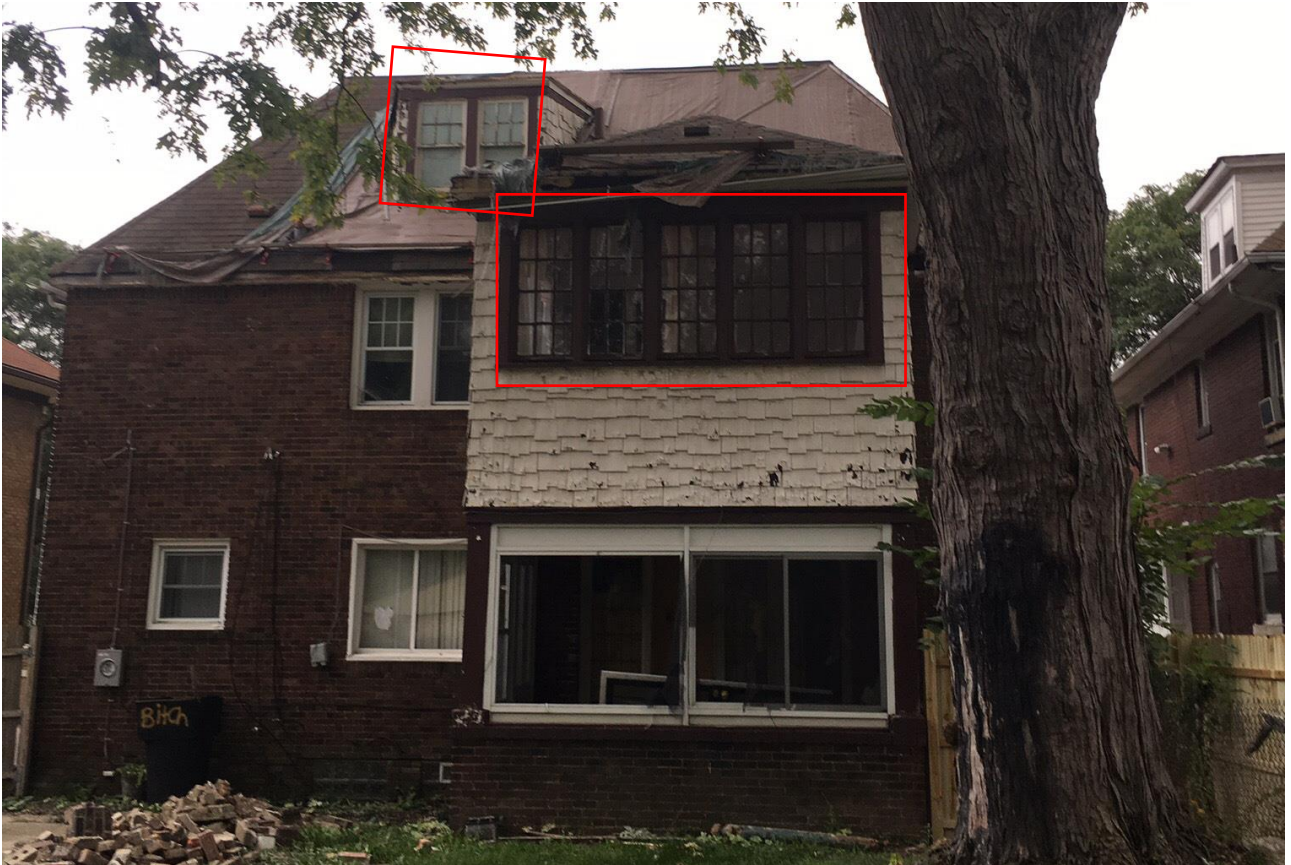
Photo taken in early 2018, prior to the fire. Wood sash casement windows outlined in red. Remaining windows are vinyl. Source, HDC files

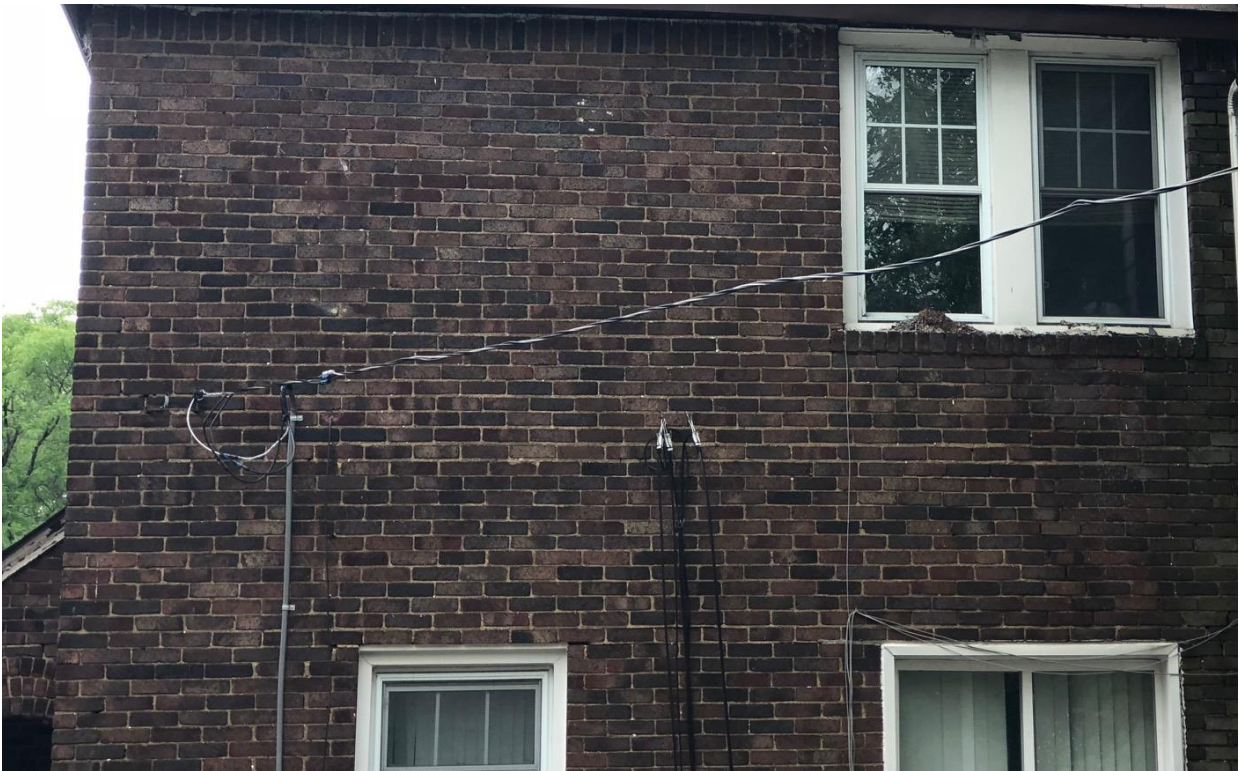
Rear wall, after the 2018 fire. Note that these windows are noncompatible, non-historic vinyl units. Photo from applicant

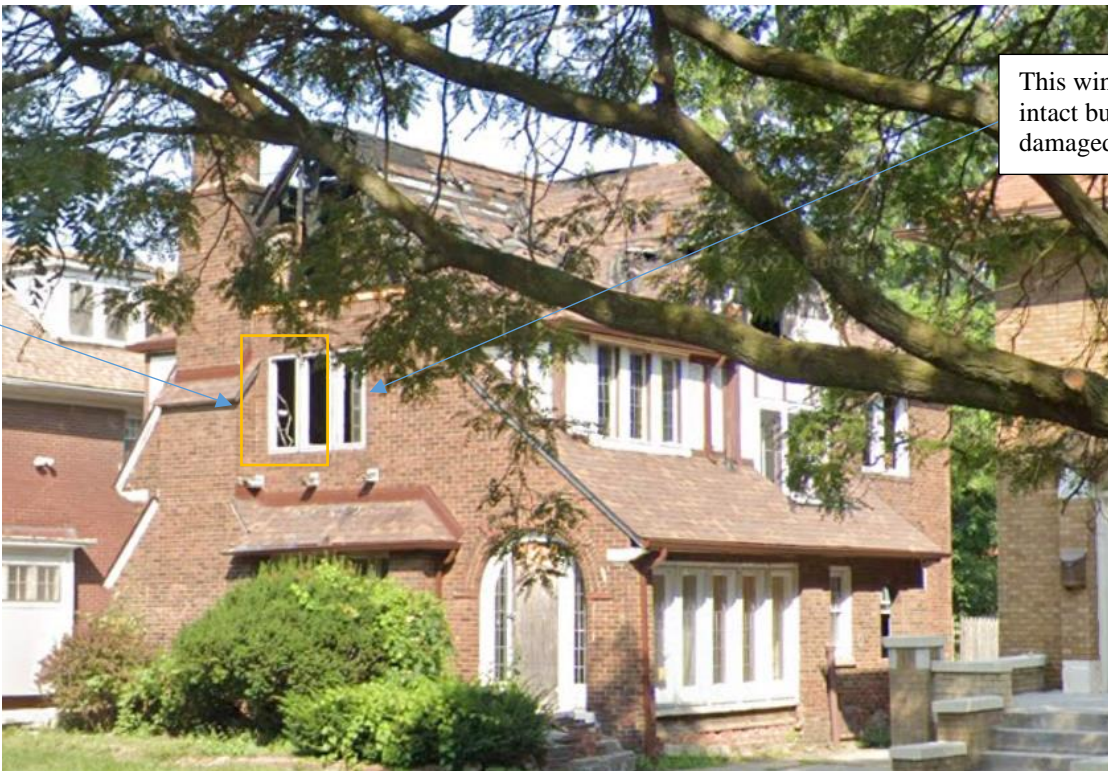
This window appears intact but heavily damaged

These two windows appear to be destroyed

August 2018, after the fire. Note that the windows and associated casing/trim at the side wall and the front door sidelites appear to be intact. Two of the three casement window sash at the front façade, second story (outlined in orange) appear to be completely destroyed although the casing/trim remained. Source, Google Streetview

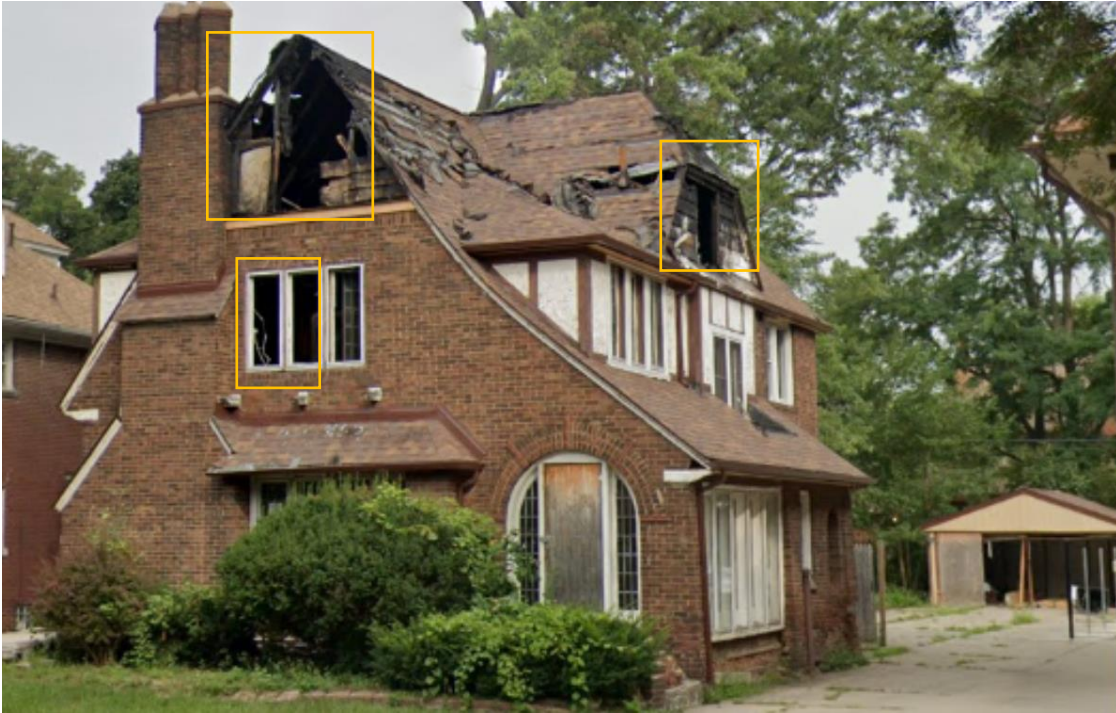
August 2018, after the fire. Note that most of the fire damage appears to be localized at the attic story and second story, west side. Windows sash and trim/casing at attic story outlined in orange appear completely destroyed. Two of the three casement window sash at the front façade, second story (outlined in orange) appear to be completely destroyed although the casing/trim remained. The rest appear to remain. The garage also appears not to have been fire damaged. Source. Google Streetview

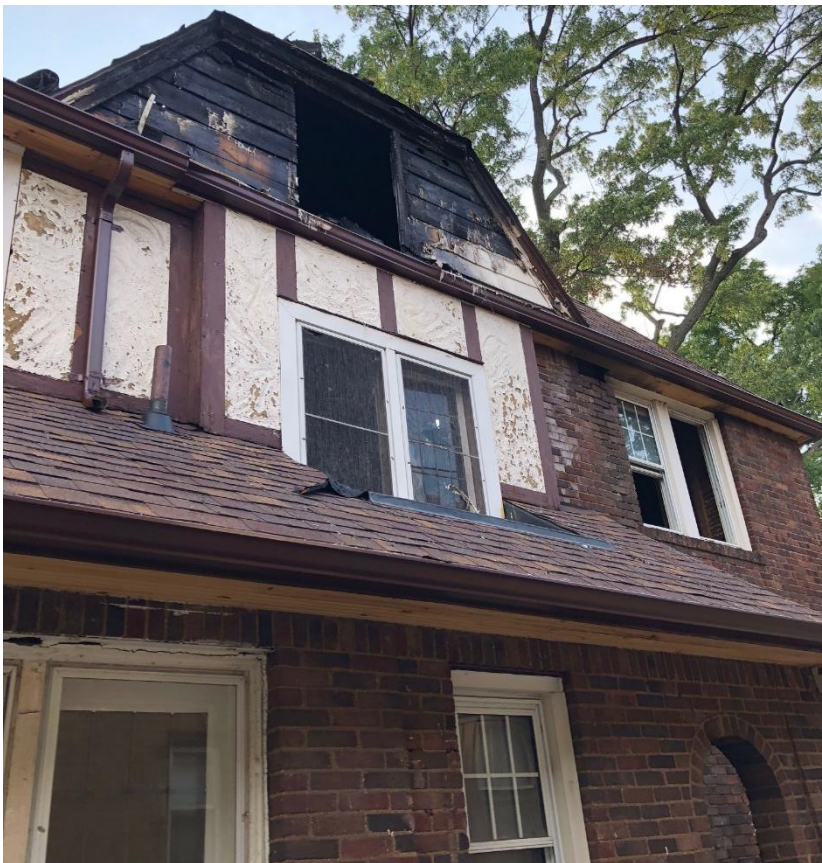
August 2018, after the fire. Detail of fire damage at rooftop dormer, east side. Photo by applicant.

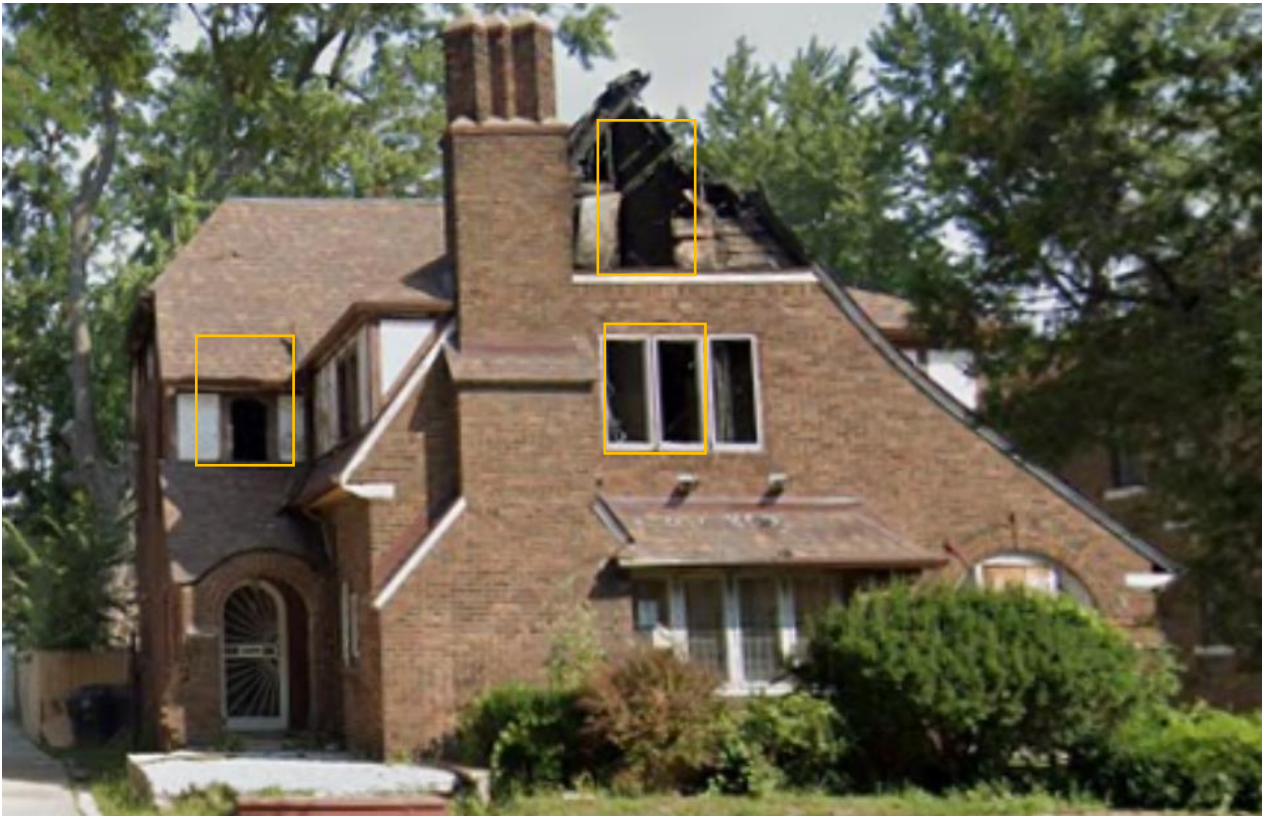
August 2018, after the fire. Window sash outlined in orange appear completely destroyed. The rest appear to remain. Source, Google Streetview

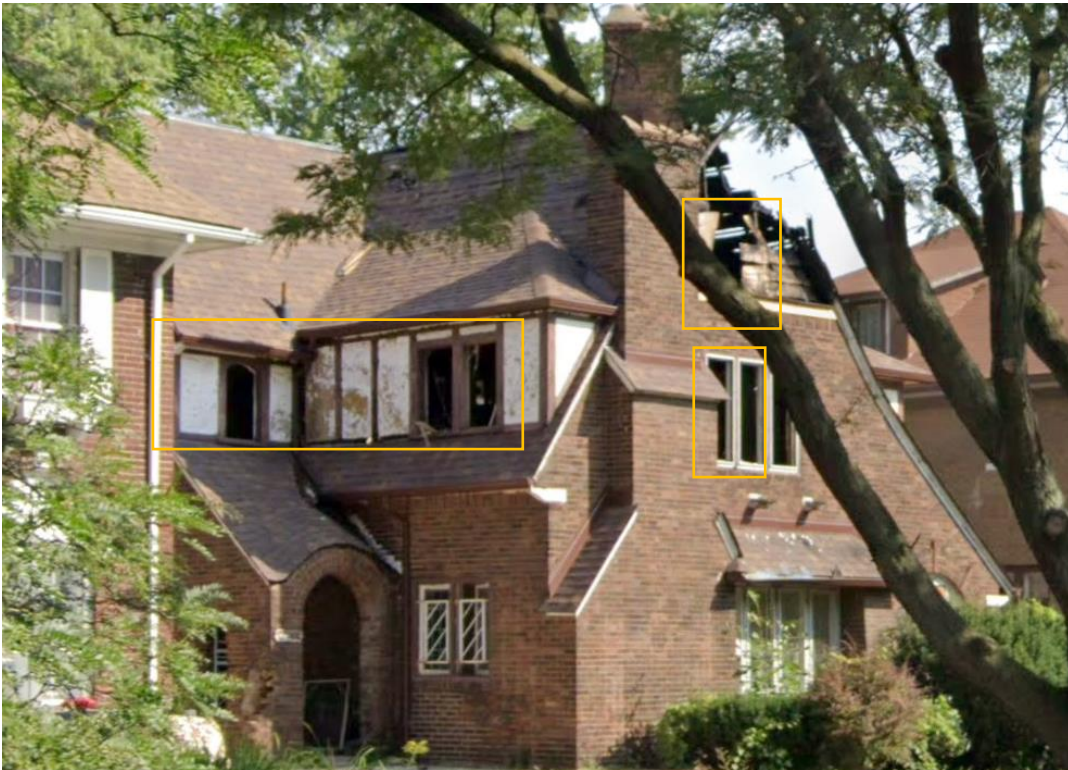
August 2018, after the fire. Window sash outlined in orange appear completely destroyed while their associated trim/casing/ remains. The rest of the windows also remain. Source, Google Streetview

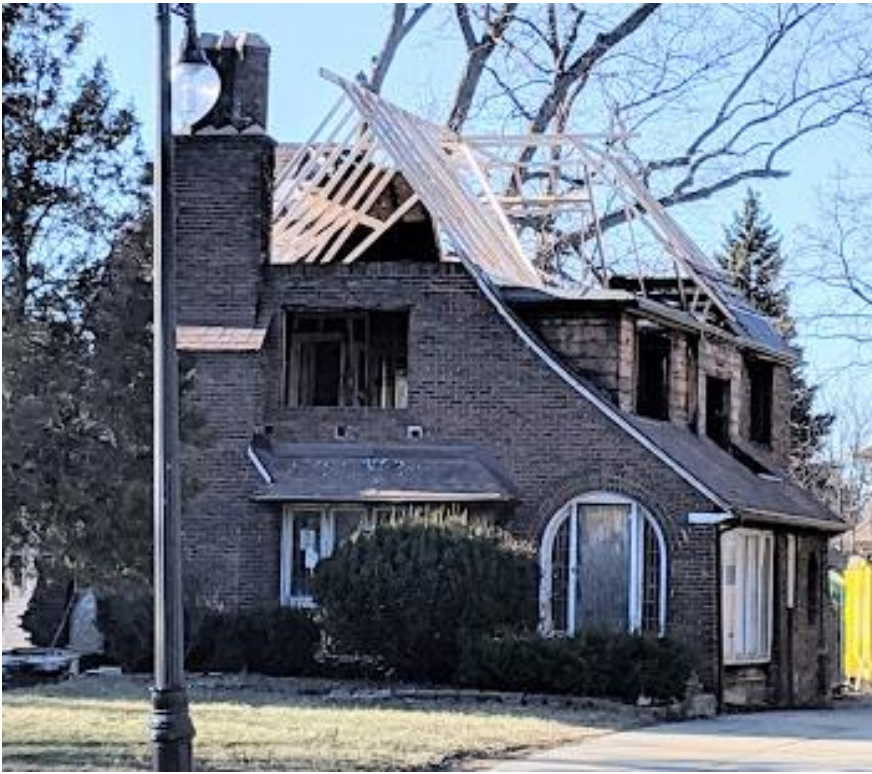
Late 2018, after the fire. Note that the rebuilding of the attic story is underway and all windows and associated casing/trim have been removed at the second story without HDC approval. Source, HDC files

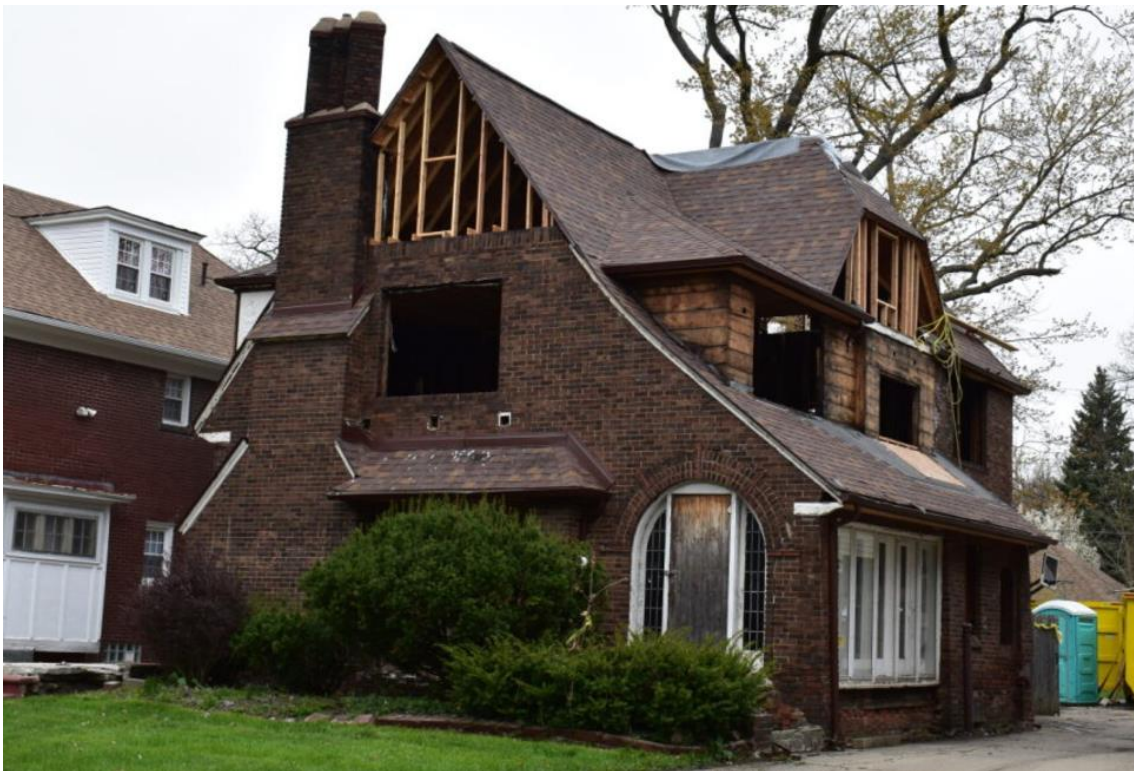
Late 2018, after the fire. Note that the attic story has been rebuilt without HDC approval. Source, HDC files

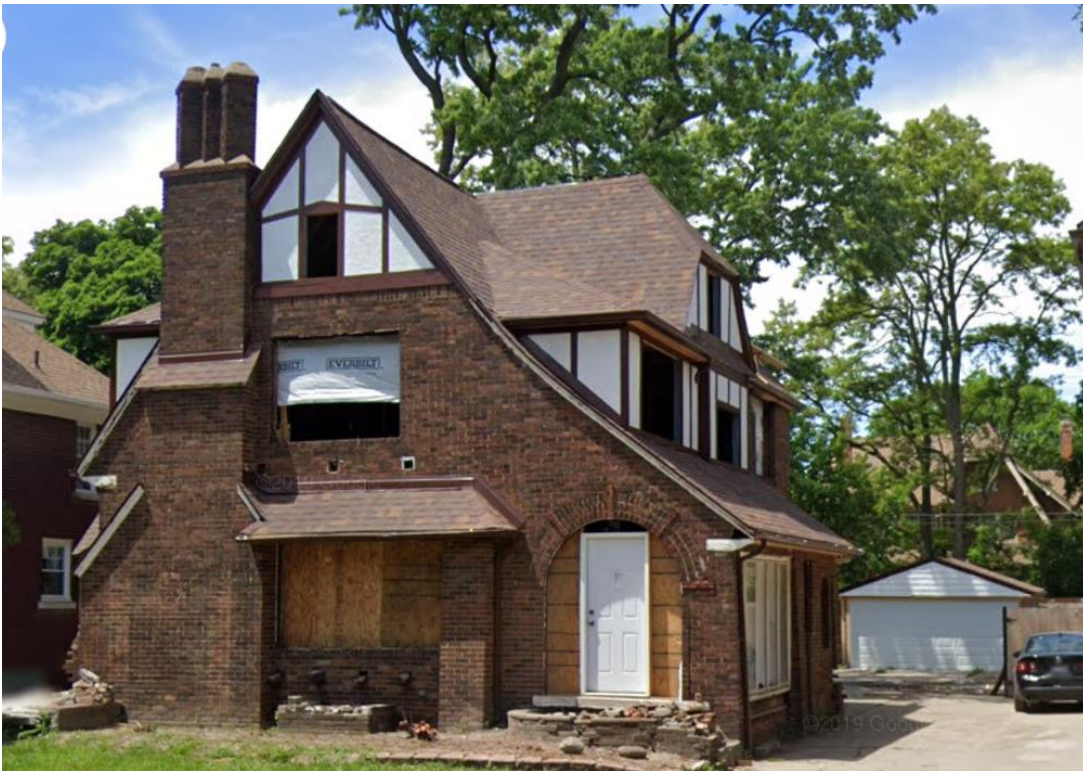
After the fire, 2019. Note that the second and attic story have been rebuilt, most windows and associated casing/brickmould have been removed to the rough opening, and front door sidelites have been removed. Garage siding has also been replaced per the 2018 COA. Source, Google Streetview

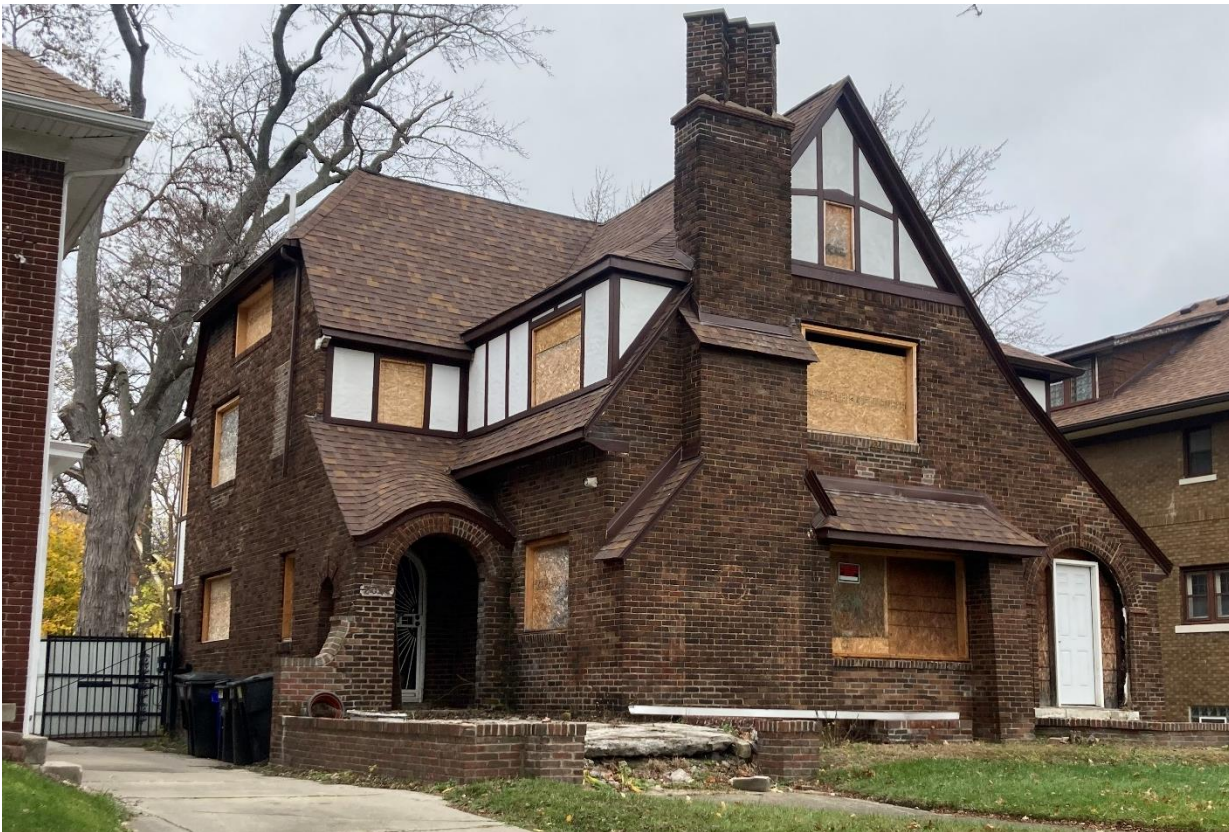
Current conditions. Note that the second and attic story have been rebuilt, most windows and associated casing/brickmould have been removed to the rough opening, and front door sidelites have been removed. Staff photo taken 11/25/2024

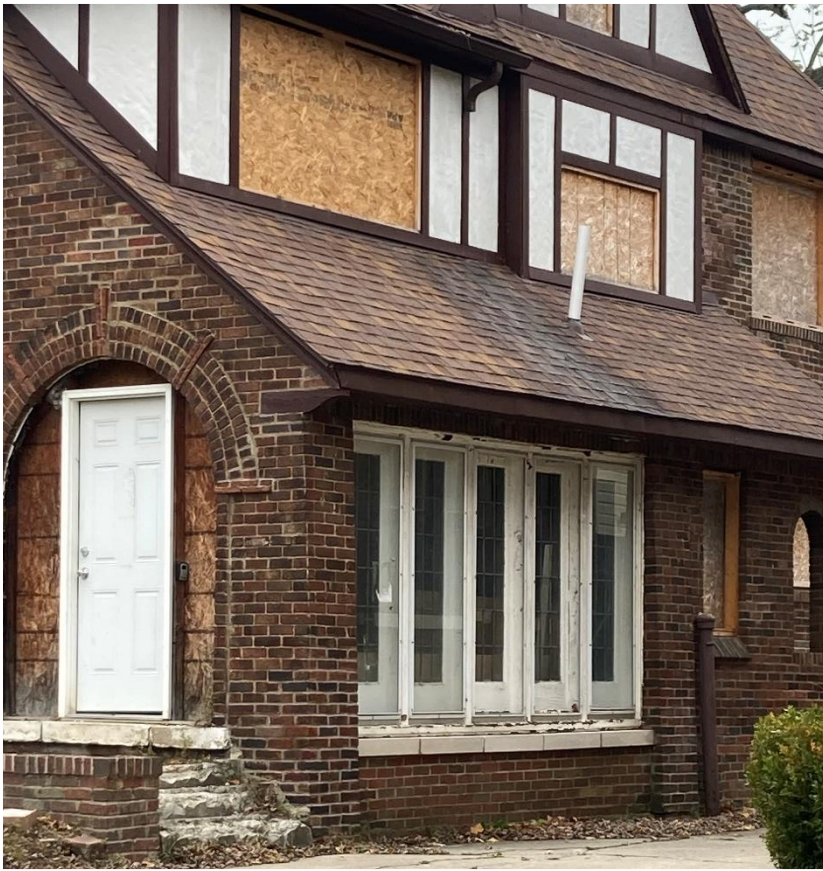
Current conditions. East wall showing only remaining original windows (wood casement with leaded glass), located at first story. Staff photo taken 11/25/2024

- The five remaining wood casement windows with leaded glass at the first story, east wall which are proposed for replacement with new aluminum clad wood casement windows are distinctive character-defining features. The current application does not provide documentation that the windows are deteriorated beyond repair nor do the replacement windows replicate the existing. The work item therefore does not meet the Standards.

- The five remaining wood casement windows with leaded glass at the first story, east wall which are proposed for replacement with new aluminum clad wood casement windows are distinctive character-defining features. The current application does not provide documentation that the windows are deteriorated beyond repair nor do the replacement windows replicate the existing. The work item therefore does not meet the Standards.

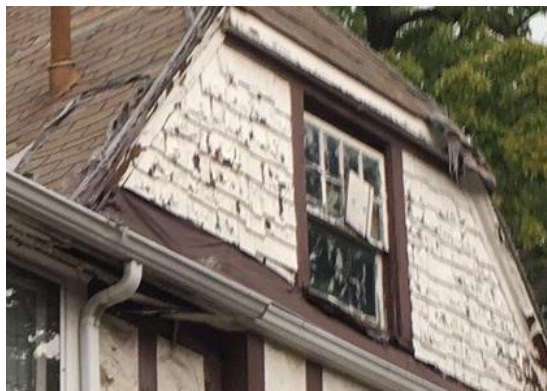
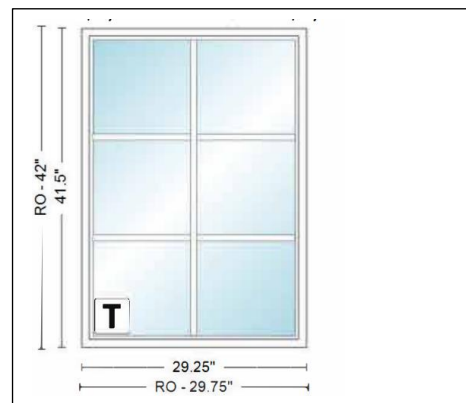
- One, double-hung, 8/1 wood window in the east elevation attic story dormer (below left photo). The proposed window is composite and wood, fixed six pane, simulated divided lite window (below right photo).

It is staff's opinion that the proposed new window is incompatible because a fixed window of this size is not commonly found at this location on a house of this vintage.

- The fixed, composite and wood, six pane, simulated divided lite window proposed for installation at the east elevation attic story dormer to replace a casement window that was destroyed by the fire is not compatible with the property's historic character as large fixed casement window would not be commonly found at this location on house of this style and vintage.

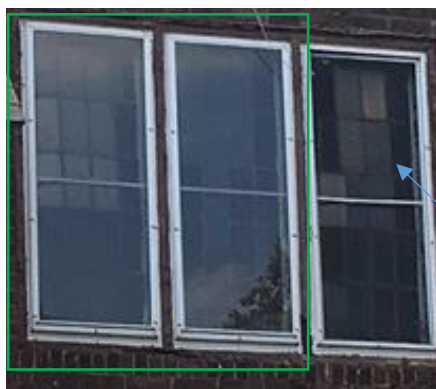
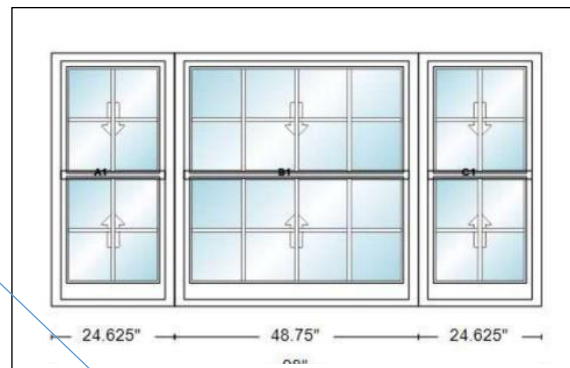
- Two, wood casement windows (outlined in green in below photo to the left) with leaded glass at the second story, front façade. The proposed windows are to be double-hung wood units with simulated divided lites. (below left photo)

It is staff's opinion that the new windows are incompatible because the size of the central window is inappropriately large. Also, the third window in the grouping did remain after the fire and therefore should be replicated per the Standards.

- The double-hung wood units with simulated divided lites proposed for installation at the front façade, second story, to replace two wood casement windows that were destroyed by the fire, are not compatible with the property's historic character as the size of the central window is inappropriately large for a house of this vintage and style.
