**STAFF REPORT: FEBRUARY 12, 2025 MEETING**

**APPLICATION NUMBER: HDC2025-00009 // VIOLATION NUMBER: 21-410**

**ADDRESS: 3470 CAMBRIDGE**

**SCOPE: REPLACE STEEL WINDOWS WITH VINYL-CLAD WOOD WINDOWS, REPLACE RAILINGS AND DOORS (WORK COMPLETED WITHOUT APPROVAL)**

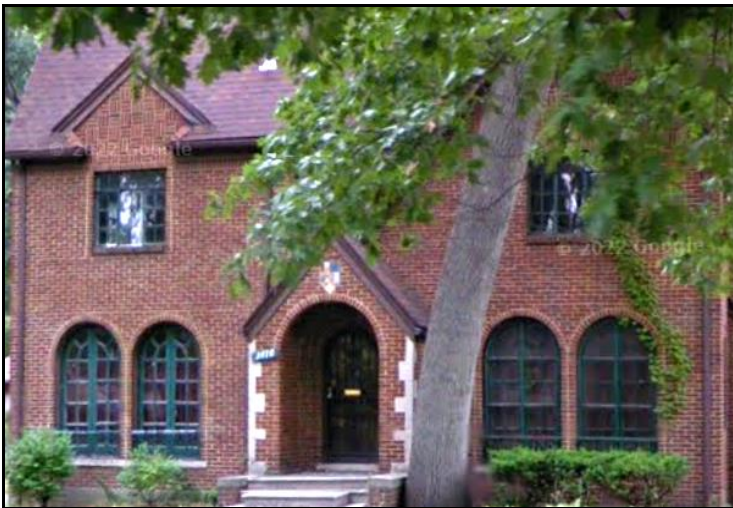
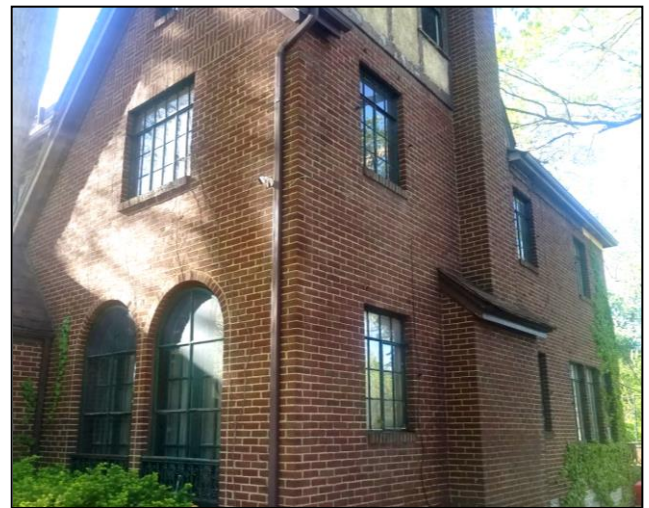
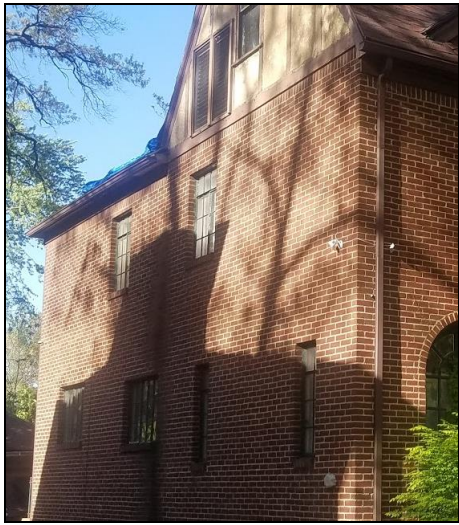
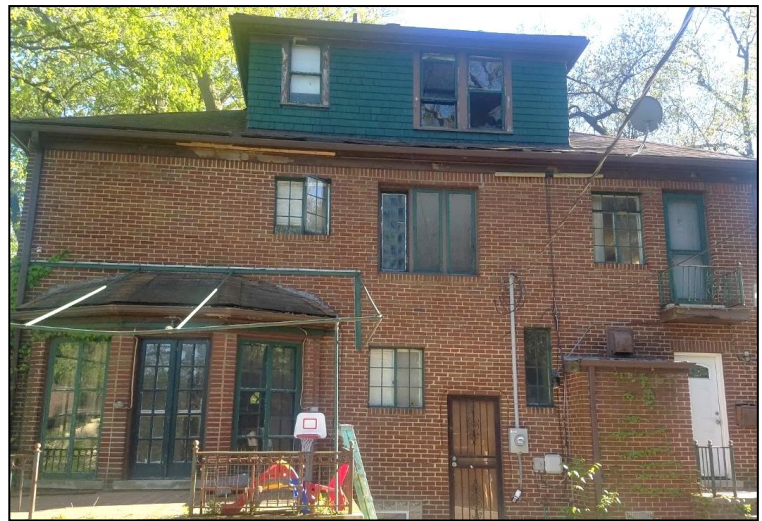
*Above: Façade. Google street view, August 2015.*

*Southeast corner of house. Updated applicant photo.*

*West side, undated applicant photo.*

*Rear, undated applicant photo.*

- The historic windows were replaced with Anderson 400 Series vinyl-clad wood windows. The majority of openings now have double-hung one-over-one windows; however, the larger openings on the front, west side, and rear have sliding units. The front sliders have between-the-glass grilles. Sliding windows and between-the-glass grilles are not consistent with the general characteristics of a historic window of the type and period of this house and are not compatible with the overall historic character of the dwelling.
- The placement of the new windows doesn't match the more deeply recessed location of the historic windows within the window openings. The depth of plane change between window and wall surfaces is an important feature on the elevations of the house and the current windows don't convey the same visual appearance.

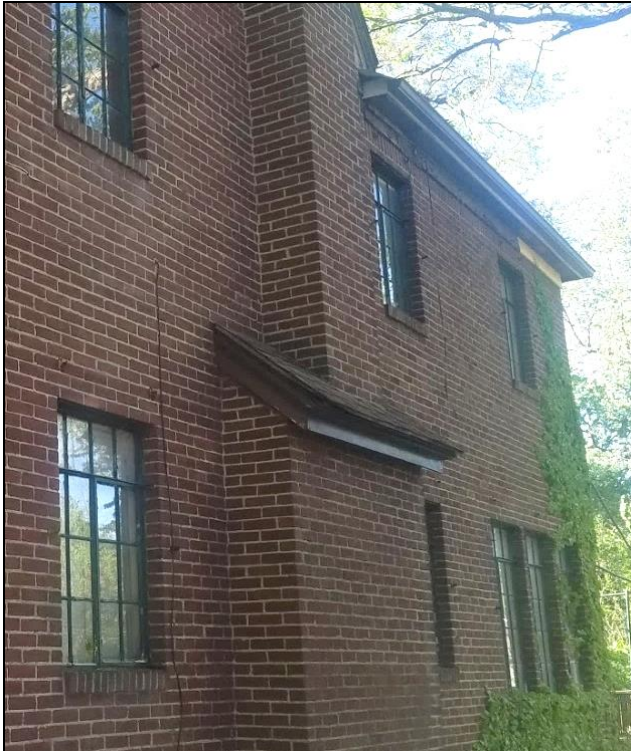
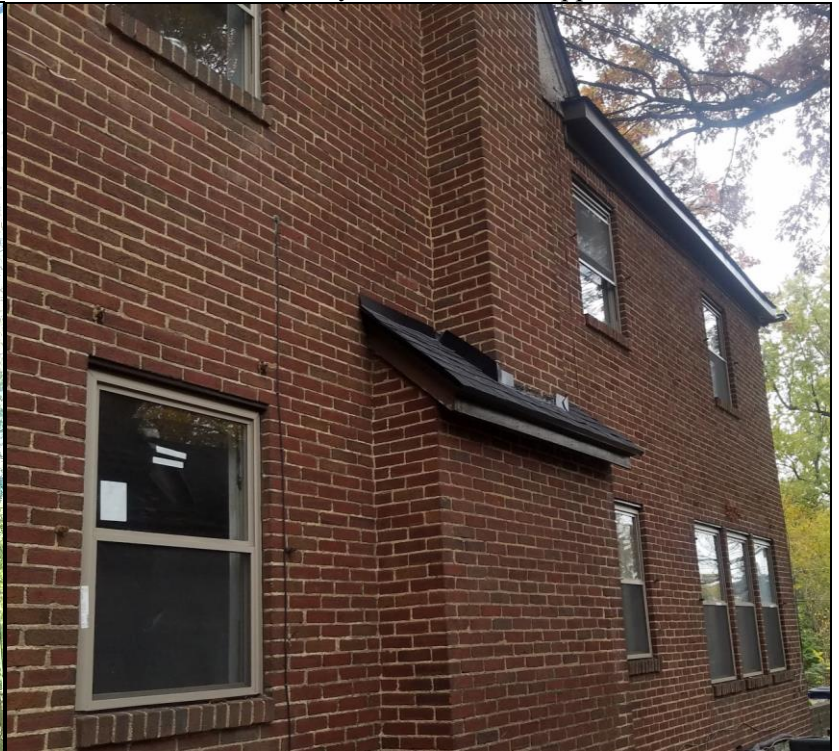
*The depth of the "before" steel windows is quite evident and clearly offers a relief from the masonry wall. The replacement windows are minimally set back in the window opening, and from a distance, appear to be in plane and a part of the exterior wall.*

- The placement of the new windows doesn't match the more deeply recessed location of the historic windows within the window openings. The depth of plane change between window and wall surfaces is an important feature on the elevations of the house and the current windows don't convey the same visual appearance.

- The windows were removed without HDC approval; the scope of work that would meet the requirements of the historic ordinance (Section 21-2-59(e)) is the fabrication and installation of new steel-framed windows with an identical pattern and operation as the historic windows, and wood one-over-one double-hung sash at the third floor, with dimensions that match the historic windows.

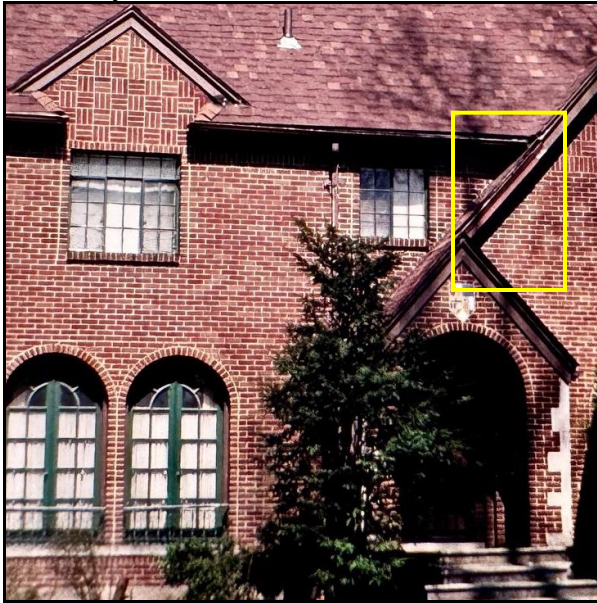
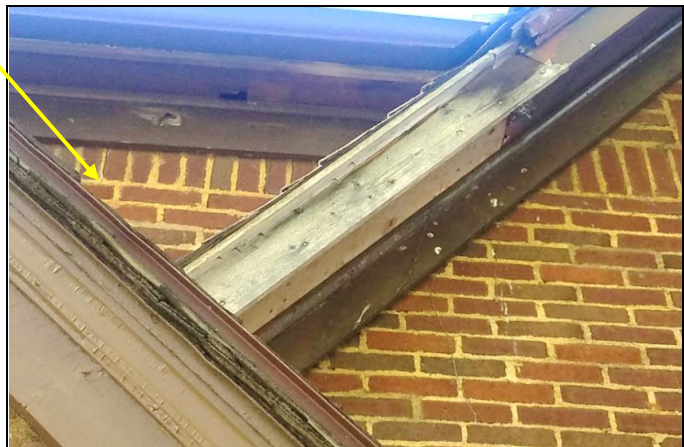
- The applicant’s photos of the west side gable wall and front entry gable show the profiles of these wood rake boards are highly dimensional. The rake board of the largest gable on the façade appears to have been repaired, and the hole in the soffit could be repaired and these components painted. Painted wood surfaces offer a mostly matte finish, in keeping with the brick wall surface. Aluminum coil only offers mostly flat, minimally bent and shiny/reflective surface.

*The rake board in the designation photo is flat and has a sheen. This indicates the rake boards were covered with aluminum.*

*This applicant photo with the aluminum removed, shows an intact and highly profiled rake board at the front entry (at left), and a partial repair of the rake board within the large gable wall (middle). The soffit and wood trim (top) have small, but repairable holes.*

- The Commission regularly does not approve the reinstallation of non-historic materials to cover intact and repairable original features and materials. Therefore, the recently installed aluminum should be removed, and the wood rake boards, fascia and soffits be repaired and painted as needed.

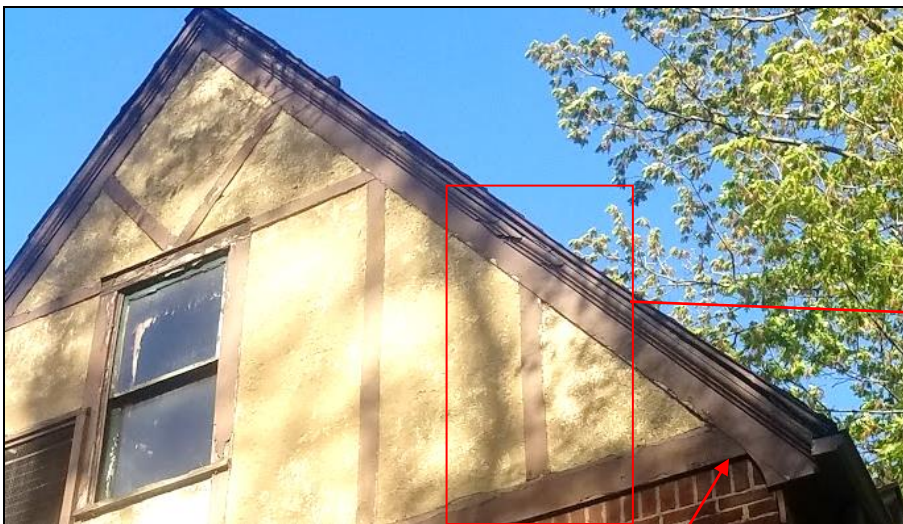
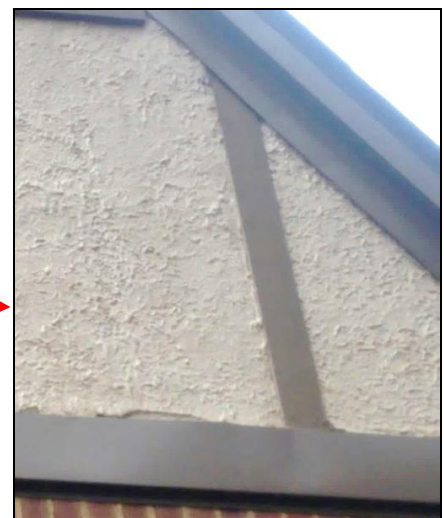
*This undated applicant photo shows an intact highly profiled rake board on the west-facing gable wall. Note the curved edge at the bottom right of the photo. This detail common on English Revival houses may have been removed upon covering the rake board with aluminum.*

*This close-up photo shows the current condition of the identified area of the photo at left.*

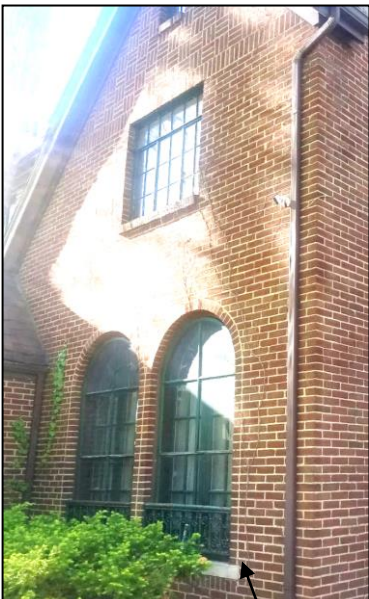
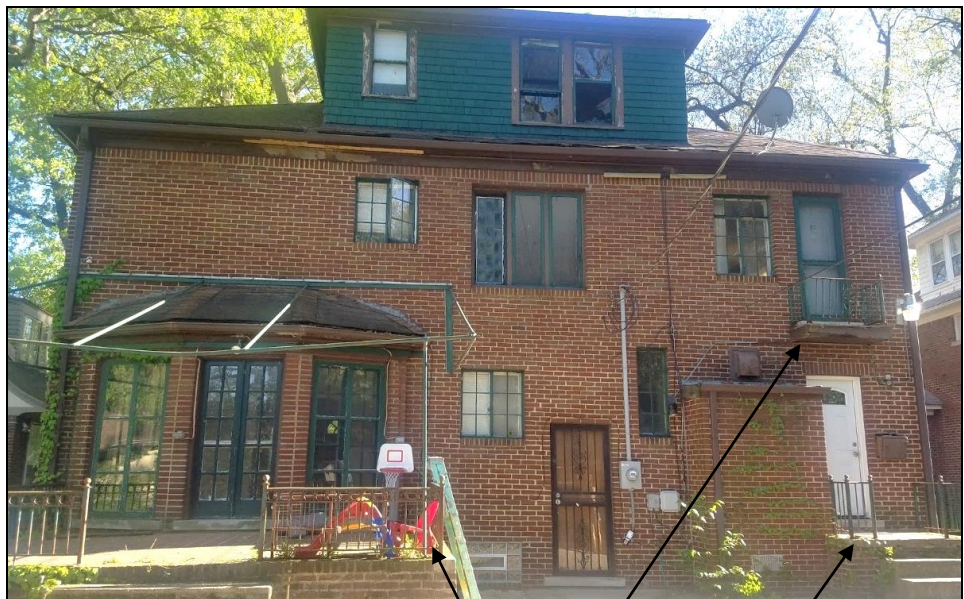
- The limited photographic documentation showed some corrosion on the rear patio railing and one set of French doors railing, but again, no repair estimate was submitted to confirm its level of deterioration (i.e., was it just surface corrosion?) and possibility of repair. The railings were intact and appeared to be repairable. No repair estimates were submitted with the 2020 application to show that they were beyond repair.

*Above left: One set of railings that closed one set of French doors.  
 Above right: Rear of house that shows the original railings in place at the raised patio, Juliet balcony and rear door.*

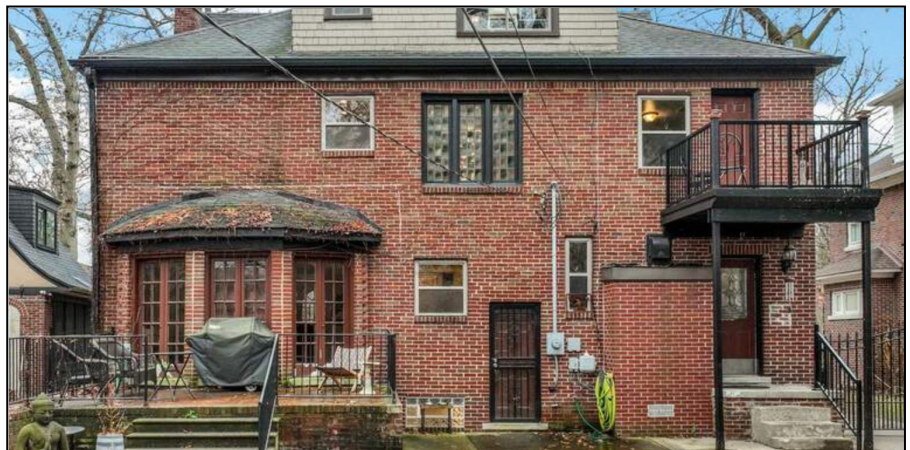
*Applicant photo.*

- The newly built large open porch and tall aluminum railings erected at the two porches and raised patio do not match the removed historic features, nor is the new work compatible with the massing, scale, physical features and workmanship of the historic property.
- The removal and/or replacement of the historic components do not meet the Secretary of the Interior Standards 2, 5, 6 and 9 (listed on page 8).

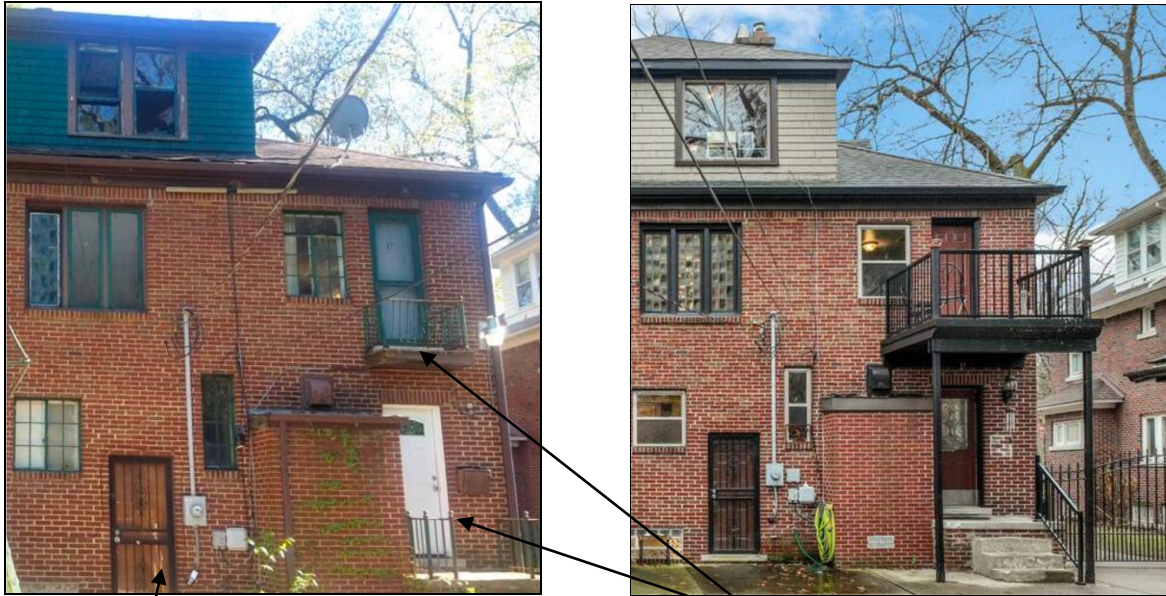
Above left: The wood door appears to be a solid, utilitarian door, and the two white non-historic doors are not appropriate for the architectural style of the house. The current replacement doors have minimal styling, and the brown color is compatible with the house's architectural design.

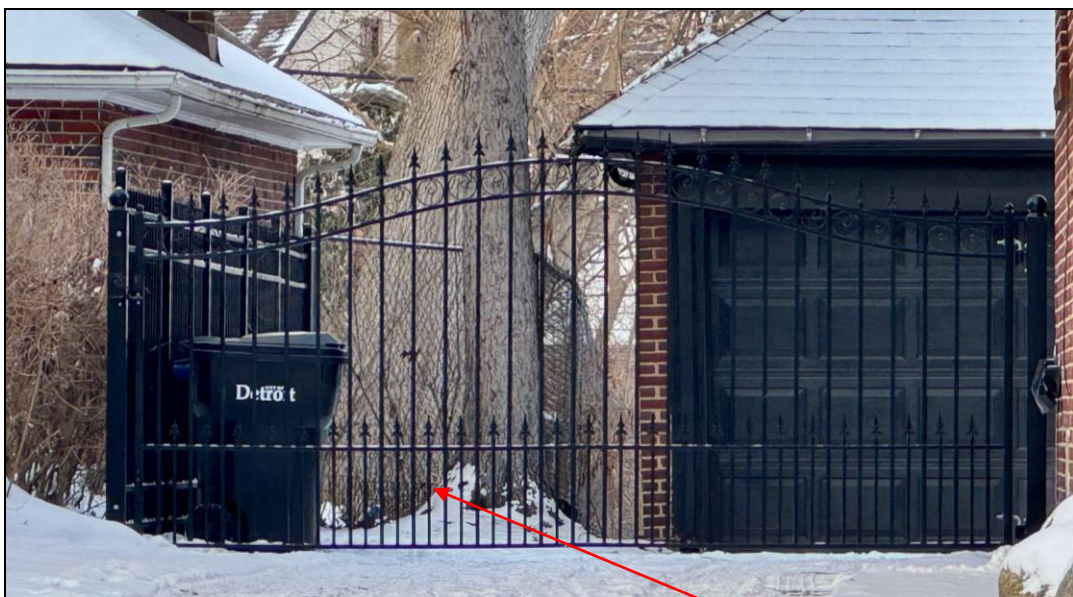
Staff photo from sidewalk, January 24, 2025.  
It appears that the black fencing was installed at the property line and a section of new chain link fencing was installed to bridge the space between the new black fence and an existing chain link fence.
