STAFF REPORT: FEBRUARY 12, 2025 REGULAR MEETING **PREPARED BY: T. BOSCARINO**
APPLICATION NUMBER: HDC2024-00700 (VIOLATION #24-891)
ADDRESS: 4340 GLENDALE
HISTORIC DISTRICT: RUSSELL WOODS-SULLIVAN
APPLICANT: KARINA LABARCA
PROPERTY OWNER: AFIWI LLC
DATE OF PROVISIONALLY COMPLETE APPLICATION: DECEMBER 10, 2024
DATE OF STAFF SITE VISIT: FEBRUARY 5, 2025

SCOPE: REPLACE WOOD WINDOWS (WORK COMPLETED WITHOUT APPROVAL) WITH ALUMINUM-CLAD WOOD WINDOWS

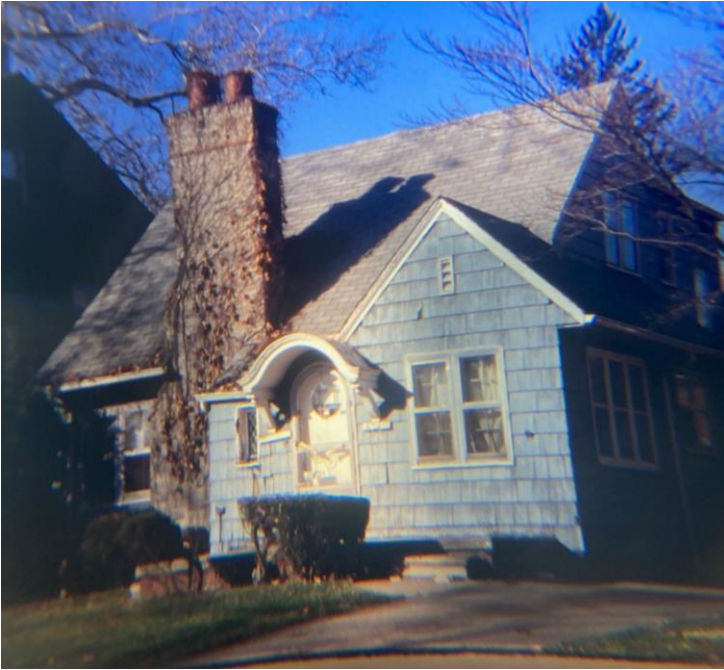
At the time the Russell Woods-Sullivan Historic District was enacted by the City Council in 1999, a photo shows original windows remained, including wood sash and casement windows. Due to storm windows over the openings and because the 1999 photo only shows one perspective, it is difficult to tell the original

configuration of the historic windows. However, it is clear that some were subdivided with muntins and at least one had a quarrel pane (that opening, beside the front door, has since been eliminated altogether).

1999 photo by the Historic Designation Advisory Board

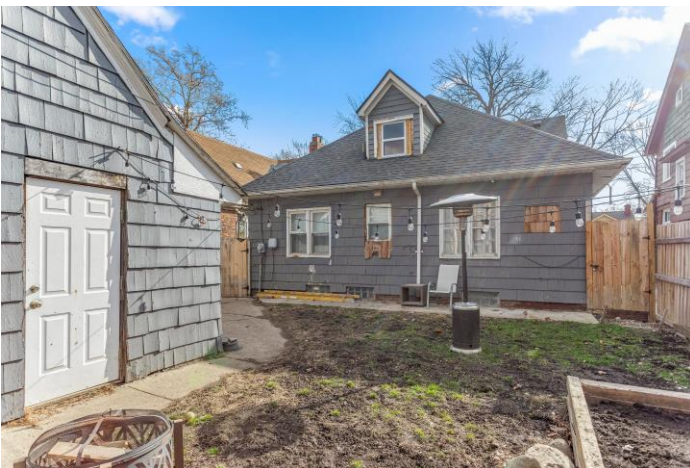
During the spring of 2024, the present applicants removed additional original windows from the sides and rear of the dwelling and replaced some of the earlier vinyl windows on the facade. Some of these windows fill the width of the original window openings, whereas others required dimensional modifications to the rough openings. The windows are a mix of double-hung, picture, and slider windows. Two window openings, one at the east wall and one at the rear, were infilled entirely. Three remaining original wood windows—a paired set on the rear and one on the garage—were still in place at that time and remain in place today.

Image from 2024 application documents showing the two remaining historic windows on the house (partly hidden behind the patio heater).

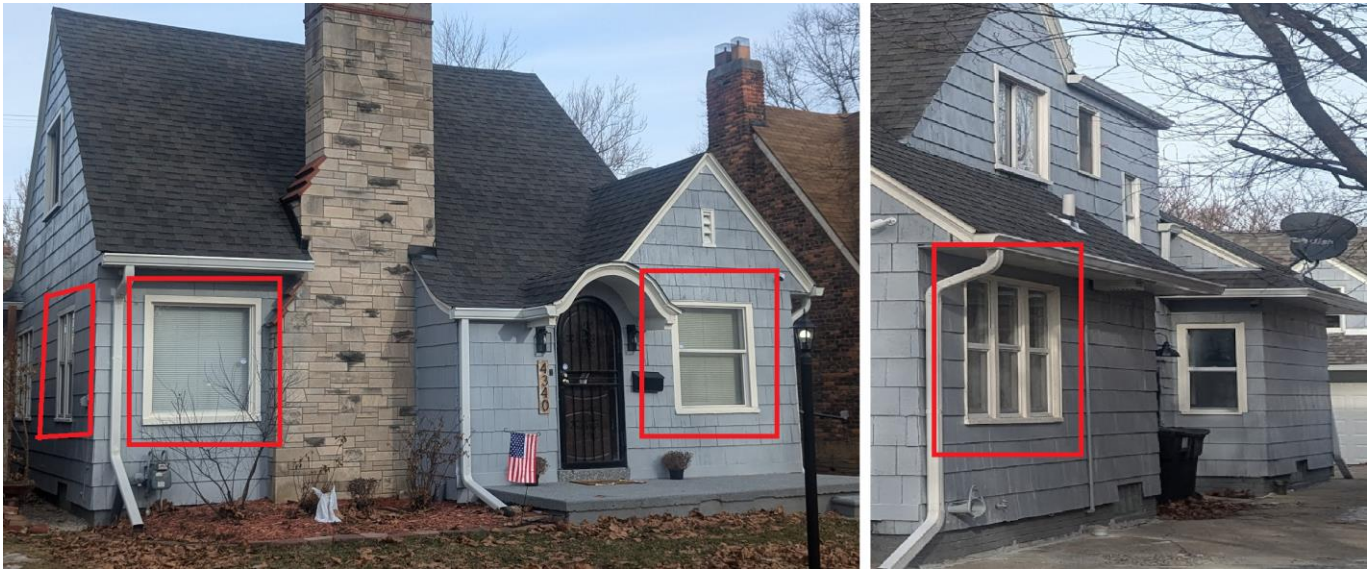
Openings proposed for replacement with aluminum-clad wood windows marked with red boxes. February 2024 photos by staff.

- Staff’s ability to assess the appropriateness of the proposed replacement windows is hindered by a lack of information on the appearance of the historic windows. The four openings appear to have been filled as follows, from east to west (right to left on the photos above):

- Frontmost opening on east elevation: Triple-ganged, mullioned sash windows, as seen in the 1999 photo. Based on other known historic windows, it is likely that a four-over-four muntin

pattern existed, but this is not certain.

- Easternmost opening on front (south) elevation: Most likely, double-ganged, four-over-four, sash windows, as seen in the 1999 photo. A pair of eight-pane casement windows is also possible, as this would not be inconsistent with the house's Tudor style.
- Westernmost opening on the front (south) elevation: Same as above.
- Frontmost opening on west elevation: The original configuration is not known.

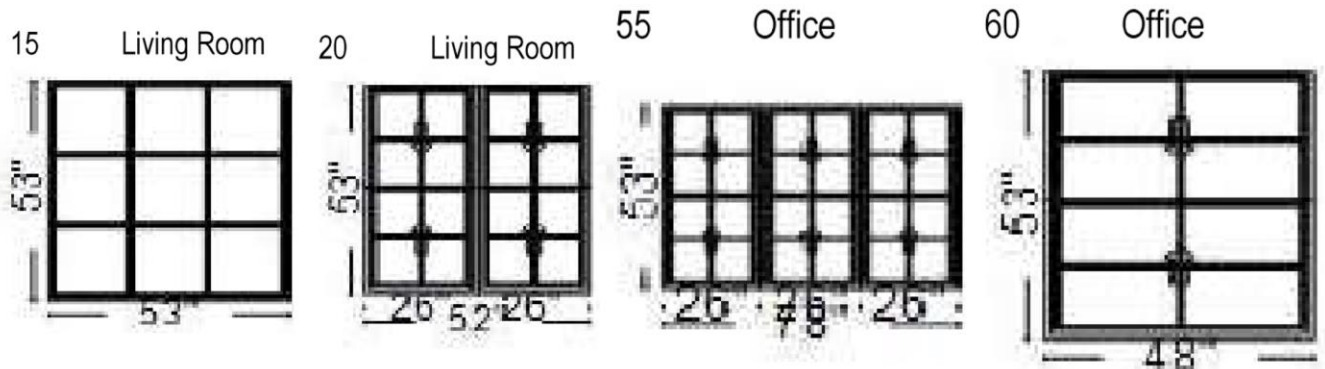
Proposed windows, not to scale. The windows marked "20" and "55" approach appropriateness. Image from submitted window schedule.

- In general, the proposed Pella Lifestyle windows have the ability to match the lost historic windows as closely as possible given the limited information available. However, the submitted window schedule falls short of appropriateness. A triple-ganged, four-over-four window shown in the submitted schedule would be a good match for the first opening mentioned above, and a double-ganged, four-over-four window would be a good match for the second opening mentioned above. However, the window schedule states these would be "FactoryMull" which is not a compatible treatment, in staff opinion. A true wood mullion would match the condition of the lost historic element. As for the other two windows, an uncommonly wide, four-over-four sash window, and fixed, nine pane window as shown would not be a good match for the remaining two openings. Further, the submitted window schedule is not clear as to which window is intended for which opening.

- The applicant has not shown that the removed windows had deteriorated beyond feasible repair.
- The four proposed replacement units do not match the three-dimensional qualities of the historic windows: two have integrated factory mullions instead of true mullions, and two have the wrong muntin pattern.

- Of the proposed four new windows, two of the units are clearly not appropriate as they do not match the old windows in design (they have muntin patterns, operation, and, consequently, profile, noticeably different than what is known to have historically existed on the property), and the other units are not appropriate as they have a factory mullion, rather than a true mullion.

Recommendation 1 of 1, Denial
