## Wrap Wood Fascia and Soffits with Dark Brown Aluminum - Facade

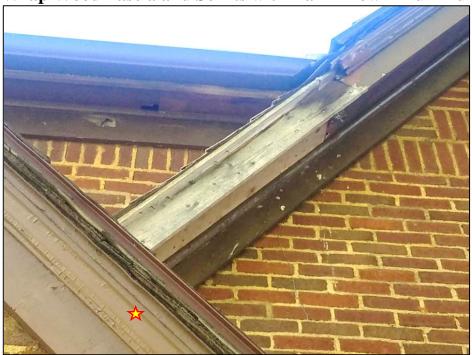
Above: "Before". Areas of soffit and fascia at front entry. 🗙

Notice profile of front porch gable trim at left. Wood components were not deteriorated beyond repair.

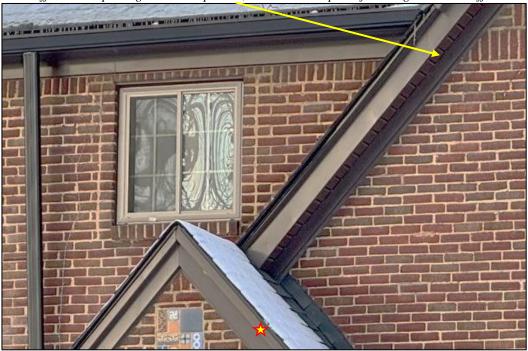
Below: "After".

Highly profiled fascia is gone; sheen of aluminum material is highly visible. New soffit has a repeating horizontal pattern, which was not part of the original wood soffit.

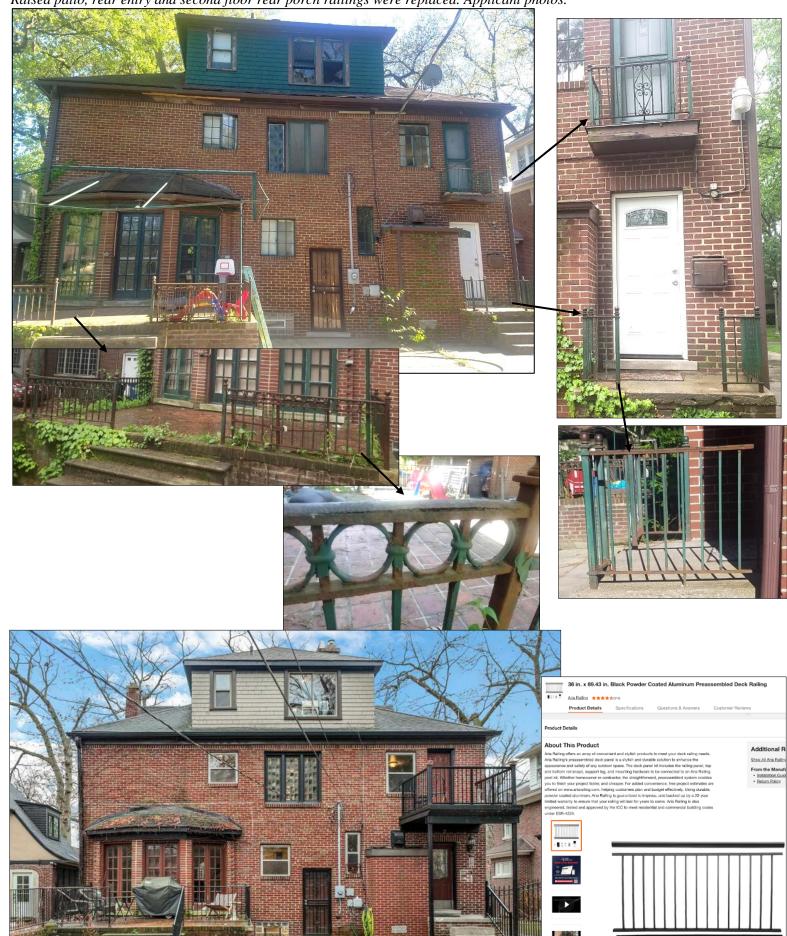
**Rear Railings**Raised patio, rear entry and second floor rear porch railings were replaced. Applicant photos.

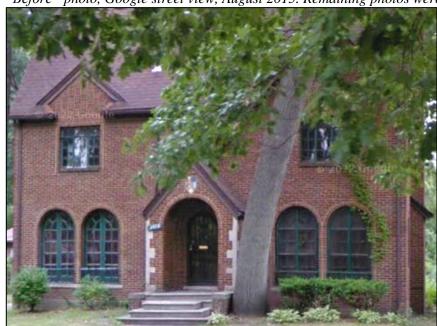
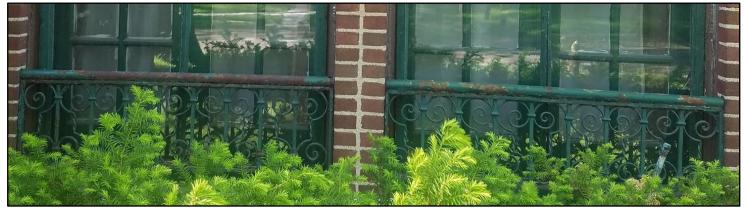
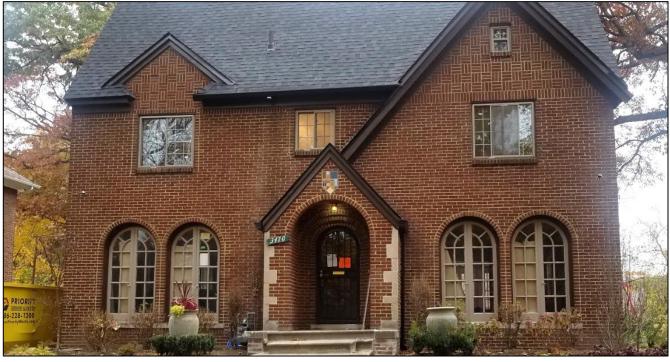
Removal of Front French door railings.
"Before" photo, Google street view, August 2015. Remaining photos were provided by the applicant.

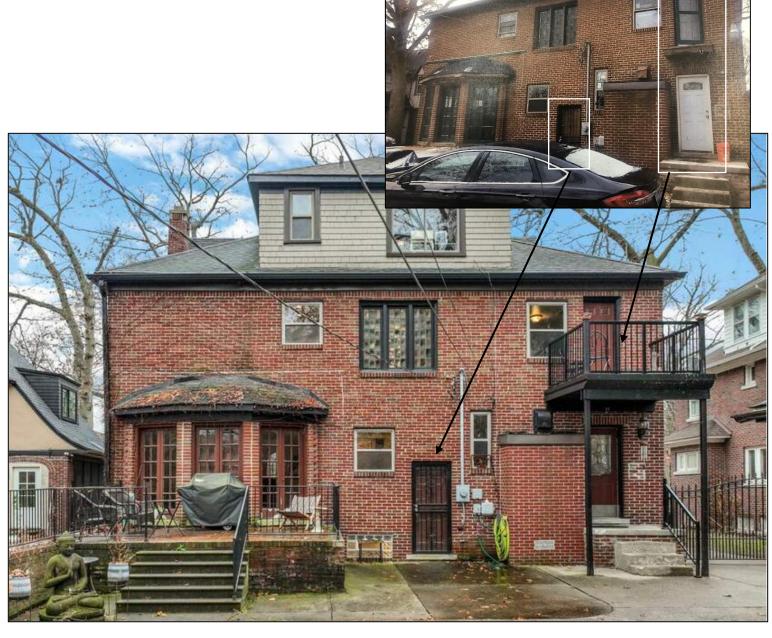
## **New exterior doors - Rear**

Applicant claims the white doors were in place at time of house purchase. Staff didn't find any previous HDC review for the white steel doors.
