STAFF REPORT: MARCH 13, 2025, REGULAR MEETING **PREPARED BY:** T. BOSCARINO & J. ROSS
APPLICATION NUMBER: HDC2025-00010
ADDRESS: 3500 MCDUGALL (A.K.A. 3100 GRATIOT AVENUE)
HISTORIC DISTRICT: PRINCE HALL GRAND LODGE
APPLICANT/ARCHITECT: KATIE COOK, KRAEMER DESIGN GROUP
PROPERTY OWNER: PRINCE HALL GRAND LODGE
DATE OF PROVISIONALLY COMPLETE APPLICATION: JANUARY 21, 2025
DATE OF STAFF SITE VISIT: FEBRUARY 28, 2025

SCOPE: REPLACE VINYL, STEEL, AND WOOD WINDOWS WITH ALUMINUM WINDOWS; INSTALL WALL SIGNS

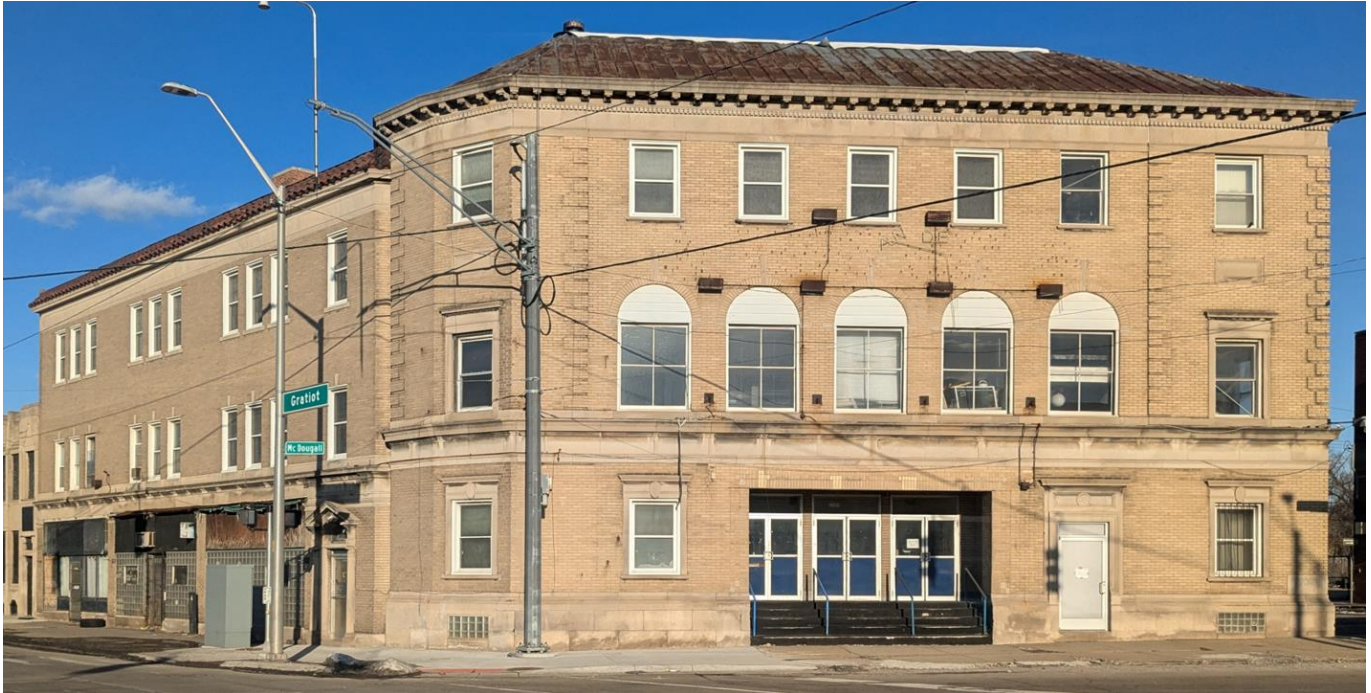
January 2025 photo by staff. The original portion of the building is the hip-roof mass in the foreground; the flat-roofed addition along Gratiot Avenue is at the left of the image.

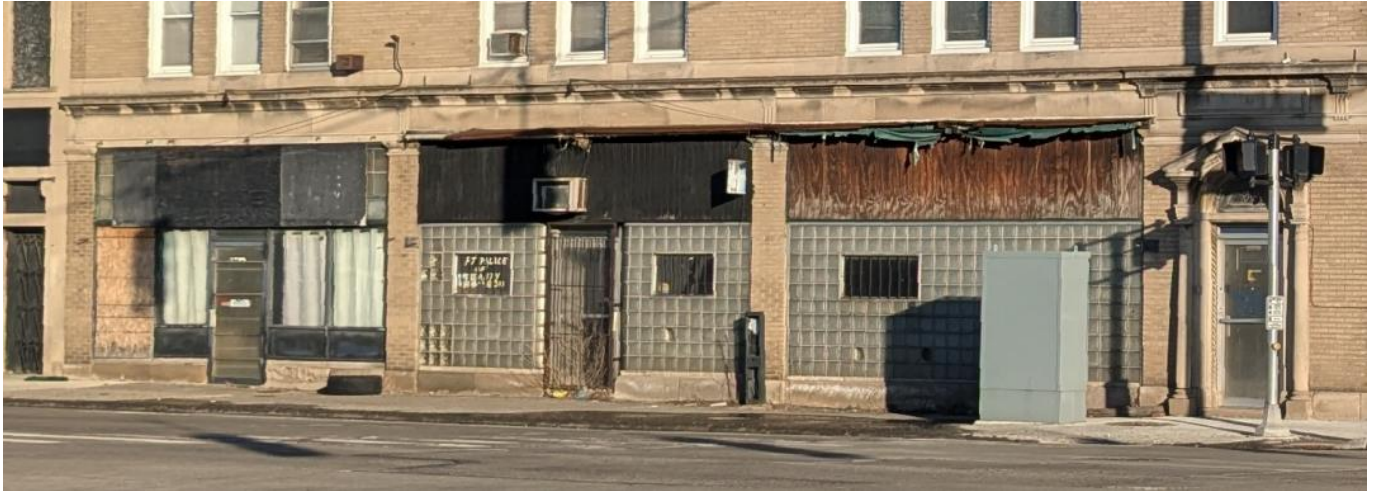
The secondary facade contains three storefronts, now filled with non-original doors, glass-block windows, and boarded-up transoms (according to the Historic Designation Advisory Board Final Report, none of these elements are original). Above, architectural detail is simpler than on the primary facade; second-floor windows have surrounds with keystones.

Detail of non-original storefronts. January 2025 photo by staff.

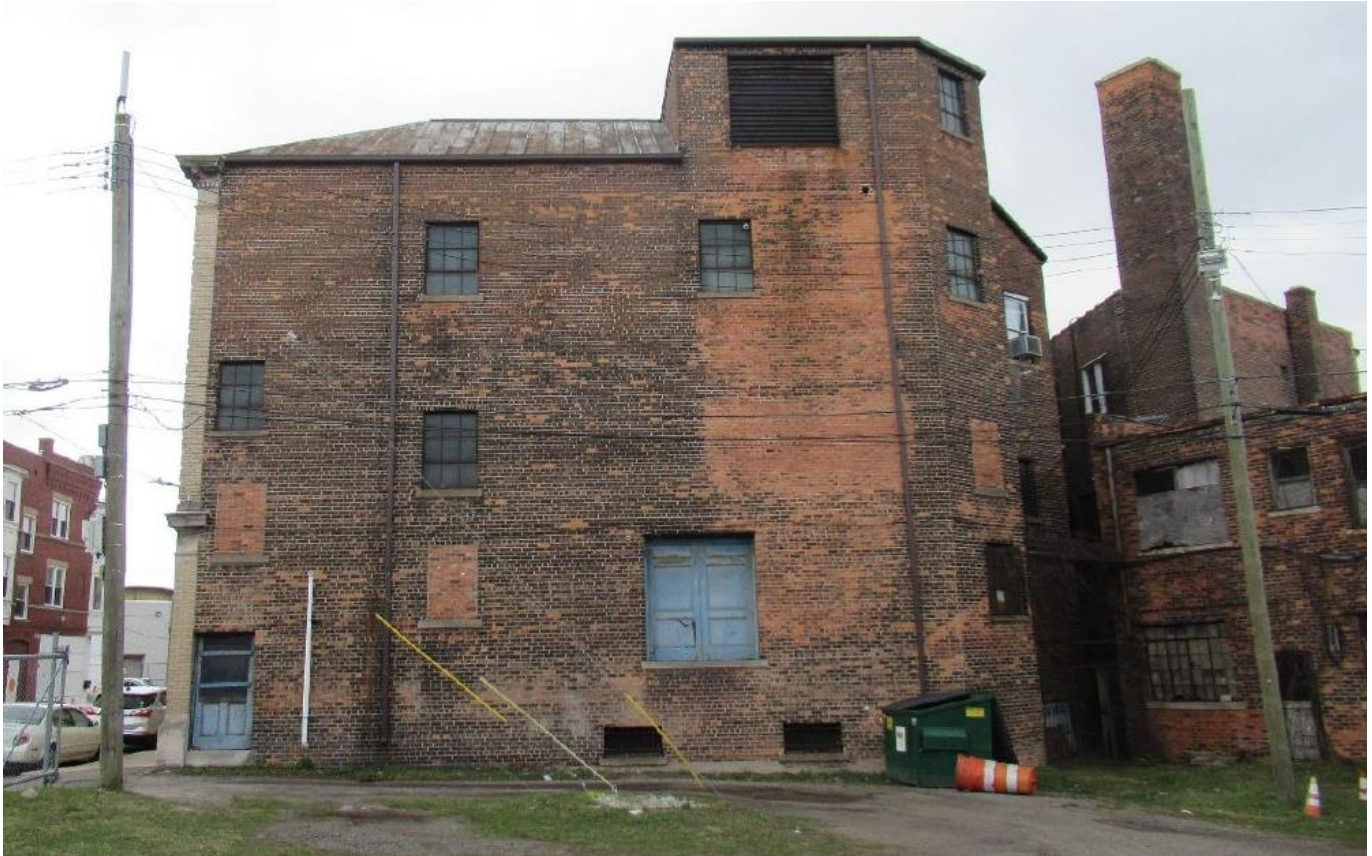
Rear (southeast) elevation. Photo from application documents.

- Window units on the rear façade of the building, facing vacant property to the east, are hot-rolled steel 6- or 9-pane factory style units with a central, pivoting sash and wire glass. These windows appear to be original, but have rusted muntins, sashes, and frames, and degraded glazing compound. Note that a full documentation of each steel window proposed for replacement at this

location was not included in the current documentation, so it is unclear if all of the units are deteriorated to an extent that merits replacement. Also, the proposed new windows do not match the existing in operation or light configuration. Therefore, staff does not recommend approval of this scope item.

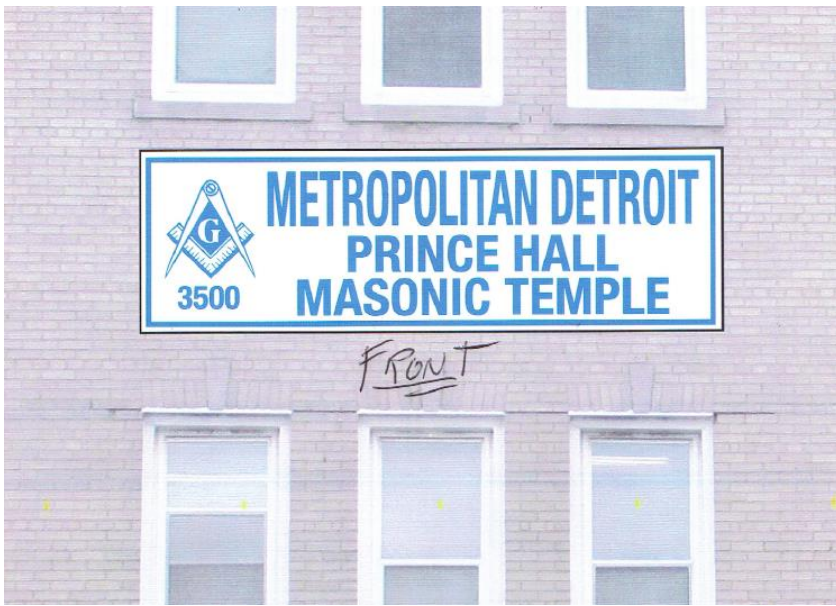
Proposed Gratiot sign. Image from application.

It is staff's opinion that the proposed signage does not meet the HDC's guidelines as the LED sign is not compatible with the design theme and use of materials on the building and the two static signs are proposed to be installed in a location which is oriented towards motorists, well above the first story storefronts. Staff has therefore forwarded the proposal to the Commission for review.

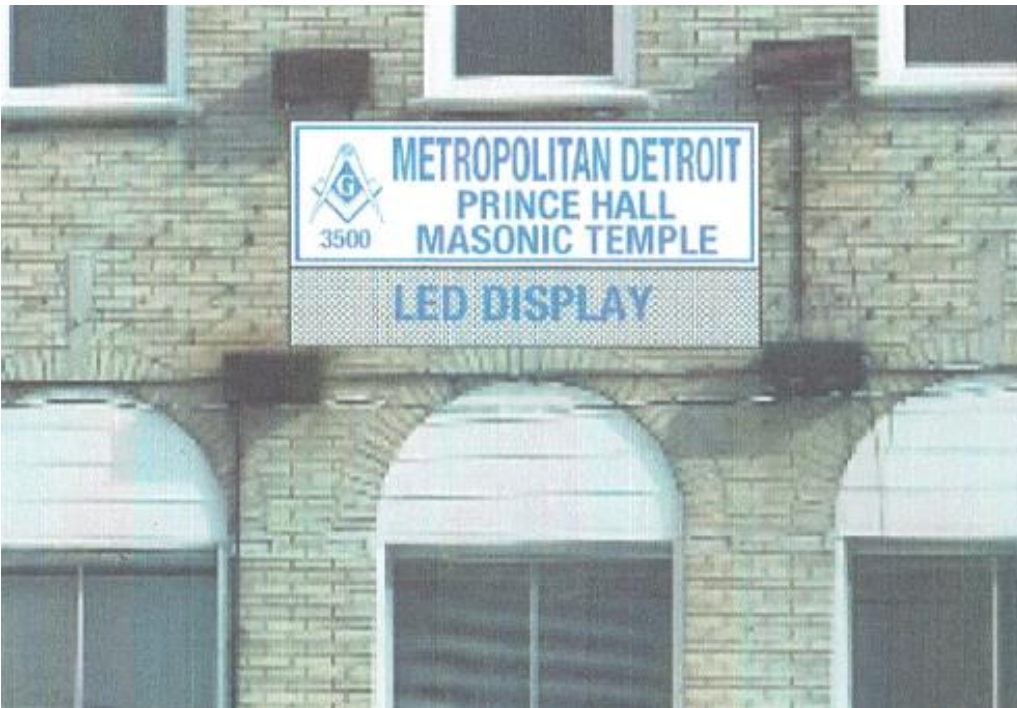
Proposed McDougall sign. Image from application.

- While the proposed LED display would not obscure significant features of the historic building, could be attached to the building carefully to avoid damage, and is relatively small in scale, it does not meet the NPS guidance nor does it meet the district's Elements of Design because it is incompatible with the building's historic materials, textures, and colors material. Staff therefore recommends denial of this scope item.

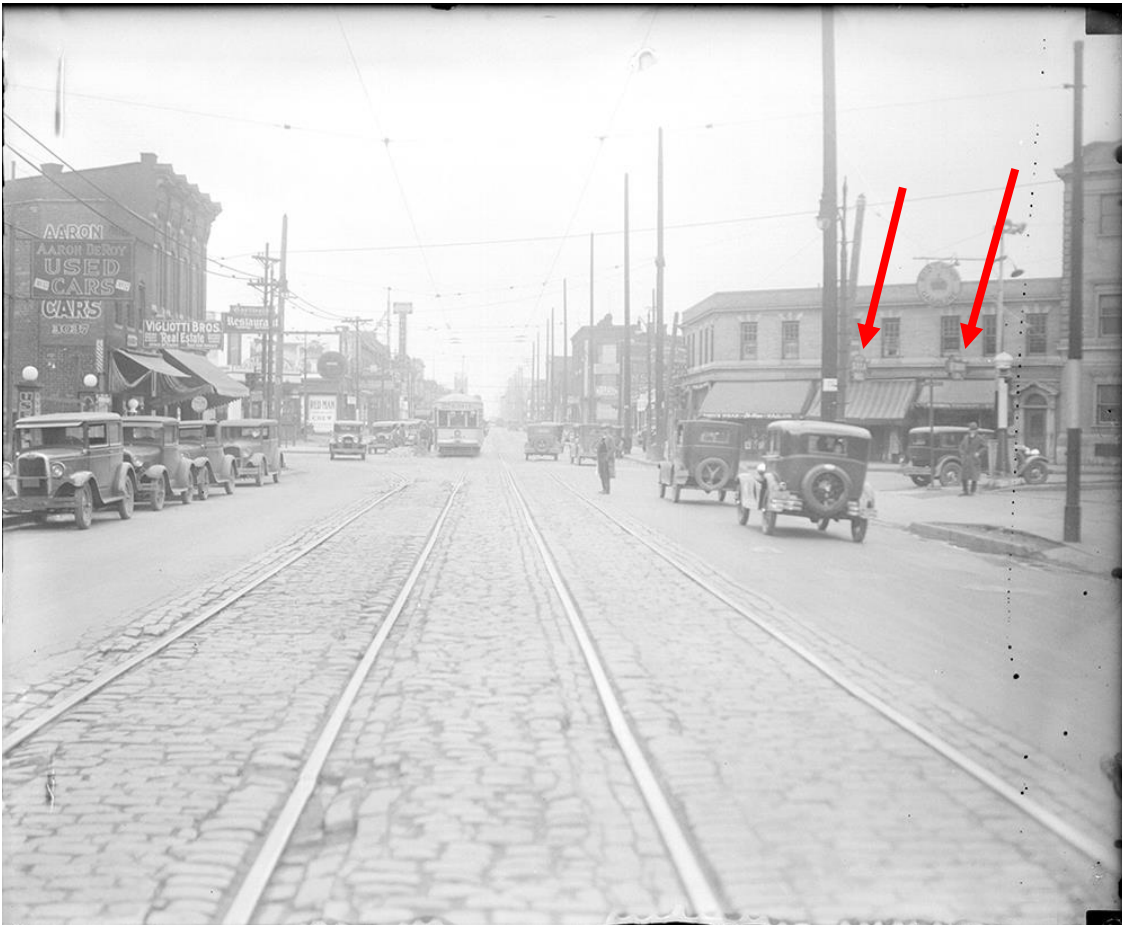
Uncredited 1920s photo provided by the applicant. A single bay of the 1924 building is visible at the far right edge of the photo. The two-story portion of the building shown was demolished when Gratiot Avenue was widened. However, note the location of signage as indicated by the red arrows.

- Per the above provided historic photograph, signage was located in the masonry cornice, above the storefronts in the original Gratiot-facing wing. While this historic location suggests that new signage is best located at the masonry cornice above the first-story storefronts at the current Gratiot-facing façade, staff does recognize that the affixing of new signs to this distinctive architectural detail would not be appropriate.

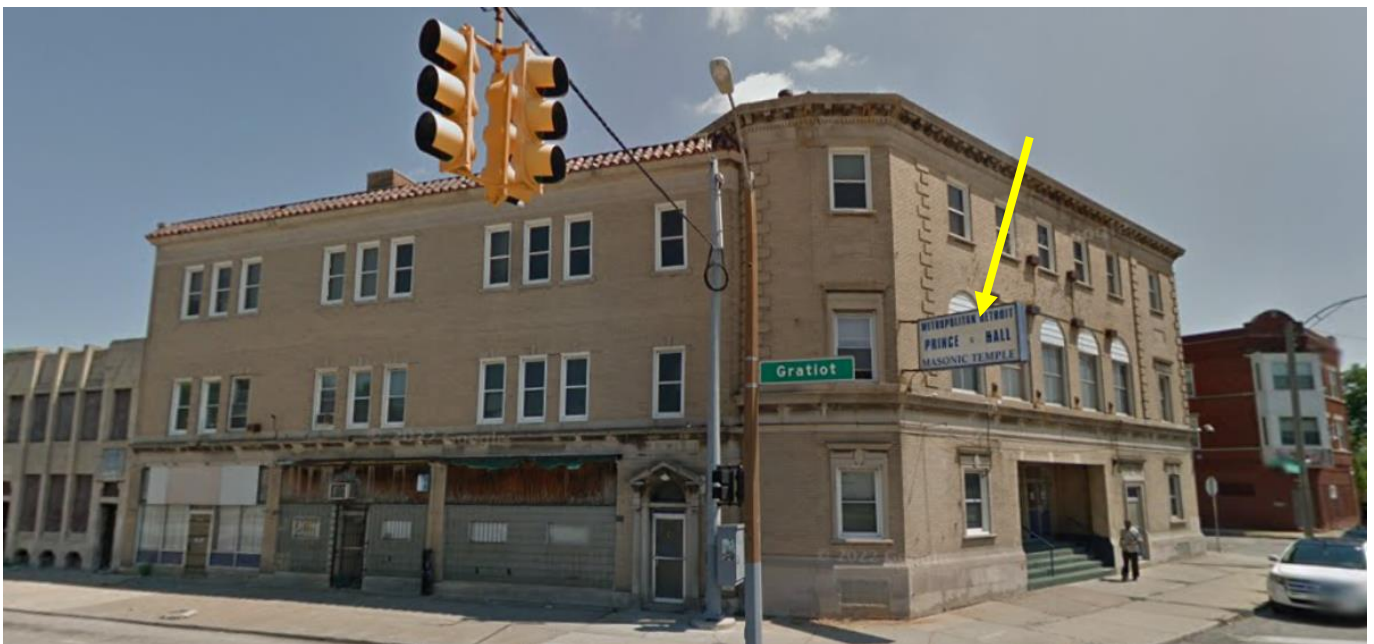
- Note that a non-historic age blade sign which existed at the building's northwest corner of the building was removed sometime between 2015 and 2017, prior to the building's designation (see below image).

Non-historic blade sign at northwest corner (indicated by yellow arrow), 2015. Google Streetview

- It is staff's opinion that the installation of new signage at the northwest corner of the building, within the same area as the sign depicted in the 2015 Google Streetview image, would be the most appropriate location as it would be oriented towards pedestrians and would not obscure distinctive architectural features. The proposed location of two new **static signs** above the second-story windows at the Gratiot and McDougall facing facades would be acceptable, in staff's opinion, as each sign is moderately sized, would not obscure or alter character-defining features of the building, and is compatible in material.
