STAFF REPORT: APRIL 9, 2025 MEETING **PREPARED BY:** D. RIEDEN, T. BOSCARINO AND A. DYE
APPLICATION NUMBER: HDC2024-00626
ADDRESS: 1101 CHICAGO
HISTORIC DISTRICT: BOSTON-EDISON
APPLICANT: VICTOR SMOLYANOV, SMOLYANOV HOME IMPROVEMENT
PROPERTY OWNER: GRACIE BROWN
DATE OF PROVISIONALLY COMPLETE APPLICATION: OCTOBER 22, 2024
DATE OF STAFF SITE VISITS: NOVEMBER 27, 2024; FEBRUARY 28, 2025; MARCH 25, 2025
SCOPE: REPLACE CLAY TILE ROOF WITH ASPHALT SHINGLE ROOF

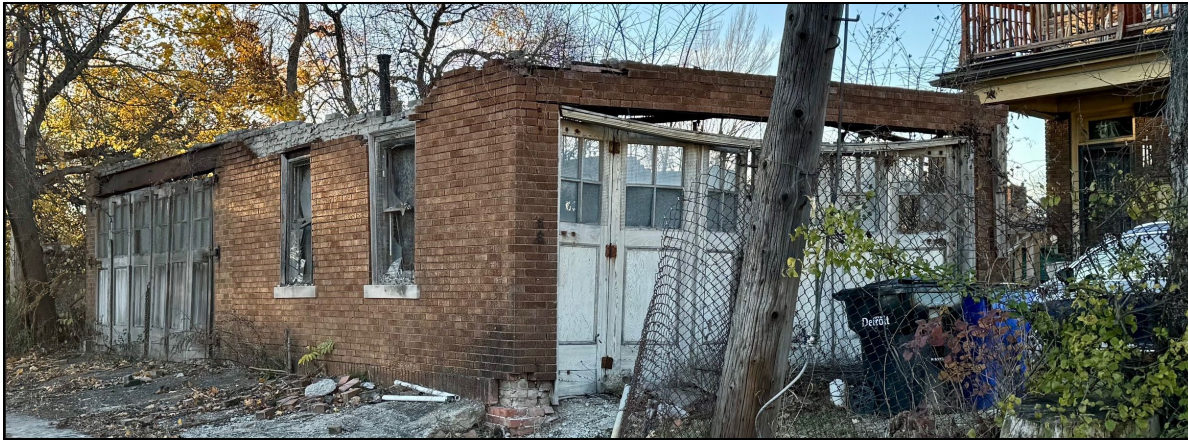
Garage viewed from Hamilton, facing northeast. November 2024 photo by staff.

Also present on the property is a garage (see photos above). At the time the Boston-Edison Historic District was established in 1974, the garage had a hip roof with green tile matching that of the house. The garage roof has since collapsed. There are no Historic District Commission approvals or other records associated with the garage.

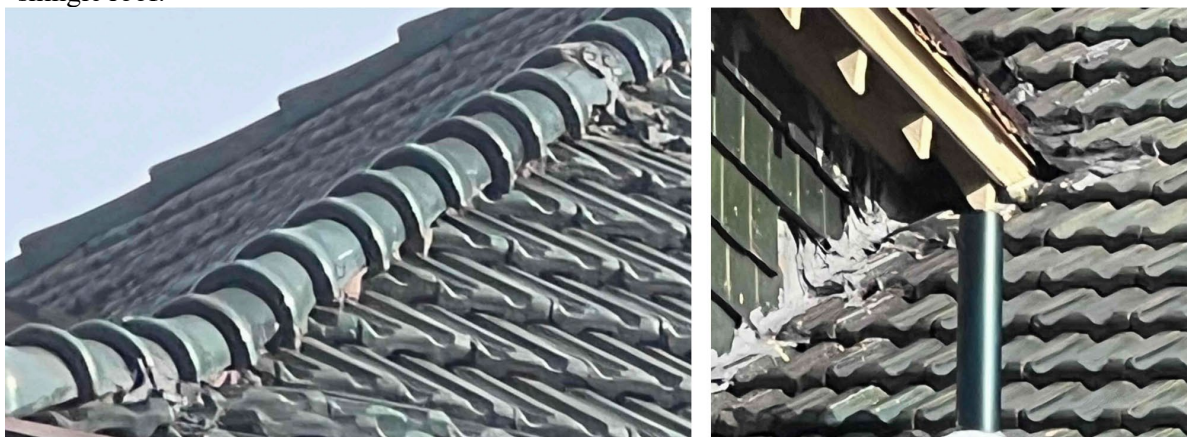
- The submitted application includes photos of the roof. The photos show some missing and loose tiles, particularly at junctions with dormers and where pantiles (curved tiles) complete the seams of the hip roof. However, the photos were taken from ground level and do not clearly show the condition of the roof. There is no indication that the damaged areas are numerous or beyond repair. Further, the planar surfaces of the roof appear to be intact.

Photos, from application documents, showing loose tiles and patched areas. Flat green tiles clad the dormer walls.

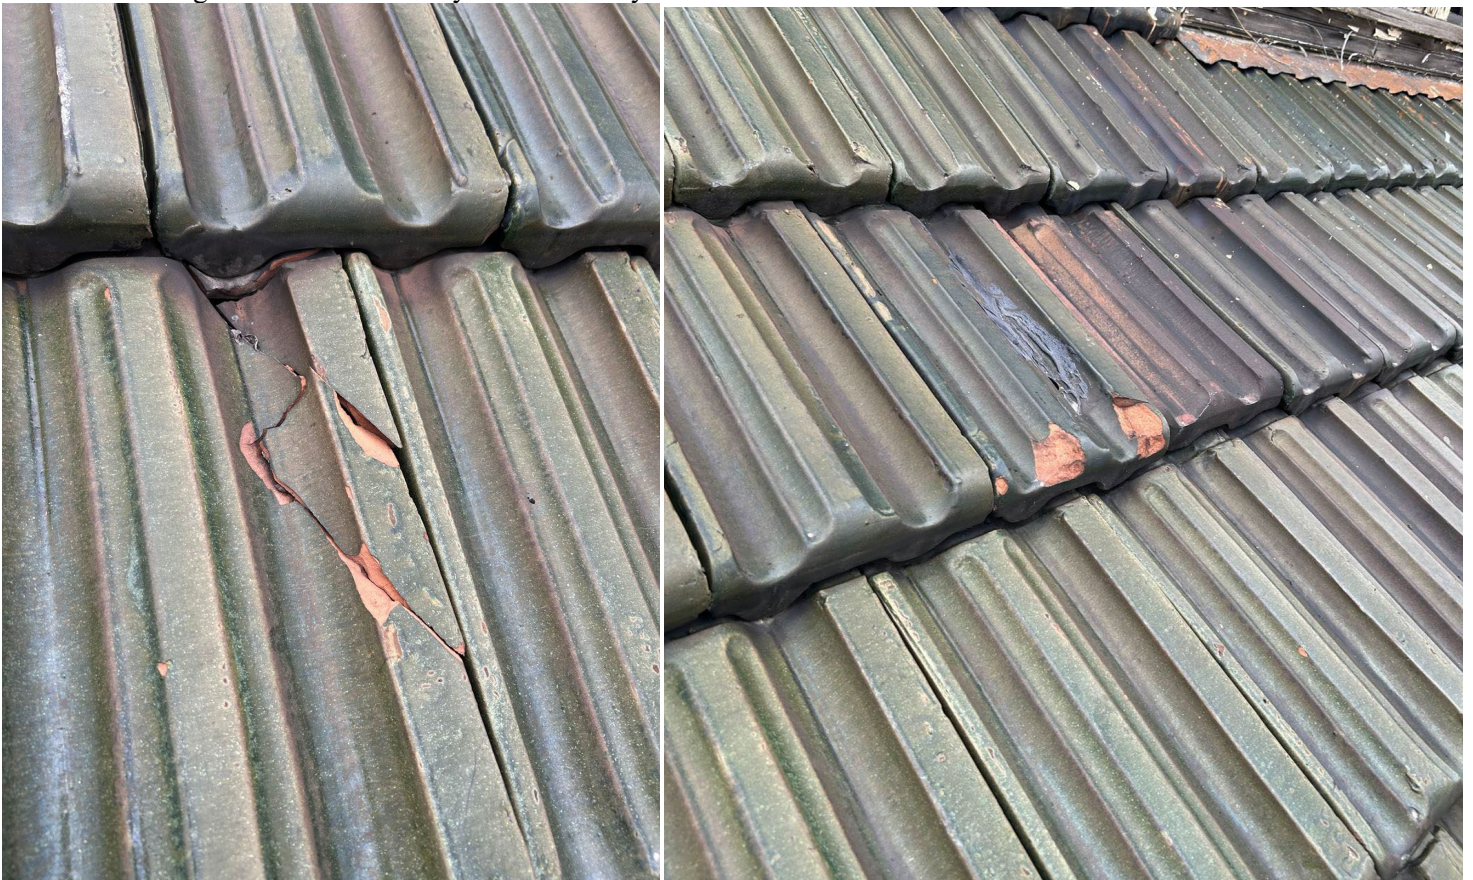
Applicant photos of cracked tiles.

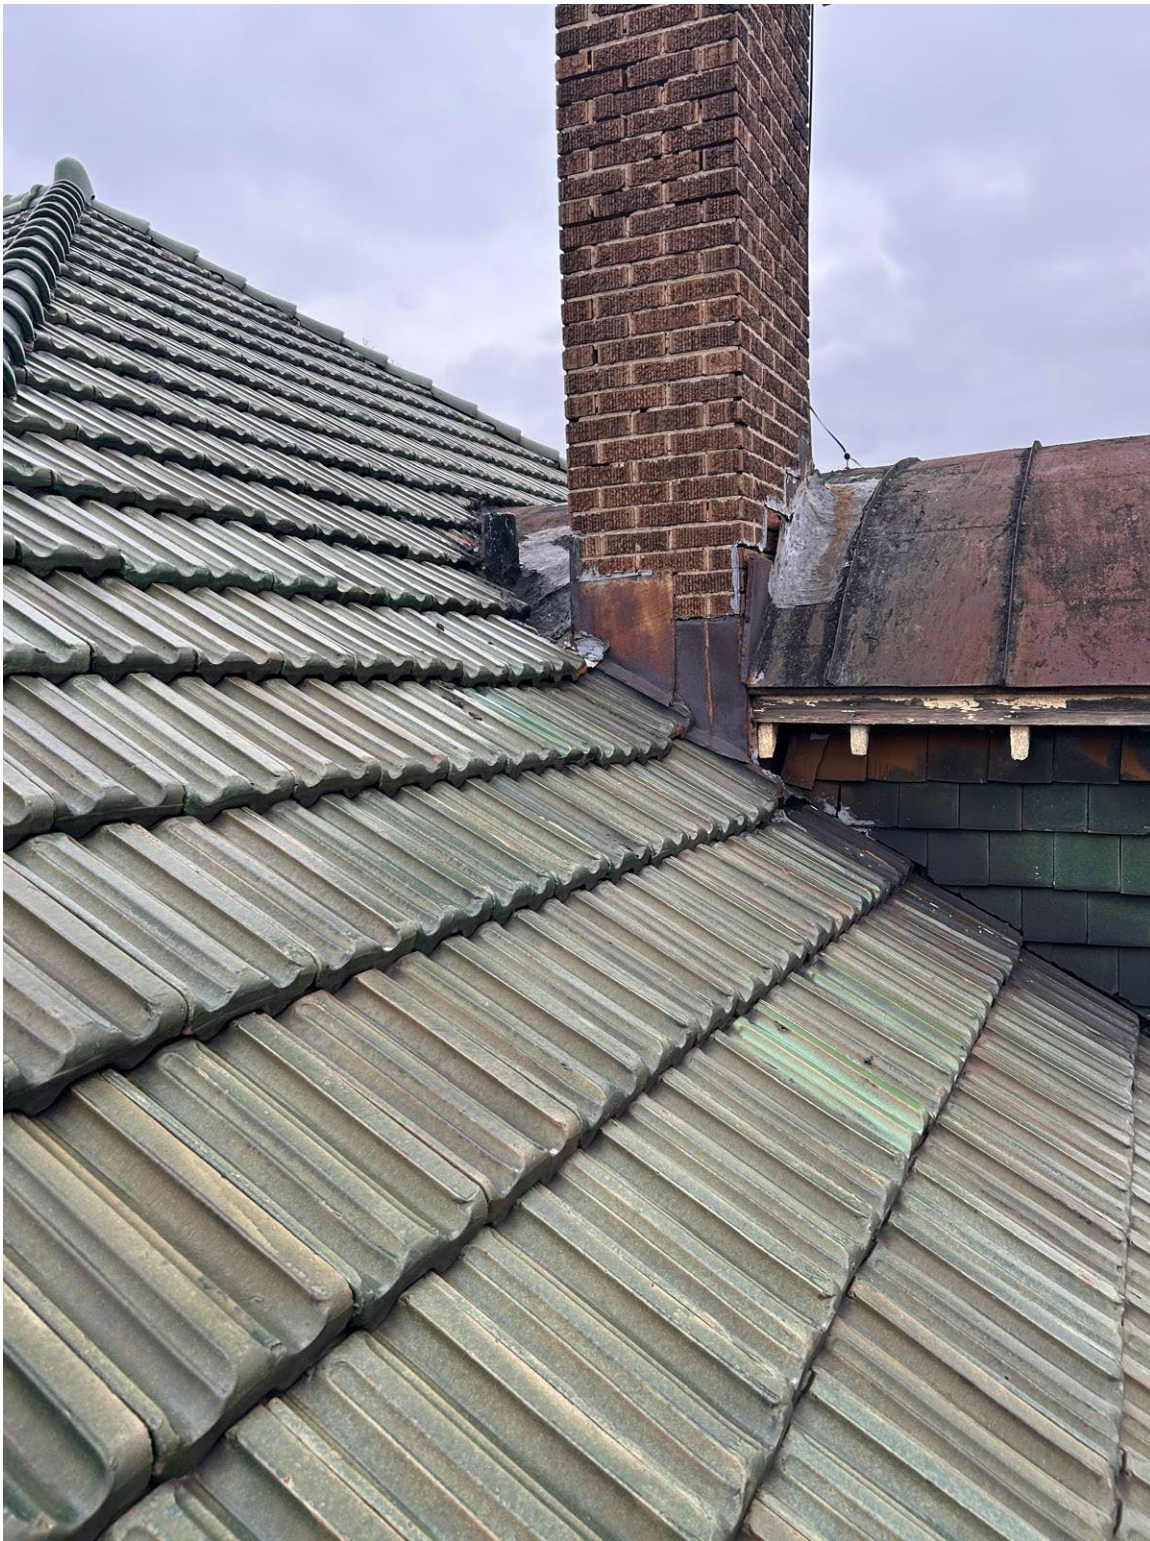
Applicant photo, flat green tiles at dormer wall are visible. The flashing at the chimney appears to need replacement.

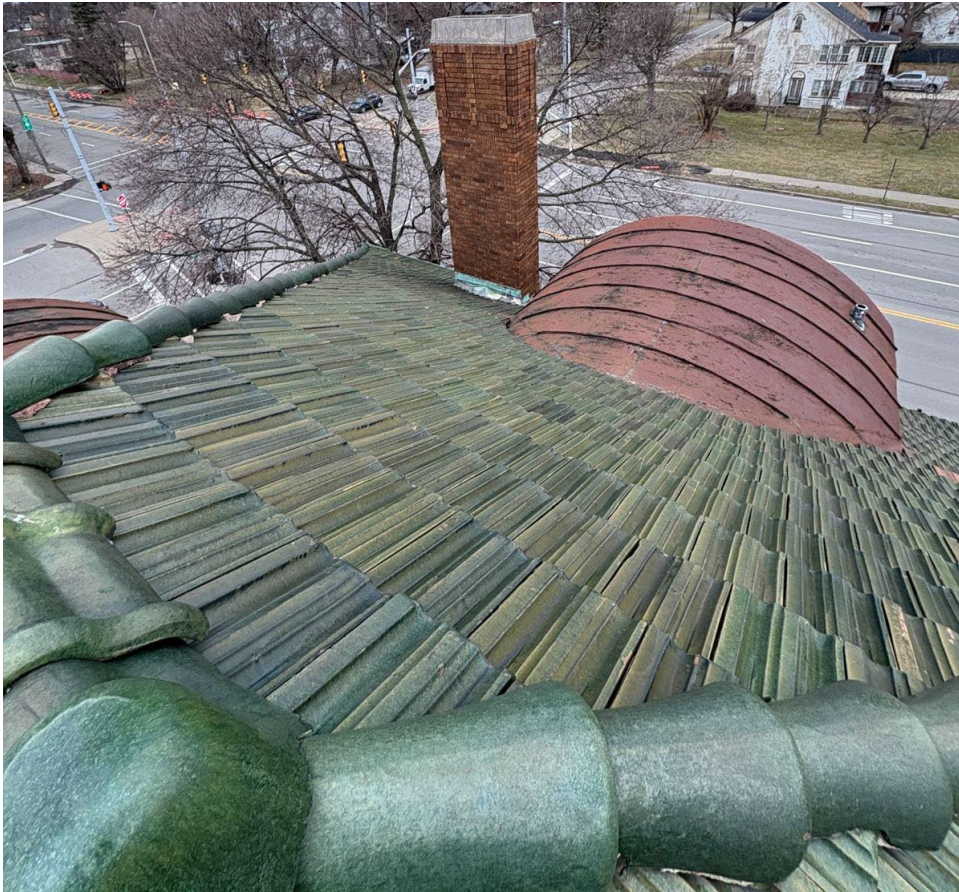
Applicant photo. View of east-facing roof, looking toward the Chicago and Hamilton intersection. The ridge and hip trim pieces appear to be in great shape.

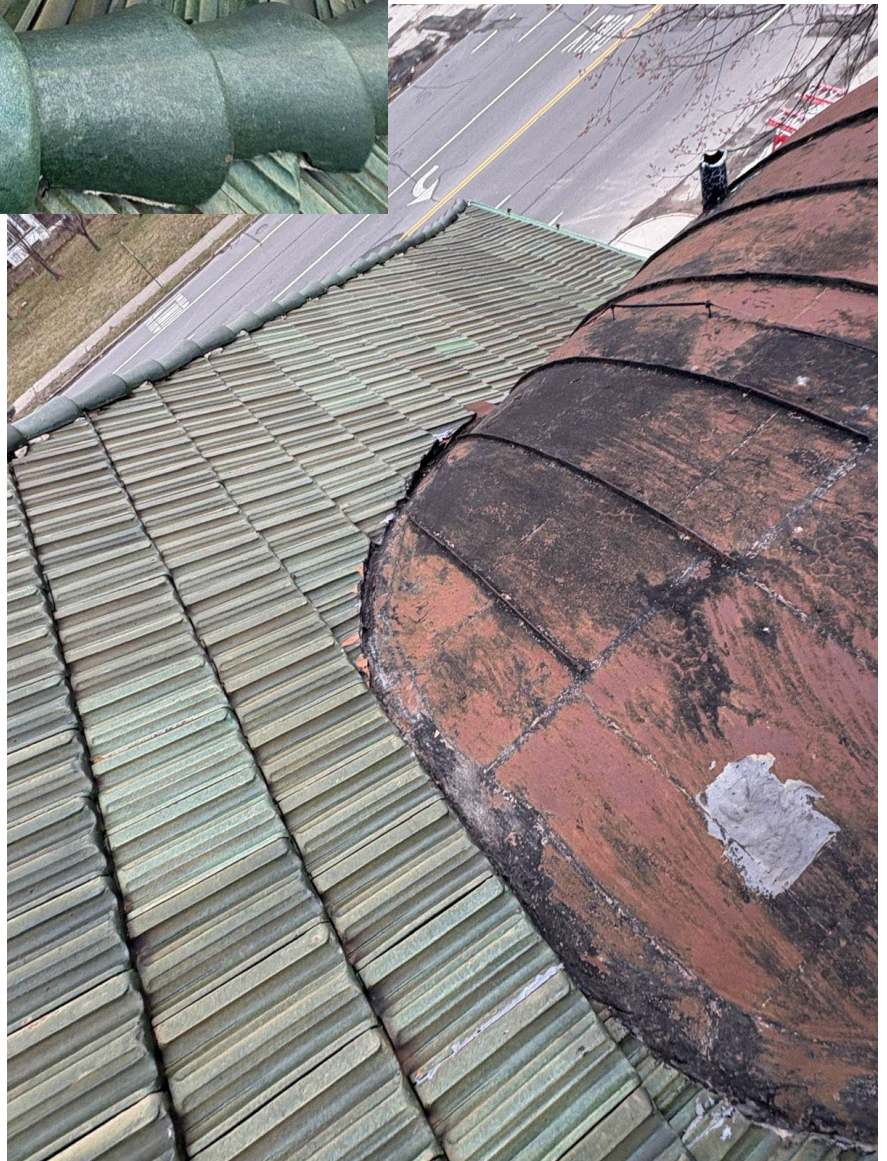
Applicant photo. This view captures a portion of the rear/south roof, which is also shown on the following page. The surfaces in most need of repair are the areas where the dormer roofs meet the tiles, as well as the standing seam metal covering the dormers.

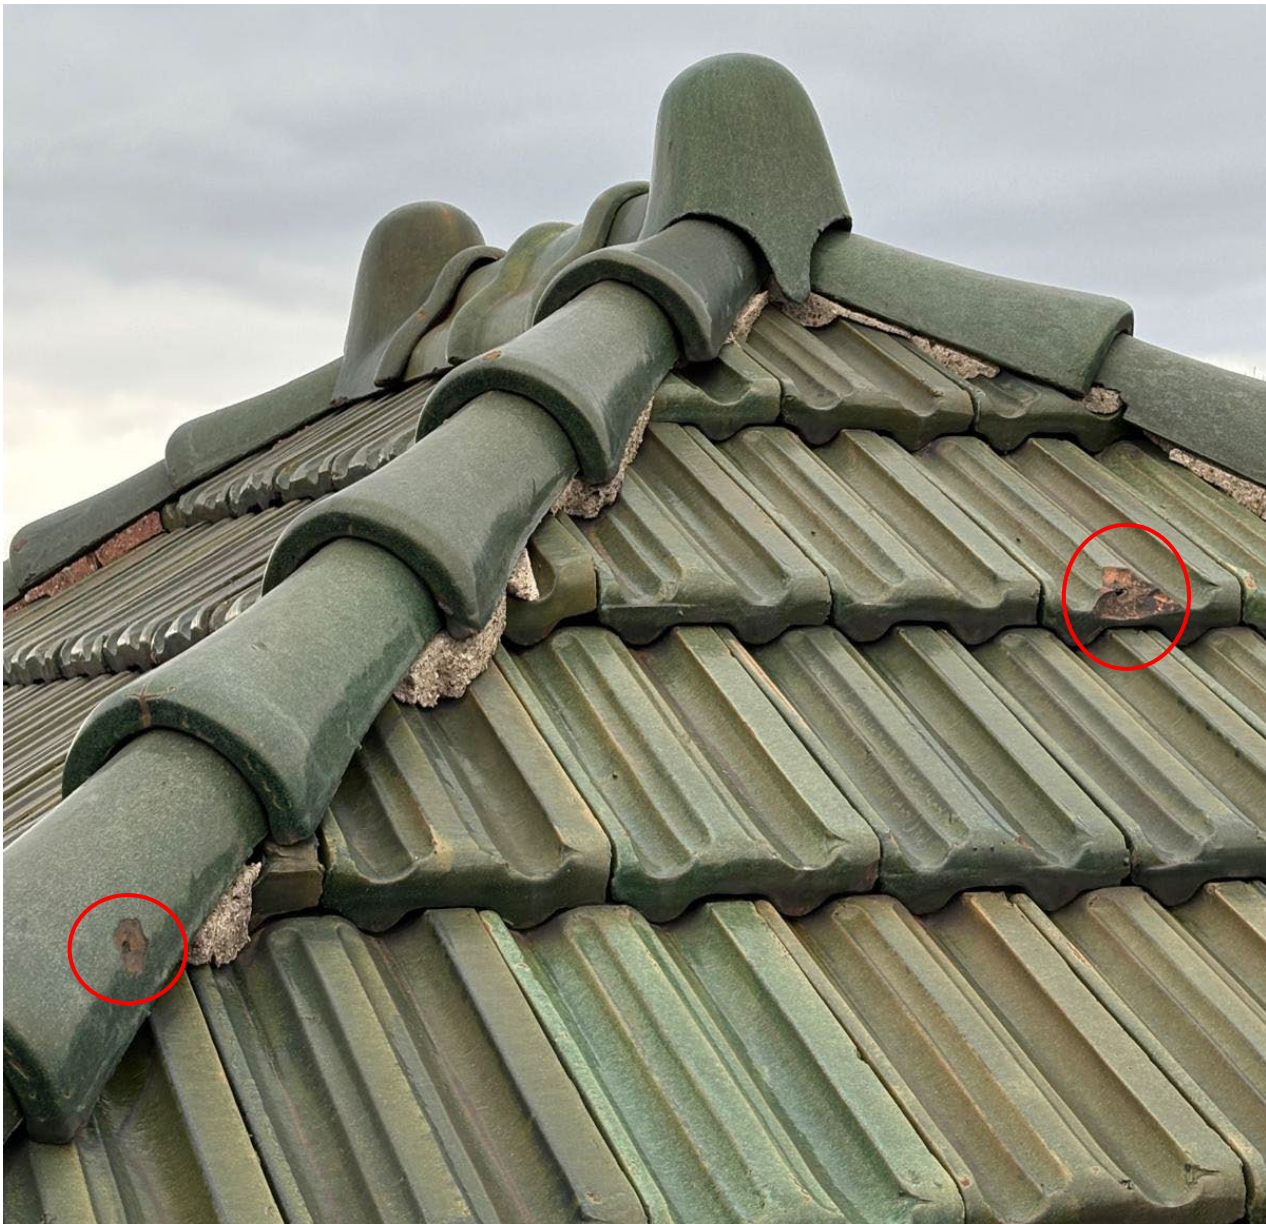
This is a view of the highly dimensional top of the roof. Within this expanse of tile, it appears there is one tile with a broken edge, and one ridge cap with a chipped finish.
