**STAFF REPORT:** APRIL 9, 2025 MEETING  
**APPLICATION NUMBER:** HDC2025-00054  
**VIOLATION NUMBER:** 25-981  
**ADDRESS:** 1760 WABASH

**HISTORIC DISTRICT:** CORKTOWN

**SCOPE:** INSTALL LAP SIDING (WORK COMPLETED WITHOUT APPROVAL), ADD DETAILS TO HISTORIC AND NEW GABLE WALLS, INSTALL WINDOW AND RESIZE EXISTING WINDOWS ON FAÇADE, REBUILD WINDOW CASINGS-ALL SIDES, REMOVE SIDING FROM CHIMNEY

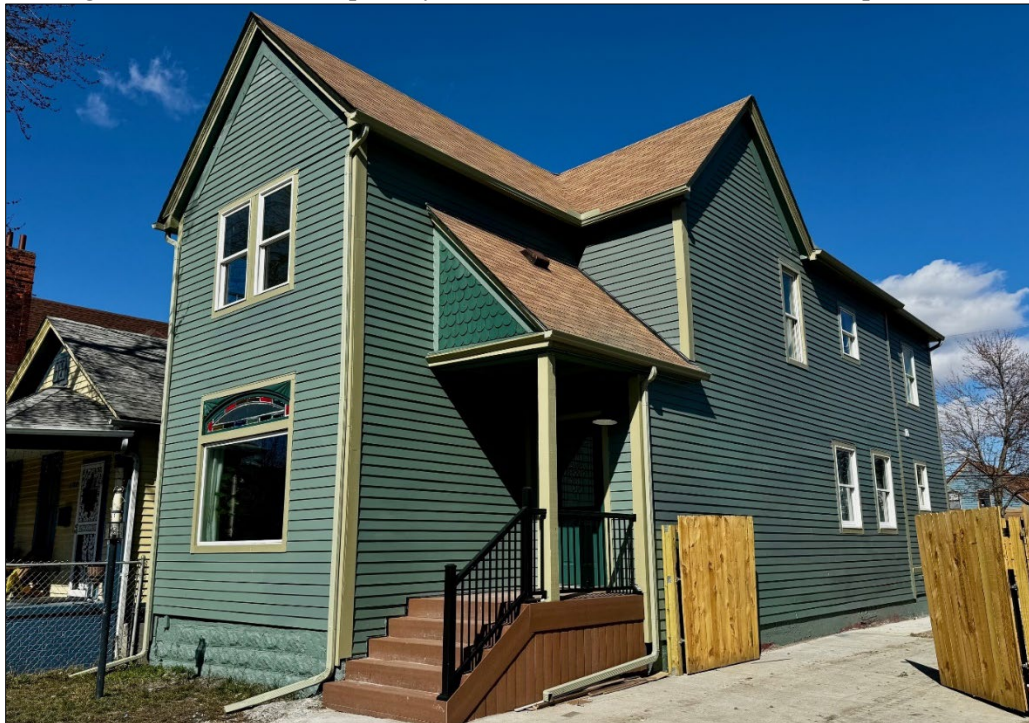
*Staff photo of front and side (south) walls. March 26, 2025.*

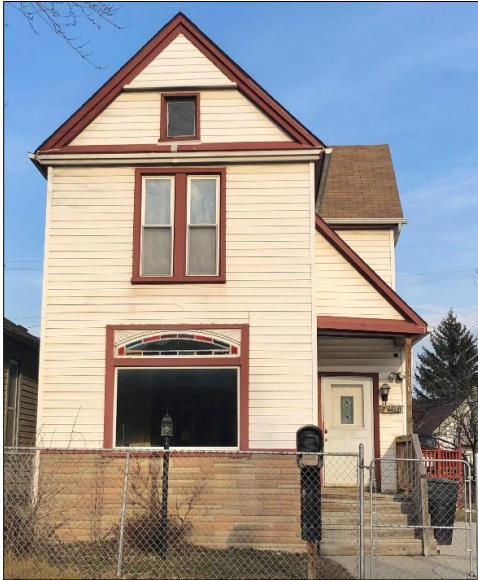
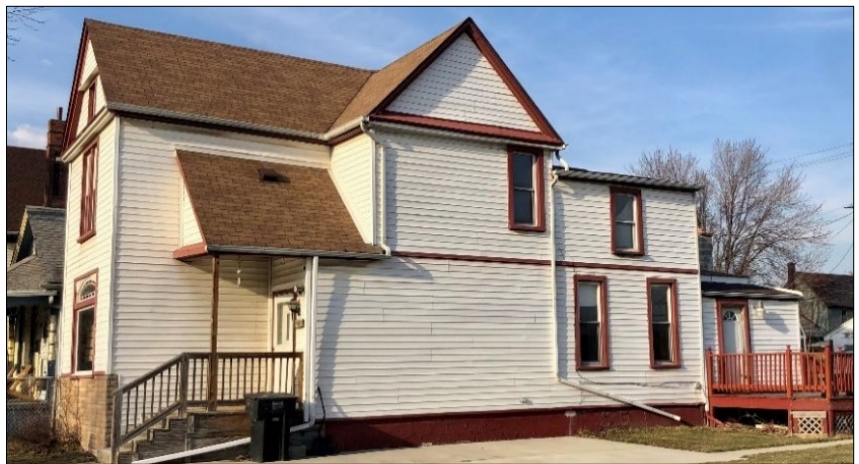
*Left and above: Existing conditions at the time of the Commission's first review of the property (24-00031, March 13, 2024 mtg.). Vinyl siding covered the walls and the windows were trimmed in aluminum coil. Staff photos, February 21, 2024.*

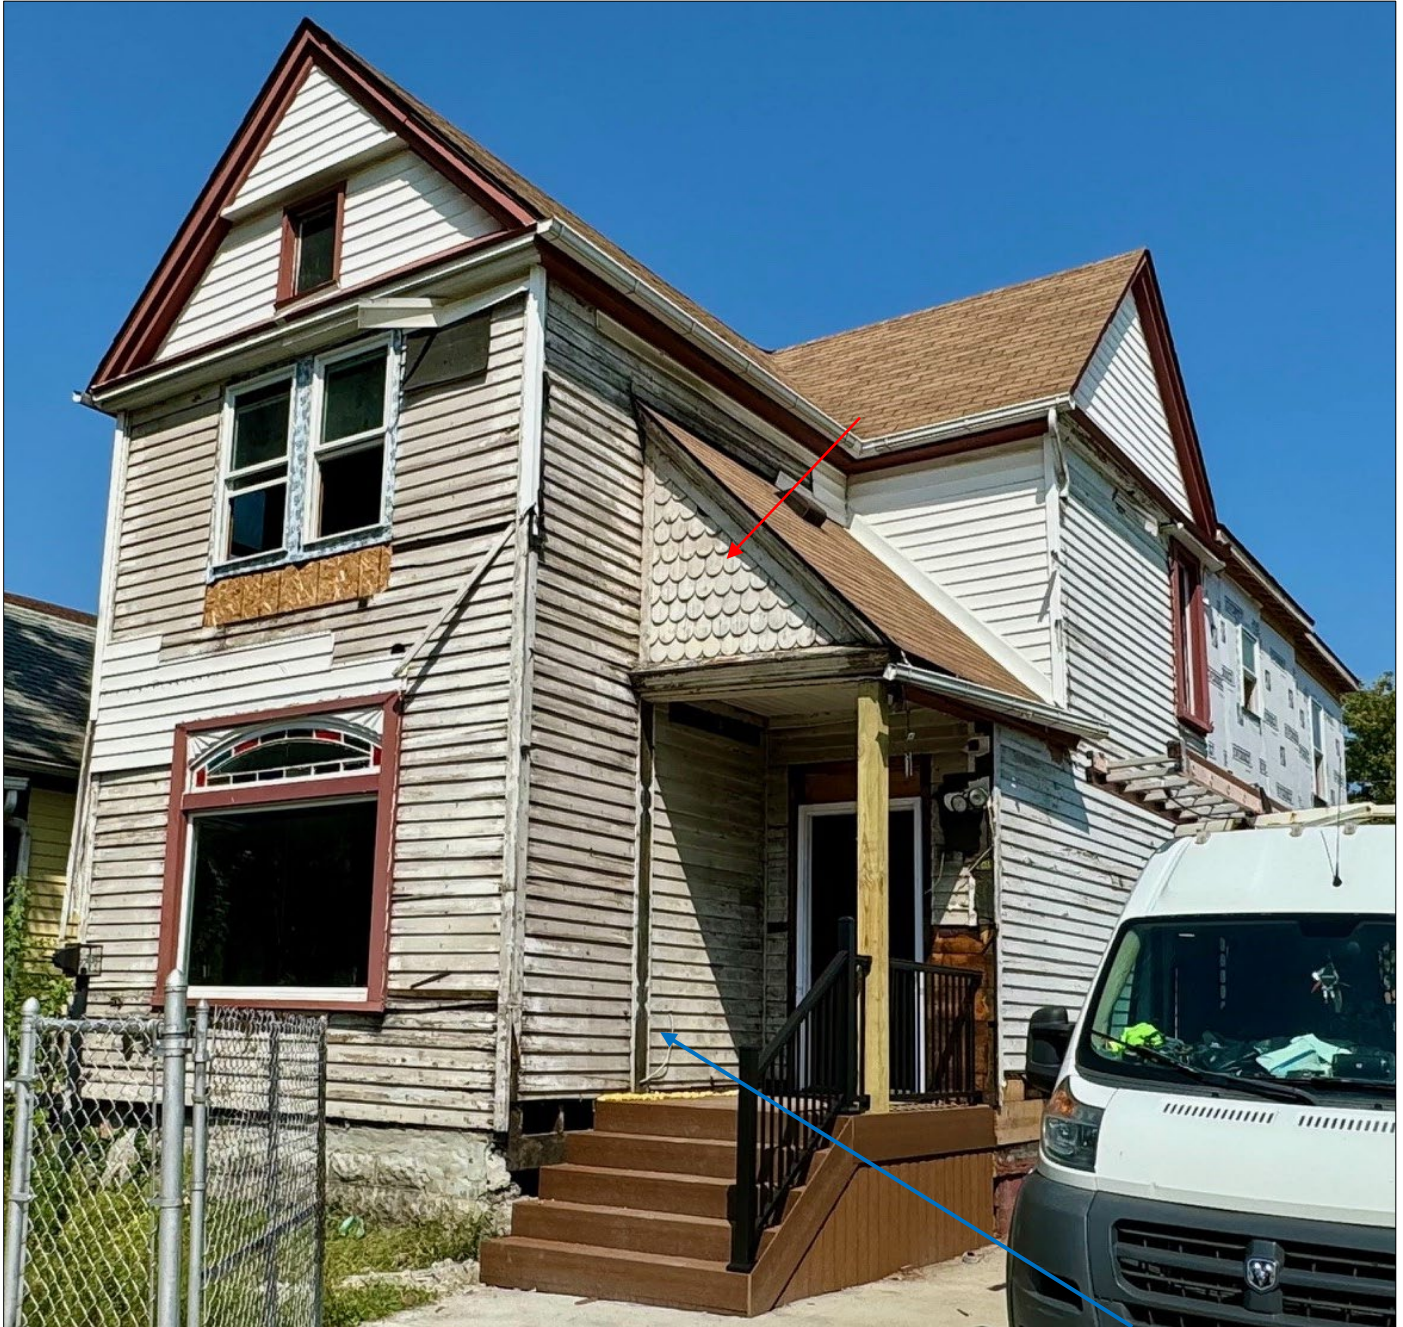
*Front and side walls. Notice the scallop siding that was uncovered at the porch (red arrow), as well as the ghost image/profile of the original porch post against the house's wall (blue arrow). Staff photo, August 2024.*

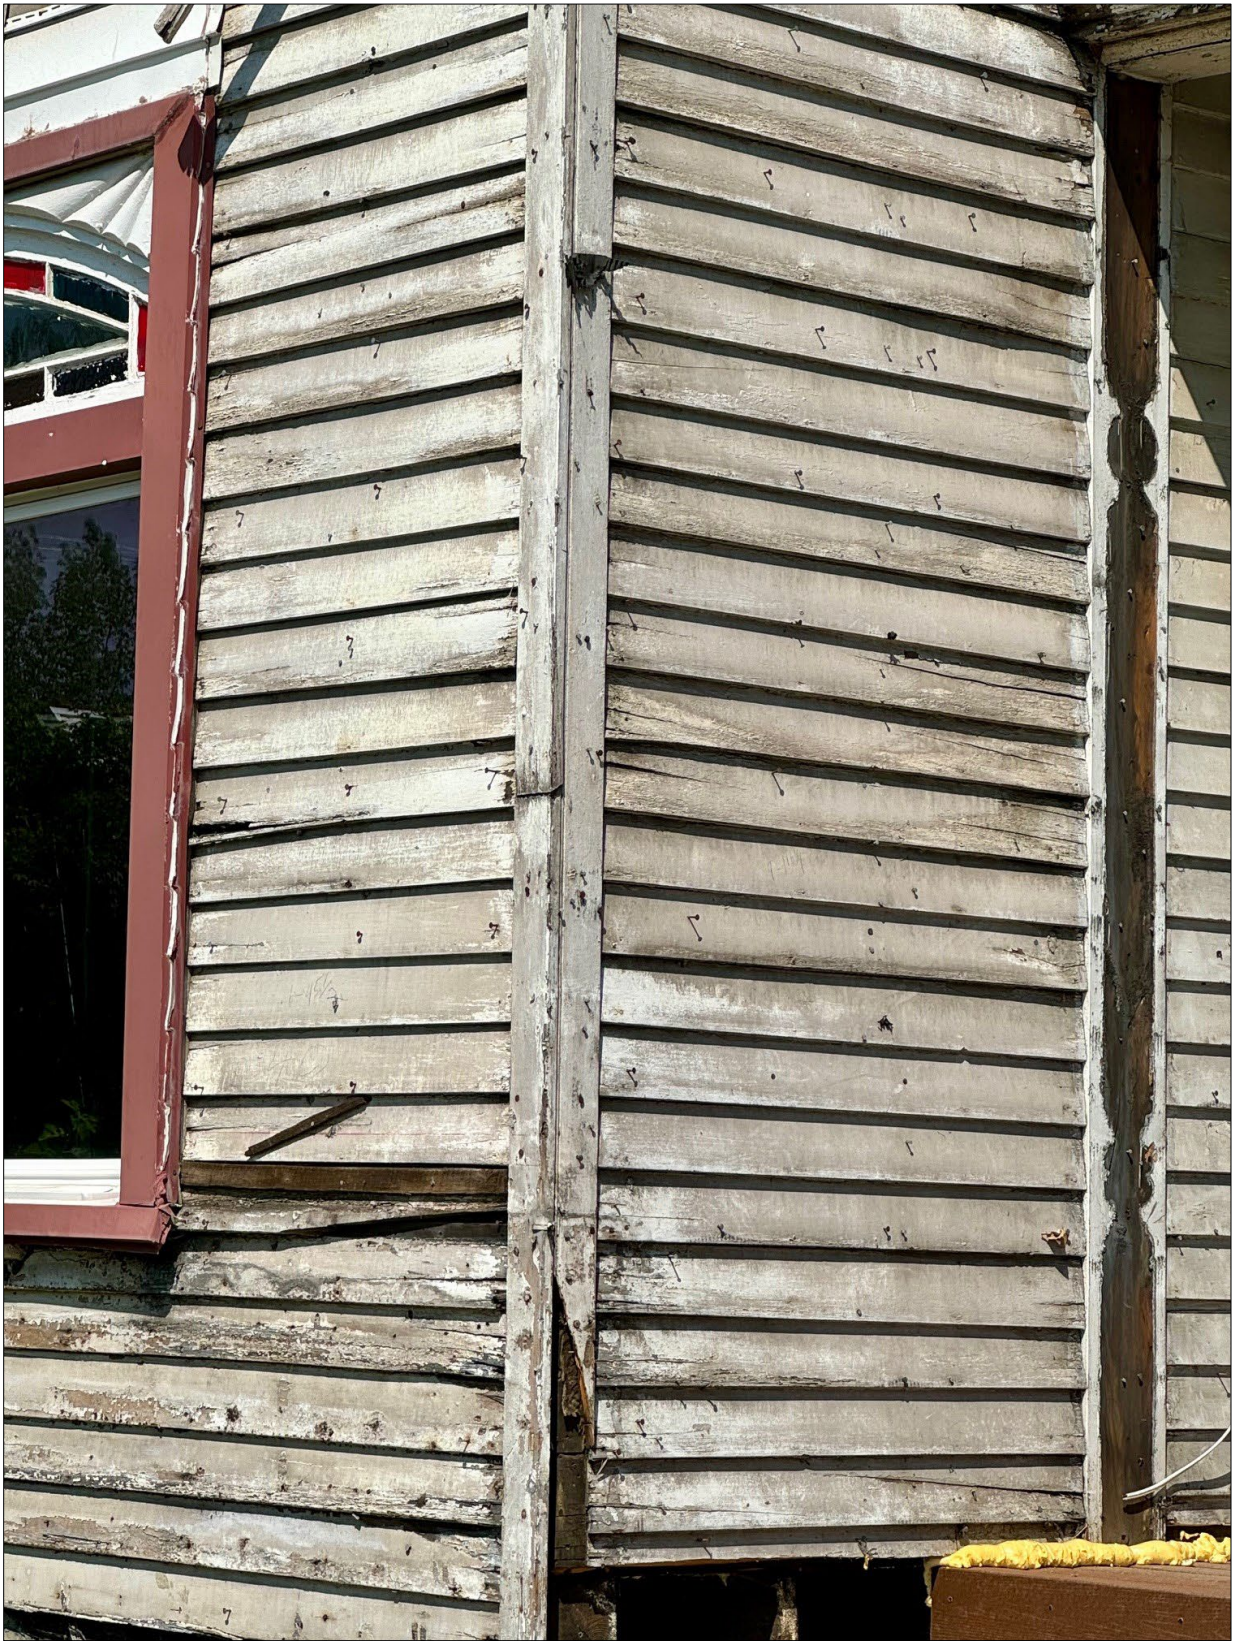
*This detail image of the southwest front corner of the house near the porch shows mostly intact lap siding with minimal deterioration (repairable deterioration is most evident where the lap siding met the corner boards). The aluminum coil stock remains on the windows casings at the front window. Staff photo. August 2024.*

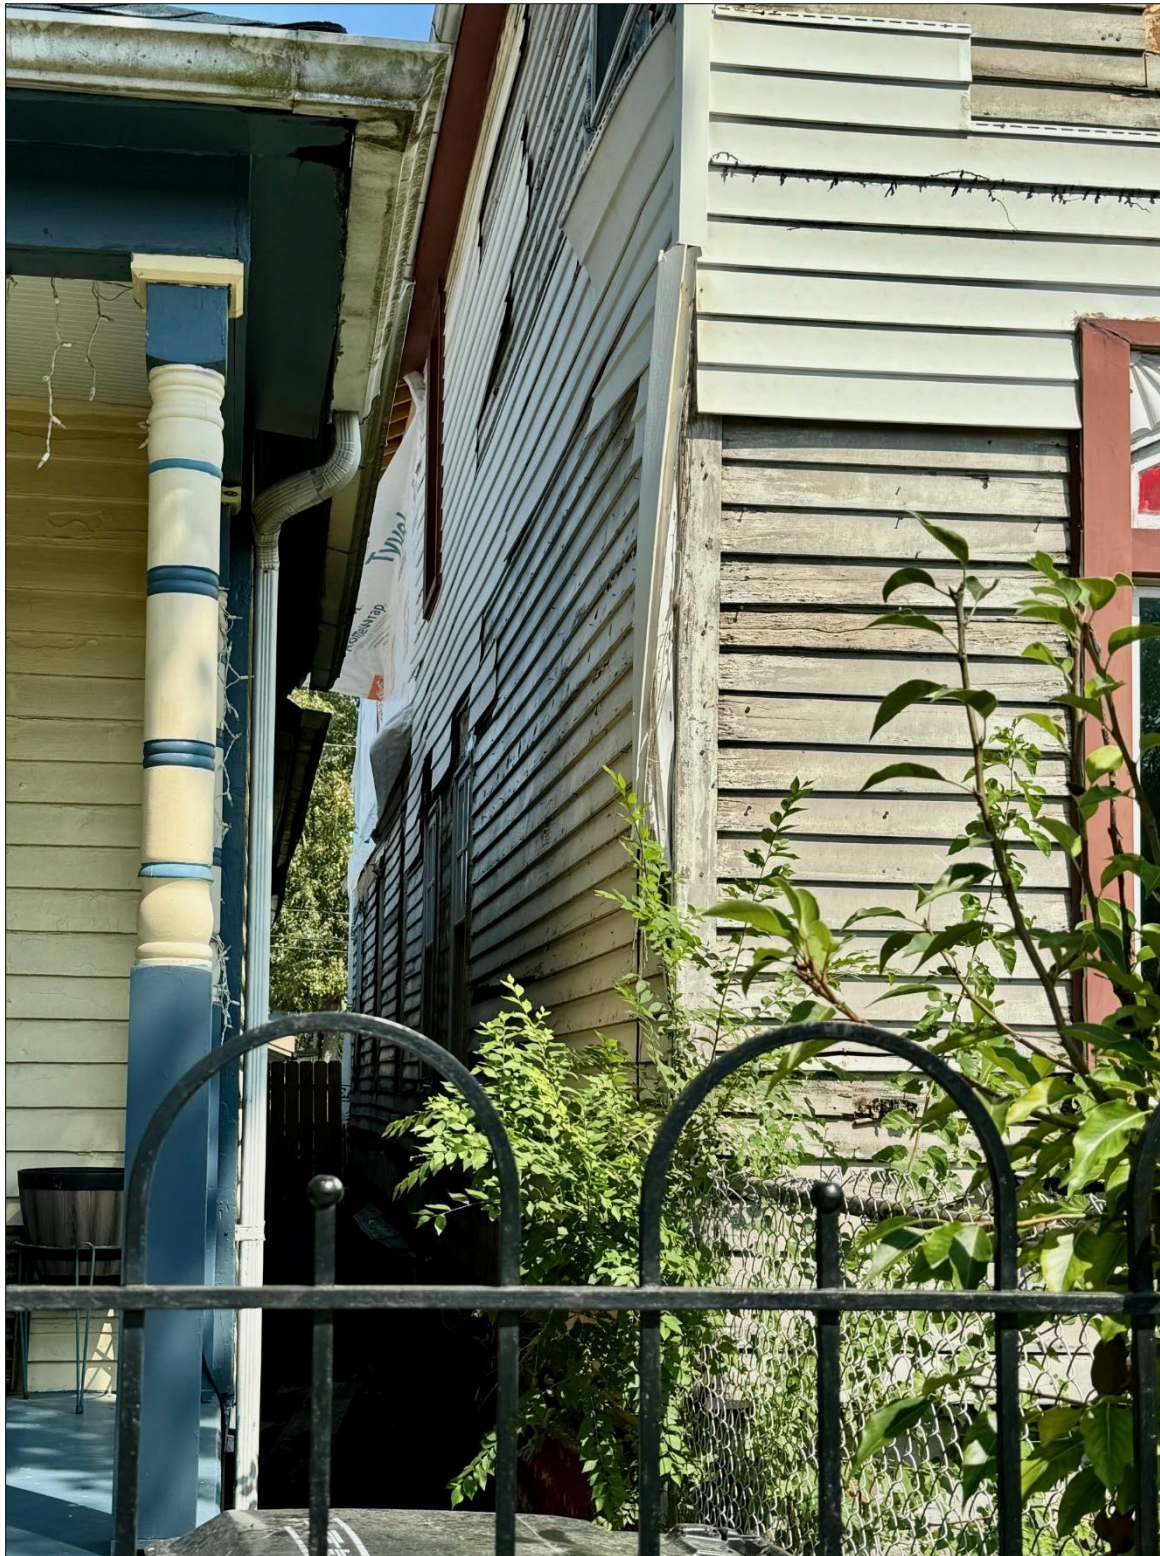
*This photo was taken from the sidewalk and shows the north wall of the house. Staff photo, August 2024.*

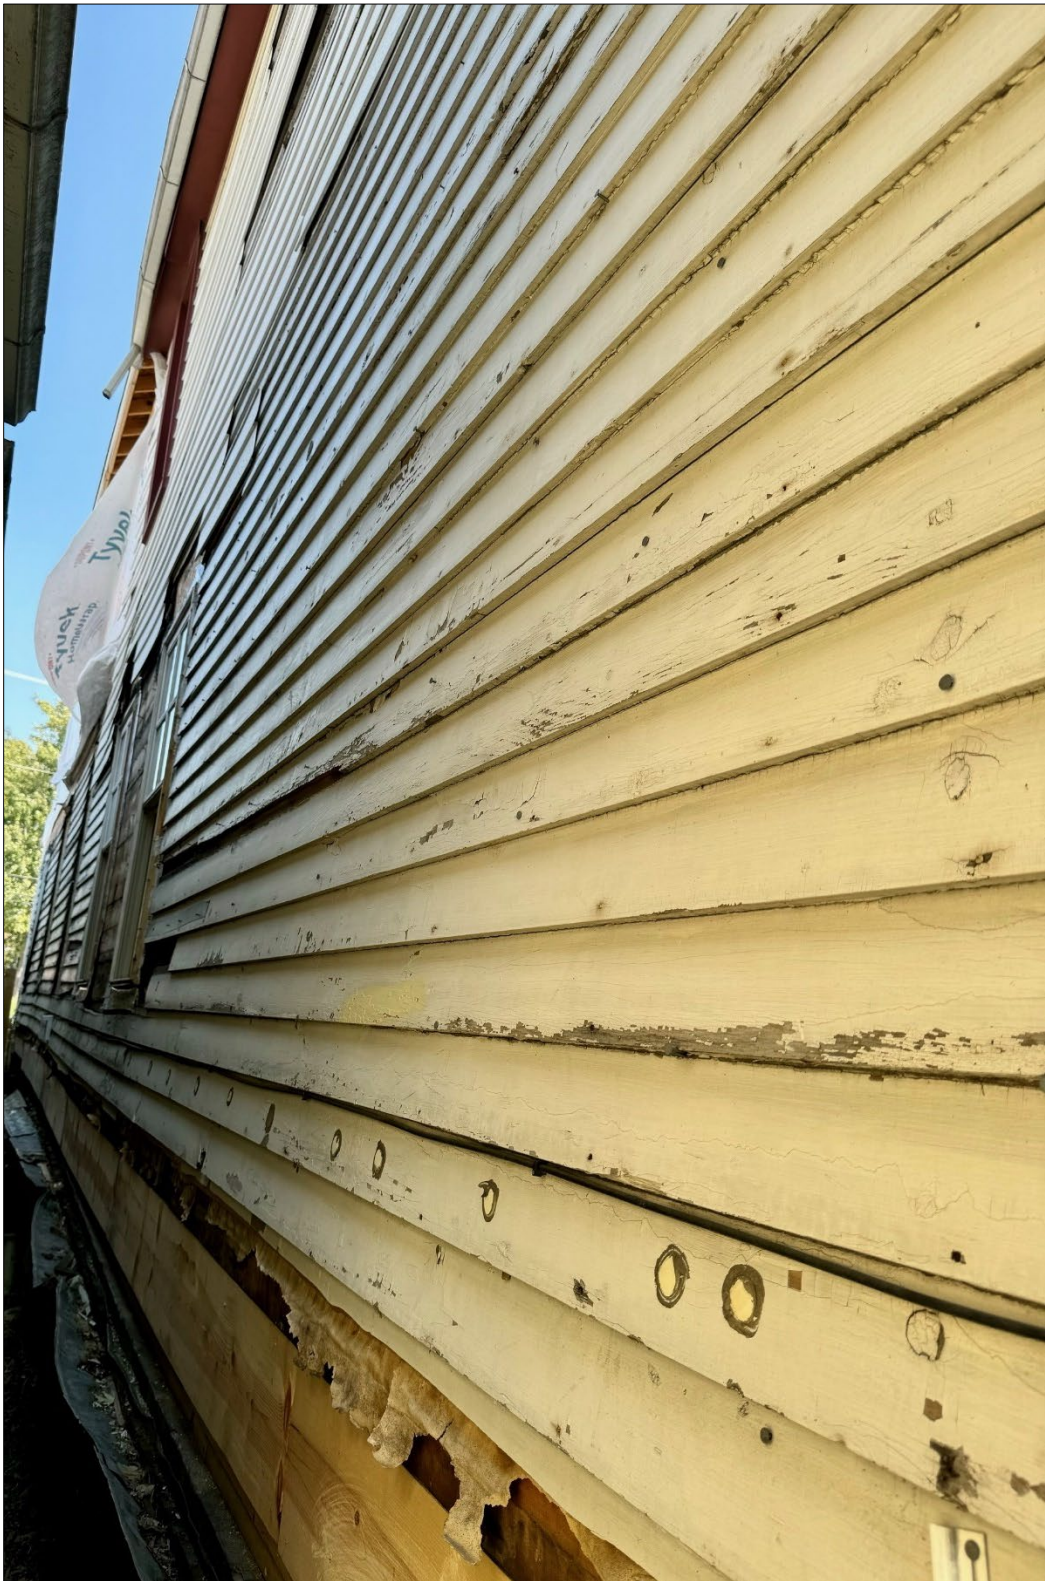
*Detail - north side wall. The contractor invited staff to closely inspect the lap siding; it was intact and in very good condition. Staff photo, August 2024.*

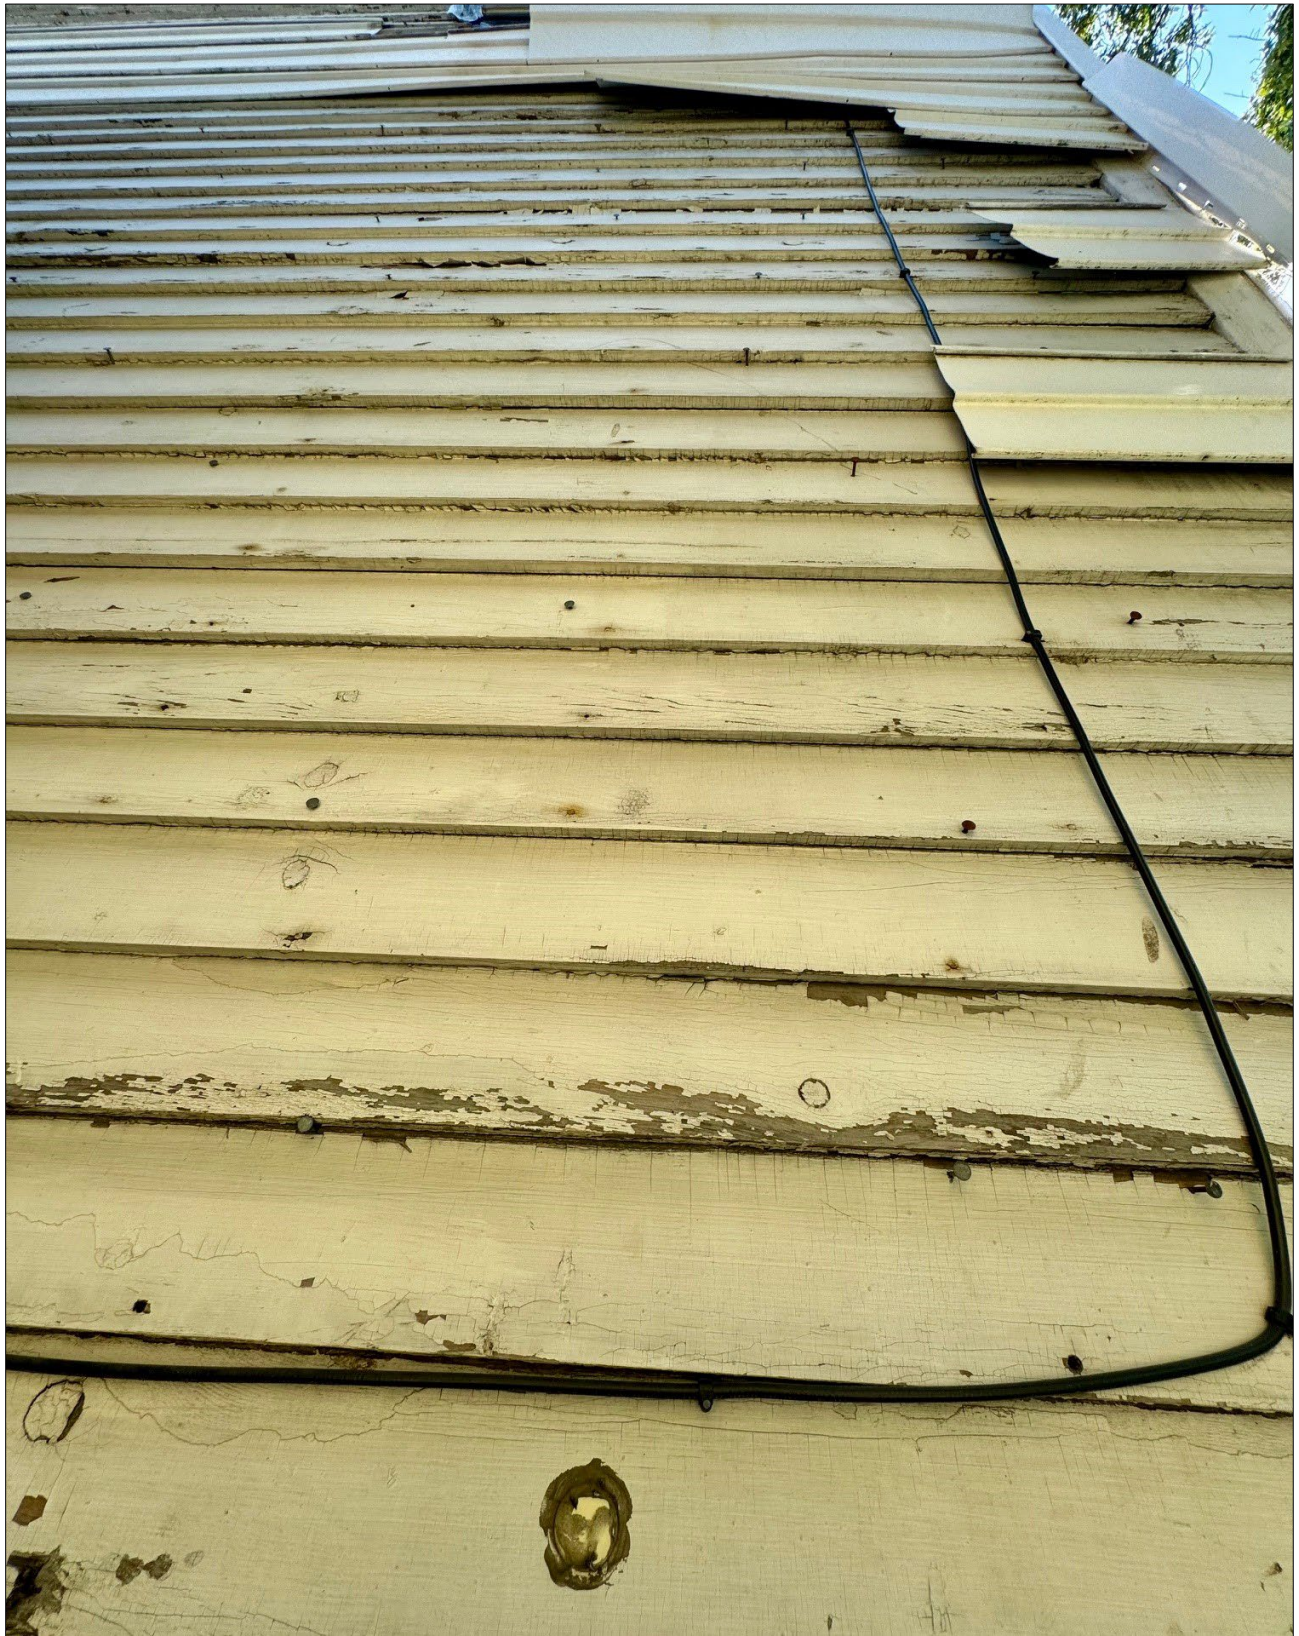
*Another partial view of the north wall, near the front of the house. The historic siding had only a small number of nail holes that would need to be filled. Staff photo, August 2024.*

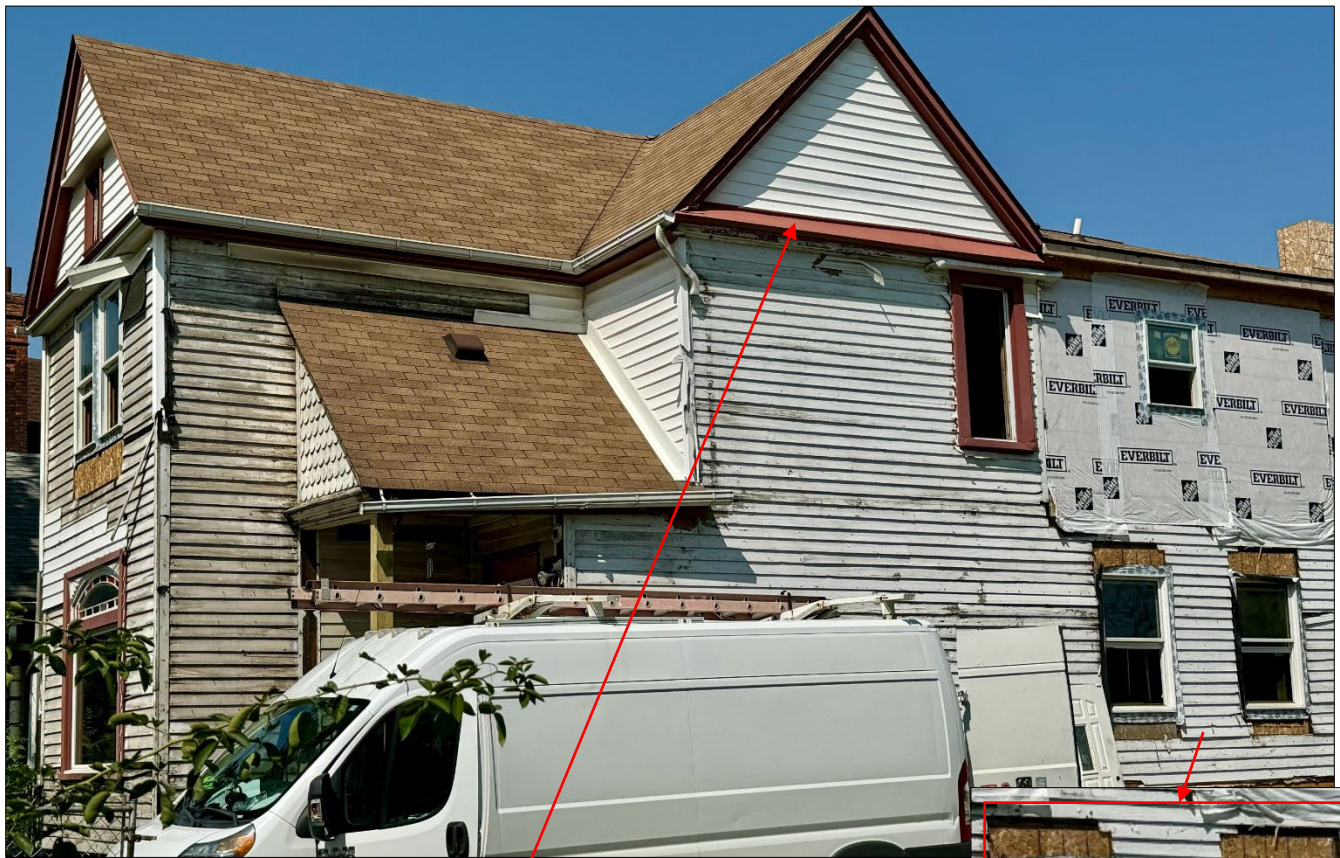
South wall. Note the similarly-closed pediment gable and pent roof. This gable wall, based on the pattern of the vinyl siding, likely didn't have multiple wall surfaces like the façade, which was common for this minimally visible side wall on a narrow lot. Within 10-20 years of when this house was built, a closely located neighboring house had been erected. Note the resized windows (wider and shorter) at the first floor. These openings will be further discussed on page 16. Staff photo, August 2024.

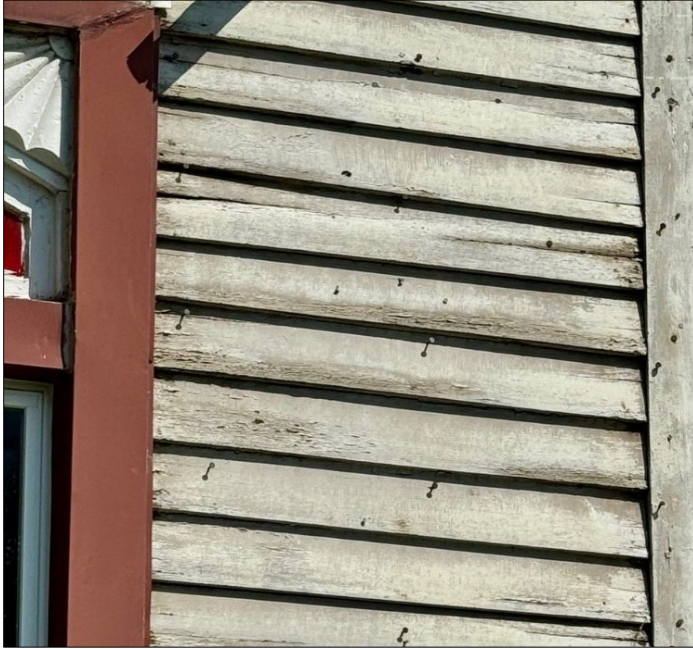
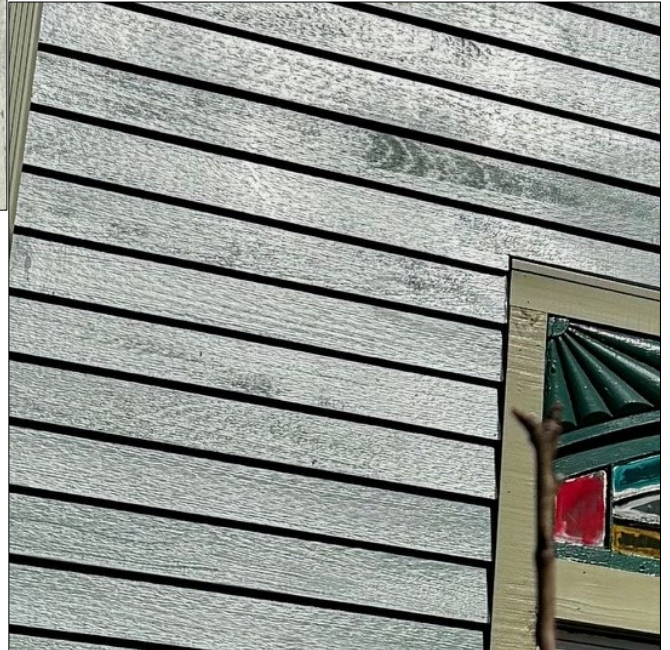
- Staff has noted differences with the existing siding, when compared to the wood siding present on the dwelling in August 2024. The old siding had a smooth surface (with exception of occasional cracks and minor deterioration at the corner trim), whereas the new siding has a consistent “fresh sawn” finish and there is no evidence of nail holes having been filled. The wood installed for windows casings is flat and has a visibly rough surface.

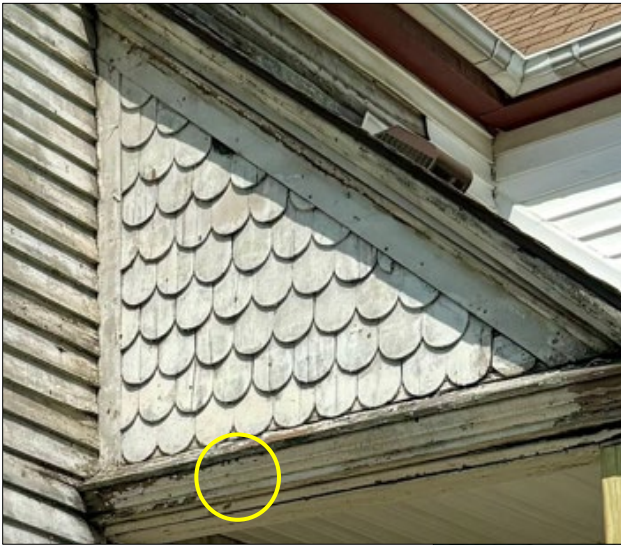
August 2024. This photo shows that the historic scallop siding had a similar smooth surface texture as the adjacent historic lap siding. The scallop siding is uniformly framed with flat trim, and then two outer sections had thickly dimensioned bargeboard trim applied to meet the roof/porch ceiling. Staff photo.

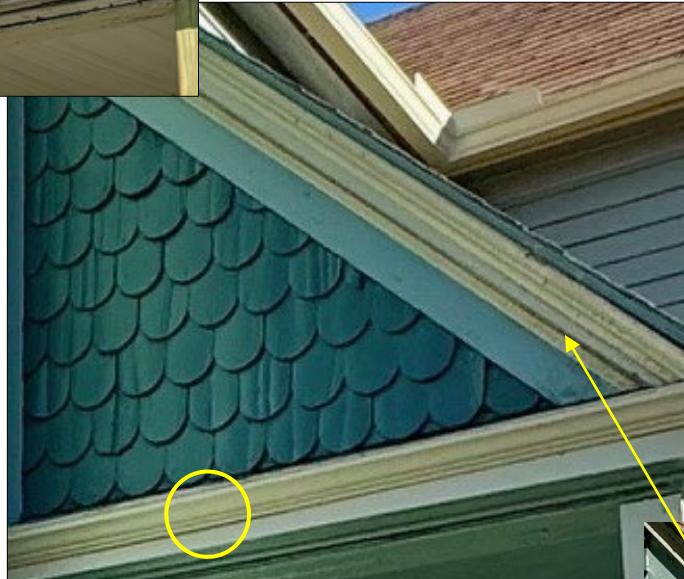
January 6, 2025. The reflective sheen of the paint shows the smooth surface of the historic scallop panels (where cracks aren't present). Note the highly profiled bargeboard at the angled roof remains, similar to the historic condition (at left), but it appears as though the lower wide bargeboard has been replaced with a narrower product. Staff photo.

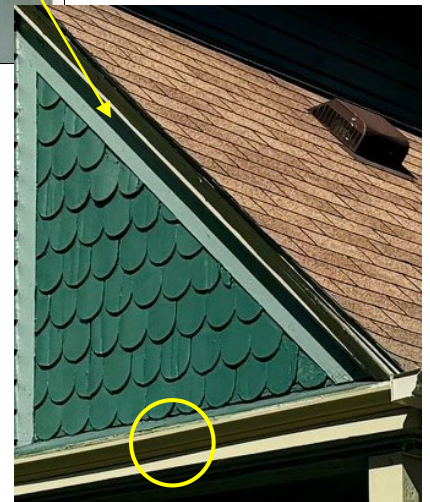
March 26, 2025. While preparing this report staff identified that the historic bargeboard at the roof edge has also been replaced with a thinner, less profiled product. Staff photo.

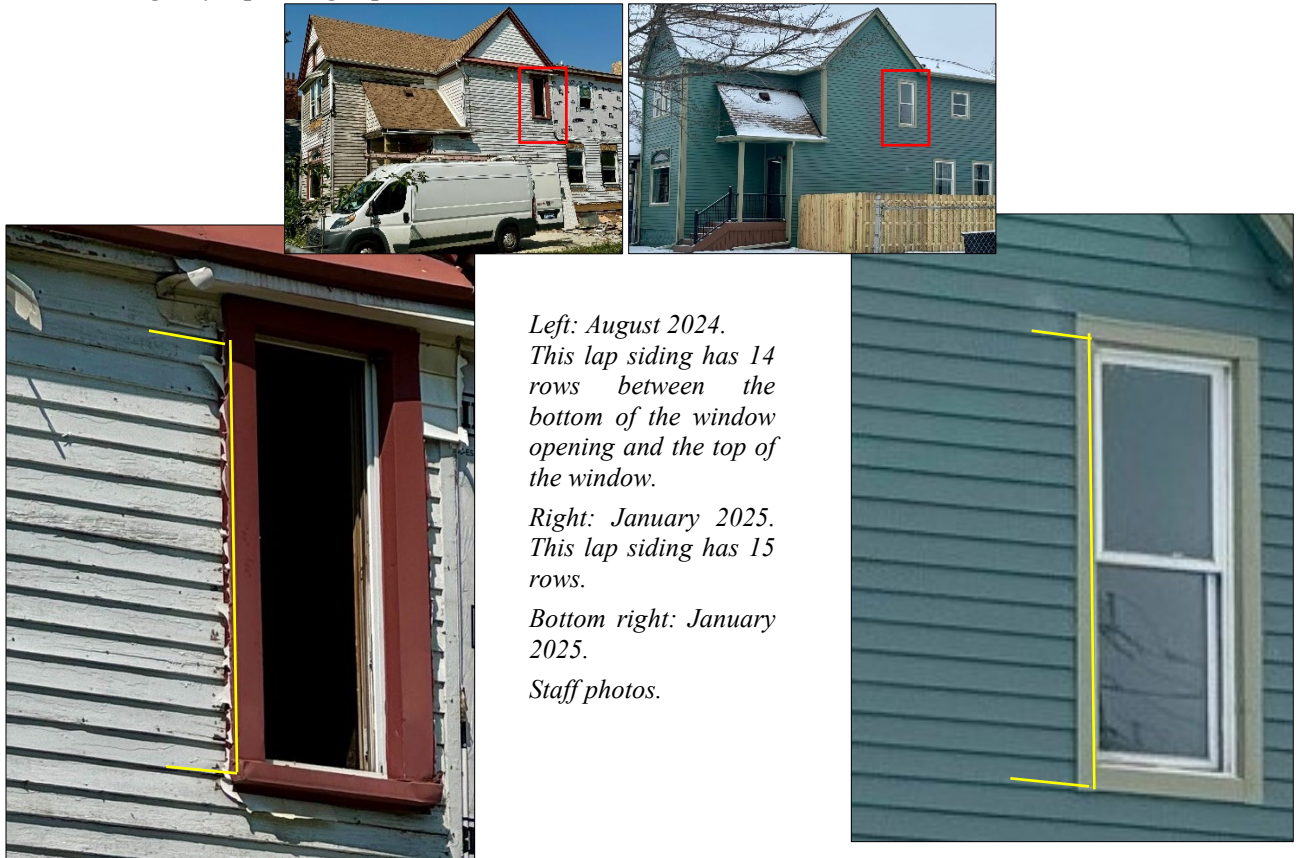
- Comparing the same window “before and after” staff counts a different number of rows of siding, going from 14 to 15.
- Another concern with the installed lap siding are the multiple gaps on the north side wall, and general waviness.

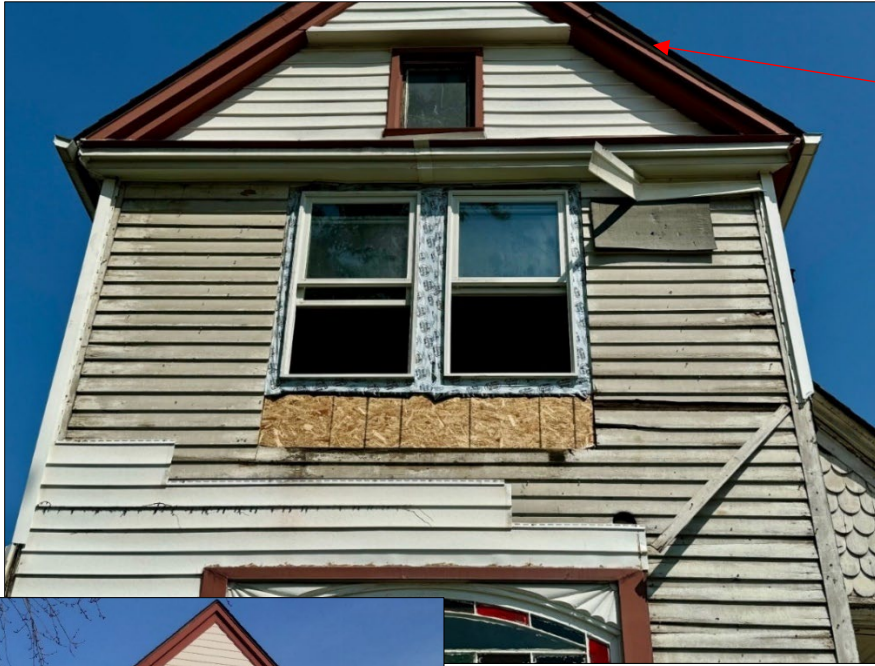
*This view shows the dimensionality of the closed pediment gable. The top portion of the wall extended forward, and an overhanging element protruded even more. The window was removed, as was the aluminum-covered bargeboard and pent roof (this angle shows the underside of the pent roof).*

*All of the removed elements were distinctive character-defining features.*

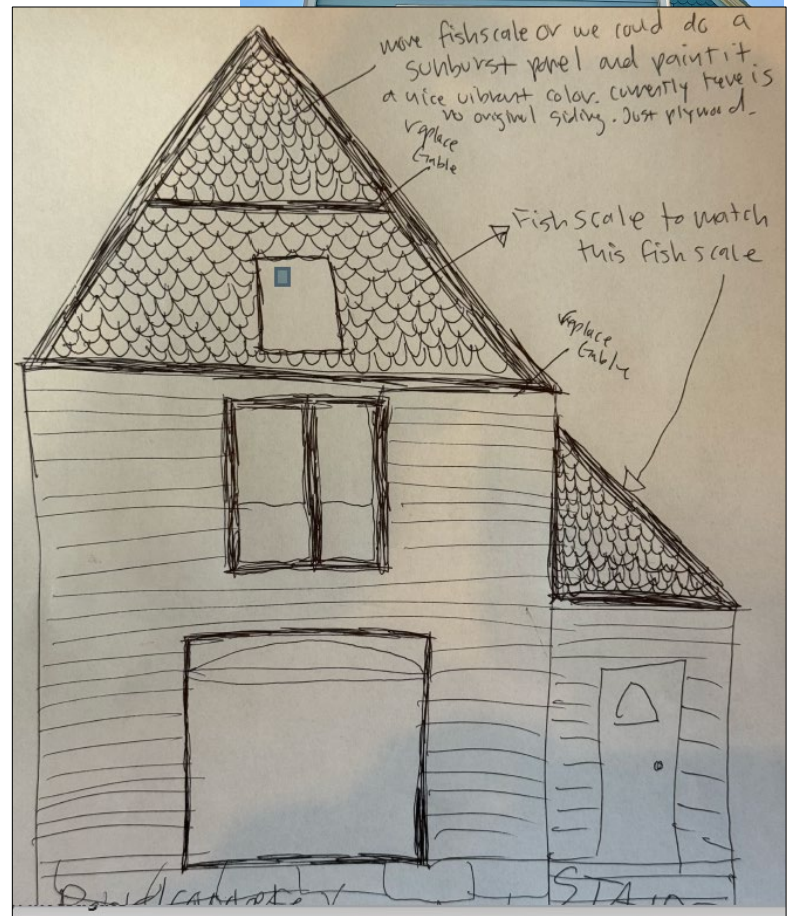
*Applicant sketch. As there is no documentation of the gable's wood siding upon removal of the vinyl siding. It is staff's opinion the elements offered in the sketch are compatible with the era and design of this Queen Anne house, with the additional expression (not called out here) of the upper gable wall extending forward of the gable's lower wall. Dimensions of each element and physical samples will be required for staff review and approval prior to any work taking place.*

- The front gable sketch included with this application is not sufficiently detailed for construction purposes. Dimensioned drawings and wall sections should be created for the front and side gables, noting all elements within each gable and specifications for painting (color(s) and sheen) will be included on the drawings and submitted to staff for review before any work takes place.
- Upon removal of the siding from the chimney, no masonry work, outside of tuckpointing (if needed) will occur without submitting to staff for review and approval - a scope of work, visual and physical documentation of existing conditions which show why the existing brick is beyond repair, and a physical sample of replacement brick.

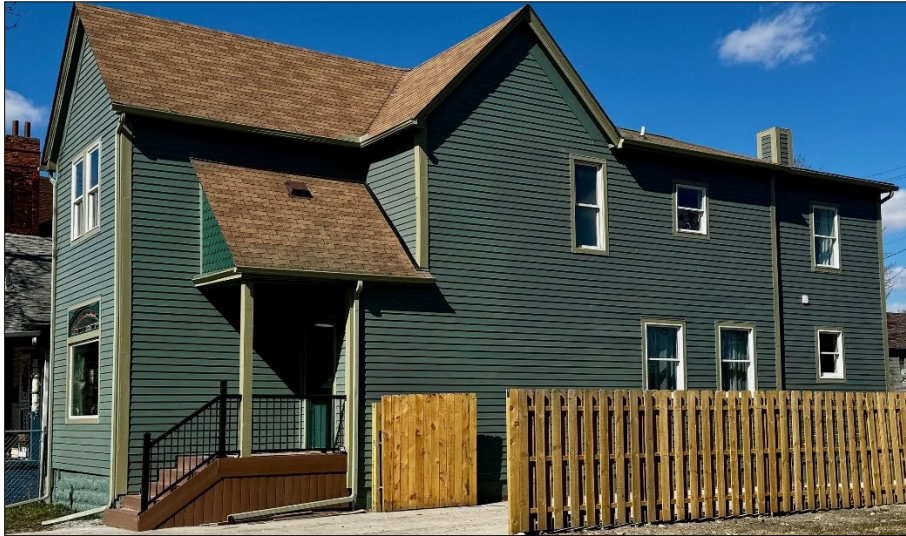
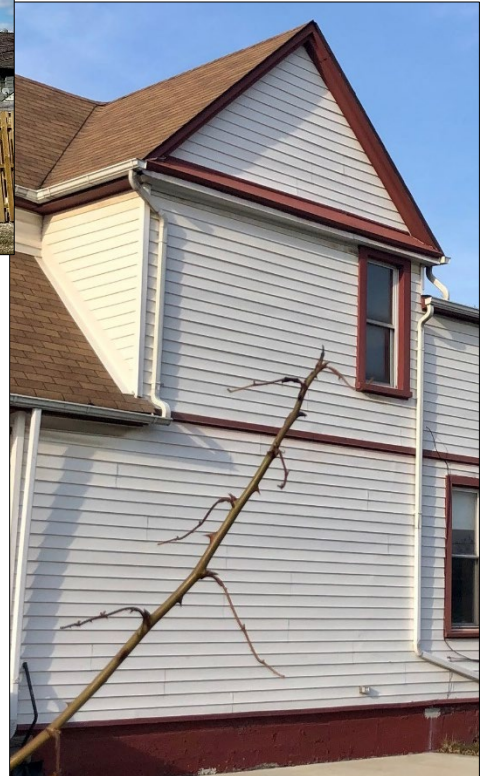
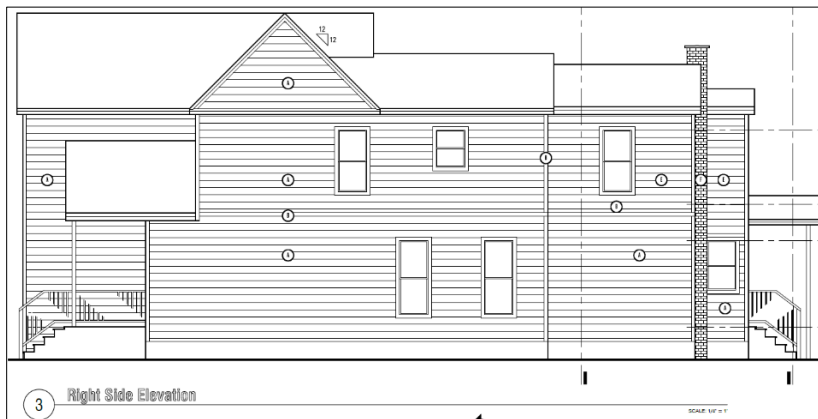
*Approved drawing shows the closed pediment.*

- An elevation drawing and wall section confirming the decorative details at this gable will need to be submitted to staff for review. It is staff's opinion that lap siding, rather than fish scale siding, can be appropriate for the gable wall at this secondary location.

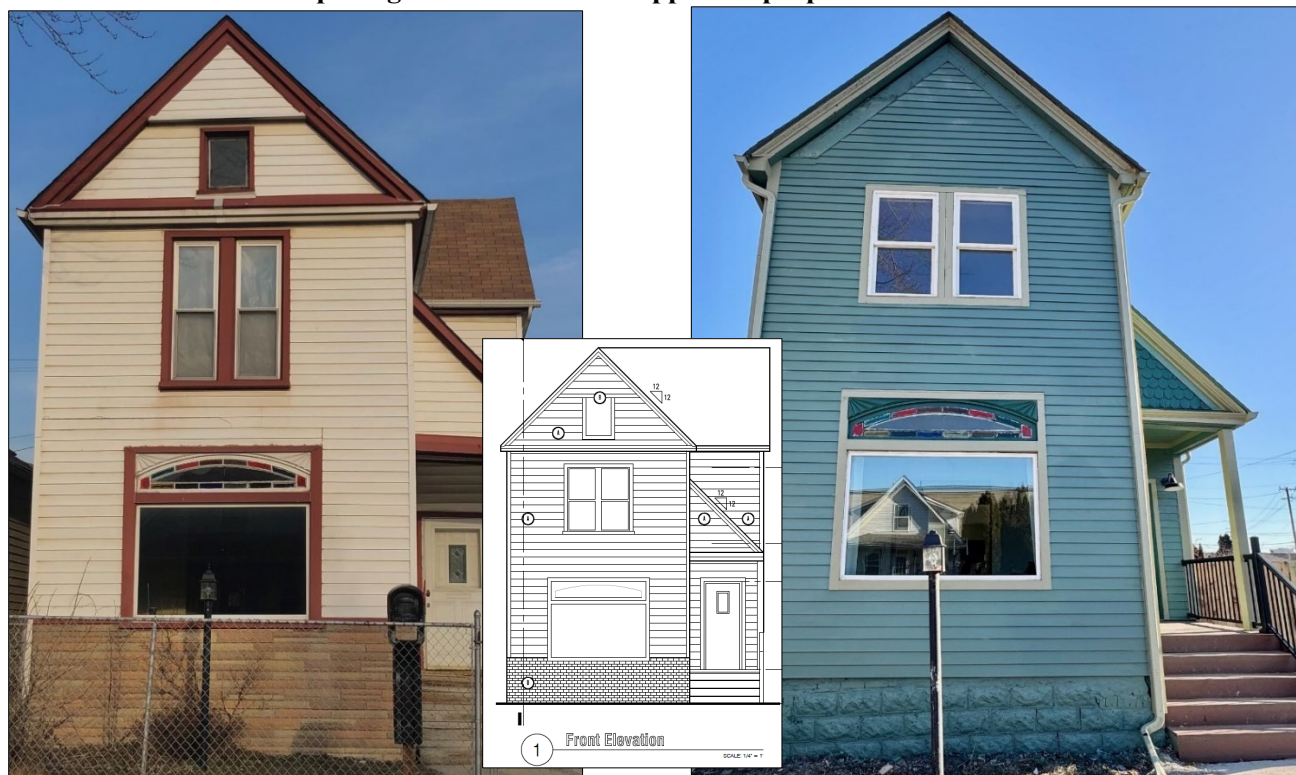
February 21, 2024      Staff photos.      January 9, 2025  
 Approved drawing of front wall, changes at right were made without HDC approval.

- The window within the gable was lost, and dimensional changes were made to the second floor windows – they are shorter in height and wider in width, the dimensional mullion was removed, they are placed forward in line with the window trim (rather than recessed like the previous replacement windows), and dimensional window casing/trim was removed and replaced with flat trim.
- A common feature on 19<sup>th</sup> century houses are tall, narrow double-hung windows. Multiple windows were joined by structural wide, flat mullions. Additional distinctive features that clearly identify dwellings of 19<sup>th</sup> century construction are the window casings: butt joints, a header with a small overhang at the top, equal-sized side trim, and a narrower, protruding sill. The February 2024 photo shows the protruding sill was still in place, covered with aluminum.

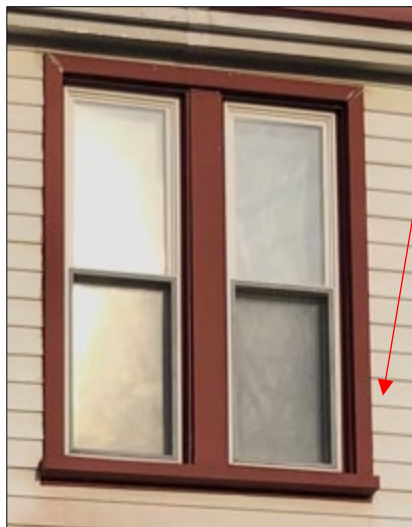
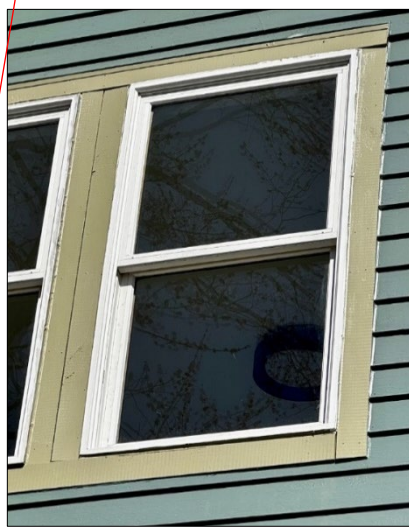
Second floor double-window opening at façade of 1760 Wabash.      16  
 Left: February 2024.      Right: March 2025.

- A dimensioned drawing of the proposed window casings, to serve as a prototype for each opening, is required for staff review, and solid wood (no composite product) will be used.
- The second story double window will be resized to match the dimensions of the original opening. A dimensioned drawing will be submitted for staff review and will confirm the recessed placement of the windows and an installation of a wood mullion, matching the one that was removed. The window order for the two double-unit windows will be submitted for staff review.

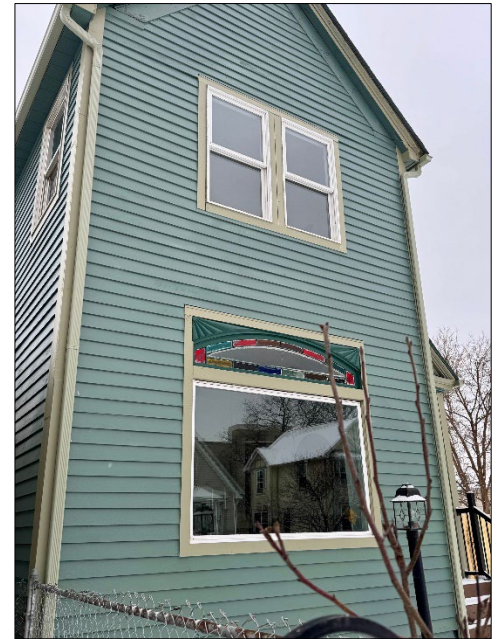
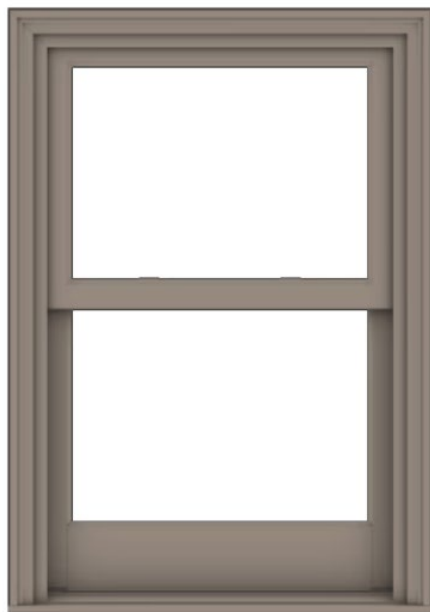
*Right: Existing replacement window in one of the new windows openings on the rear wall.*

*The dimensions and depth of framing of the Anderson window is more compatible with the dimensions and profile of a historic wood window.*

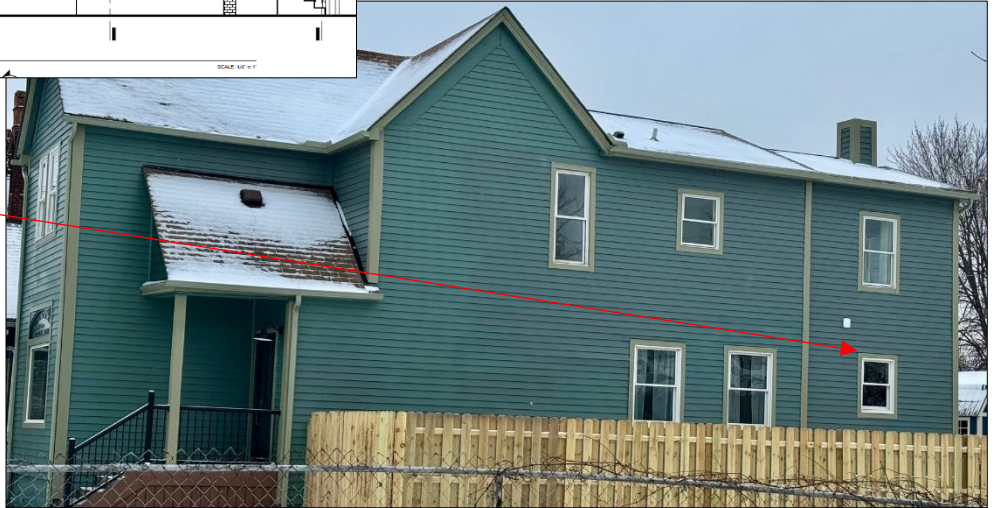
- As first identified on page nine, while reviewing photos for this staff report, staff noticed that at least one window opening doesn't fully fit the cut opening on the south-side wall.
