**STAFF REPORT:** APRIL 9, 2025 MEETING  
**APPLICATION NUMBER:** HDC2025-00054  
**VIOLATION NUMBER:** 25-981  
**ADDRESS:** 1760 WABASH

**HISTORIC DISTRICT:** CORKTOWN

**SCOPE:** INSTALL LAP SIDING (WORK COMPLETED WITHOUT APPROVAL), ADD DETAILS TO HISTORIC AND NEW GABLE WALLS, INSTALL WINDOW AND RESIZE EXISTING WINDOWS ON FAÇADE, REBUILD WINDOW CASINGS-ALL SIDES, REMOVE SIDING FROM CHIMNEY

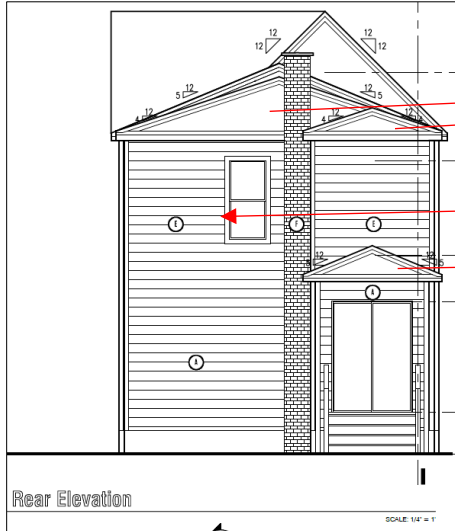
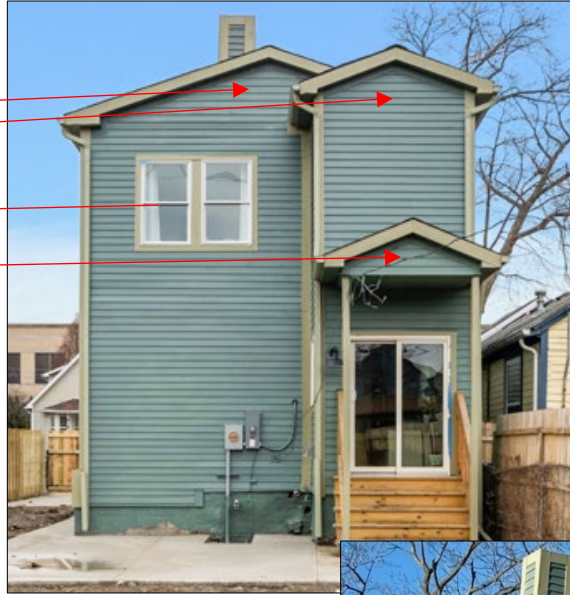
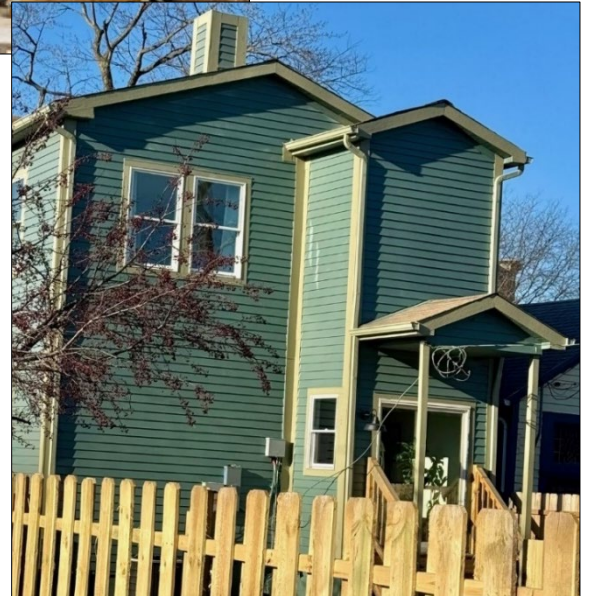
- Changes made to the approved project at the rear wall include:
  - One additional window at the second floor.
  - No closed gables.
  - The historic chimney clad in siding.

- Raised height of the rear porch roof.
  - New chimney not erected.
- It is staff's opinion that the location of the additional window opening is appropriate, however the window itself, its placement within the opening, and lack of mullion and dimensional trim, is not.

- The gables for the rear-facing walls and covered porch were erected with a different design than originally proposed, and the applicant submitted a drawing to show how the gables could be enclosed. These walls and gables are of different proportions (including roof pitch) than the historic gables and all relate to each other on the rear wall, so staff believes the open design and flat rakeboard are compatible for new construction and this rear-facing location.

- The cladding of the chimney is not compatible with the age and architectural design of the house, and staff agrees with the applicant's proposal to remove the siding and expose the historic brick. The recladding of this feature without submitting visual and physical documentation that the existing brick and chimney is beyond repair, would not be approved/recommended by staff.
