STAFF REPORT: APRIL 9, 2025 MEETING
APPLICATION NUMBER: HDC2025-00070
ADDRESS: 3417 SEMINOLE

PREPARED BY: A. DYE

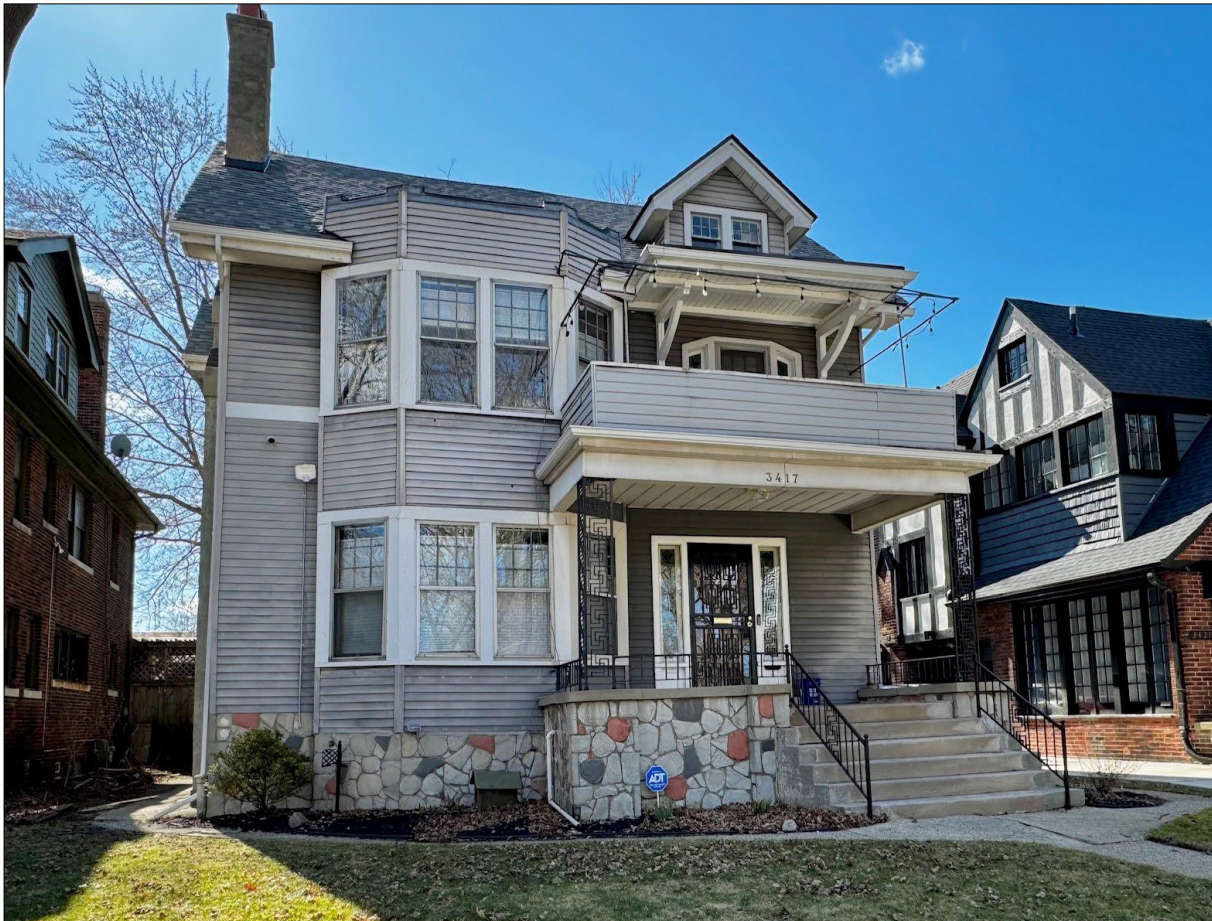
Facade, east-facing wall. Staff photo, March 26, 2025.

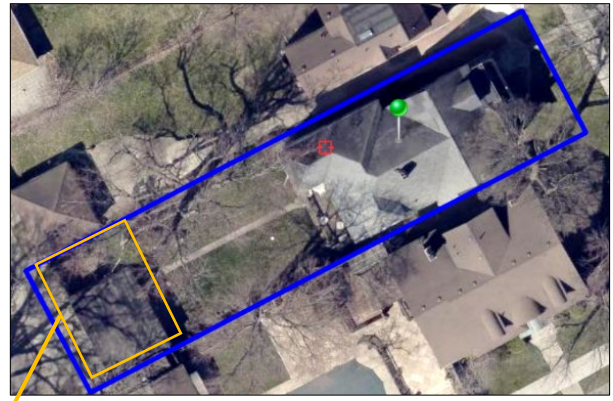
This aerial view shows the structure functions as a two-car garage. April 2022. EagleView.

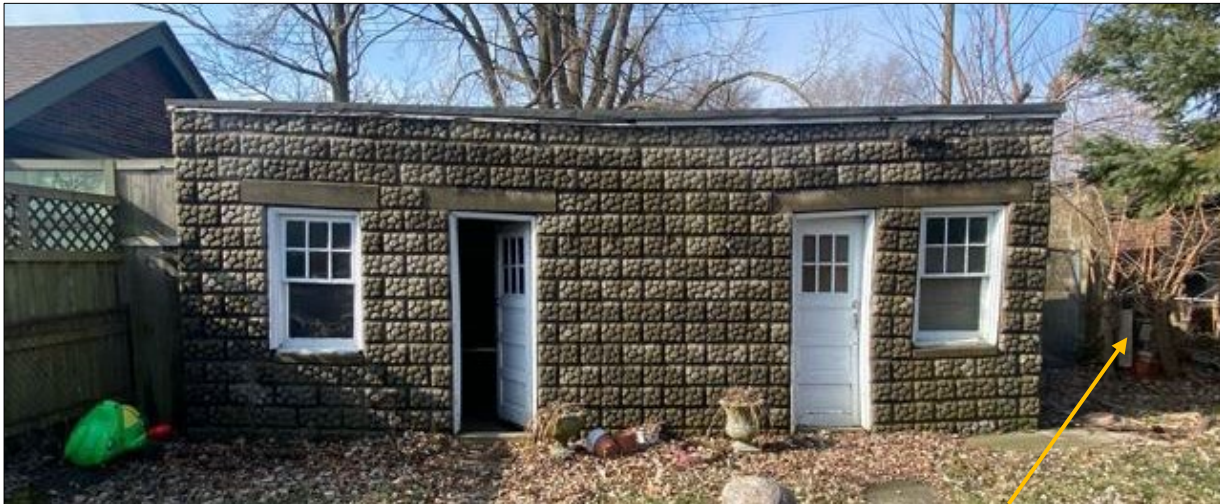
East wall of garage facing the rear yard and back of house. The third bay is essentially missing, with only one wall fully intact. Applicant photo.

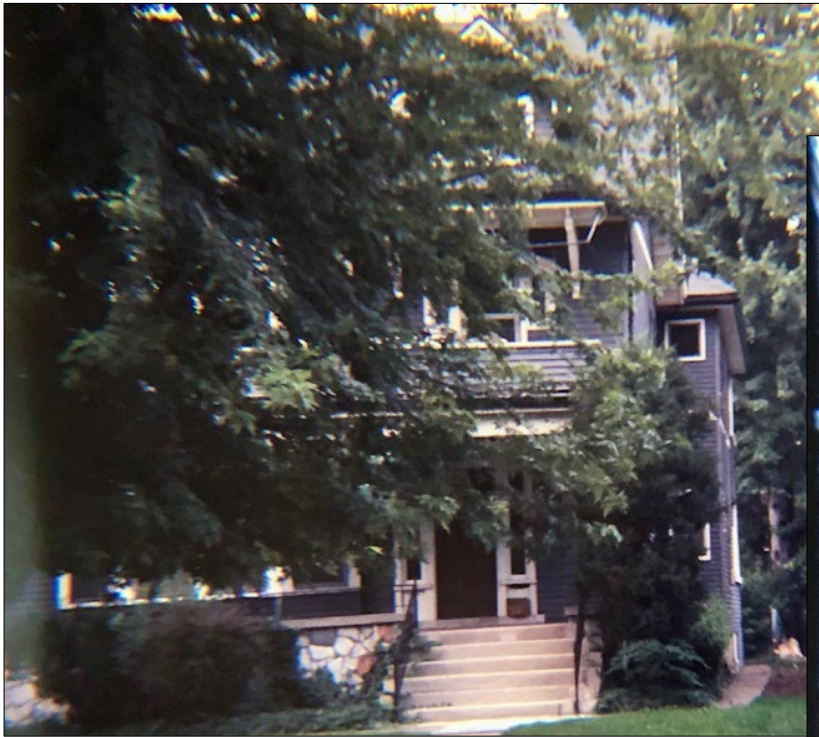
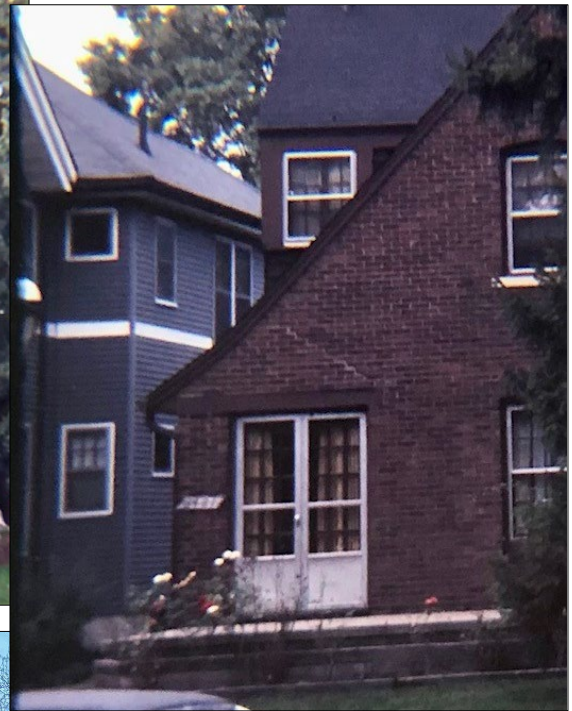
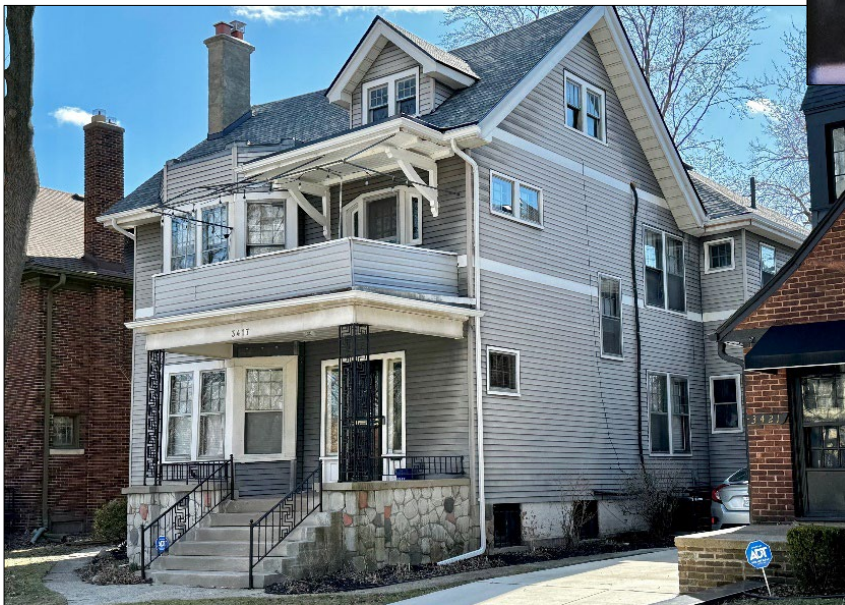
Above: Historic Designation Advisory Board photos, 1971. At time of designation, the front porch had been altered, and the vinyl siding was in place.

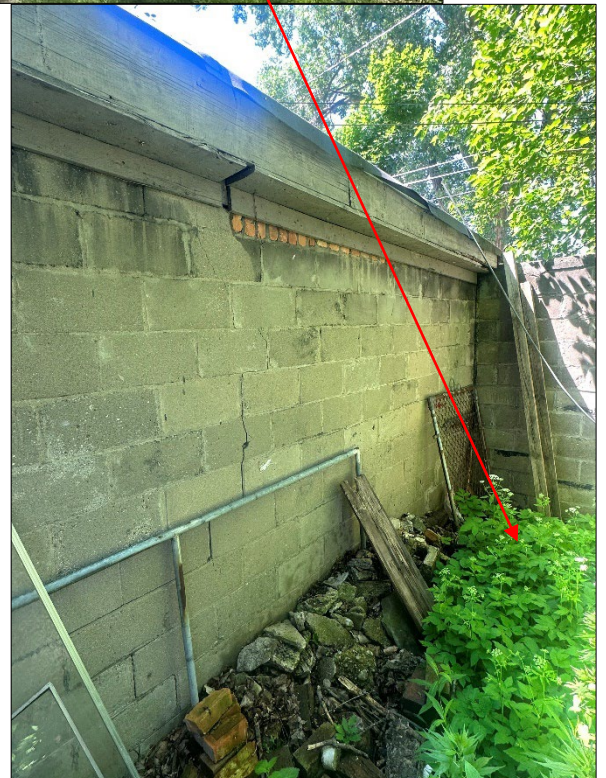
At an unknown time, the roof and east wall of the northern bay were removed, and the overhead door opening was filled in with matching concrete block (likely reused from the now-demolished east wall). Staff didn't find Commission approval for this alteration.

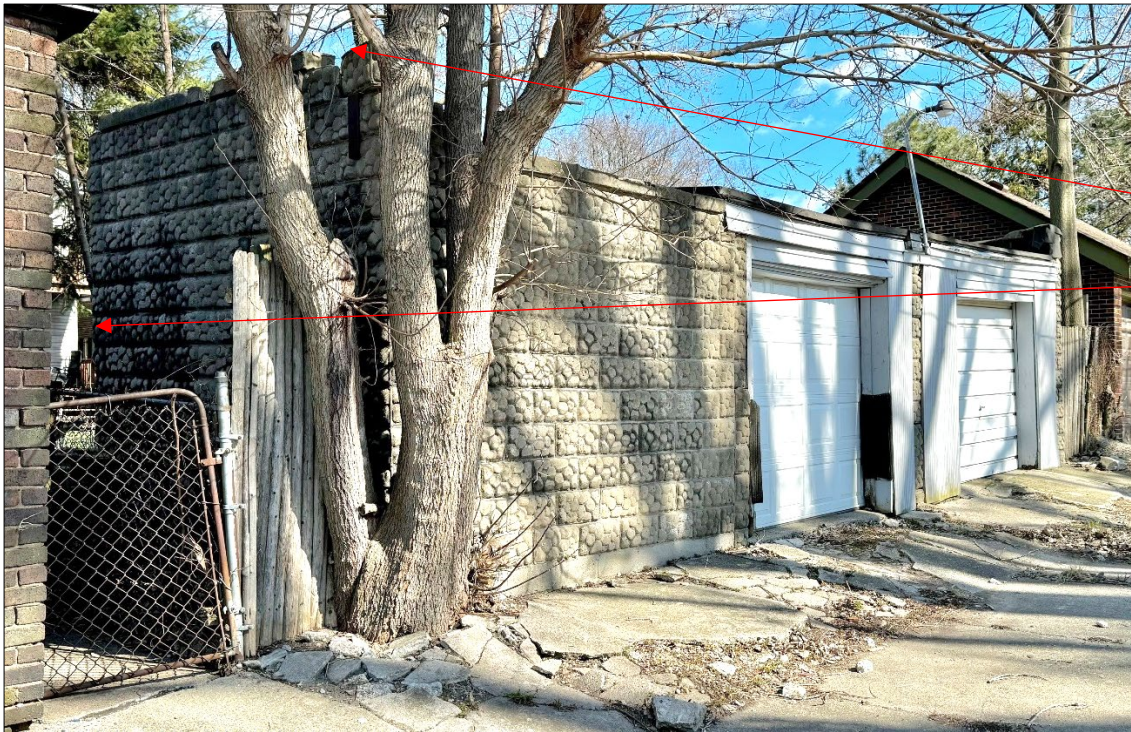
This view of the northwest corner of the garage shows that portion of the north wall's parapet is missing as well as the jagged edge of the partially destroyed wall.

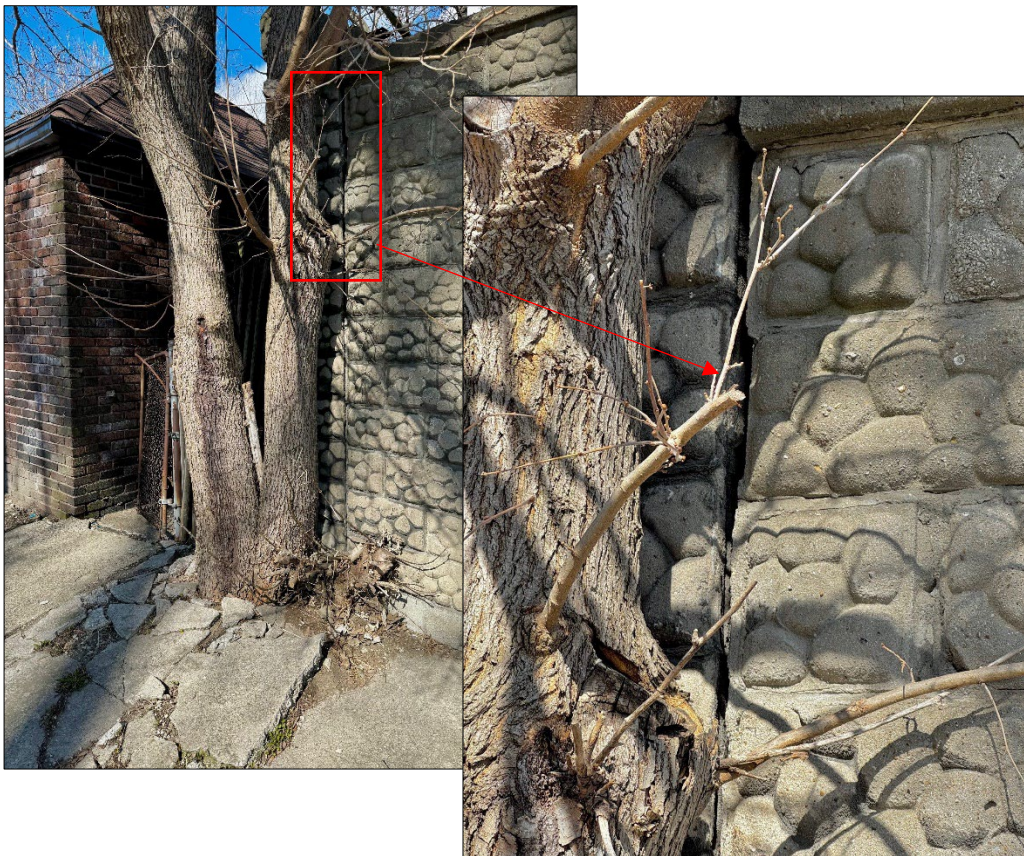
This alternative view of the northwest corner shows how the growth of this tree and its root system caused the pavement to buckle, as well as undermine the stability of the north wall, as it has begun to lean away from the west wall.

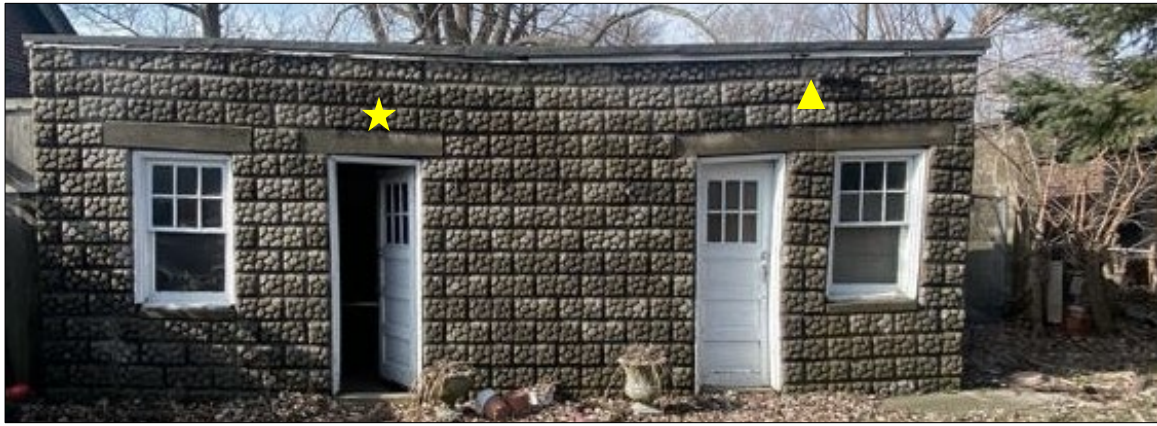
East wall facing the house. Applicant photo.

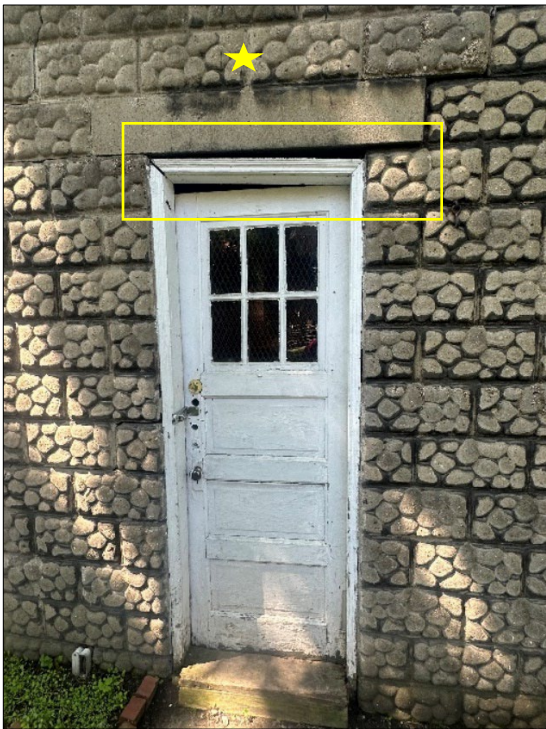
These close-up photos clearly show the impact of the long-standing issue with settlement, which has caused the lintels and door and window frames to become unlevel.

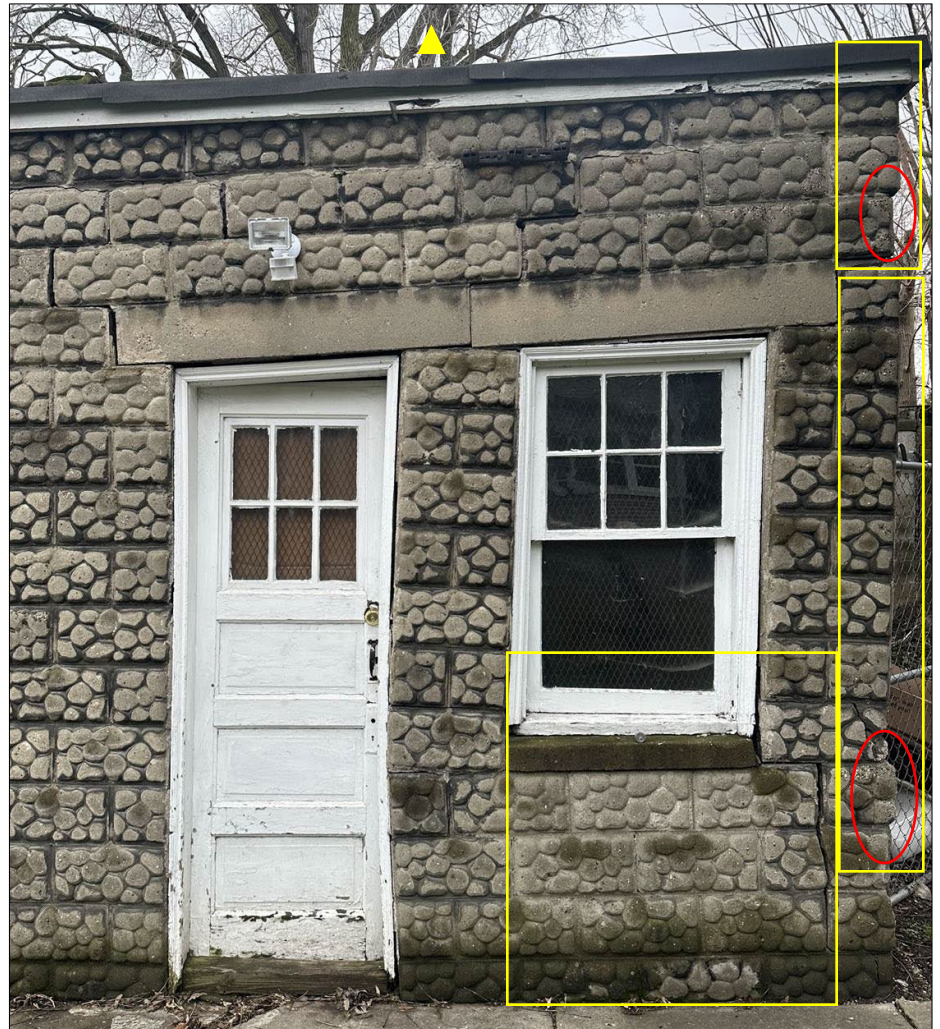
The areas adjacent and below the window show wood and stone deterioration which has created holes in the walls, further exacerbating mortar and block deterioration between the window to grade.

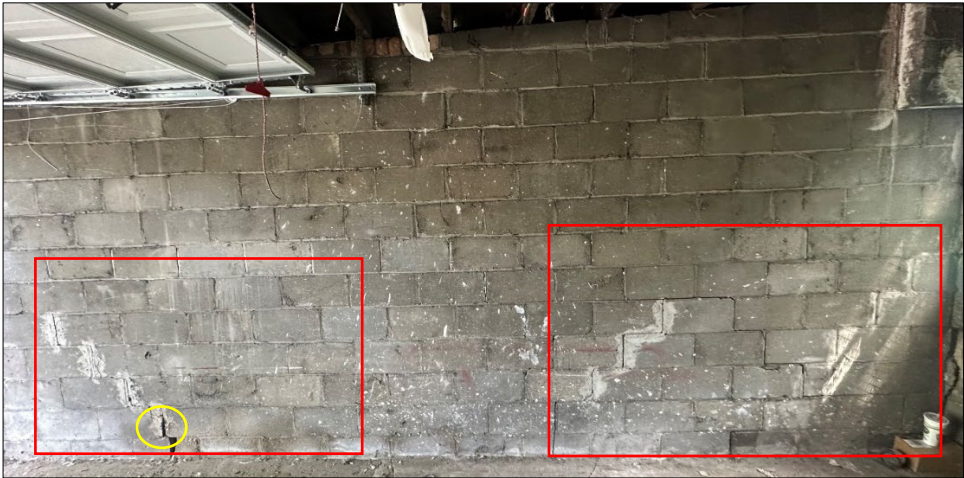
Step crack and cracked block

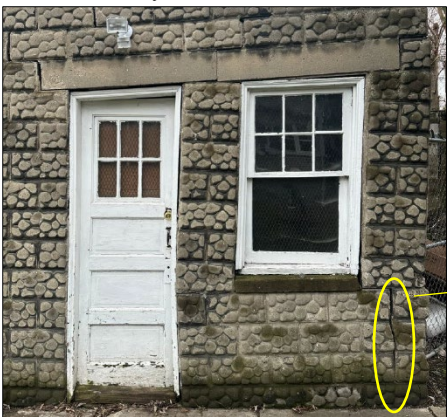
Exterior view of wall at right.

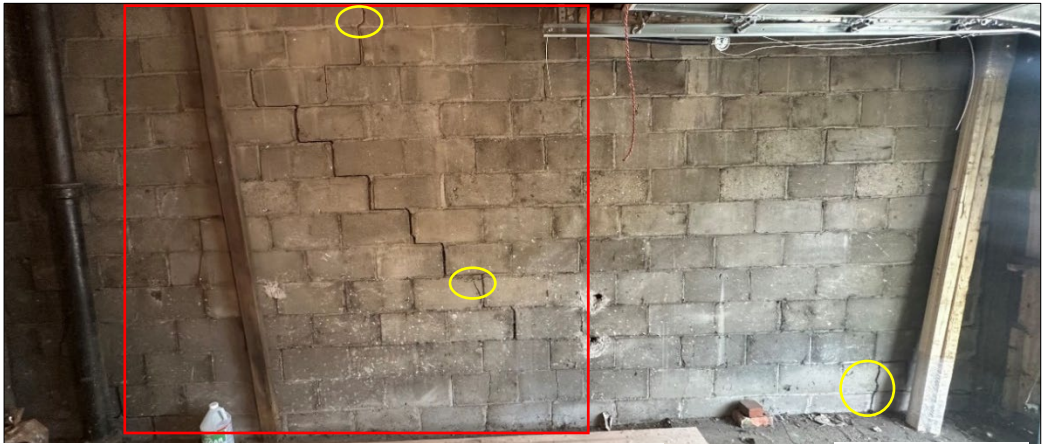
Large step crack, broken blocks at top and near middle of wall

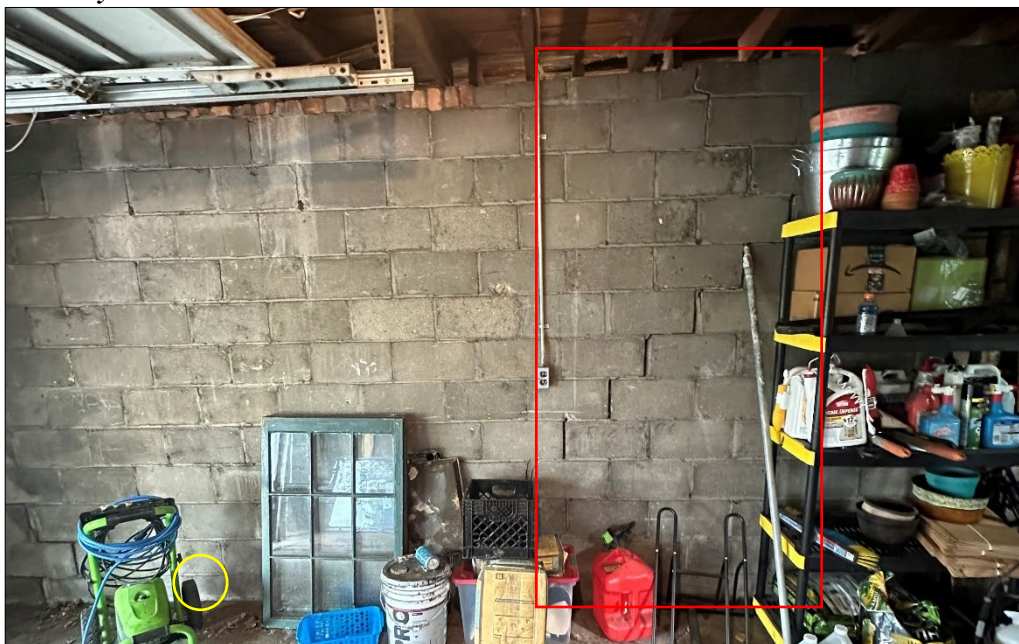
This is the other side of step crack, shown on page 8 (middle bay-south interior wall).

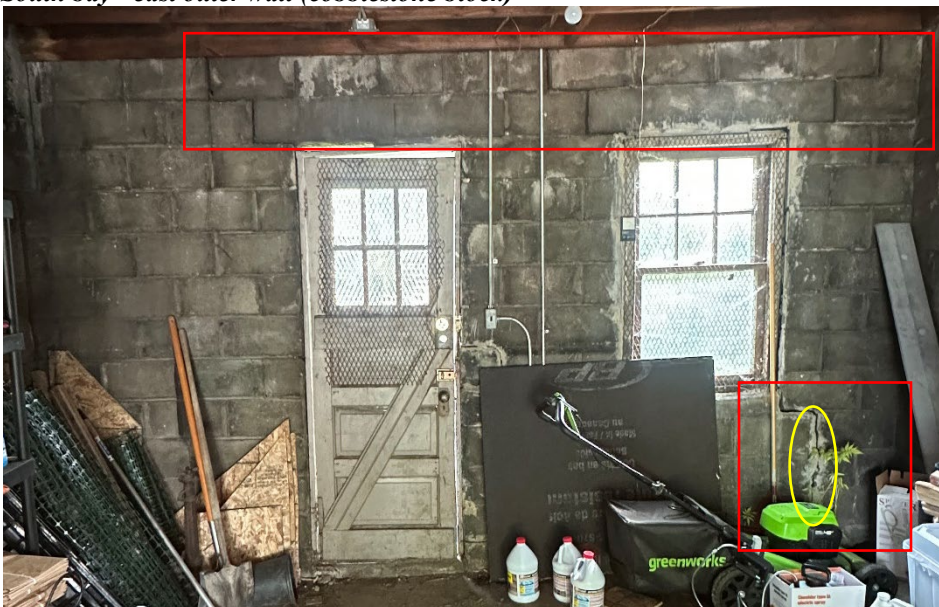
Step cracks above the window and door. Cracked tile below window.

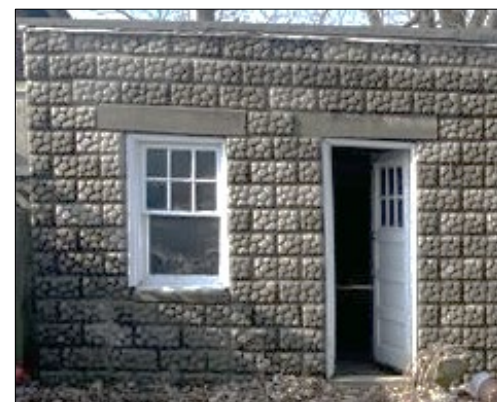
Exterior view of wall at left.

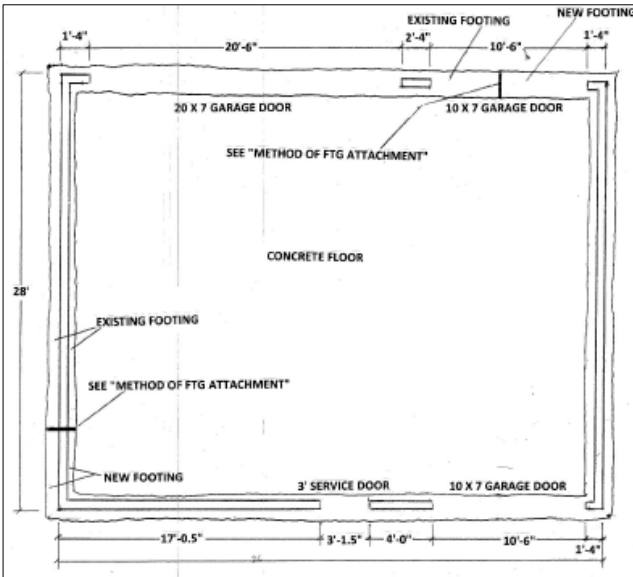
Unidentified drawing - staff believes it is a foundation plan.

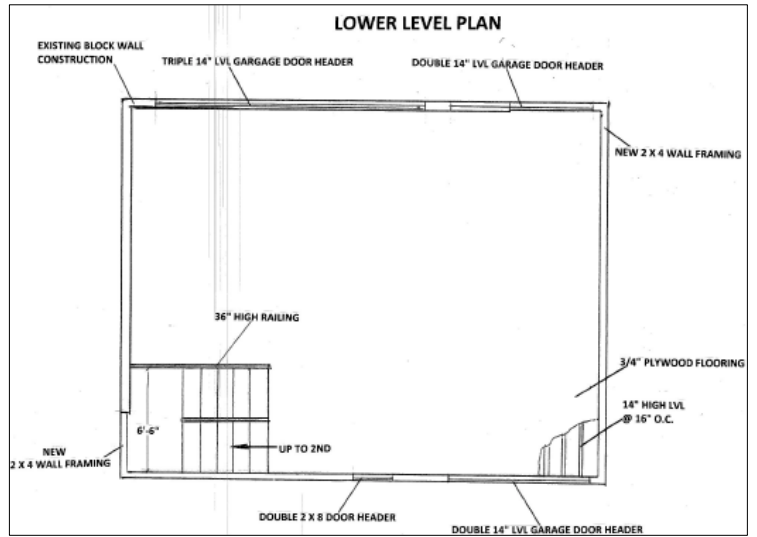
Floor plan for first level of garage. Window openings are not shown.
