**STAFF REPORT: APRIL 9, 2025 MEETING**

**APPLICATION NUMBER: HDC2025-00117**

**ADDRESS: 3470 CAMBRIDGE**

**SCOPE: REPLACE STEEL AND WOOD WINDOWS WITH VINYL-CLAD WOOD WINDOWS (WORK COMPLETED WITHOUT APPROVAL)**

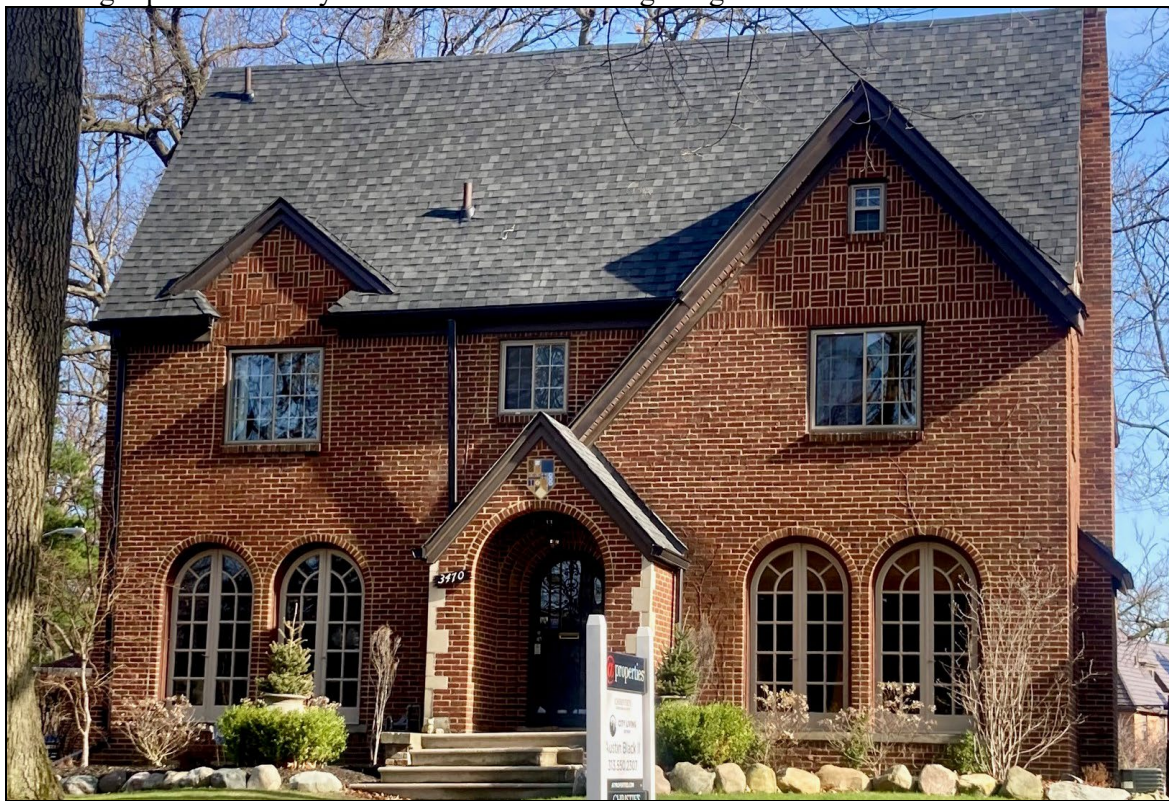
The house at 3470 Cambridge, constructed in 1927, is clad with reddish-brown brick and has a steeply pitched side gable roof that is covered with asphalt shingles. The brick wall surface on the two front-facing gable walls were set in a contrasting basket weave pattern. The sloping western roof of the large gable extends down the façade and meets the front entry's front-facing and projecting gable roof. The three-bay wide house is accentuated by arched openings at the first floor, which is comprised of two sets of French doors on either side of the arched front porch entrance and front door. A decorative crest and stone quoins further articulate the recessed front entry. The historic wood French doors remain in place, however the window sash are sliding or double-hung replacement vinyl units with between-the-glass grids.

*Above: Staff photo, April 3, 2025.*

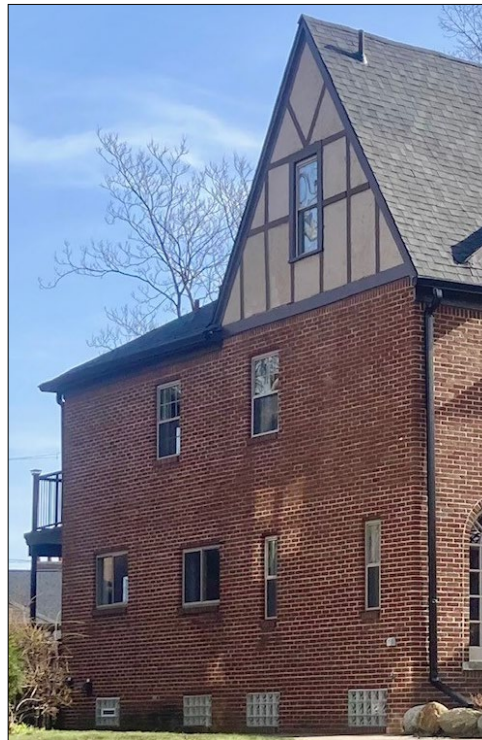
*West-side wall.*

The walls of the dormers on the side elevations are faced with a half-timber/stucco design. The windows are vinyl replacement units, double-hung and sliding units.

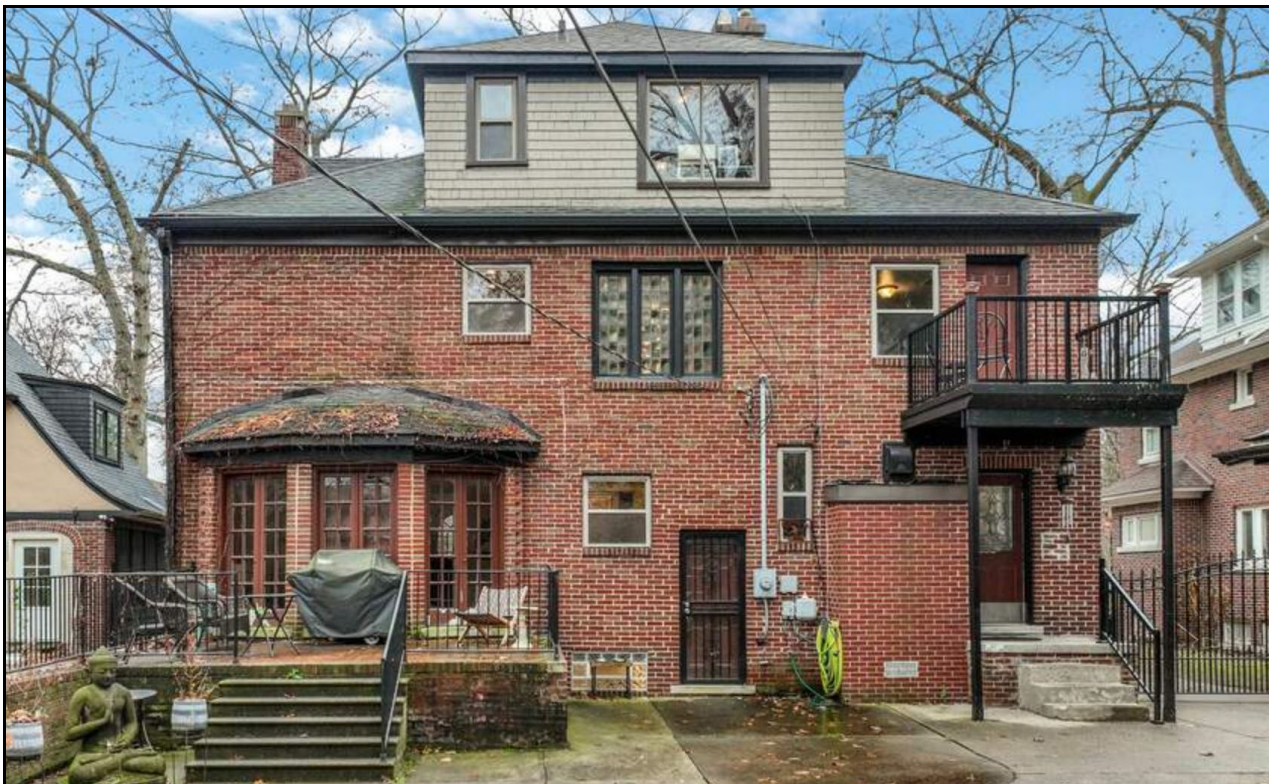
*Rear wall, applicant photo, 2025.*

The rear wall has a large shed dormer faced with wood shake siding and a raised patio extending from three sets of French doors. The historic wood French patio doors remain, as do the leaded glass fixed window sash in the triple window opening. The remaining windows are vinyl replacement units of double-hung or sliding operation. The three entrance doors have been replaced, a large second floor porch has been erected, and all the railings are new.

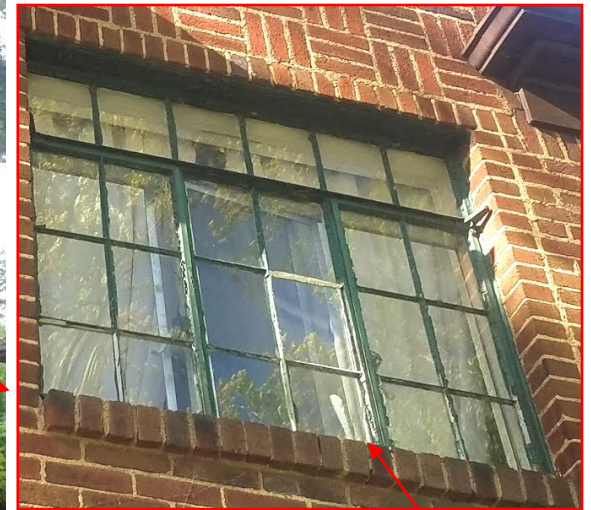
*Above: The large square-shaped windows at the front of the house appear to have had central operating casements (2w/3h) between two sidelights (2w/3h), all of which were below a full width (4w/1h) transom.*

*Below: The taller-than-wide windows on the side walls (and one opening at the rear-second floor) of the house appear to have had a single operating casement (2w/3h) with one adjacent sidelight (2w/3h), all of which were below a full width (4w/1h) transom.*

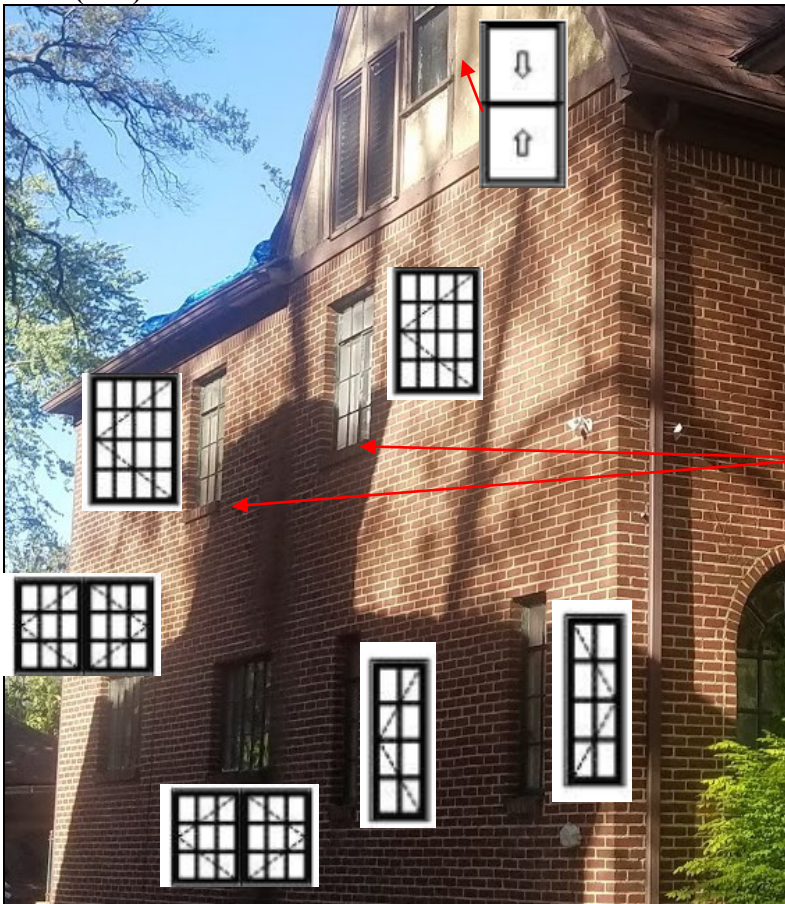
### West (side) Wall

First Floor: 10 & 15 - Dining Room, 50 & 55 - Kitchen

Second Floor: 70 - Back Bedroom West, 85 – Front Bedroom

Third Floor: 125 – 3<sup>rd</sup> Floor Big Room

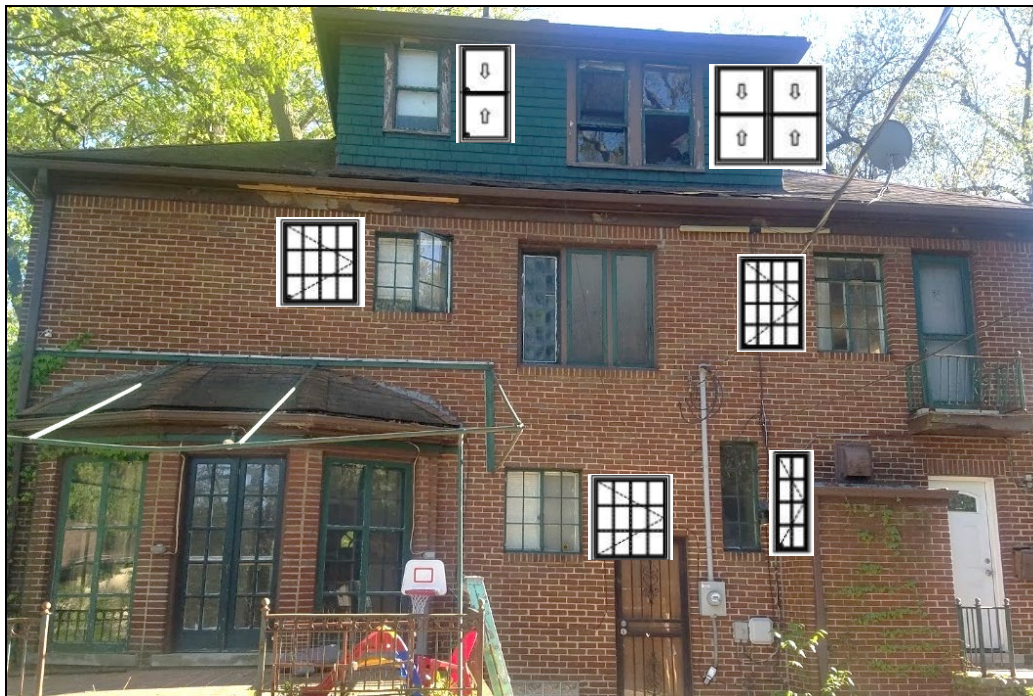
## Rear Wall

*First Floor: 45 – ½ Bath, 60 – Back Stairs*

*Second Floor: 110 – Master Bath, 65 – Back Bedroom West*

*Third Floor: 115 – 3<sup>rd</sup> Floor Bath, 120 - Office*

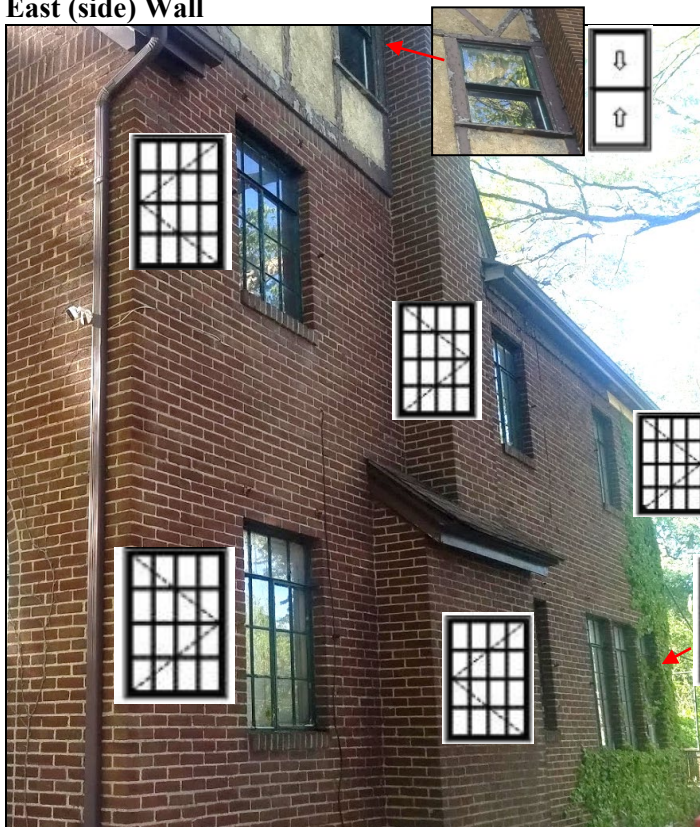
## East (side) Wall

*First Floor: 20 & 25 – Living Room, 30, 35 & 40 – Exercise Room*

*Second Floor: 95 & 100 – Master Bedroom, 105 – Master Bath*

*Third Floor: 130 – 3<sup>rd</sup> Floor Big Room*

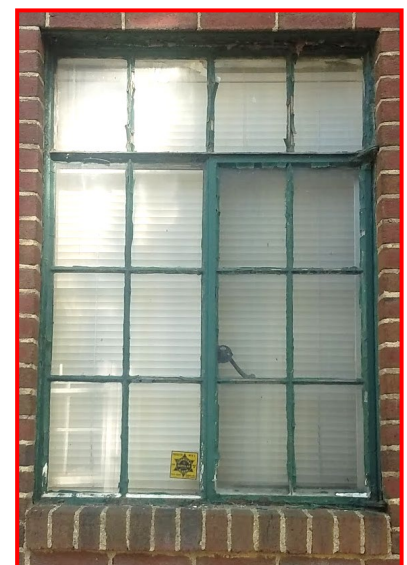
*Above: The taller-than-wide window was the dominant style and operation on the east side wall.*

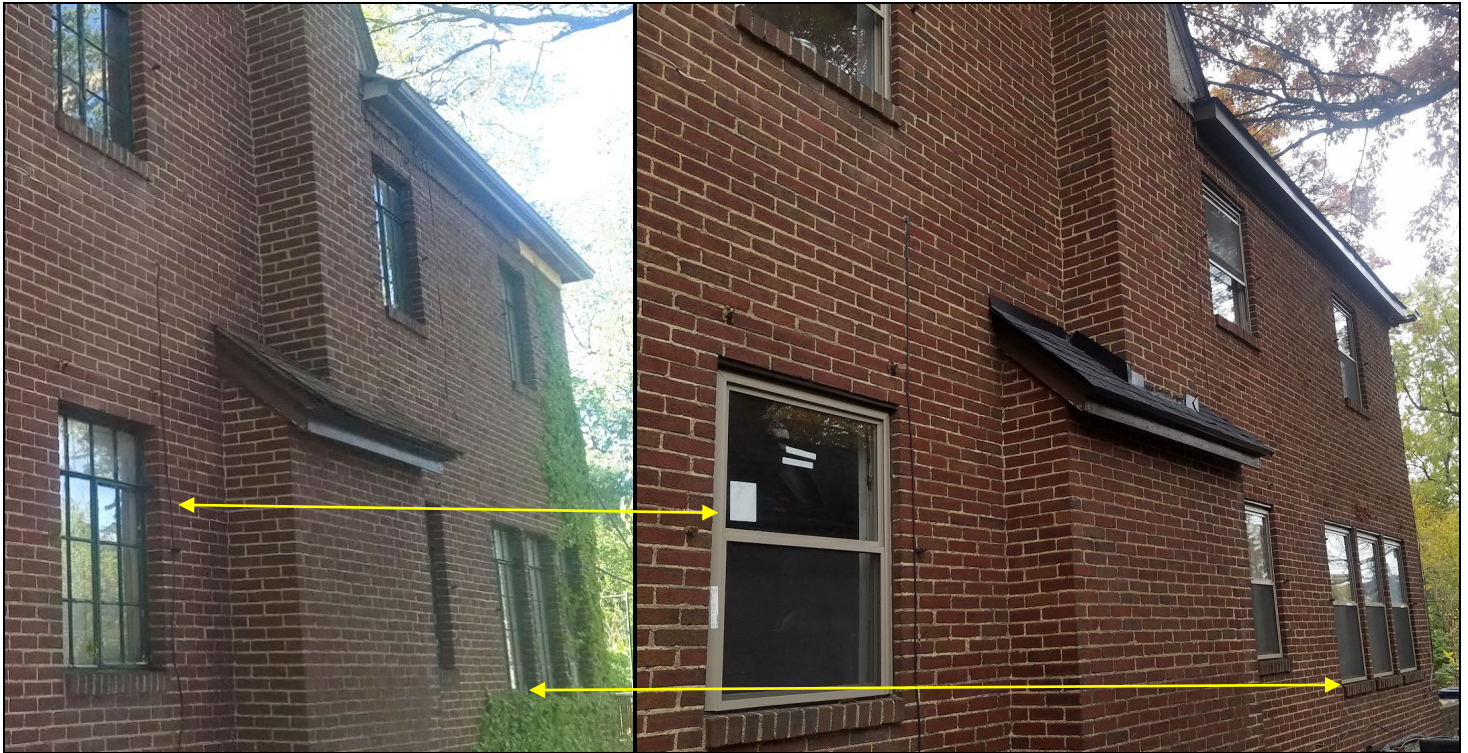
- If the Commission considers the installation of the proposed aluminum-clad windows, the placement of the new windows should match the more deeply recessed location of the historic windows within the window openings. The depth of plane change between window and wall surfaces is an important feature on the elevations of the house and the current windows don't convey the same visual appearance.

*The depth of the “before” steel windows is quite evident and clearly offers a relief from the masonry wall. The replacement windows are minimally set back in the window opening, and from a distance, appear to be in plane and a part of the exterior wall. Applicant photos.*

- The placement of new windows often doesn't match the deeply recessed location of the historic windows within the window openings. The depth of plane change between window and wall surfaces is an important feature on the elevations of the house.
