ADDRESS: 4340 GLENDALE

APPLICATION NO: HDC2025-00116

HISTORIC DISTRICT: RUSSELL WOODS-SULLIVAN

SCOPE: REPLACE WOOD WINDOWS WITH ALUMINUM-CLAD WOOD WINDOWS

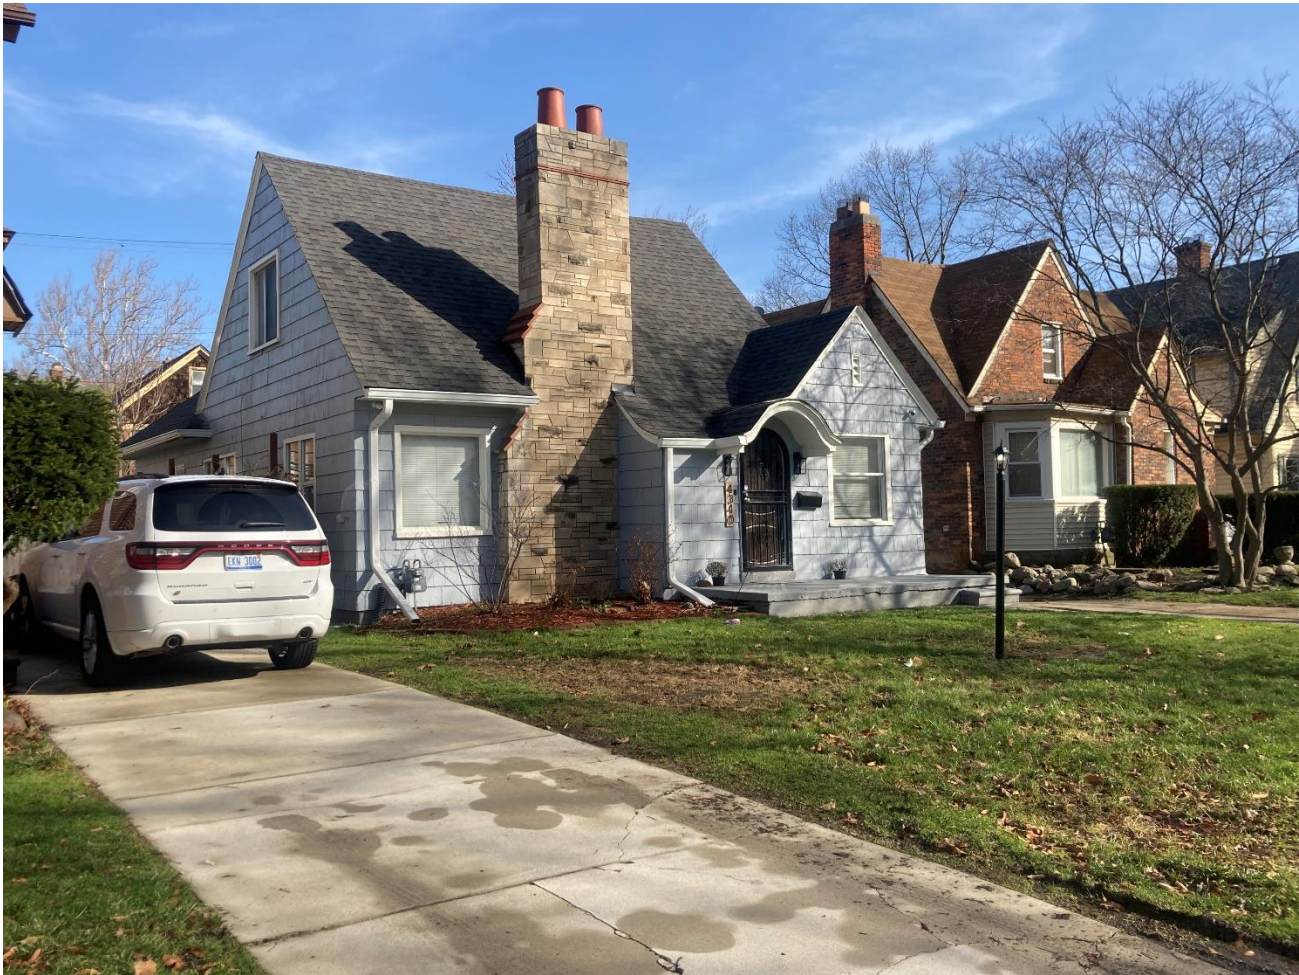
4340 Glendale. Current appearance. Photo by HDC staff, 3/25/2025

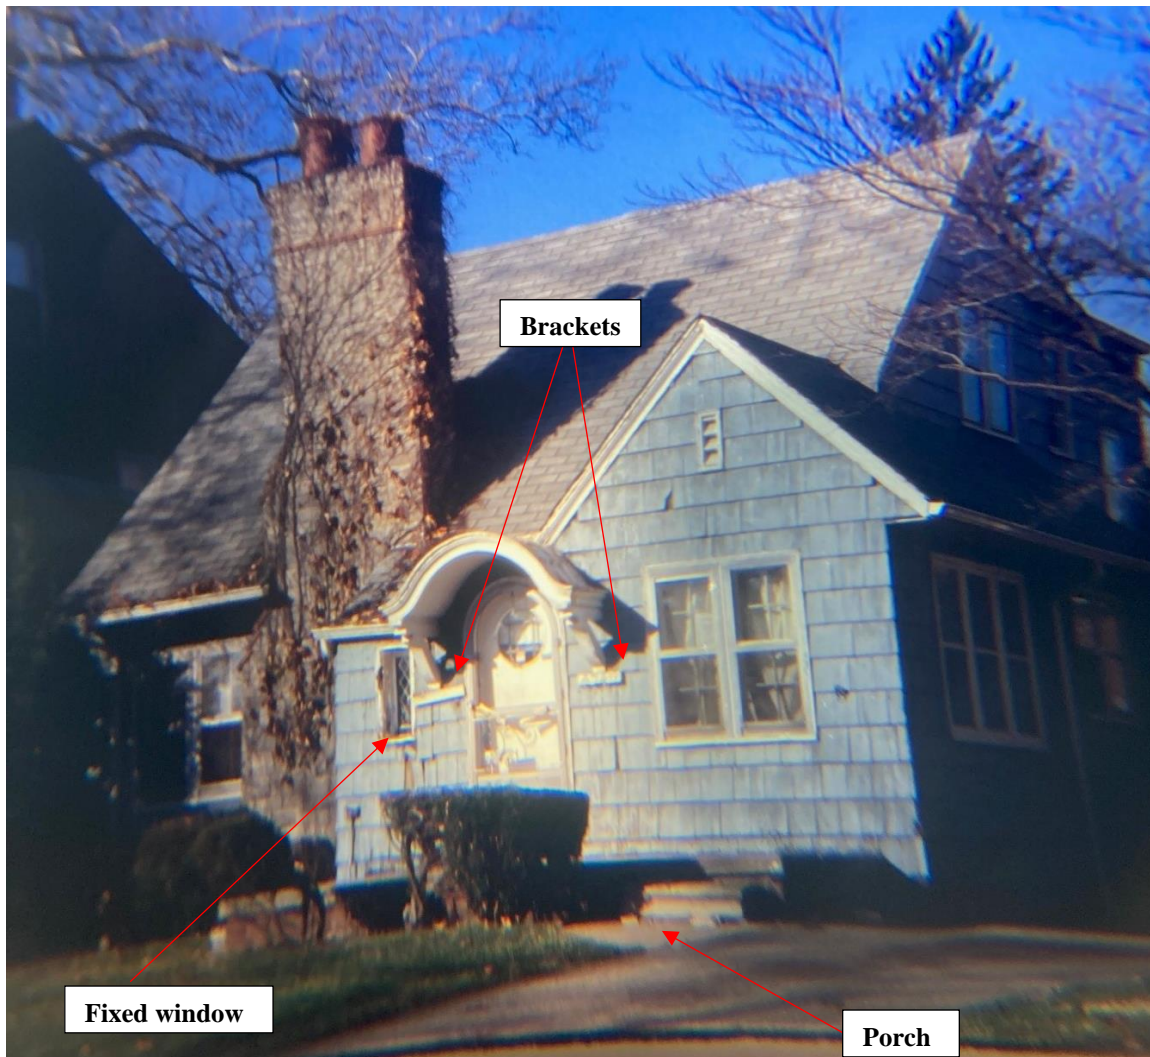
- The Russell Woods-Sullivan Historic District was designated in 1999. See the below designation photo, taken in 1999 by Historic Designation Advisory Board (HDAB) staff. Note that the original 4/4 wood windows and front were extant, a fixed, diamond patterned window was present to the left of the front door, the original porch remained, and triangular brackets were present at the primary entry's arched canopy.

Appearance in 1999, at the time of the district's designation. Source, HDAB

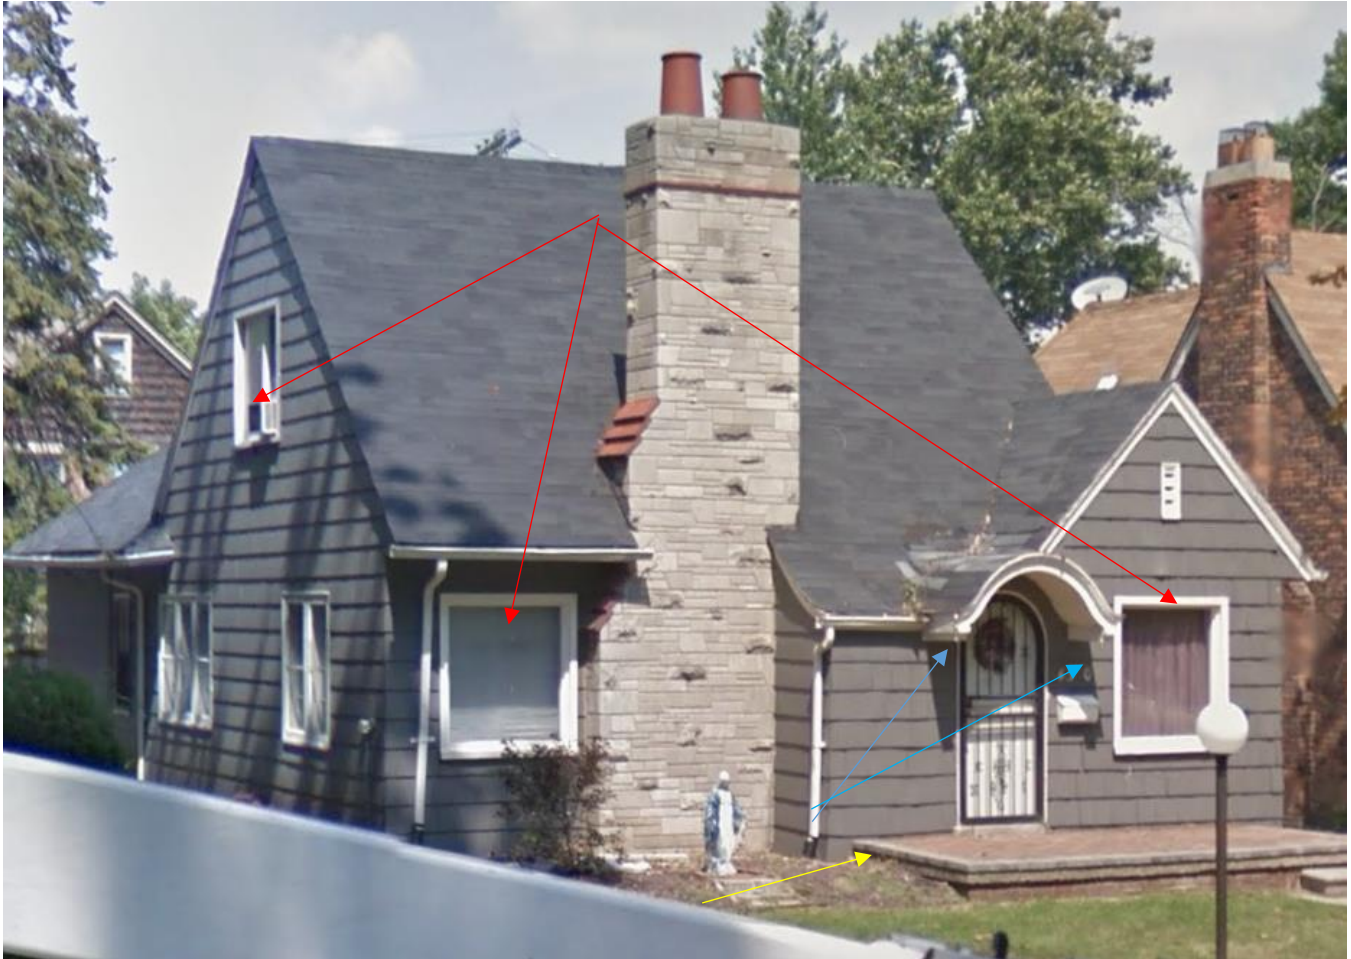
Appearance in 2013. Source, Google Streetview. Between 1999 and 2013 new vinyl windows (indicated by red arrows) and porch (indicated by yellow arrow) were installed. Also, the historic brackets at the front door canopy were removed (indicated by blue arrow).

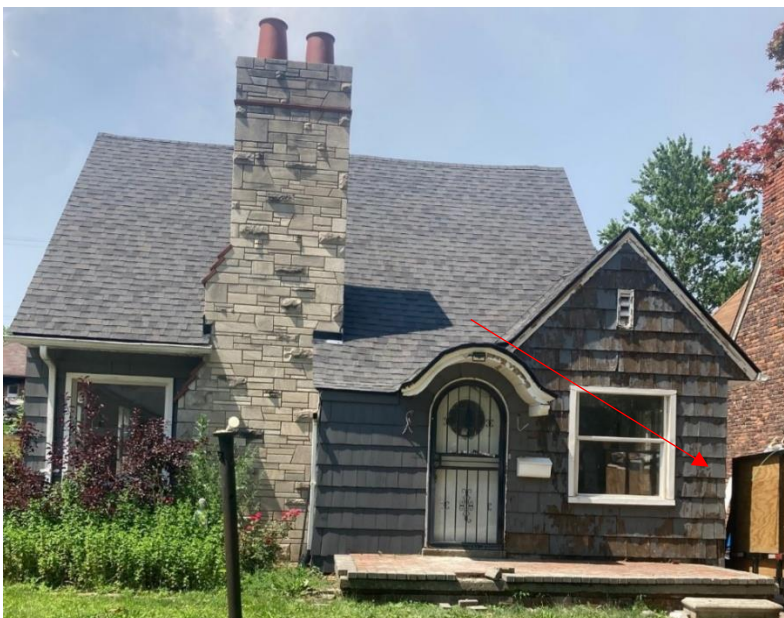
Front façade. Photo taken in 6/2024 by HDC staff. New 1/1, vinyl added in 6/2024 without HDC approval (indicated by red arrow).

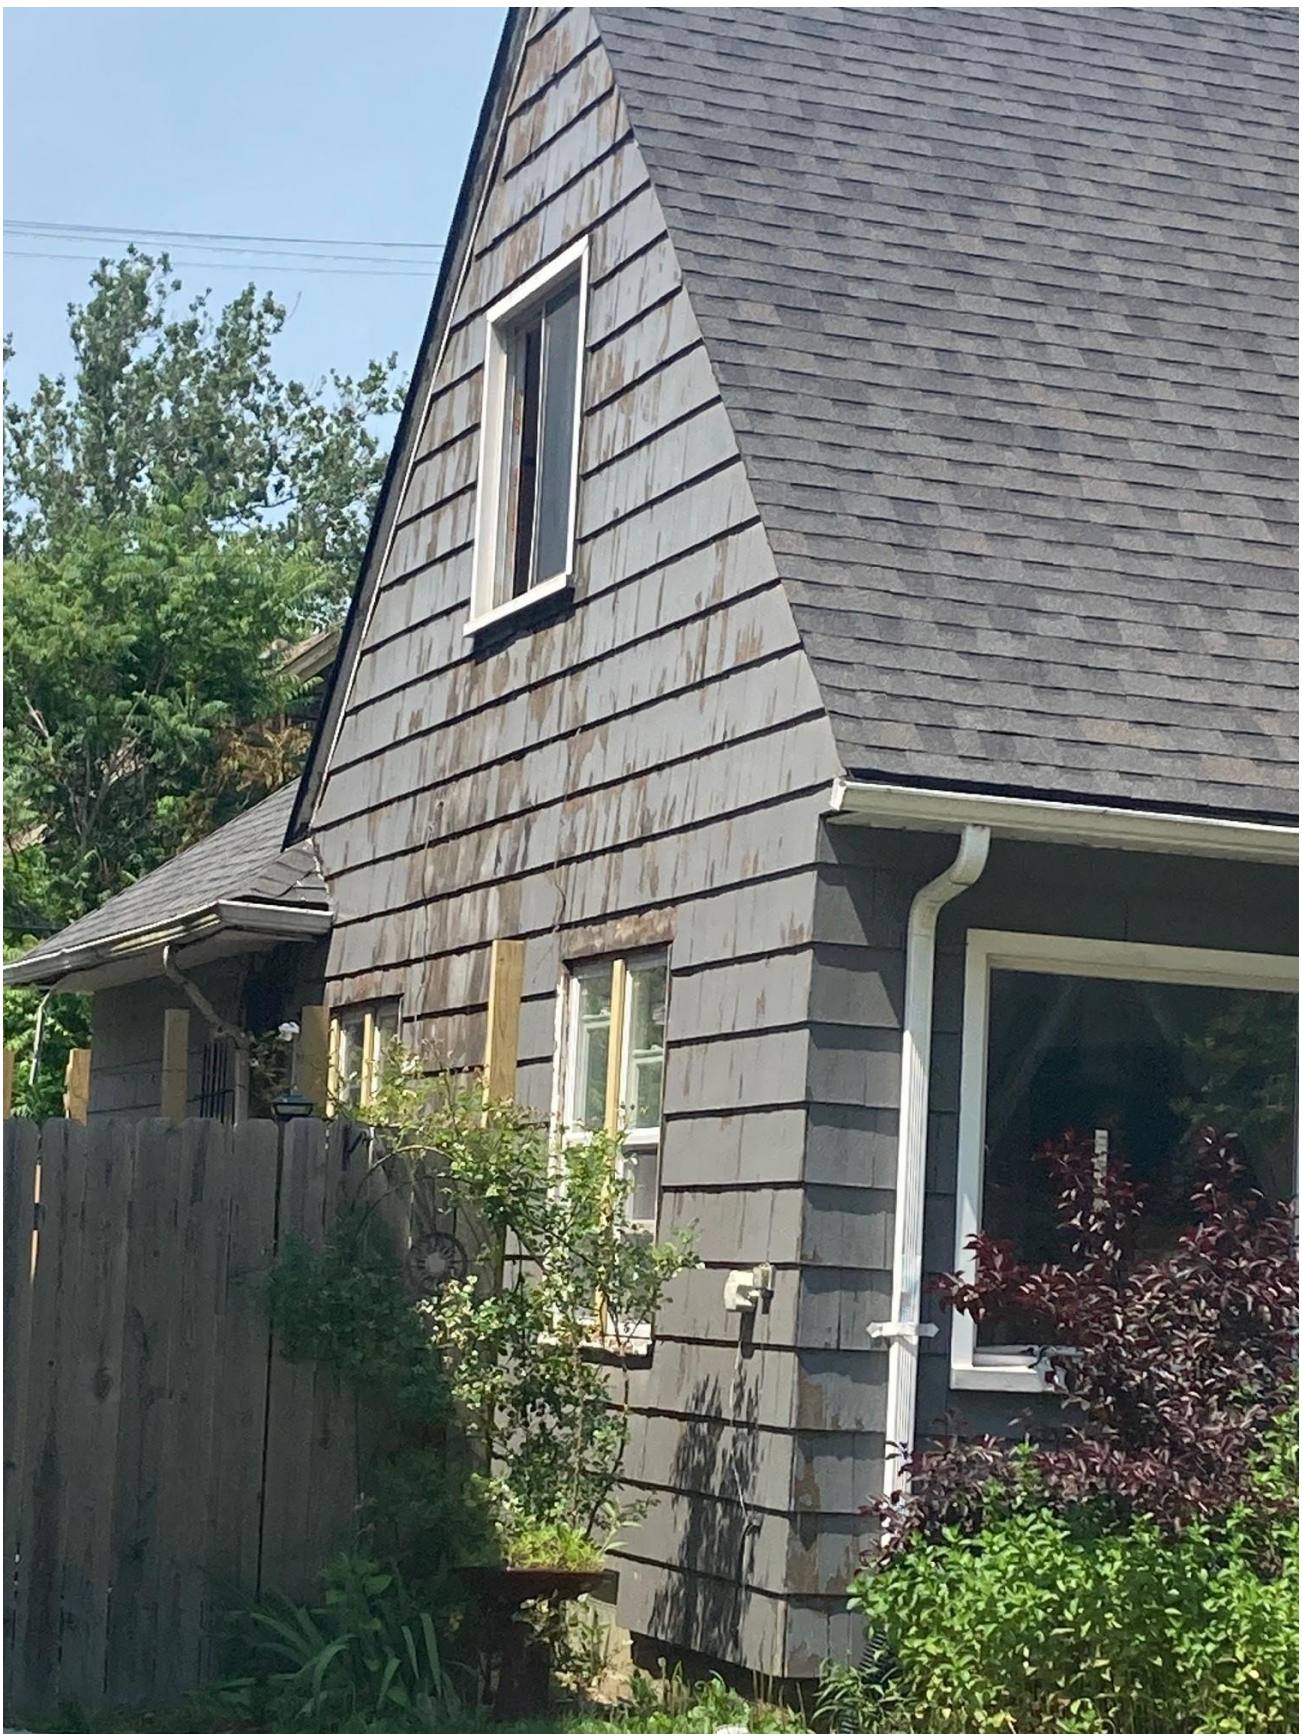
West/side wall, showing unapproved vinyl window installation and window enclosure. Photo taken in 6/2024 by former applicant

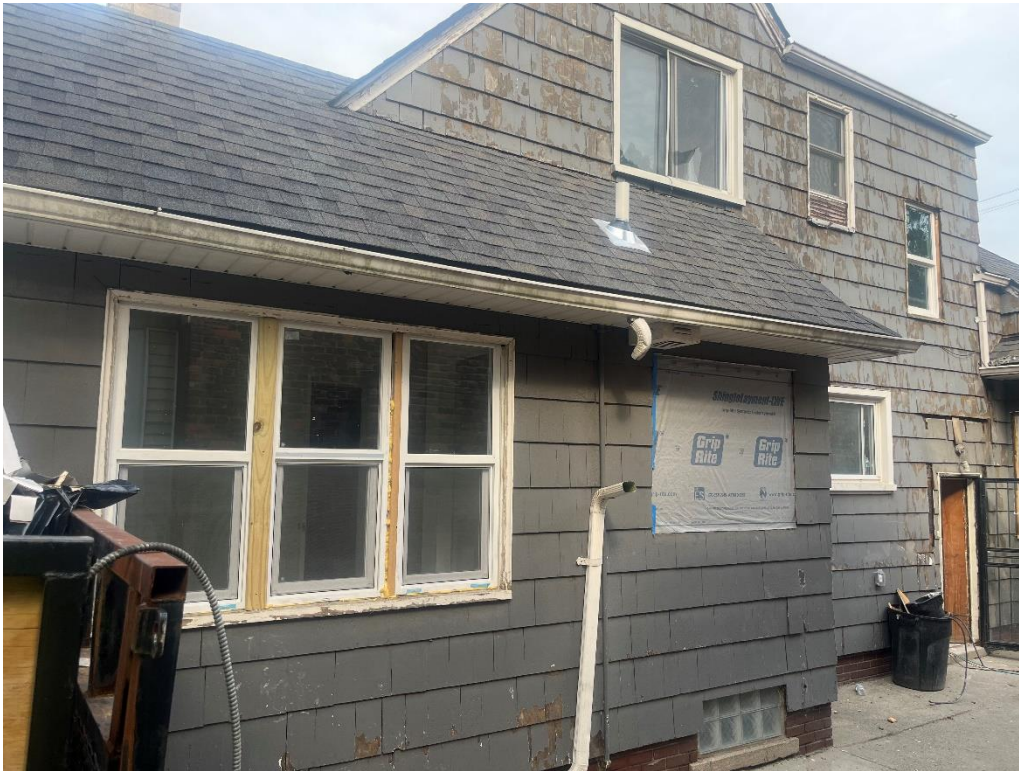
East/side wall, showing unapproved vinyl window installation and window enclosure. Photo taken in 6/2024 by former applicant

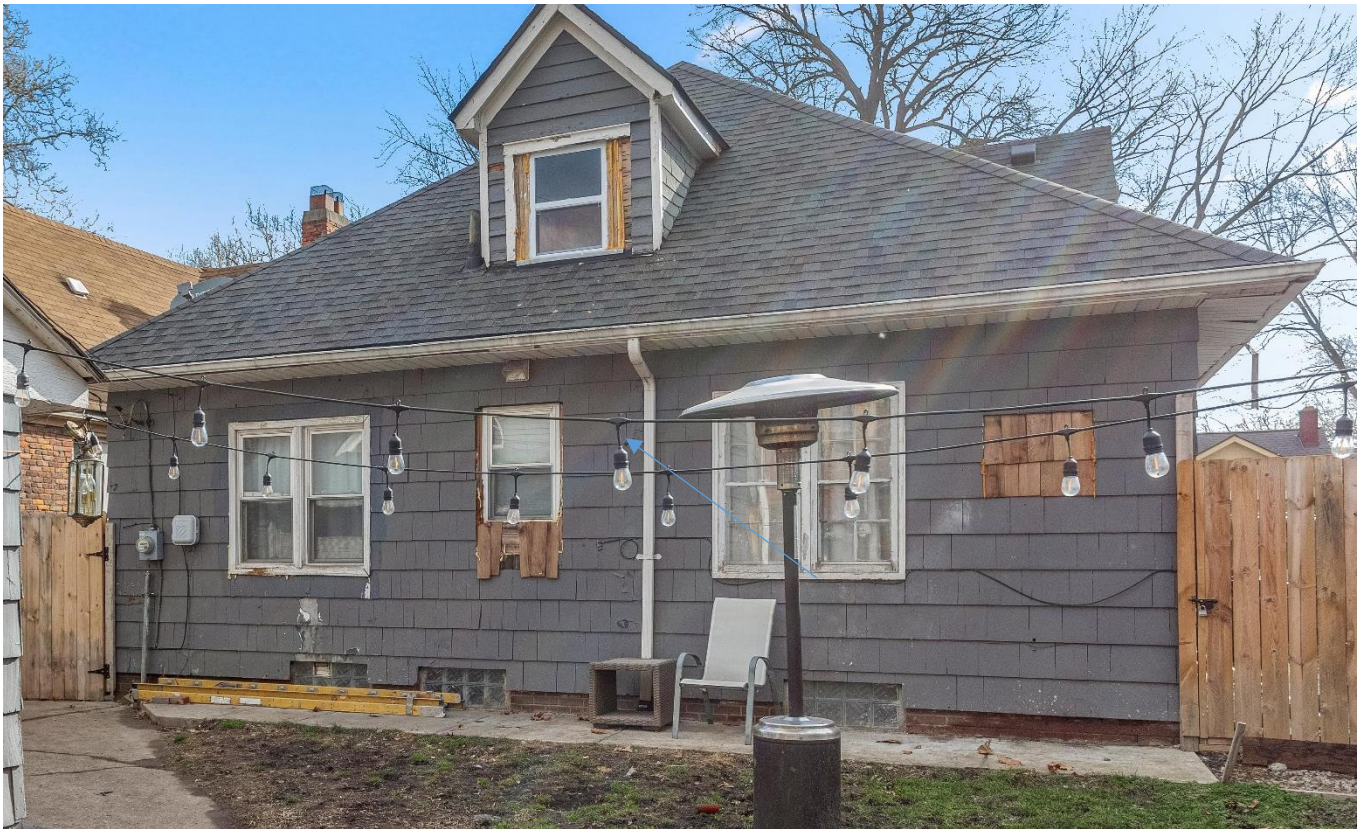
Rear wall showing unapproved vinyl window installation and window enclosure. Note that the one set of original 4/4, paired/mulled wood windows remained at this time (indicated by blue arrow). The windows have since been removed. Photo taken in 6/2024 by former applicant.

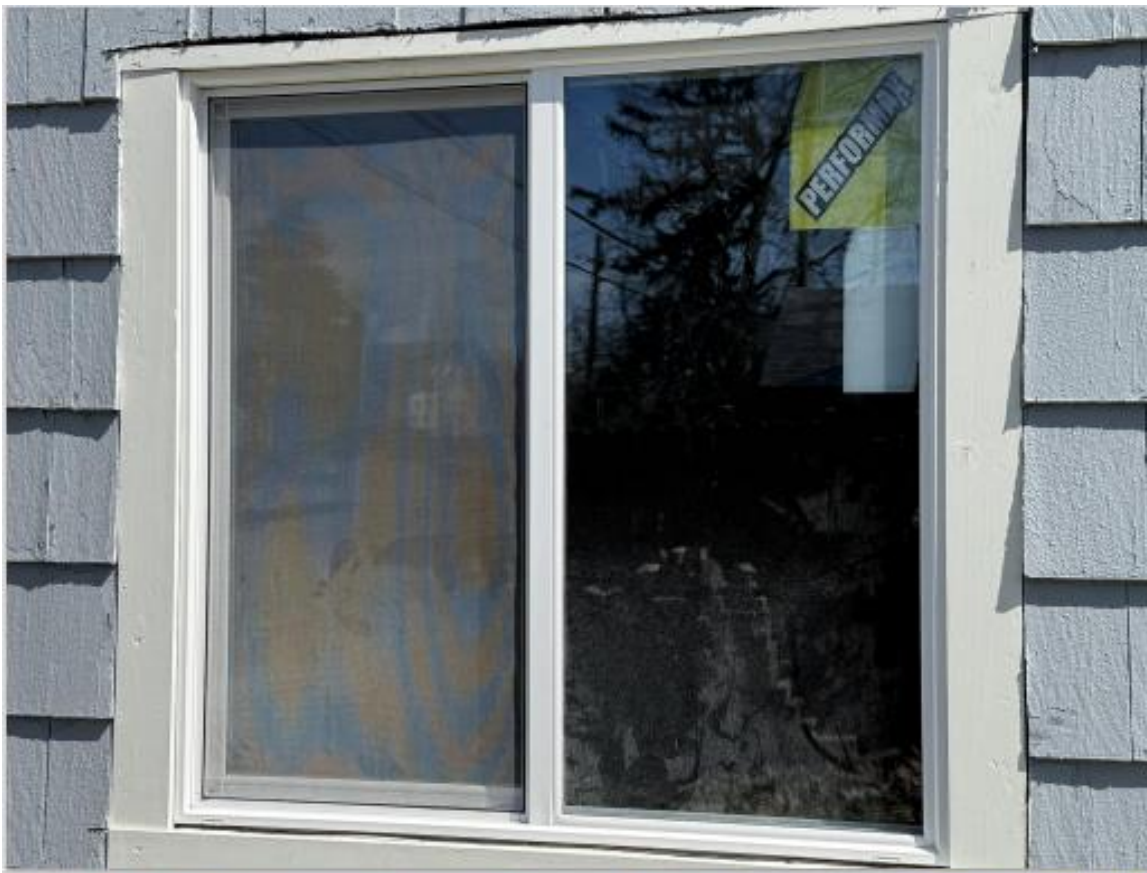
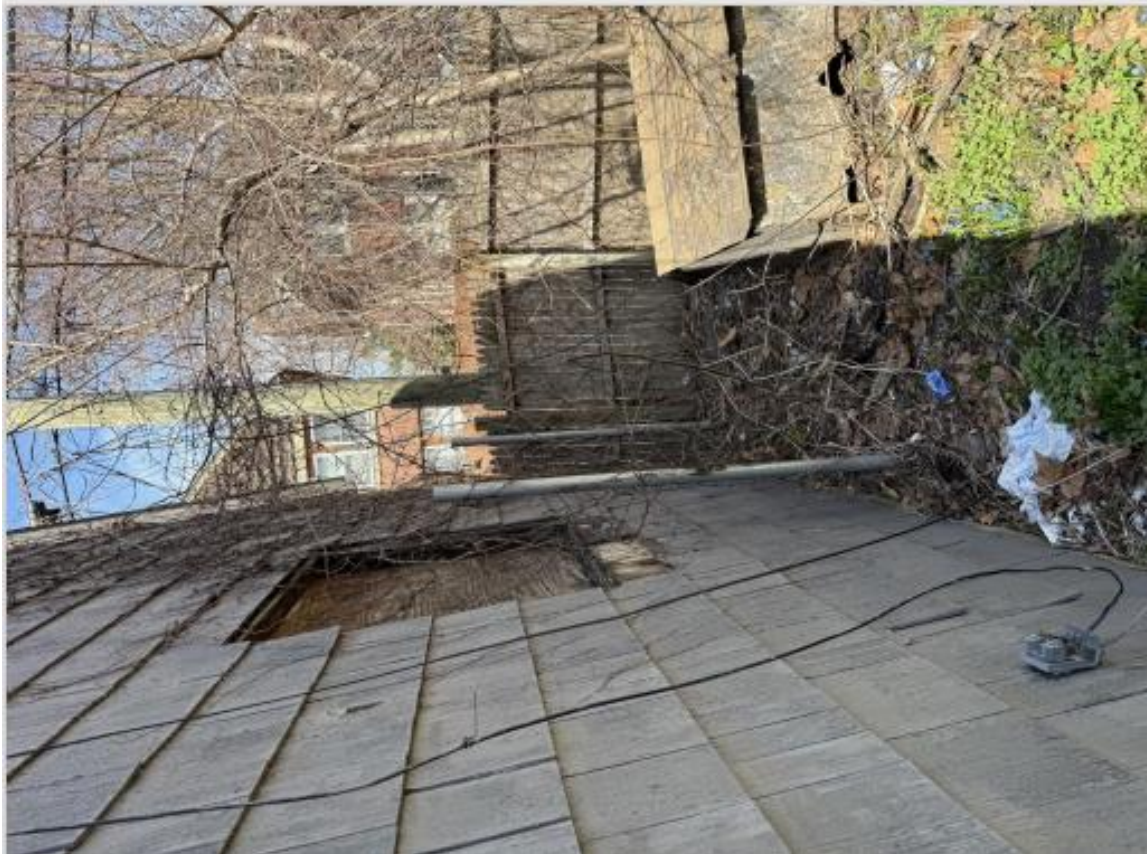
Pictures of the garage which depict work undertaken in 2024 by previous owner. Note that pictures of the full facades of the garage so it is unclear to staff if other unapproved work was taken at the garage

- With respect to the work proposed for the garage staff does note that the applicant is seeking approval to retain the unapproved vinyl slider window and removal of one window. It is staff's opinion that the vinyl slider windows are not appropriate to the building's historic character for the following reasons:

- They do not adequately resemble the historic units in terms operation.
 - Vinyl windows are not appropriate replacements for wood sash windows, due to their synthetic appearance and poor durability

Finally, staff notes that the window opening proposed for removal and enclosure at the garage wall is not visible from the public right-of-way. However, it is staff's opinion that the proposed enclosure of the opening with plywood is not an appropriate long-term treatment for the opening because plywood panel is not compatible with garage's existing siding and/or historic appearance. Rather, the opening should be enclosed with wood shake to match the adjacent siding.

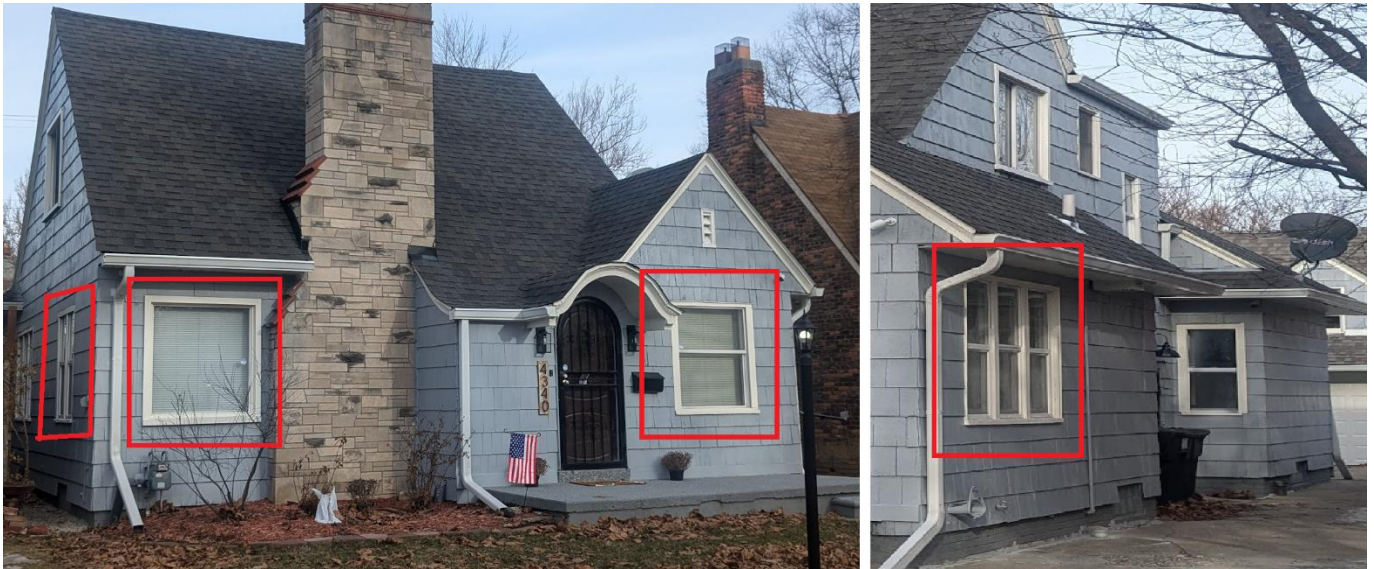
Windows proposed for replacement in February 2025 HDC application (outlined in red). Photos by staff in 2024.

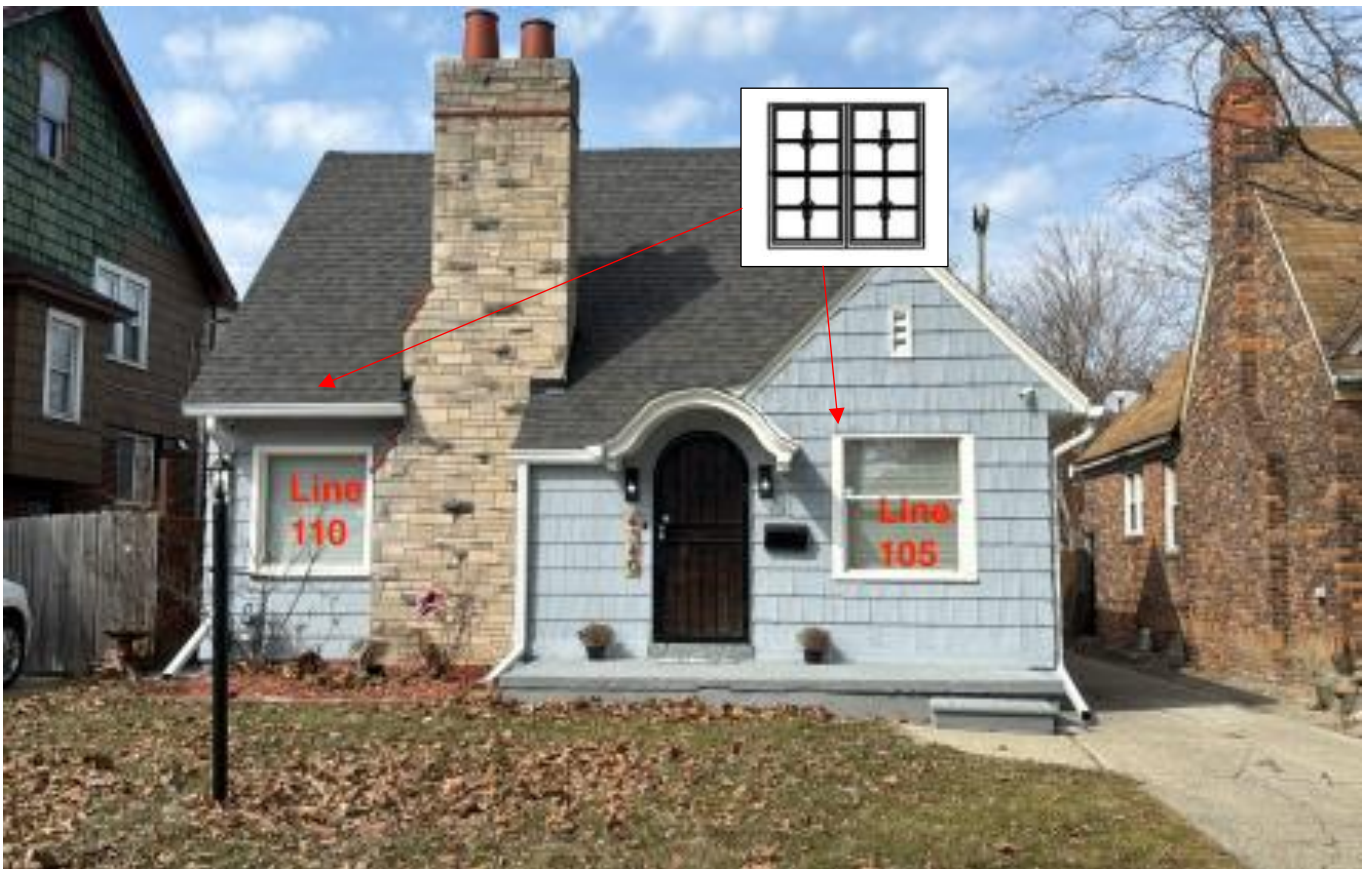
Front façade. Two (2) sets of paired 4/4 double-hung windows with factory mull to be installed. Existing wood trim will be retained

- It is staff's opinion that the proposed factory mullions do not adequately replicate the profile, width and depth of historic mullions. Staff therefore recommends that true wood mullions which match the existing be installed where missing at paired windows.

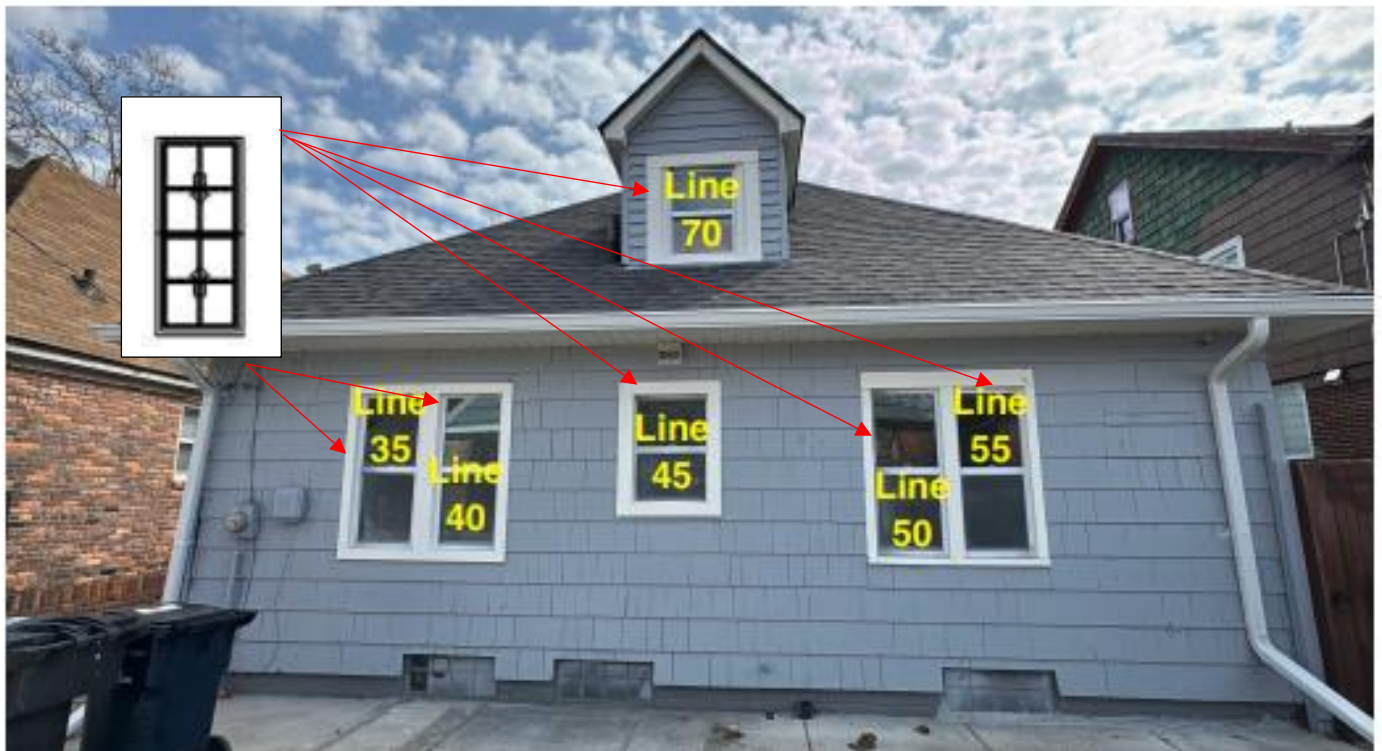
Rear elevation. Six (6), 4/4, double-hung, aluminum clad wood sash windows to be installed. Existing wood trim will be retained. Note that vinyl siding appears to have been installed at the dormer; the opening for window labeled “Line 45” has been partially infilled and covered with singles; and an opening to the right of the window labeled “Line 55” has been infilled and covered with shingles.

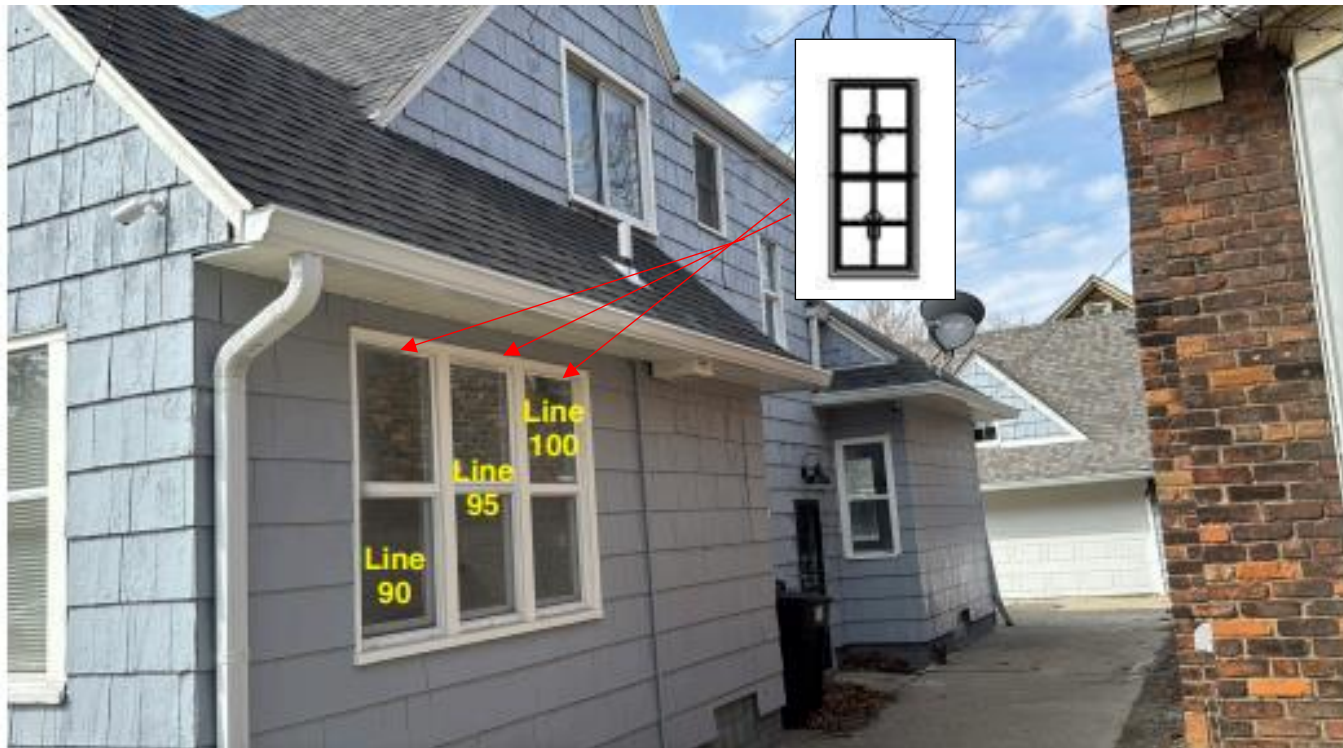
East façade. Three (3), 4/4, double-hung windows to be installed. Existing wood trim will be retained

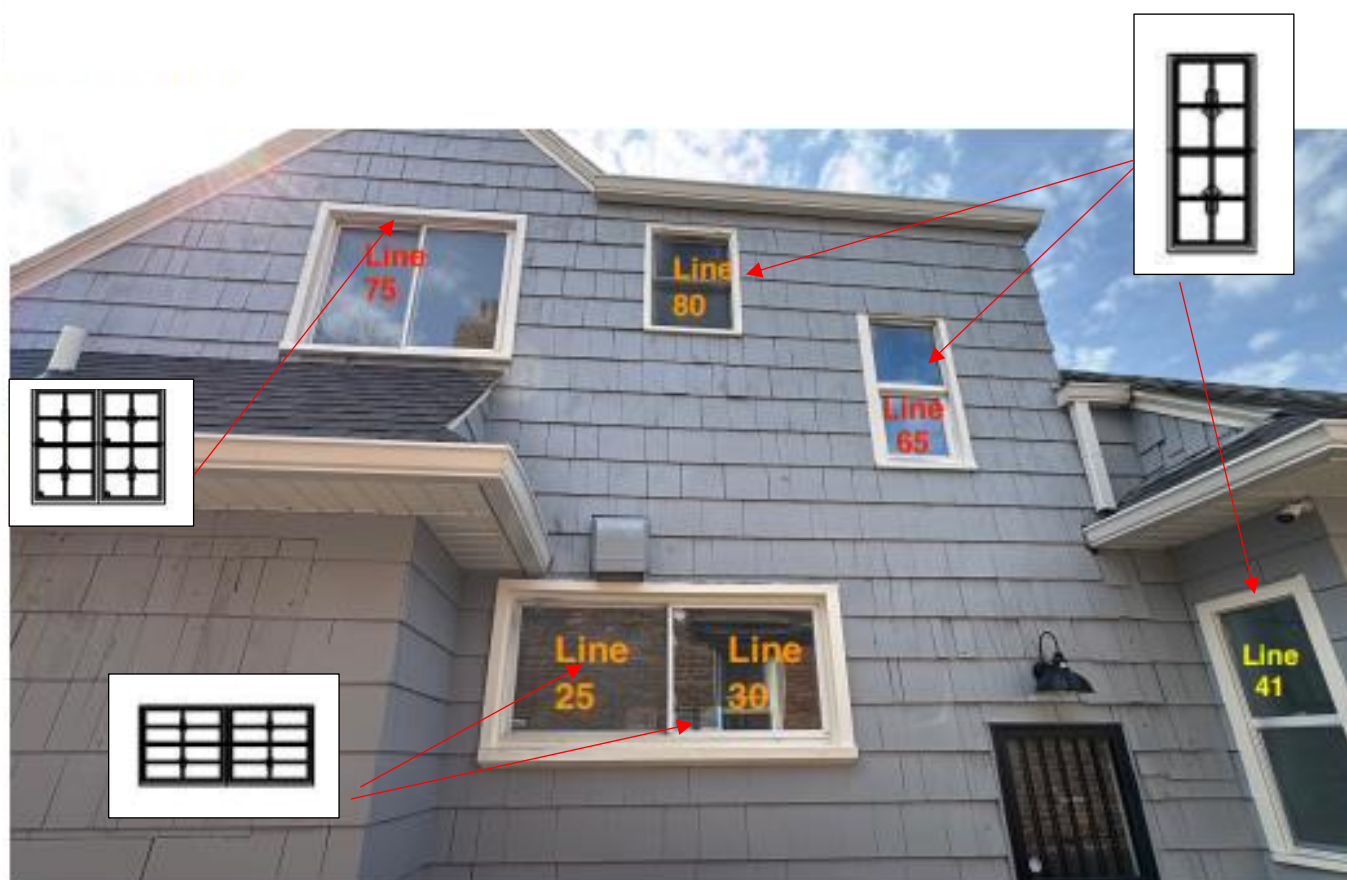
East façade. Three (3), 4/4, double-hung windows, three (3) sets of paired 4/4 double-hung windows with factory mull to be installed. Existing wood trim will be retained

- The double-hung, 4/4 windows proposed for installation at the kitchen/east façade, first story are not compatible with the building's historic character. Rather, multiple lite, casement units would be more appropriate replacement windows at this location **should the Commission approve this application.**

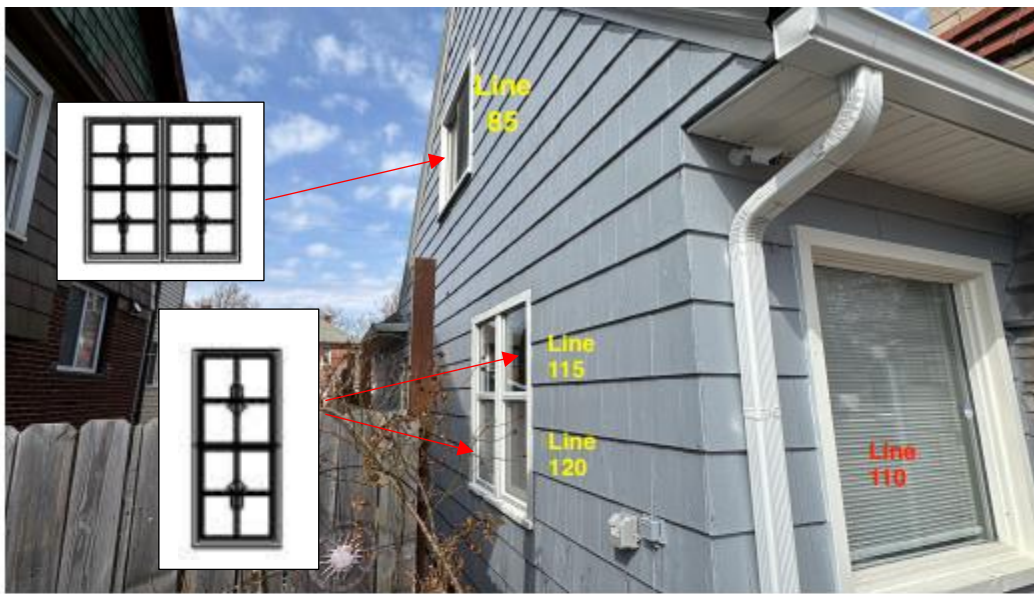
West façade. Two (2), 4/4, double-hung windows and a set of paired 4/4 double-hung windows with factory mull to be installed. Existing wood trim will be retained

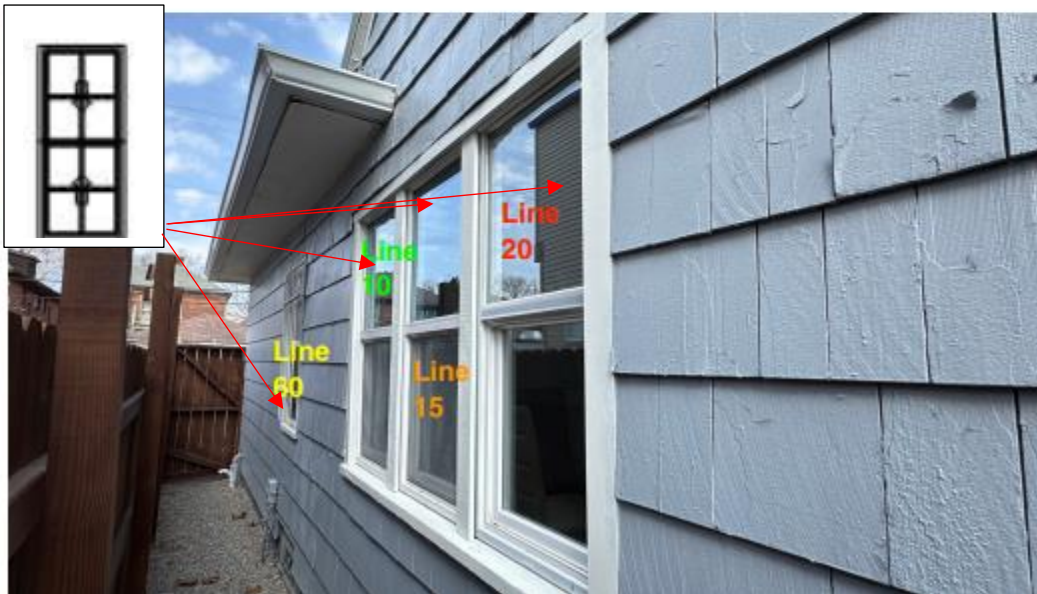
West façade. Four (4), 4/4, double-hung, aluminum clad wood sash windows to be installed. Existing wood trim will be retained
