STAFF REPORT: 04/09/2025 MEETING
APPLICATION NUMBER: HDC2025-00062
ADDRESS: 15150 WARWICK

HISTORIC DISTRICT: ROSEDALE PARK
APPLICANT / PROPERTY OWNER: ERIC DANIEL
DATE OF PROVISIONALLY COMPLETE APPLICATION: 03/16/2025
DATE OF STAFF SITE VISIT: 03/29/2025

SCOPE: REPLACE WOOD WINDOWS WITH VINYL WINDOWS

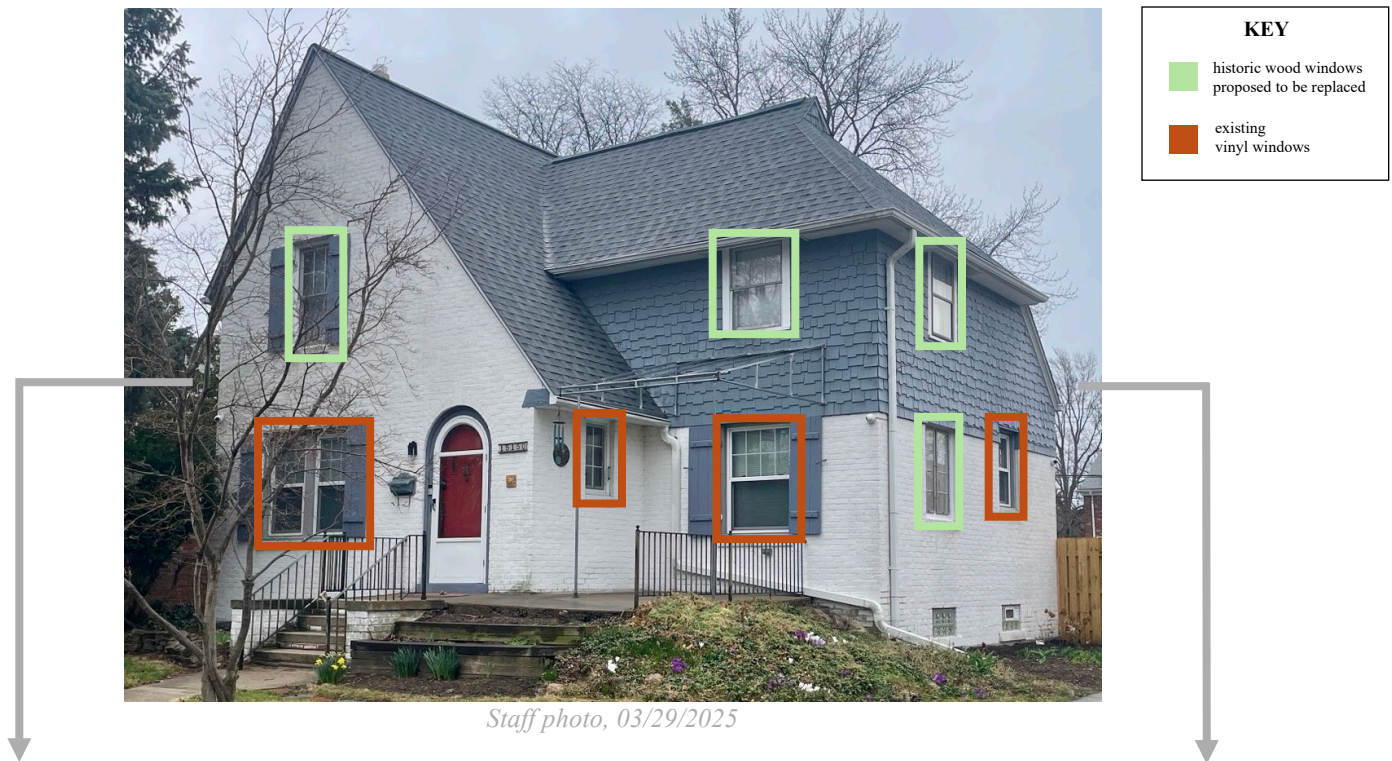
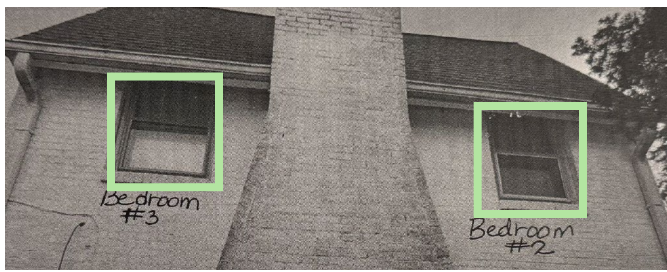
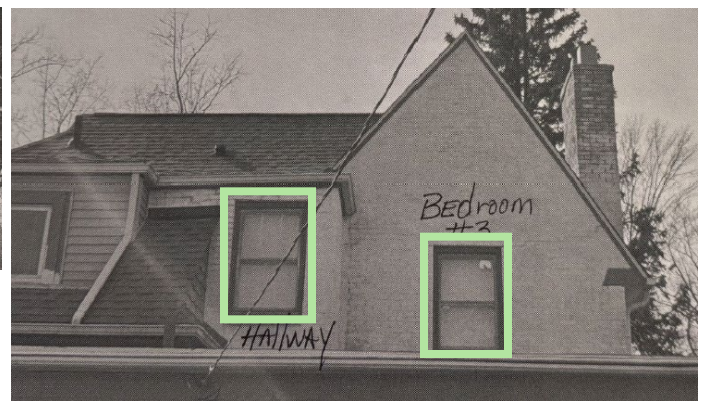
- The first floor windows, with exception of one pair of casements, have been replaced by the previous owners (not the current owner / applicant) without approval from the Commission in 2016.

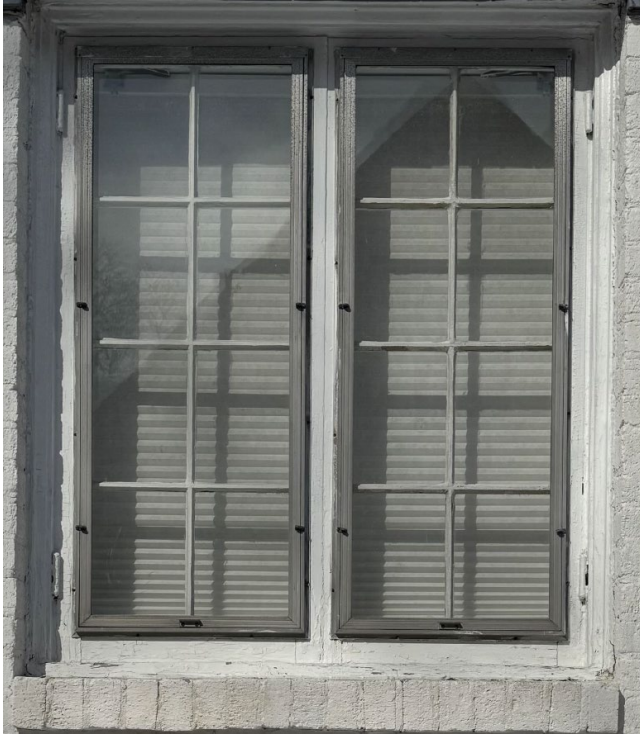
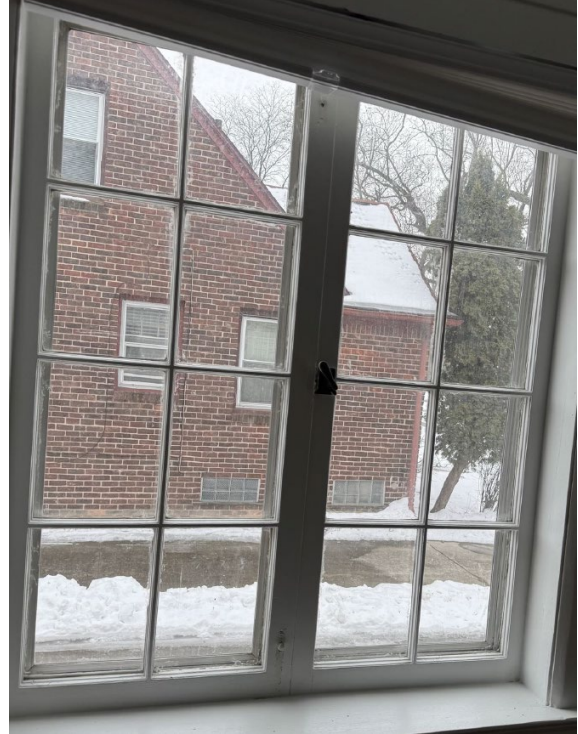
Photos from application, South elevation casements

- Photos provided with the application show additional, relatively minor, deterioration, such as peeling paint and cracked glazing. Photos also show that some of the windows seem to have been painted over multiple times, a condition that will impair their operation.

- The deterioration noted above constitutes typical maintenance needs of old windows and is repairable (per *Preservation Briefs: 9* linked below). Any areas of damaged wood appear, to staff, to be minor and localized, and repairable. Thus, the windows do not seem to meet the standard of being “deteriorated beyond repair,” the standard required for their replacement under the Secretary of the Interior’s Standards for Rehabilitation (quoted in full below).
