STAFF REPORT: 05/14/2025 MEETING

ADDRESS: 1624 EDISON

APPLICATION NO: HDC2025-0200

SCOPE: REHABILITATE DWELLING AND GARAGE (WORK COMPLETED WITHOUT APPROVAL)

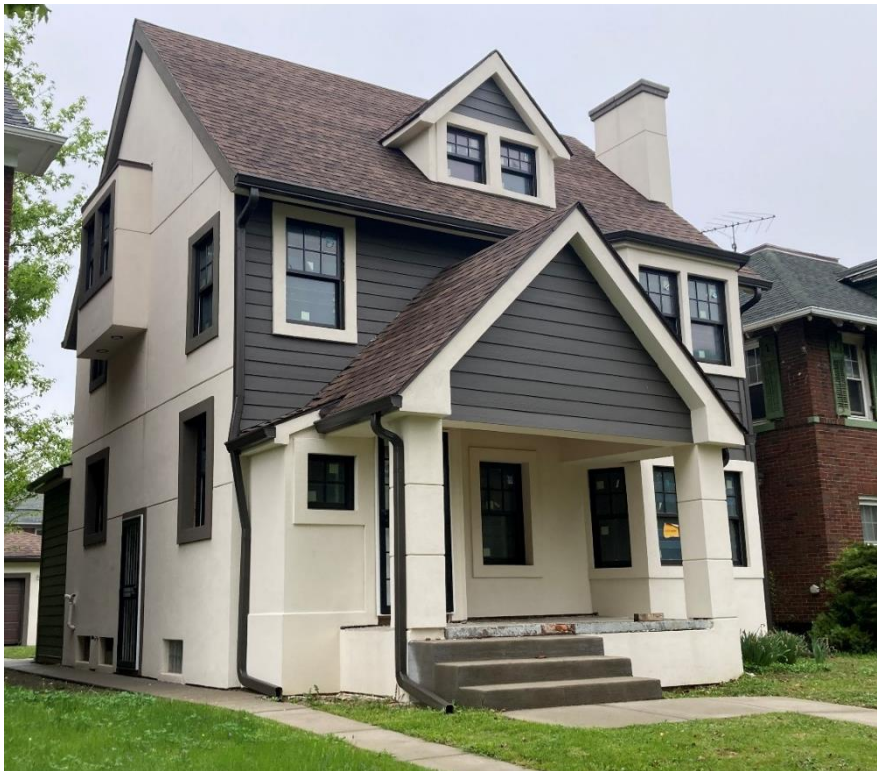
Current condition. Staff photo taken 4/25/2025

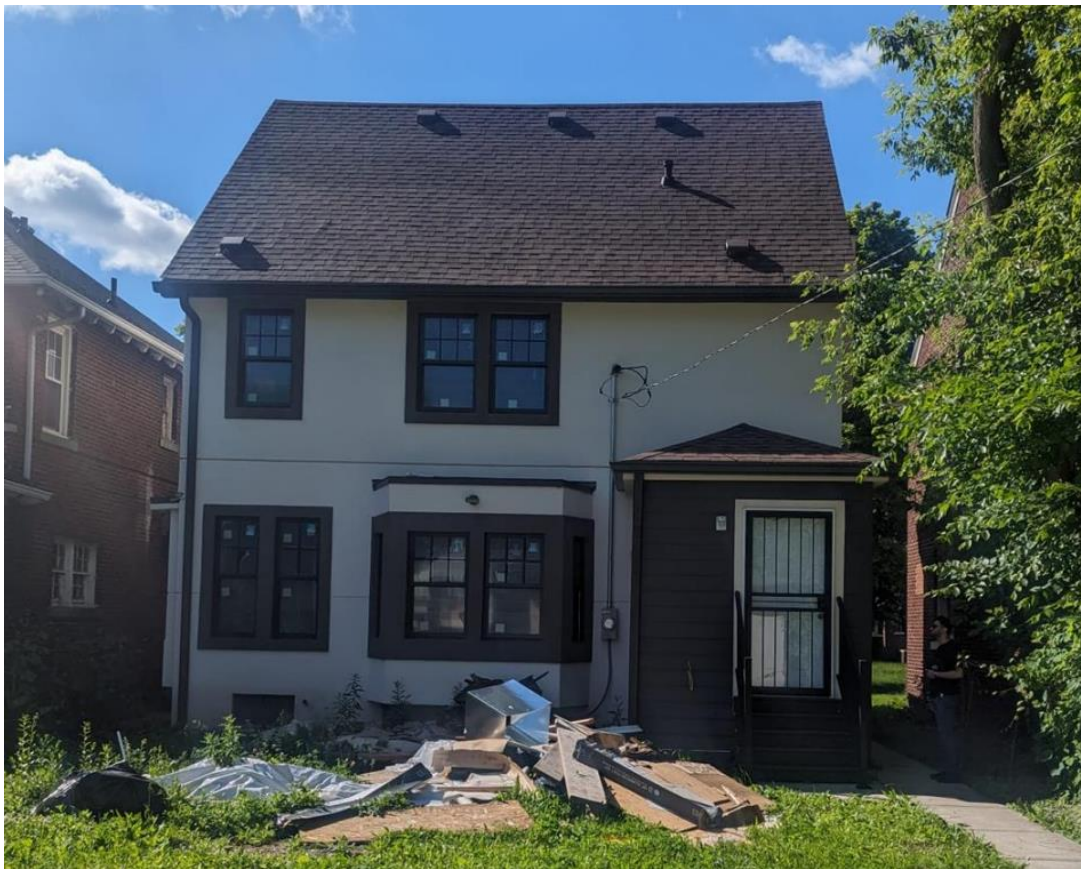
Current condition at rear. Photo by applicant

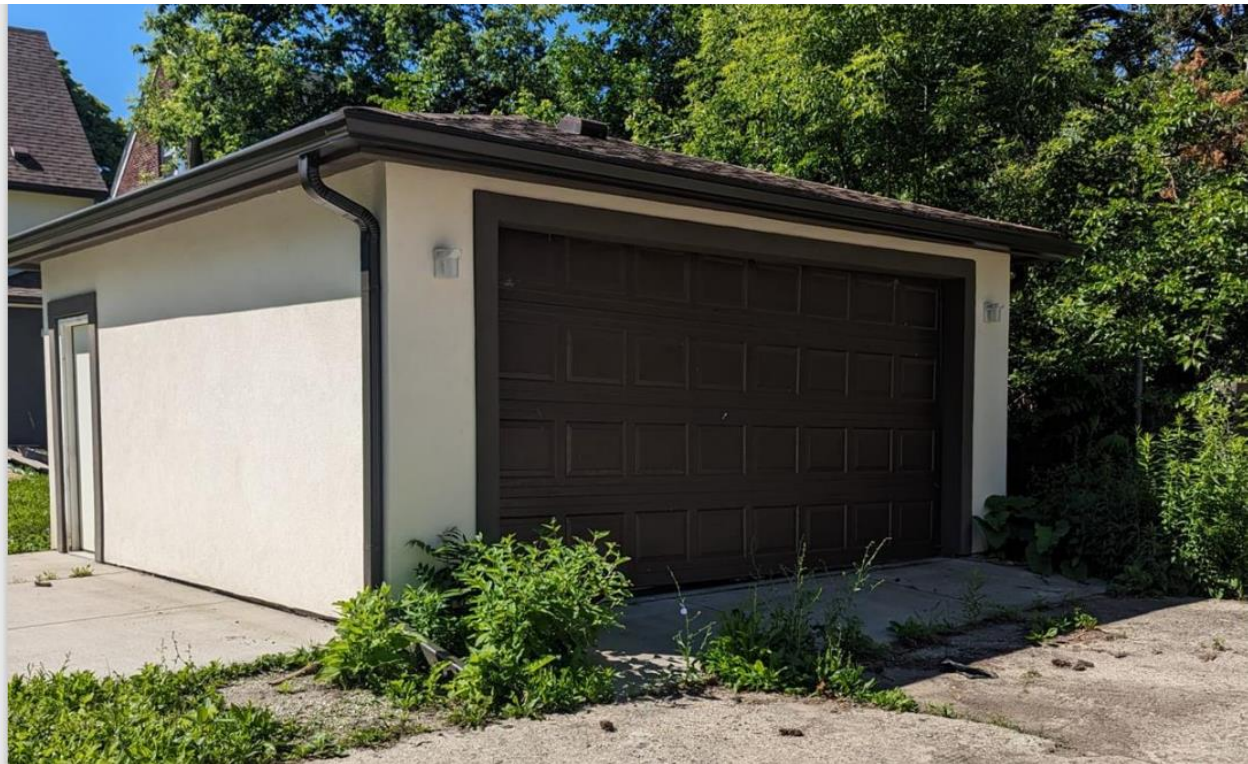
Current condition of garage. Photo by applicant

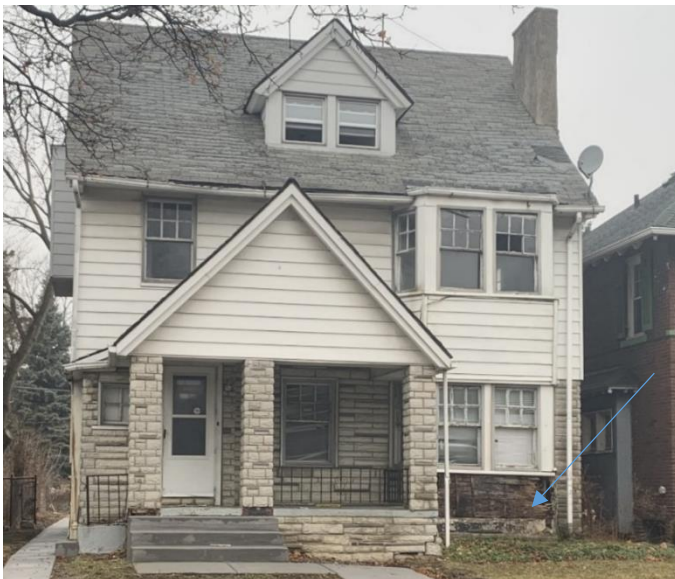
Front façade, 2020 photo taken by owner. Note area where Permastone has fallen off (indicated by blue arrow)

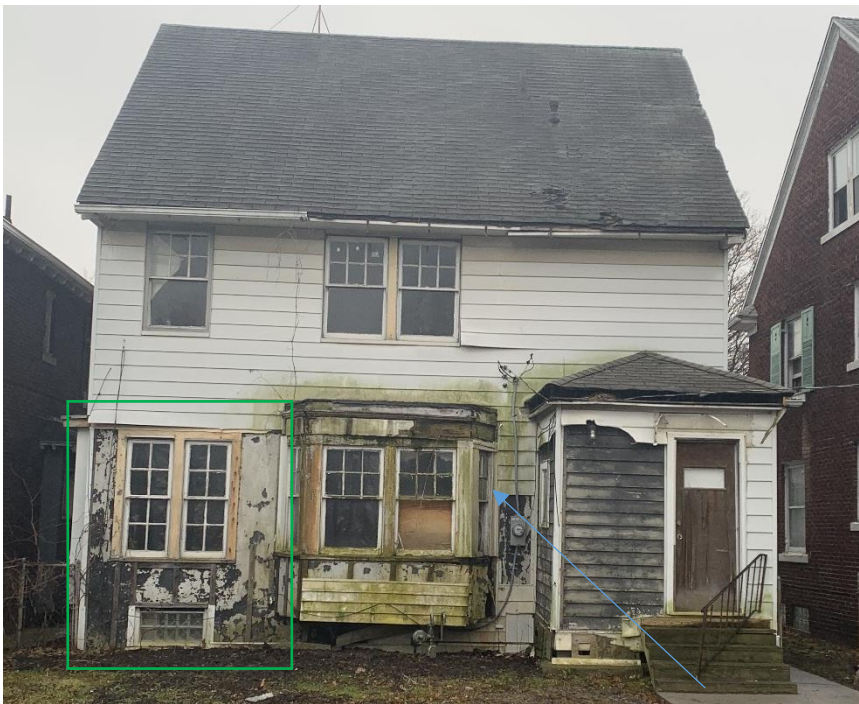
Rear, photo taken in 2020 by owner. Note apparent fire damage at first story. The area outlined in green shows original stucco finish at first story. Also, note that the fire has exposed the historic lapped wood siding at the siding at the hipped roof wing

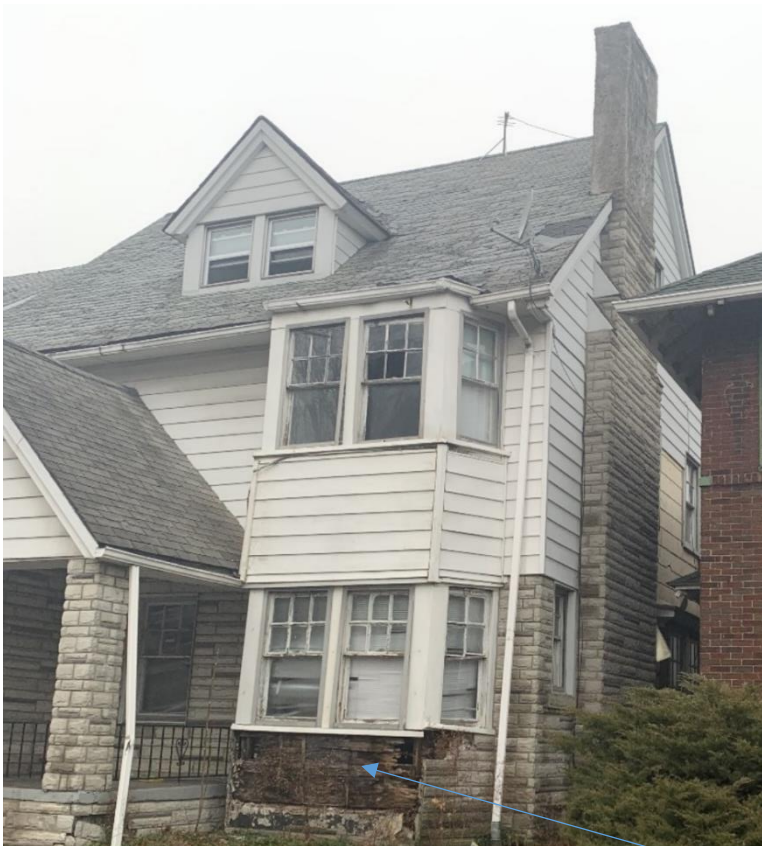
Photo taken in 2020 by owner. Note area where aluminum siding has fallen off, revealing synthetic shingle siding underneath.

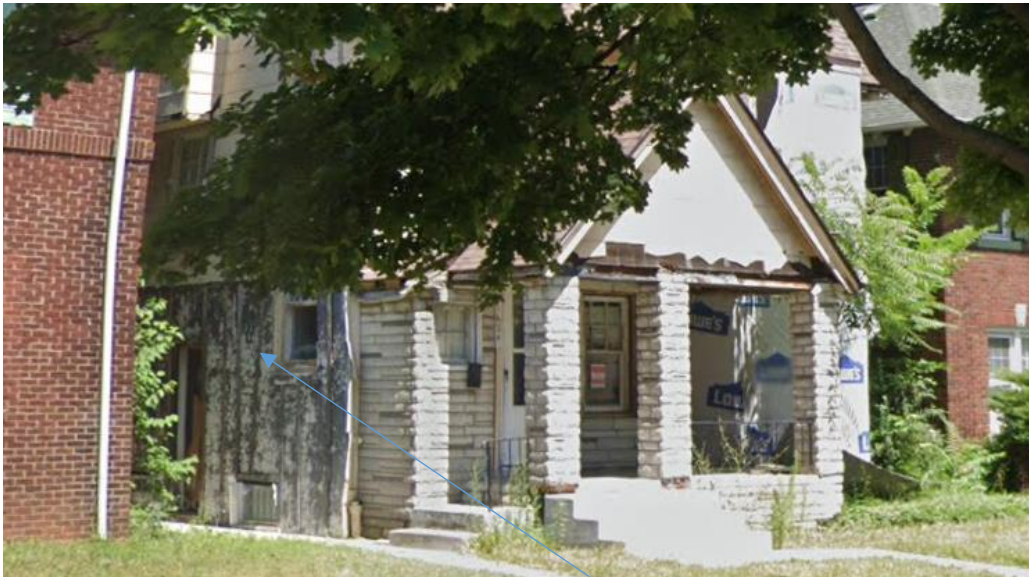
Conditions in 2020, per Google Streetview. Note where PermaStone has been removed to reveal original stucco finish at first story

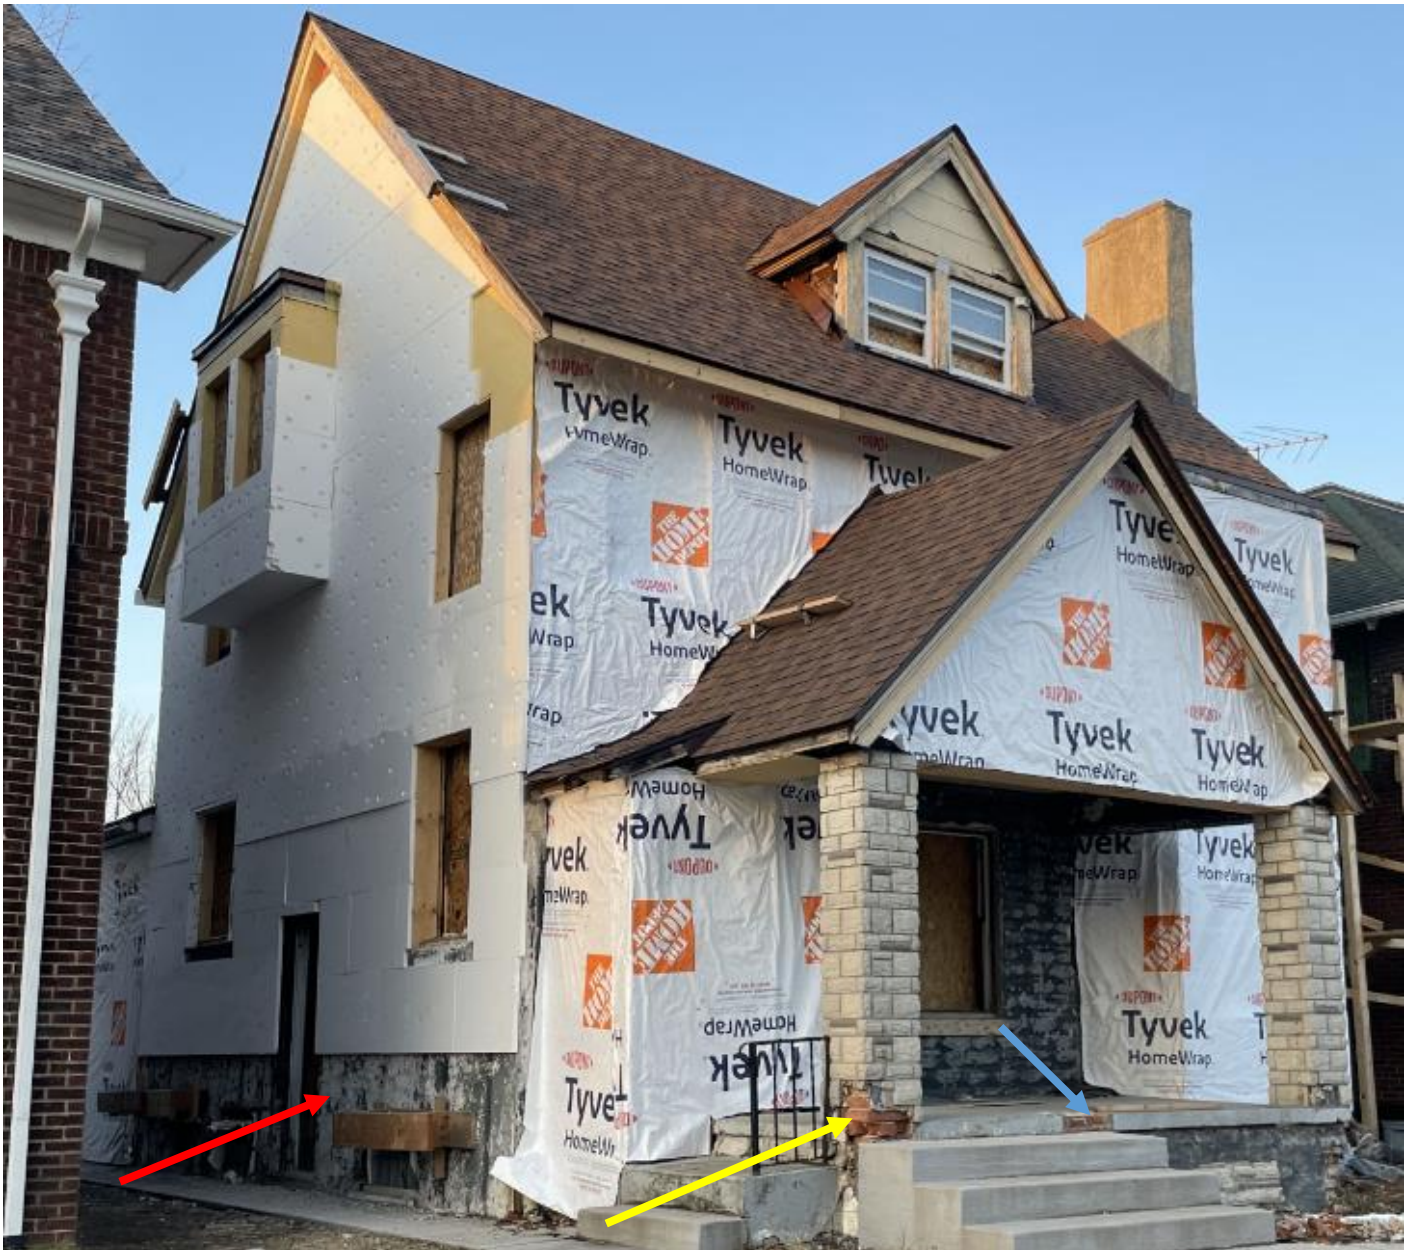
Conditions on 1/24/2023. Photo by HDC staff. Note that stucco remains beneath the current EIFS at the first story (red arrow). Also, note that the original masonry porch columns were masonry with stucco, as seen beneath the Permastone (yellow arrow). A centrally-located porch column had been removed by this point (blue arrow)

- The EIFS at the first story should be removed throughout. The original stucco cladding underneath should be retained and repaired where necessary. If the stucco is deteriorated beyond repair, it should be replaced with a new true stucco system to match the original/historic in material, design, and texture.

- The EIFS should be removed from the front porch posts and deck. If the original stucco cladding underneath remains, it should be retained and repaired where necessary. If the stucco is deteriorated beyond repair, it should be replaced with new stucco (pargecoat at the porch deck exterior) to match the original/historic in material, design, and texture.

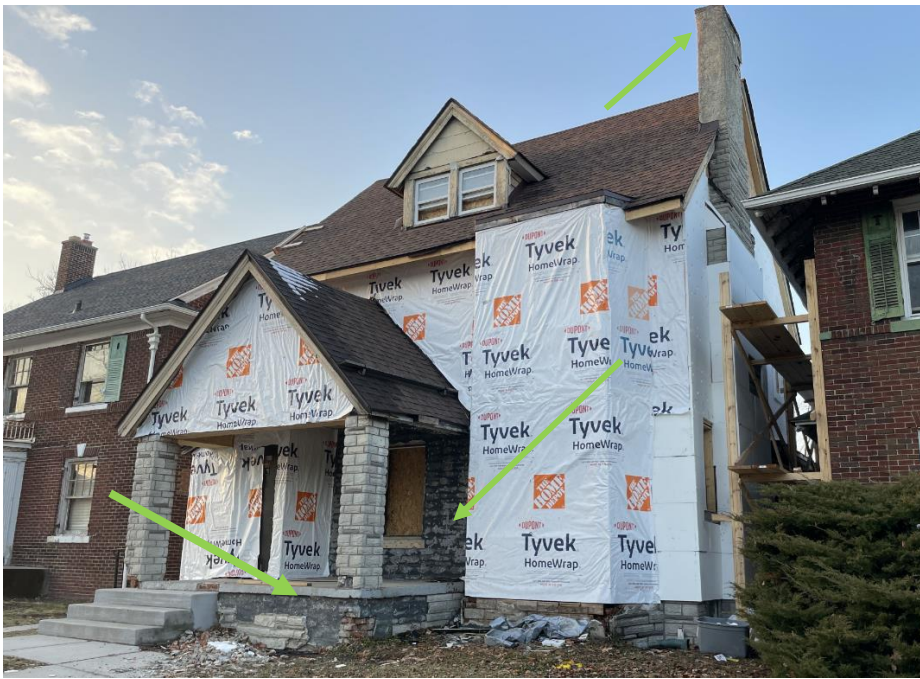
Conditions on 1/24/2023. Photo by HDC staff. Note stucco at chimney, porch floor and front wall (green arrows)

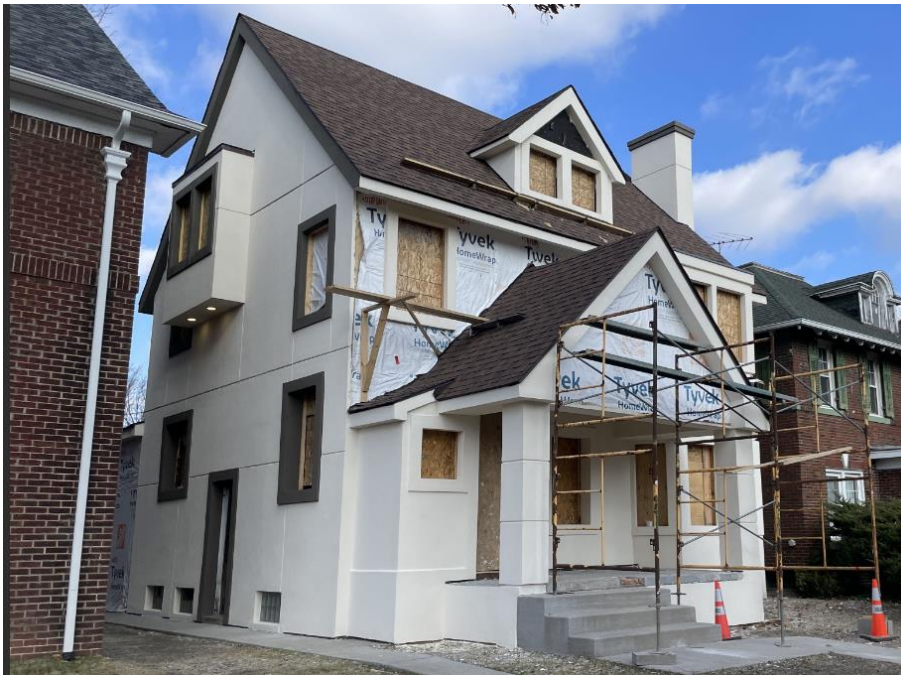
- On December 12, 2023, HDC staff visited the site a second time to note ongoing unapproved work at the property. At this point, new EIFS siding had been added throughout and new synthetic/EIFS fascia and soffit had been installed at the roof. HDC staff forwarded the report of unapproved work to the building department for enforcement that same day. The following photo illustrates conditions in December 2023.

Photo by HDC staff, taken on 12/12/2023

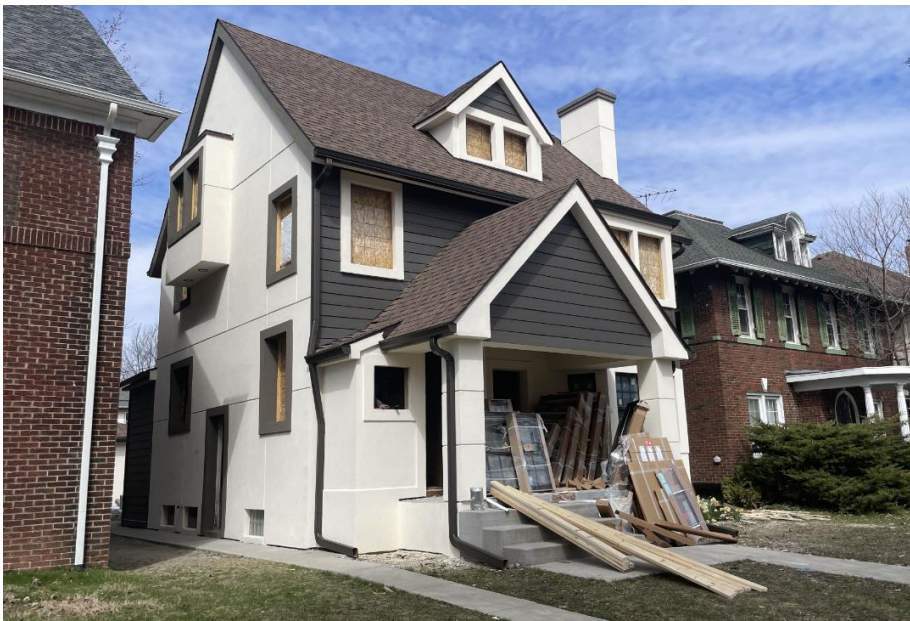
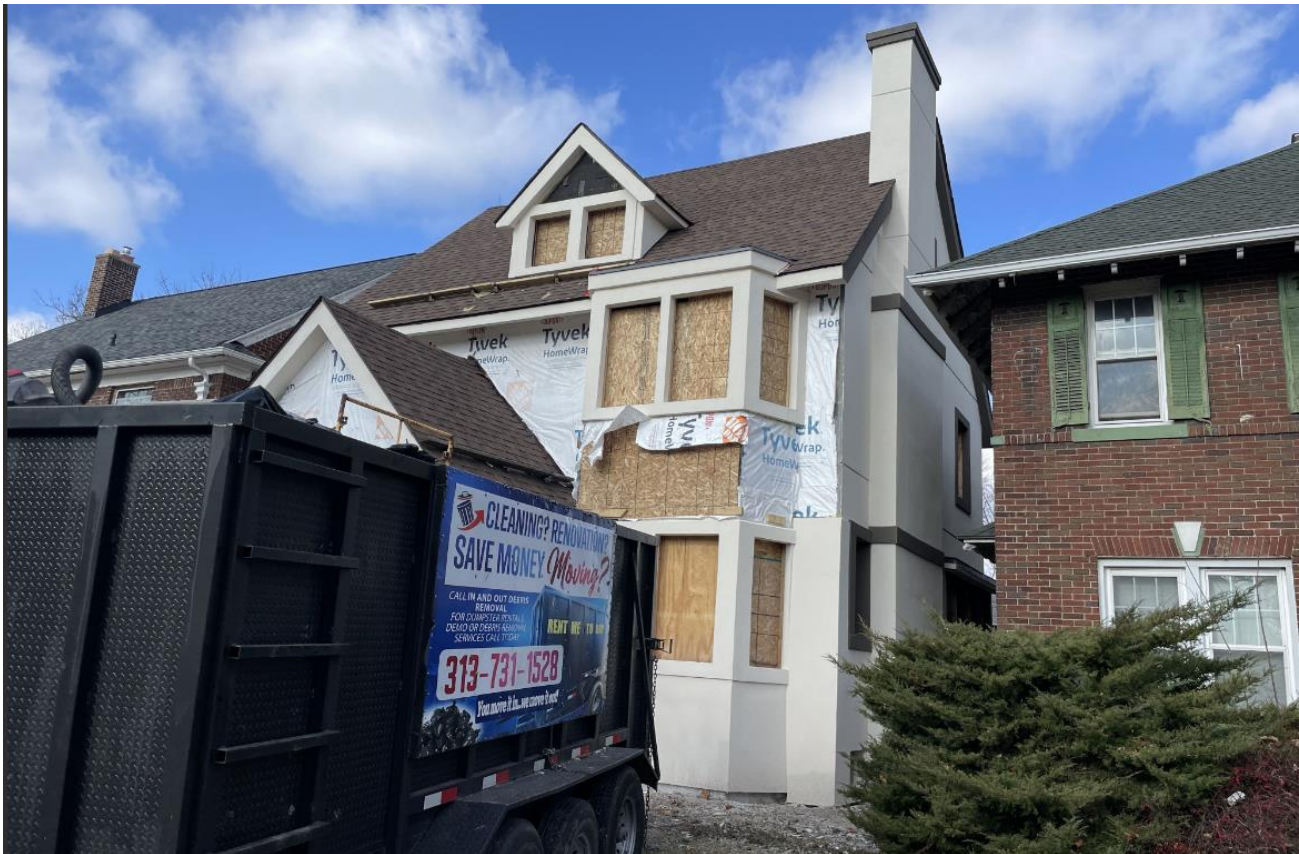
- On March 21, 2024, HDC staff visited the site for a third time, noting that construction continued unabated, to include the installation of cement fiber siding. HDC staff reported the unapproved work to the building department that same day. In response, the building department visited the site on 3/26/2024 and issued a stop work order. Please see the below photos which recorded conditions on 3/21/2024:

Front façade. Photo taken by HDC staff on 3/21/2024
