STAFF REPORT: 5/14/2025 MEETING

ADDRESS: 2044 CHICAGO

APPLICATION NO: HDC2024-00199

SCOPE: REPLACE WINDOWS AND REBUILD 2nd AND 3RD STORY

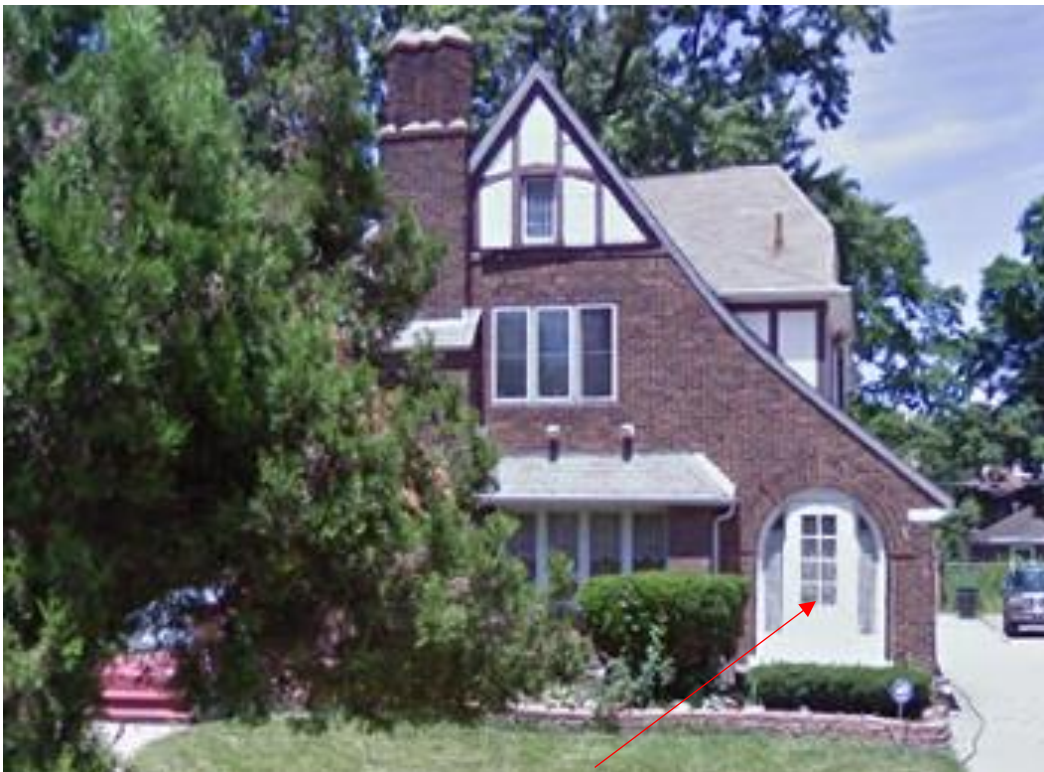
Google Streetview, 2013. Note that historic wood door with leaded glass sidelites are present

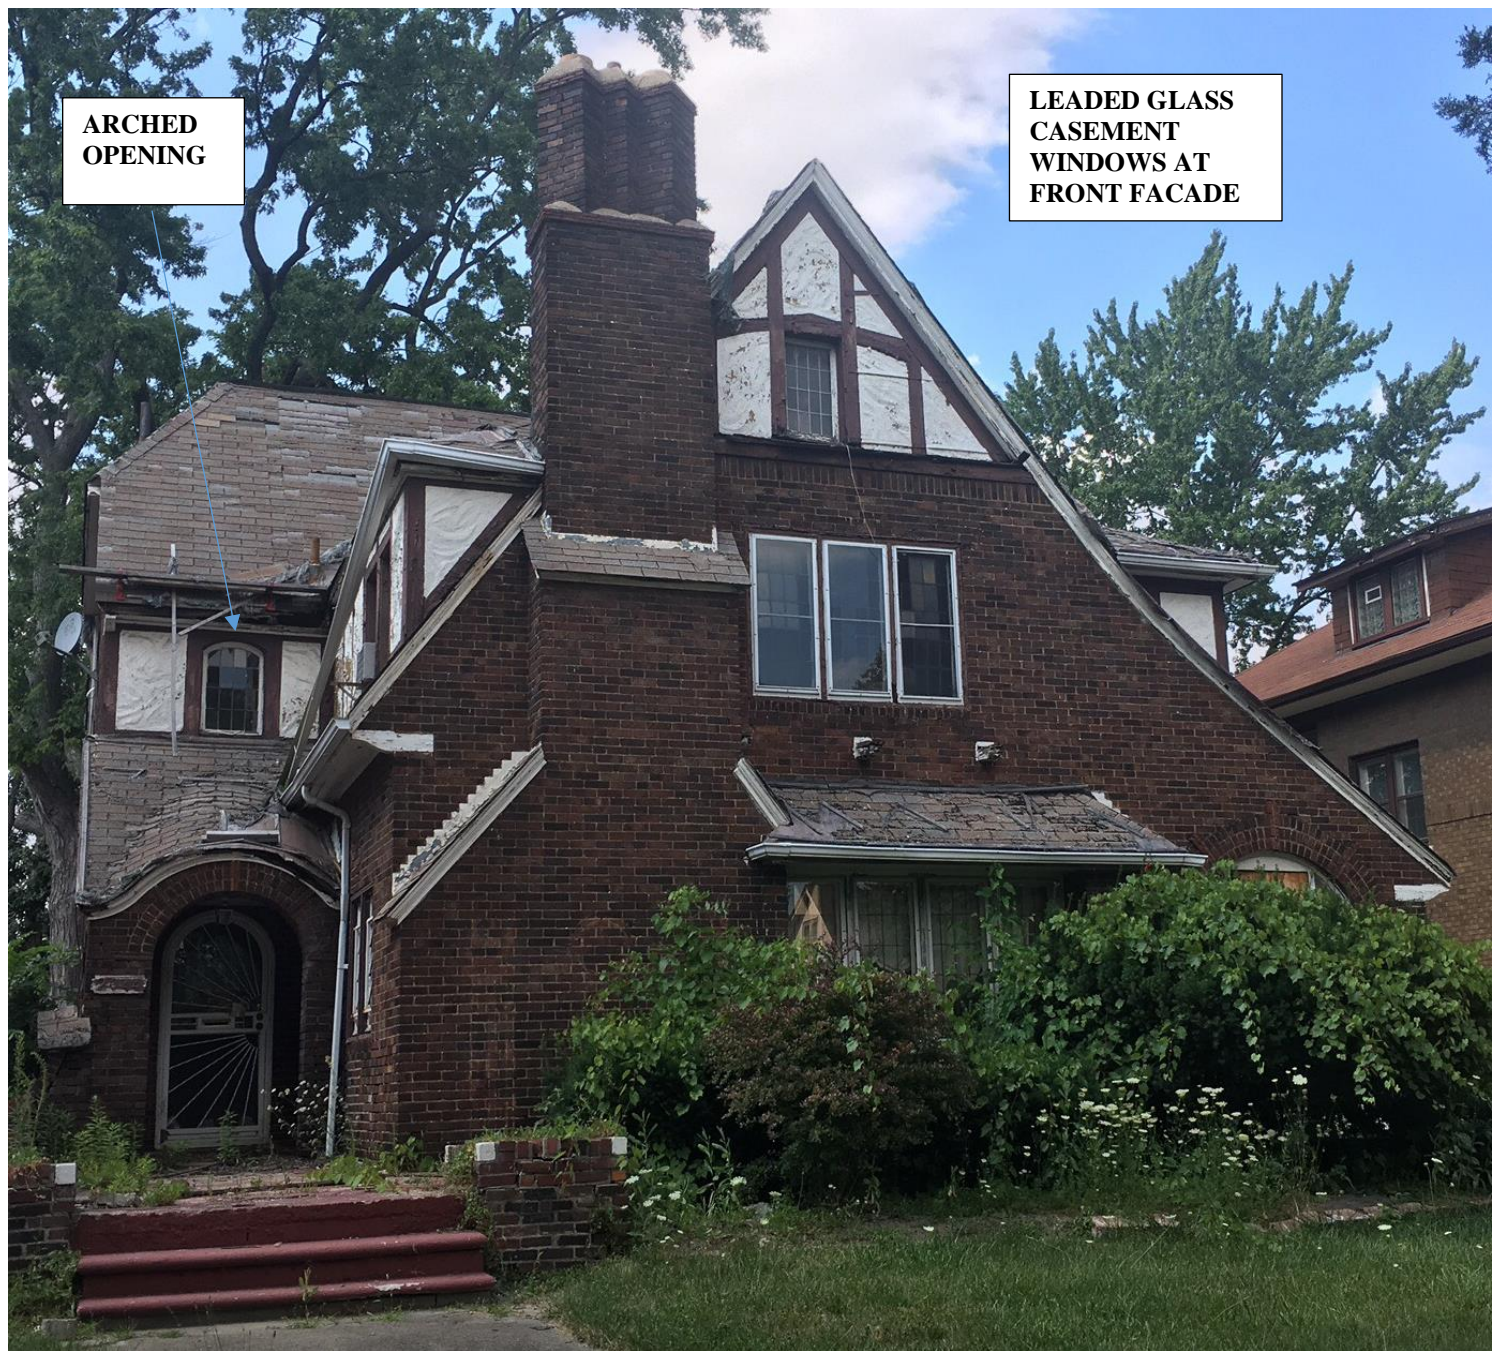
Photo taken in early 2018, prior to the fire. Note that all windows at the front are wood casement windows with leaded glass. The windows at the second story are covered by aluminum windows. Source, HDC files

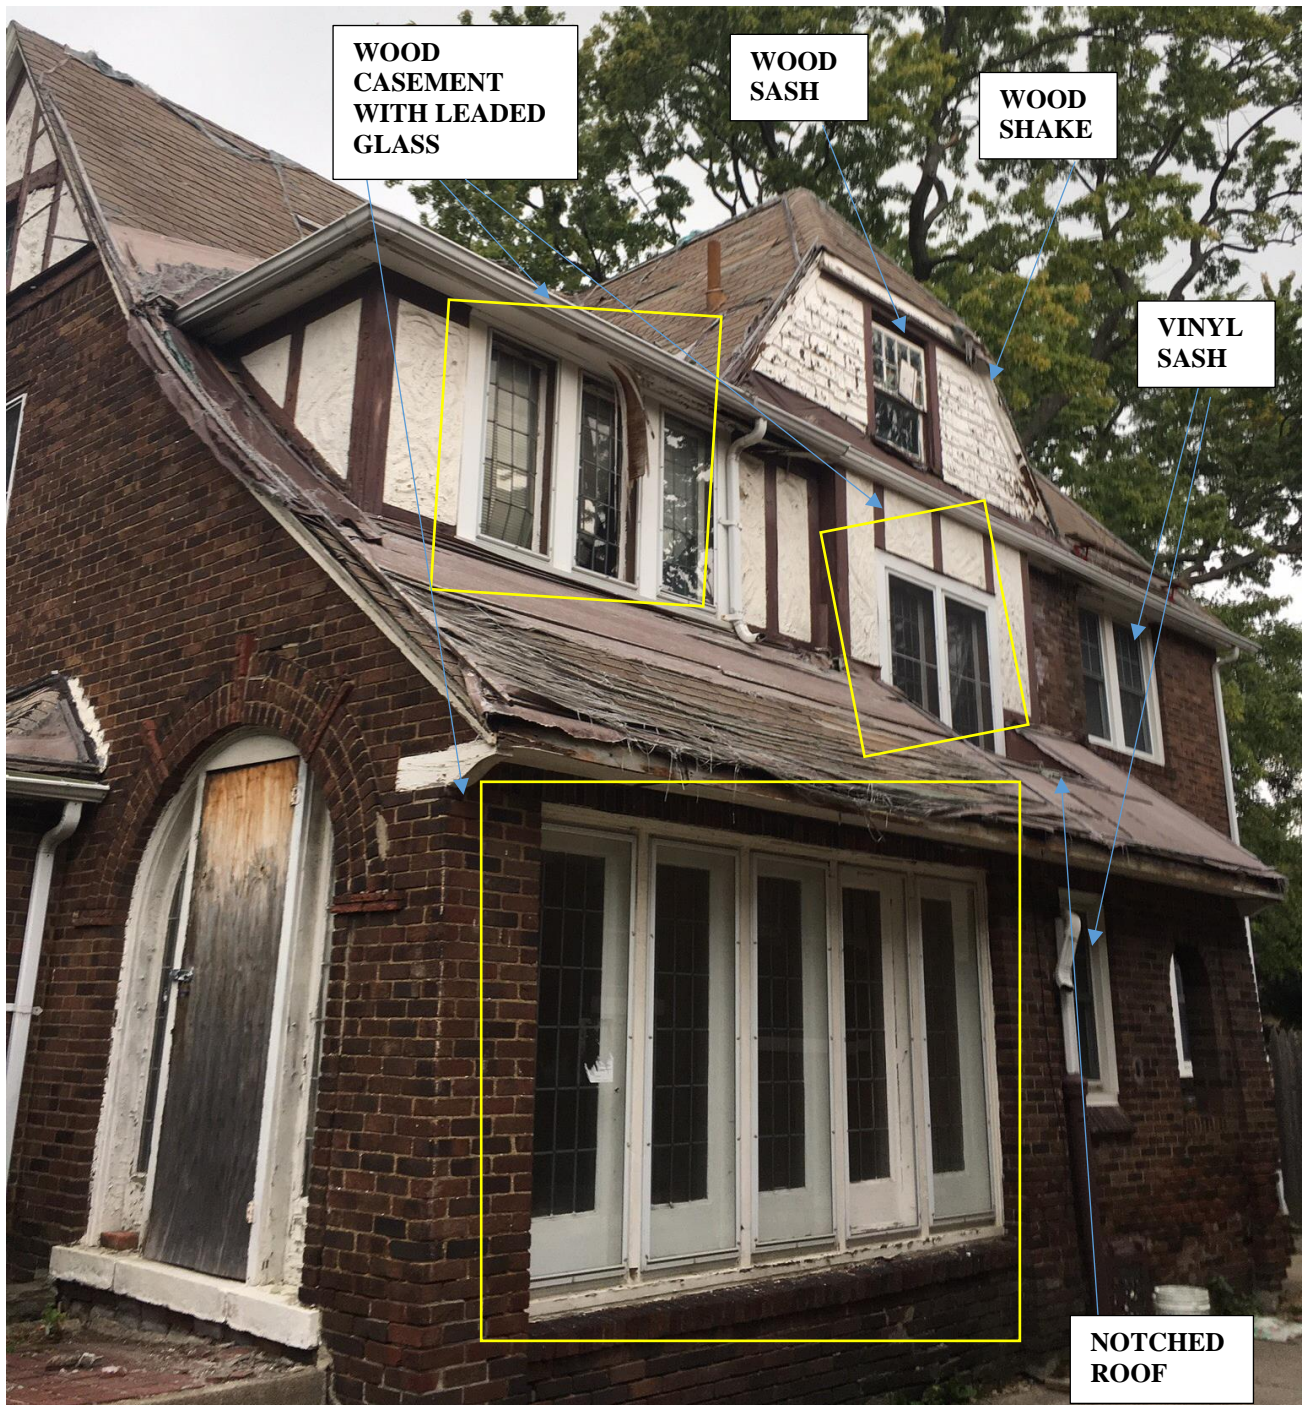
Photo taken in early 2018, prior to the fire. Note that all windows outlined in yellow are wood casement windows with leaded glass. The dormer has wood sash and the remaining visible windows at the second story are vinyl units. Also note the wood shake at the dormer and the notched roof. Source, HDC files.

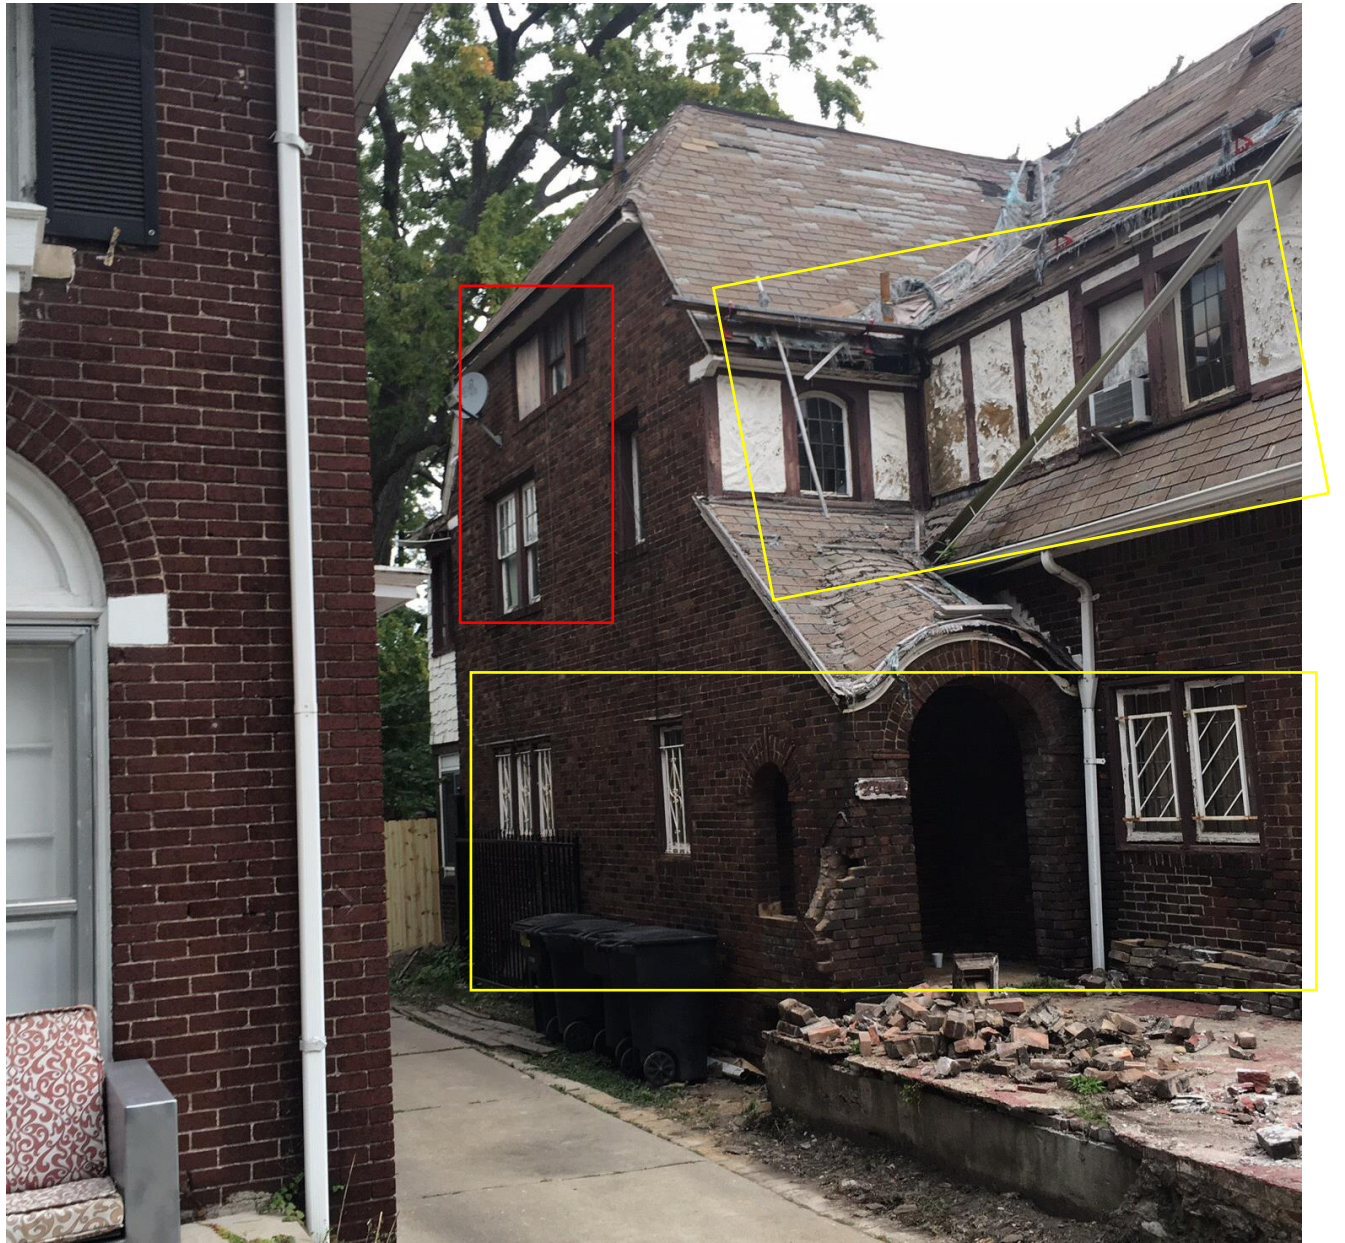
Photo taken in early 2018, prior to the fire. Note that all windows outlined in yellow are wood casement windows with leaded glass and those outlined in red are wood, double hung units. Source, HDC files.

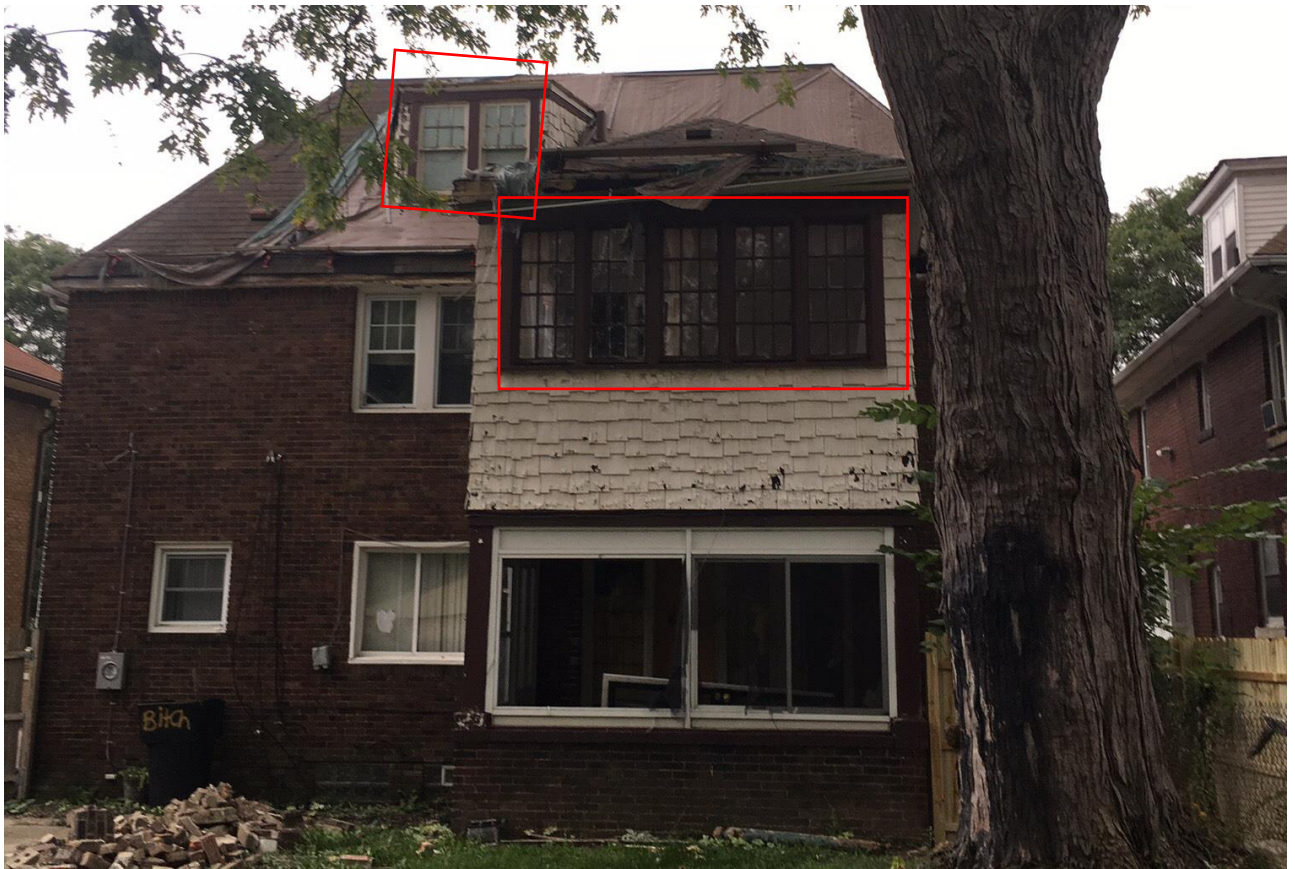
Photo taken in early 2018, prior to the fire. Wood sash casement windows outlined in red. Remaining windows are vinyl. Source, HDC files

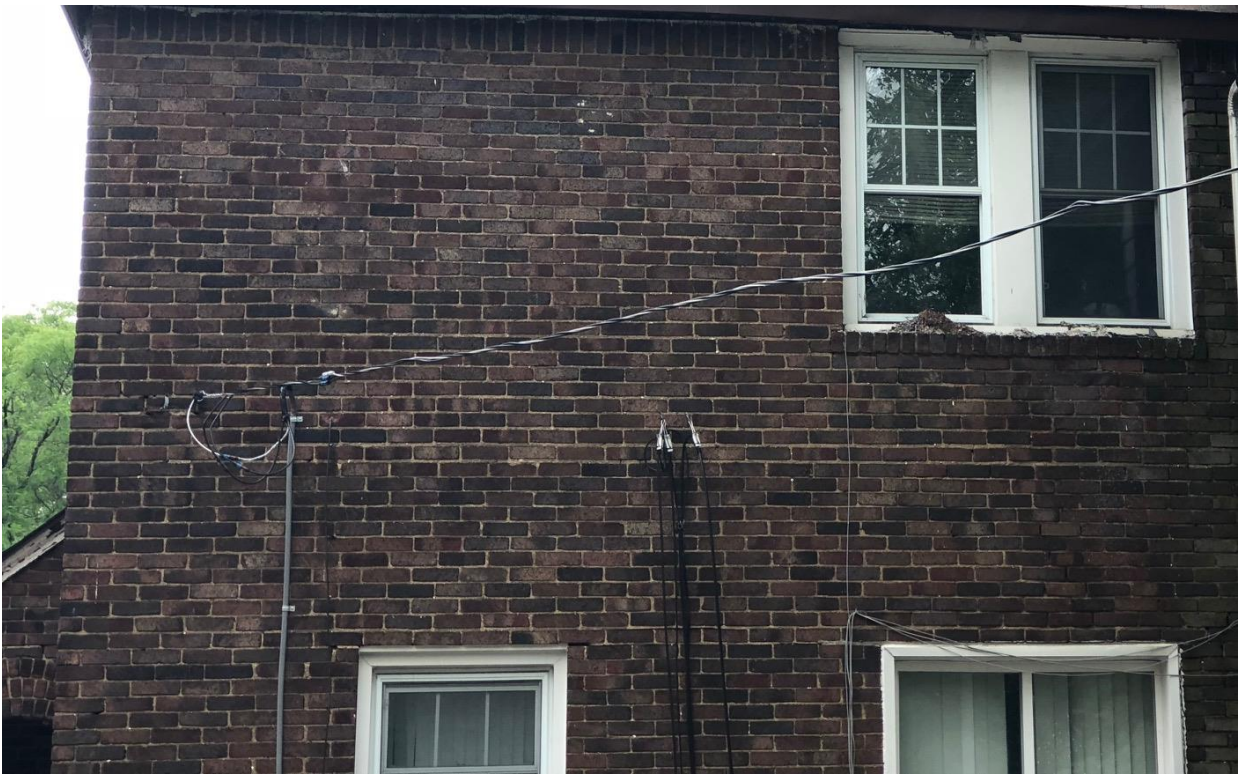
Rear wall, after the 2018 fire. Note that these windows are noncompatible, non-historic vinyl units which were approved for installation in 1985. Photo from applicant

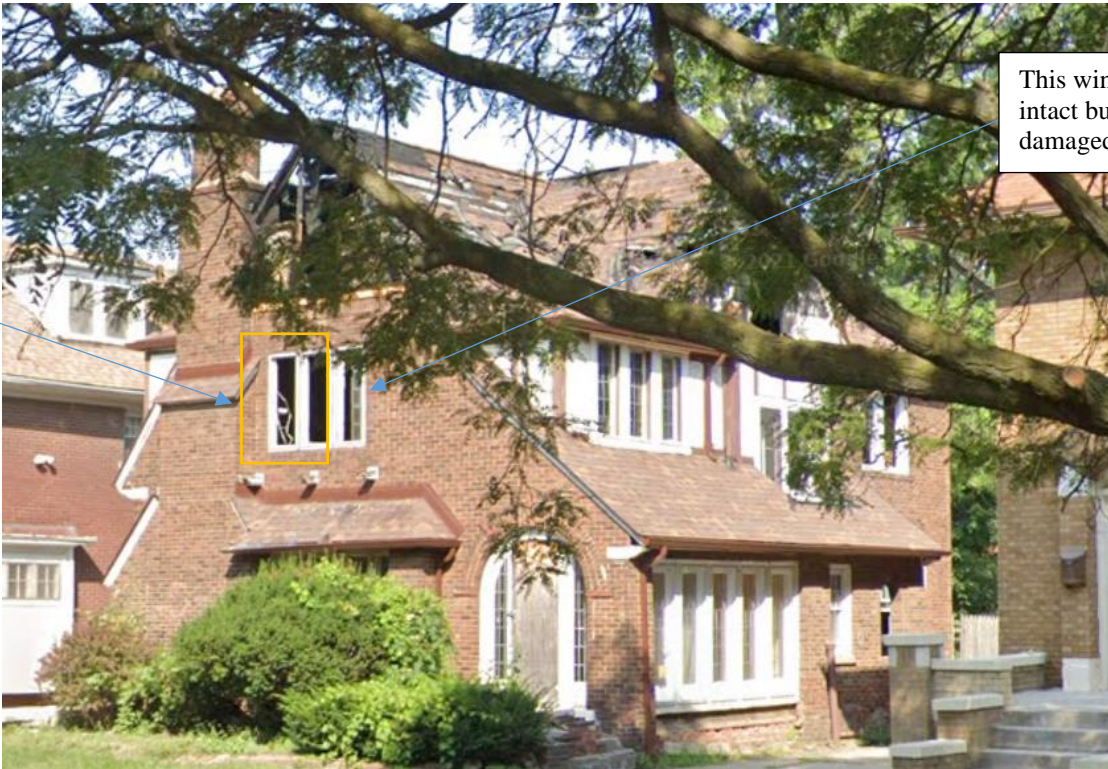
These two windows appear to be destroyed

This window appears intact but heavily damaged

August 2018, after the fire. Note that the windows and associated casing/trim at the side wall and the front door sidelites appear to be intact. Two of the three casement window sash at the front façade, second story (outlined in orange) appear to be completely destroyed although the casing/trim remained. Source, Google Streetview

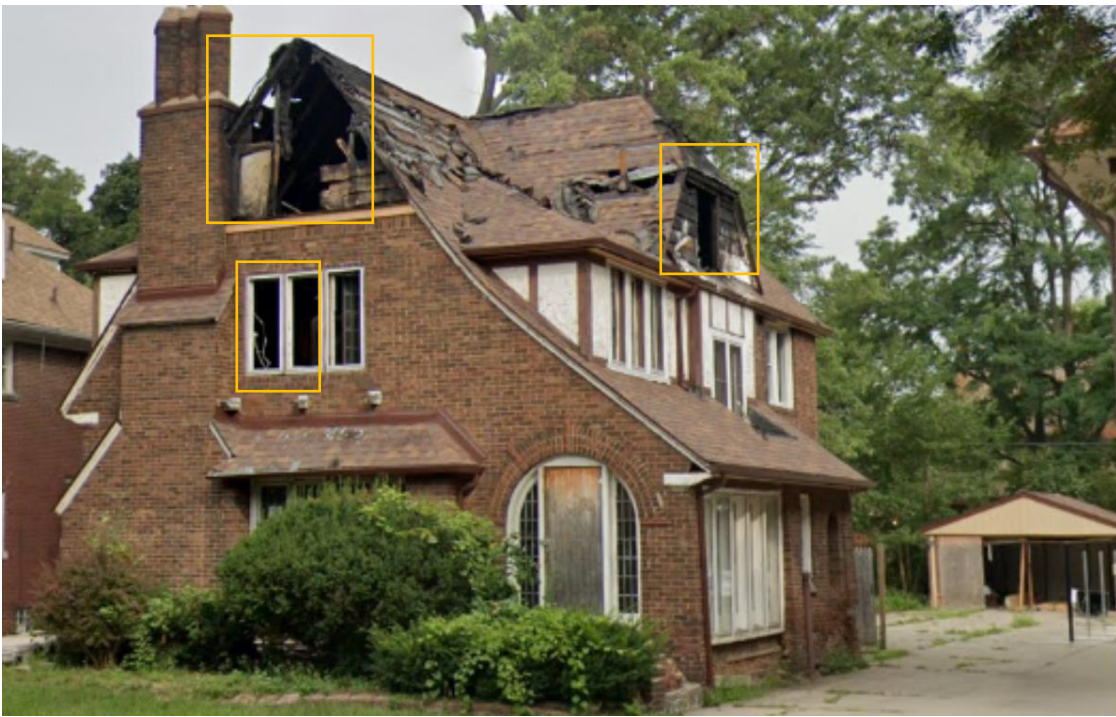
August 2018, after the fire. Note that most of the fire damage appears at the attic story and second story, west side. Windows sash and trim/casing at attic story outlined in orange appear completely destroyed. Two of the three casement window sash at the front façade, second story (outlined in orange) appear to be completely destroyed although the casing/trim remained. The rest appear to remain. The garage also appears not to have been fire damaged. Source. Google Streetview

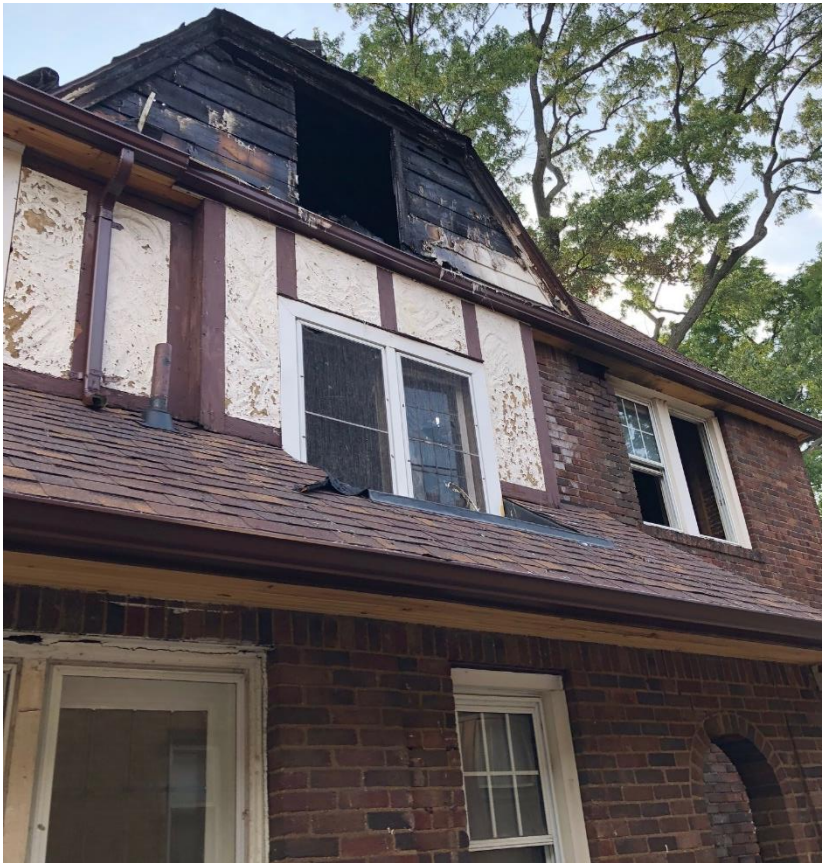
August 2018, after the fire. Detail of fire damage at rooftop dormer, east side. Photo by applicant.

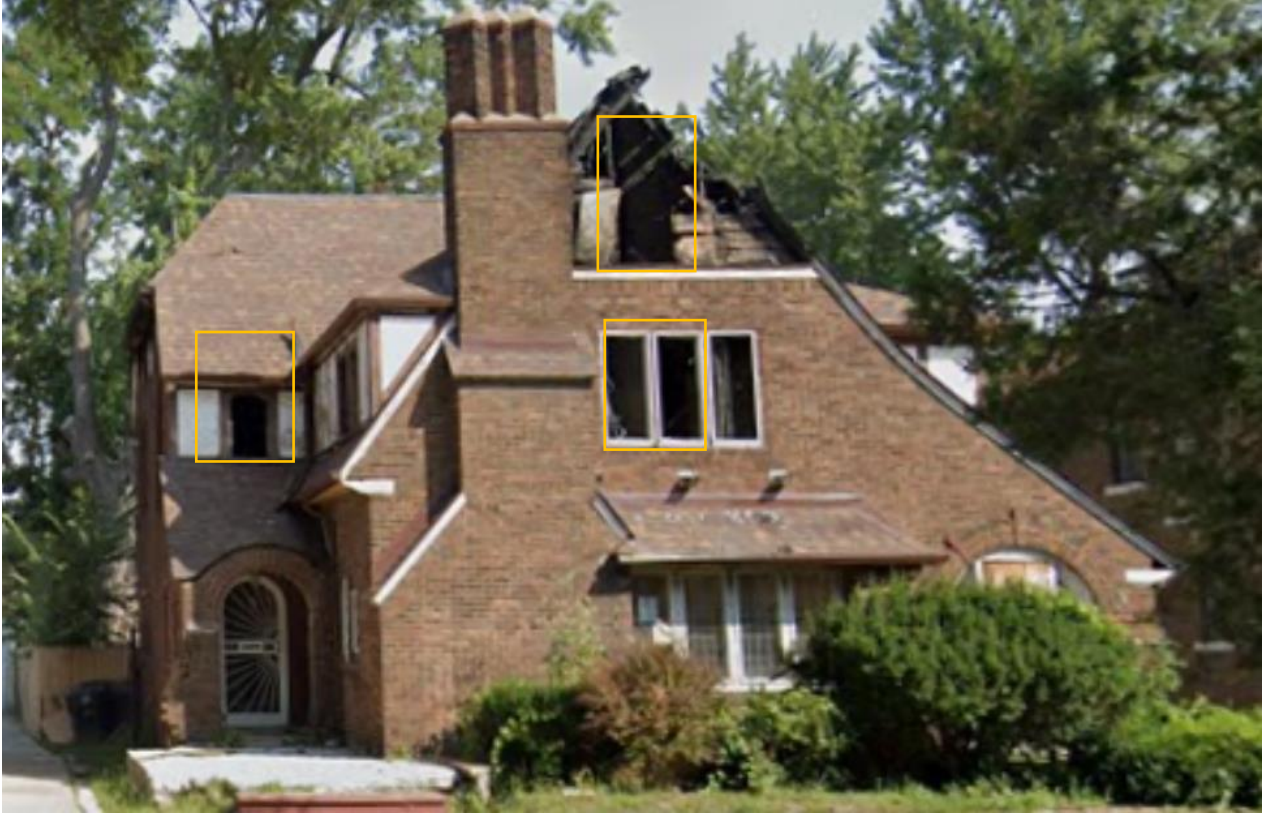
August 2018, after the fire. Window sash outlined in orange appear completely destroyed. The rest appear to remain. Source, Google Streetview

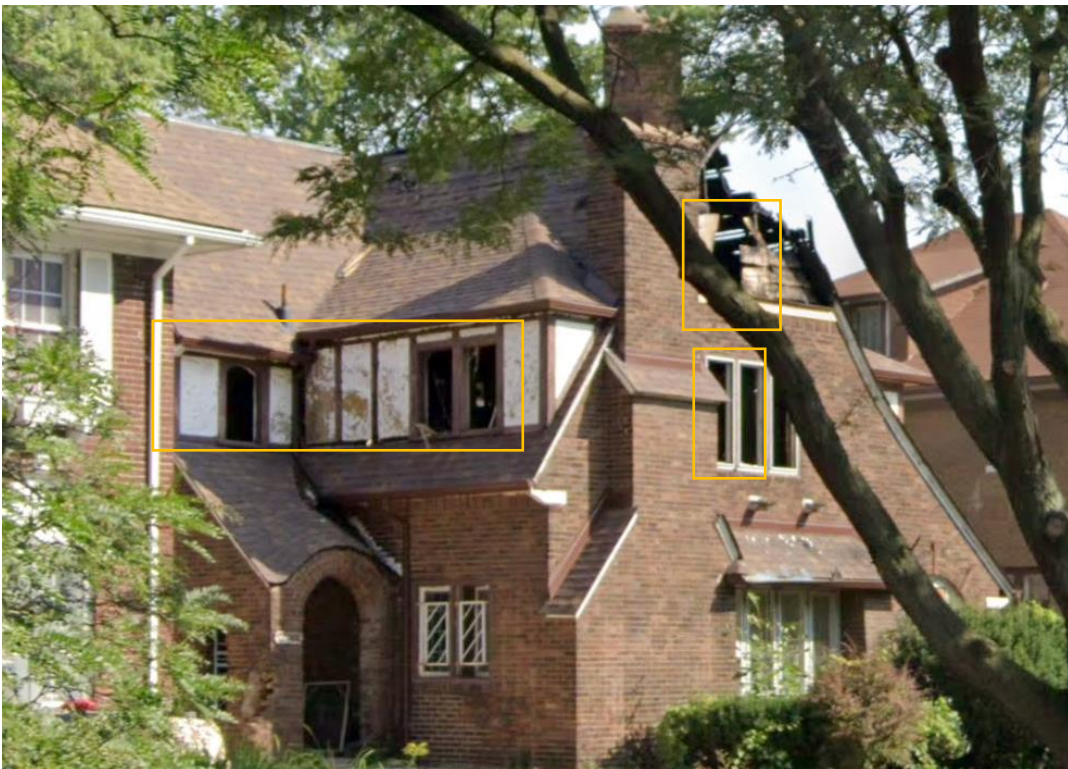
August 2018, after the fire. Window sash outlined in orange appear completely destroyed while their associated trim/casing/ remains. The rest of the windows also remain. Source, Google Streetview

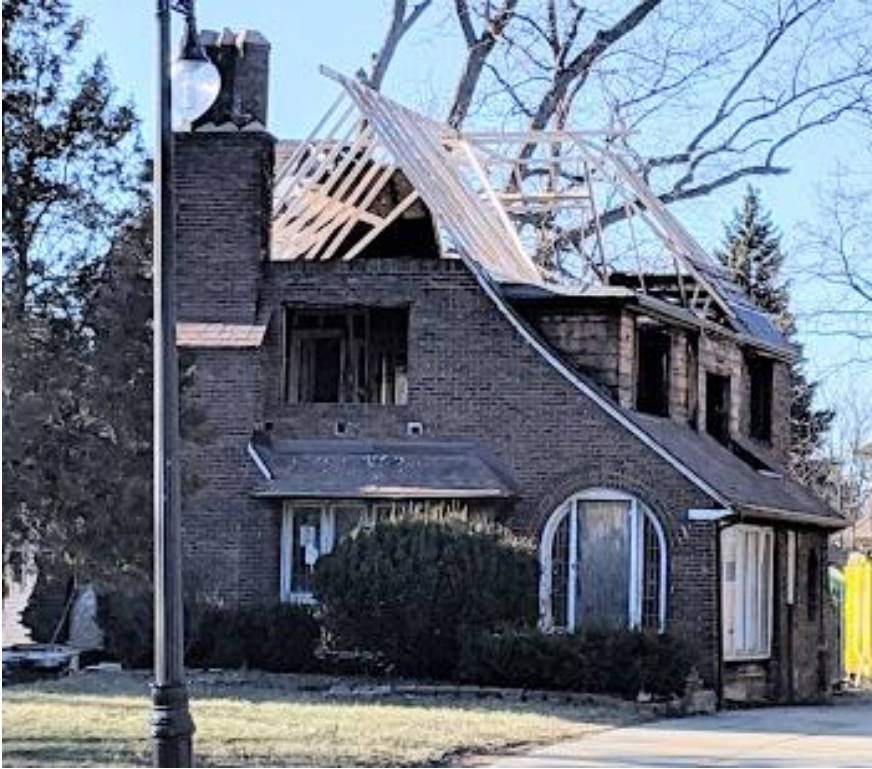
Late 2018, after the fire. Note that the rebuilding of the attic story is underway and all windows and associated casing/trim have been removed at the second story without HDC approval. Source, HDC files

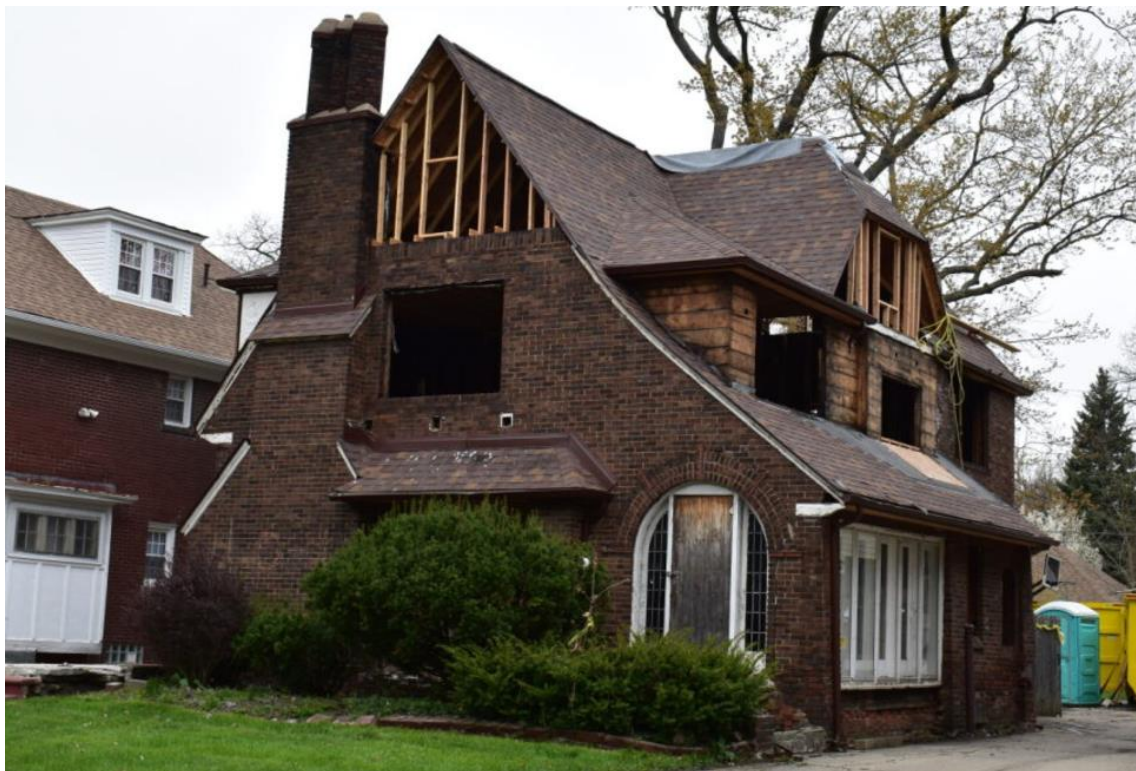
Late 2018, after the fire. Note that the attic story has been rebuilt without HDC approval. Source, HDC files

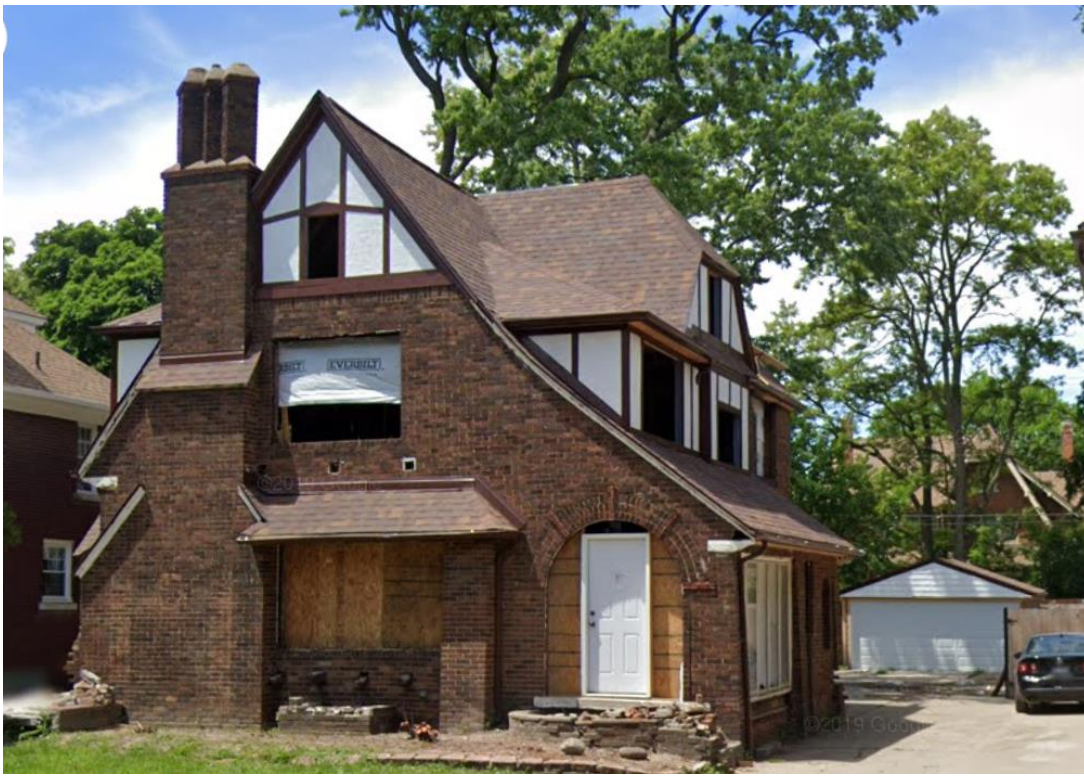
After the fire, 2019. Note that the second and attic story have been rebuilt, most windows and associated casing/brickmould have been removed to the rough opening, and front door sidelites have been removed. Garage siding has also been replaced per the 2018 COA. Source, Google Streetview

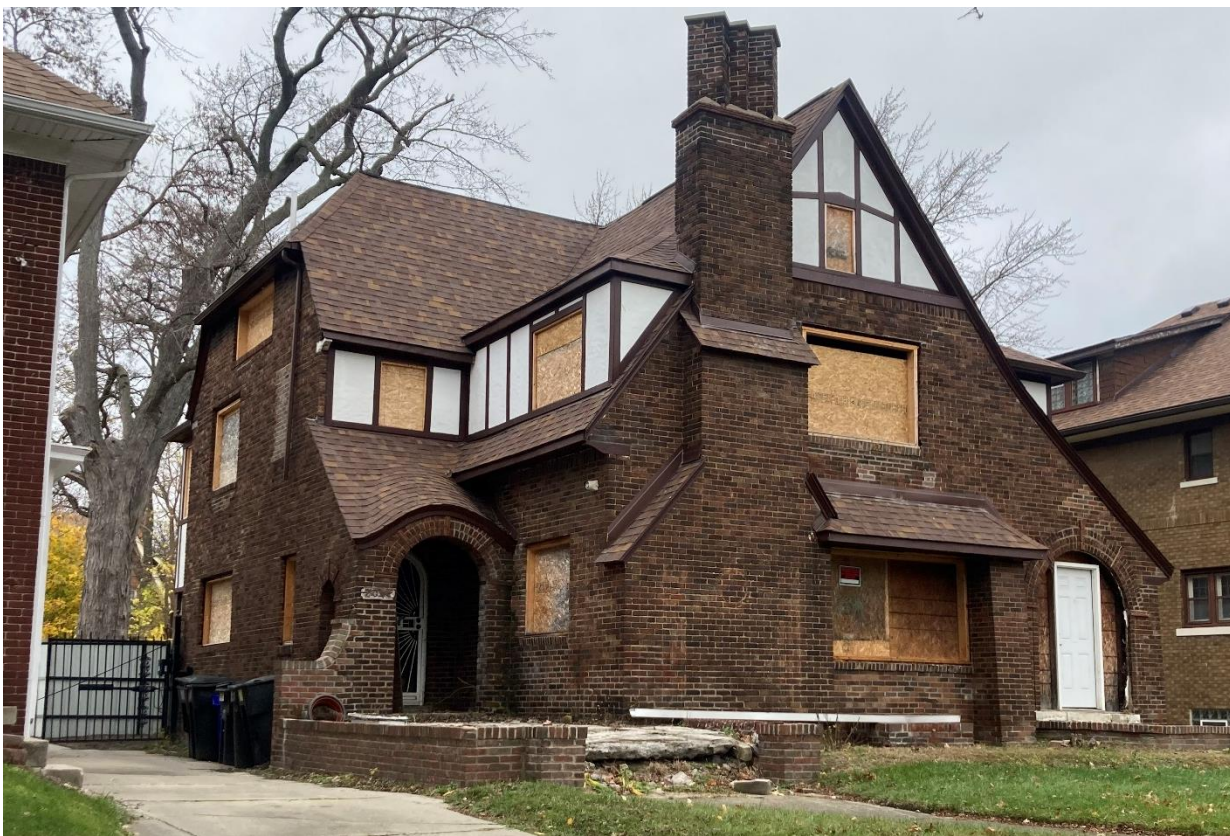
Current conditions. Note that the second and attic story have been rebuilt, most windows and associated casing/brickmould have been removed to the rough opening, and front door sidelites have been removed. Staff photo taken 4/25/2025

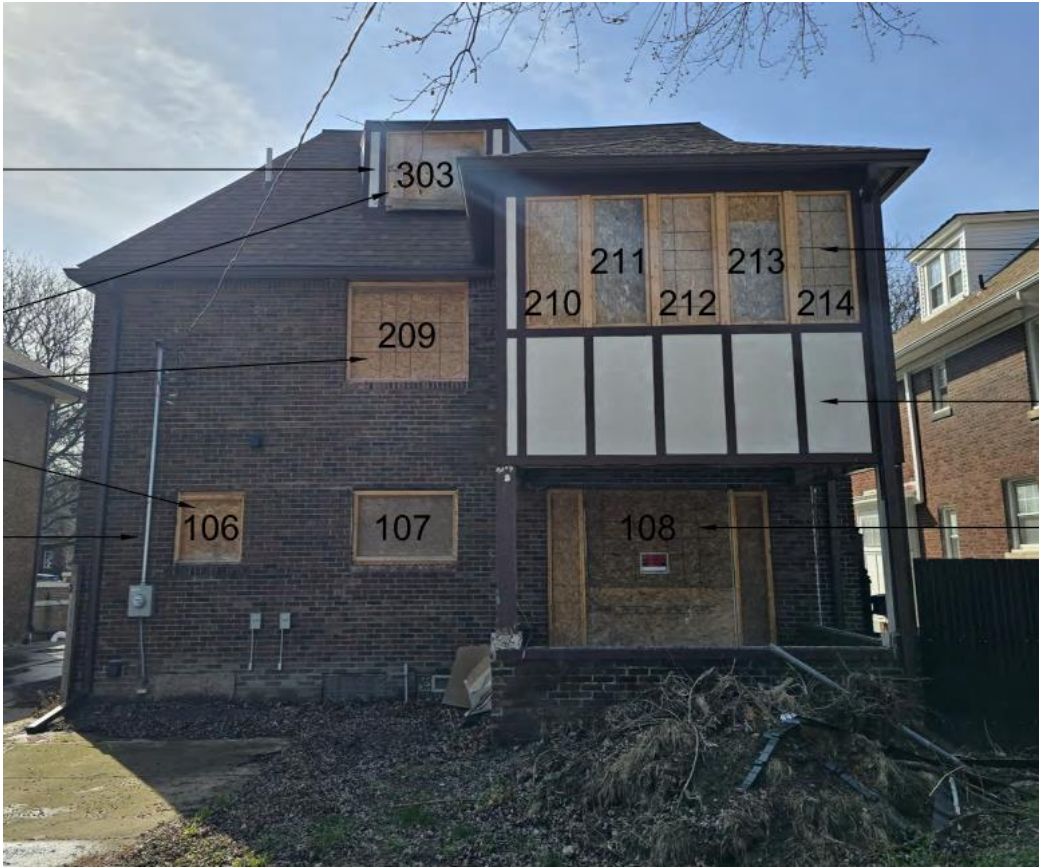
Current conditions at rear. Photo provided by applicant
