**STAFF REPORT: MAY 14, 2025 MEETING**

**APPLICATION NUMBER: HDC2025-00114**

**ADDRESS: 2233 PARK AVENUE (AKA IODENT BUILDING)**

**SCOPE: REPLACE WOOD WINDOWS**

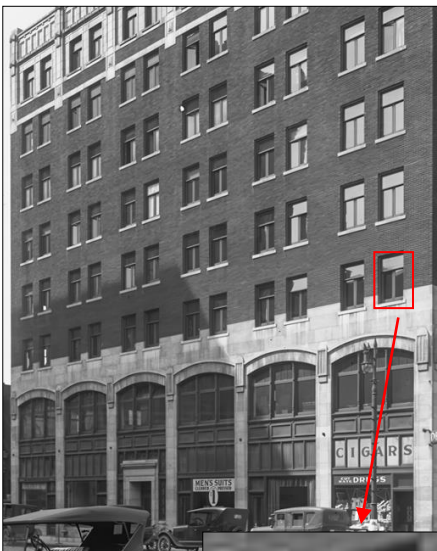
The windows at 2233 Park are unique in design and operation and are a distinctive character-defining feature of the building. With the windows closed and viewed from a distance, it appears that each opening is comprised of a double casement window with an undivided transom above.

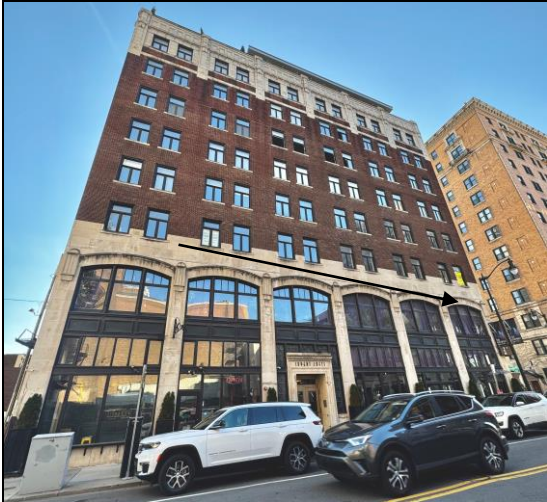
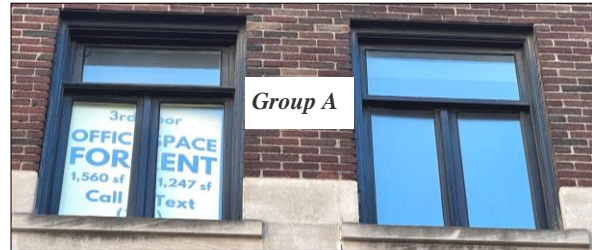
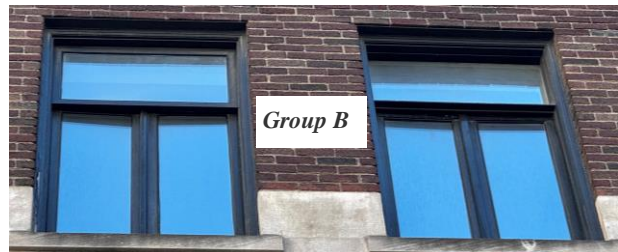
*Photos of side-by-side windows from the building's façade. When looked at closely, there are three different transom conditions, and are discussed below. Staff photos, April 24, 2025.*

- The submitted visual exterior analysis by staff shows that there is no clear understanding of what, if any, original historic material remains, beyond the brick mould. It is staff's opinion that before the Commission can consider any level of a window replacement project, a window survey documenting the details of each window opening must be completed.

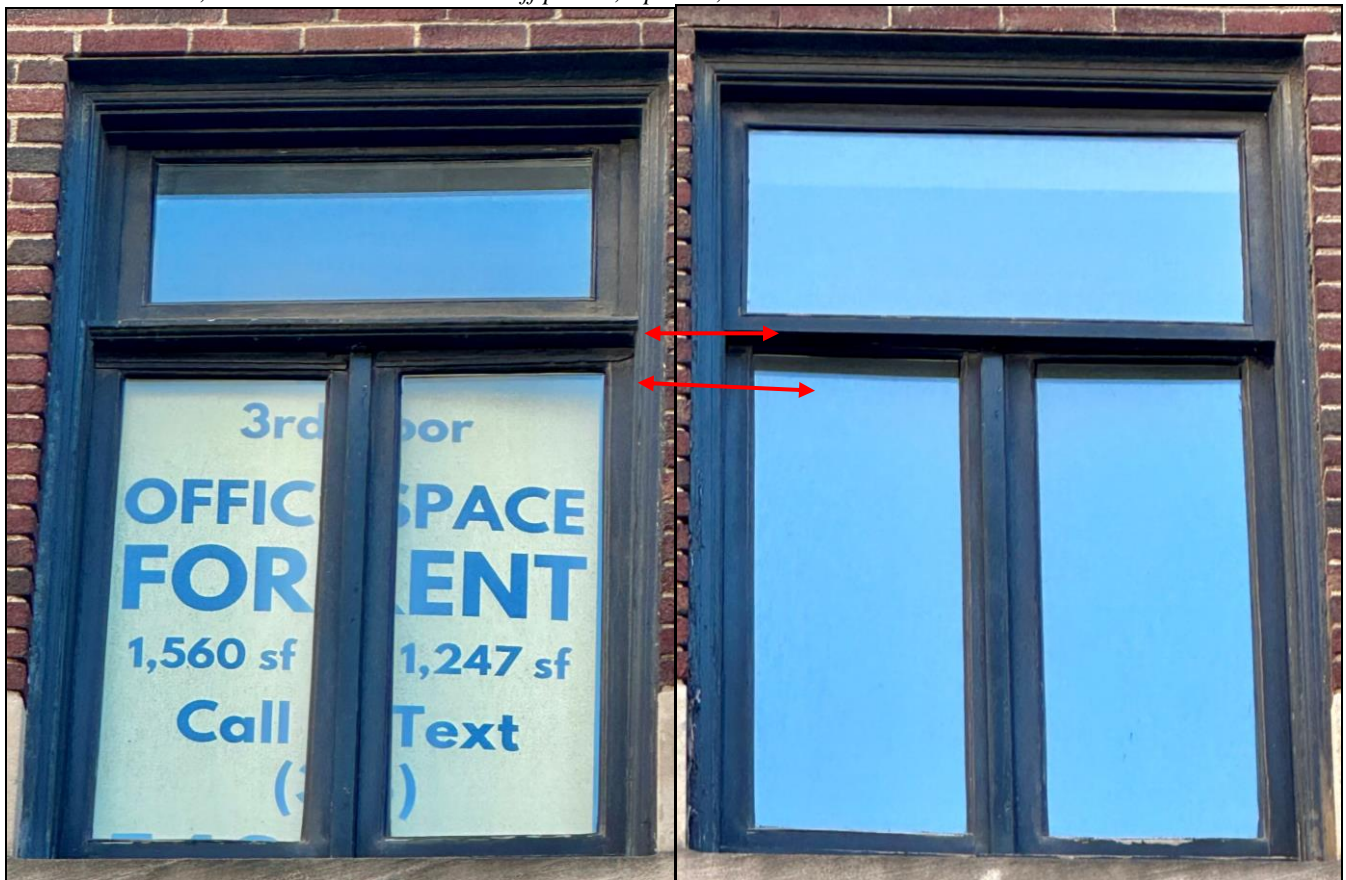
**Group A, Second Floor** – Both openings have matching highly profiled, and likely original, wood brick mould. The frames of the French windows at left have a visible top sash, whereas the top sash at right is minimally visible.

*The transom in the left window sits back in the window frame and has additional wood framing, creating a smaller glass area; the horizontal mullion is thin and offers some dimensional profile. In contrast, the transom at right sits forward in a uniformly flat frame and doesn't have a mullion. Staff photos, April 2025.*

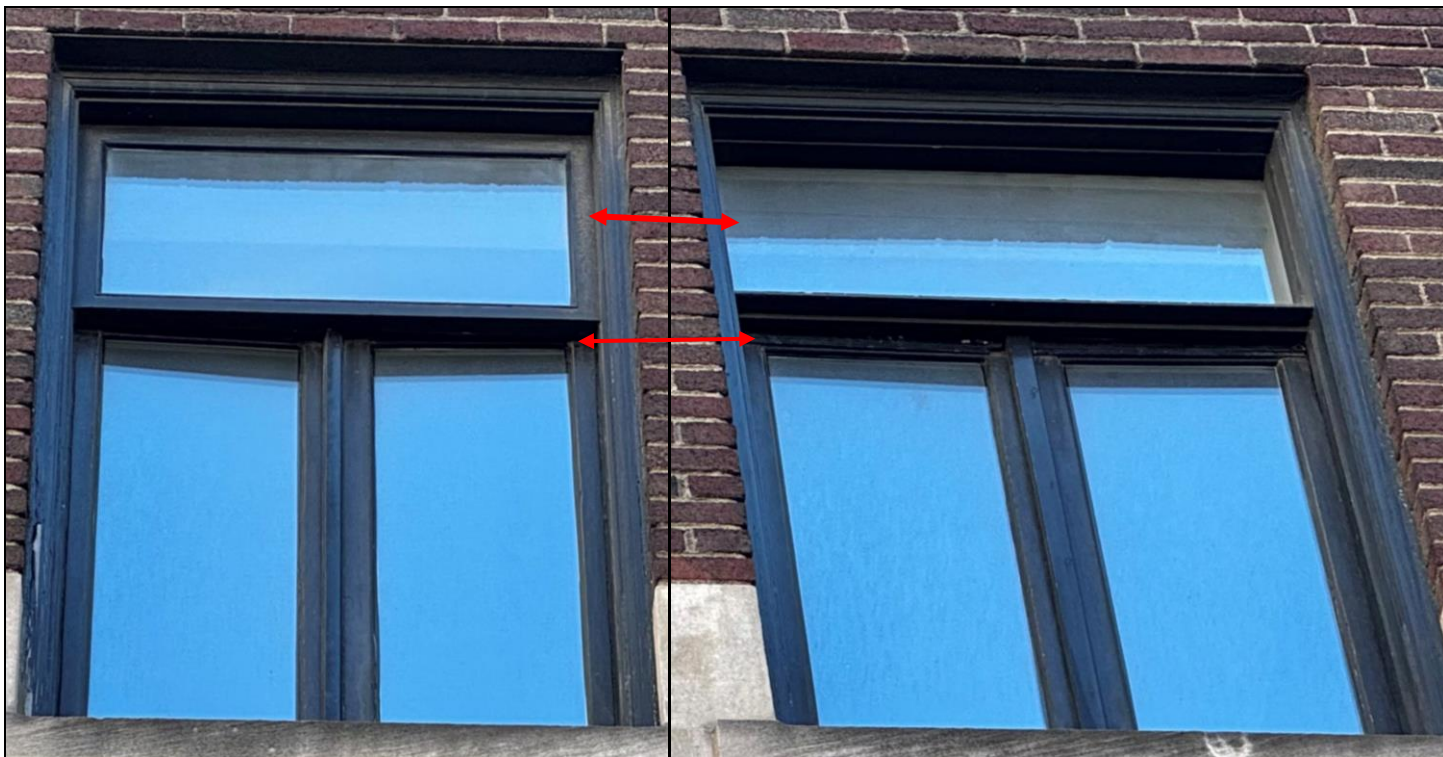
**Group B, Third Floor** – Both openings again have matching highly profiled, and likely original, wood brick mould. Contrasting with Group A, the top sash of the French windows at left have the partially obscured top sash, and the window at right has the mostly exposed top sash.

The transom in the left window sits forward in a uniformly flat frame and doesn't have a mullion. The transom in the opening at right is a different (and now third) example of the glass extending to the outer window frame. There is a thin, deep mullion, but no dimensional trim as shown in the Group A window at left. Staff photos, April 2025.

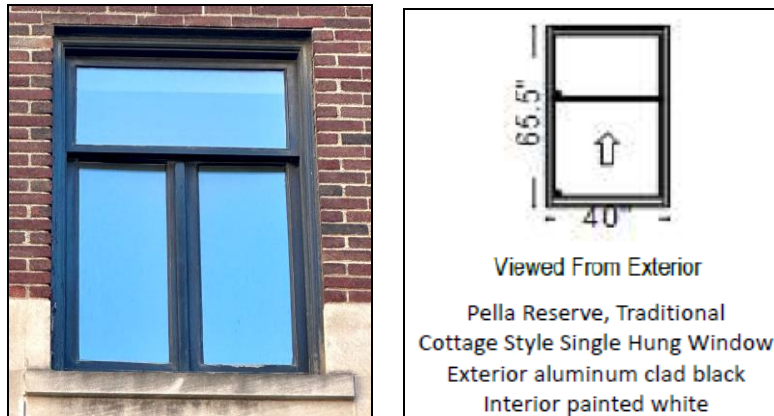
- While the review of replacing the existing windows is premature, staff can offer comments on the selected replacement window. The application proposes to install “cottage-style” windows from the third through eighth floors on three sides of the building. The installation of this new window type would obliterate the distinctive, character-defining feature of the existing windows and would alter the features that characterize this building.
- Additionally, the proposal is to remove or cover all remaining details, including the profiled wood brick mould. The brick mould is one of the most visible components of a window opening due to its proximity to the masonry wall. Aluminum trim cannot be bent in such a way as to match the highly profiled wood brick mould. The flatter surface and sheen of aluminum is not compatible with a building erected in the early 20<sup>th</sup> century.

*Comparison of one existing window and the proposed window. Staff photo, applicant drawing.*
