STAFF REPORT: 05/14/2025 MEETING

ADDRESS: 4015 GLENDALE

APPLICATION NO: HDC2025-00065

SCOPE: REPLACE STEEL CASEMENT WINDOWS (WORK COMPLETED WITHOUT APPROVAL)

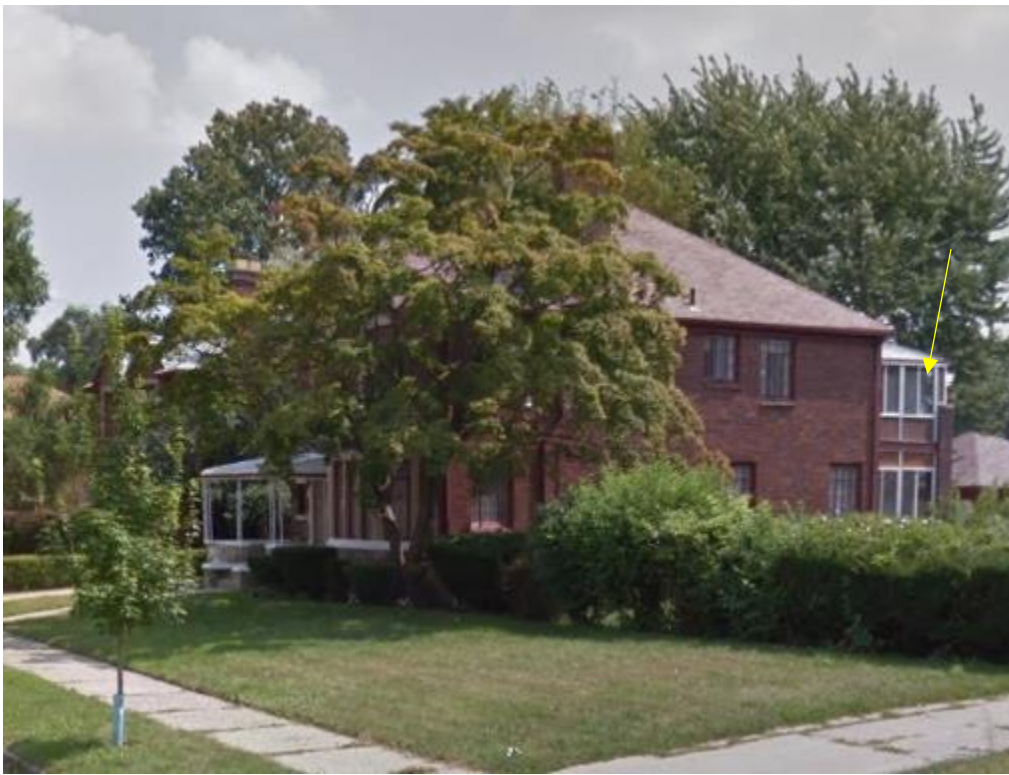
Google Streetview, 2015. Note ca. 1970 rear porch enclosure (indicated by yellow arrow)

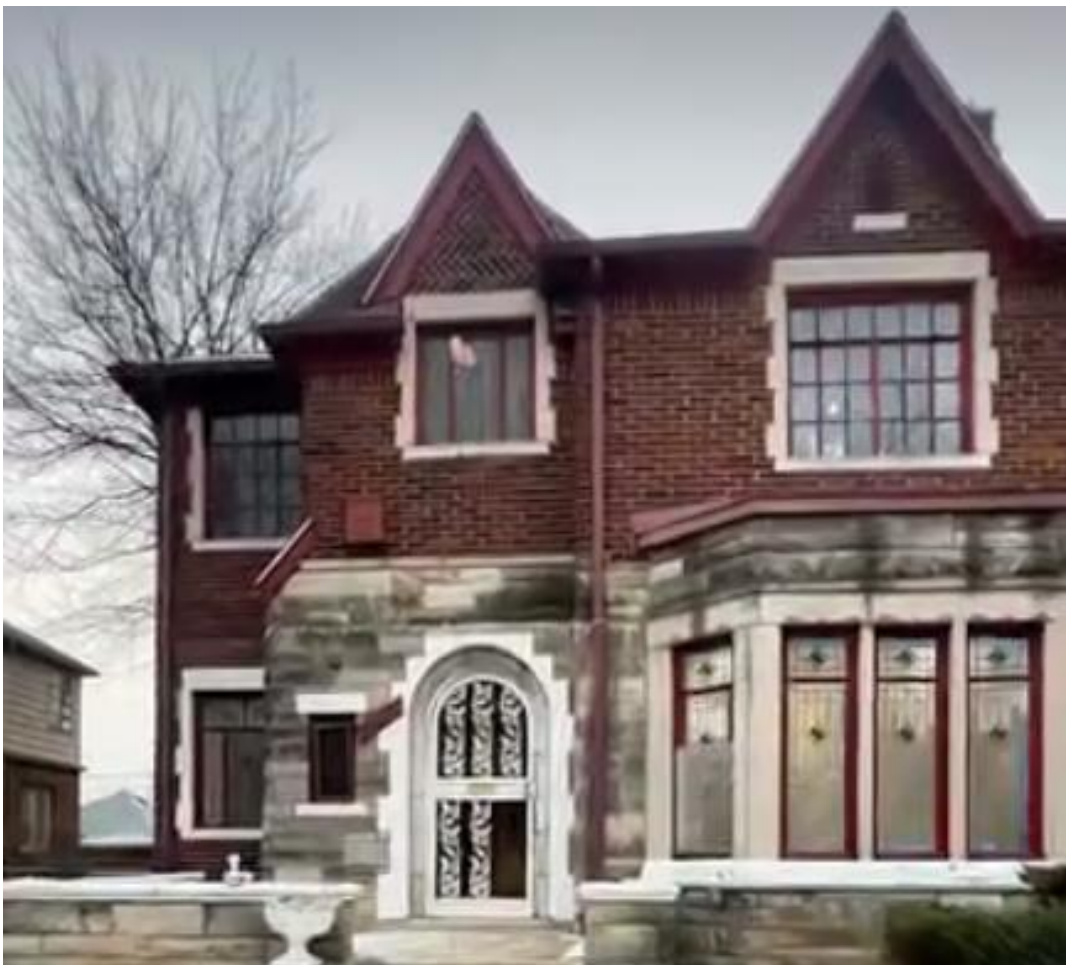
Conditions in December 2023/January 2024. Screenshot from video posted on Facebook. Note that the non-historic/ca. 1970s aluminum front porch canopy and columns are no longer extant

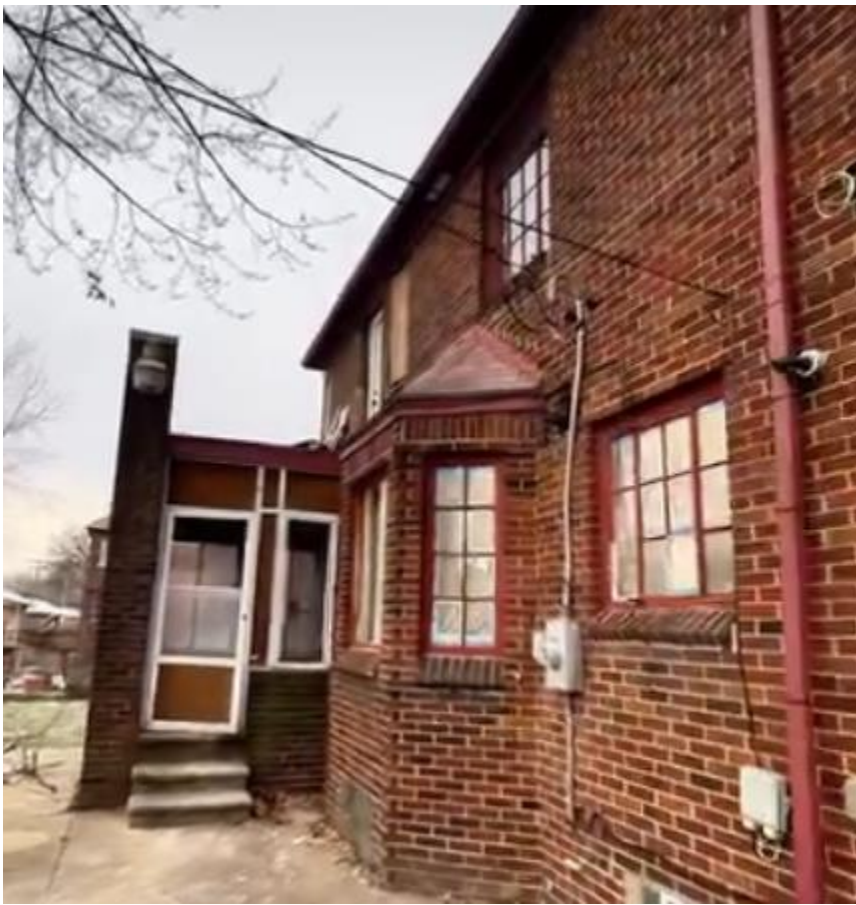
Conditions in in December 2023/January 2024. Screengrab from video posted on Facebook. Note that the 1970s/non-historic aluminum second story panels/porch enclosure and roof are no longer extant

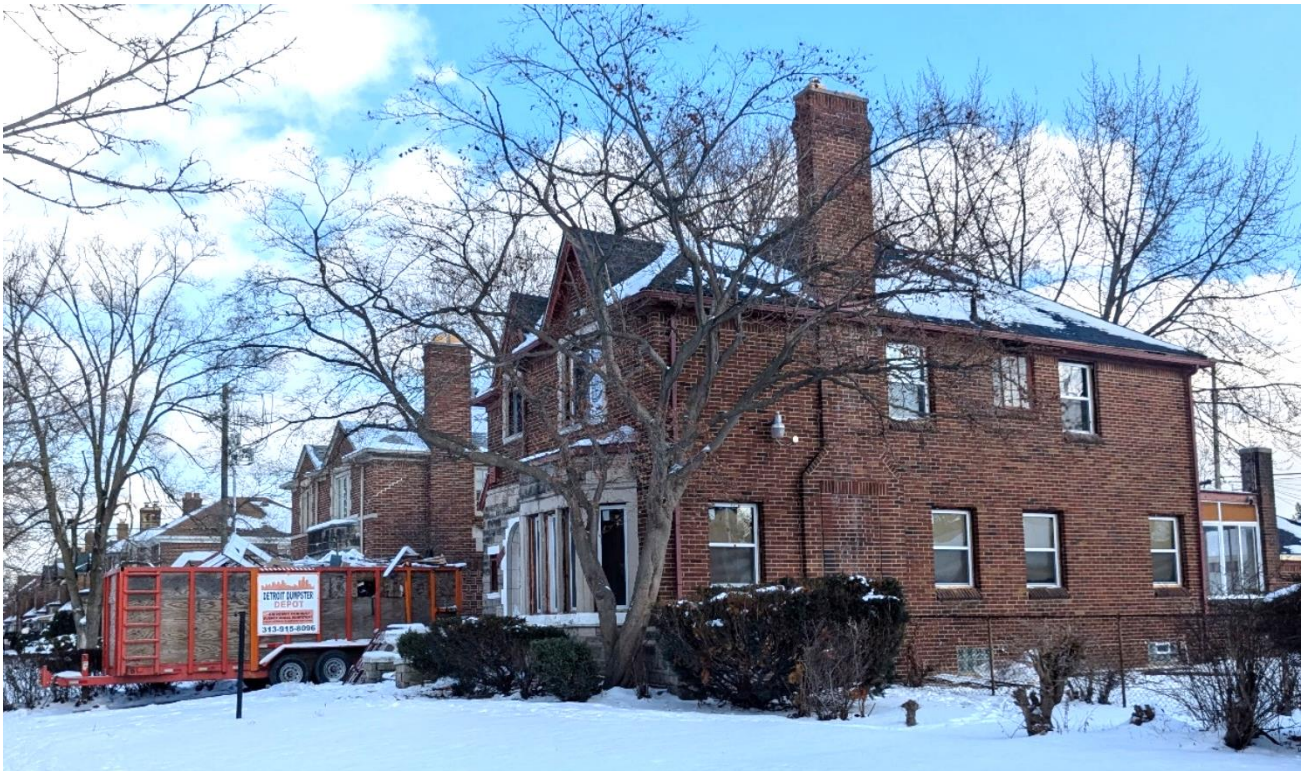
- On 1/14/2025 HDC staff visited the site and noted that all but one of the original windows had been removed and had been replaced with the current vinyl units. See the below photos, taken by HDC on 1/14/2025. The Detroit Buildings, Safety Engineering, and Environmental Department therefore issued a Stop Work order to forestall any further unapproved/unpermitted work.

4015 Glendale. Staff photo taken in 1/2025, while the unapproved window replacement was in progress

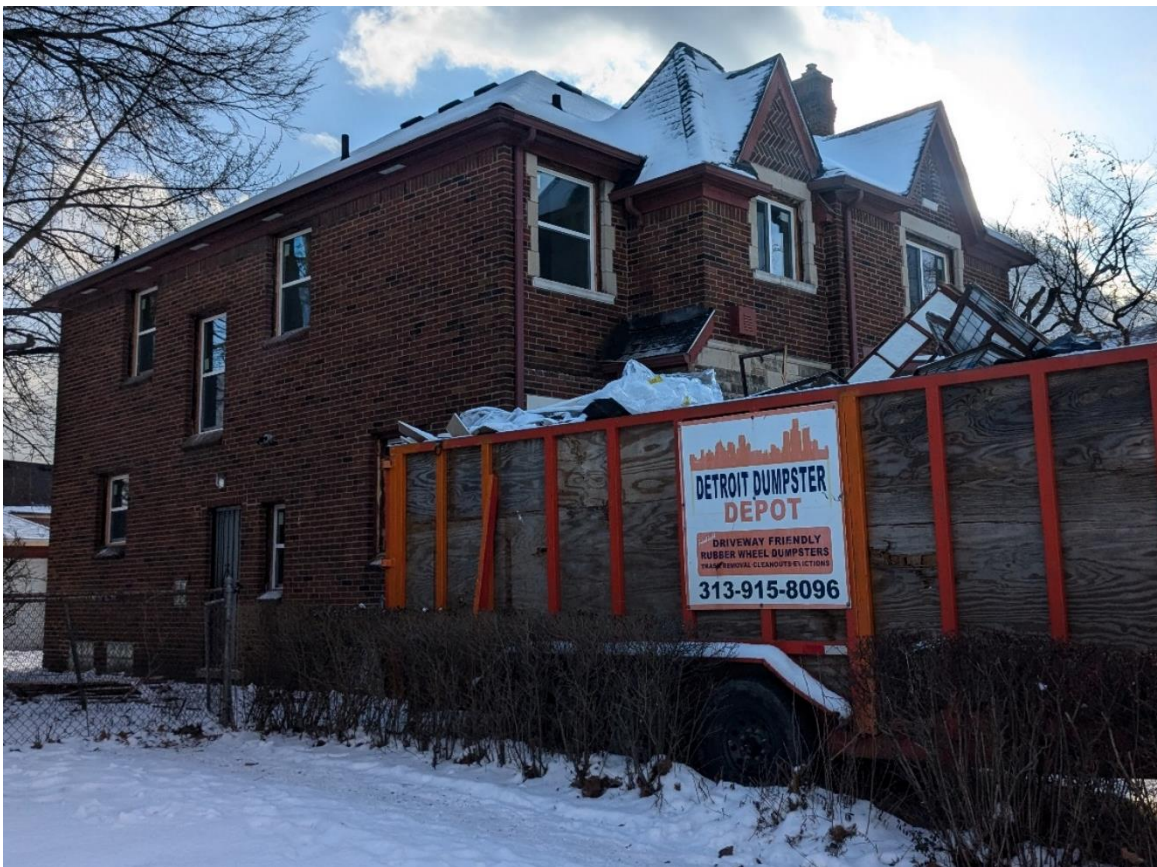
4015 Glendale. Staff photo taken in 1/2025, while the unapproved window replacement was in progress

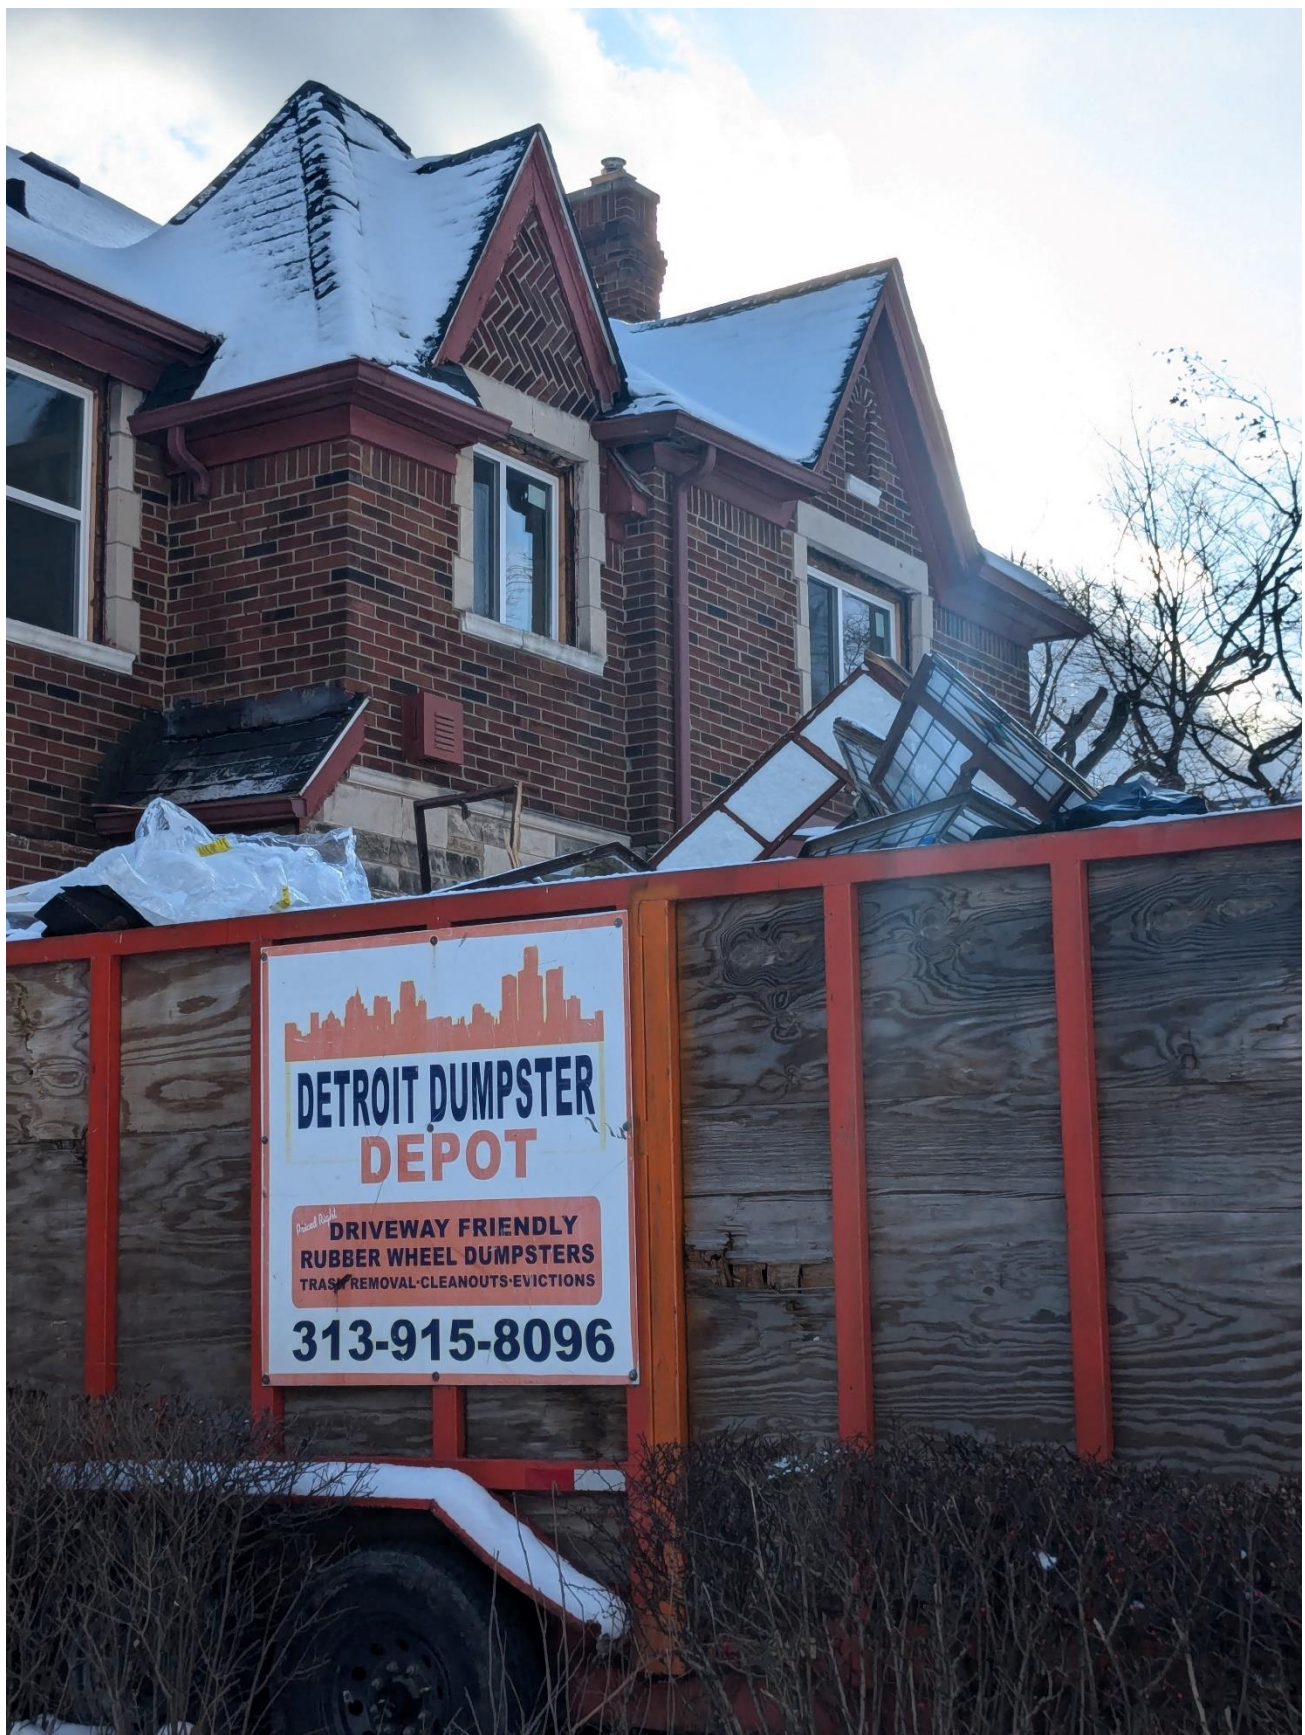
4015 Glendale. Staff photo taken in 1/2025, while the unapproved window replacement was in progress

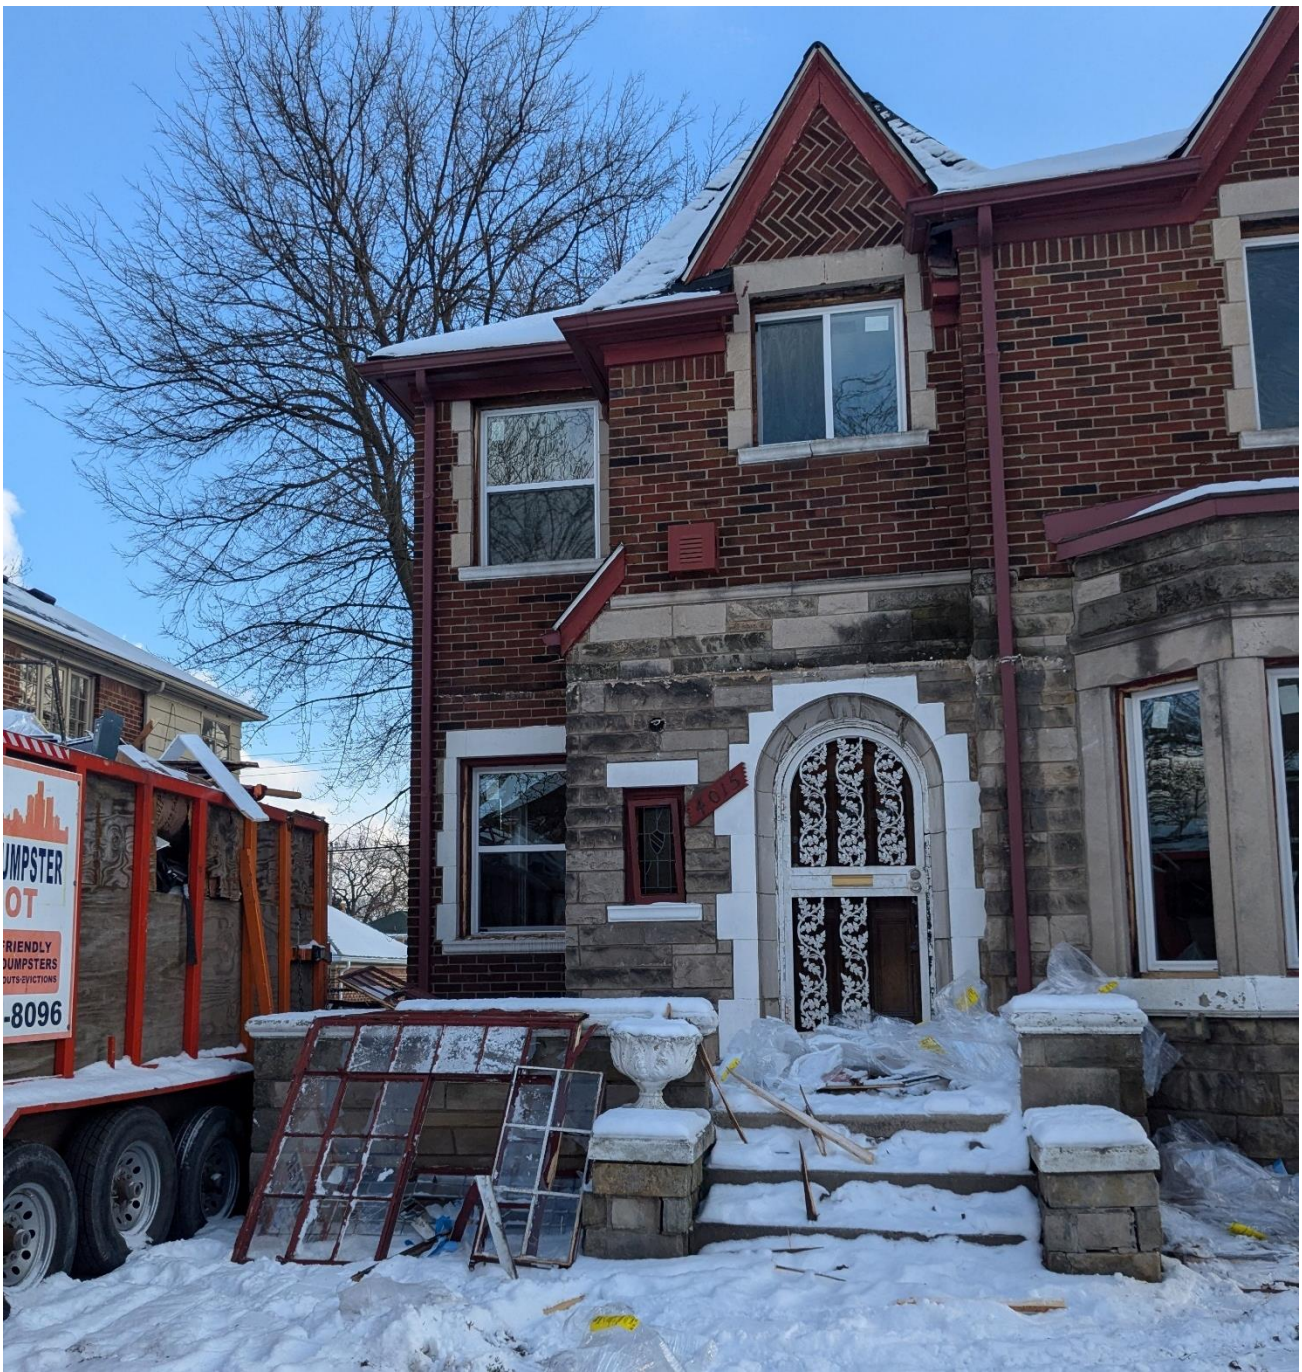
4015 Glendale. Staff photo taken in 1/2025, while the unapproved window replacement was in progress

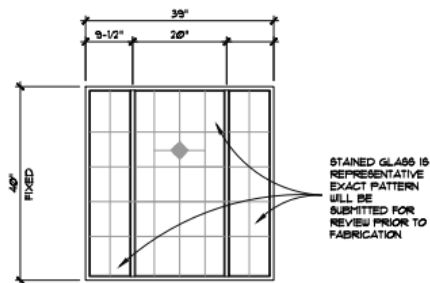
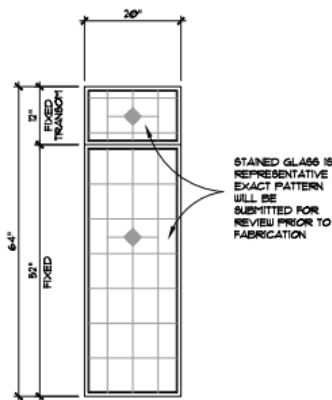
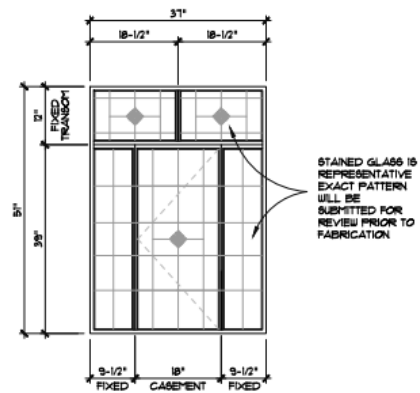
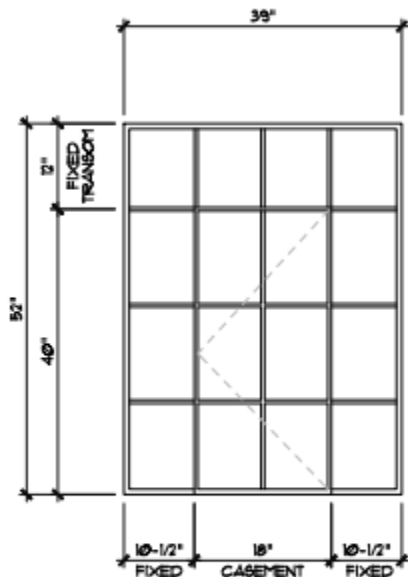
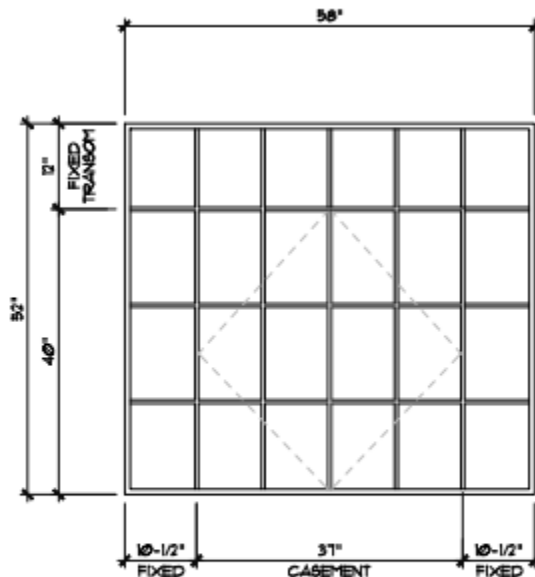
- See the below submitted drawings which depict the new windows which will be installed at the front façade to replace those which were removed. While the new steel casement labeled F and G generally appear to match the original, the more decorative windows, labeled A, B, and C, do not clearly indicate that the windows will include lead coming to match the original. Should the Commission approve this work item (replace original windows at the front façade per the submitted application), staff recommends that they do so with the condition the applicant provide clear documentation of the design of the windows prior to their removal, the new windows exactly match the original in operation, material, design, and dimension, and that staff be afforded the opportunity to review and approve the final proposal prior to issuance of the permit.
