STAFF REPORT: 05/14/2025

APPLICATION NUMBER: HDC2025-00196

ADDRESS: 1162 VINEWOOD

SCOPE: REPLACE WINDOWS, ADD WINDOWS TO EXTERIOR OF EXISTING WINDOWS, REPLACE STORM DOOR

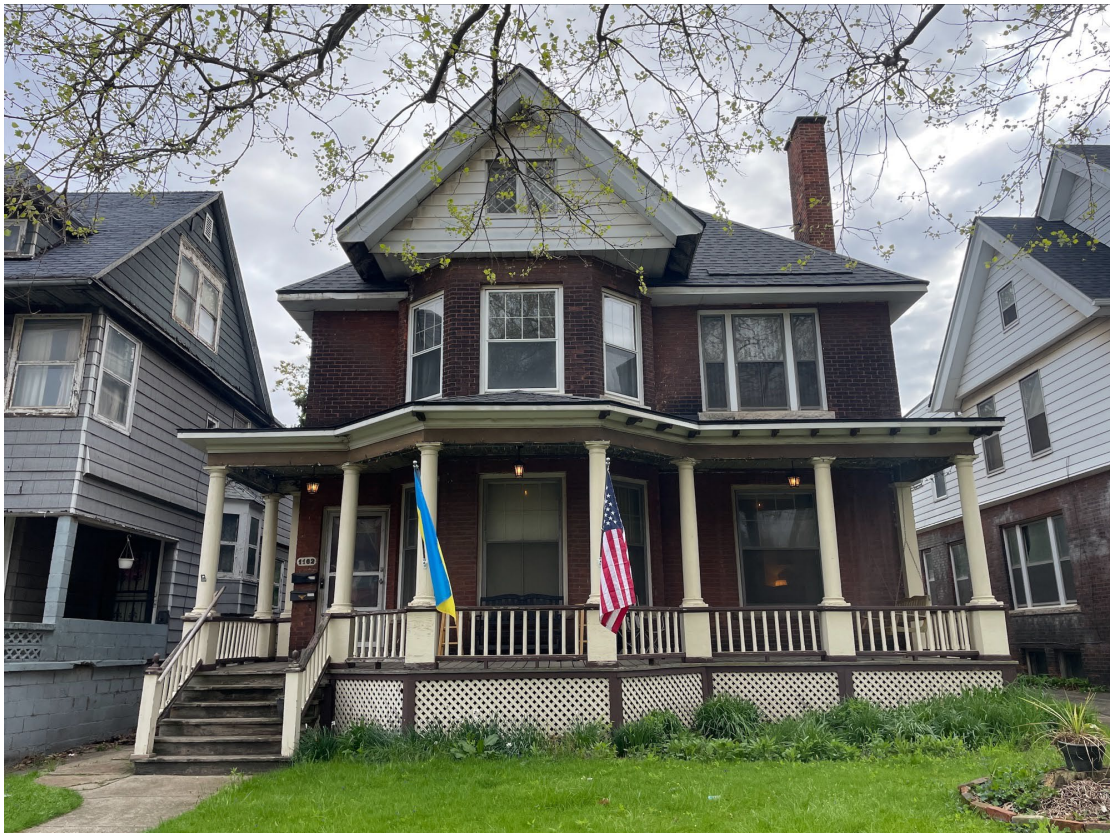
Staff photo, 05/08/2025

No Certificate of Appropriateness (COA) was found for the installation of the siding over the gables and dormer nor the front façade replacement vinyl windows, which has impacted the property's historic character.

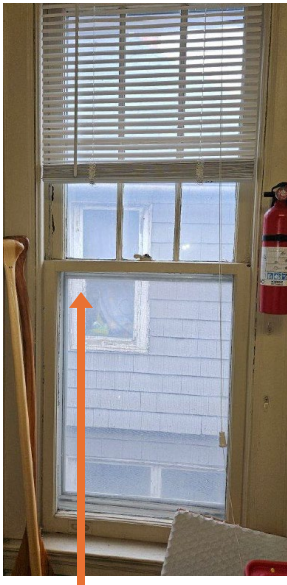
*North elevation, Second floor
Photos from application*

- Applicants' reasoning for replacements is that the existing historic wood windows are "old and inefficient."
- The existing wood windows are distinctive character-defining features that have not been proven to be beyond feasible repair.
- Photos provided with the application show relatively minor issues, such as missing sash rope or spots that could use a dutchman repair.
- The Elements of Design (Sec. 21-2-157) mention windows as "most often subdivided" and "the most common window type being doublehung sash, whose area is generally further subdivided by muntins." The Elements of Design also note "a variety of rich textural relationships exist in the district—those created by the juxtaposition of various materials, such as brick ... and/or wood."

- The proposed replacement of historic windows and addition of window units are not compatible with the overall historic character of the dwelling.
- The deterioration noted above constitutes typical maintenance needs of old windows and is repairable (per Preservation Briefs: 9 linked below). Any areas of damaged wood appear, to staff, to be minor and localized, and repairable. Thus, the windows do not seem to meet the standard of being “deteriorated beyond repair,” the standard required for their replacement under the Secretary of the Interior’s Standards for Rehabilitation (quoted in full below).

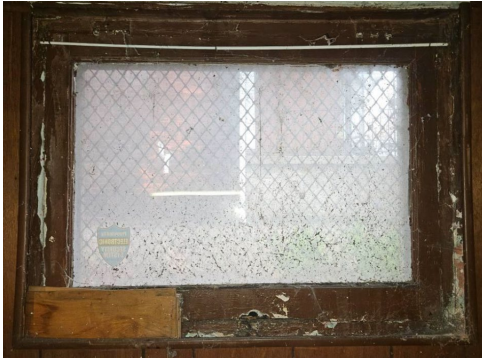
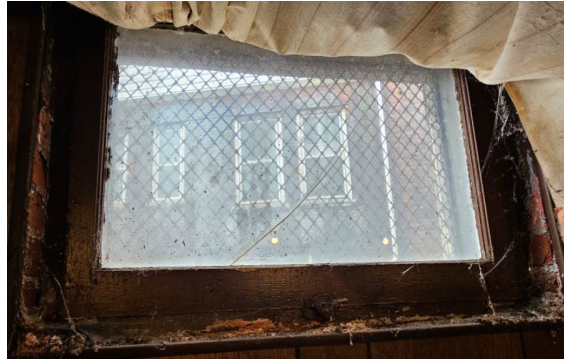
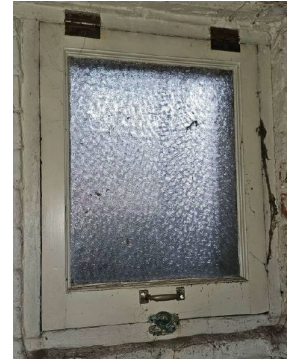
*Select basement windows
Photos from application*

- Applicants' reasoning for replacement is that there is no way to keep them open, the exterior has metal grates over them, and they have rotting issues due to being at ground and below ground level.

- Customarily the Commission allows, though does not recommend, glass block for basement window replacement, but the existing historic windows have not been proven to be beyond feasible repair nor do the proposed window replacements address potential safety concerns.

- Staff has authority to approve glass block basement windows granted they meet the following applicable conditions:
 - The proposal meets the Secretary of the Interiors Standards; i.e., the alteration does not damage or destroy the property's historic character or character-defining features / elements.

- The glass block shall be located at the same plane as the existing historic window, set back from the face of the building wall.
 - The glass block shall be covered with the historic screen placed back in the window or with a new screen.

- Glass block will only be permitted in basement window openings.
 - Openings with glass block that are on the front or visible from a side street shall be screened with foundation plantings that cover the windows.

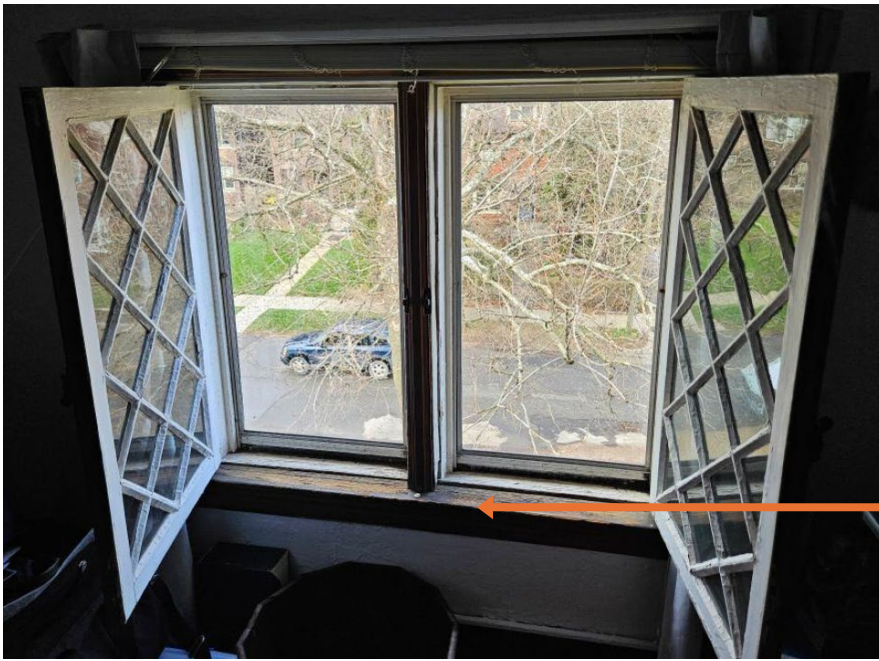
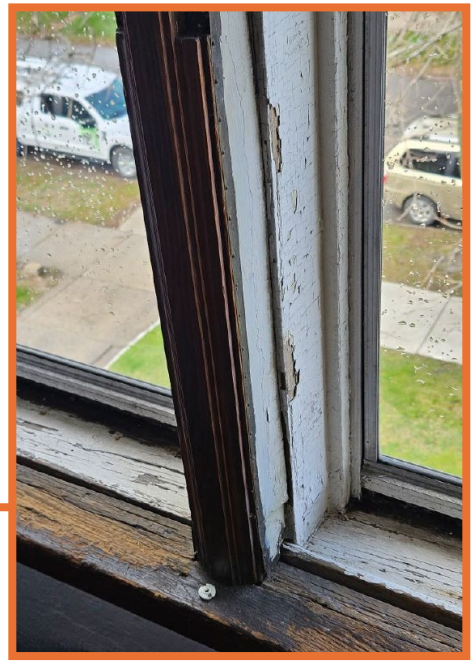
*West elevation, Third floor
Photos from application*

- Applicants' reasoning for adding an exterior window is that the existing configuration, historic wood casement window and aluminum storm window with screen inserts, is to improve energy efficiency.

- The windows proposed to be covered are historic and unambiguously character-defining as they are subdivided, as described in the Elements of Design, adding textural interest to the façade and a prominent visual component of the building.

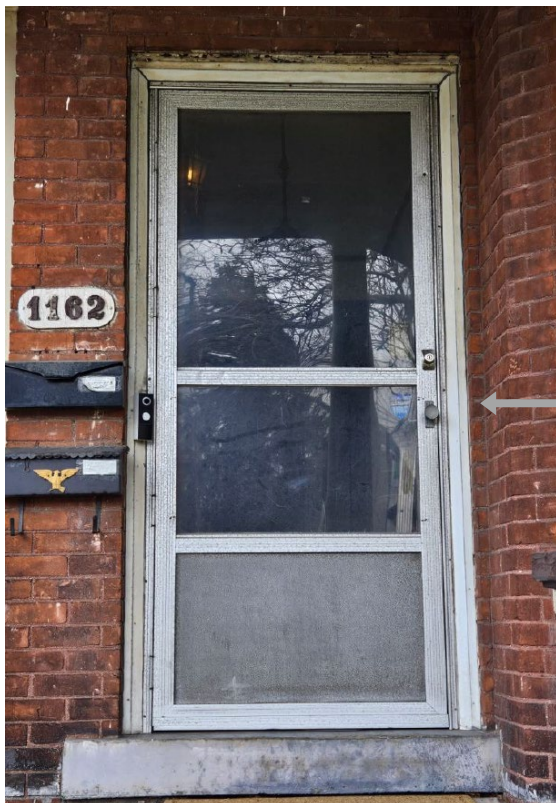
Photo from application

- The existing non-historic, though vintage, storm door is aluminum and divided into three sections.
- Due to not having architectural or historic significance and the proposed door being compatible with the property, the existing storm door can be replaced without impact to the historic character of the house.

Recommendation 2 of 2 – COA – Replace aluminum storm door for full-view storm door

- Subject to staff approval of selected design/profile.
