STAFF REPORT: 06/11/2025 MEETING
ADDRESS: 141 W. BOSTON BOULEVARD
APPLICATION NO: HDC2025-00238
VIOLATION NO: 1023

HISTORIC DISTRICT: BOSTON-EDISON
APPLICANT: STEVE DEBRUYN/STEVE'S IMPROVEMENT SERVICES
OWNER: DEREK AND SANDHYA BERK
DATE OF STAFF SITE VISIT: 4/30/2025 & 5/25/2025
DATE OF PROVISIONALLY COMPLETE APPLICATION: 4/19/2025

SCOPE: REMOVE CLAY TILE ROOF AND REPLACE WITH ASPHALT ROOF (WORK STARTED WITHOUT APPROVAL)

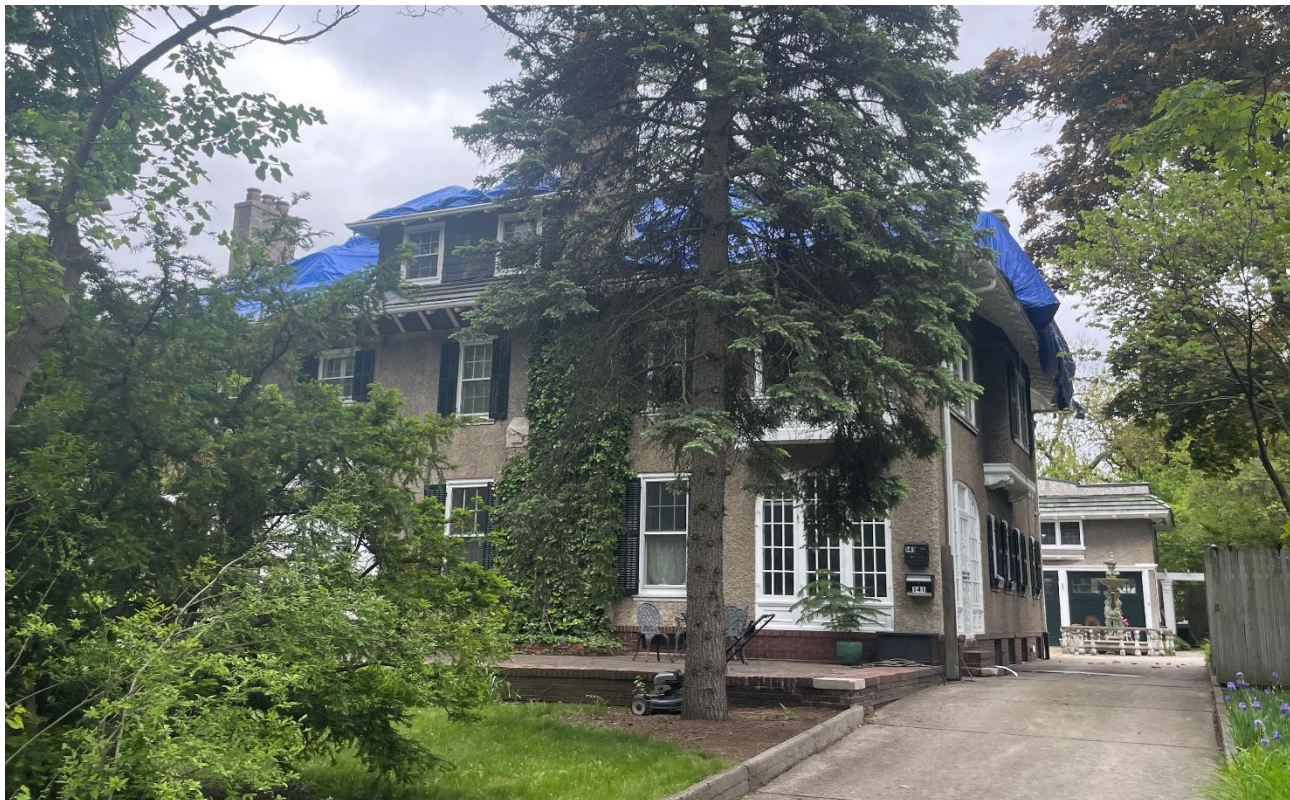
141 W. Boston. Photo taken by staff on 5/23/2025. Note the tarp covering the area of roof tiles that were removed without HDC approval.

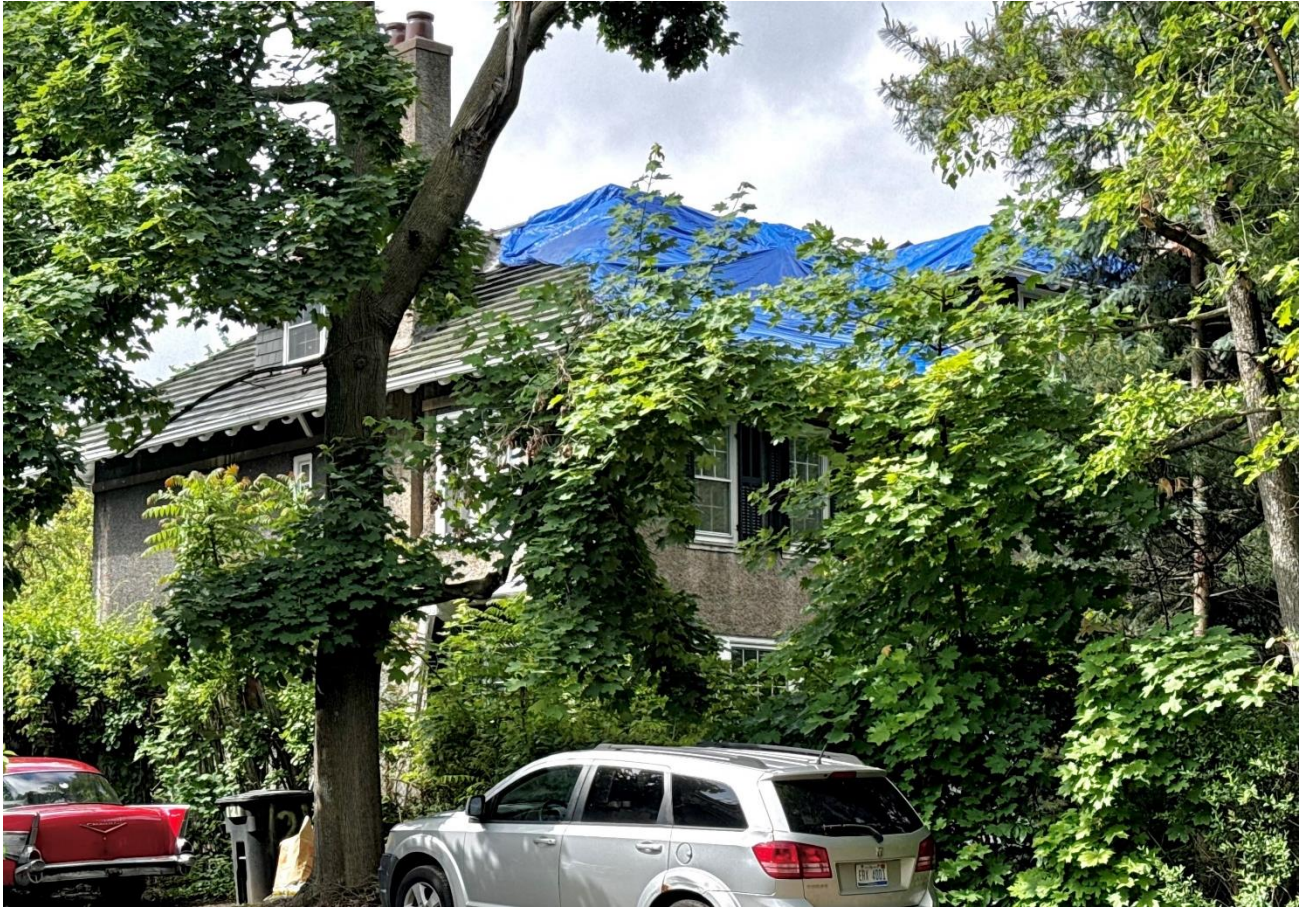
141 W. Boston. Photo taken by staff on 5/23/2025. Note the tarp covering the area of roof tiles that were removed without HDC approval.

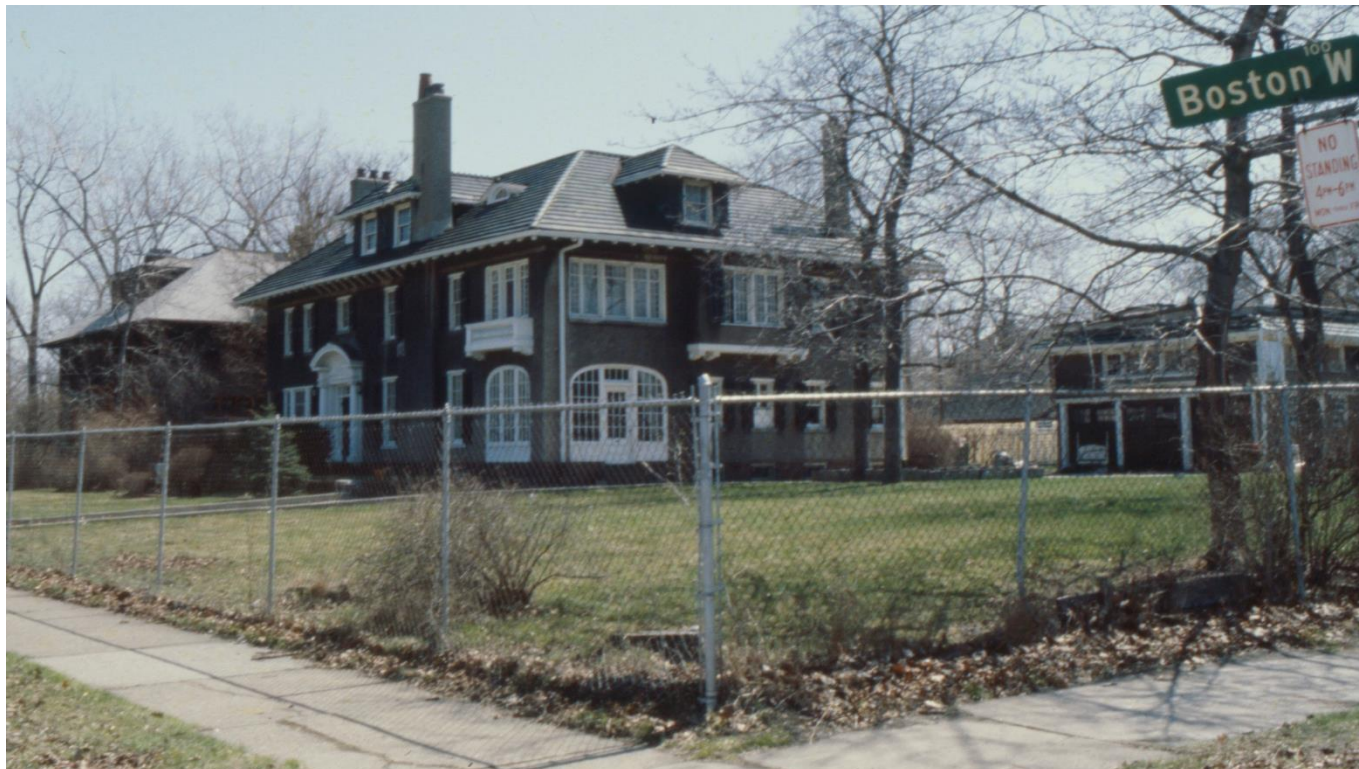
141 W. Boston. Photo taken in 1982 by HDC staff. Showing condition of the roof and the garage/carriage house to the rear

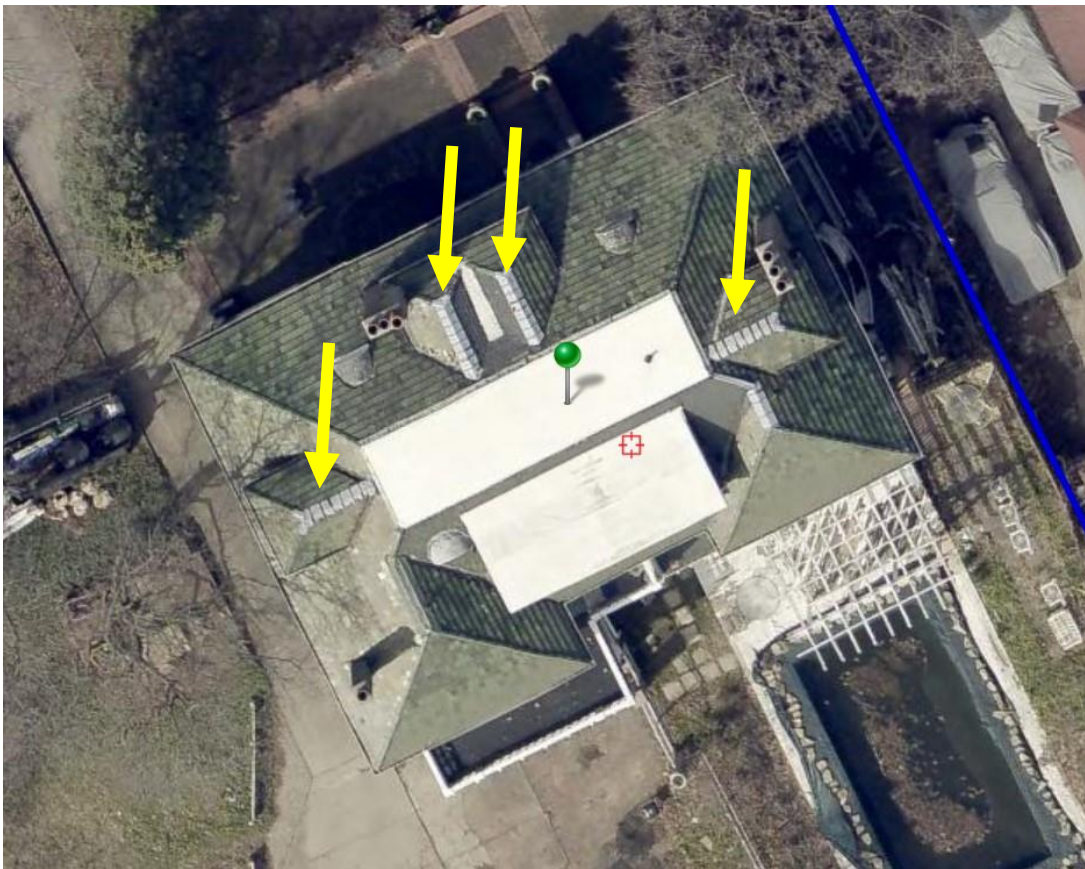
Eagle View aerial, 2024. Yellow areas indicate areas of past repairs

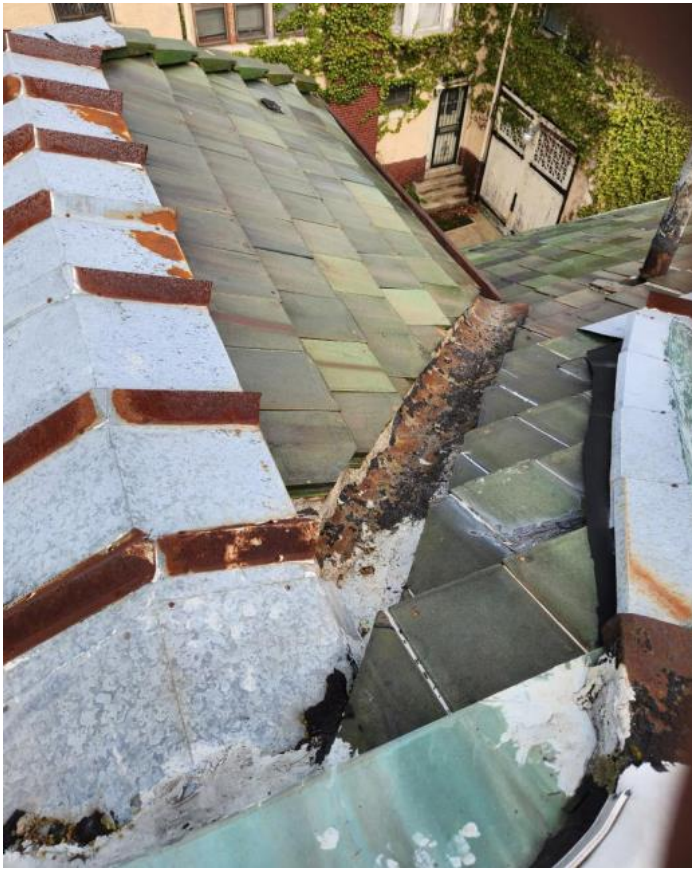
Photo by applicant. Showing area of past roof repair

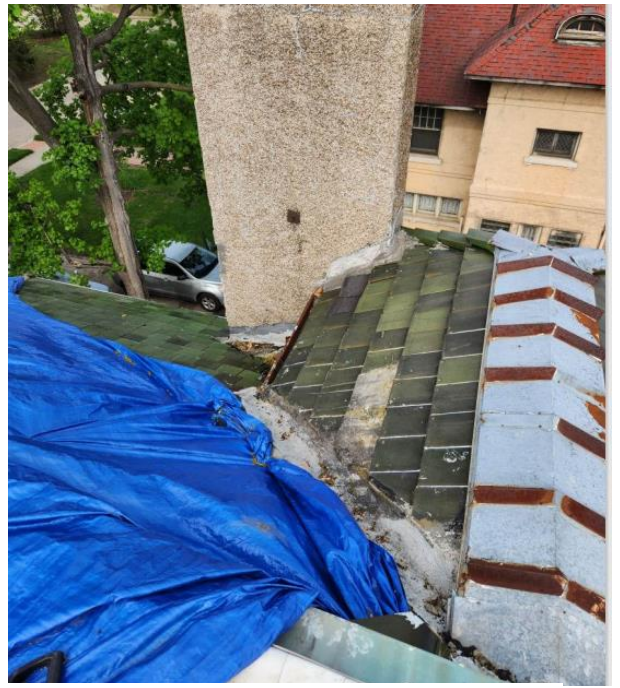
Photo by applicant. Showing area of past roof repair

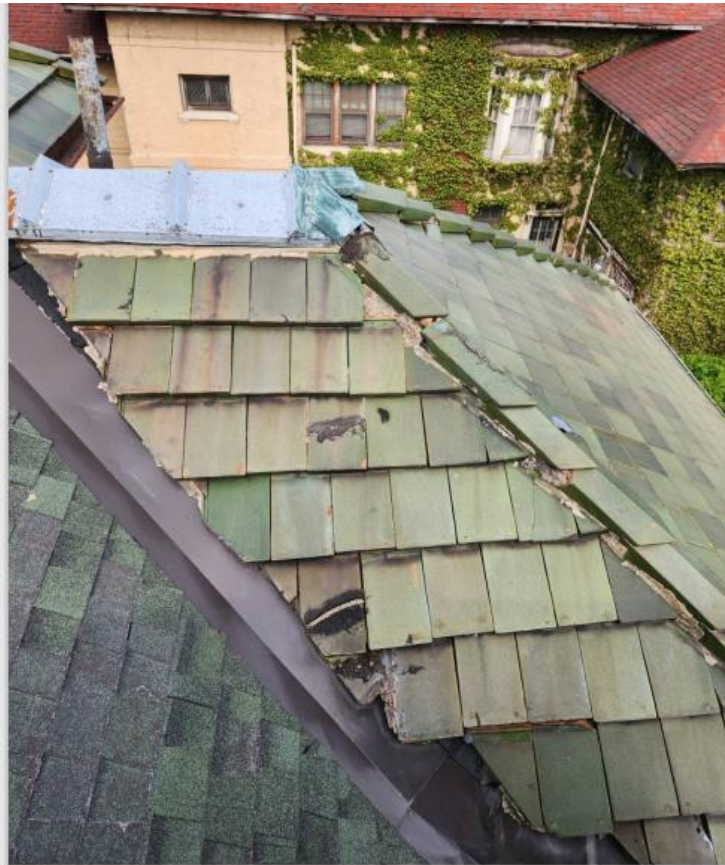
Photo by applicant. Showing area of past roof repair. Note areas of asphalt roofing

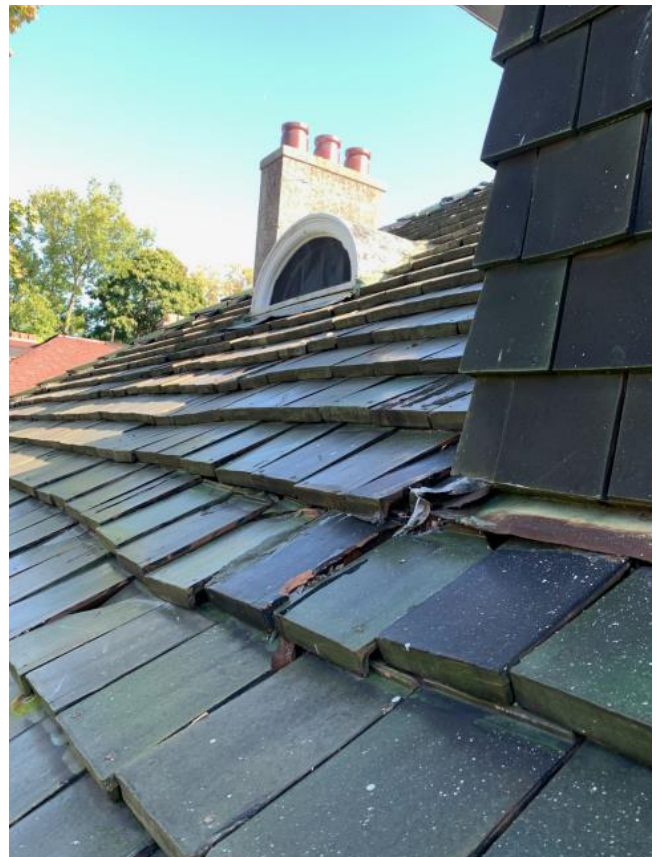
Photo by applicant. Showing condition of clay tile

- A full photographic documentation can often suffice in re: to demonstrating the condition/level of deterioration of an historic roof. However, as the roof was not fully documented before the unapproved clay tile removal was undertaken, staff is left to rely on the few submitted photos to understand the condition of the entirety of the historic clay tile roof. It is not clear to staff that the few submitted photos clearly indicate that remaining tiles could not have been salvaged for reinstallation.

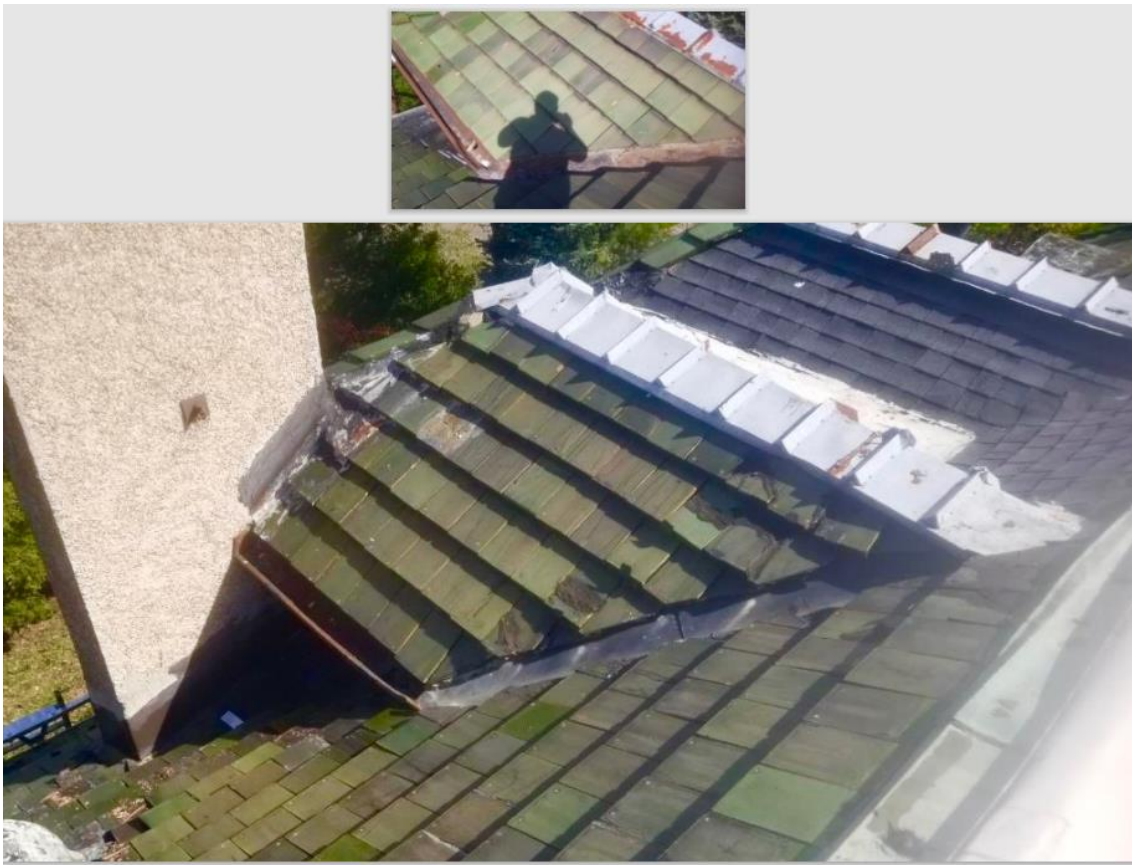
Photo by applicant. Showing area of roof repair at front paired dormers. Note small area of asphalt roofing

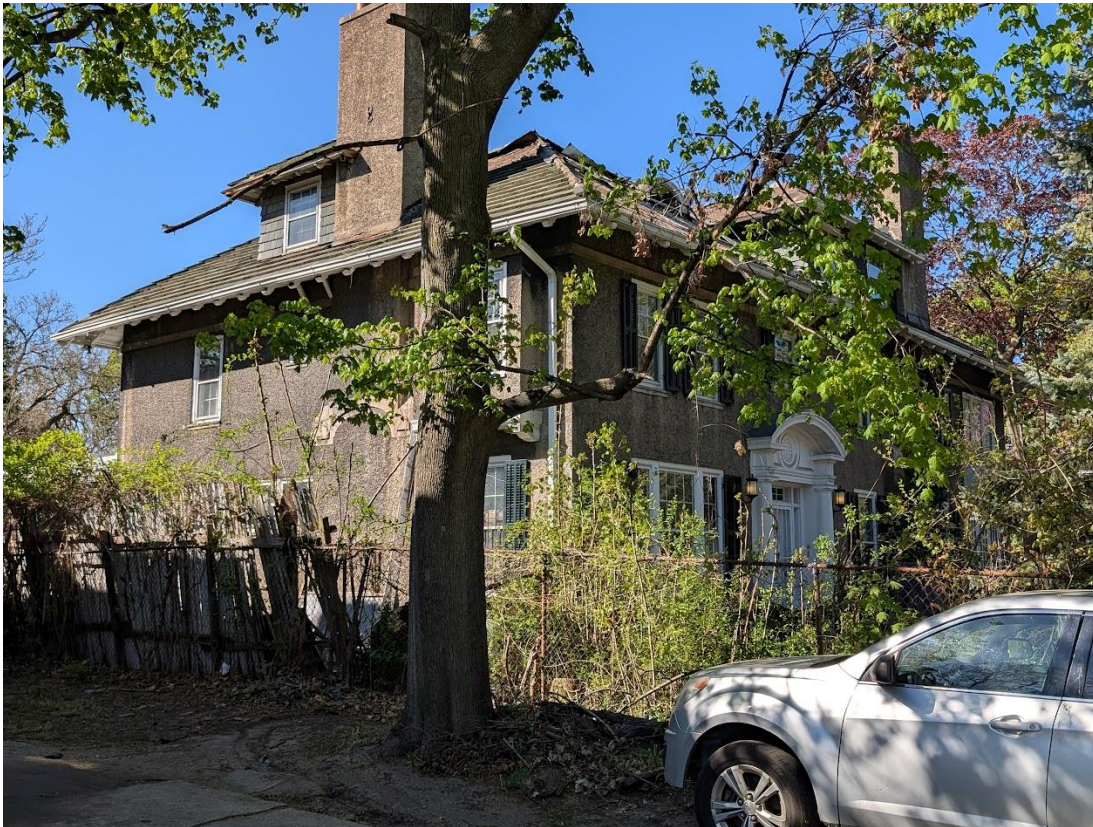
141 W. Boston. Photo taken on 4/30/2025 by HDC staff, showing current unapproved roof removal in progress

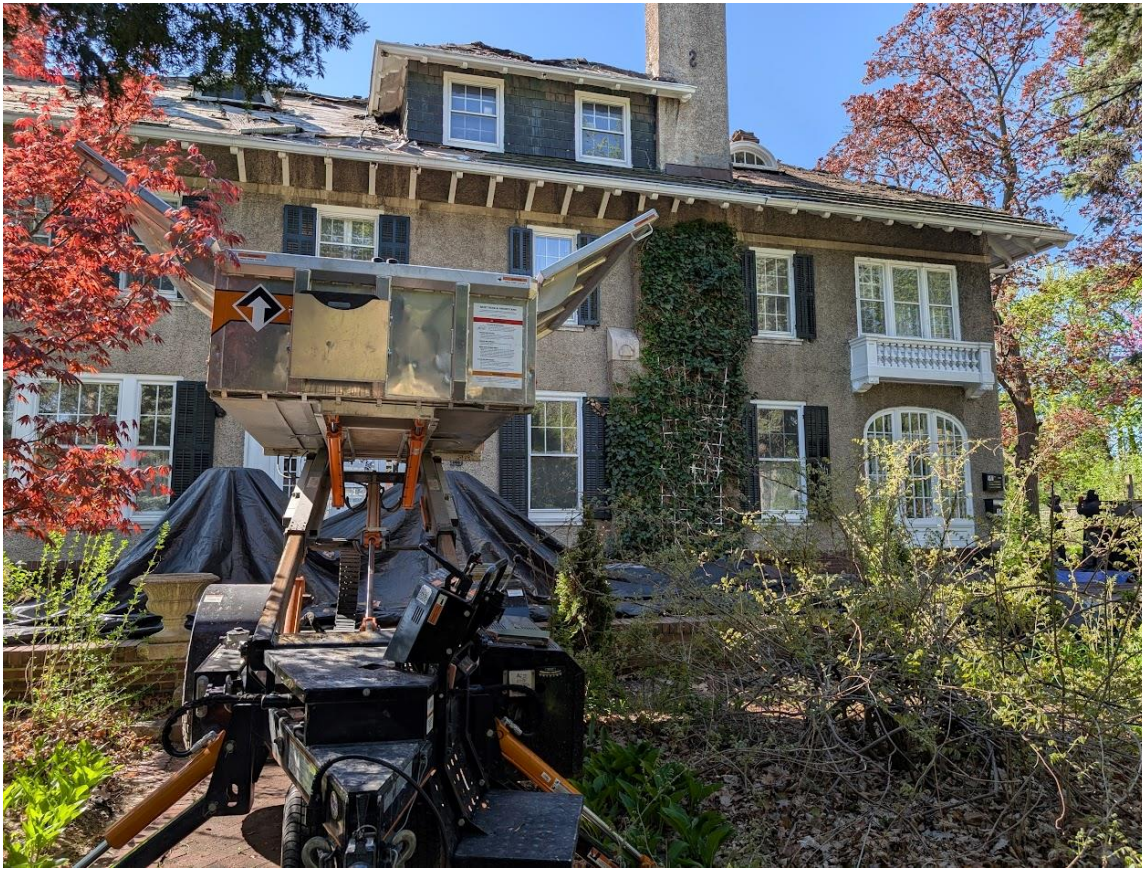
141 W. Boston. Photo taken on 4/30/2025 by HDC staff, showing current unapproved roof removal in progress

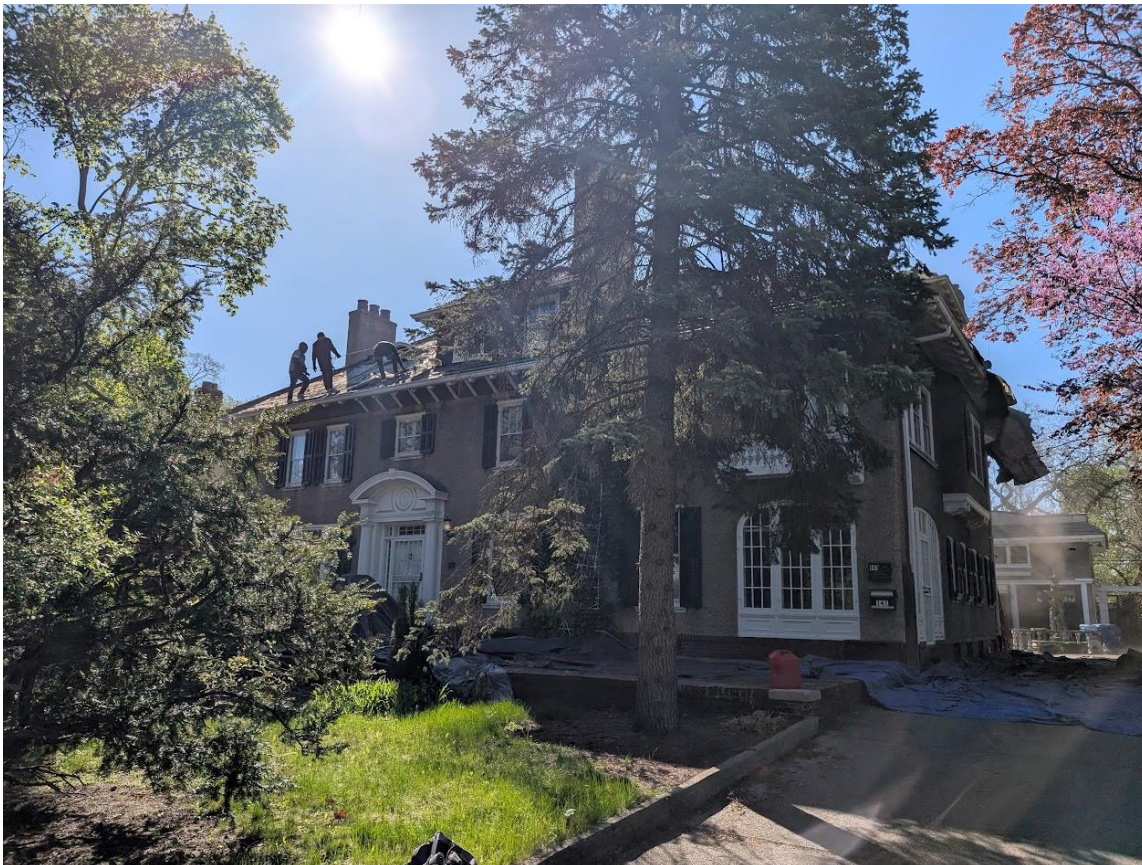
141 W. Boston. Photo taken on 4/30/2025 by HDC staff, showing current unapproved roof removal in progress
