PREPARED BY: A. DYE **REVISED STAFF REPORT:** JUNE 11, 2025 MEETING

APPLICATION NUMBER: HDC2025-00274

ADDRESS: 1760 WABASH

SCOPE: INSTALL ALUMINUM-CLAD WOOD WINDOWS AND REPLACE HISTORIC WOOD SIDING

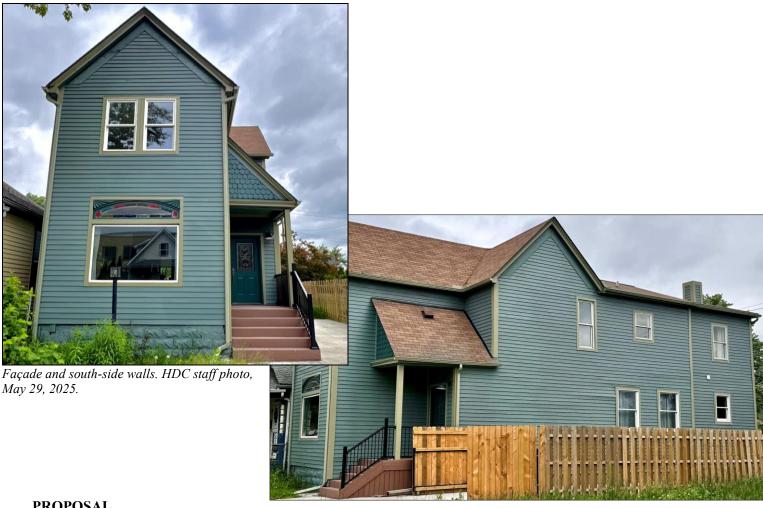
The two-story wood-framed dwelling is located on the east side of Wabash Street, between Marantette and Bagley. The dwelling was erected ca. 1889 and the rear addition erected in 2024. New lap siding on each side of the house was installed within the last year (subject of this application), and some historic details within the front and (south) side gables will be rebuilt, as will the front-facing gable window that was removed (without HDC approval) in 2024. New windows were recently installed without HDC review and are the subject of this application.

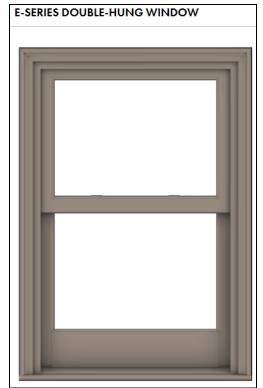
This current application states Anderson E-series windows were installed within most of the openings on house (historic and new openings), but it is staff's opinion that the installed windows do not match the dimensions and profile of an Anderson E-series window, as the installed are exceptionally thin and minimally profiled window frames. Additionally, the approved cladding color for the new windows was black. Bright white window frames, as installed, are a contemporary color and offer too high a contrast against this 19th century dwelling. Victorian houses were replete with multiple color exterior palettes, but bright white was not historically used. Staff copied the available color selection offered within the Anderson E-series line. The majority of the colors available (outside of the bright whites and possibly cardinal red) could be appropriate for this dwelling and are readily available through the manufacturer.

Close-up of installed window, at second floor rear (new construction). Staff photo, March 26, 2025.

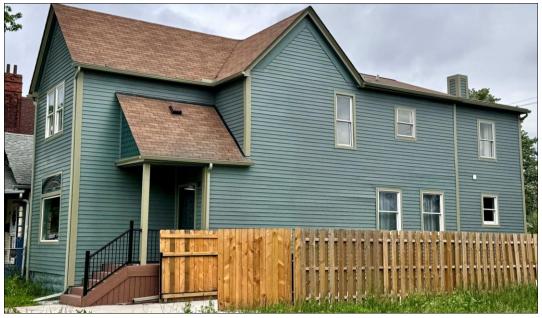
Comparison #1 - "after" and "before". Above: Staff photo, May 2025 // Below: Staff photo, February 2024.
The majority of the windows (at the front and side walls) in the above 2025 photo are in line with the wall surface. Whereas the below windows, likely the historic openings but filled with non-historic vinyl windows, are all recessed. Even in partial visibility, you can notice the recessed windows at the second floor on the front façade.

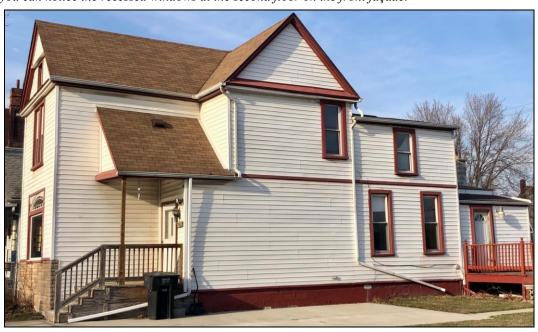
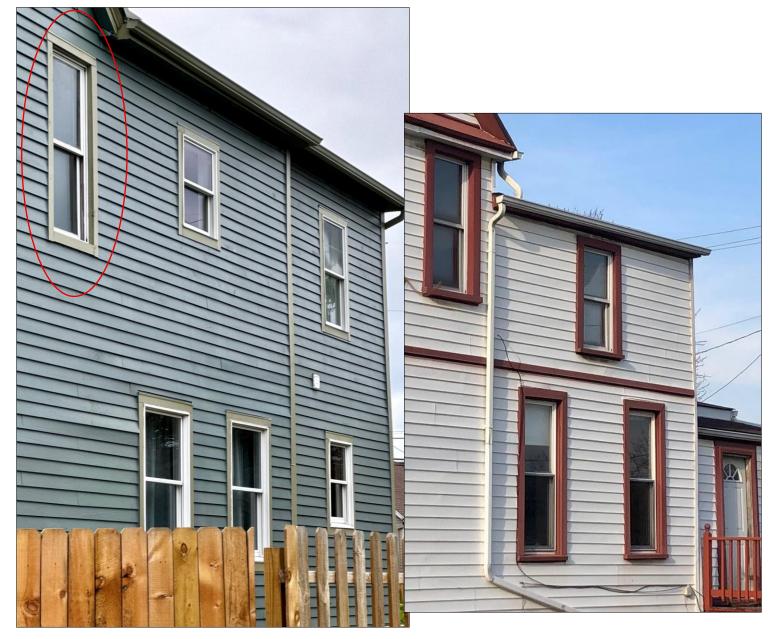
Comparison #2 - "after" and "before". Above left: Staff photo, May 2025 // Above right: Staff photo, February 2024. The close-up view of the 2025 south-side wall shows inconsistent window placement. All of the openings (except one which is circled) have windows installed at the front of the window opening; the window trim actually extends past the flat window casings. Conversely, the windows in February 2024 were uniformally recessed, which is the appropriate placement for windows within historic dwellings. Even windows in the new construction should be recessed to be compatible with the historic window openings.

Please note: the construction of flat window casings was denied by the Commission and the applicant must still build new dimensional casings similar to the pattern seen in the February 2024 photo. The Commission also placed a condition that the new casings be constructed of solid wood.
