**STAFF REPORT: JUNE 11, 2025 MEETING**

**APPLICATION NUMBER: HDC2025-00203**

**ADDRESS: 4069 STURTEVANT**

**SCOPE: REPLACE ASPHALT ROOF WITH METAL ROOF, INSTALL GUTTERS/DOWNSPOUTS, REPLACE REAR PORCH ENCLOSURE, (WORK COMPLETED WITHOUT APPROVAL), INSTALL RAILING AT FRONT PORCH**

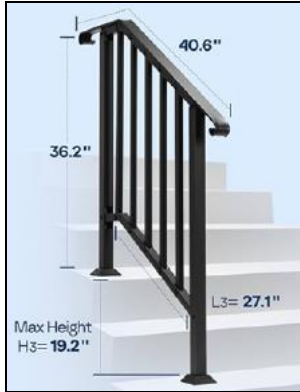
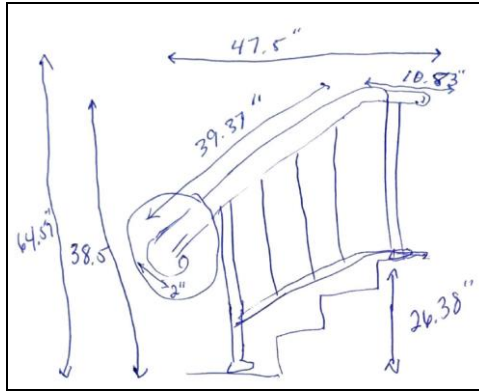
*Applicant cut-sheet and drawing of proposed railings for front porch stairs.*

- Regarding the proposed front porch railing, it appears a black metal railing was in place at time of designation (as was the chain-link driveway gate). The main issue staff has with the proposed railing is the stated 45" height. A 36" railing would be appropriate and proportional for the stairs. The applicant should confirm in writing that no railing will be applied to the low masonry walls.

- The top railing of the porch railing be a maximum 36" from the step surface.
- The gutters, downspouts and collector boxes will be painted dark brown, similar to the asphalt shingle roof and brick veneer on the house walls; or, the Sherwin Williams Sage Green Light, which will be used on the house's trim.

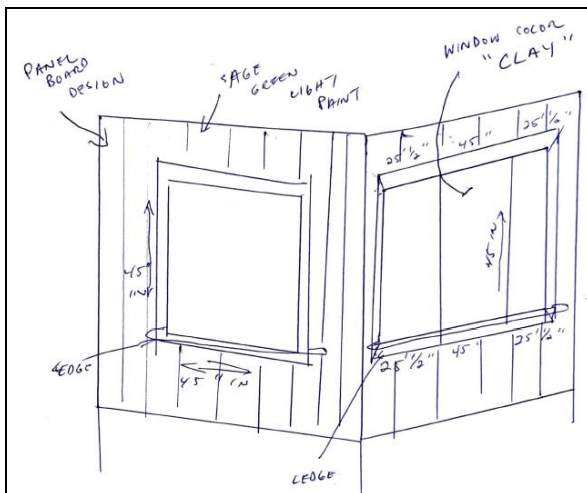
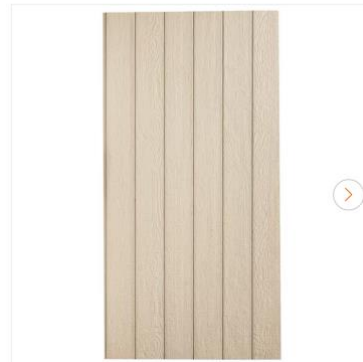
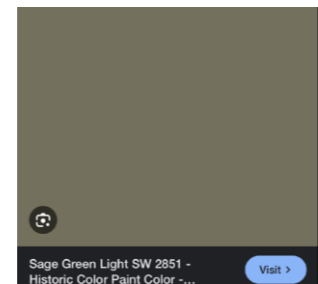
*Applicant sketch, wall siding cut sheet and wall paint color*

- Additionally, the vertical LP Smartside siding, proposed to enclose the areas above and below the windows, is an engineered wood product made from smaller pieces of wood, such as wood fibers or particles, and bound together with adhesives. It is a panelized product with a faux raised wood grain and shiplap edges and does not adequately replicate painted historic, horizontal wood lap siding. Additionally, wood lap siding is readily available and can offer a matching texture (smooth finish), exposure and edge profile to historic wood siding.

- Additionally, the vertical LP Smartside siding, is a panelized product with a faux raised wood grain and shiplap edges and does not adequately replicate painted historic, horizontal wood lap siding.

Staff recommends that the metal roof at the bay window, front porch masonry walls, and rear porch enclosure will be inappropriate according to the Secretary of the Interior’s Standards for Rehabilitation and the Russell Woods-Sullivan Historic District’s Elements of Design, specifically:

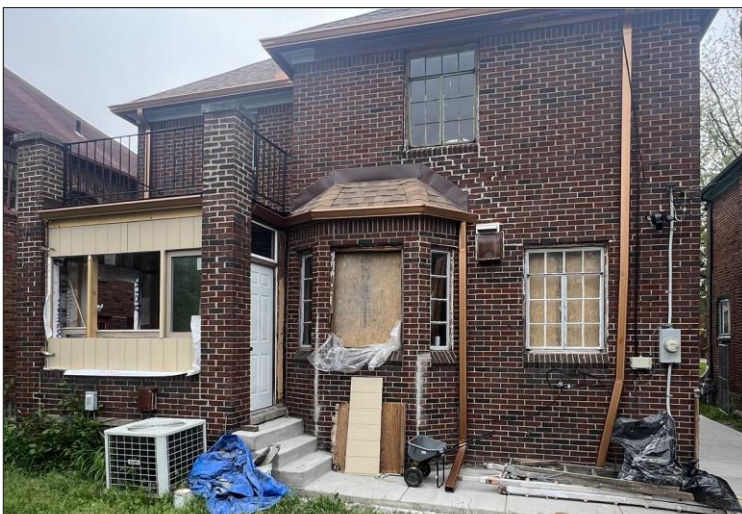
*Applicant photo – rebuilt enclosure partially completed*

- The current design of the first floor rear porch, as partially constructed, encloses the porch further through the installation of shorter windows and erection of small sections of walls below and above the windows. The three-unit grouping of fixed and operation windows is similar to the previous condition: a wide, central fixed window is flanked by narrow operable windows; however, the operational windows changed from double-hung to casement.

- It is staff's opinion that the previous enclosure using windows that extended the full opening was a compatible solution for three-season living space and the current proposal of windows and walls is not appropriate as it alters the features, massing and proportions of the rear porch structure and does not meet the following Standards:

- The previous exterior condition of the first floor rear porch had fixed and operable vinyl windows extending the entire width and height of the masonry openings. The current design of this porch, as partially constructed, encloses the porch further through the installation of shorter windows and erection of small sections of walls below and above the windows, which alters the features, massing and properties of the porch.

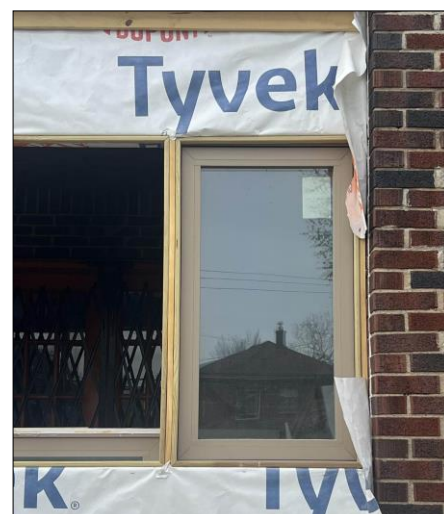
*Applicant photo of installed window within newly sized opening.*

- The new windows are vinyl framed units and replace vinyl windows. Although the previous non-historic windows were within a non-historic opening, the rear porch structure is an original or historic-age component of the house and any changes/alterations proposed for must be appropriate and compatible with the early 20<sup>th</sup> century house. It is staff's opinion, through limits of fabrication and material, vinyl windows are not appropriate for historic districts.

- The new windows are vinyl framed units. The rear porch is an original or historic-age component of the house and proposed alterations must be appropriate and compatible with its early 20<sup>th</sup> century date of construction and architectural style. Through limits of fabrication and material, vinyl windows are not appropriate for historic districts.

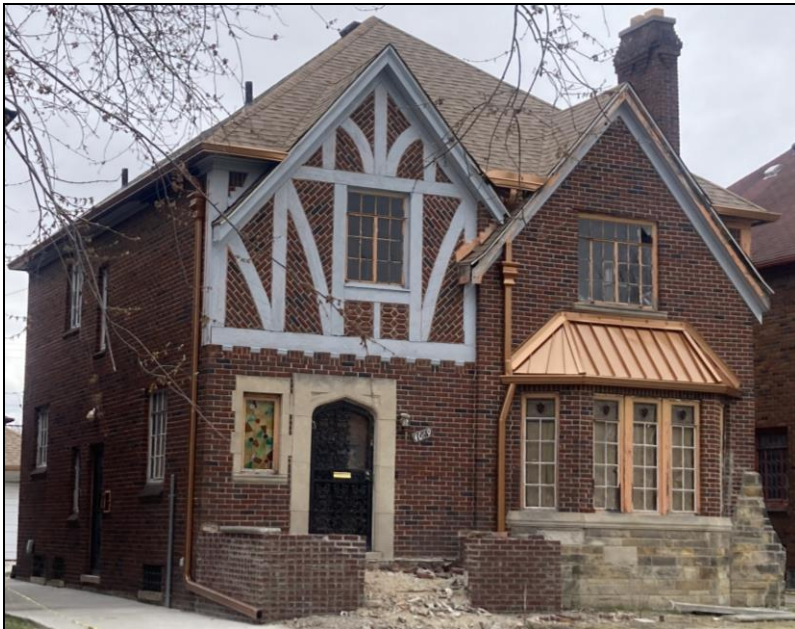
- April 15, 2025 SeeClickFix photo submitted to notify continued work at property.
- April 15, 2025 Staff visits site and takes photos of additional completed work, including gutters/downspouts/collector boxes and metal roof at bay window.
- April 22, 2025 Applicant submits initial application for work items; HDC staff has numerous requests for additional documents and photographs in order to review the application.

*HDC staff photo, April 15, 2025*

- The “coppertone” color of the installed gutters, downspouts and collector boxes is bright and shiny; and, unlike real copper, will retain its bright, shiny finish for the duration of their installation. This unchanging contrast of color and finish with the dark brick exterior walls is not compatible for this English Revival dwelling, where the overall color palette for this architectural style is muted and with matte finishes.

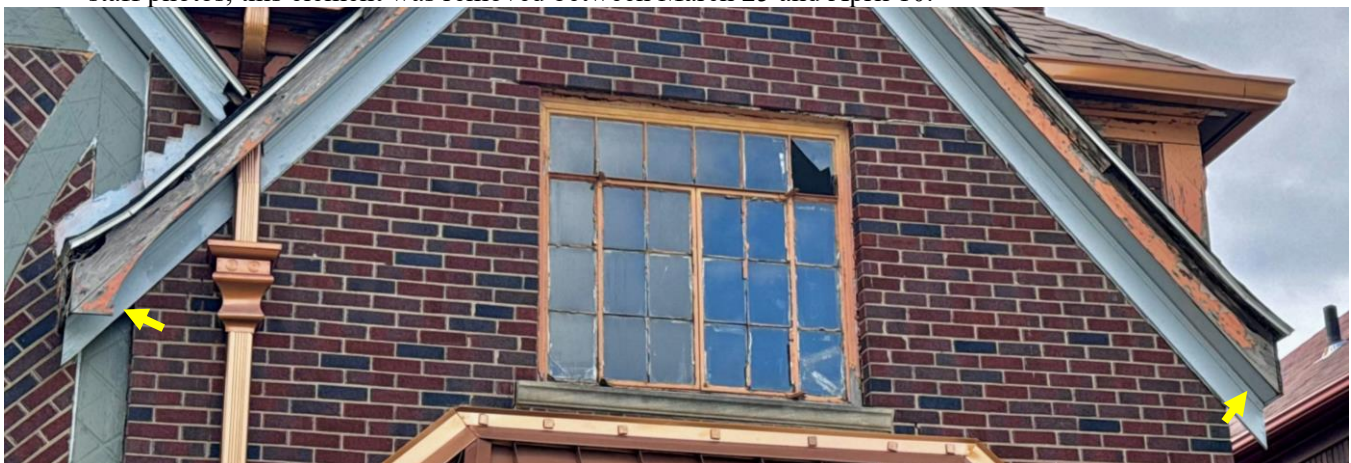
- During the research of this staff report, staff identified that the end/edge trim on the front gable's rakeboard (right side) has been removed. The edge detail, although small, is a distinctive character-defining feature of early 20<sup>th</sup> century English Revival design and must be retained and reinstalled. According to the timeline of staff photos, this element was removed between March 25 and April 10.

*HDC staff photo, May 29, 2025.*

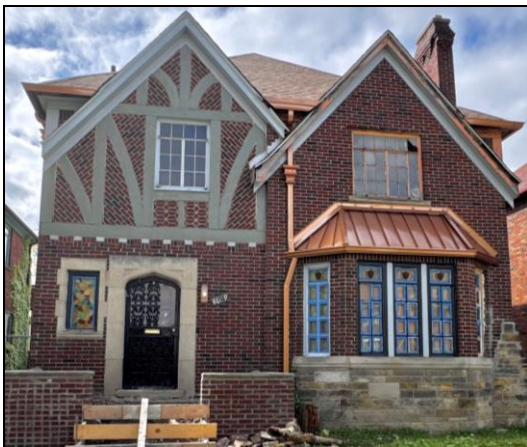
- Staff has a similar concern with the finish of the metal roof installed at the bay window and has additional concerns with the specific metal used due to the highly dimensional surfaces. The material, color and dimensionality causes this roof to be the dominant feature on the front of the house, rather than being one of collection of decorative features. Staff offers a visual comparison of the installed metal roof, an installed copper roof (located on a property in Rosedale Park), a historic metal roof (located on a property in Russell Woods) as well as the asphalt shingle roof that was previously in place at this bay window.

*Contemporary metal roof, 4069 Sturtevant*

- The metal roof installed at the bay window will similarly have an incompatible bright and shiny never-changing finish, as well as highly dimensional surfaces which are not characteristic of metal roofed bay windows. The material, color, and dimensionality of the installed product causes this roof to be the dominant feature on the front of the house, rather than being one of collection of decorative features.

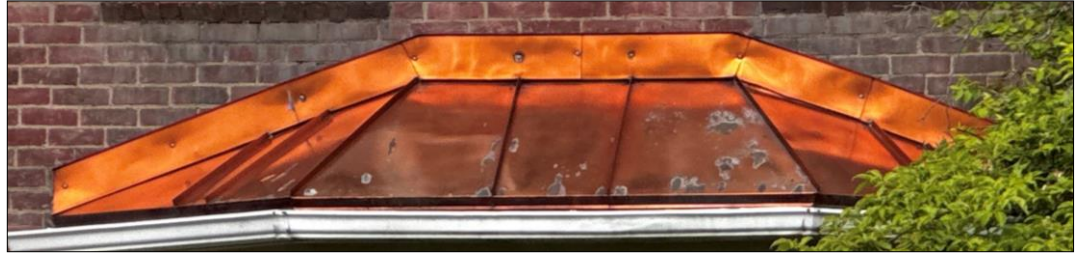
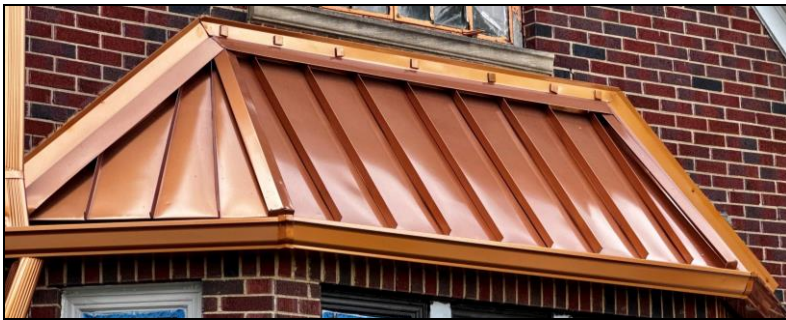
*Conversely, the seams of the new metal roof protrude quite far, and corner pieces add additional depth. The "flashing" edge pieces against the house and roof are laid over the seamed roof, creating a shadow line. Applied decorative square components at the top adds yet another dimensional feature/pattern that is not found on the copper and historic-age metal roofs.*

- The metal roof installed at the bay window will similarly have an incompatible bright and shiny never-changing finish, as well as highly dimensional surfaces which are not characteristic of metal roofed bay windows. The material, color, and dimensionality of the installed product causes this roof to be the dominant feature on the front of the house, rather than being one of collection of decorative features.

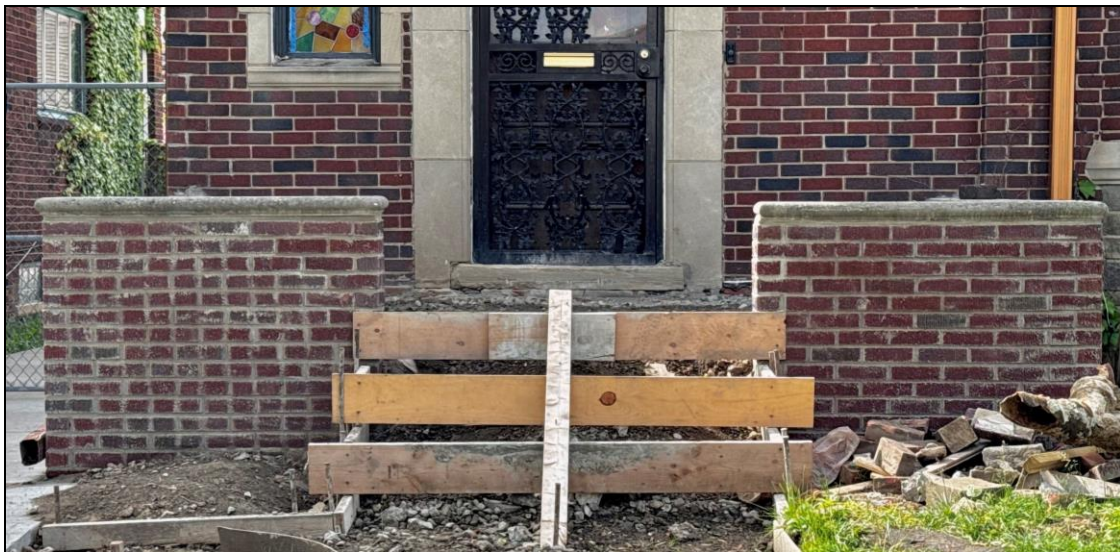
- Staff is confused over the existing condition of the front porch walls. The photo taken by staff on May 29 shows a stacked bond pattern on the left wall and a running bond (matching the pattern of the house) on the right wall. Based on the photos of the porch before demolition, the bricks appeared to be intact and reusable when the structure was rebuilt. The COA stipulated the porch be rebuilt in-kind - based on the May 29 photos, it is staff's opinion this was not done. The dimension and color of the new red bricks is compatible, but the omission of randomly placed gray/black bricks (as clearly seen on the house) also does not meet the scope of work in the COA. Furthermore, the mortar joints on the new walls are not consistent with each other and do not match the historic mortar joints (profile, texture, dimension) on the house, and mortar appears to have been spread across many bricks.

- Strangely, the photos submitted by the applicant one month earlier as part of the staff review application show different masonry walls. A running bond pattern used on both walls, and the mortar joints appear to be consistent within the new construction and closer in dimension to the thin mortar joints on the house. The existing condition shown in the May 29 photo does not meet the approved scope of work listed in the Certificate of Appropriateness.

*HDC staff photo, May 29. 2025.*
