STAFF REPORT: JUNE 11, 2025 MEETING

APPLICATION NUMBER: HDC2025-00269

ADDRESS: 3928 PORTER STREET

SCOPE: REPLACE HISTORIC WOOD WINDOWS

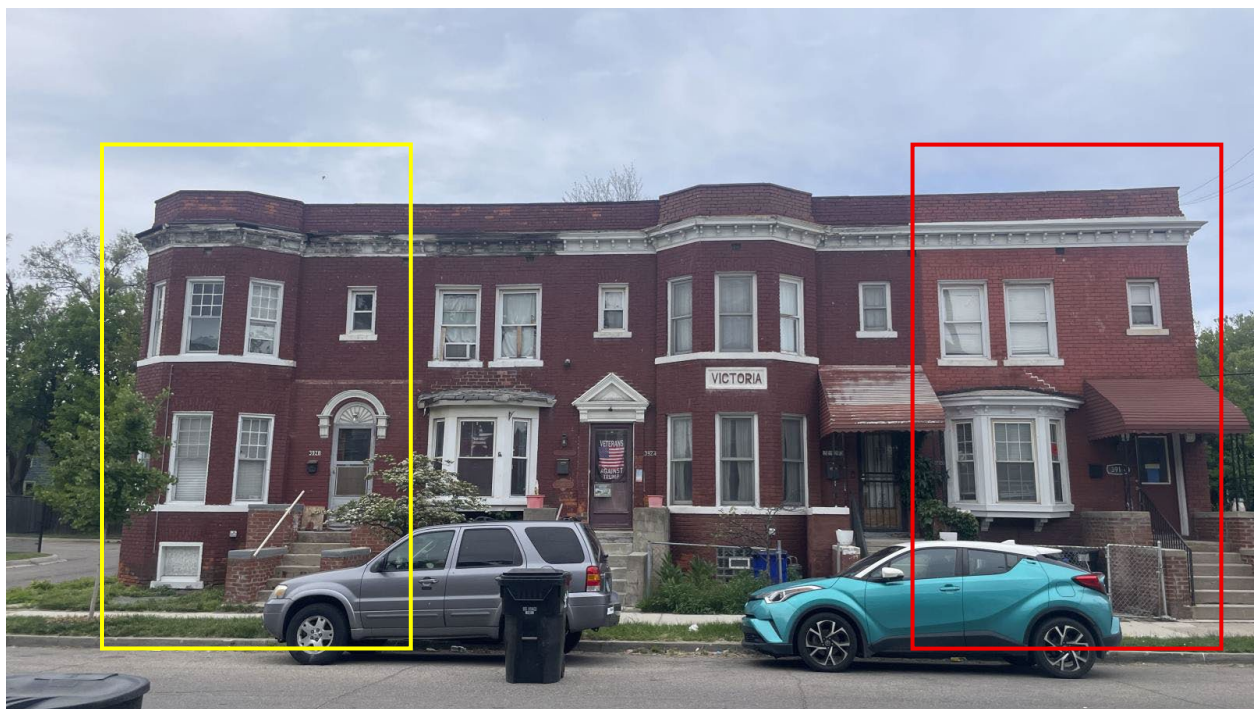
3916 Porter (RED) to the right, where work was meant to be done (without HDC approval). 3928 Porter (YELLOW) where the work was done without owners' permission and HDC approval. Photo taken by staff on 05/27/2025.

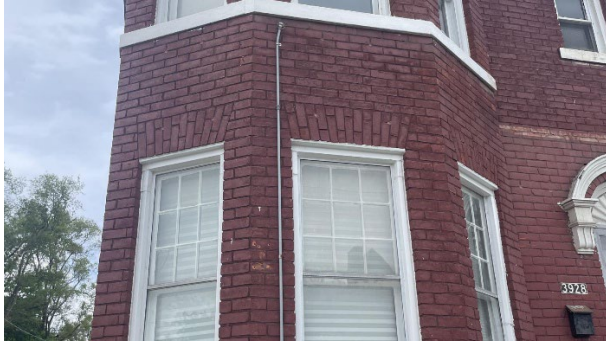
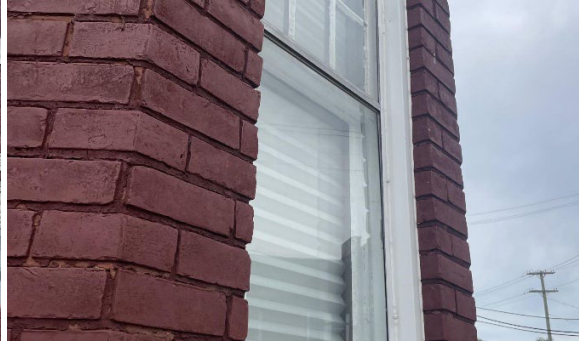
HDC Staff Photos, taken 05/27/2025

- The windows proposed for replacement are historic age and are distinctive character defining features of the property in staff's opinion.
- A review of the current conditions reveal that the caulk has potentially been added to the storms rather than the actual windows themselves.
- In staff's opinion, the windows are in repairable condition. Therefore, per the Elements of Design and SOI Standard #6, these windows should not be removed.
- Please refer to the below photo's for current window conditions.

Existing Condition of front façade windows

Recommendation 1 of 1 – Denial – Replace historic wood windows

- The historic windows proposed for removal are still in well enough condition to be preserved and repaired.
- The historic windows proposed for removal are significant historic features that contribute to the character of the property and as they have been shown to be in repairable condition, should be retained.

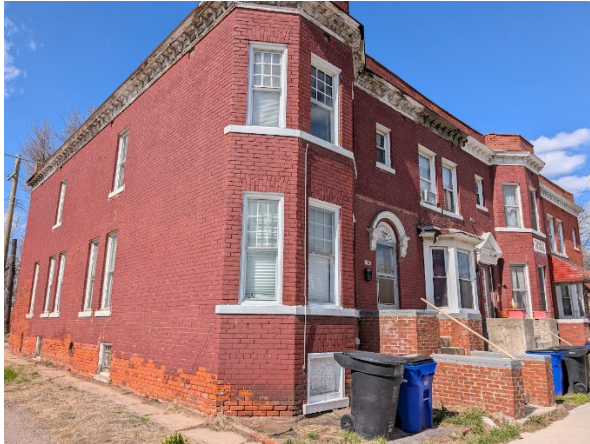
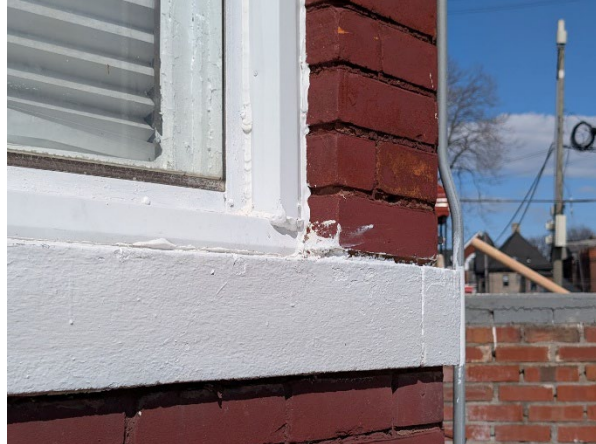
HDC Staff Photos 04/11/2025

Existing Condition of Windows, view from sidewalk

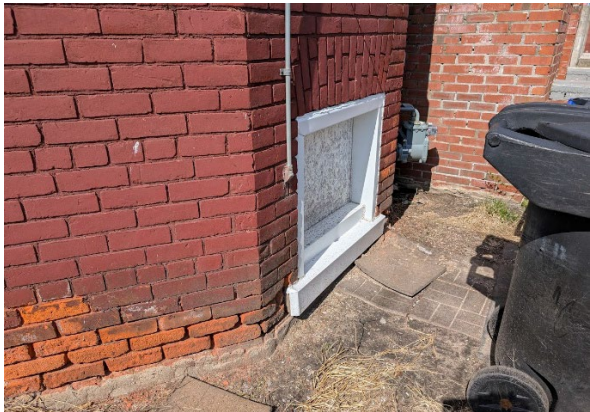
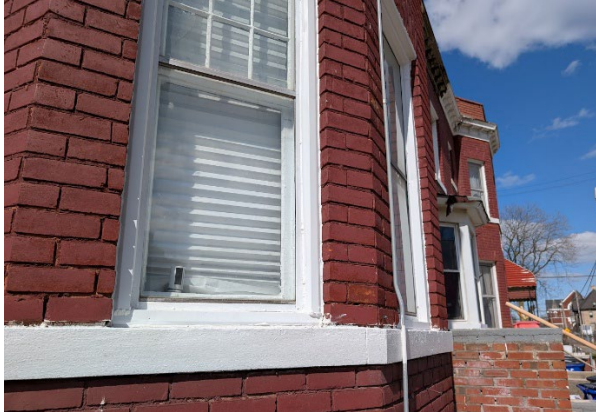
HDC Staff Photos 04/11/2025

Basement Window Opening and Side of 3928 Porter

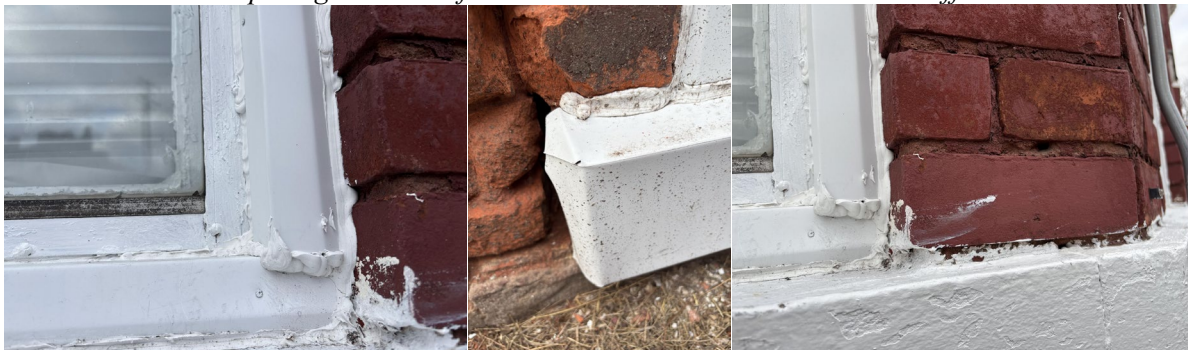
Photos taken by applicant.

- The applicant has provided an assessment of the wood windows for replacement, completed by contractor, Time and Tool:
 - *Polyurethane sealant/caulking was applied to the brick. Sealant applied to storm windows covering screws and access points for removal of storm windows. This has effectively rendered the windows inaccessible, as many storm windows are in a non-functional condition. Broken panes in multiple sashes are now inaccessible for repair without full removal of the sash from the interior. Simply cleaning the windows is now an impossible task for the homeowner.*

- *Tub/Tile enamel has been applied to the windows. Old glazing on the panes and paint on the sashes were not repaired/prepped prior to painting, creating a prohibitively difficult process to restore the window without breaking the glass.*

- *Excessive nails have been driven through the aluminum trim that was applied to all brick molding and exterior sills. Removal of this aluminum trim would likely damage the original wood beyond repair. Old wood rot was not remediated prior to applying aluminum, and the lack of air exposure caused by the application of aluminum will exacerbate rot issues.*
