**STAFF REPORT:** 06/11/2025 **REVISED**  
**APPLICATION NUMBER:** HDC2025-00192  
**VIOLATION NUMBER:** 25-1005  
**ADDRESS:** 3751 LESLIE

**HISTORIC DISTRICT:** RUSSELL WOODS-SULLIVAN  
**APPLICANT / PROPERTY OWNER:** KAYODE ADEKOYA  
**DATE OF PROVISIONALLY COMPLETE APPLICATION:** 05/05/2025  
**DATE OF STAFF SITE VISIT:** 05/27/2025

**SCOPE:** REPLACE HISTORIC WINDOWS, MULTIPLE EXTERIOR ALTERATIONS

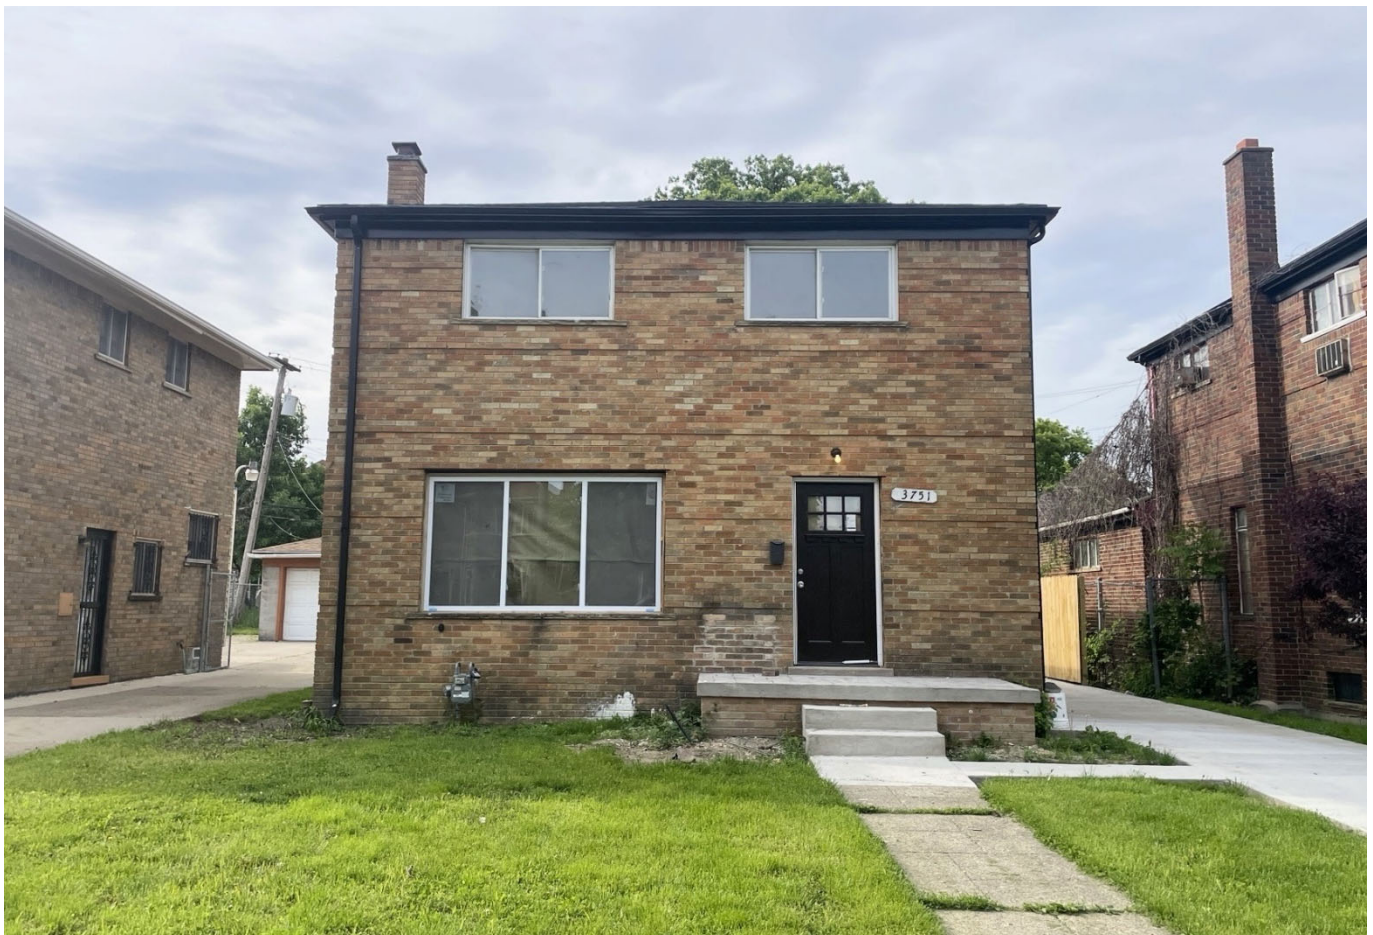
*Staff photo, 05/27/2025*

No Certificate of Appropriateness (COA) was found for the installation of the front façade replacement vinyl windows, which has impacted the property's historic character.

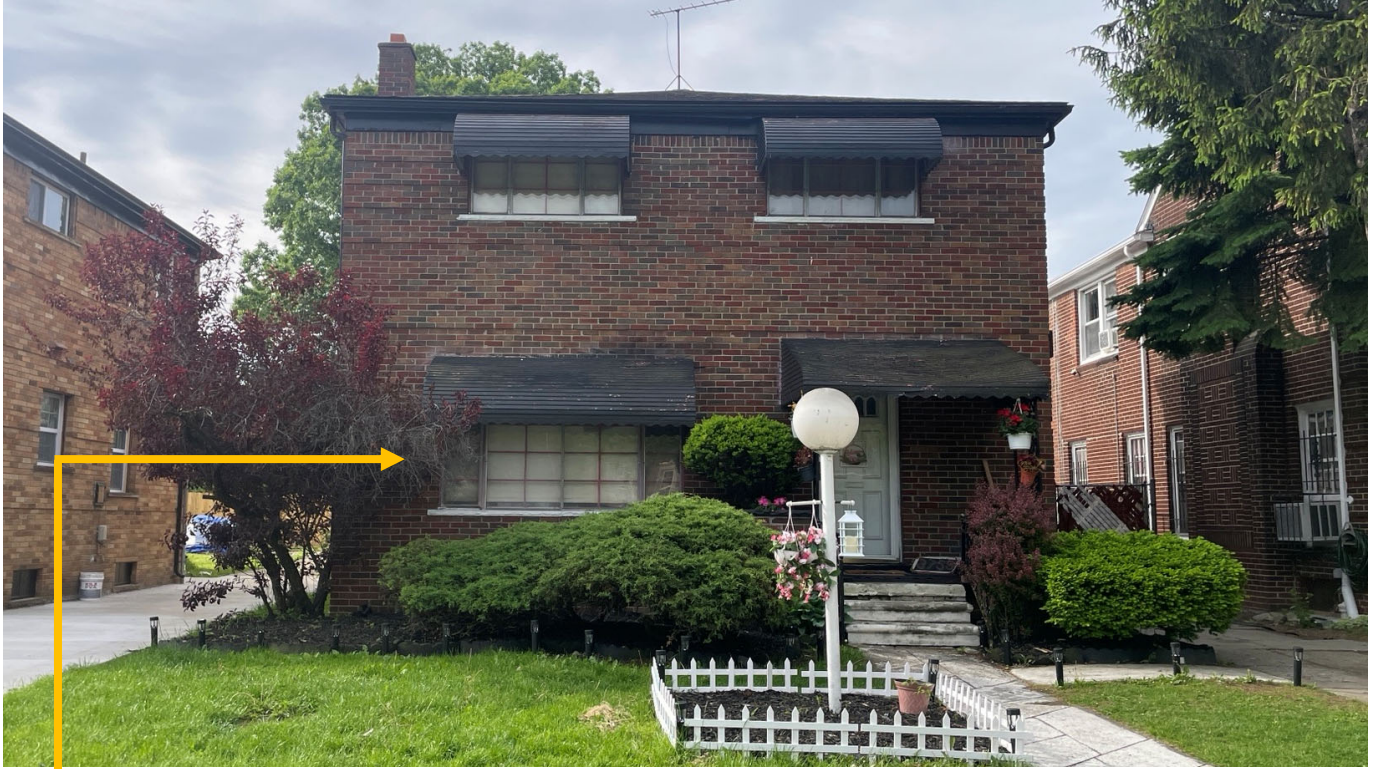
*Staff photo of 3759 Leslie, 05/27/2025, a nearby house to the subject property*

- Similar, if not the same, historic steel casement windows adorn the house at 3759 Leslie, located directly to the West of 3751 Leslie.

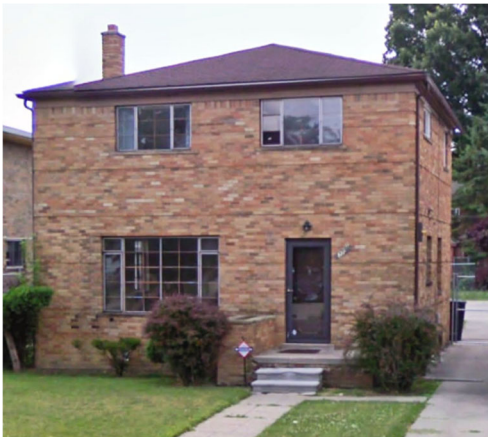
*Google street view, 07/2009, of subject property, 3751 Leslie*

- The front façade, second level historic steel windows were replaced sometime between 2009 and 2011 from a previous owner, without the approval of the HDC.

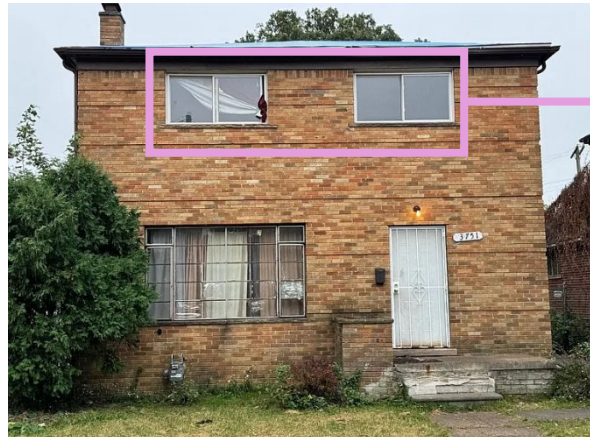
*Photo from real estate listing, 09/2024, 3751 Leslie*

- Note that the black, aluminum wrapping around the trim/soffits/fascia, also installed without the approval of the HDC.

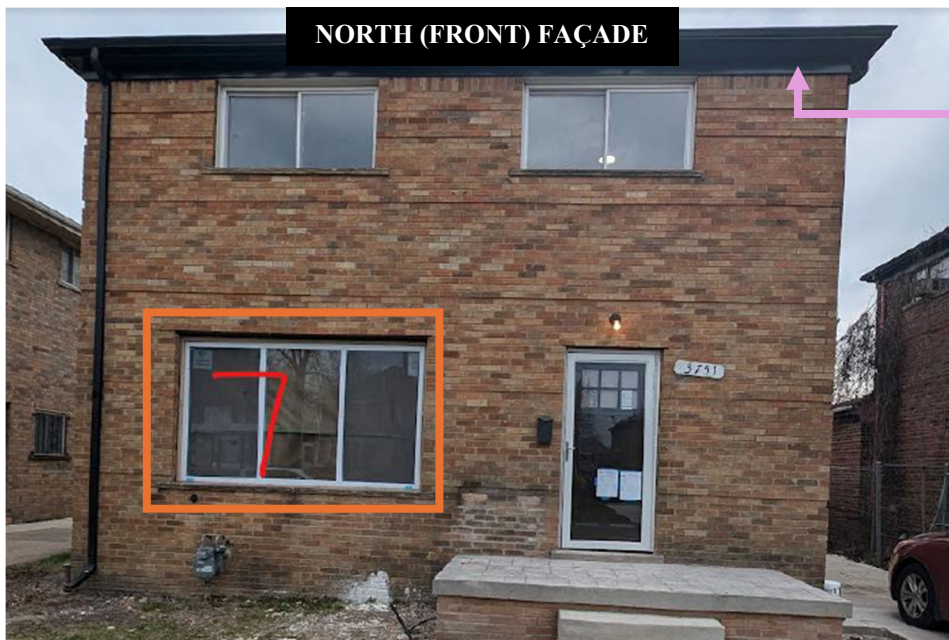
**NORTH (FRONT) FAÇADE**

Previously historic steel windows, replaced with vinyl windows by applicant

Previously vinyl windows, replaced with vinyl windows by applicant

**Recommendation 1 of 2 – Denial – Remove historic steel windows and vinyl windows to replace with vinyl windows, ~~add aluminum wrap to windows, install shutters, install front door and storm door, add faux-architectural elements, and outdoor wall lights~~**

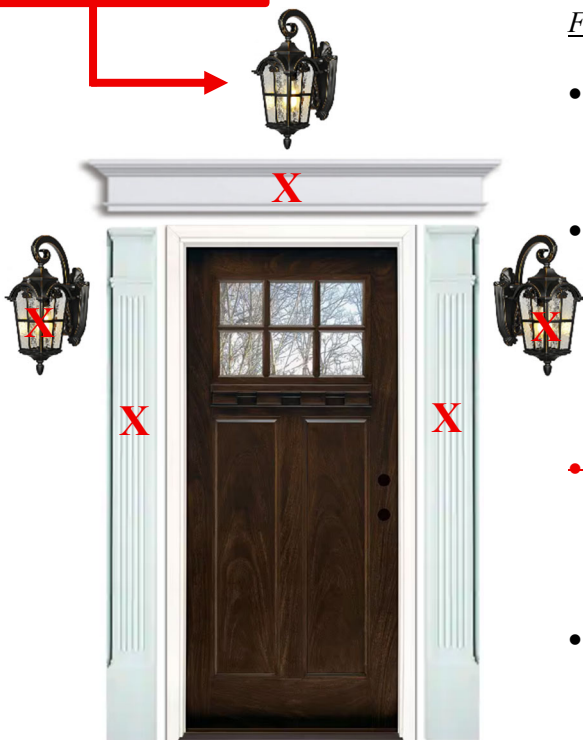
*Images from application*

The applicant proposes to replace the existing entrance light, which is located centered above the front door.

- The proposed outdoor wall lights ~~have~~ has ornate details, which goes directly against the International influence of this dwelling and it is staff's opinion that ~~they are~~ it is inappropriate. ~~Additionally,~~ the current single light above the door is likely the original exterior light placement, as multiple houses of this style on Leslie have it as well.

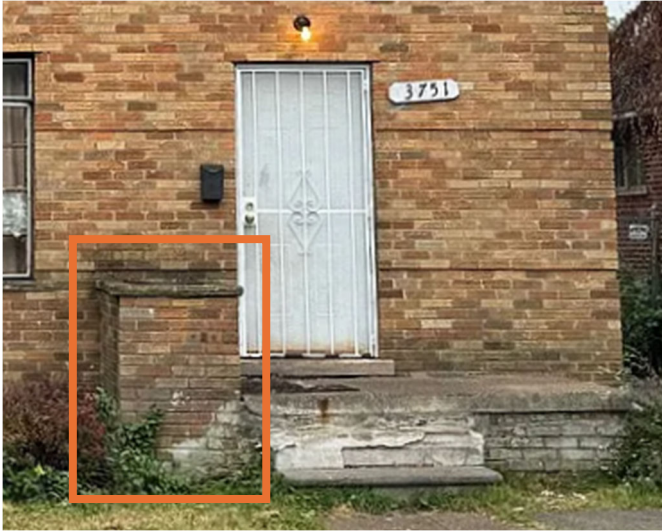
*Photo from real estate listing, 09/2024*

- Though the previous porch seemed to be in a state of deterioration, the removal of the historic brick planter box does not meet the standards. As stated in the [NPS Standards for Rehabilitation](#): “deteriorated historic features shall be repaired rather than replaced. Where the severity of deterioration requires replacement of a distinctive feature, the new feature shall match the old in design, color, texture, and other visual qualities and, where possible, materials.”

- Rebuild historic brick planter box in-kind, with staff to review and approve
- Staff is to review foundational planting scope

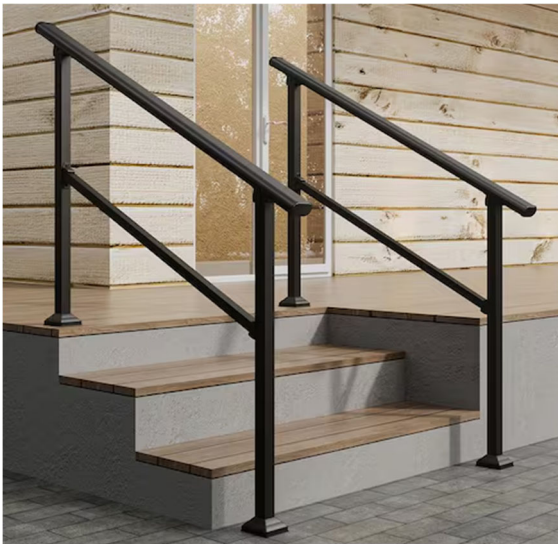
- It is staff's opinion that the proposed railing is appropriate due to its compatibility in minimal design, dimensions, and color. Additionally, the installation of the railing does not result in the replacement or removal of existing historic features.

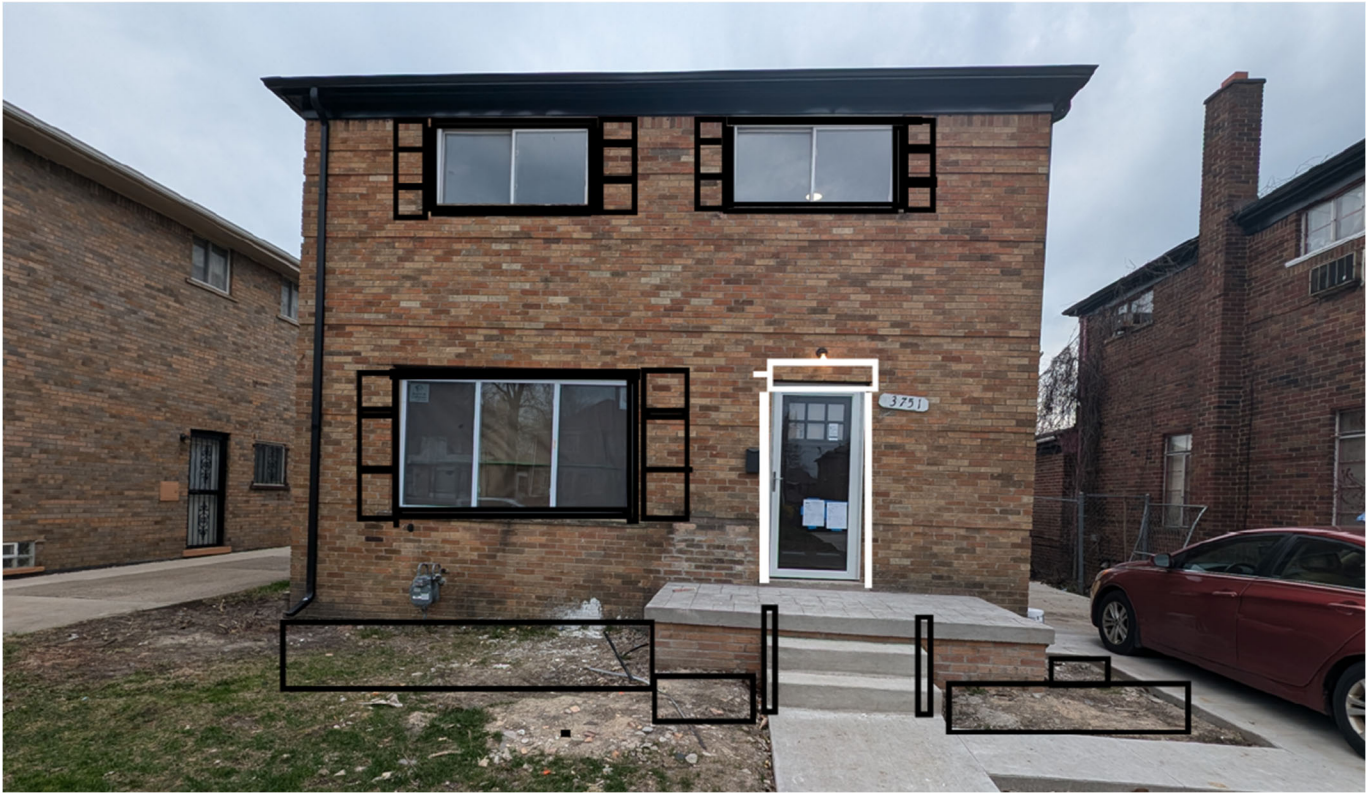
*Photo with mark-ups from application*

- The applicant proposes flower beds at the front of the house with plastic or metal landscape edging.
