**STAFF REPORT:** 06/11/2025

**APPLICATION NUMBER:** HDC2025-00154

**ADDRESS:** 4282/4284 WAVERLY

**SCOPE:** REPLACE WINDOWS, ADD WINDOWS TO EXTERIOR OF EXISTING WINDOW, INSTALL WINDOWS WHERE CURRENT WINDOWS ARE MISSING

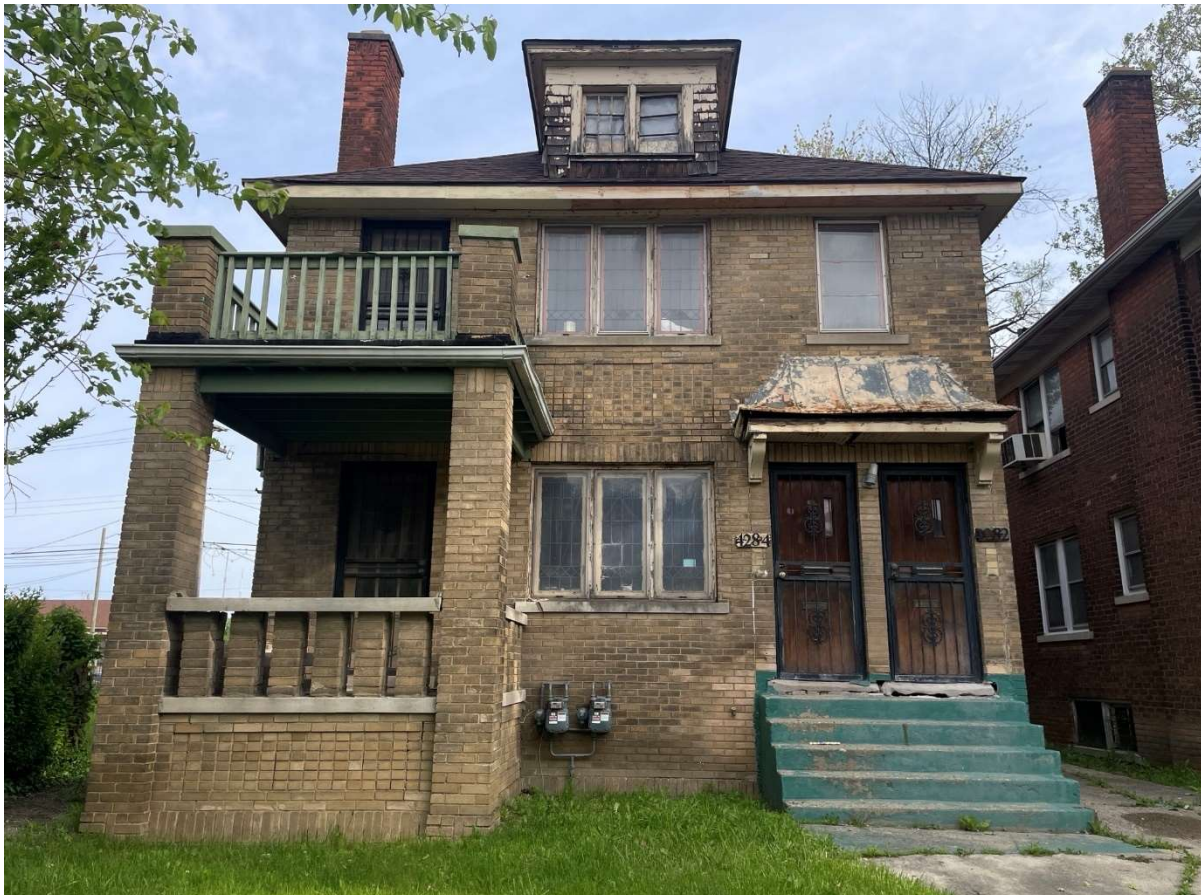
The south (front) facade predominantly features historic wood, leaded glass casements, multi-lite windows in the dormer, and what is likely a mid-century window with horizontal panes on the second floor. The other elevations are comprised of mostly single-lite, double-hung wood windows with some additional leaded glass casements with aluminum storm windows.

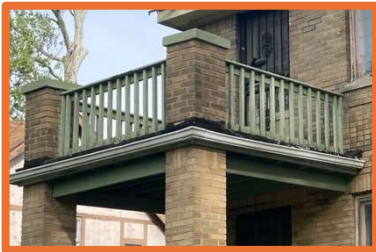
- The second level porch railing was replaced sometime between 1999 and 2009. At this time, staff doesn't have confirmation of review and approval and will follow up with property owner as necessary.

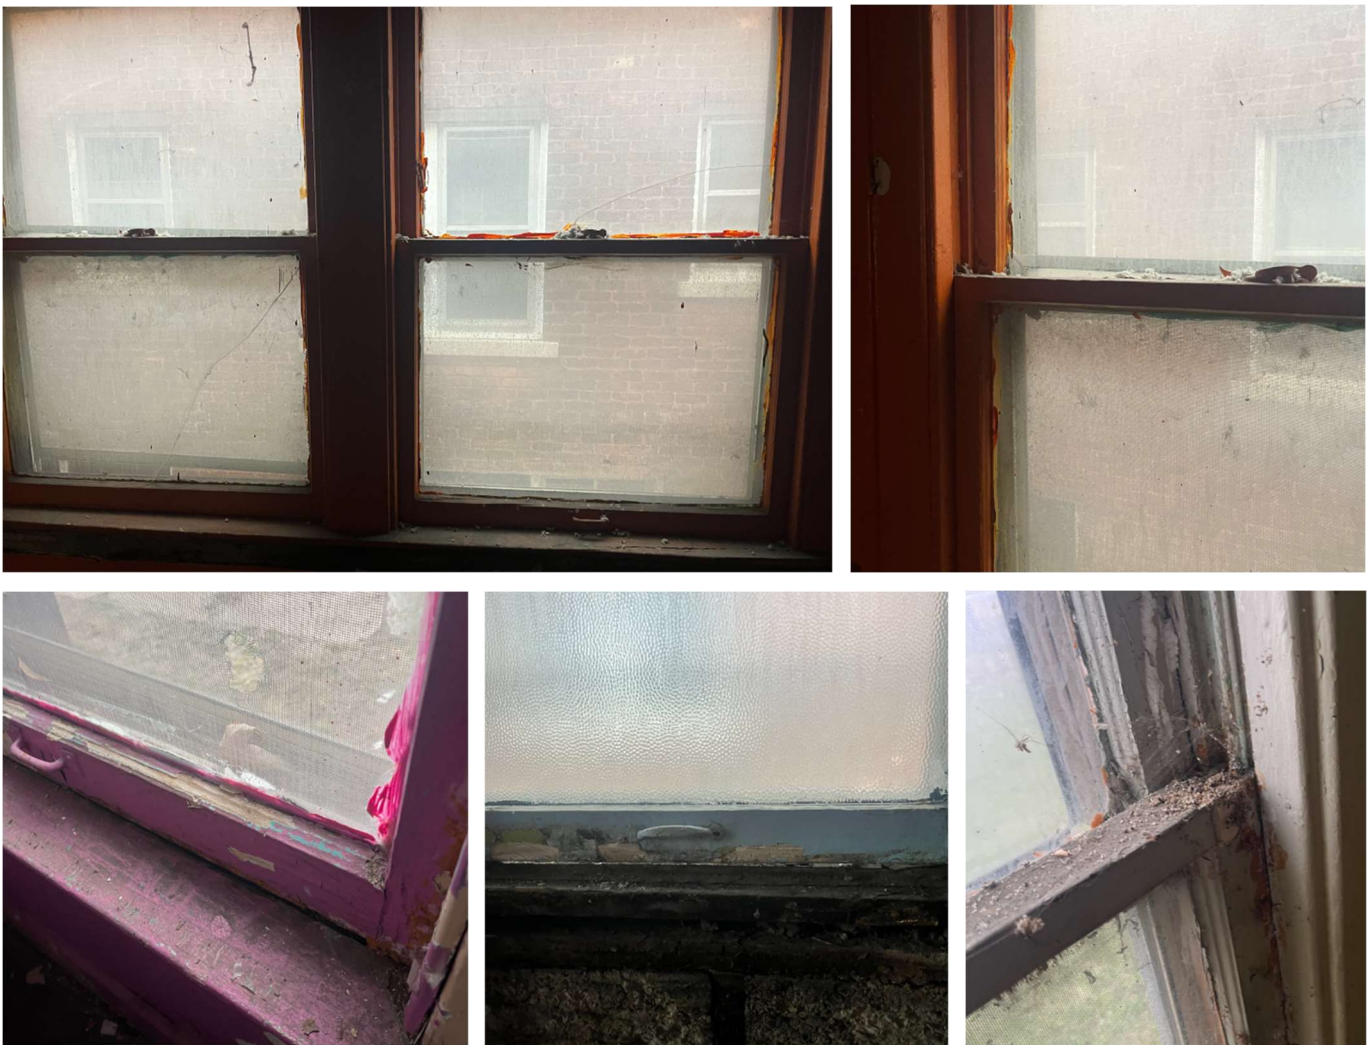
### Double-hung Window Analysis

- Photos provided with the application show additional, relatively minor, deterioration, such as peeling paint and cracked glazing. Photos also show that some of the windows seem to have been painted over multiple times, a condition that will impair their operation.

- The deterioration noted above constitutes typical maintenance needs of old windows and is repairable (per Preservation Briefs: 9 linked below). Thus, the windows do not seem to meet the standard of being “deteriorated beyond repair,” the standard required for their replacement under the Secretary of the Interior’s Standards for Rehabilitation (quoted in full below).

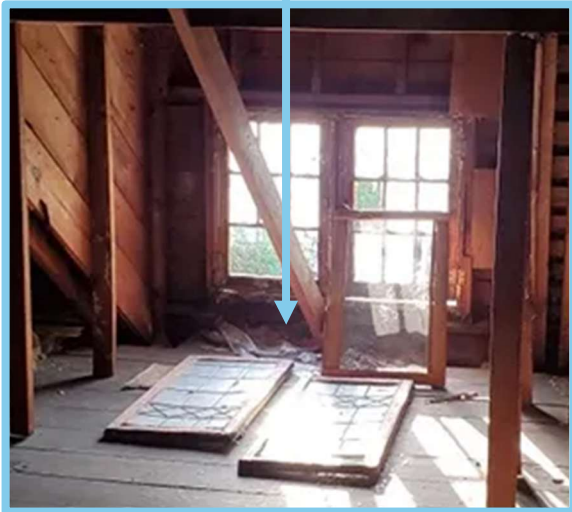
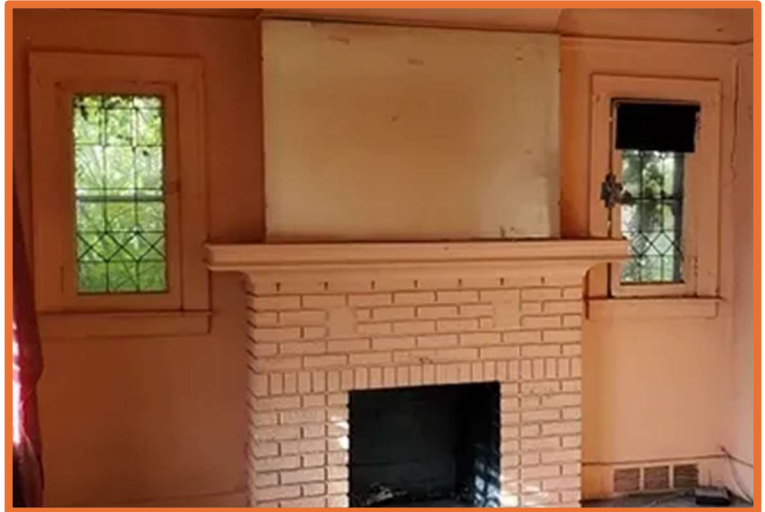
- The applicant states that there currently are no windows on the second floor flanking the fireplace, but as shown in an attic photo from the property owner's website, the historic wood leaded glass casements seem to still exist, though not currently installed.

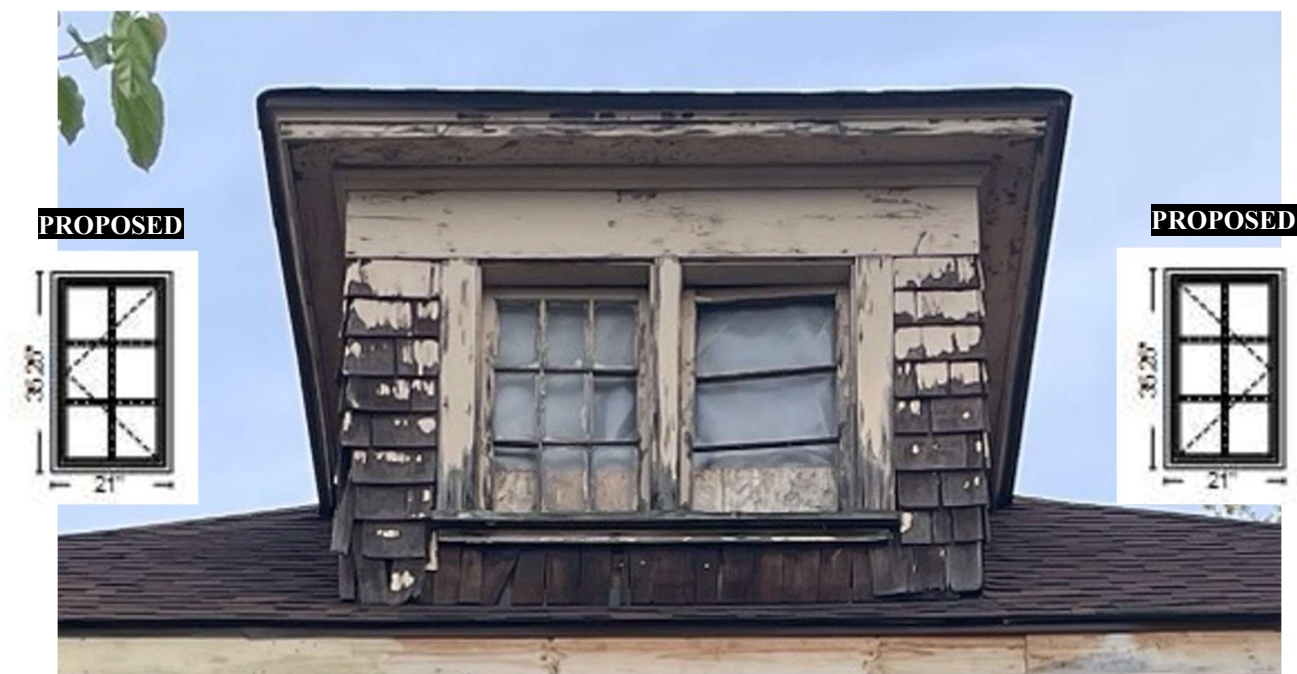
### Casements with 9-Lite Analysis

- It is staff's opinion that the right casement window is beyond repair. To preserve the visual and architectural continuity of the paired casements, it is recommended that the right casement be replicated and the left casement be restored. If the left casement is proven to be beyond feasible repair, staff recommends replacement casements simulate the 9-lite division of the historic windows.

- If window #301 (and thus #302) proves to be beyond feasible repair, subject to staff approval, replacement aluminum clad casement windows with 9-lite configuration is allowed.

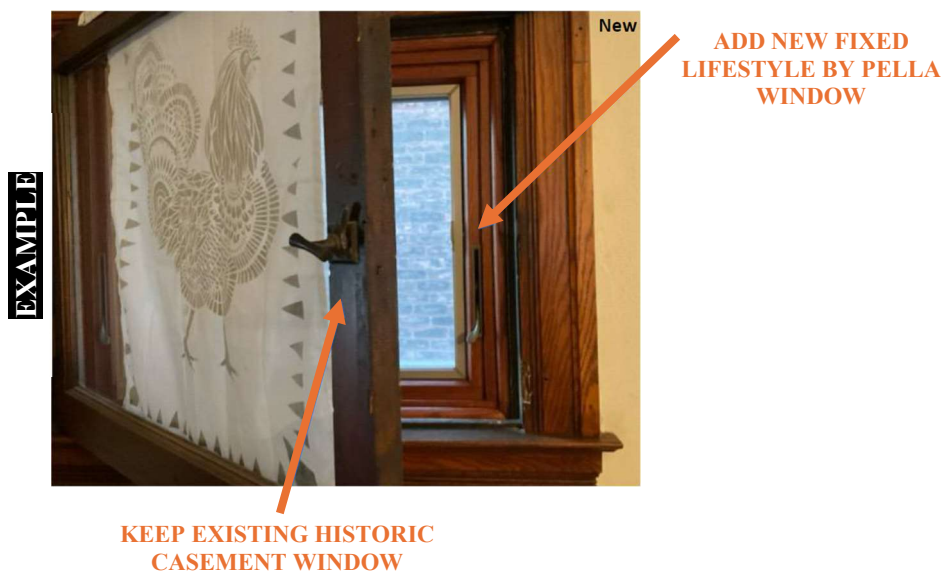
### Casements with Leaded Glass Analysis Pt. 2

- Applicant states that the “new [fixed] window will go outside the existing window, but leave the [existing] leaded glass [casements] in place so that it shows through the new window.”

- The windows proposed to be covered are historic and unambiguously character-defining as they are leaded glass, and as described in the Elements of Design, “create considerable interest” when referencing the relationship of textures.
