**STAFF REPORT: JULY 9, 2025 MEETING**  
**APPLICATION NUMBER: HDC2025-00291**  
**ADDRESS: 1068 HUBBARD**

**HISTORIC DISTRICT: HUBBARD FARMS**  
**APPLICANT: MATTHEW RYAN LENHOFF**  
**PROPERTY OWNER: MATTHEW RYAN LENHOFF**  
**DATE OF PROVISIONALLY COMPLETE APPLICATION: JUNE 13, 2025**  
**DATE OF STAFF SITE VISIT: JUNE 23, 2025**

**SCOPE: REPLACE WINDOWS ON THE FIRST AND SECOND FLOORS**

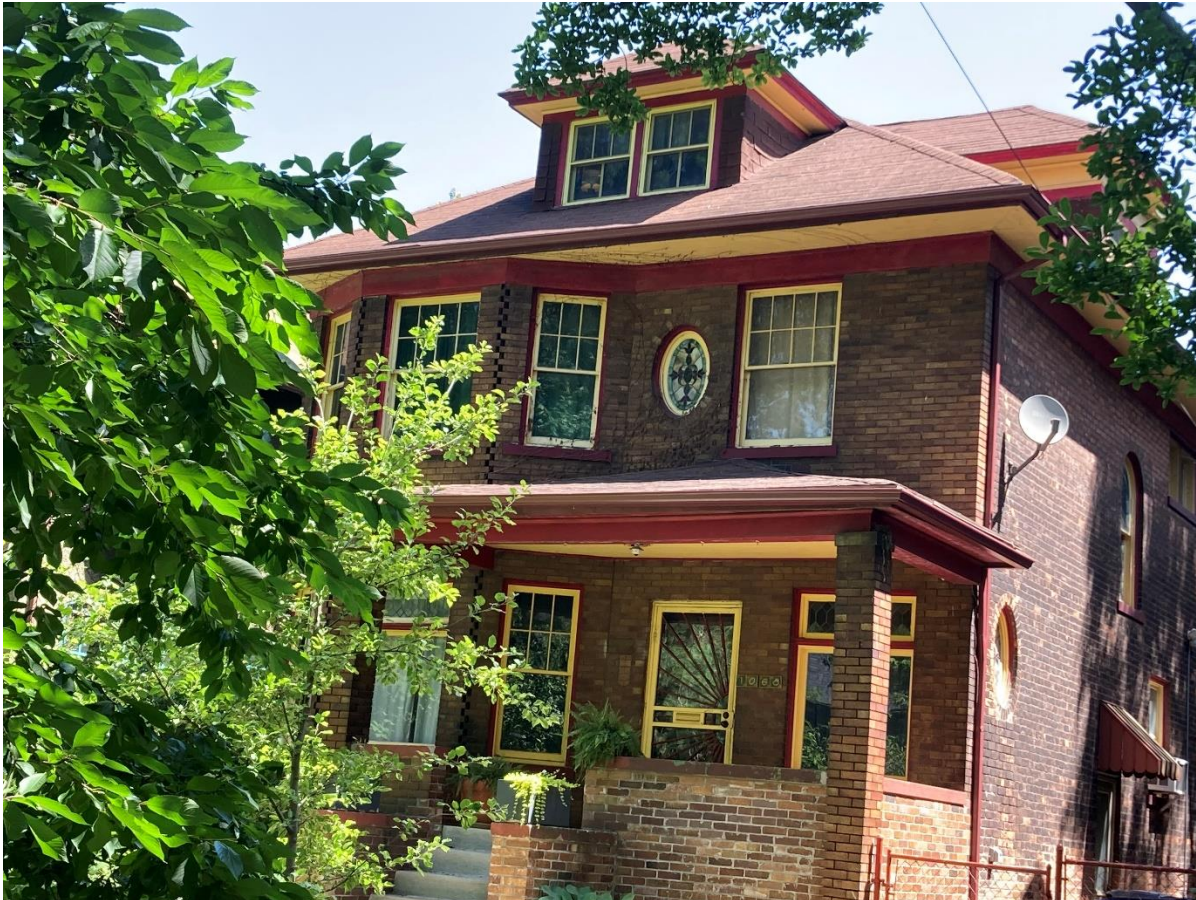
The 2-1/2 story dwelling at 1068 Hubbard is an American four-square house of reddish-brown brick with a clay-colored asphalt roof. Three dormer windows punctuate the main hipped roof on the house's north, west, and south sides. The front (west) elevation features a two-story bay window and a one-story front porch with square brick columns, low brick walls around the porch, and brick wing walls flanking the front steps. The City's building permit records show that the house was built in 1911. It has a high degree of historic integrity and contributes to the Hubbard Farms Historic District. From the sidewalk, besides the sashes in the dormer windows, all of the windows look to be: historic wood windows with divided lights in the upper sashes; fixed windows with leaded glass transoms; or stained glass windows. All appear to be in good condition from the sidewalk.

*Photo 1, west (front) facade, some of the south façade also visible, site visit, 6/23/25, staff.*

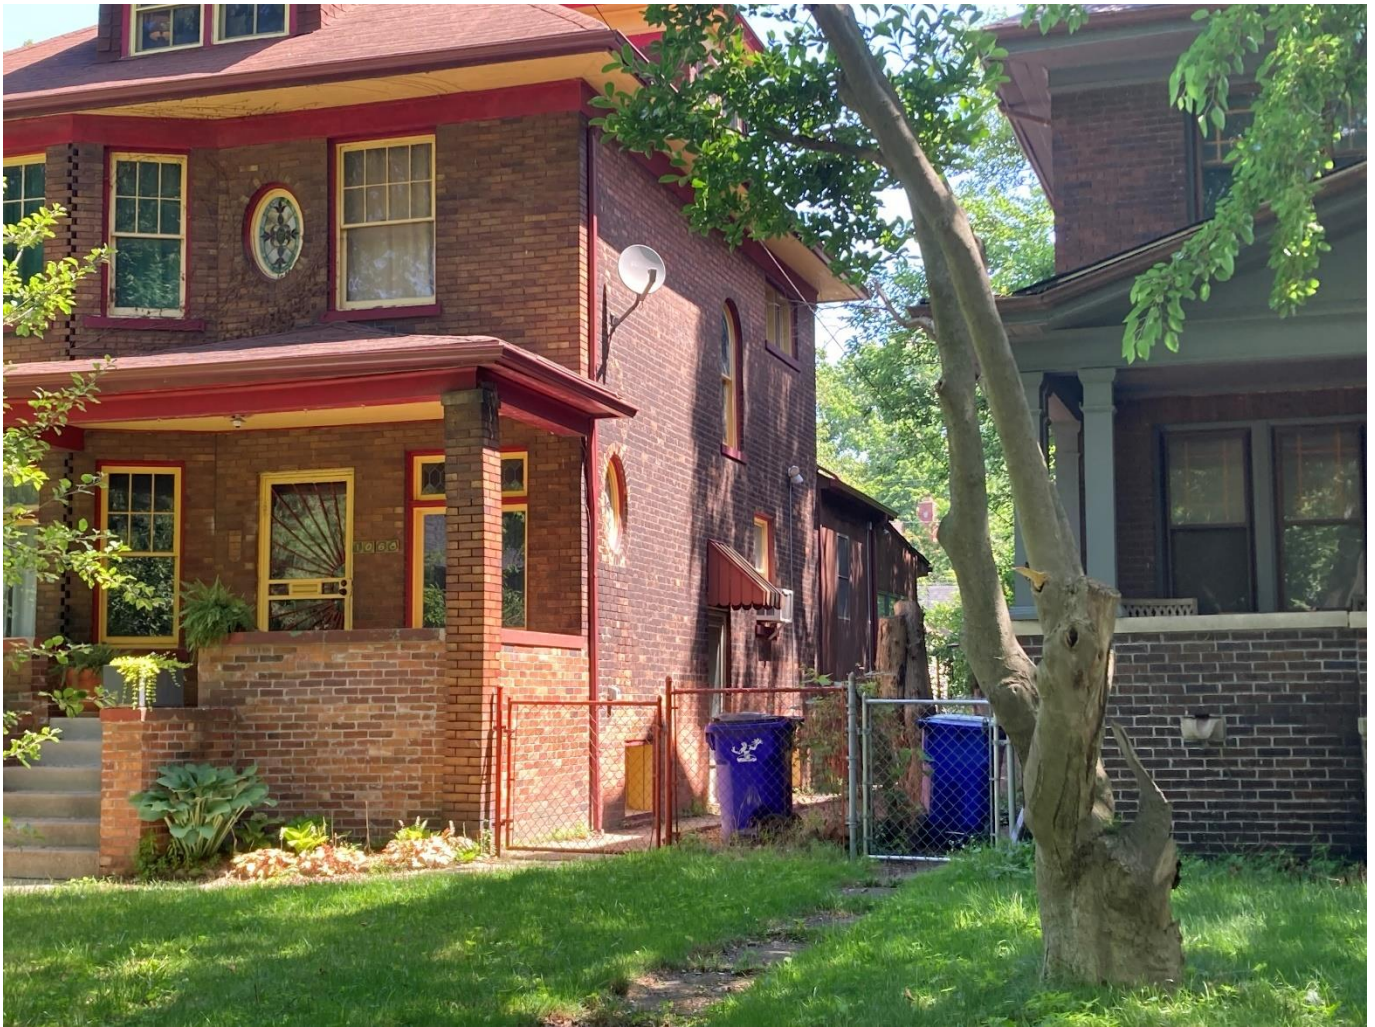
*Photo 2, south façade with some of the west (front) façade visible, site visit, 6/23/25, staff. Stained glass is in the oval window close to the front porch, and leaded or stained glass is in the central arched window. On the front of the house, an oval stained glass window is visible centered above the front door and a transom with leaded glass is barely visible behind the square porch column.*

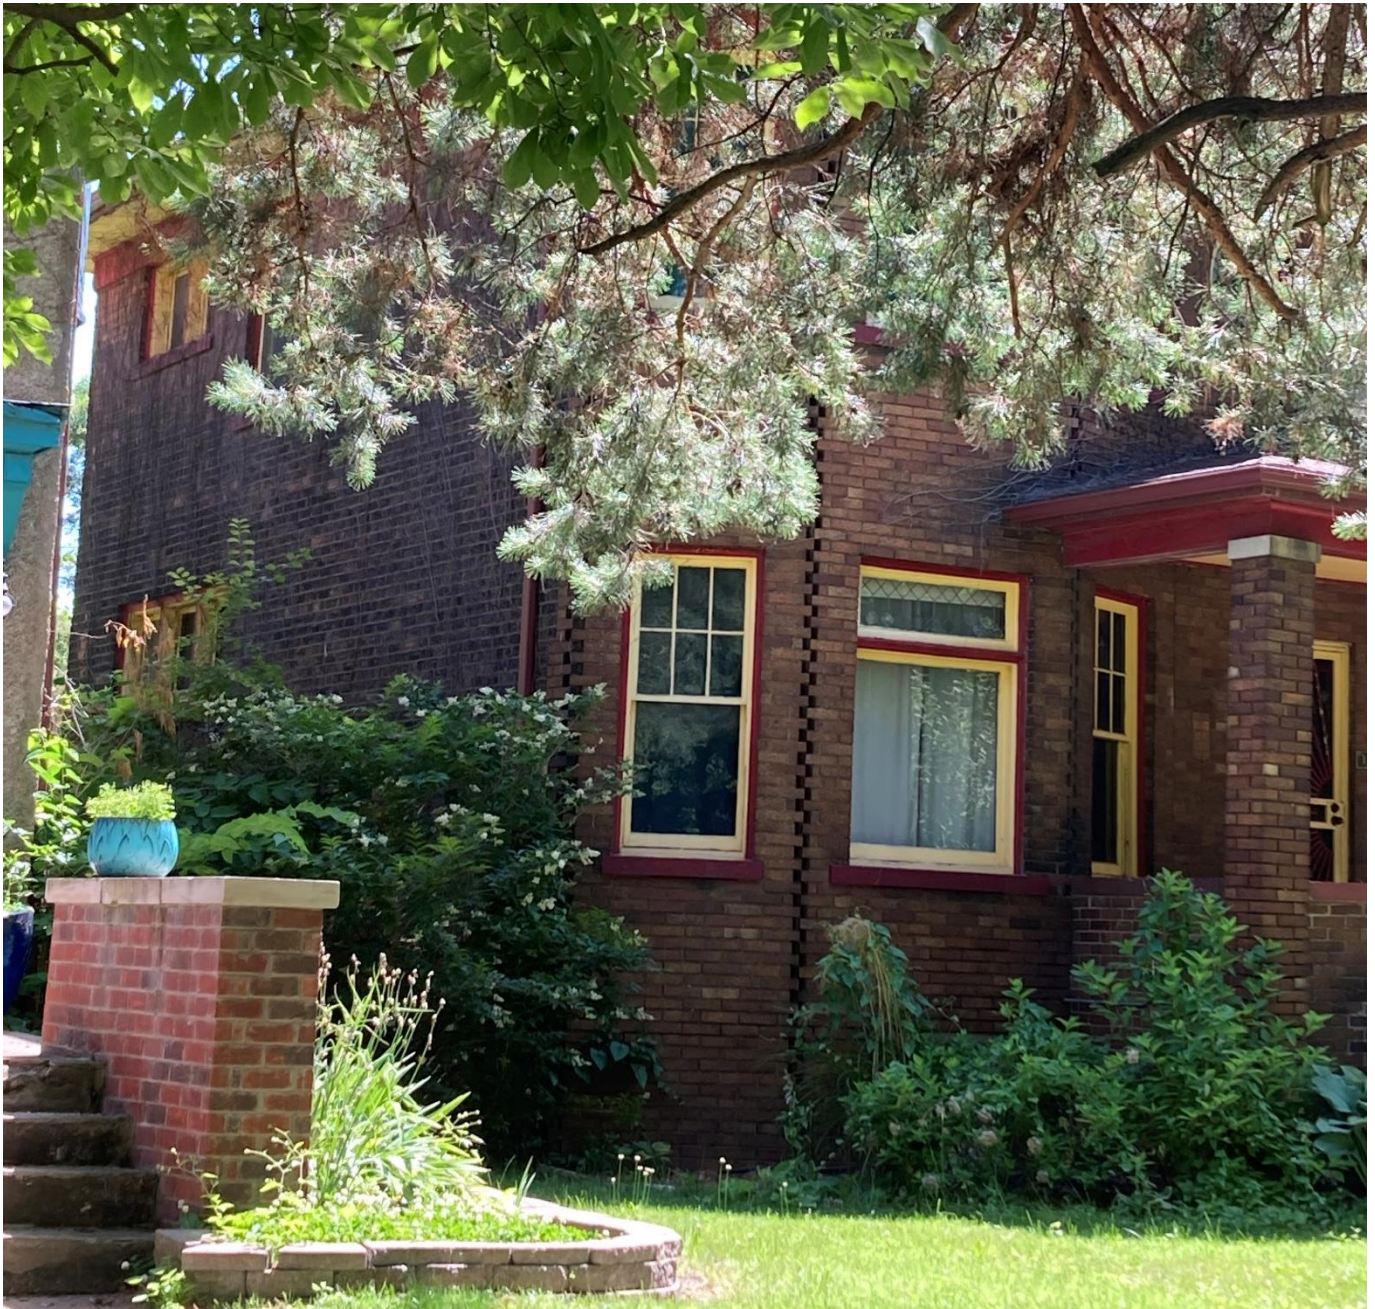
*Photo 3, north façade with some of the west (front) façade visible, site visit, 6/23/25, staff. Because the houses on this side of the property are close together, it is difficult to get an assessment of the north-side windows from the street. On the front of the house, the leaded glass in the bay window mirrors the leaded glass transom behind the porch column shown in Photo 2.*
