STAFF REPORT: 07/09/2025 MEETING
ADDRESS: 141 W. BOSTON BOULEVARD
APPLICATION NO: HDC2025-00338
VIOLATION NO: 1023

HISTORIC DISTRICT: BOSTON-EDISON
APPLICANT/OWNER: DEREK AND SANDHYA BERK
DATE OF STAFF SITE VISIT: 4/30/2025, 5/25/2025 & 6/27/2025
DATE OF PROVISIONALLY COMPLETE APPLICATION: 6/16/2025

SCOPE: REMOVE HISTORIC CLAY TILE ROOF,* INSTALL ROOF

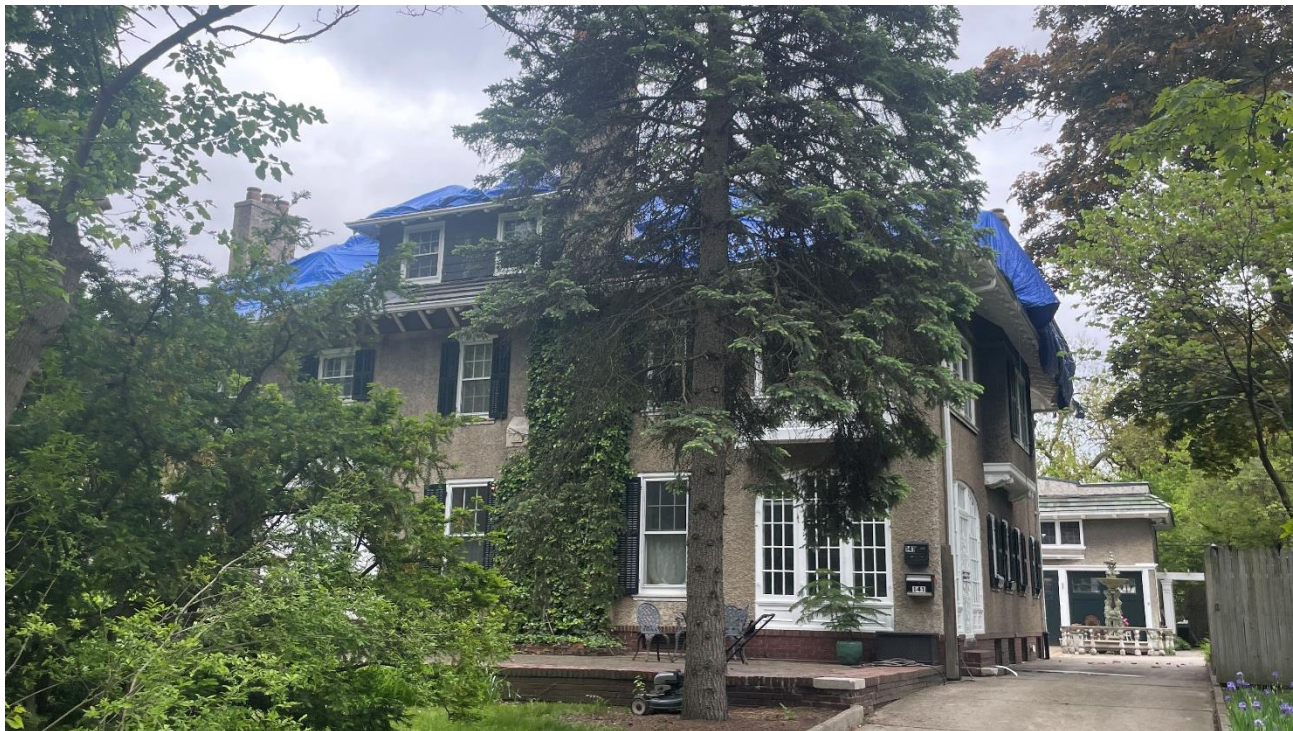
141 W. Boston. Photo taken by staff on 6/27/2025. Note the tarp covering the area of roof tiles that were removed without HDC approval.

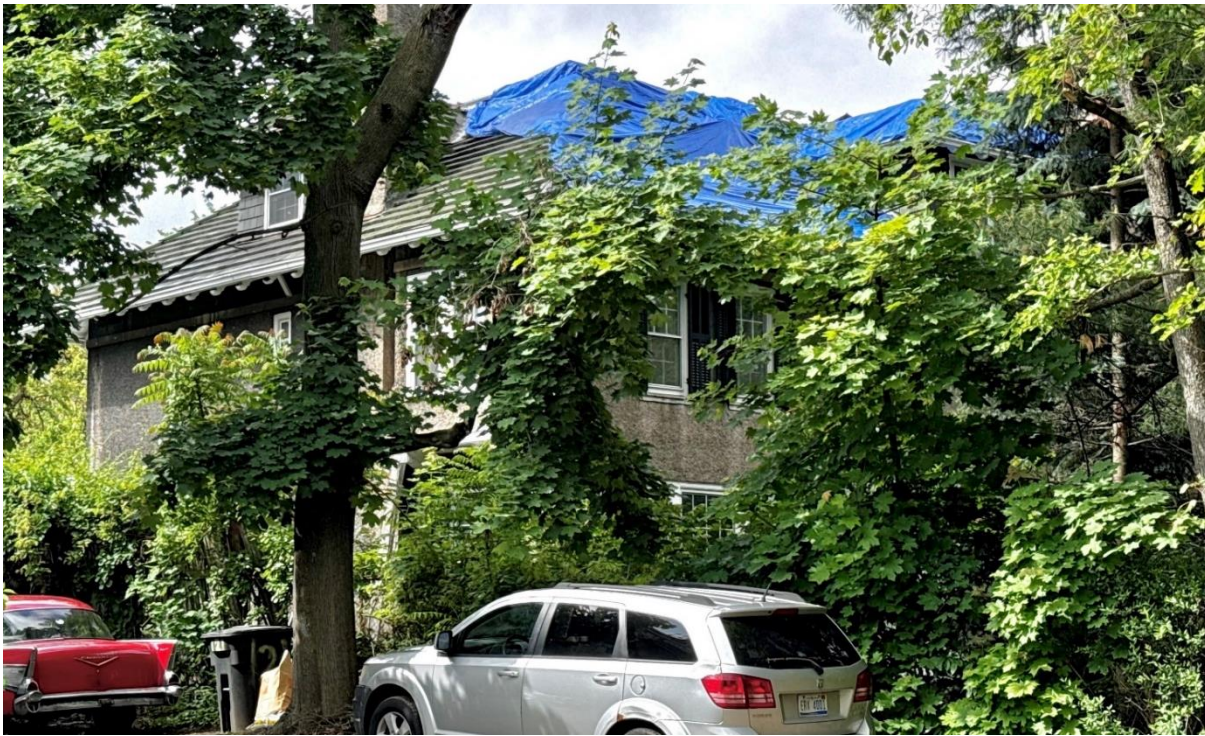
141 W. Boston. Photo taken by staff on 5/23/2025. Note the tarp covering the area of roof tiles that were removed without HDC approval.

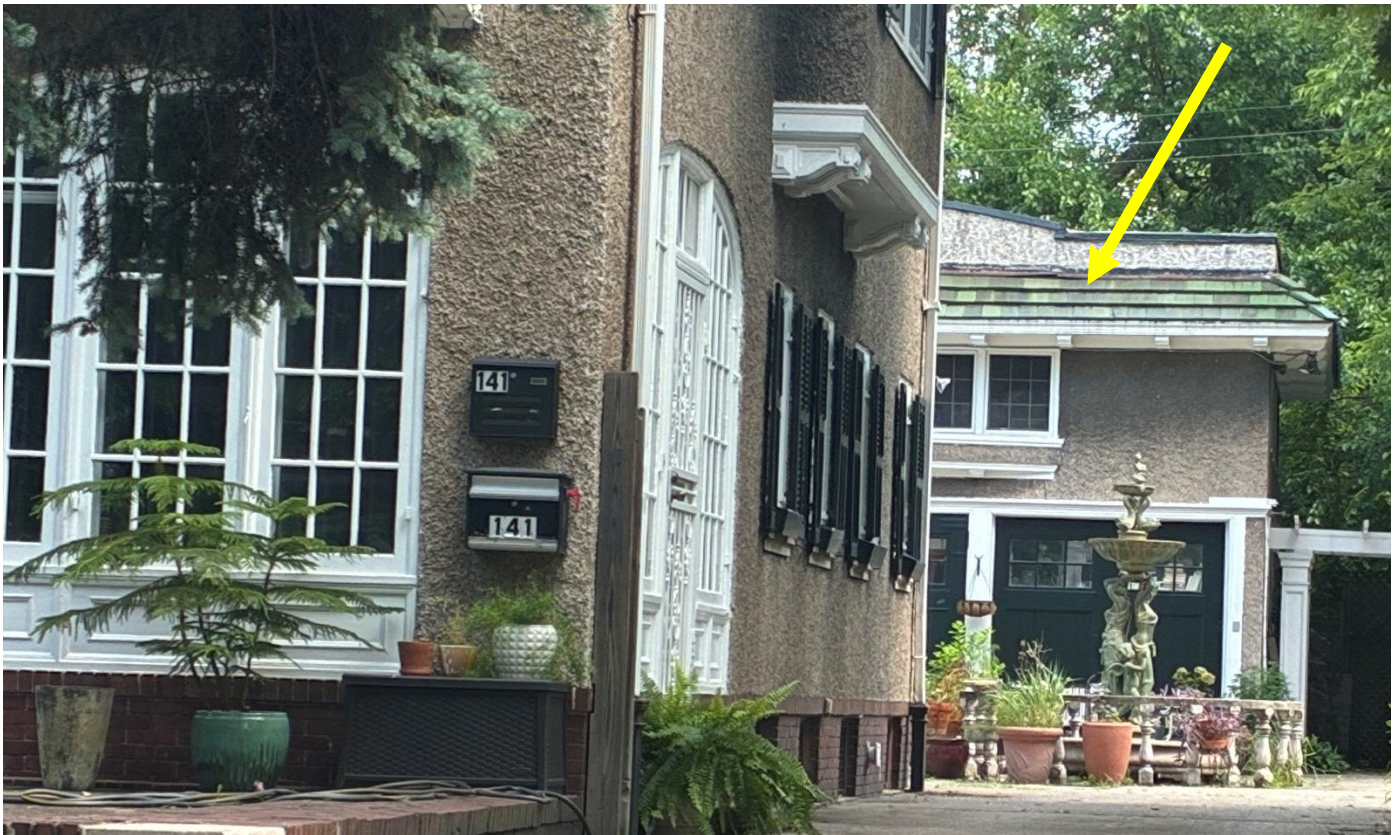
141 W. Boston. Photo taken by staff on 6/27/2025. Note rear garage/carriage house. Pent roof/canopy is covered with historic clay tiles

- As noted above, the proposal includes the removal of the remaining clay tile at the garage/carriage house’s front façade pent roof/overhang. Staff notes that the tile at this location appears to be in good condition/does not appear to merit replacement. Therefore, as this tile does remain as a distinctive character-defining feature of the property and is in good condition in staff’s opinion, its removal does not meet the Standards.

- The remaining clay tile at the garage/carriage house’s front façade pent roof/overhang proposed for removal appears to be in good condition/does not appear to merit replacement. Therefore, as this tile does remain as a distinctive character-defining feature of the property and is in good condition in staff’s opinion, its removal does not meet the Standards

- The remaining clay tile at the property's carriage house/garage be retained/shall not be removed

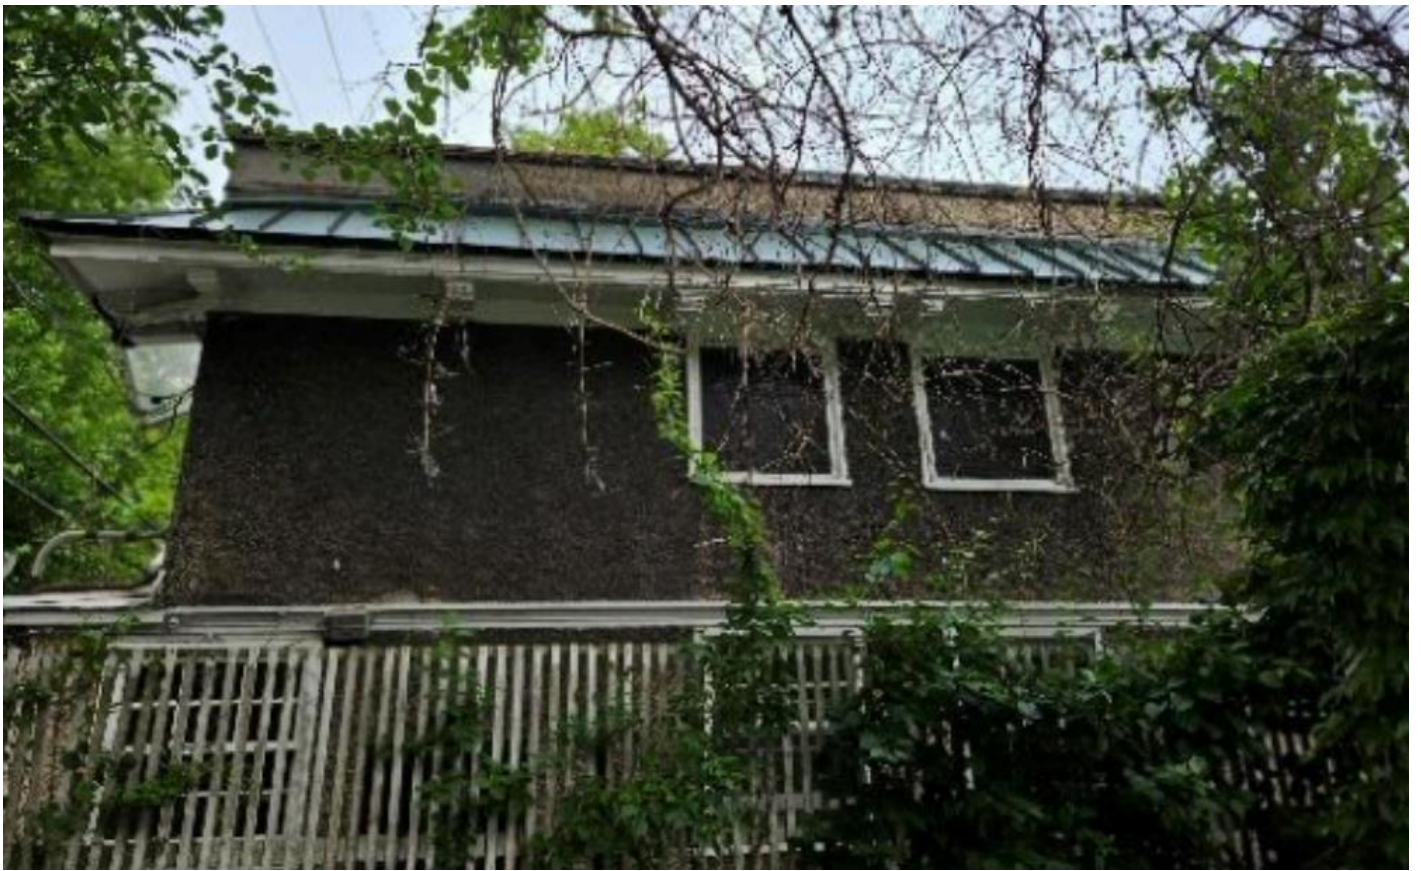
141 W. Boston. Photo provided by applicant. Showing metal roofing at rear garage/carriage house's pent roof/canopy, at the west/side façade. The roof at the east/side façade is also covered with metal roofing

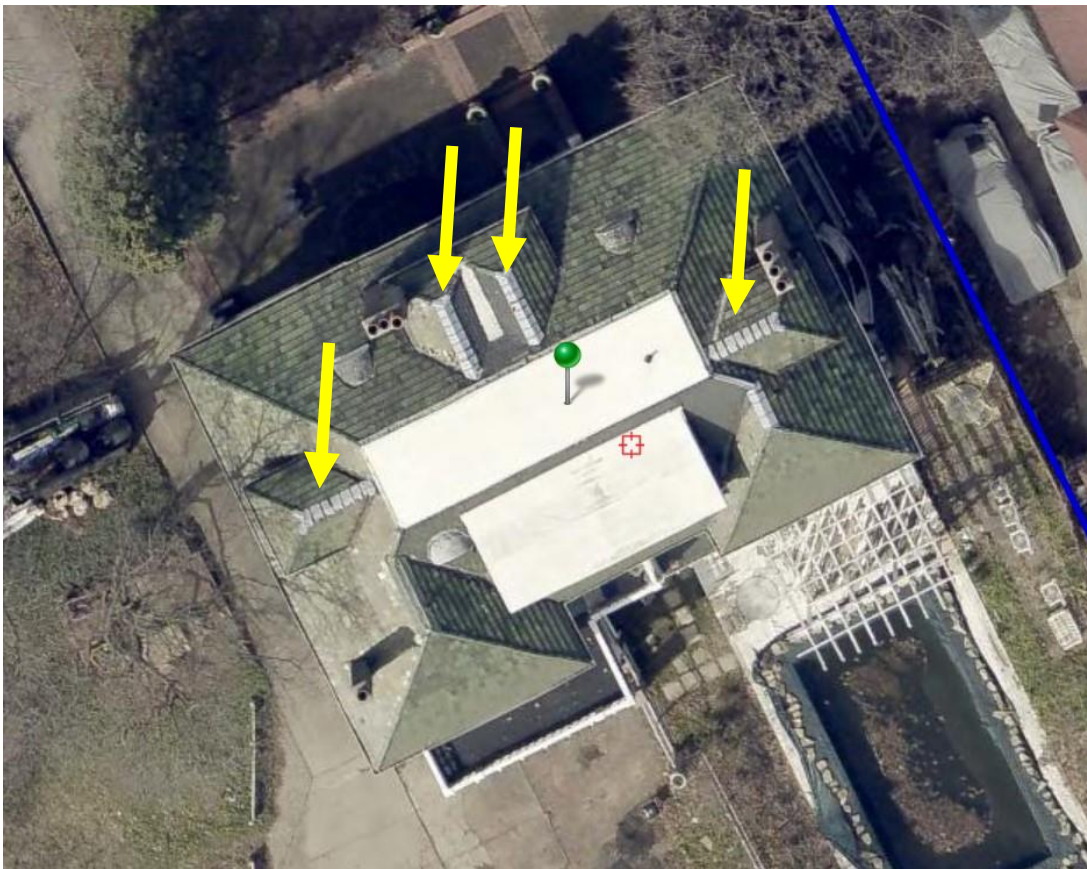
Eagle View aerial, 2024. Yellow areas indicate areas of past repairs

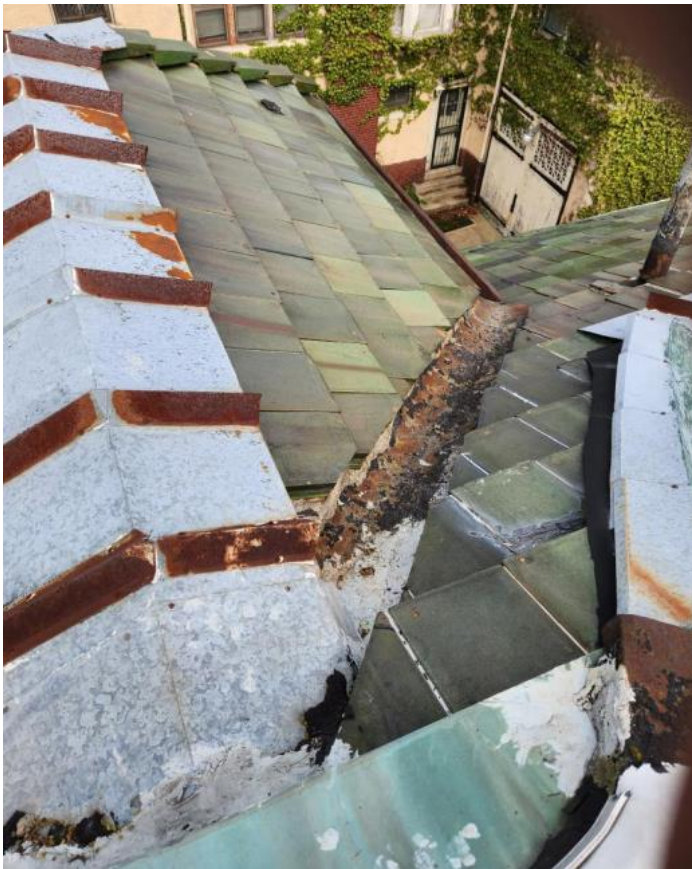
Photo by applicant. Showing area of past roof repair

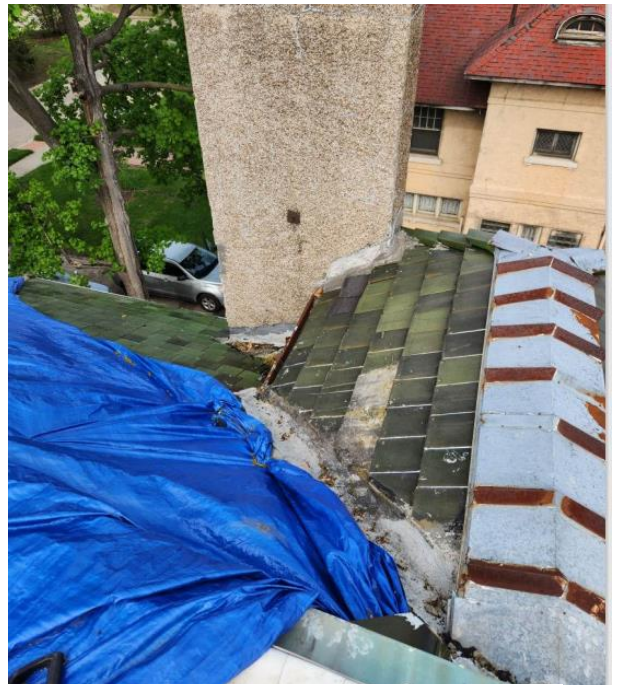
Photo by applicant. Showing area of past roof repair

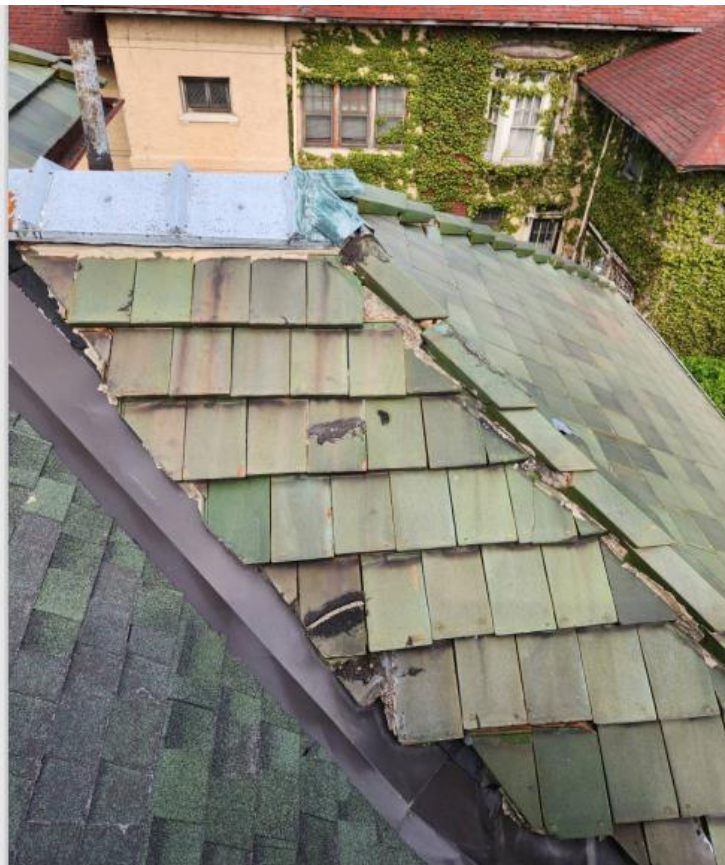
Photo by applicant. Showing area of past roof repair. Note areas of asphalt roofing

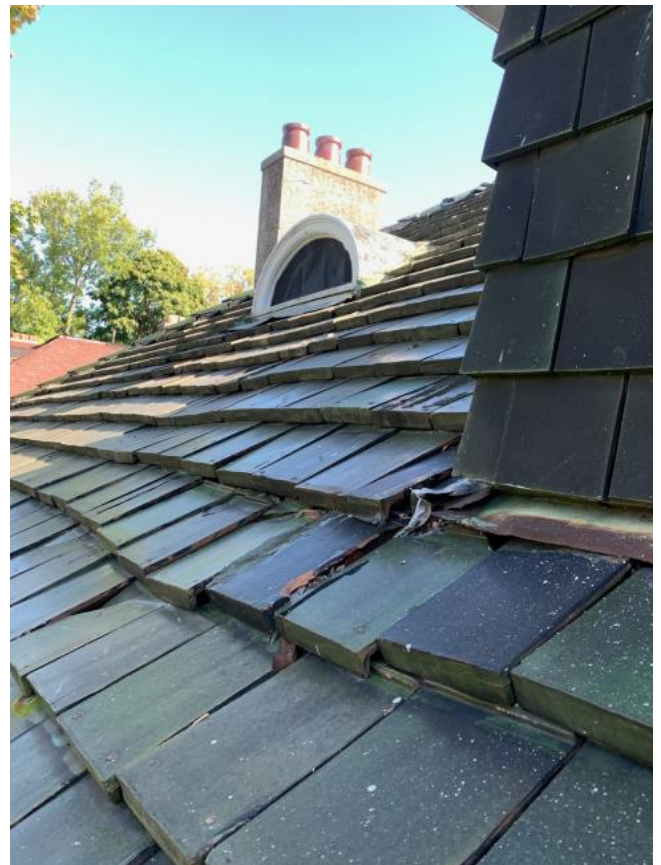
Photo by applicant. Showing condition of clay tile

- Staff did review the condition report of the house's roof which has been submitted with the current application and concluded that this 115-year-old roof does appear to merit wholesale removal and replacement. Specifically, the roof does appear to suffer from broken, deteriorated, and missing tiles throughout; numerous unapproved past repairs; and unapproved replacement of sections of tile roofing with asphalt shingles at the front dormers and the rear of the roof. However, the application does not include documentation/which indicates that the clay tile roof at the garage merits repair. An assessment of the garage roof's remaining clay tiles from the public right-of-way,

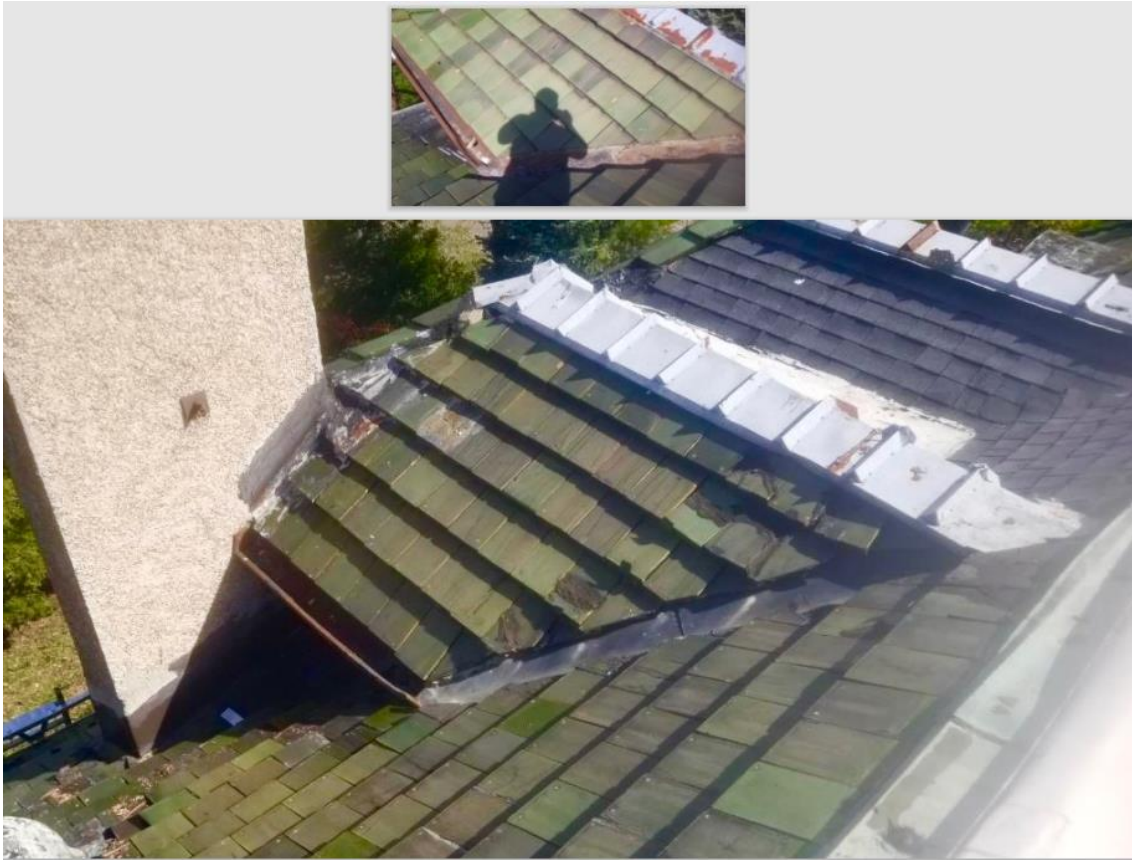
Photo by applicant. Showing area of roof repair at front paired dormers. Note small area of asphalt roofing

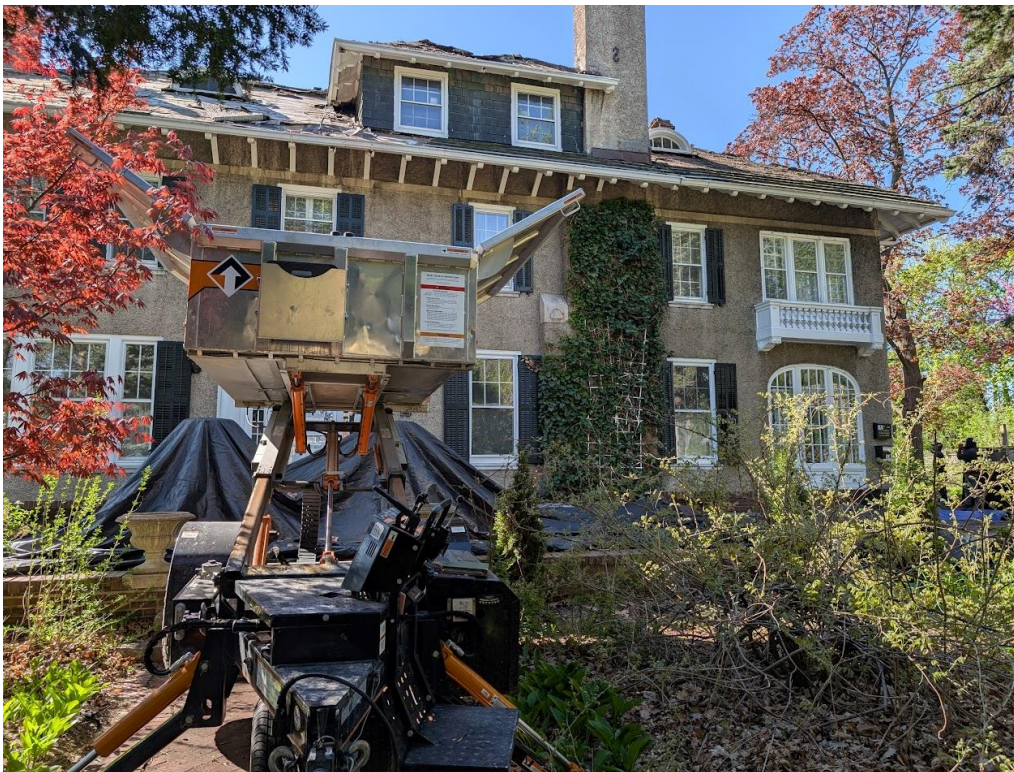
141 W. Boston. Photo taken on 4/30/2025 by HDC staff, showing current unapproved roof removal in progress

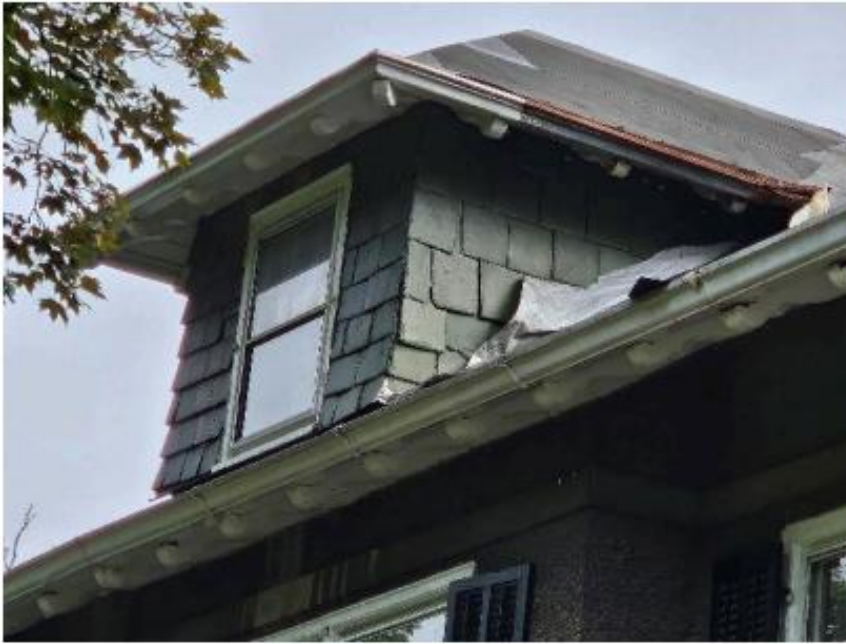
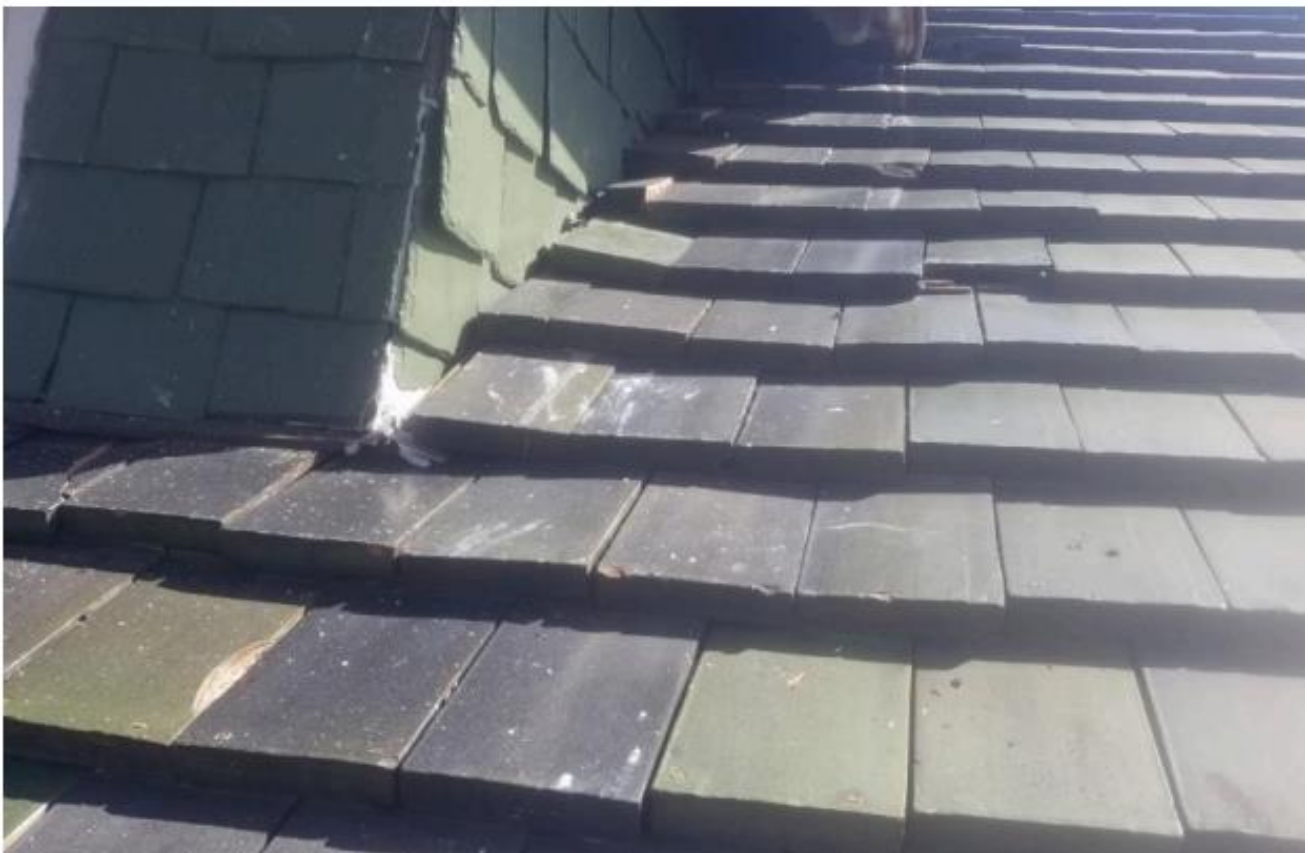
West side dormer, clad with slate, painted green. Photos provided by applicant

- As previously noted, one of the dormers, at the side elevation, is currently clad with slate tiles which have been painted green. The primary/street facing double dormer is clad with slate tiles. While the slate at the west side dormer is likely historic age, it has been painted green, presumably in an effort to match the appearance of the clay tile found at the main roof surface and the primary double dormers which are located at the front façade roof surface. Also, it is likely that the slate was not original to the house’s construction. Given the cumulative/overall result of the installation of a new clay tile roof at the property, it is staff’s opinion that the replacement of slate with clay tile at the west side dormer’s front and sidewalls would be a reasonable and appropriate approach.

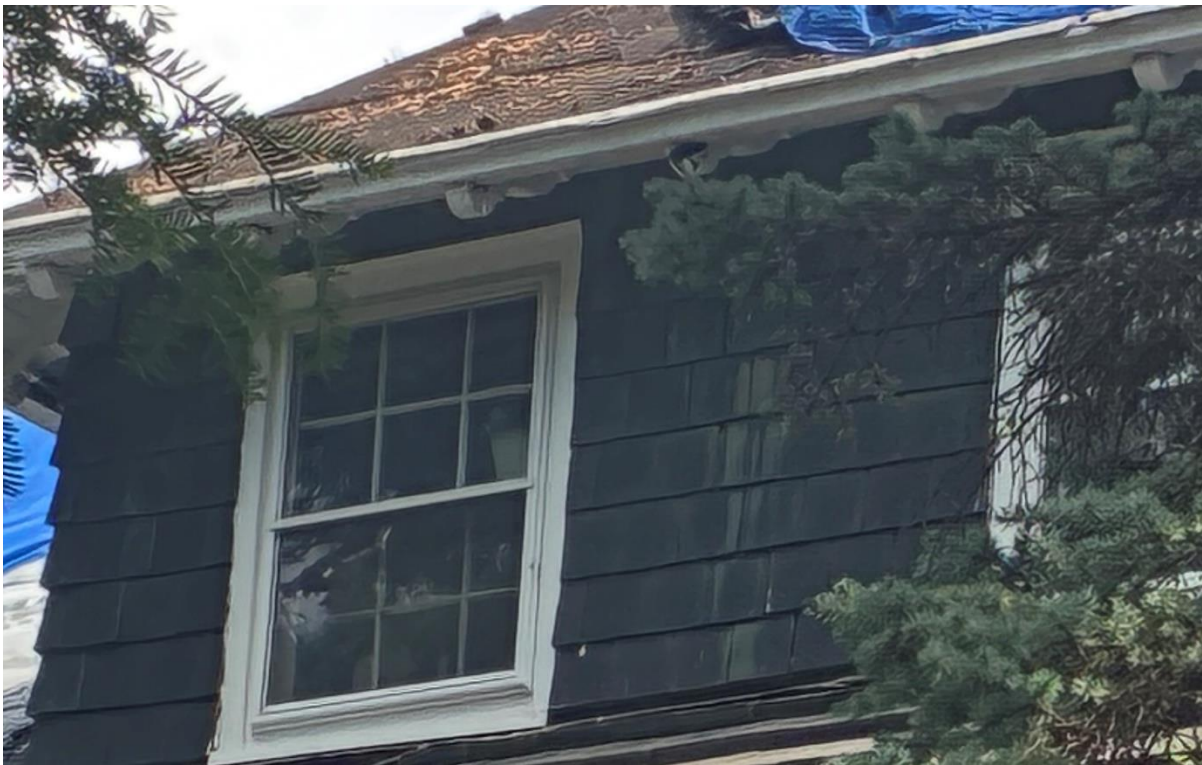
Front/primary façade double dormer. Clad with clay tile. Photo by staff, 6/27/2025

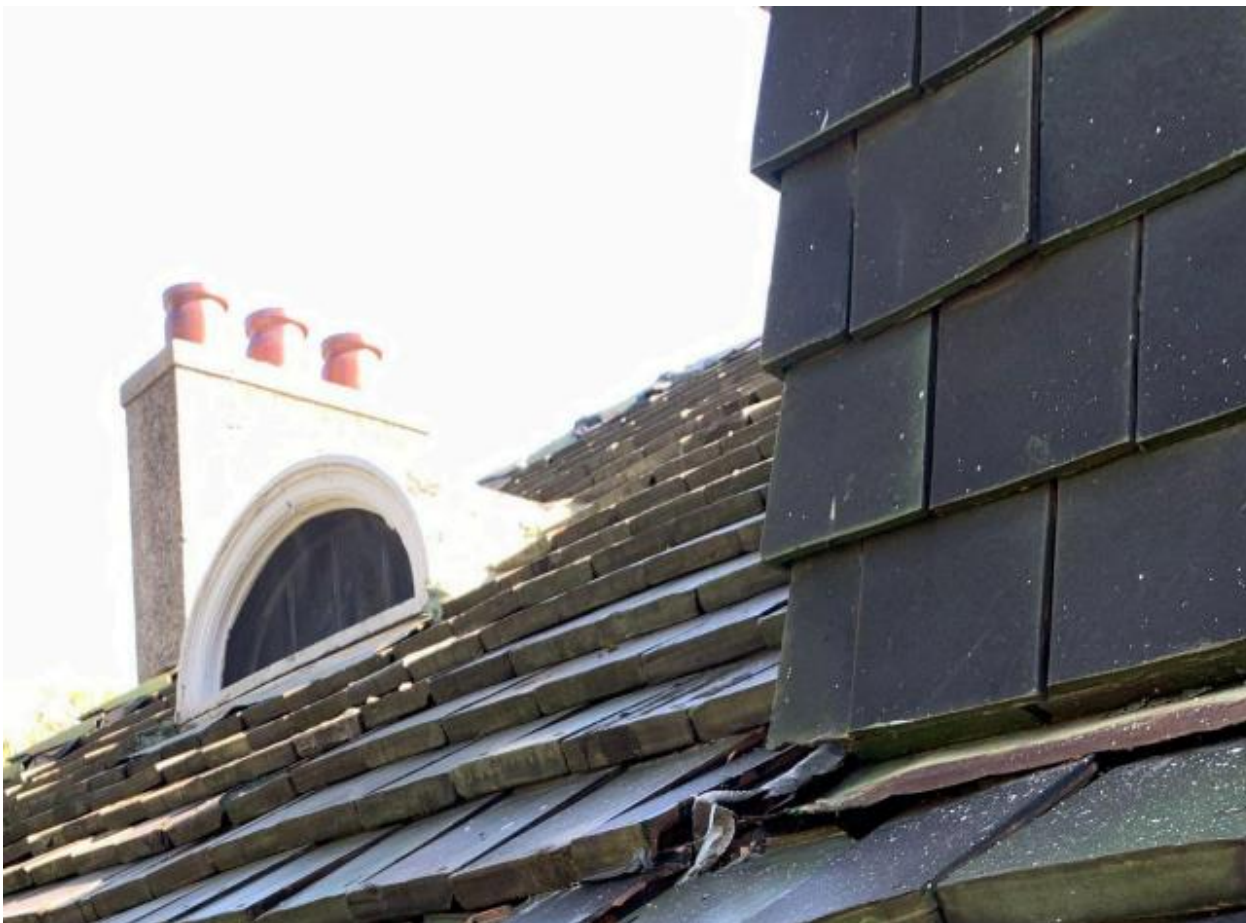
Front/primary façade double dormer. Clad with clay tile. Photo by applicant
