**STAFF REPORT: JULY 9, 2025 MEETING**

**APPLICATION NUMBER: HDC2025-00**

**ADDRESS: 1676 CHICAGO BLVD**

**SCOPE: REPLACE ROOF, REPLACE SOFFITS\***

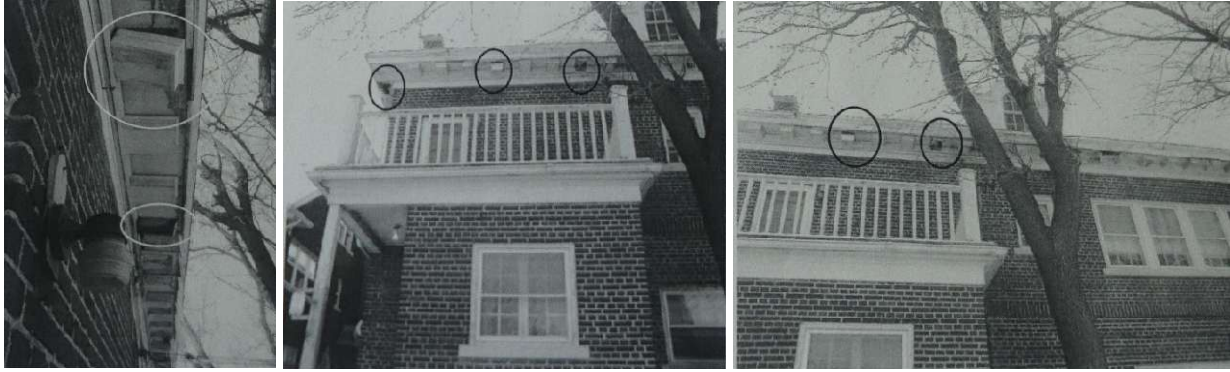
- At the April 10, 2002 Regular Meeting, the HDC issued a Notice to Proceed for the replacement of the original clay tile roof and internal gutter system at the house due to the roof’s high level of deterioration. The scope of work submitted with the application specifically stated that the clay tile roof would be replaced and wood elements of the roof would be replaced where necessary. With respect to the roof’s soffits, the April 10, 2002 staff report for the project indicated “...at the rear of the house, the applicant has a pile of dentil blocks, which have fallen off the cornice on all sides of the structure. The cornice at the rear of the of the house shows extreme water damage. Many dentil blocks have separated from the building and will soon fall off...the east and west sides of the house also show some water damage with missing dentil blocks...”

*Photos from April 10, 2002 Staff Report showing areas of deterioration at the soffit/eaves of the roof.*

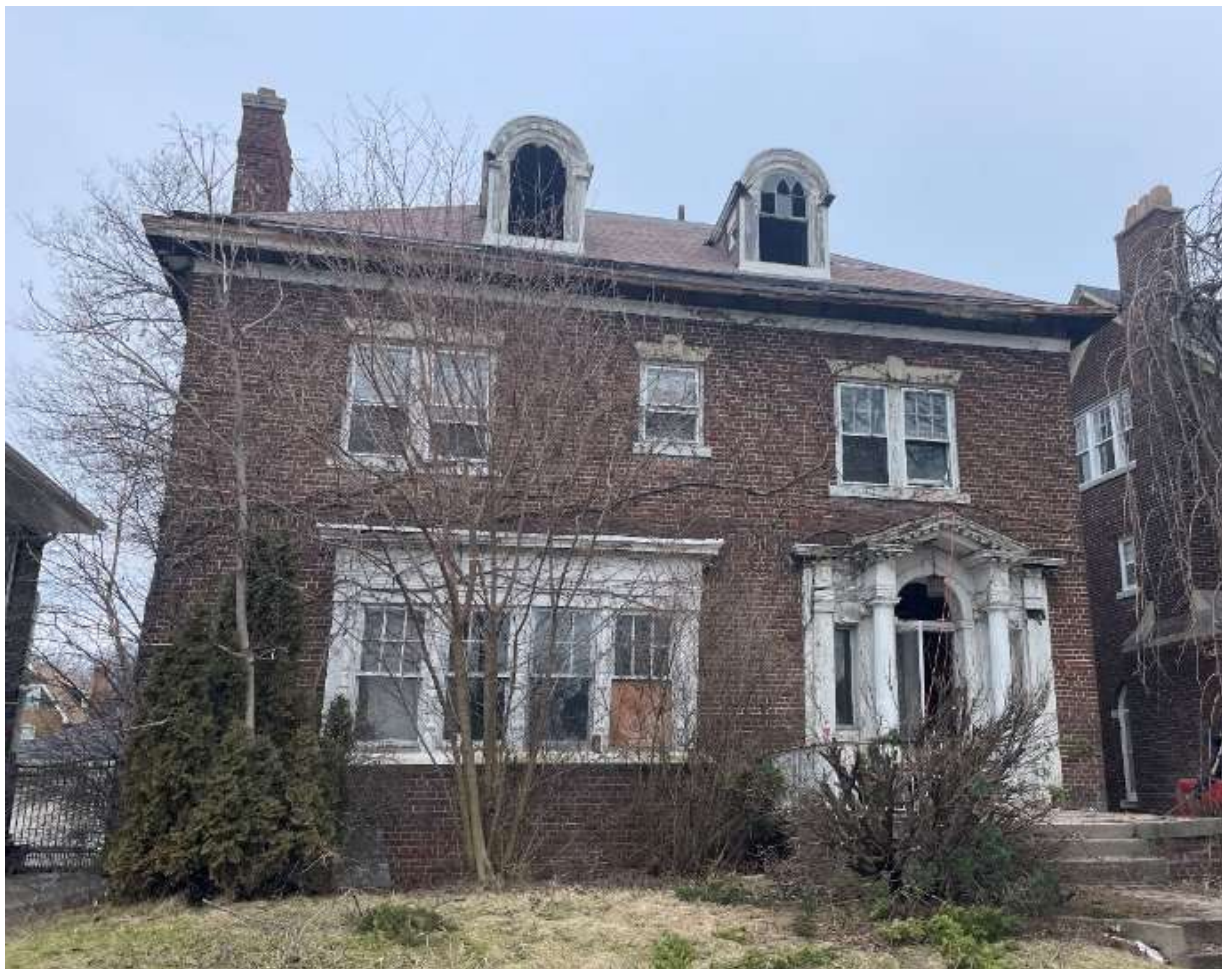
*1676 Chicago Boulevard, photo taken by staff 02/04/2024.*

- In February 2024, HDC Staff was made aware that exterior work was being undertaken at the property, to include the installation of new asphalt shingles and dentiled soffit at the roof. Staff reviewed files maintained by the HDC and building department and concluded that a COA had not been issued for the work (see the below photos taken by staff at the time of the reported violation)

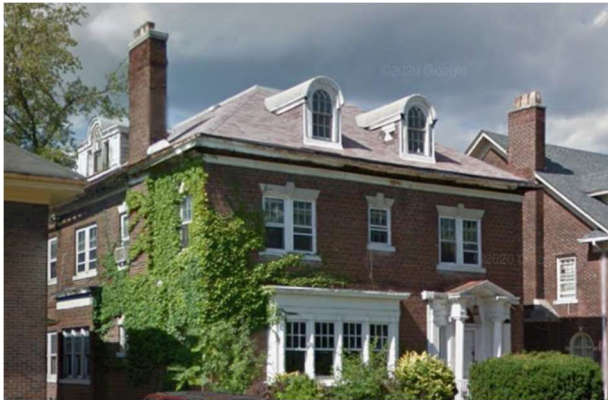
*August 2015 Google Street View*

- In 2015, the soffit/eave area began to display high levels of deterioration as all of the dentils at the front façade's eaves appear to have fallen from the soffit.

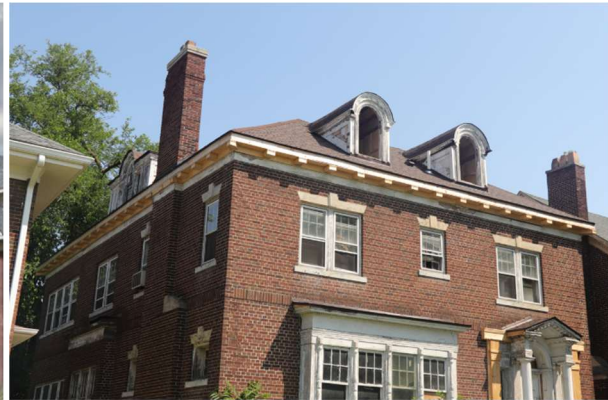
*June 2025 photo taken by staff*

- While the newly installed soffits/dentils are wood, in keeping with the original soffit's material, they do not match the historic appearance.
  - The number of front facing dentils (excluding the corners) was reduced from 22 to 13. The spacing of the original dentils created a rhythm that aligned with the outer walls of the dormers (see arrows), and tied together the elaborate portico, the linear keystones above the windows, as well as the vertical pattern of the original tile roof.

- The new existing widely spaced dentils are out of proportion with the cohesive patterning of the applied ornament and the decorative coursing of the brick veneer.

- It is therefore staff's opinion that the current soffit which was installed without HDC approval/ for which the current application is seeking a COA, does not represent an adequate match to the building's original element.

- It is therefore staff's opinion that the new soffit does not meet the standards as the soffit that was removed was a distinctive, character-defining feature of the property which, per the Standards, should be matched if deteriorated beyond repair.

#### **Recommendation 1 of 2 – Denial – Replace soffits; install asphalt shingles at dormer roofs**

- While the newly installed soffits/dentils are wood, in keeping with the original soffits material, they do not match the historic appearance.
- The soffit that was removed was a distinctive character-defining feature of the property which, per the standards, should be matched if deteriorated beyond repair.
- The number of front facing dentils (excluding the corners) was reduced from 22 to 13. The spacing of the original dentils created a rhythm that aligned with the outer walls of the dormers (see arrows), and tied together the elaborate portico, the linear keystones above the windows, as well as the vertical pattern of the original tile roof.
- The new existing widely spaced dentils are out of proportion with the cohesive patterning of the applied ornament and the decorative coursing of the brick veneer.

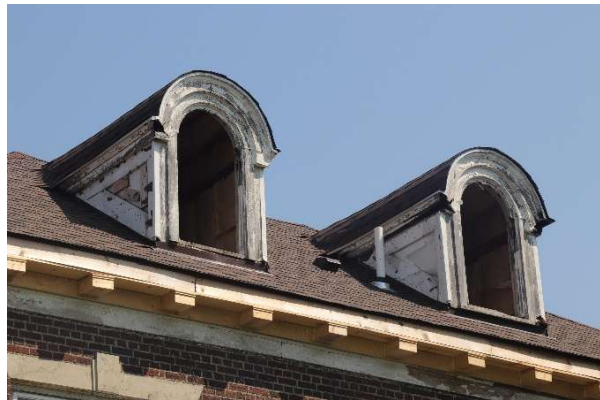
*Front facing dormers*

- It is staff's opinion that the current asphalt shingles which have been installed at the dormer roofs are not consistent with the building's historic appearance/is not appropriate for the following reasons:

- The current work includes the installation of dimensional asphalt shingles at both the main roof surface and the arched dormer, destroying the historic contrast in texture and color between the two roof areas.

*Photo of existing conditions.*

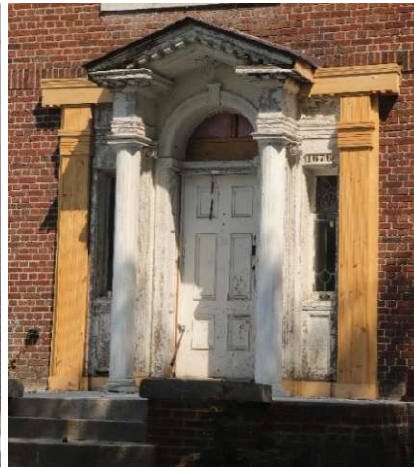
*Current condition of house 2025.*

*The elaborate, front-facing, portico has accrued significant deterioration in this century old house. **Please note:** While this is not included in the current application, staff asks that the applicant submit an additional application in replacing the portico and dormer windows.*
