STAFF REPORT: JULY 9, 2025 MEETING
APPLICATION NUMBER: HDC2025-00300
VIOLATION NUMBER: 1019
ADDRESS: 1725 SEYBURN
HISTORIC DISTRICT: WEST VILLAGE
APPLICANT: TRACY LOWE
PROPERTY OWNER: TRACY LOWE
DATE OF PROVISIONALLY COMPLETE APPLICATION: 6/17/25
DATE OF STAFF SITE VISIT: 6/23/25

SCOPE: REPLACE HISTORIC WINDOWS, MULTIPLE EXTERIOR ALTERATIONS (WORK COMPLETED WITHOUT APPROVAL)

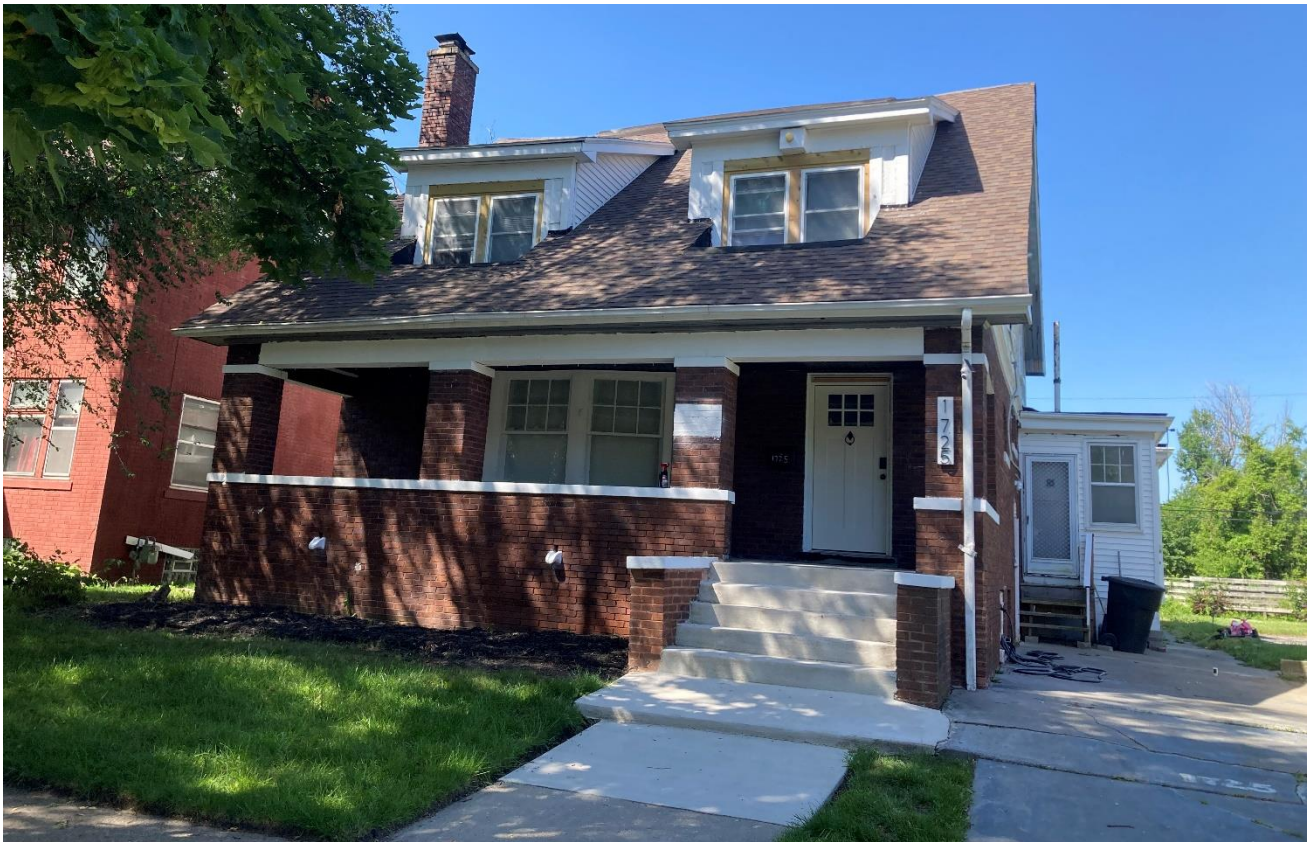
Photo 1 from site visit 6/23/25, staff. To the right of the house, the driveway is visible and at the end of the drive, the end of a one-story addition is visible. On that addition, an entry door, a storm door, a six-over-one window, and vinyl siding are visible.

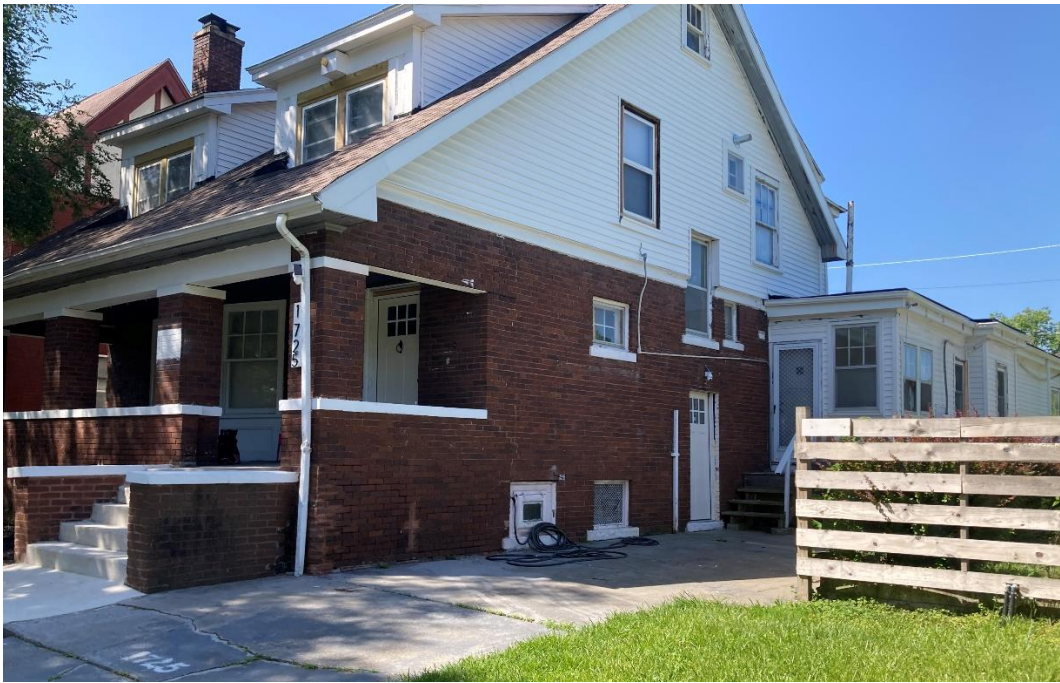
Photo 2 from site visit 6/23/25, staff. House's north side. Vinyl siding, a variety of windows, a non-historic door, an unpainted fence, and the one-story addition extending from the rear corner of the house are all visible.

between the first and second floors also remains in place. **The character-defining second-story wood shingles have been covered with white vinyl lap siding, and staff observes that not only does the vinyl siding change the house's character, proportions, and texture, but it gives the centered window between both floors a very recessed appearance.**

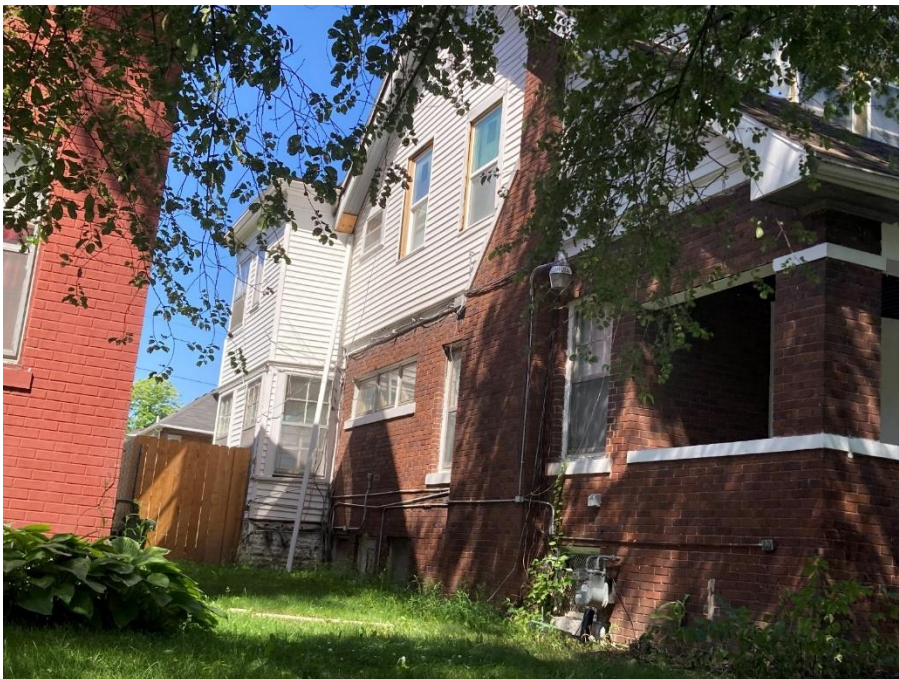
Photo 3, site visit 6/23/25, staff. Side of the historic house opposite the driveway, or the house's south side for the purposes of this report.

- On the house's **south side**, two second-floor new replacement windows are identifiable by the visible new wood and manufacturer stickers, two historic windows flank the fireplace, and the ribbon of three windows set higher in the brick wall appears to have storm windows installed, making the sashes difficult to see clearly from the sidewalk. Similarly, the small window above the tripartite window also has a storm, making it difficult for staff to determine whether that small second-story window is historic. There are basement windows along the base of this wall, but they're difficult to see from the sidewalk. At the rear corner of this side of the house, a rear two-story addition is visible and at least some historic windows are visible in the addition. The house's second floor and the addition have both been covered in white vinyl lap siding. See *Photo 3* above and *Figure 3* below.

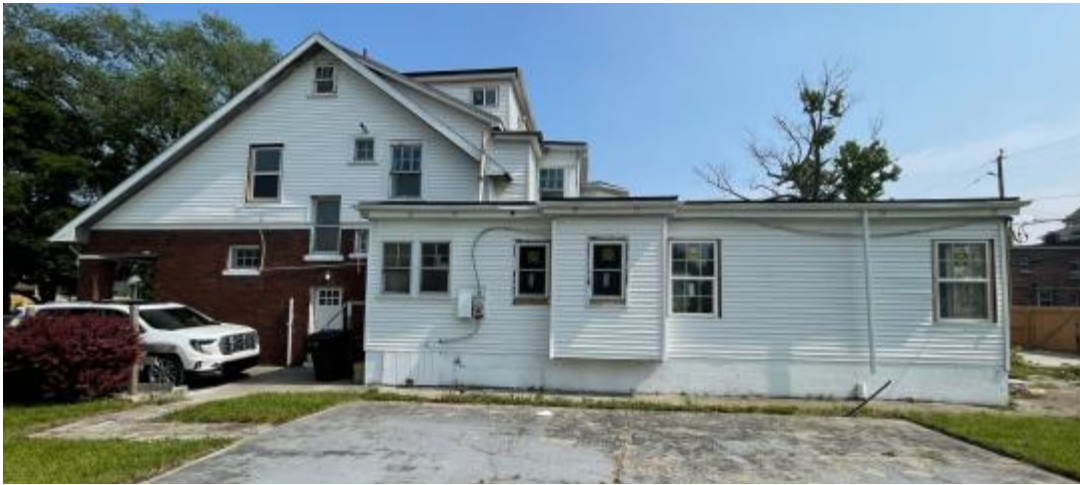
Photo 4, provided by applicant. 1725 Seyburn, north side, original historic house volume and one-story addition toward the northwest corner of the house, currently sided with white vinyl siding and exhibiting a variety of window types, materials, and configurations. The siding and the window replacements are included in this application.

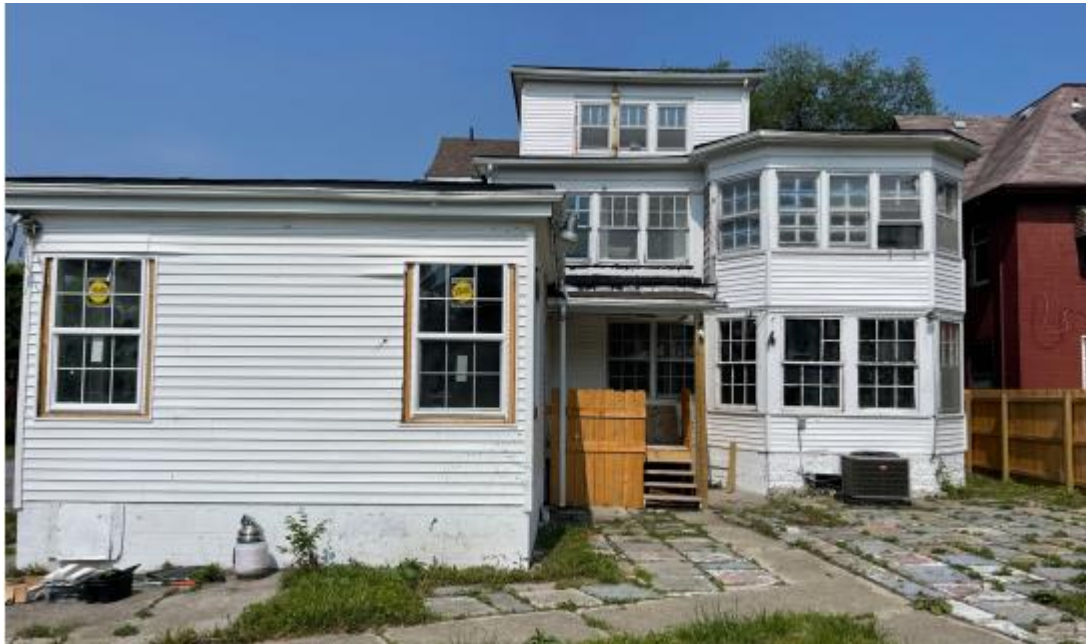
Photo 5, provided by applicant. 1725 Seyburn, rear (west) end, currently sided with white vinyl siding and exhibiting a variety of window types, materials, and configurations. The vinyl siding and the two replacement windows visible here on the one-story addition are included in this application.

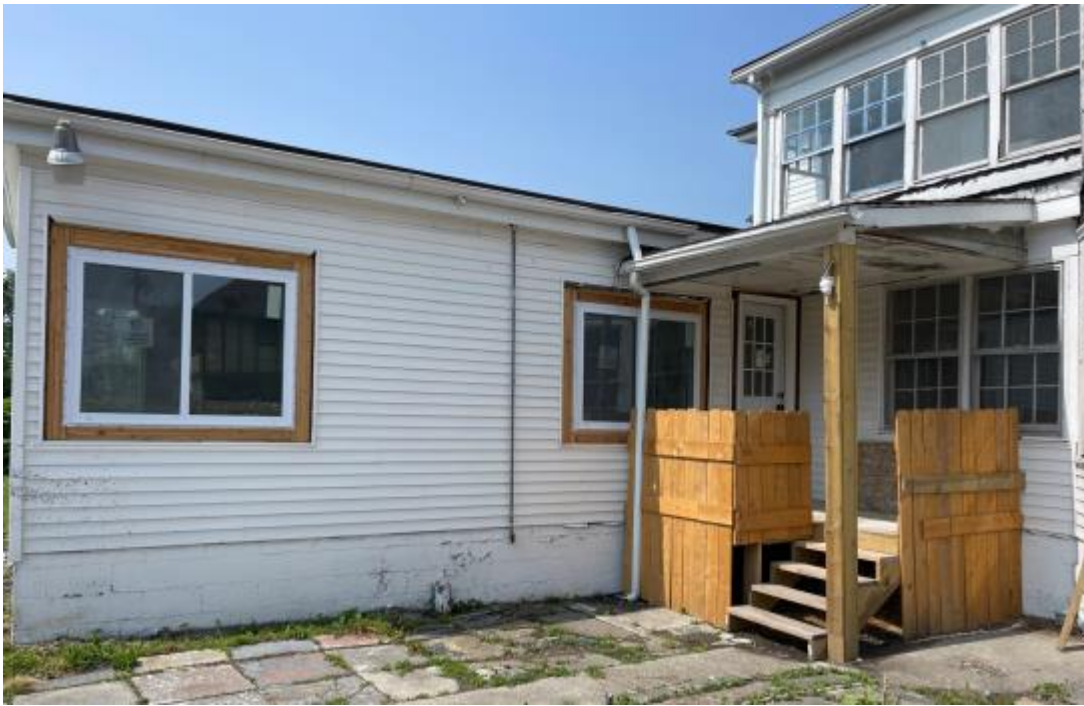
Photo 6, provided by applicant. 1725 Seyburn, south side of the long, one-story addition attached to the house's northwest corner. The two new sliding windows shown are included in the application. The white vinyl siding and the porch shown are both included in the application, but a replacement exterior door visible here is not included in the application.

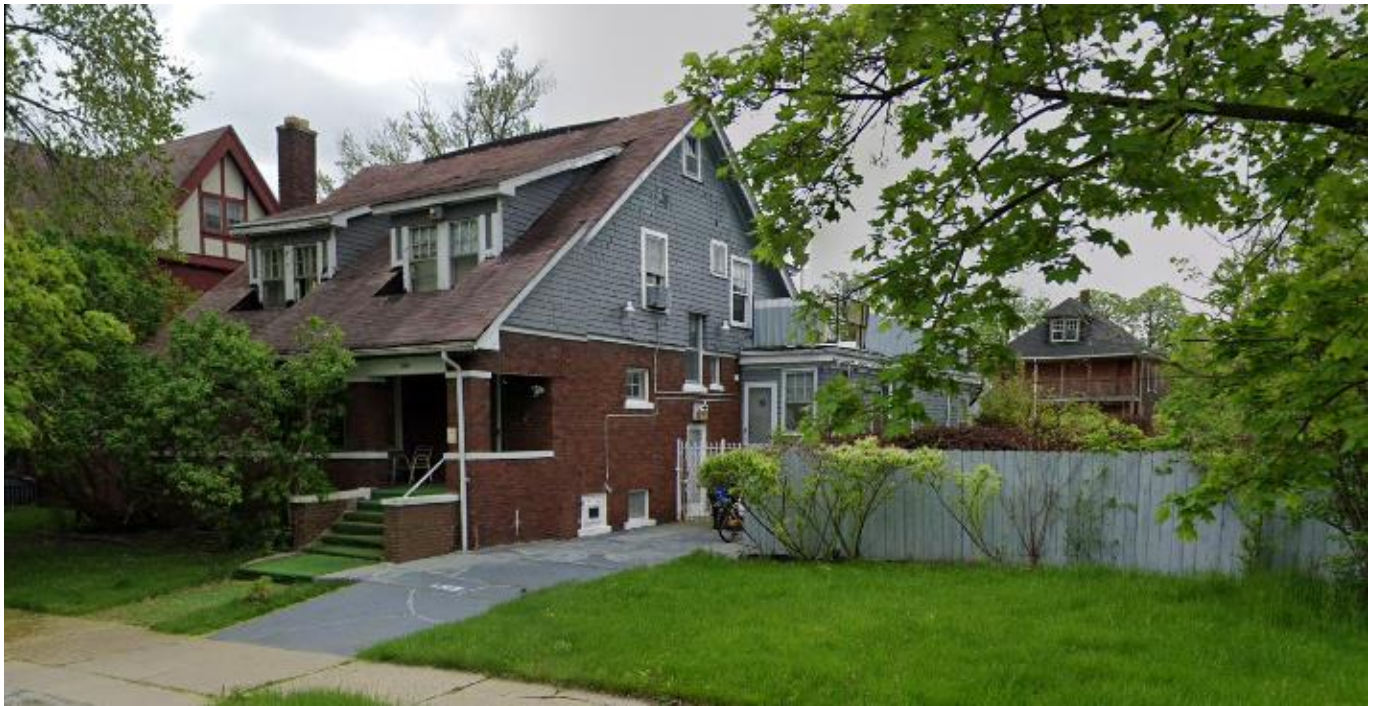
Photo 7, 1725 Seyburn, May 2019, Google streetview. Conditions prior to the recent unapproved work. Note wood windows and wood shake siding at gable ends and dormers.

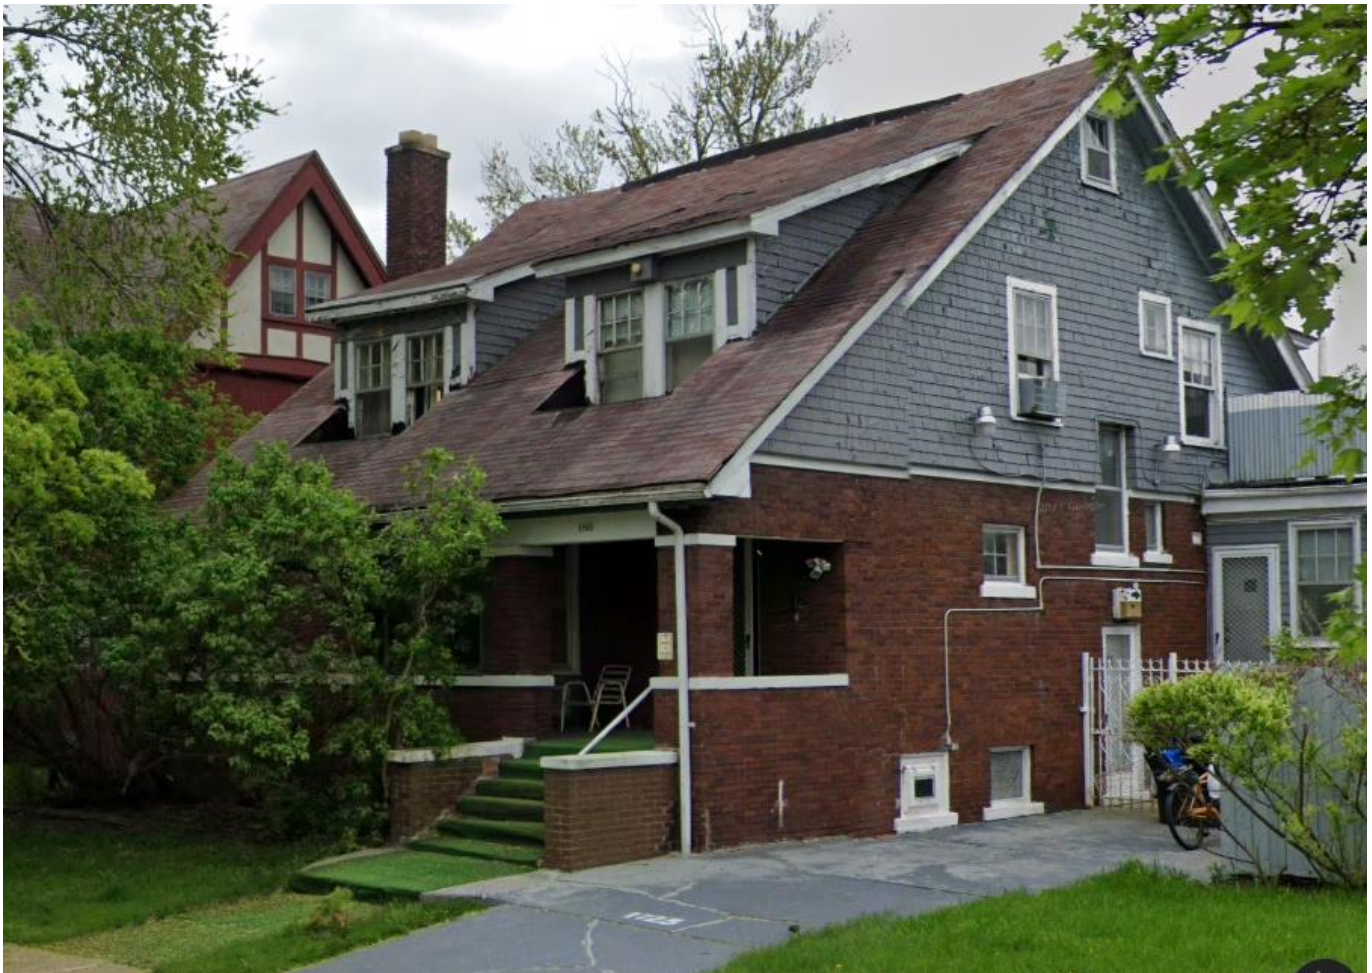
Photo 8, 1725 Seyburn, May 2019, Google streetview, more detailed view. Conditions prior to the recent unapproved work. Note wood windows and wood shake siding at gable ends and dormers.

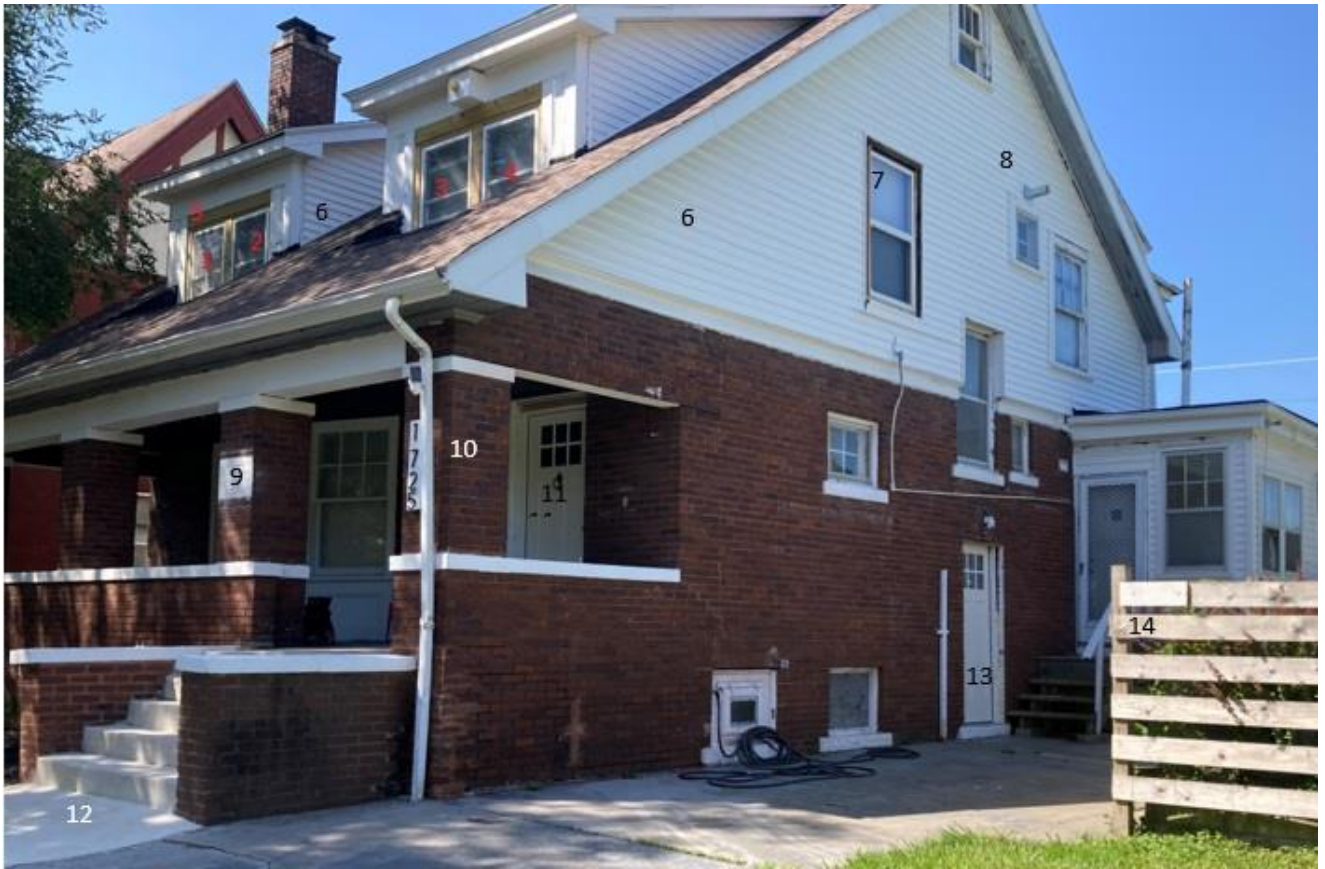
Figure 2. To summarize the changes on the facades, staff marked up Staff Photo 2 to show elements on these two facades that have changed between 2019 and 2025.

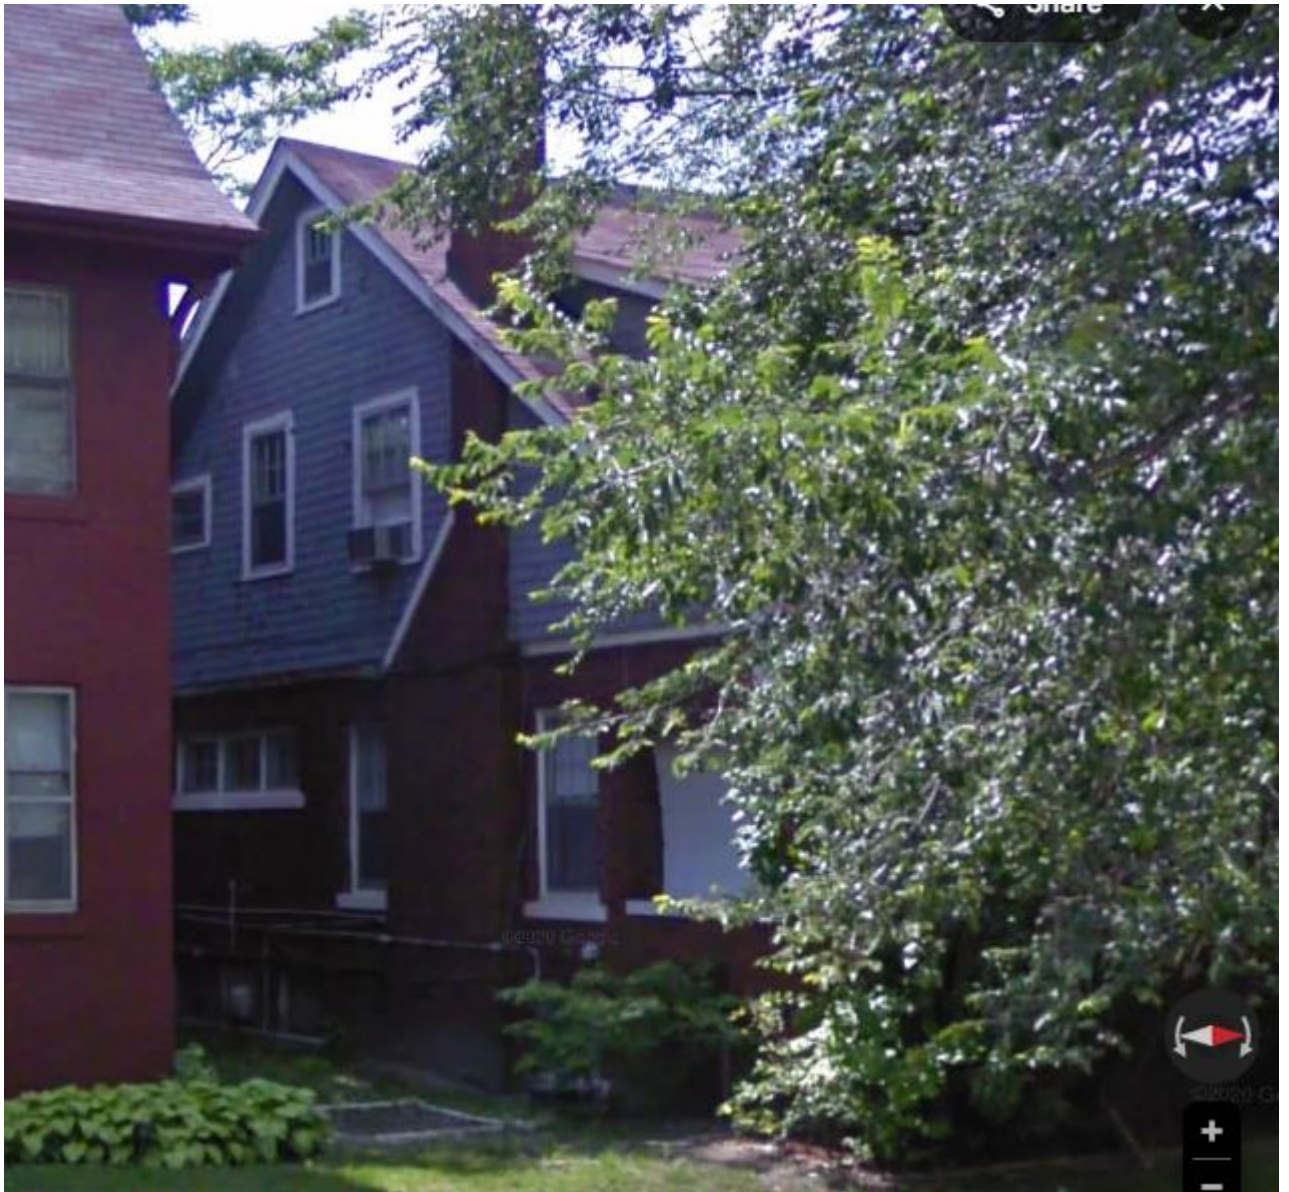
Photo 9, July 2009, Google streetview of house's south side. Many available Google streetviews from May 2019 back to July 2009 have a lot of shrubbery blocking this view. This is the only Google streetview staff could find that showed the historic windows and siding on this side of the house.

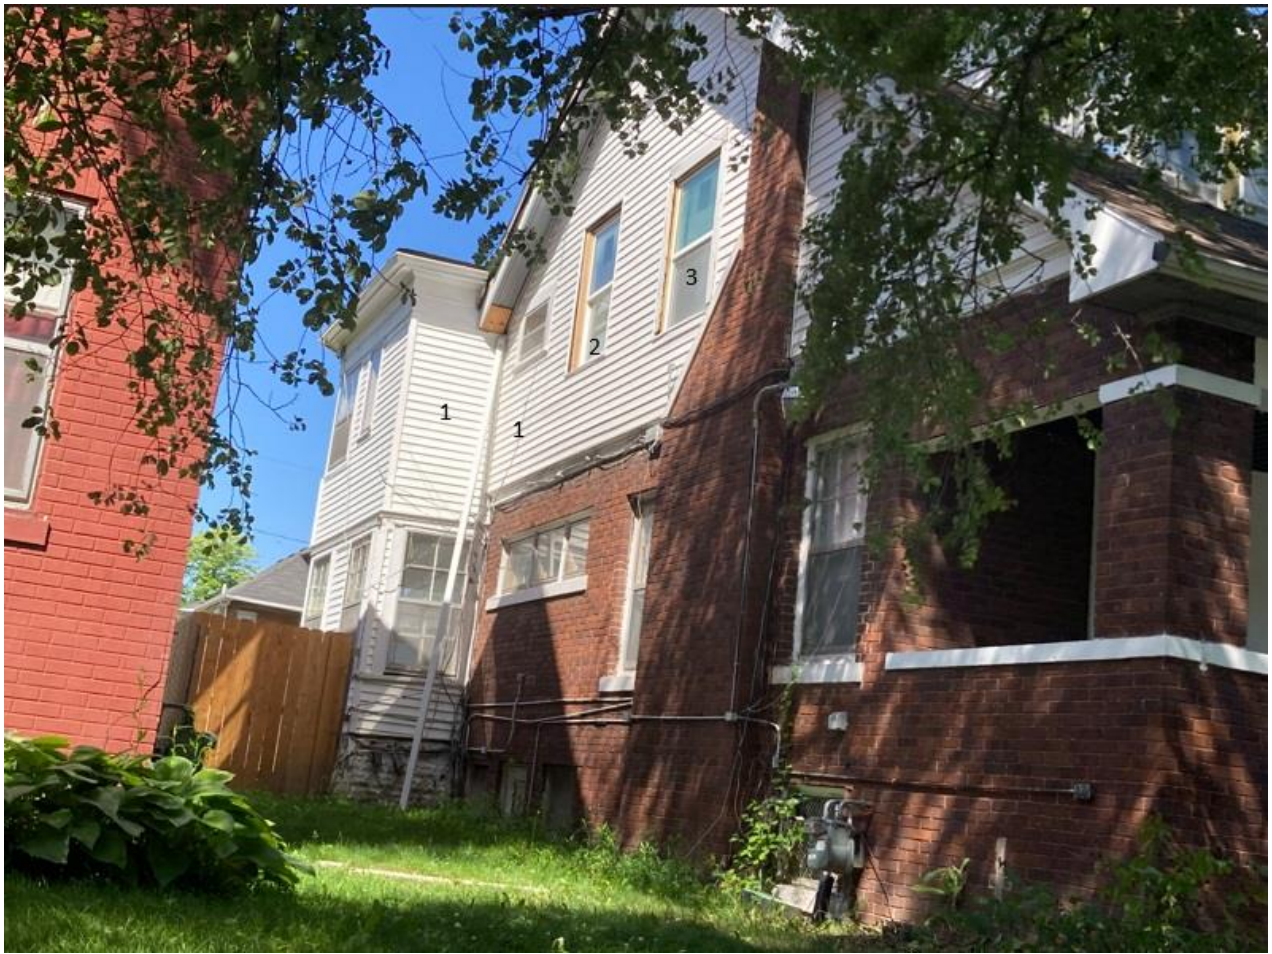
Figure 3. Staff marked up Photo 3 of the house's south side from June 2025 to show the new elements staff can see plainly from the sidewalk, marked with red triangles. Those recent changes include the two new windows where six-over-ones used to be, and the white vinyl siding installed over the historic gray wood siding on the house. It is currently unknown what material covered the rear addition before the white vinyl. The addition on the north side had gray siding, so it's possible that this part of the addition had gray siding also.

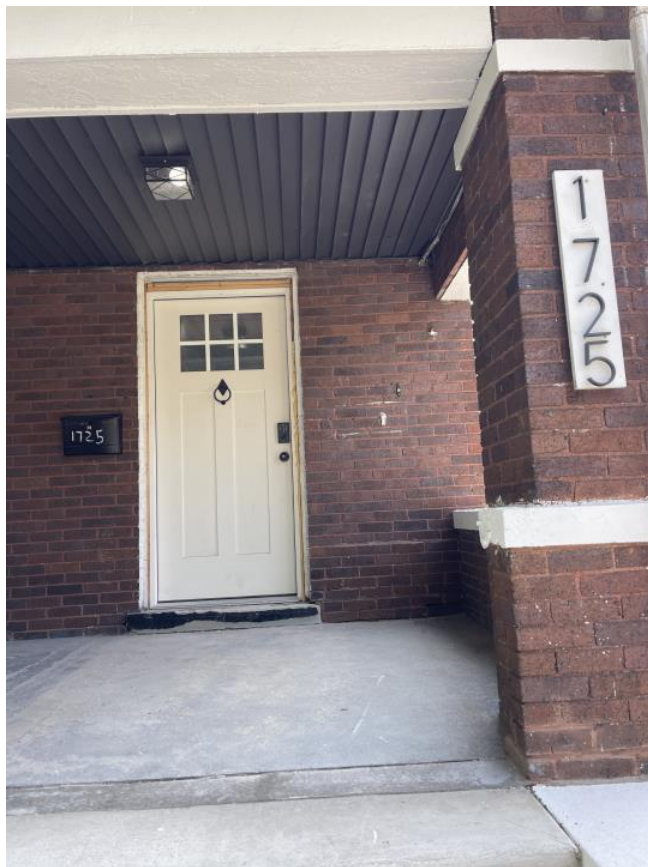
Photo 10, provided by applicant. Photo appears to show lap siding installed on the ceiling of the front porch. Also pictured is the replacement front door and new address plate installed on the brick column.

- In their application, the applicant included a photo of the front entry (reproduced above, *Photo 10*) that shows lap siding on the ceiling of the front porch. Staff is unsure as to what the historic material was (or is) under that installed modern siding, but historic porches would typically have wood porch ceilings—often beadboard. Staff does not believe that this application of lap siding is appropriate for the historic resource, but more information is needed regarding what the historic material is (underneath) or was (if it was removed) on the front porch’s ceiling in order to apply the Standards.

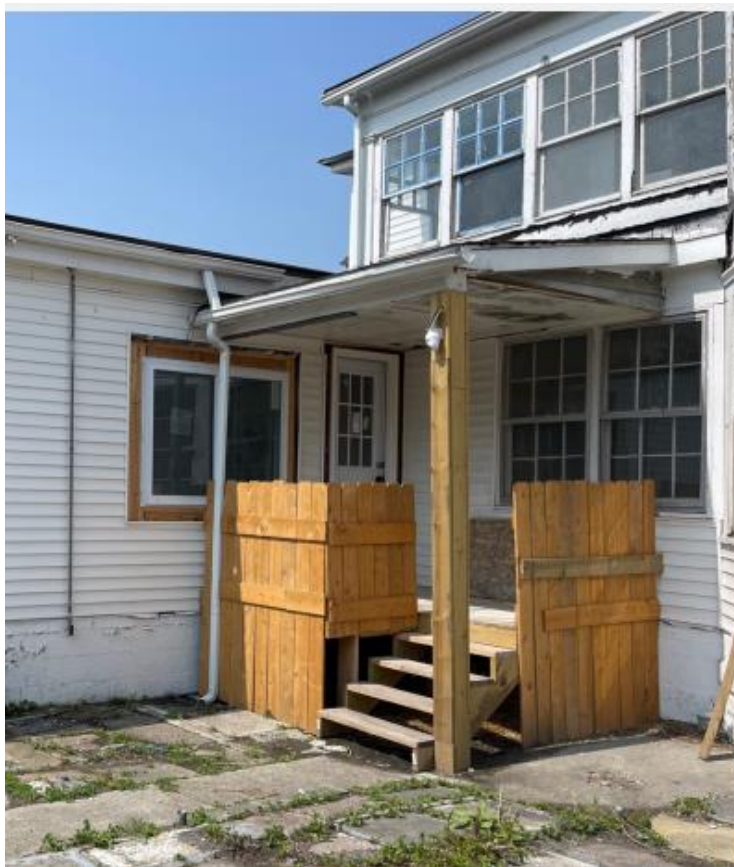
Photo 11. Applicant’s photo (cropped) from the Cycle 1 application.

- The applicant refers to rebuilding the side porch. It appears to staff that the applicant is referring to the porch on the rear of the house, as shown in *Photo 11* below. The rear porch, as completed without historic district commission approval, appears to have been built of pressure-treated wood decking, post, and steps, with pressure-treated wood fencing serving as the guardrail. Staff does not believe that this work meets the Secretary of the Interior’s Standards for Rehabilitation, specifically Standard 9. Standard 9 states that new work “will be compatible with the historic materials, features, size, scale and proportion, and massing to protect the integrity of the property and its environment.” It is staff’s opinion that the completed rear porch work is not compatible with the house’s historic materials or features. Typically, even simple, rear porches in the district would have painted wood surfaces, some simple trim detailing where the post meets the porch surface and porch ceiling, stairs with closed risers, porch skirting, and a simple coordinating guardrail and handrail that is sympathetic to the house’s historic materials and features.

- The proposed/installed porch is not compatible with the house's historic materials or features. Specifically, the use of the fencing as porch guardrail and the pressure-treated post extending to the ground instead of to

a porch deck surface are not appropriate the house's Craftsman character, both in terms of materials and design.
