STAFF REPORT: 07/09/2025 REGULAR MEETING

APPLICATION NUMBER: HDC2025-00230

ADDRESS: 1039 SEYBURN

SCOPE: MULTIPLE EXTERIOR ALTERATIONS

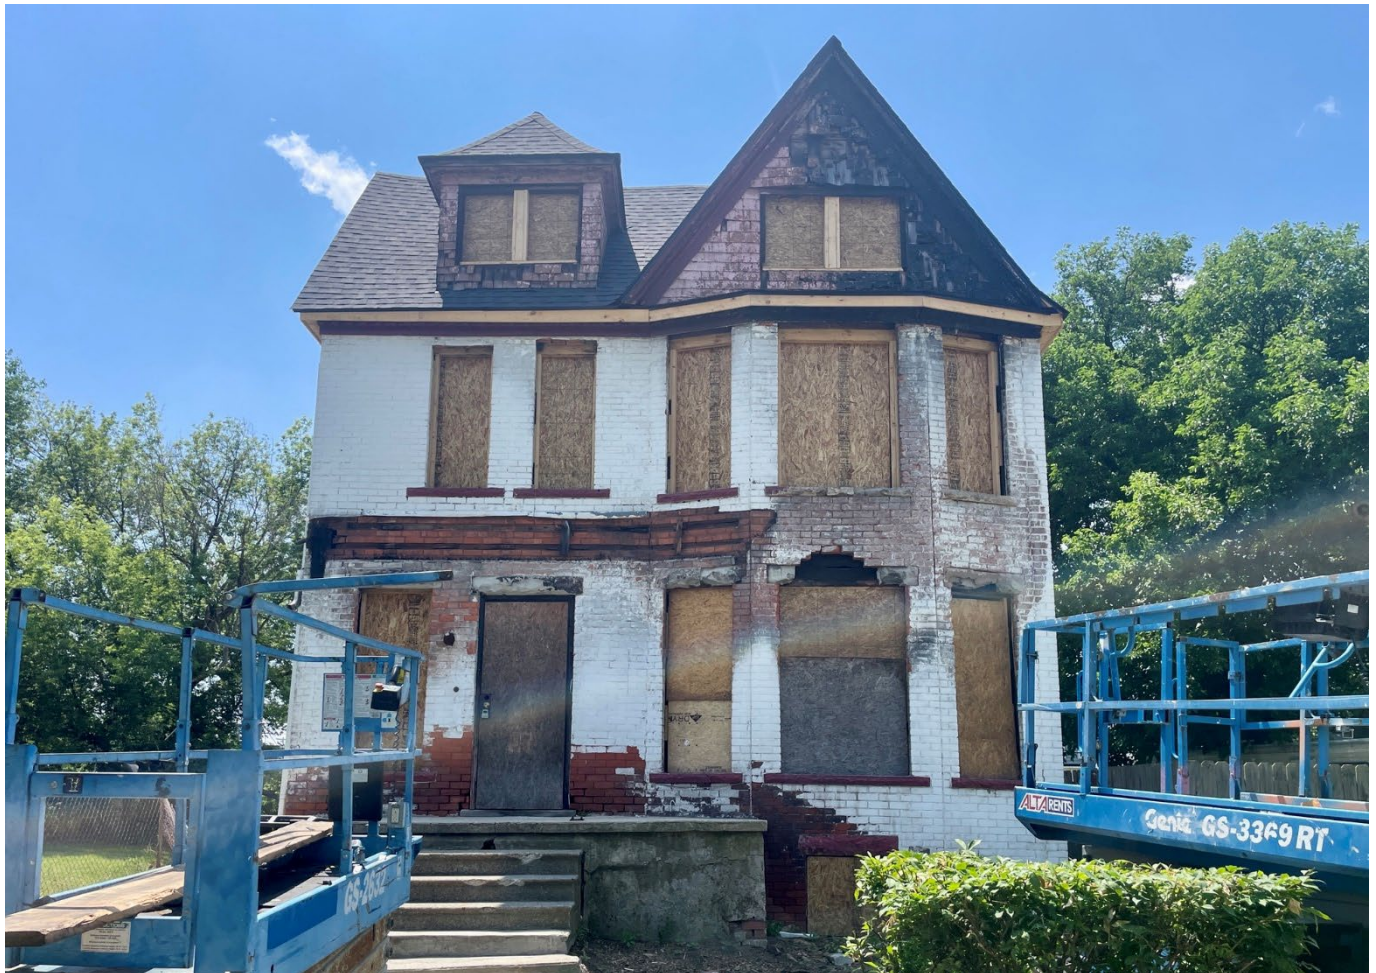
Staff photo, 06/27/2025

The dwelling located at 1039 Seyburn is a brick, Queen Anne style house built in the West Village neighborhood in the early 20th Century. The house is two-and-a-half stories and features a side-gabled roof with a front-facing gable and a dormer. The gable-ends and dormers are adorned with what remains of wood shingle siding. With the partial-width porch, these architectural elements combine to create an asymmetrical façade.

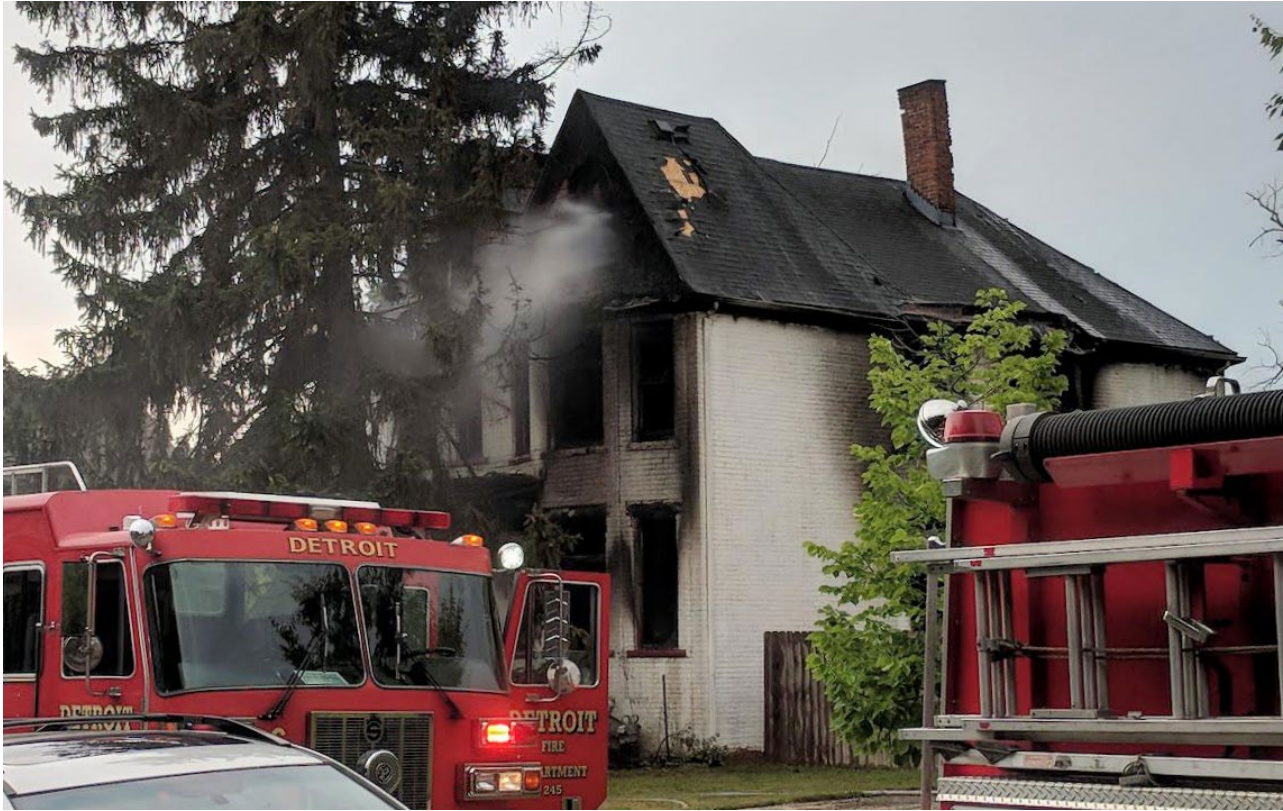
Staff photo, 08/06/2018

- 1039 Seyburn caught fire August 6, 2018, which caused extensive interior and exterior damage.

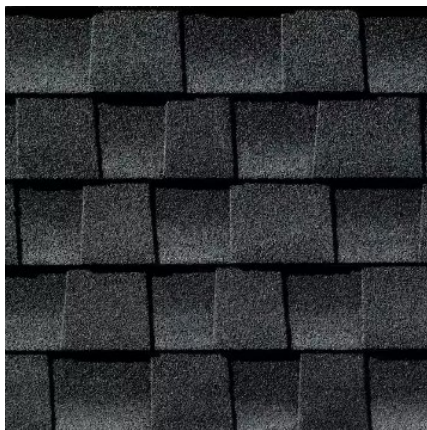
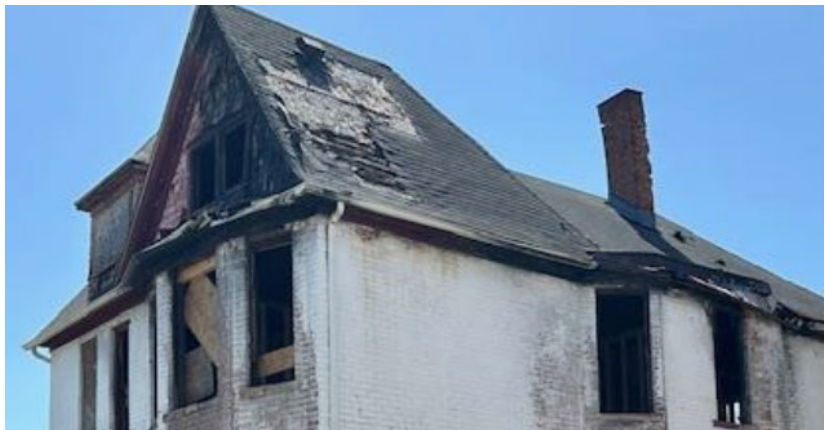
- Installed without Historic District Commission approval
- GAF Timberline HD Dimensional Asphalt Shingles in Charcoal
- Photos from application show previous asphalt roof had extensive damage from the fire
- Staff finds this work item to be appropriate and recommends the approval

Proposed (installed without approval)

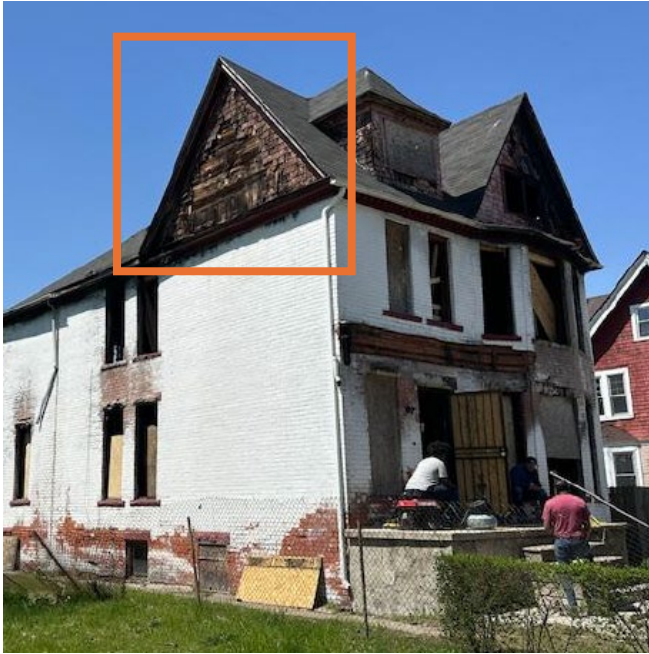
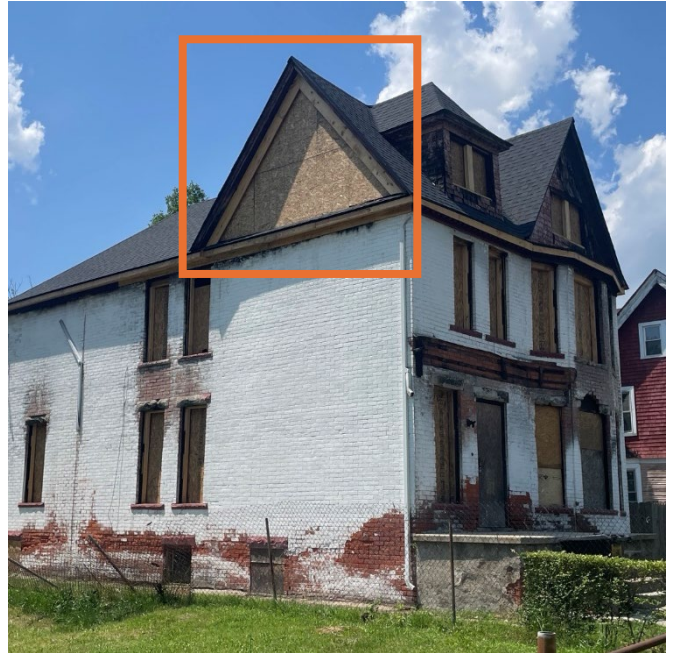
- Since the submission of the application on 04/29/2025 and the staff site visit on 06/27/2025, the cedar shingle on the South facing gable-end was removed without approval.

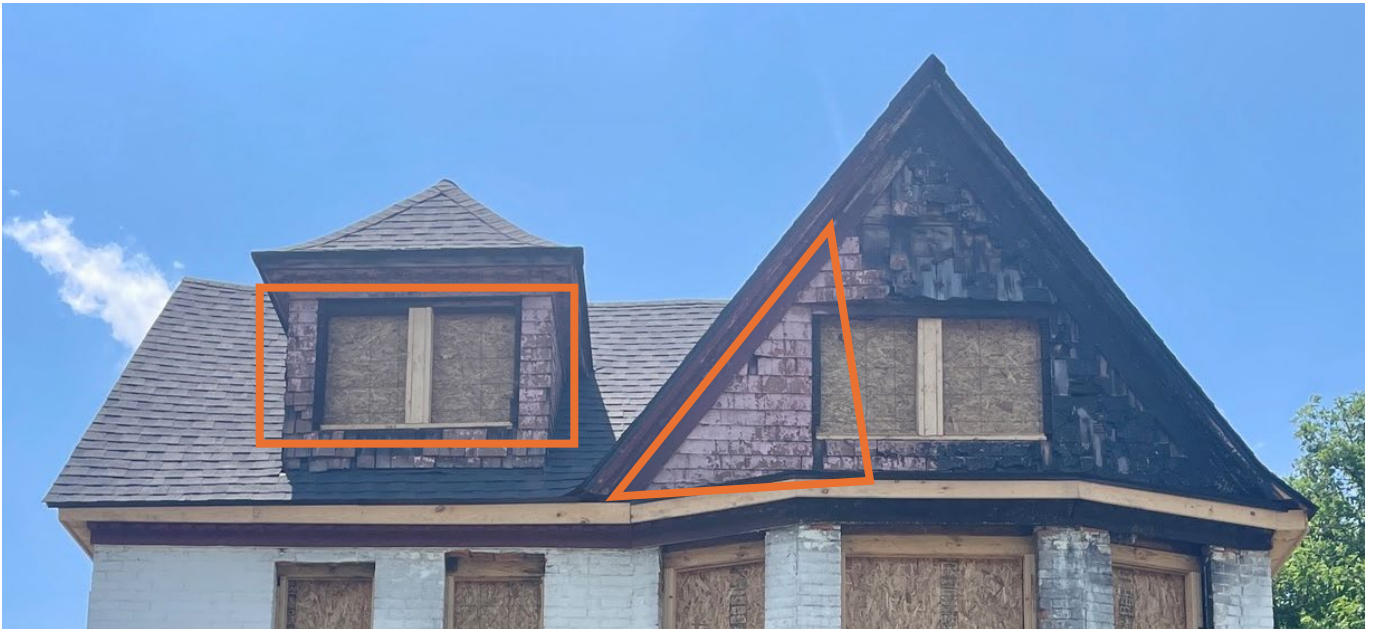
Staff photo 06/27/2025

- It is of staff's opinion that some of the remaining cedar shingle siding is in repairable condition, as outlined below.

- For the remaining missing or damaged cedar shingle siding, the applicant proposes to install cedar shingles to match the existing.

- It is staff's opinion that this scope item is appropriate, with the condition that the existing cedar shingle within the areas outlined above are retained and repaired.

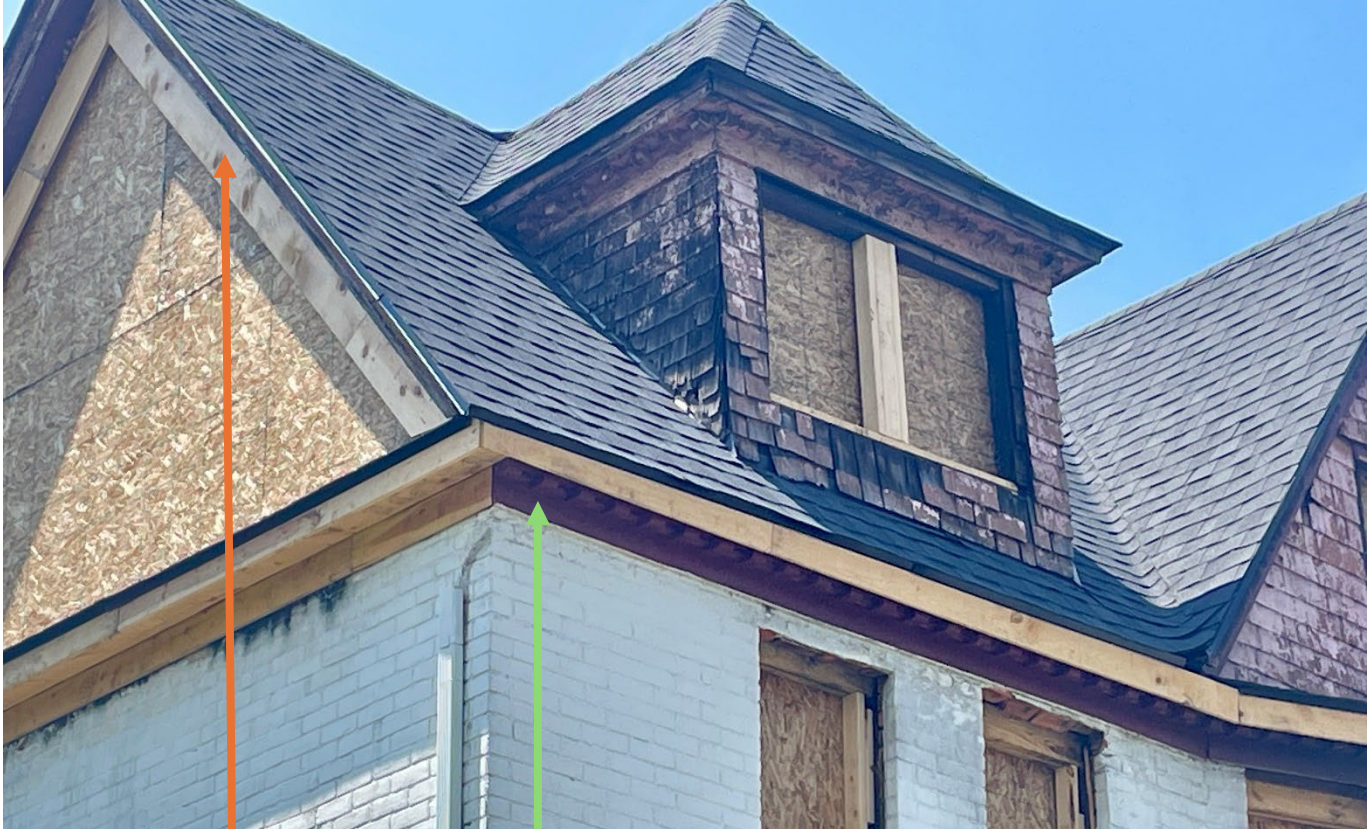
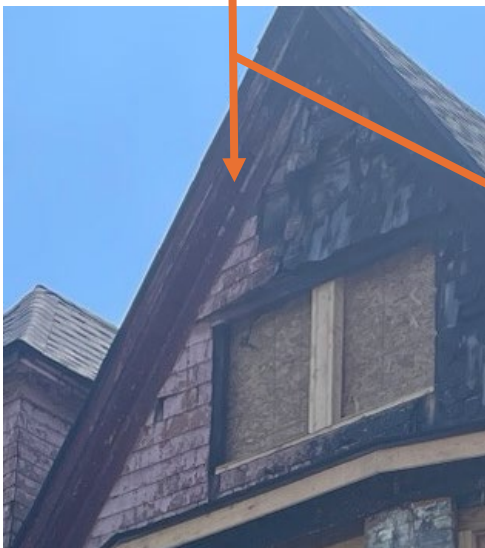
- Since the submission of the application on 04/29/2025 and the staff site visit on 06/27/2025, some of the wood trim was replaced without Historic District Commission approval.

- The soffit and fascia installed, without approval, surrounding the roof edge does not include the dentil detailing as shown with the existing historic soffits.
- Within the South facing gable-end, the applicant installed a simple frieze board, without approval, which does not match the existing historic wood trim at the front-facing gable-end.
- The applicant states that the “existing 1x6 fascia and solid wood soffit to remain; new pine or fir wood to be installed where existing is missing or damaged” and that “other trim (rake, frieze, etc) to be replaced as necessary with similar sized wood product.”
- It is staff's opinion that this scope item is appropriate, with the condition that any decorative detailing within the eaves areas/soffit/fascia that was not destroyed by the fire be replicated.

- The wood trim and finish carpentry, including the fascia, soffits, and porch roof, shall replicate the historic details in-kind. The project drawings shall be revised to reflect the replication of the damaged detail.

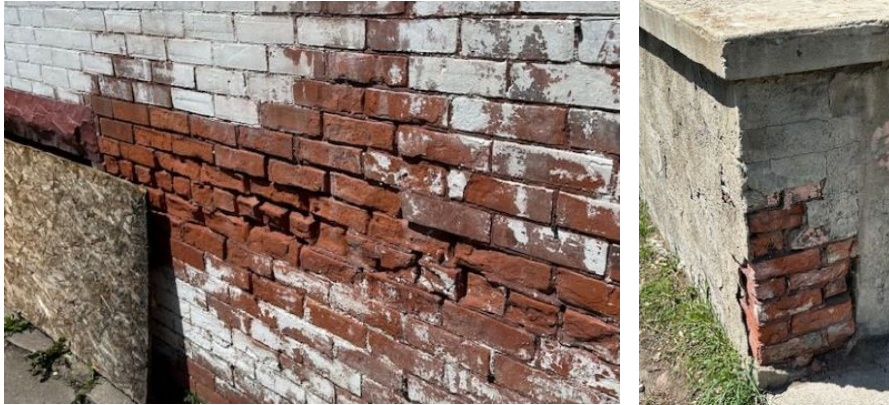
Photos from application

- The applicant proposes to replace any crumbling brick with “reclaimed common brick” and to tuckpoint where there are areas of missing mortar, though applicant does not specify the type of mortar that will be used.

- It is staff’s opinion that this work item is generally appropriate with the condition that the applicant consult the NPS’ guidance on tuckpointing historic masonry (see [Preservation Brief 2: Repointing Mortar Joins in Historic Masonry Buildings](#)) and identify a product that is of an appropriate composition/that matches the strength of existing historic mortar. An off-the-shelf mortar product would not be appropriate for a house of this age.

- Specifications for the glass transparency level
 - Specifications of the opacity of the screens
- A historic mortar mix shall be used for the proposed tuckpointing, as the mortar must be softer than the historic brick and match the composition of the existing historic mortar.

- A sample of the replacement brick shall be provided to staff for review and approval to ensure that it is suitable for exterior use and is compatible in texture, color, and dimension with the adjacent historic brick.

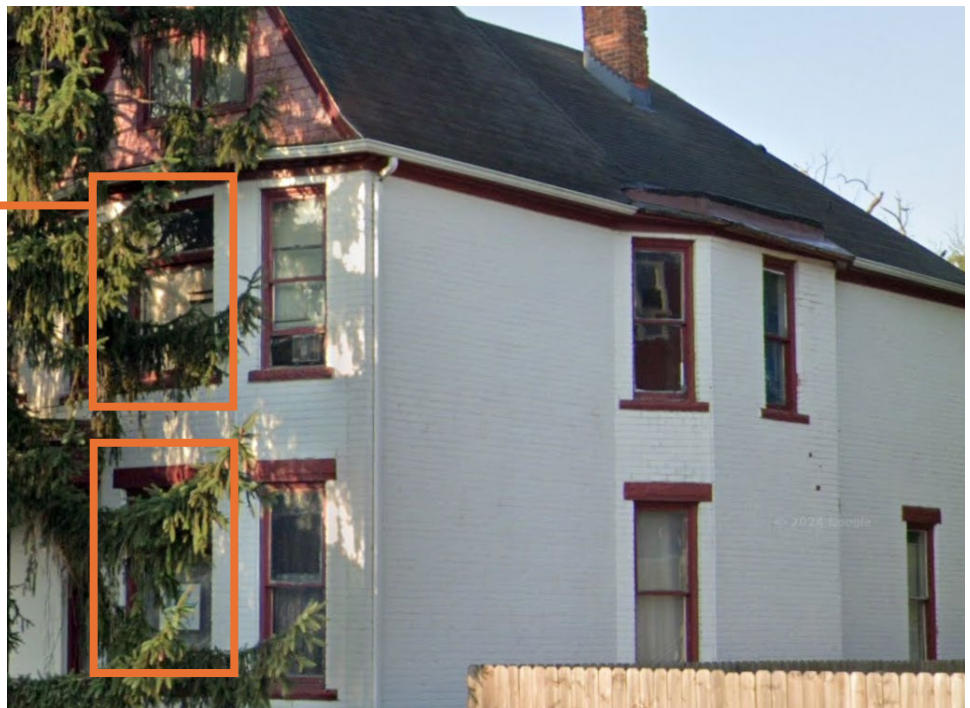
Google Street View, 08/2018

- There are currently no existing windows, leaving only window openings.
- As of 08/2018, right before the fire, the existing historic wood windows were double-hung one-over-one lite, with the centered bay windows being a fixed window with a transom.

- Proposed centered bay windows to not include transom, like what was originally the historic configuration.
- Typically houses of this era and style would have the centered bay window a larger, single pane fixed window with a leaded glass transom.

- A final window order shall be submitted to staff for review, which includes:
 - Transom windows at the two centered bay windows at the front (East) façade

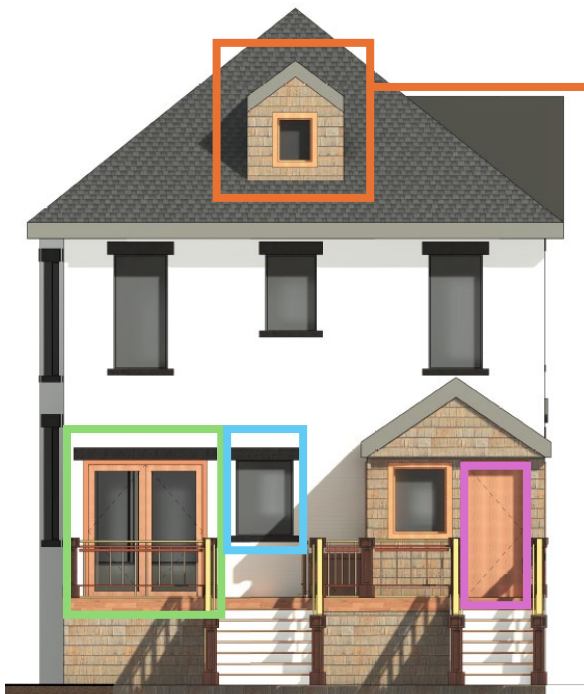
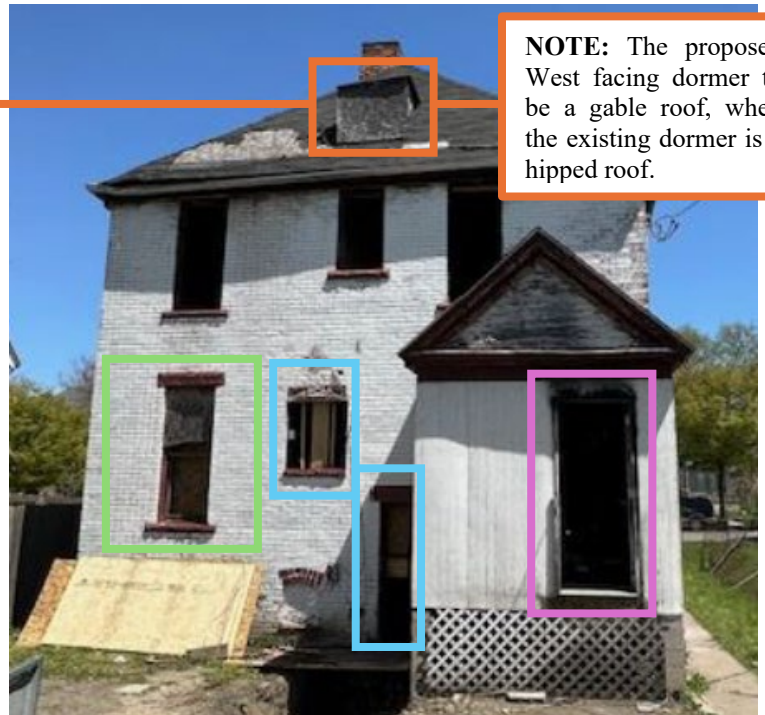
Back (West) elevation drawing and photo from application

- Per the drawings submitted on 05/22/2025, the proposed windows and doors are to keep their current opening dimensions, except for existing two window openings and one door opening to be altered.
 - Back (West) elevation window opening to be enlarged and replaced with a double-door.
 - The double-door product specifications was not included in the application materials. Staff requested specifications via email on 06/27/2025.
 - Back (West) elevation window and door opening to the right of the proposed double-door to be infilled with brick, though it does not correlate with the submitted drawings.

NOTE: The proposed West facing dormer to be a gable roof, when the existing dormer is a hipped roof.

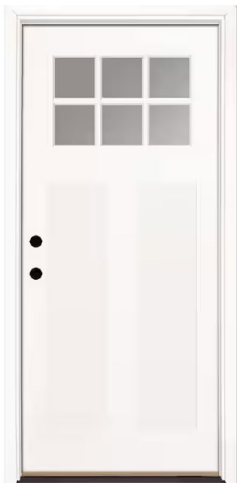
- 6 Lite Clear Craftsman Unfinished Fiberglass Rehung Front Door
 - It is staff's opinion that the proposed front and back door is inappropriate, especially given its distinctive Craftsman style.

- It is staff's opinion that proposed approach for the installation of new windows and doors is generally appropriate, with the following exceptions:
 - The proposed craftsman style door is not appropriate for installation at a house of this style and date of construction. If a vision panel is desired, a simple, unadorned, and undivided $\frac{3}{4}$ to full-lite window would be more compatible selection in this case.
 - The large, fixed undivided windows proposed for the front façade, central bay is not compatible with the building's historic appearance, in staff's opinion. As noted above, a window which includes a large, central pane with a smaller transom above would be more appropriate for these openings.

- A new design for the back and front doors, research porch/deck and railing, and front porch roof and railing shall be selected and submitted to staff for review and approval.

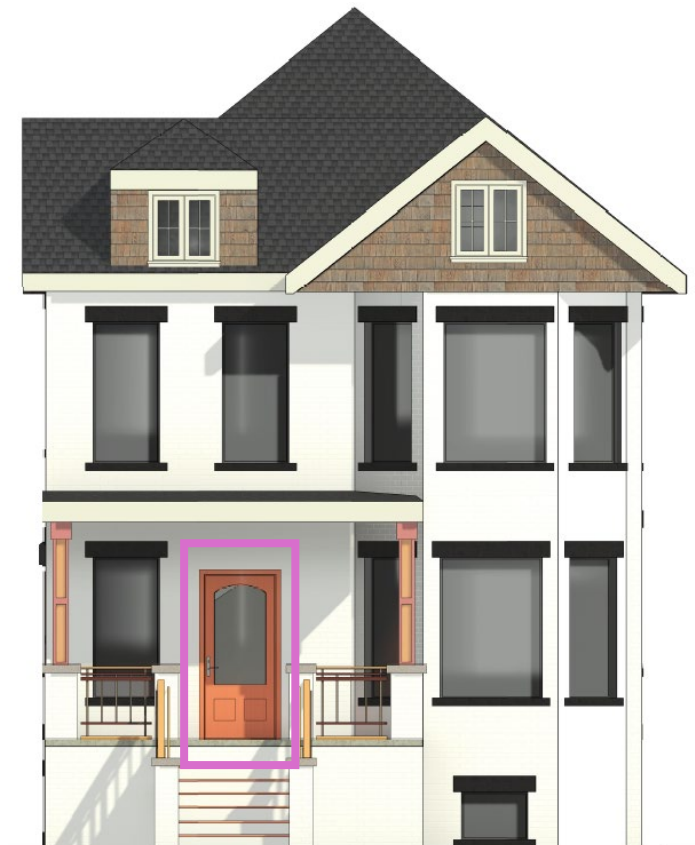
Front (East) elevation drawing from application

- Masonry front porch to be rebuilt, complete with reclaimed brick walls and new slab. Dimensions remain unchanged.
- The applicant proposes a "new wood framed, shingled shed roof over rebuilt front porch" with the roof to match the dimensions of the porch.
- For the railing, the applicant proposes to "install new wood railing system and wood steps on front porch. ...Railing to measure 42" H." No additional detailing, including materials, were provided.

- The current application lacks a dimensioned floor plan for the rear porch/deck.
 - With respect to the front porch, it is staff's opinion that the proposed height (42") and design and materiality of the railings (likely metal balusters) is not compatible with the property's historic appearance. A simple wood railing with square balusters of an appropriately lower height is recommended. Also, while the replication of the original porch roof is not required since it was destroyed by the fire, staff does recommend that the new porch roof borrow some design cues from the original porch to ensure that it is compatible with the historic character of the house and the contemporaneous houses within the district. It is staff's opinion that the current design presents a wholly modern appearance that is not appropriate for a front porch of a Queen Anne style house. See the photos below of examples of front porches in the near vicinity and note that multiple houses on Seyburn between E. Lafayette and Agnes still showcase historic porch detailing at the cornice combined with simple, thick wood posts.

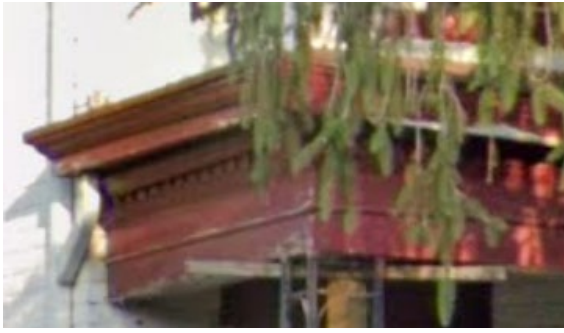
Google Street View 08/2018

- With Google Street View in 08/2018, right before the fire, you can see the historic porch roof detailing remained. Also, the porch supports were non-historic, C. 1970's metal columns. However, the fire destroyed the front porch roof and columns, while the porch deck and floor remained.

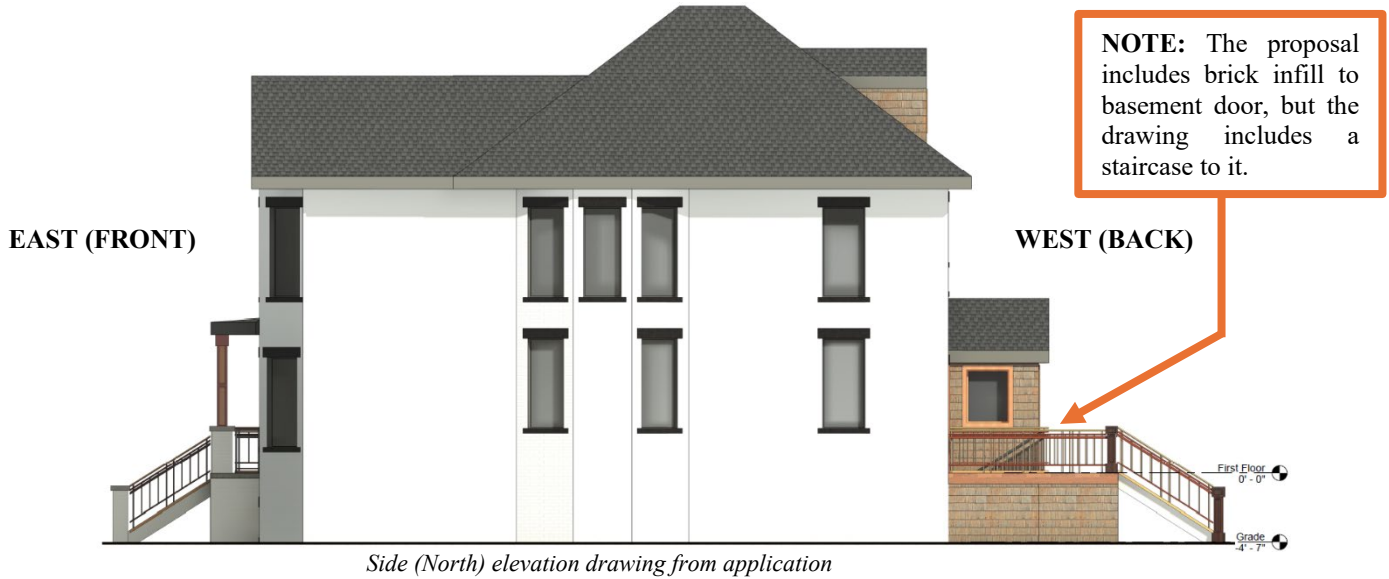
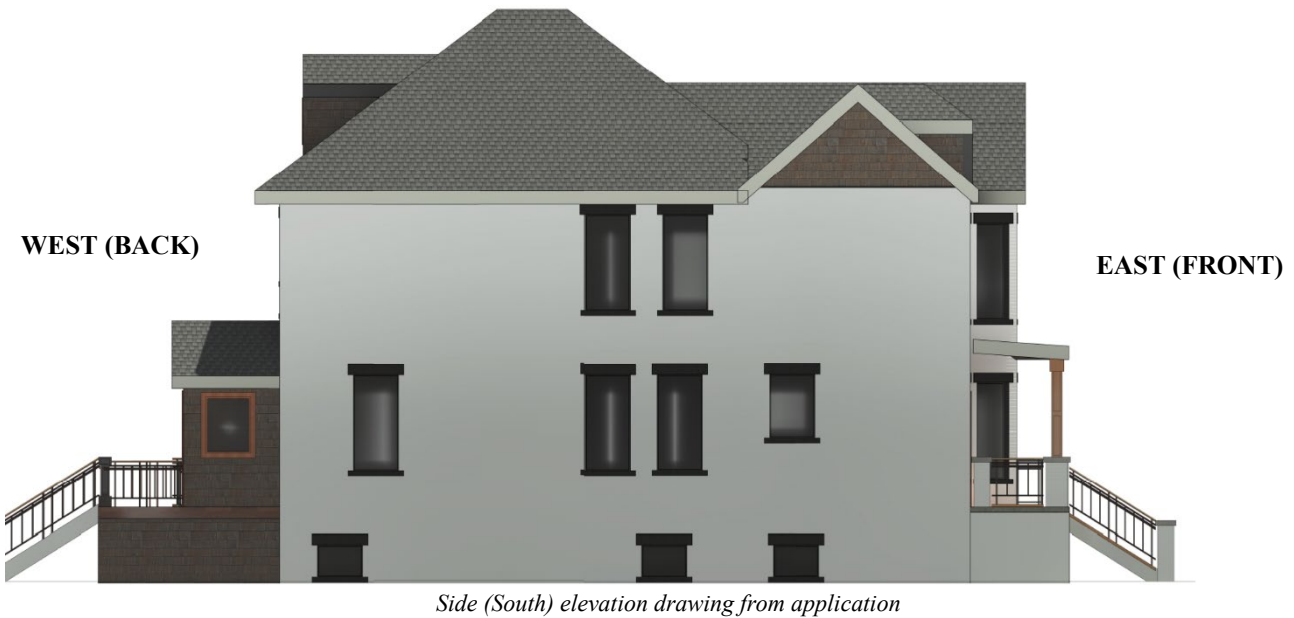
- Although staff request via email on 06/27/2025, no dimensioned floor plan drawing was provided of the back porch by the applicant.

- The rear porch/deck should present a more simplified appearance than that proposed, IE, the deck should be constructed of wood and should not be clad with wood shingles. Also, the railing should be made of wood and display an appropriately compatible appearance to this Queen Anne style house.

- A final dimensioned plan for the new rear deck shall be submitted to staff for review and approval.

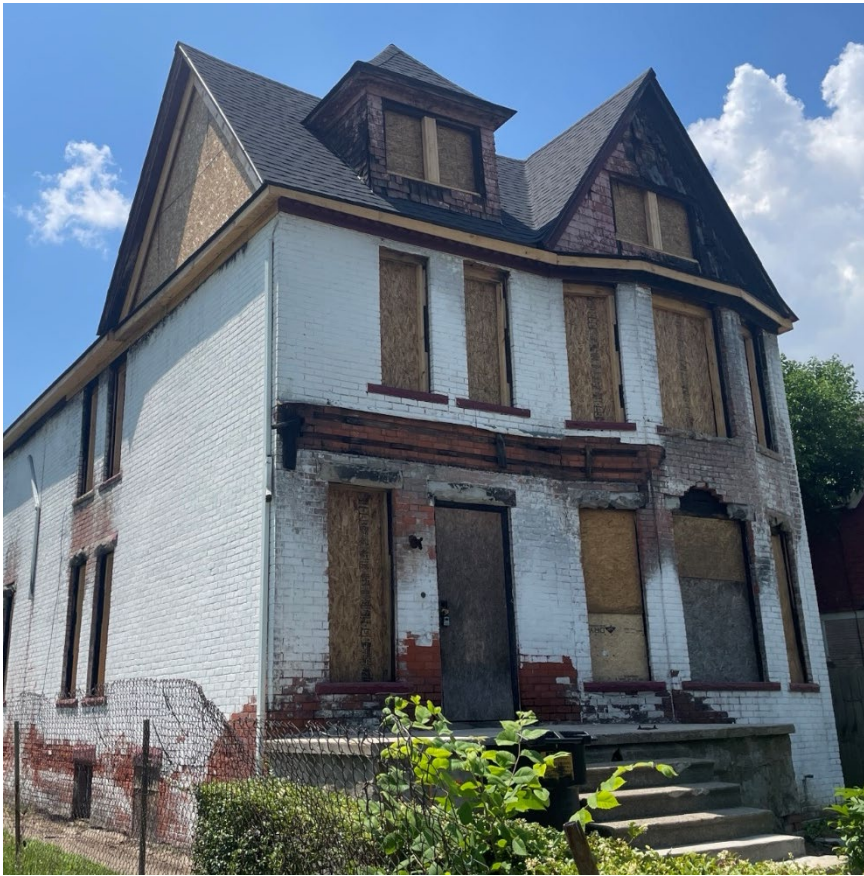
- Per the Historic District Commission Color System B, the proposed brick (body) in Alabaster does not follow the guidelines. It is in staff's opinion that the cedar shingle and trim colors are appropriate, but that the brick paint color is not appropriate due to the Queen Anne house style and age, especially considering the house historically would have been unpainted red brick.
