**STAFF REPORT: AUGUST 13, 2025 REGULAR MEETING**

**APPLICATION NUMBER: HDC2025-00422**

**ADDRESS: 2200 CHICAGO BOULEVARD**

**SCOPE: ERECT FENCE, INSTALL VINYL WINDOW (WORK COMPLETED WITHOUT APPROVAL)**

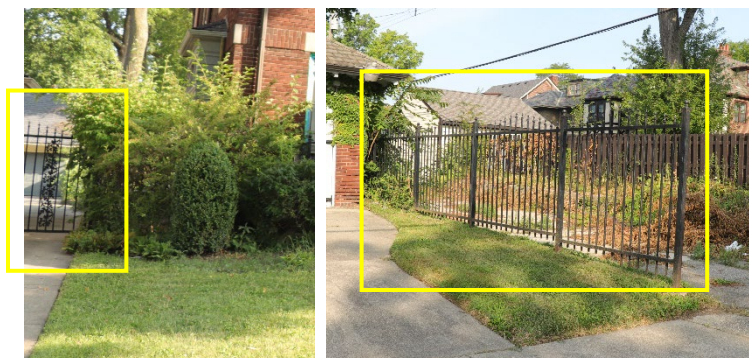
There is an existing wrought iron style aluminum fence at the edge of the property between the garage and the alleyway. The neighboring property to the west/left of 2200 Chicago has a wrought iron style gate on their driveway. This addition will create a continuity between the existing conditions of both properties  
*Left: Neighbors gate (2214 Chicago)*  
*Right: Garage side fence*

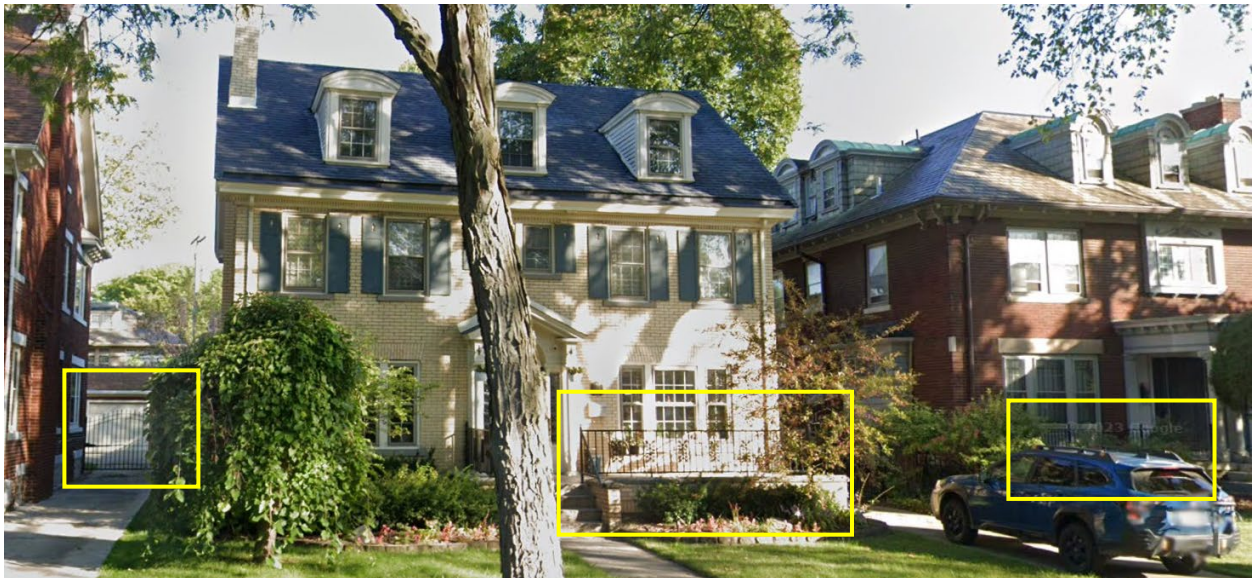
- The Google Street View Image (*below*) from September 2023, shows 2200 Chicago in relation to its neighboring properties, both of which have wrought iron style elements. These elements are present on the front porch railing of 2214 Chicago and the wrought iron style gate in the driveway of 2224 Chicago.

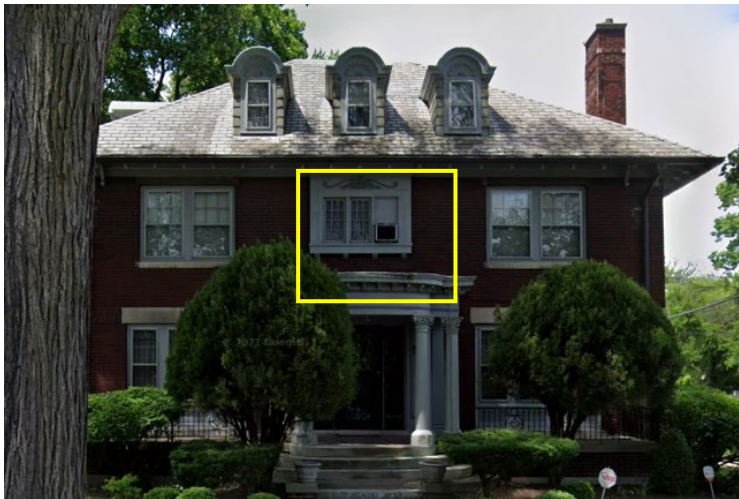
2200 Chicago Google Street View Image from 2019.

Google Street View shows that the historic windows were replaced with a vinyl window sometime between 2019-2022, without HDC approval. According to the applicant, this work was completed by a previous owner.

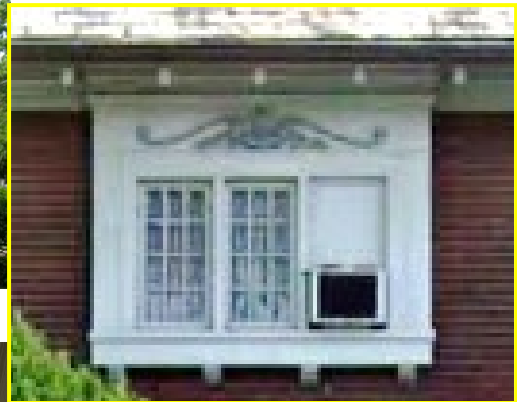
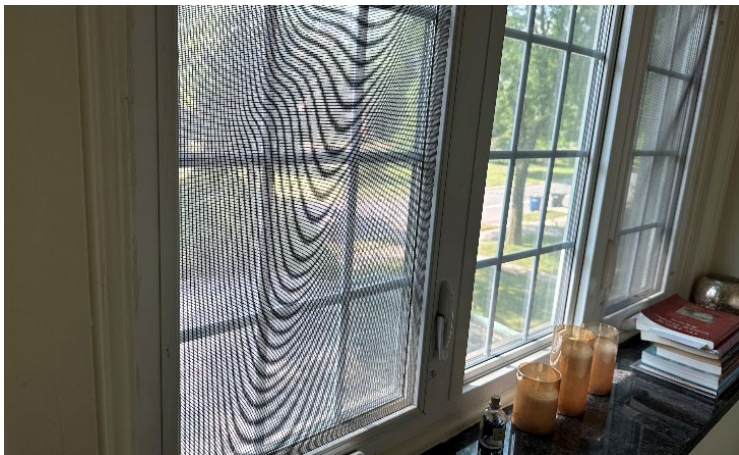
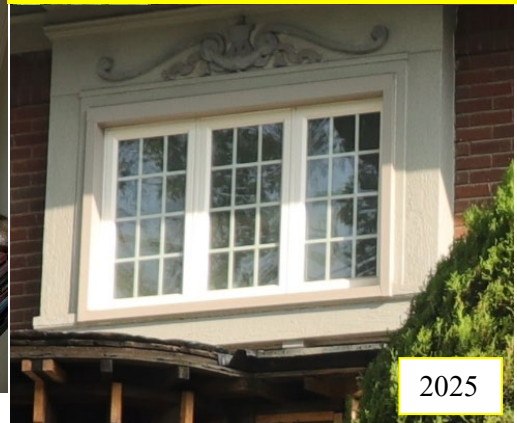
Interior window photograph provided by the applicant.

- The original wood windows at the front of the house were a distinctive, character-defining feature for this property. The three original wood windows with mullions in the center of the second story were removed without HDC approval. The wood windows were replaced with a three-unit, factory-mulled, white vinyl window.

- Between-the-glass grilles are flat and obscured by the sheen of the glass. They do not match the profile/dimensionality and appearance of true divided-light historic windows and are not "consistent with the general characteristics of a historic window of the type and period" and are not "compatible with the overall historic character of the building".

- As the windows were removed without HDC approval, the scope of work that would meet the requirements of the historic ordinance (Section 21-2-59(e)), is the fabrication and installation of new wood casement windows with structural mullions and simulated divided-lites; thereby matching the material, pattern, dimensionality and operation of the historic windows.

- It is therefore staff's opinion that the vinyl replacement window is not compatible with the historic district standards and must be replaced with a window type that matches the original historic window.

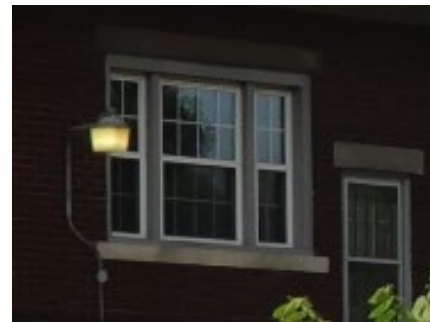
- At a later site visit, staff observed other windows at the rear of the home that were altered between 2019-2022. The property owner will be notified (see picture)
