**STAFF REPORT:** 08/13/2025

**APPLICATION NUMBER:** HDC2025-00113

**ADDRESS:** 8715 WOODWARD

**SCOPE:** REPLACE HISTORIC WOOD & STEEL WINDOWS

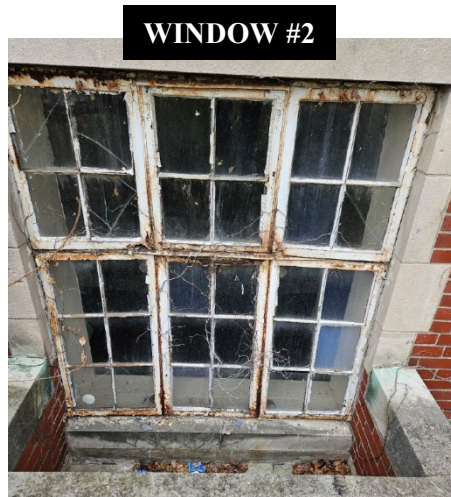
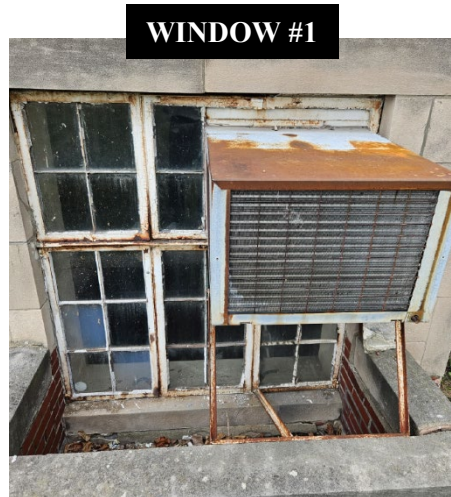
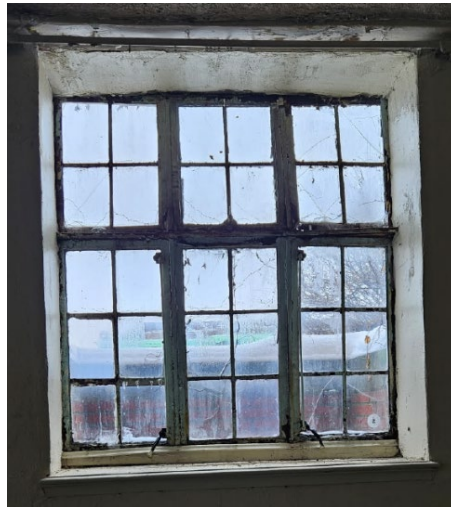
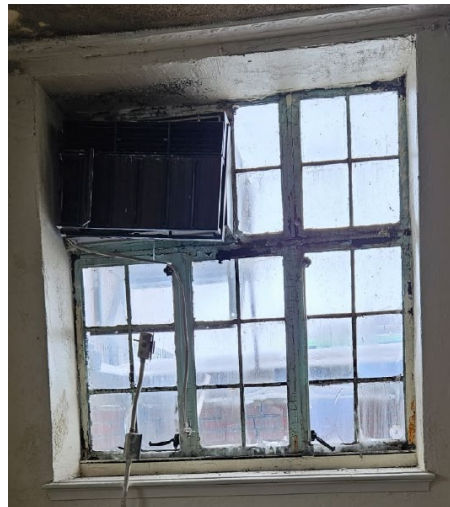
- Windows #1 and #2 face Woodward Ave and are visible from the sidewalk and the street.

- Although the existing steel casement windows are distinctive, character-defining features, considering the amount of bowing, deterioration from rust, and alteration to include the AC unit, it is staff's opinion that the existing historic steel casement window units are beyond repair.
- The Elements of Design (Sec. 21-2-150) mention that "metal occurs in doors and in window frames in some openings in the church complex."

- The historic leaded glass, wood and steel casement windows are distinctive, character-defining features with the leaded glass, wood windows not proven to be beyond repair.
- Though the existing historic steel windows appear to be deteriorated beyond feasible repair, the proposed windows are not in-kind matches to the historic windows at this property.
- Due to limitations in material quality and fabrication, vinyl windows are not appropriate for use in historic districts.

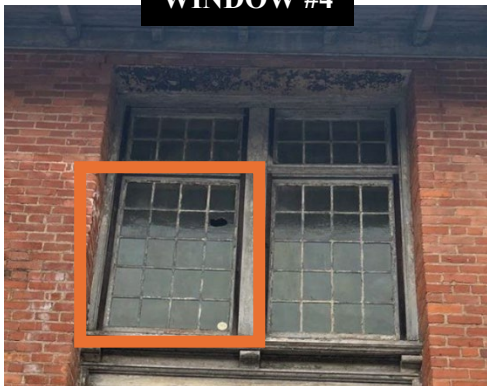
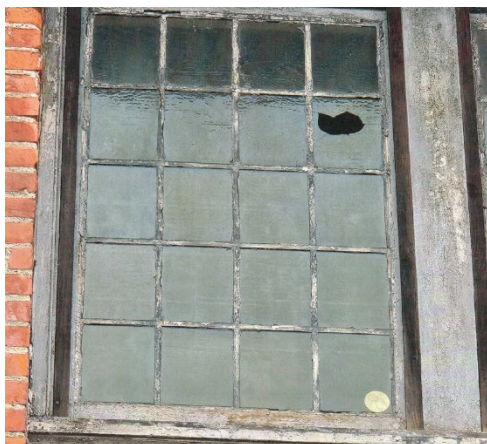
**WINDOW #4**

- Photos provided with the application show relatively minor deterioration of the wood windows, such as peeling paint and broken panes of glass.
- The installation of the vinyl windows and aluminum wrap does not follow NPS guidelines for replacement windows. As stated on the [Replacement Windows that Meet the Standards](#), “When historic windows exist, they should be repaired when possible. When they are too deteriorated to repair, selection of the replacement windows must be guided by Standard 6. Design, visual qualities, and materials are specific criteria provided by the Standard that are pertinent to evaluating the match of a replacement window. Evaluating the adequacy of the match of the replacement window involves the consideration of multiple issues.” Specifically, referencing the factors to consider in evaluating the match of a window:

- The historic leaded glass, wood and steel casement windows are distinctive, character-defining features of the property. The historic leaded glass, wood windows are not documented to be beyond repair.
